## **CONTROLLED WATERS RISK ASSESSMENT FOR RESIDENTIAL DEVELOPMENT ON LAND AT WATER'S EDGE, WHITEHAVEN**

81900R13/MAY 2023

| REPORT TITLE | Controlled Waters Risk Assessment for Residential<br>Development on Land at Water’s Edge, Whitehaven | |

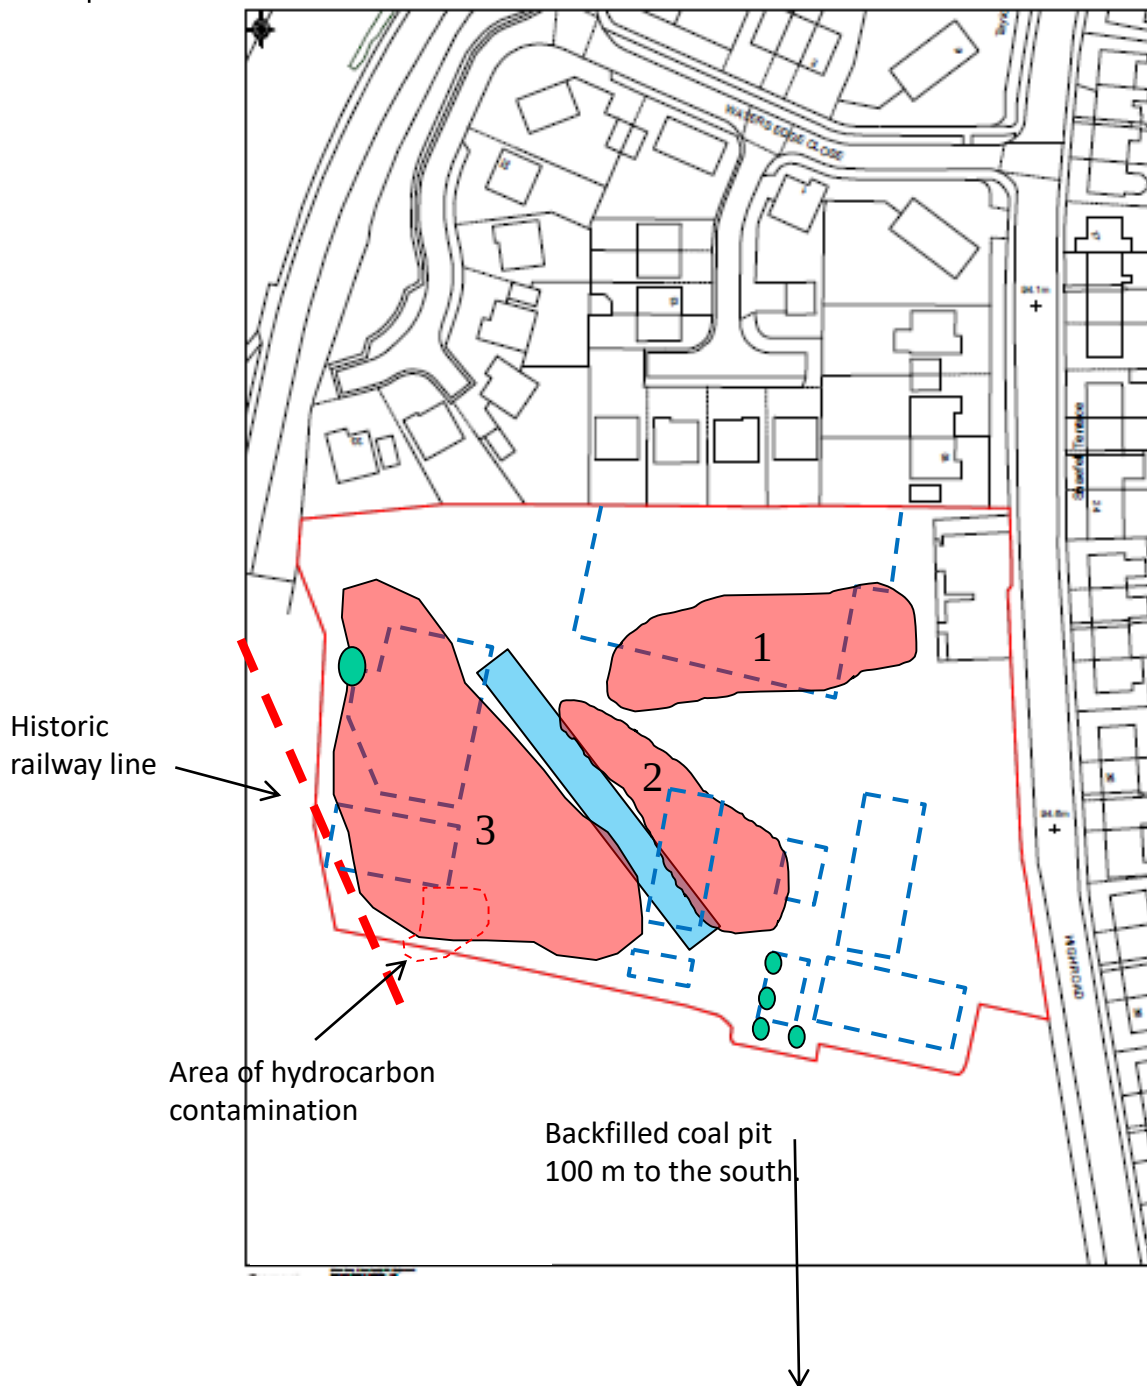
| <b>NOTES / KEY</b><br><div> <div>SITE LOCATION</div> <div>FOOTPRINT OF HISTORIC BUILDINGS</div> <div>DEMOLITION STOCKPILES</div> <div>WATERLOGGED GROUND</div> </div> | | | | <b>DRAWING TITLE</b><br>SITE FEATURES<br><br><b>PROJECT TITLE</b><br>WATER'S EDGE, WHITEHAVEN | <b>CLIENT</b><br>GLEESON HOMES CUMBRIA<br><br><b>STATUS</b><br>FINAL<br><br><b>DRAWN BY</b><br>GH<br><br><b>SCALE</b><br>NOT TO SCALE | <b>PROJECT NUMBER</b><br>8190<br><br><b>DATE</b><br>April 2019<br><br><b>DWG. No.</b><br>81900001Rev1 | <p> 1 Redwood Crescent,<br/> Office 1-8, Peel Park<br/> East Kilbride<br/> South Lanarkshire<br/> G74SPA<br/> <br/> Tel: 01355 207 778<br/> admin@fwsconsultants.com www.fwsconsultants.com </p> |
