# GEO-ENVIRONMENTAL SITE INVESTIGATION PROPOSED CARE HOME, COACH ROAD, WHITEHAVEN, CA28 9DF

REC REFERENCE: 45418P1R1

REPORT PREPARED FOR: MAPLE GROVE DEVELOPMENTS  
LTD

JUNE 2014

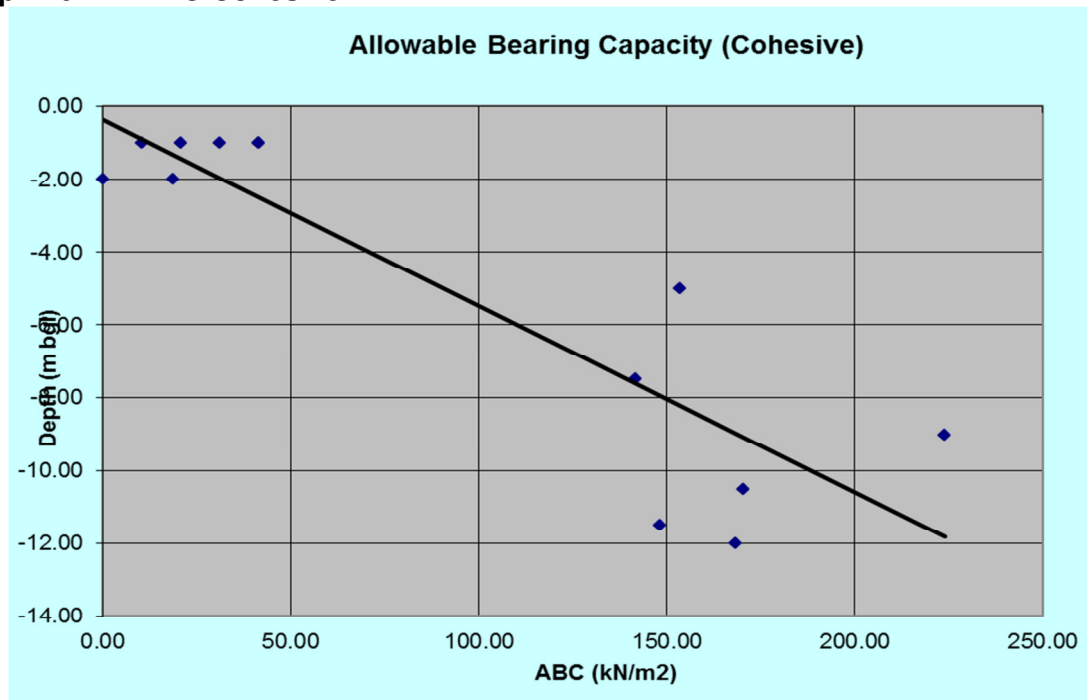
**Graph 10.1 ABC Cohesive**

Graph 10.1 shows that the shallow clay deposits across the site are generally of a low strength with an ABC less than 50kN/m<sup>2</sup> expected to depths of 2.0m bgl. The natural alluvial clay generally shows an increase in strength with depth.

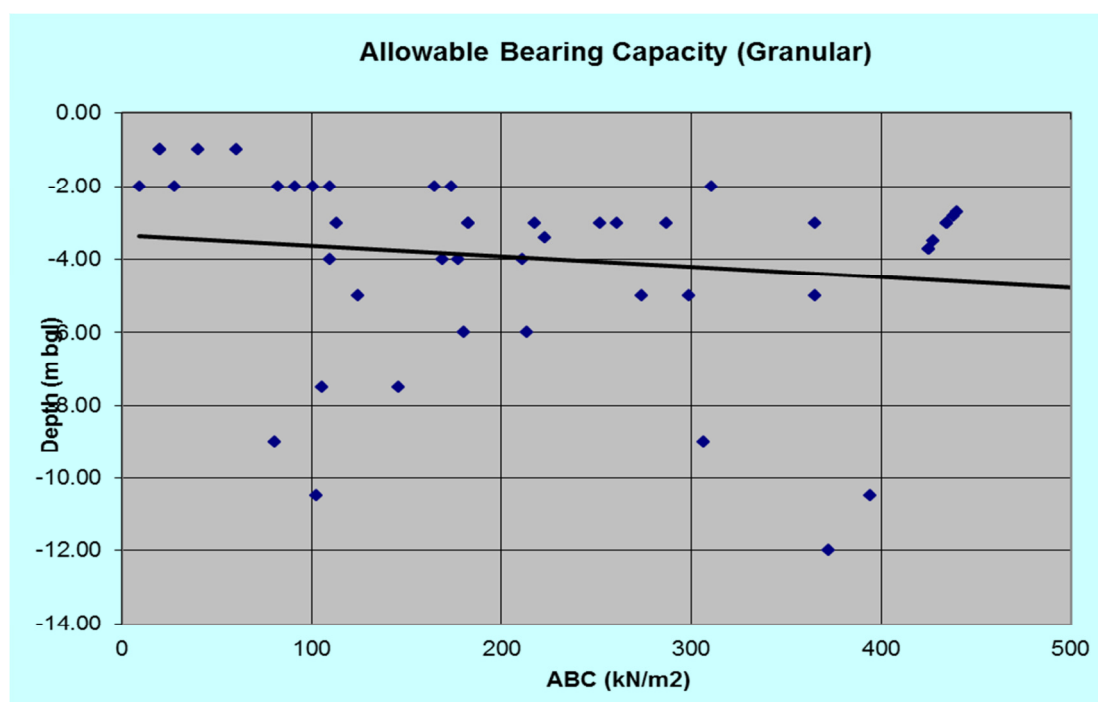
**Graph 10.2 ABC Granular**

Graph 10.2 shows that the shallow granular deposits across the site are generally of a loose density with an ABC less than  $50\text{kN/m}^2$  expected at a depth of 1.0m bgl increasing to  $80\text{kN/m}^2$  at a depth of 2.0m bgl. The natural sand generally shows an increase in density with depth to circa 4.0m bgl then the trend is one of reducing ABC with depth, likely due to the presence of groundwater from circa 4.0m bgl.

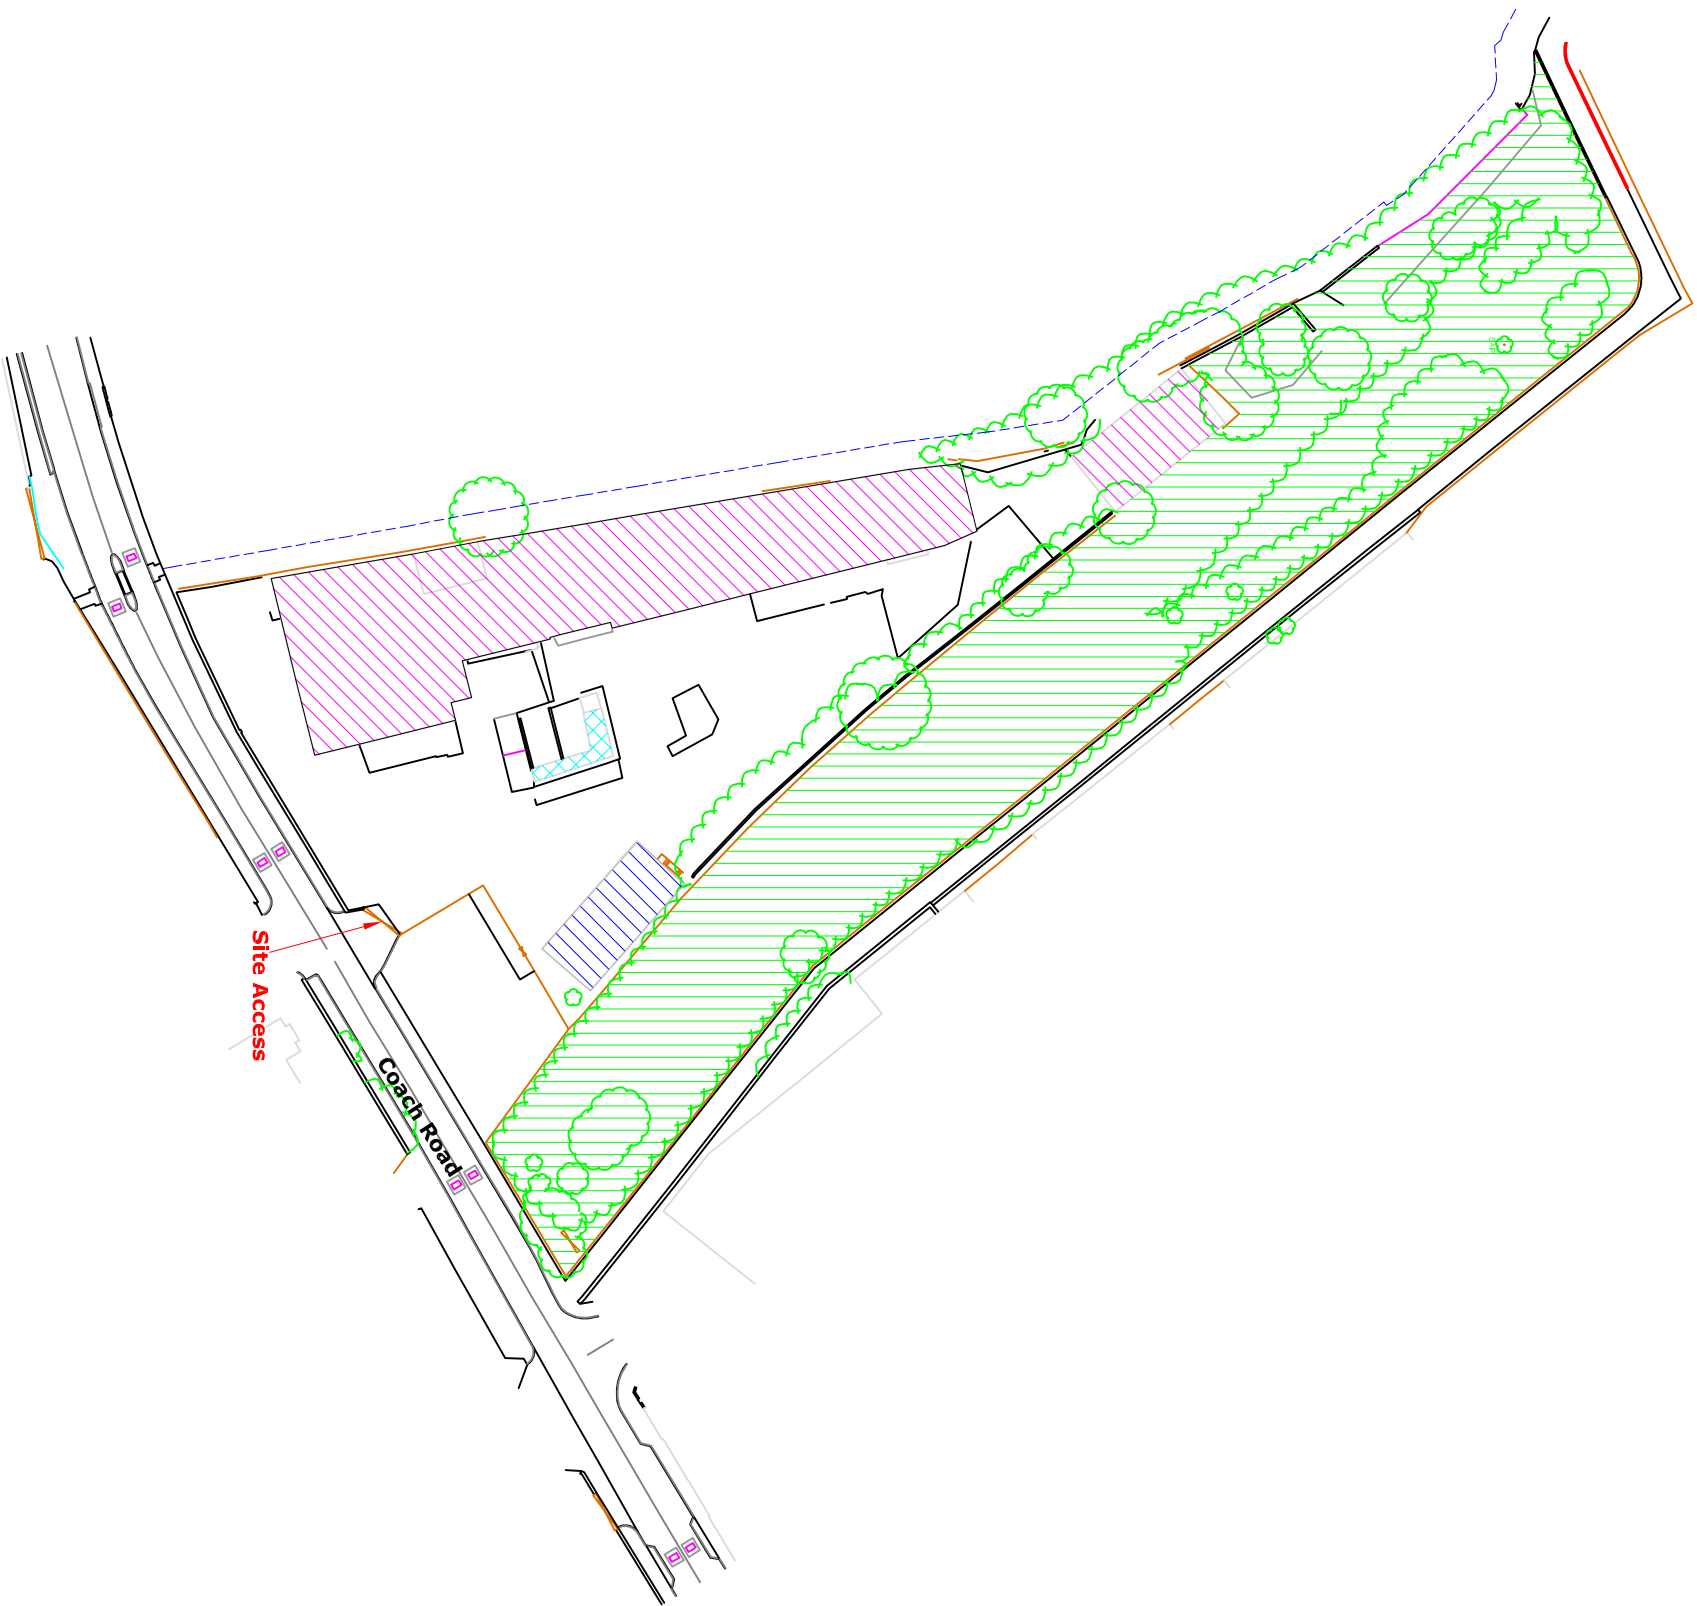
- Key:
- Inaccessible Due to Dense Vegetation
  - Existing Industrial Units
  - Former Office Block
  - Former Fuel Pumps
  - Pow Beck (Culverted)

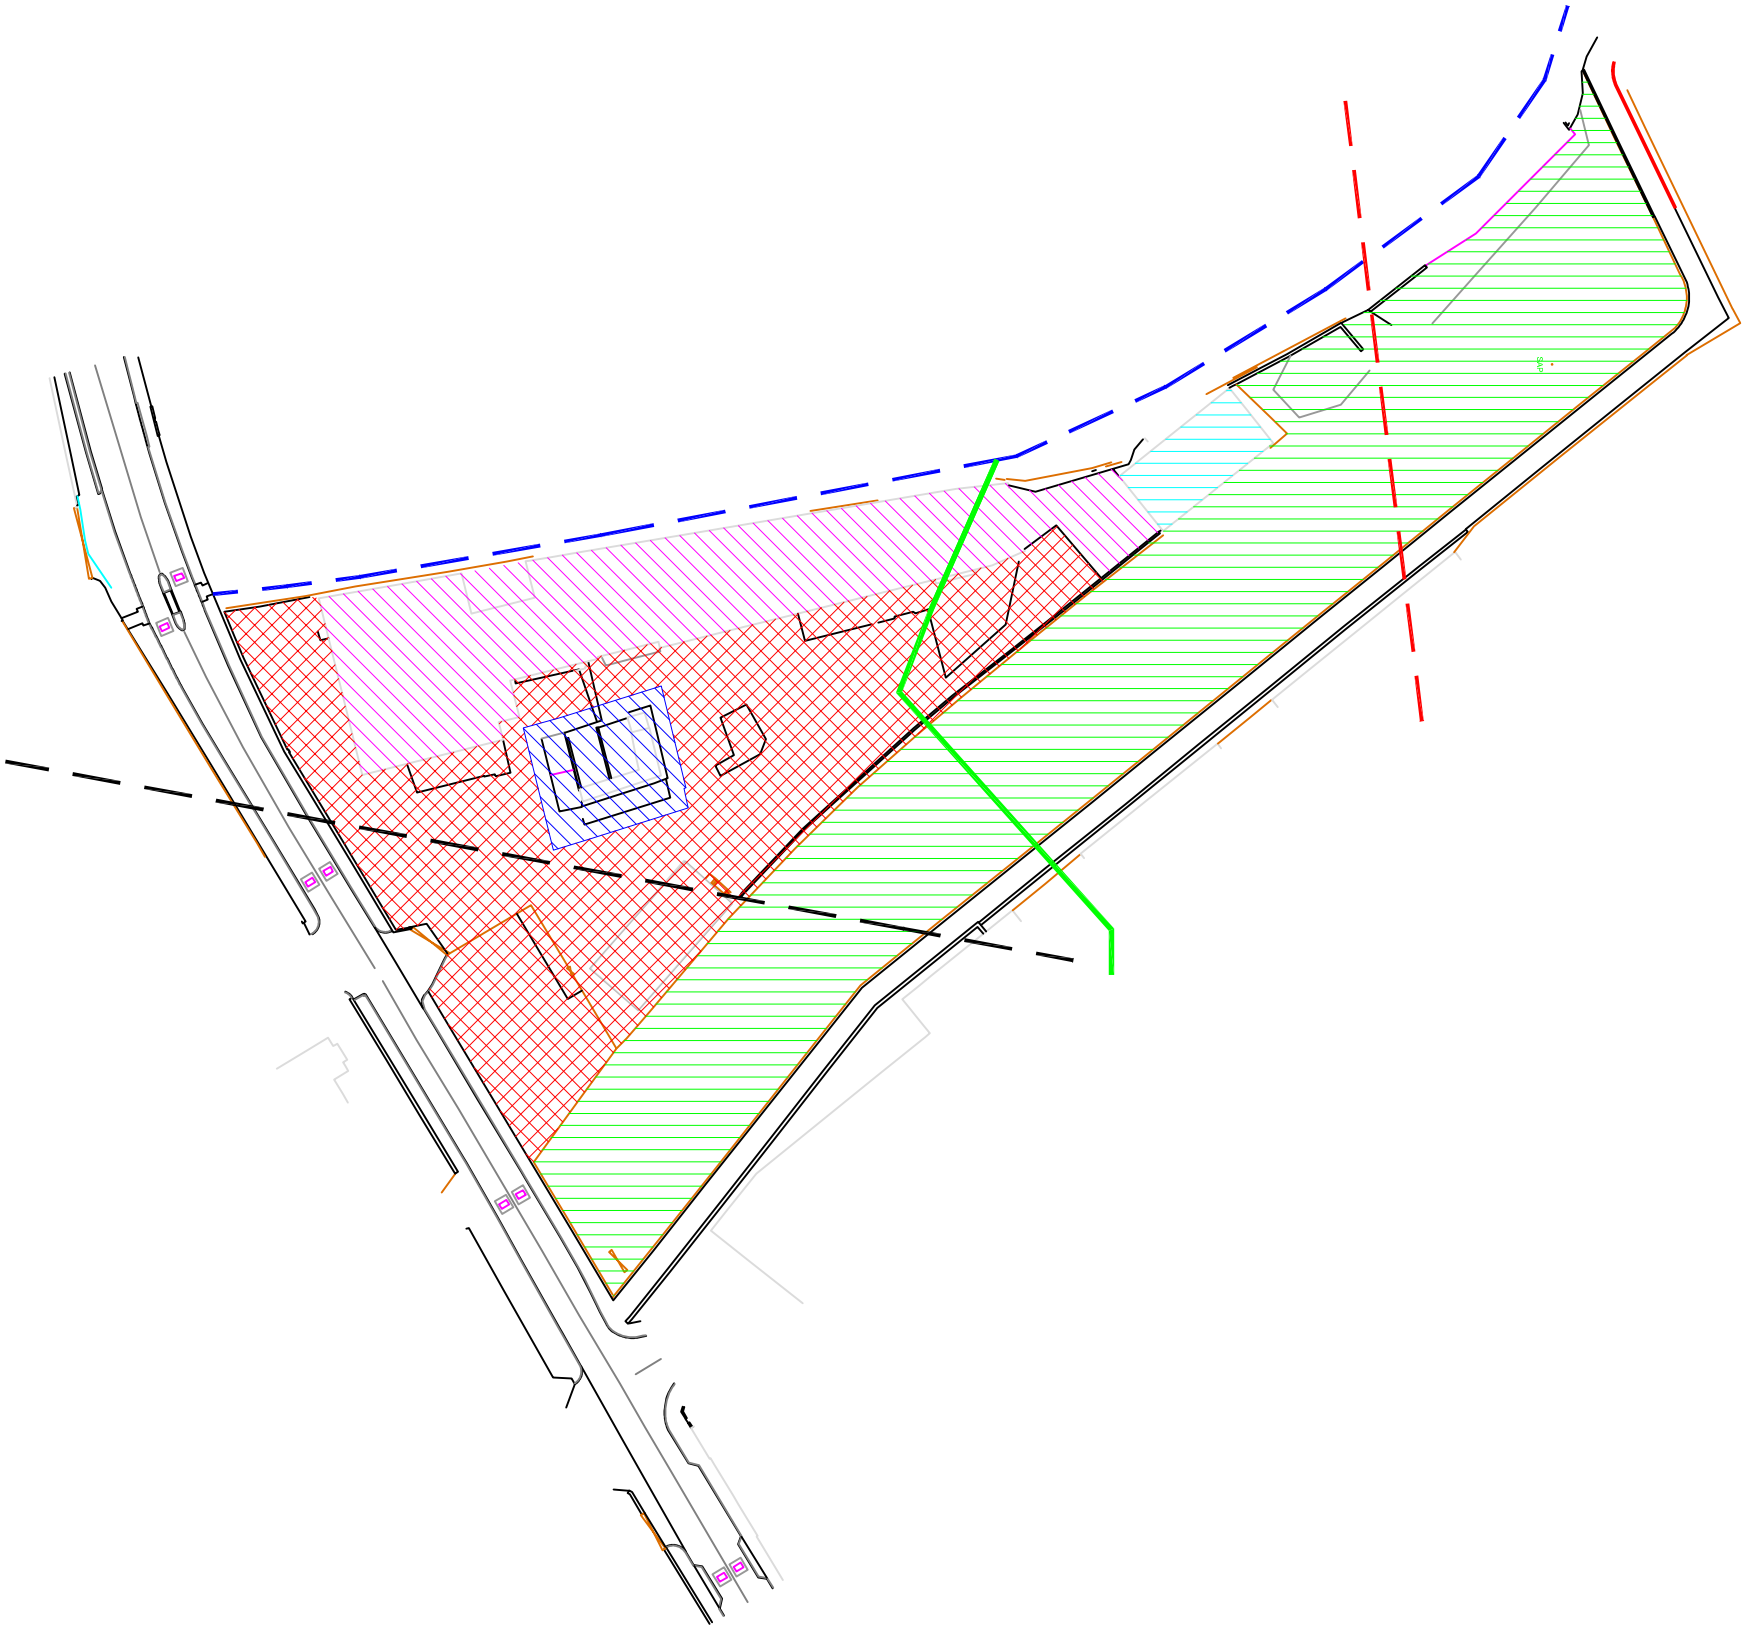
- Key:
- Former railway land & sidings, potential hydrocarbon, PAH & heavy metal contamination
  - Former boat builders, potential SVOCs, VOCs, PAH & hydrocarbon contamination
  - Location of underground fuel storage tanks, potential hydrocarbon contamination
  - Former garage, potential hydrocarbon contamination
  - Former timber yard, potential SVOCs, VOCs, PAH & heavy metal contamination
  - Surface Water Sewer
  - Pow Beck (Culverted)
  - Raven Hill Fault (Approximate location)
  - Main Seam Outcrop (Inferred) Up To 4m Thick

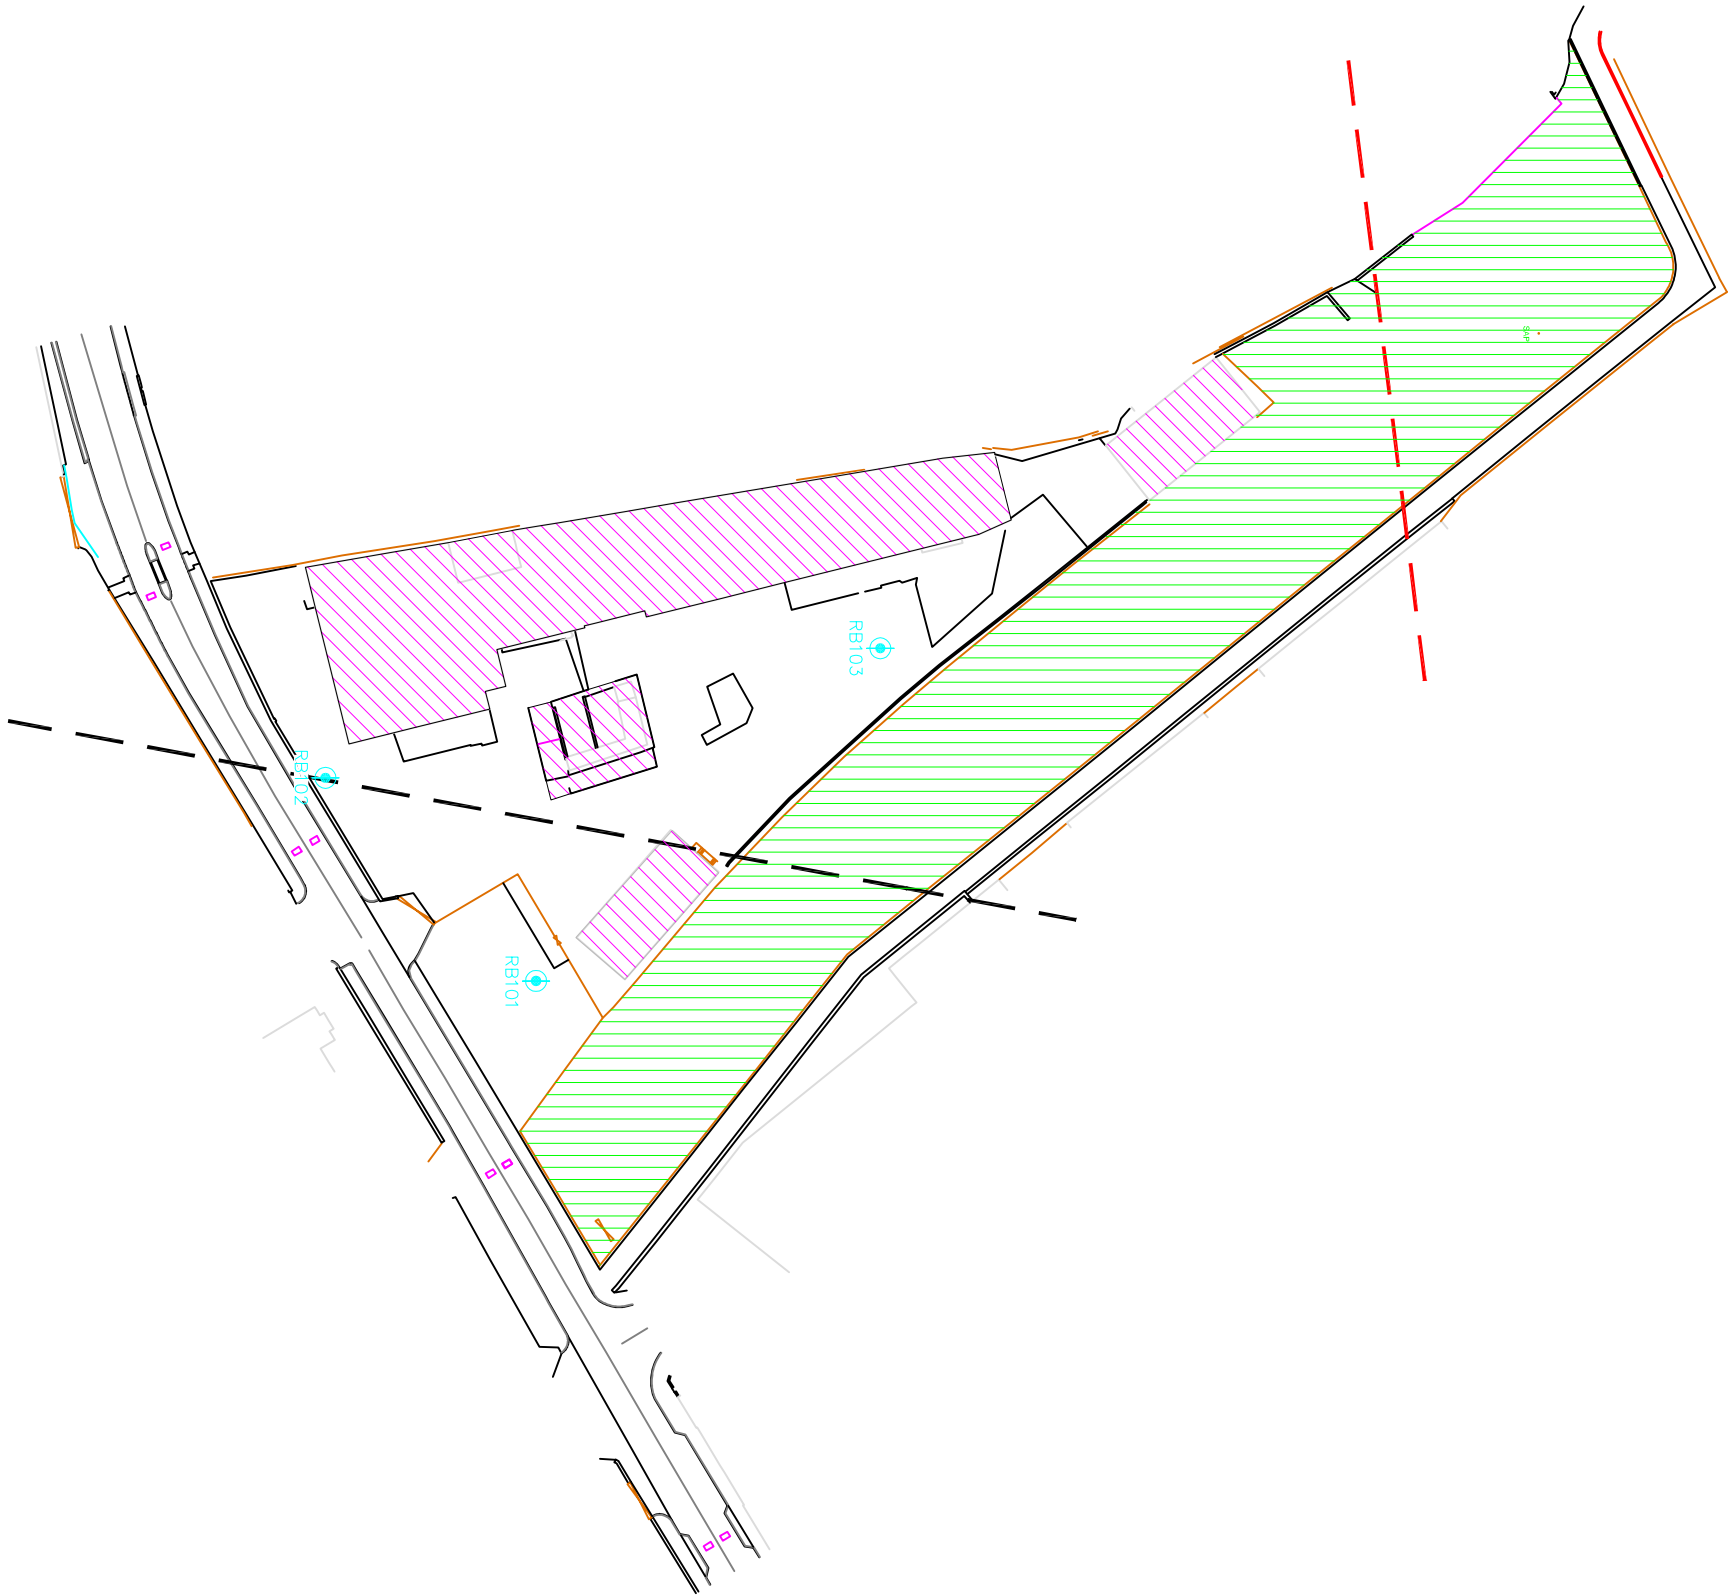
- Key:
- Raven Hill Fault (Approximate Location)
  - Main Seam Outcrop (Inferred) Up To 4m Thick
  - Inaccessible Due to Vegetation
  - Existing Buildings
  - RB1 Approximate Rotary Borehole Location

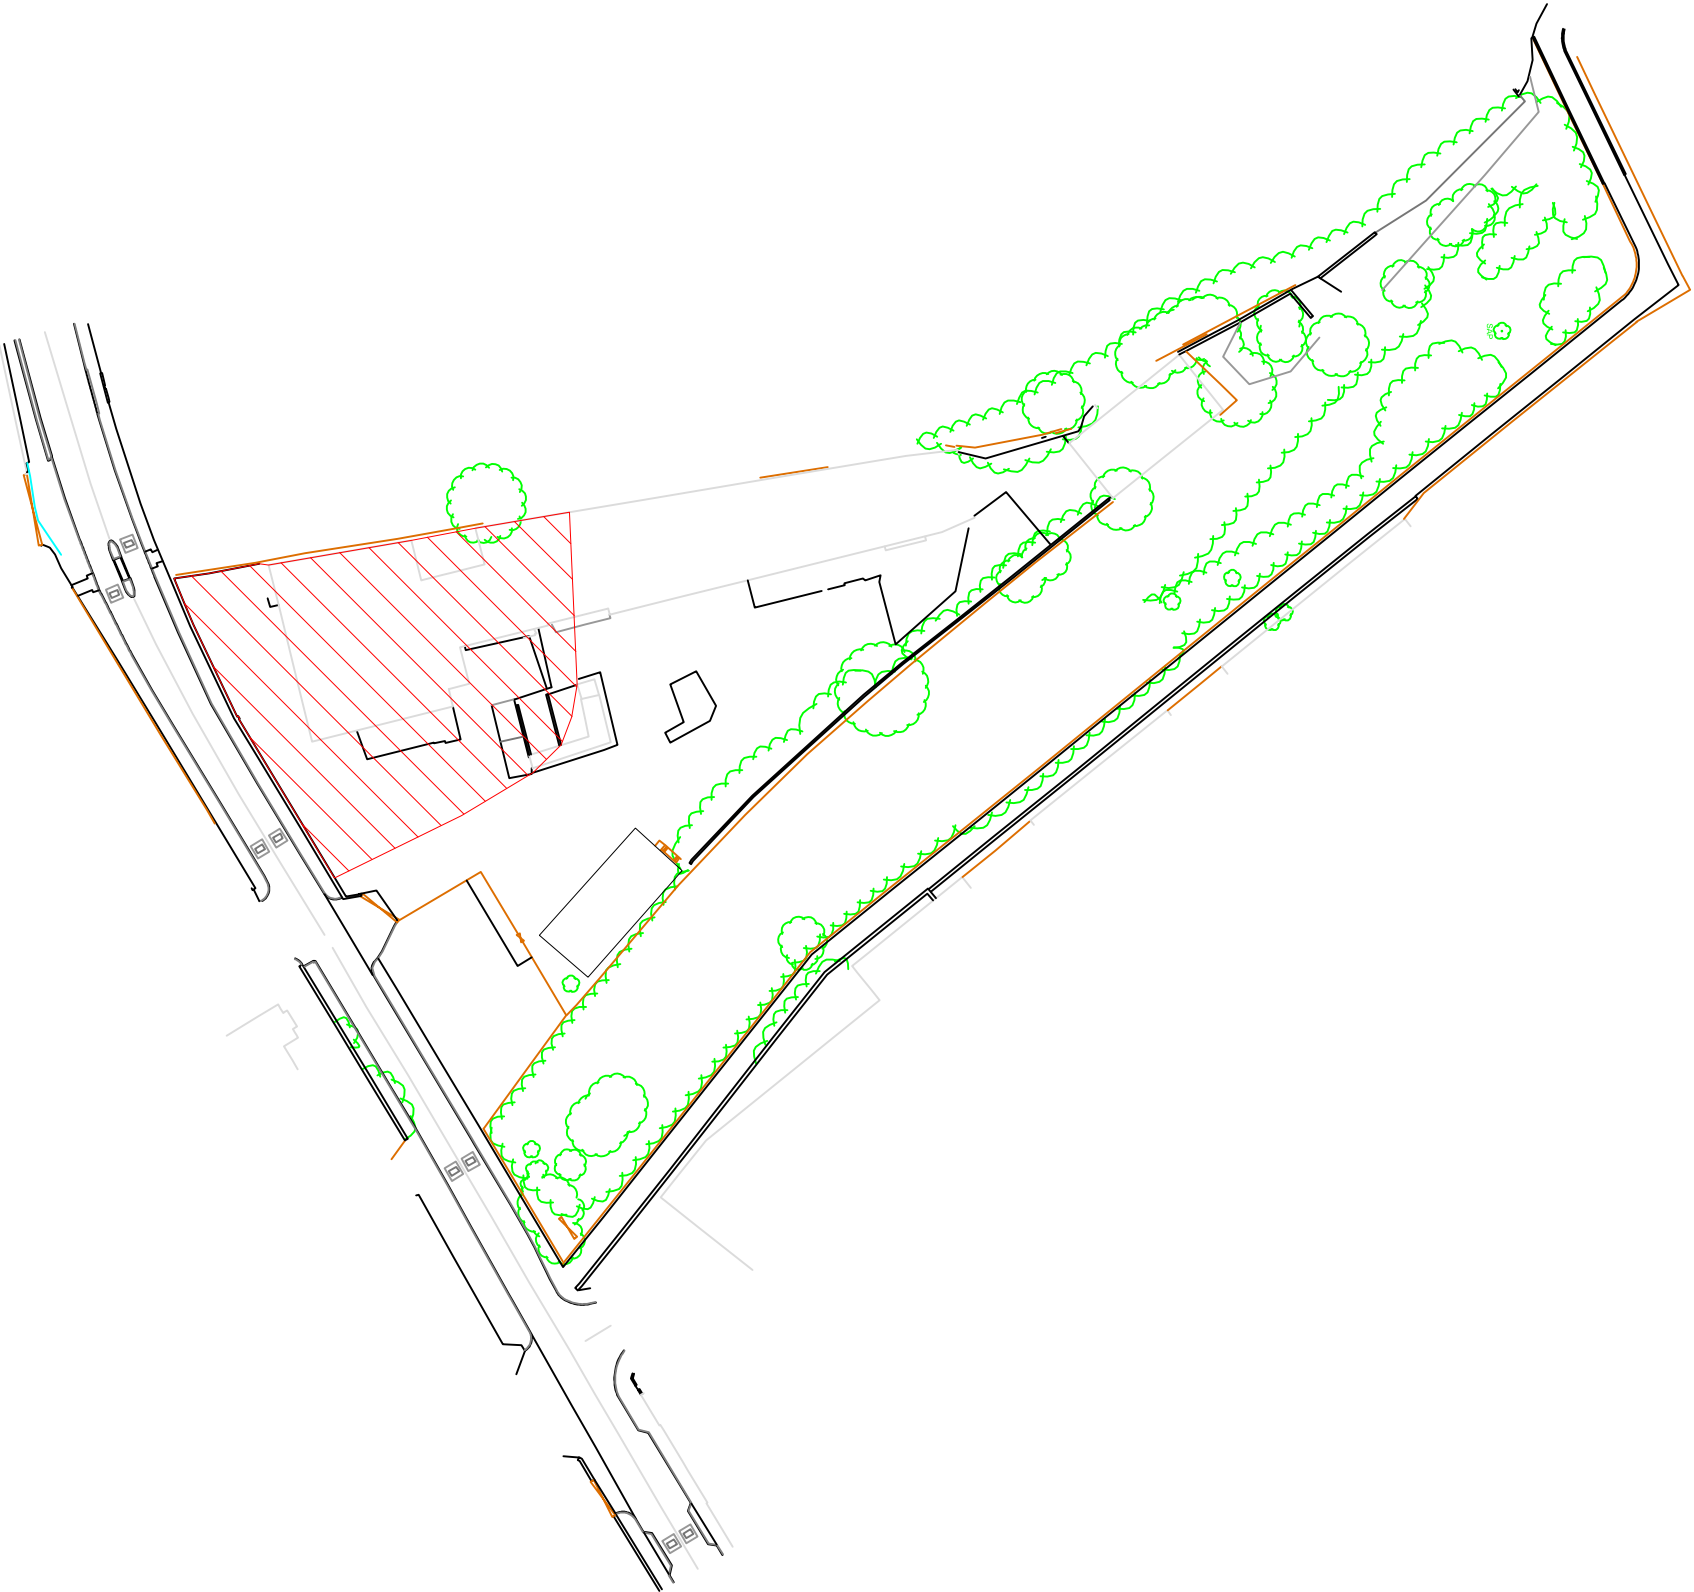
Methane concentration in excess of 5% v/v - CS3 gas protection measures required. Removal of source may reduce the level of protection required.

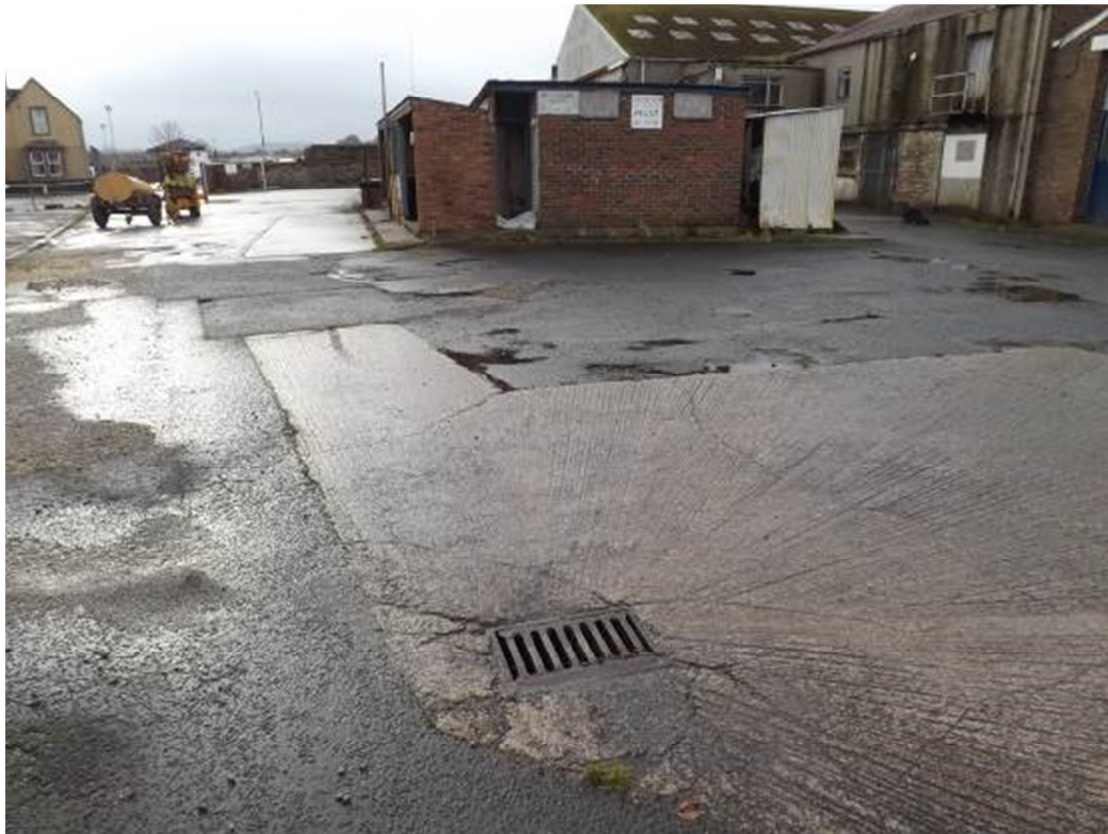
**PLATE 3 – EXISTING BUILDING CONTAINING FUEL PUMPS**

A site walkover has identified a brick-built structure in the centre of the site containing 2 fuel pumps (Plates 3 and 5) which was found to be in a poor state of repair. A manhole cover on the west side of the structure provides access to a potential underground storage tank (UST) (Plate 4). It was noted during the walkover that areas in the vicinity of the fuel pumps where the concrete surfacing has been previously disrupted and in turn re-concreted may indicate the location of further potential underground storage tanks. A low-rise brick bunded area to the rear of the fuel pumps may indicate the location of previous above ground storage tanks.

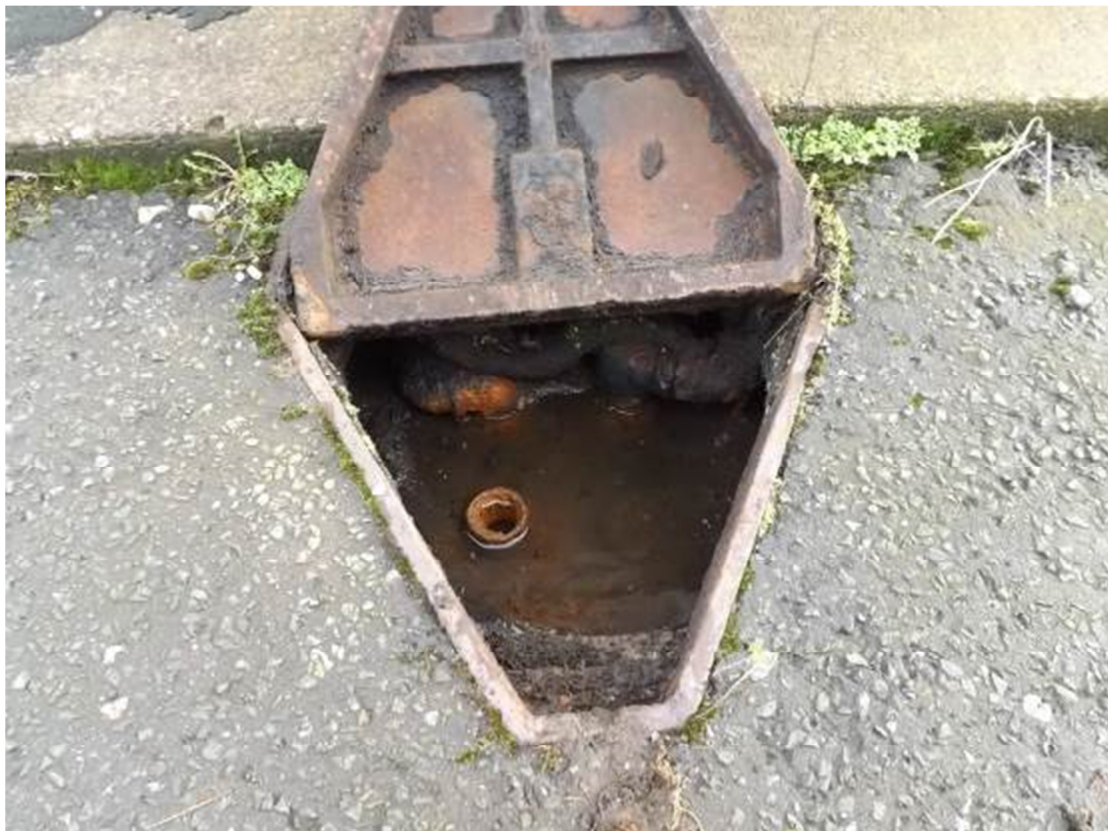
**PLATE 4 – MANHOLE COVER WITH ACCESS TO UST AT REAR OF FUEL PUMPS**

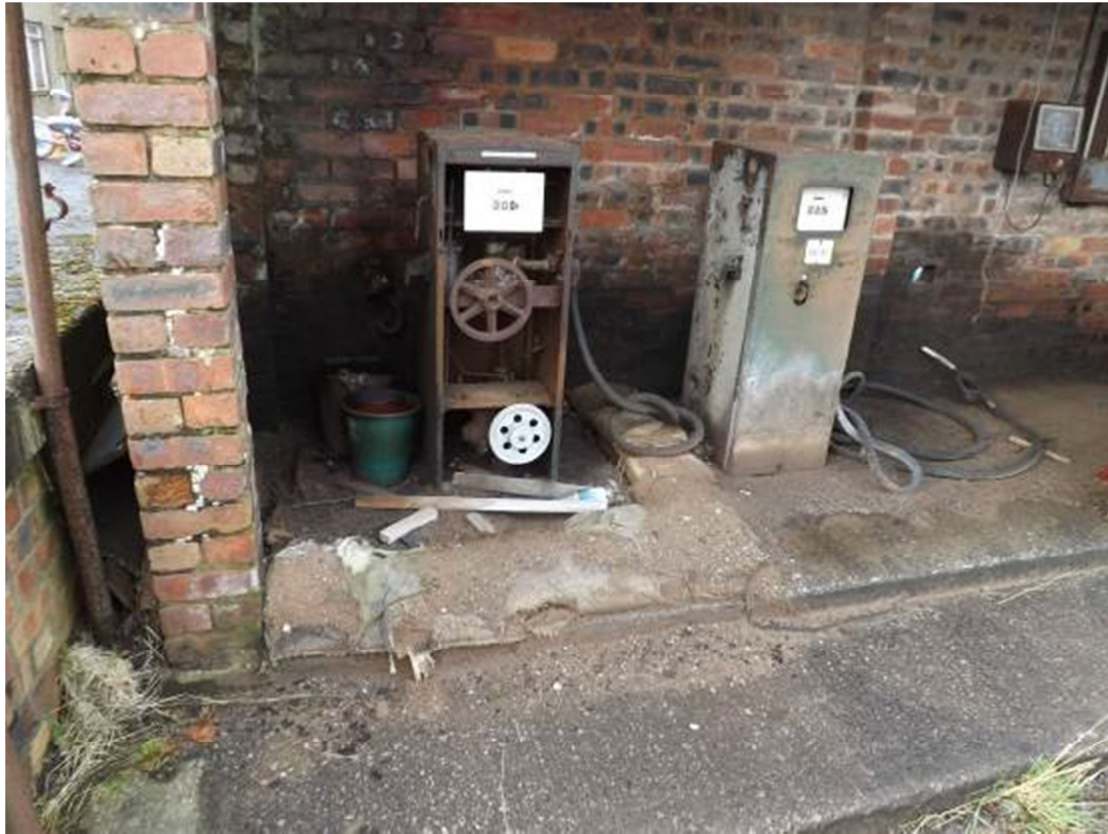
**PLATE 5 – FUEL PUMPS**

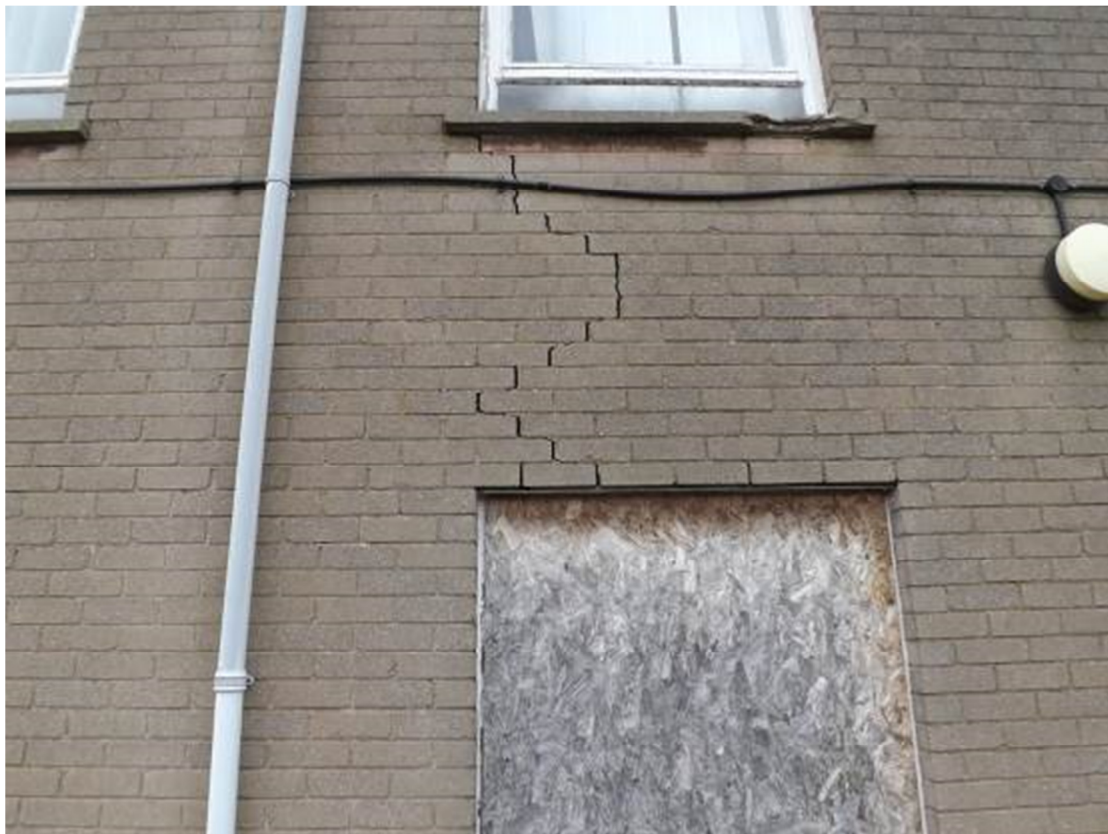
A visual inspection of the on-site buildings indicated a single crack in the external brickwork to the 2 storey office block propagating from the first storey down to ground level (Plate 6). No other external cracks were observed on any of the other buildings.

**PLATE 6 – VERTICAL CRACK TOP TO BOTTOM OF OFFICE BUILDING**

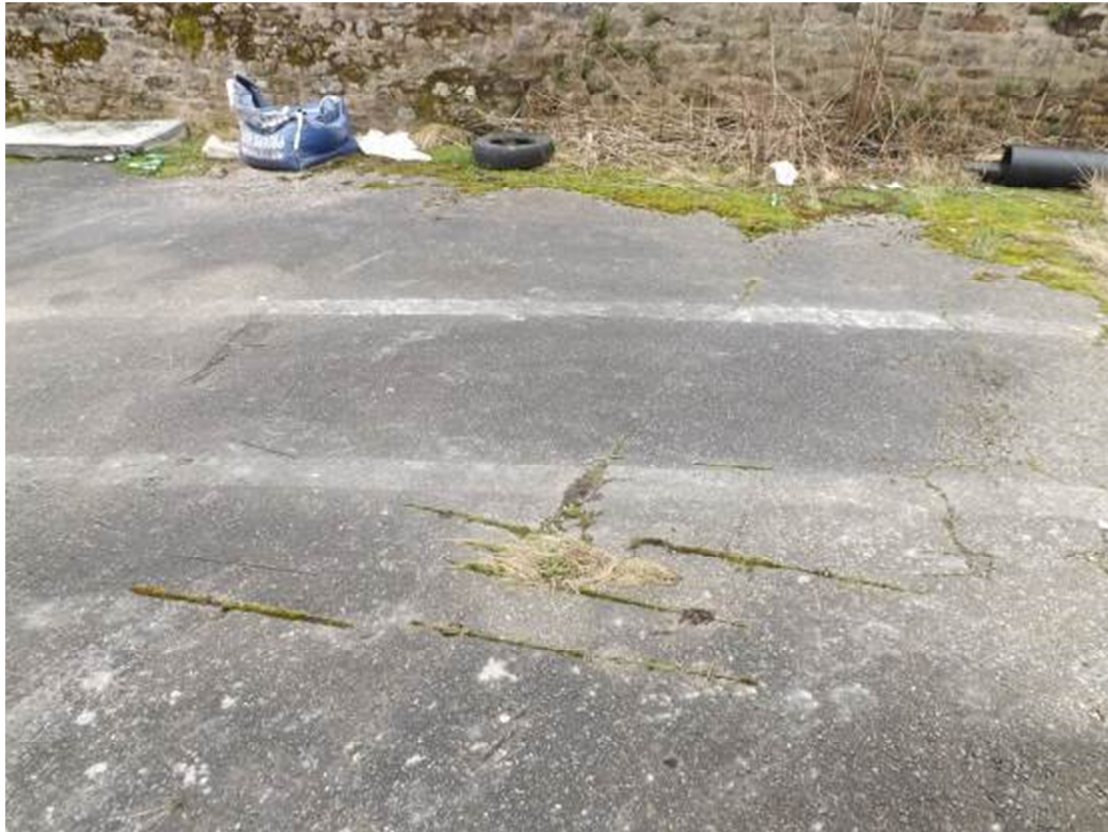
The majority of the central and western sections of the site are surfaced in concrete or asphalt hardstanding. The eastern and northern sections of the site are densely vegetated and were inaccessible during the site investigation. A slight disruption in the asphalt surface was observed to the south west of the commercial units (Plate 7).

**PLATE 7 – AREA OF SURFACE SUBSIDENCE IN SOUTHERN AREA OF SITE**

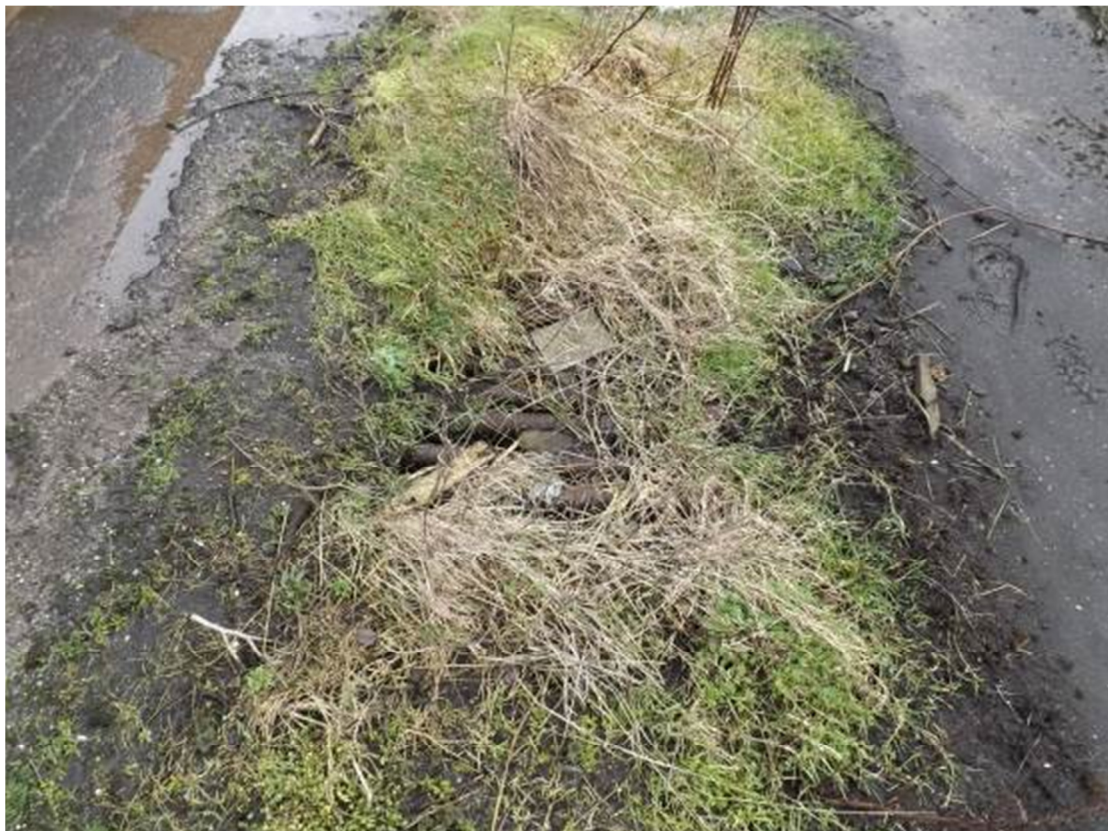
**PLATE 8 – DRAINAGE GRID/INTERCEPTOR IN SOUTHERN AREA OF SITE CLOSE TO CP103**
