## Technical Note

Subject: Calder Land Clearance - Sellafeld Bat Emergence Surveys

Atkins, member of SNC-Lavalin Group, was commissioned by Sellafield Ltd to undertake bat emergence surveys in connection with the proposed demolition of two ancillary buildings, as part of a scheme known as 'Calder Land Clearance' (hereafter referred to as the Proposed Scheme).

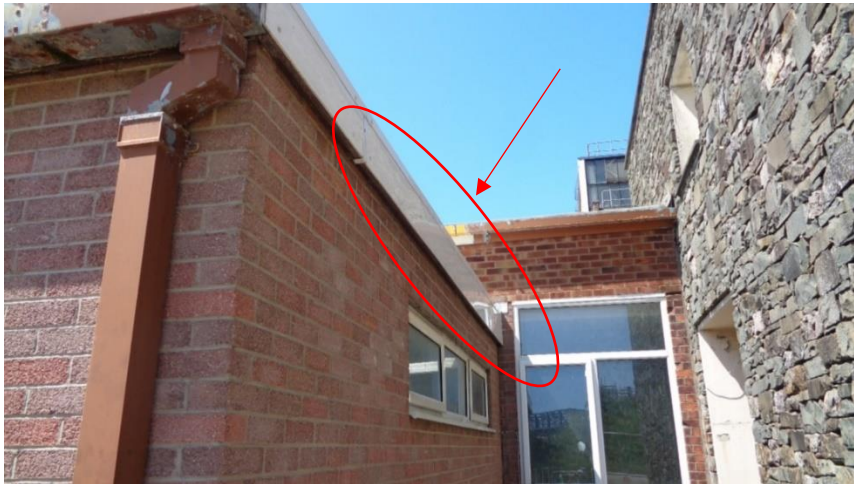
Bats were recorded emerging from building F4b during all three dusk emergence surveys completed. A peak count of 25 common pipistrelle bats were recorded emerging from the soffit boards of Building F4b (spanning two exit locations as shown by Photographs 3-1 and 3-2 below) on 24 May 2023. 23 common pipistrelles exited from the northern location and 2 common pipistrelles exited from the southern location.

Photograph 3-1: Exit location on the northern face of Building F4b

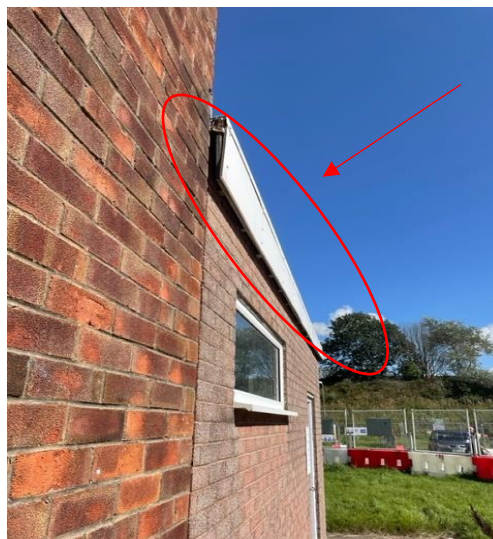
Photograph 3-2: Exit location on the southern face of Building F4b

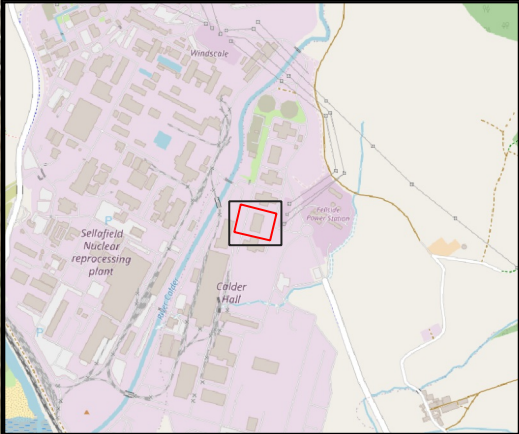
Figure number: C5b

Title: Survey Area
