# Cleator Moor Innovation Quarter

## BAT ROOST ASSESSMENT REPORT

784-B029668 Rev 2

Copeland Borough Council

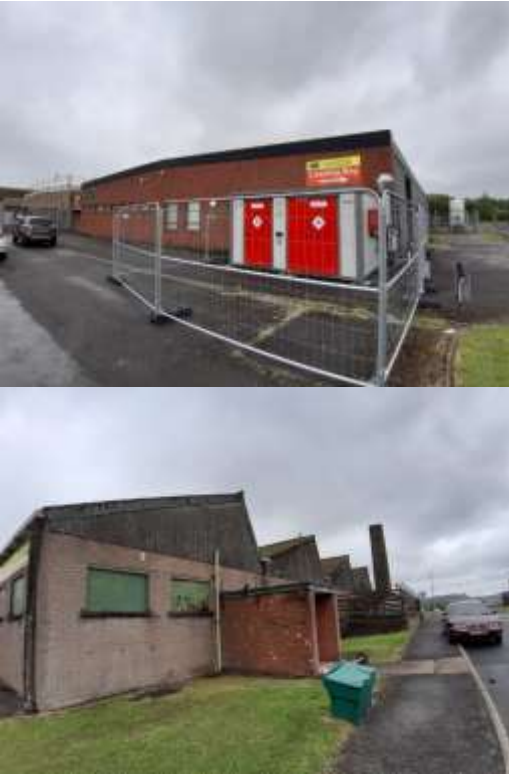
| Building | Description | Photographs |
|---|---|---|
| <b>Building B1</b> | <p>B1 comprised a large single storey industrial structure consisting of multiple sections / blocks. The walls were brick-built with exception of the north-east elevation of the northern block / warehouse which comprised of corrugated steel profile sheeting.</p> <p>The roof of the southern block had multiple double-pitched 'crest' covered with corrugated asbestos cement profile sheeting. The roofs of the three northern sections were flat with bitumen and steel finish.</p> <p>A number of features with potential to be used by roosting bats were identified within B1, these are shown and described in Appendix C.</p> <p>No bat droppings / signs of bat occupancy were noted on the exterior of B1.</p> <p><b>B1 was considered to offer low suitability for use by roosting bats during the active season but was unlikely to be suitable for use by maternity colonies or hibernating bats. Some sections of the building (including north-east elevation of the northern warehouse) were considered to be of negligible suitability for bats.</b></p> | |

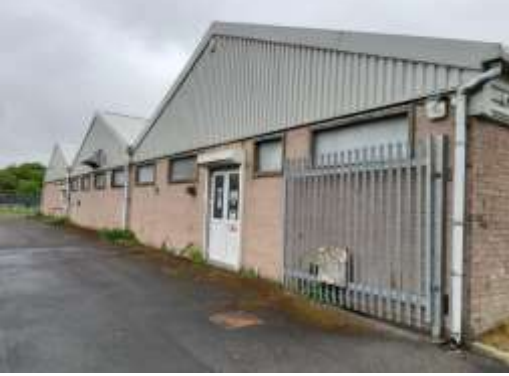
| Building | Description | Photographs |
|---|---|---|
| <b>Building B2</b> | <p>B2 comprised a large single storey brick building with a three-pitch corrugated steel roof. The building had PVC doors and windows along the southern and northern elevation and small flat roof lean-to along the eastern elevation.</p> <p>A number of features with potential to be used by roosting bats were identified within B2, these are shown and described in Appendix C.</p> <p>No bat droppings / signs of bat occupancy were noted on the exterior of B2.</p> <p><b>B2 was considered to offer low suitability for use by roosting bats</b></p> | |

| Building | Description | Photographs |
|---|---|---|
| | <p>during the active season but was unlikely to be suitable for use by maternity colonies or hibernating bats.</p> | |

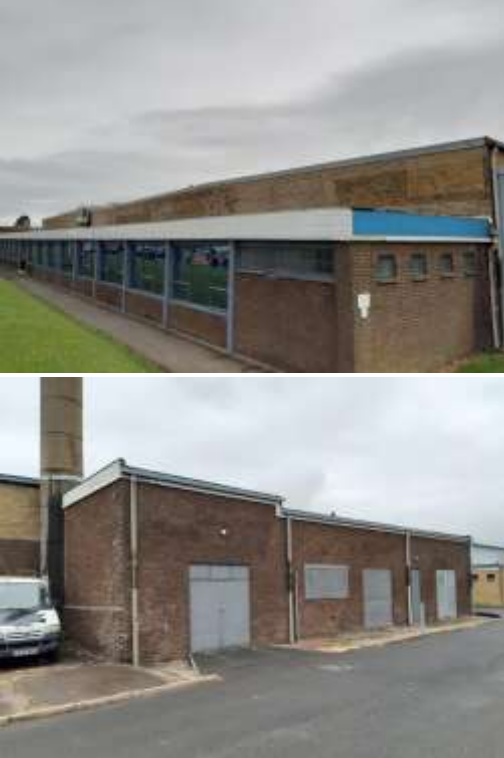
| Building | Description | Photographs |
|---|---|---|
| <b>Building B3</b> | <p>B3 comprised large warehouse building with brick walls and steel flat roof and corrugated steel panelling predominantly along the northern and western elevations.</p> <p>The building had several single-storey flat roof lean-to structures adjacent along all off the elevations; these comprised garages / warehouses with steel metal doors / window or office blocks with PVC doors and windows. The windows along the northern elevations were boarded at the exterior.</p> <p>A number of features with potential to be used by roosting bats were identified within B3, these are shown and described in Appendix C.</p> <p>No bat droppings / signs of bat occupancy were noted on the exterior of B3.</p> <p><b>B3 was considered to offer low suitability for use by roosting bats during the active season but was unlikely to be suitable for use by maternity colonies or hibernating bats.</b></p> | |

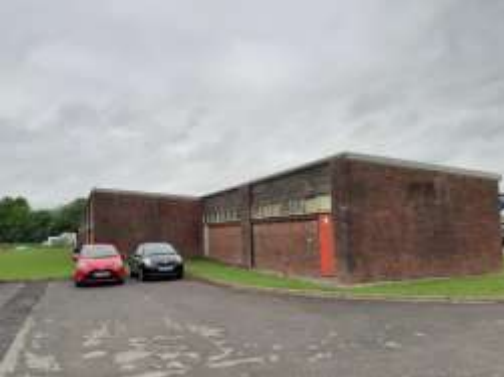
| Building | Description | Photographs |
|---|---|---|
| <b>Building B4</b> | <p>B4 comprised a single-story brick building with a slight single pitch facing north. The upper section of the southern elevation had wood panelling above the row of single-glazed windows with timber frames. The northern elevation comprised several steel garage doors with steel shutters covering doors and windows.</p> <p>A number of features with potential to be used by roosting bats were identified within B4, these are shown and described in Appendix C.</p> <p>No bat droppings / signs of bat occupancy were noted on the exterior of B4.</p> | |

| Building | Description | Photographs |
|---|---|---|
| | <p><b>B4 was considered to offer low suitability for use by roosting bats during the active season but was unlikely to be suitable for use by maternity colonies or hibernating bats.</b></p> | |

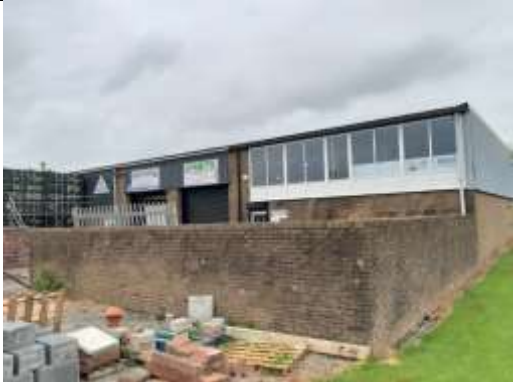
| Building | Description | Photographs |
|---|---|---|
| <p><b>Building B5</b></p> | <p>B5 comprised a single-storey brick building with flat roof and corrugated steel panelling along the top external walls (most elevations). Along the southern elevation, several large steel garage doors were present large single-glazed windows were located along the upper section of the elevation (interlaced with the steel panelling).</p> <p>Two corrugated steel lean-to structures adjoined the B5 along the southern elevation.</p> <p>Few features with potential to be used by roosting bats were identified within B5, these are shown and described in Appendix C.</p> <p>No bat droppings / signs of bat occupancy were noted on the exterior of B5.</p> <p><b>B5 was considered to offer low suitability for use by roosting bats during the active season but was unlikely to be suitable for use by maternity colonies or hibernating bats.</b></p> | |

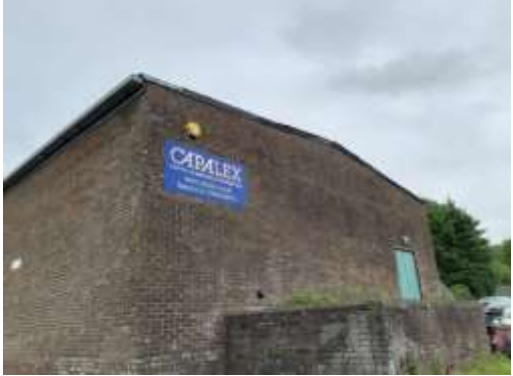
| Building | Description | Photographs |
|---|---|---|
| <p><b>Building B6</b></p> | <p>B6 comprised a tall brick-built building with a slight double pitched roof covered with finished with bitumen. The building had large steel garage door along the western elevation and smaller (regular size) doors along the southern, western and northern elevations. There was a small storey brick structures adjoining B6 along the north-east elevation; this was linked with B6 through the open walk-trough section with concrete roof.</p> <p>A number of features with potential to be used by roosting bats were identified within B6, these are shown and described in Appendix C.</p> | |

| Building | Description | Photographs |
|---|---|---|
| | <p>No bat droppings / signs of bat occupancy were noted on the exterior of B6.</p> <p><b>B6 was considered to offer low suitability for use by roosting bats during the active season but was unlikely to be suitable for use by maternity colonies or hibernating bats.</b></p> | |

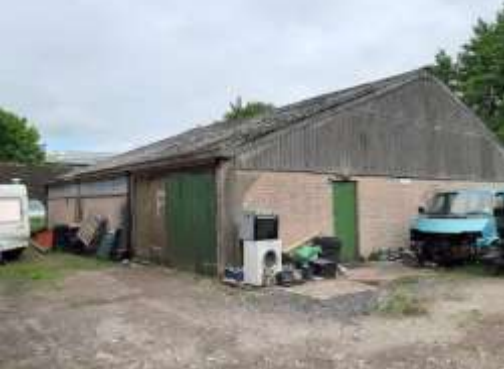
| Building | Description | Photographs |
|---|---|---|
| <b>Building B7</b> | <p>B7 comprised a brick-based building / garage with a corrugated profiled asbestos cement roof . The building appeared to have a concrete frame and some steel panelling along the western elevation.</p> <p>A number of features with potential to be used by roosting bats were identified within B7, these are shown and described in Appendix C.</p> <p>No bat droppings / signs of bat occupancy were noted on the exterior of B7.</p> <p><b>B7 was considered to offer low suitability for use by roosting bats during the active season but was unlikely to be suitable for use by maternity colonies or hibernating bats.</b></p> | |

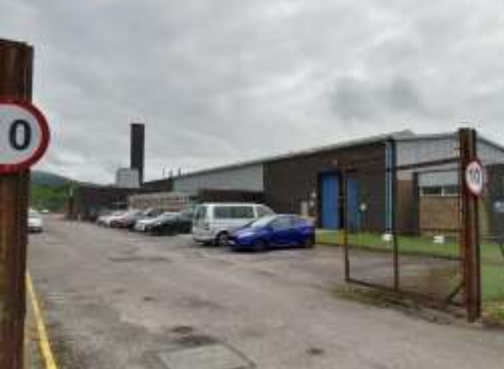
| Building | Description | Photographs |
|---|---|---|
| <b>Building B8</b> | <p>Comprised a large warehouse building with brick-build walls and mixture of corrugated steel and glass roof covering.</p> <p>There was a single storey brick-build and flat roof office extension along the eastern elevation of B8 and two brick-built flat roof lean-to structures along the northern elevation. Corrugated steel and glass warehouse extension were adjacent along the eastern elevation.</p> <p>A number of features with potential to be used by roosting bats were identified within B8, these are shown and described in Appendix C.</p> <p>No bat droppings / signs of bat occupancy were noted on the exterior of B8.</p> | |

| Building | Description | Photographs |
|---|---|---|
| | <p>B8 was considered to offer low suitability for use by roosting bats during the active season but was unlikely to be suitable for use by maternity colonies or hibernating bats.</p> | |

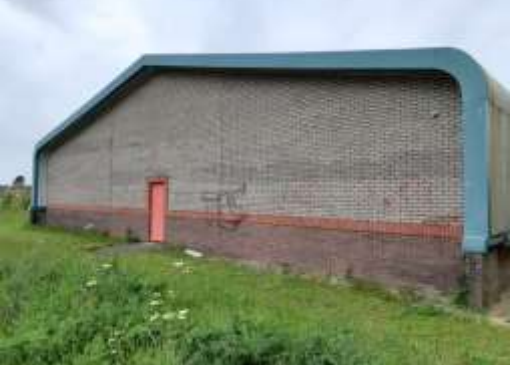
| Building | Description | Photographs |
|---|---|---|
| <b>Building B9</b> | <p>B9 comprised a brick-based structure with a corrugated metal roof / frame overlapping south and north elevations.</p> <p>Few features with potential to be used by roosting bats were identified within B9, these are shown and described in Appendix C.</p> <p>No bat droppings / signs of bat occupancy were noted on the exterior of B9.</p> <p><b>B9 was considered to offer low suitability for use by roosting bats during the active season but was unlikely to be suitable for use by maternity colonies or hibernating bats.</b></p> | |

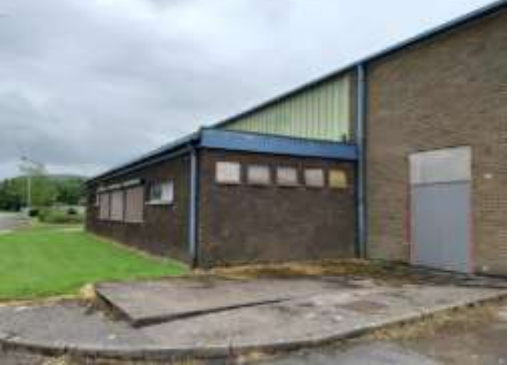
| Building | Description | Photographs |
|---|---|---|
| <b>Building B10</b> | <p>B10 comprised a tall, brick-built garage with a flat roof. The southern and eastern elevation comprised predominantly of a profiled steel panels / frame. Two single-storey flat roof extension were adjacent along the northern and western elevation of B10.</p> <p>A number of features with potential to be used by roosting bats were identified within B10, these are shown and described in Appendix C.</p> <p>No bat droppings / signs of bat occupancy were noted on the exterior of B10.</p> <p><b>B10 was considered to offer low suitability for use by roosting bats during the active season but was unlikely to be suitable for use by maternity colonies or hibernating bats. The building is unlikely to be suitable for use hibernating bats.</b></p> | |

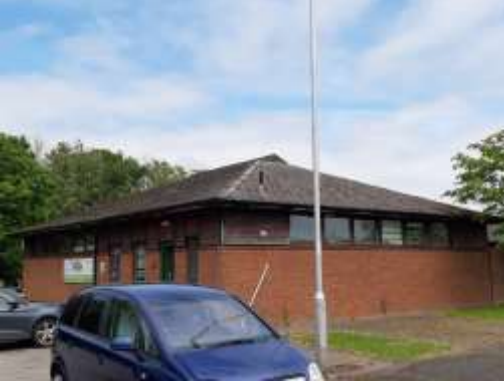
| Building | Description | Photographs |
|---|---|---|
| <b>Building B11</b> | <p>Comprised brick-built nursery building with tiled hip roof . The building was single storey with wooden cladding along the upper elevations. The roof appeared to have an internal roof space and long wooden soffits along all elevations.</p> <p>A number of features with potential to be used by roosting bats were identified within B101, these are shown and described in Appendix C.</p> <p>No bat droppings / signs of bat occupancy were noted on the exterior of B11.</p> <p><b>B11 was considered to offer moderate suitability for use by roosting bats during the active season with potential suitability for maternity roosts within the roof area. The building is unlikely to be suitable for use hibernating bats.</b></p> | |

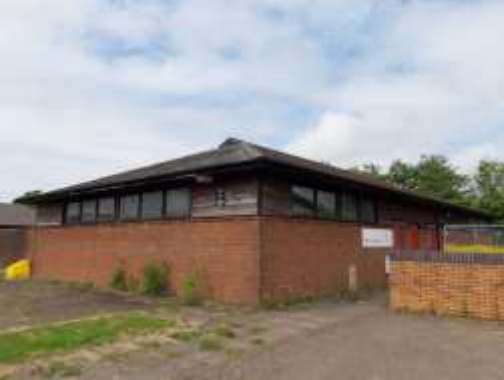
| Building | Description | Photographs |
|---|---|---|
| <b>Building B12</b> | <p>Comprised brick-built office building with tiled hip roof . The structure of the B12 was very similar to B11 with the exception that B12 was several meters longer.</p> <p>A number of features with potential to be used by roosting bats were identified within B12, these are shown and described in Appendix C.</p> <p>No bat droppings / signs of bat occupancy were noted on the exterior of B12.</p> <p><b>B12 was considered to offer moderate suitability for use by roosting bats during the active season with potential suitability for maternity roosts within the roof area. The building is unlikely to be suitable for use hibernating bats.</b></p> | |

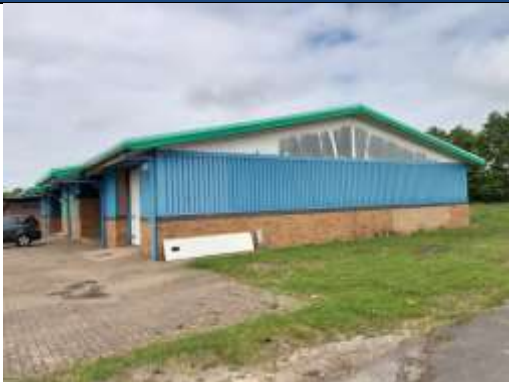
| Building | Description | Photographs |
|---|---|---|
| <b>Building B13</b> | <p>B13 comprised a warehouse building brick-built base and double pitched steel roof and steel wall cladding.</p> <p><b>The exterior of B13 was considered to offer negligible suitability for use by roosting bats.</b> However, since there was no access to the interior, it was not possible to completely rule out likelihood of bats using the internal area of the building therefore it was upgraded to low suitability so that this limitation could be addressed through nocturnal survey</p> | |

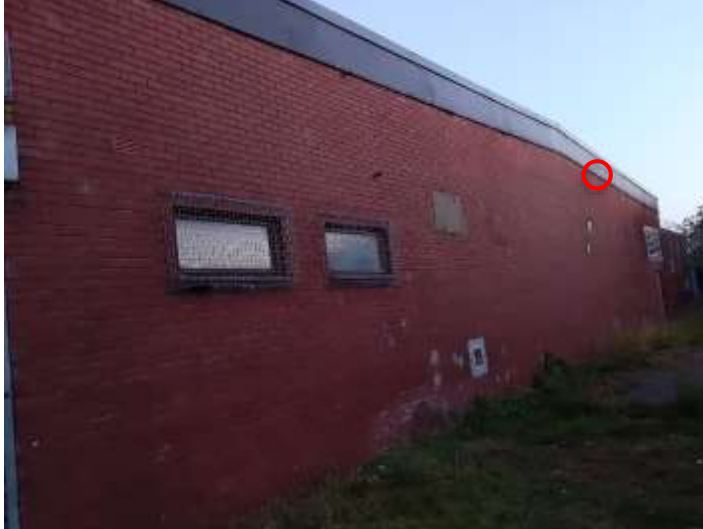
Photograph 1 – Roost 1, Building B1

During the dusk emergence survey, a single common pipistrelle bat was observed emerging from the gap behind the PVC fascia along western elevation of B1 at 22:08, 36 minutes after sunset. (See Figure 3 – Roost R1 and Photograph 1 below).

Moderate common pipistrelle activity involving between one and three bats was observed along the western elevation throughout the survey.

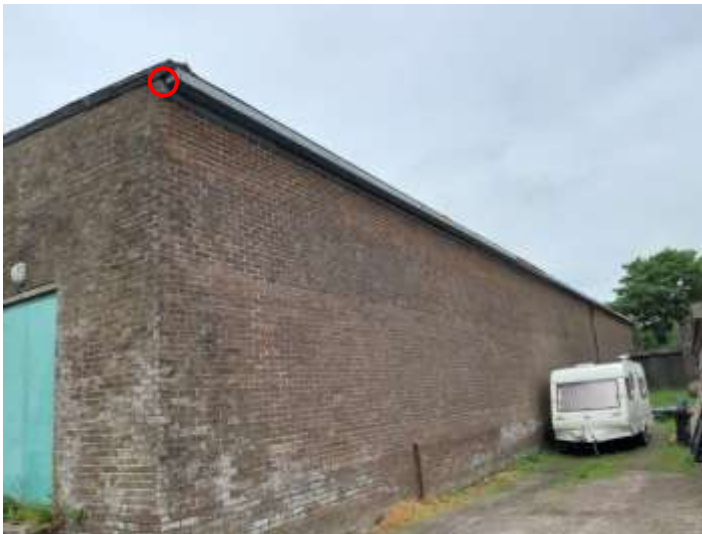
Photograph 2 – Roost 2, Building B6

During the dusk emergence survey, a single common pipistrelle bat was observed emerging from the gap between the brick wall top and the wooden fascia / bitumen roof overlap on the southern corner of B6 at 21:42, (22 minutes after sunset. (See Figure 3, Roost R2 and Photograph 15 below).

Moderate to low common pipistrelle and soprano pipistrelle activity was observed throughout the survey with majority for the activity concentrated east and north of the building (near the young woodland W4).

| Contents | Summary |
|---|---|
| <b>Recommendations</b> | <p>An EPSML must be obtained from Natural England prior to commence of development works at B6. This can be a standard EPSML or site registration under the BMCL.</p> <p>The EPSML can only be gained once full planning consent has been granted and will place reasonable conditions on the development to ensure that no bats are killed / injured during works and that the favourable conservation status of the species present is maintained.</p> <p>An outline mitigation strategy for works has been provided as part of this report; it is proposed that the roost R2 will be replaced with 2 no. bat boxes. Full details of the mitigation strategy will be provided within the EPSML method statement / BMCL site registration form &amp; class licence, and in consultation with the consultants/contractors appointed to undertake the proposed works.</p> <p>No active bat roosts were identified within building B4, B7 B11, B12 and B13 during bat emergence and re-entry surveys. No further survey, licensing or mitigation is required for roosting bats and works can proceed to these buildings without the risk of causing an offence under relevant wildlife legislation.</p> |

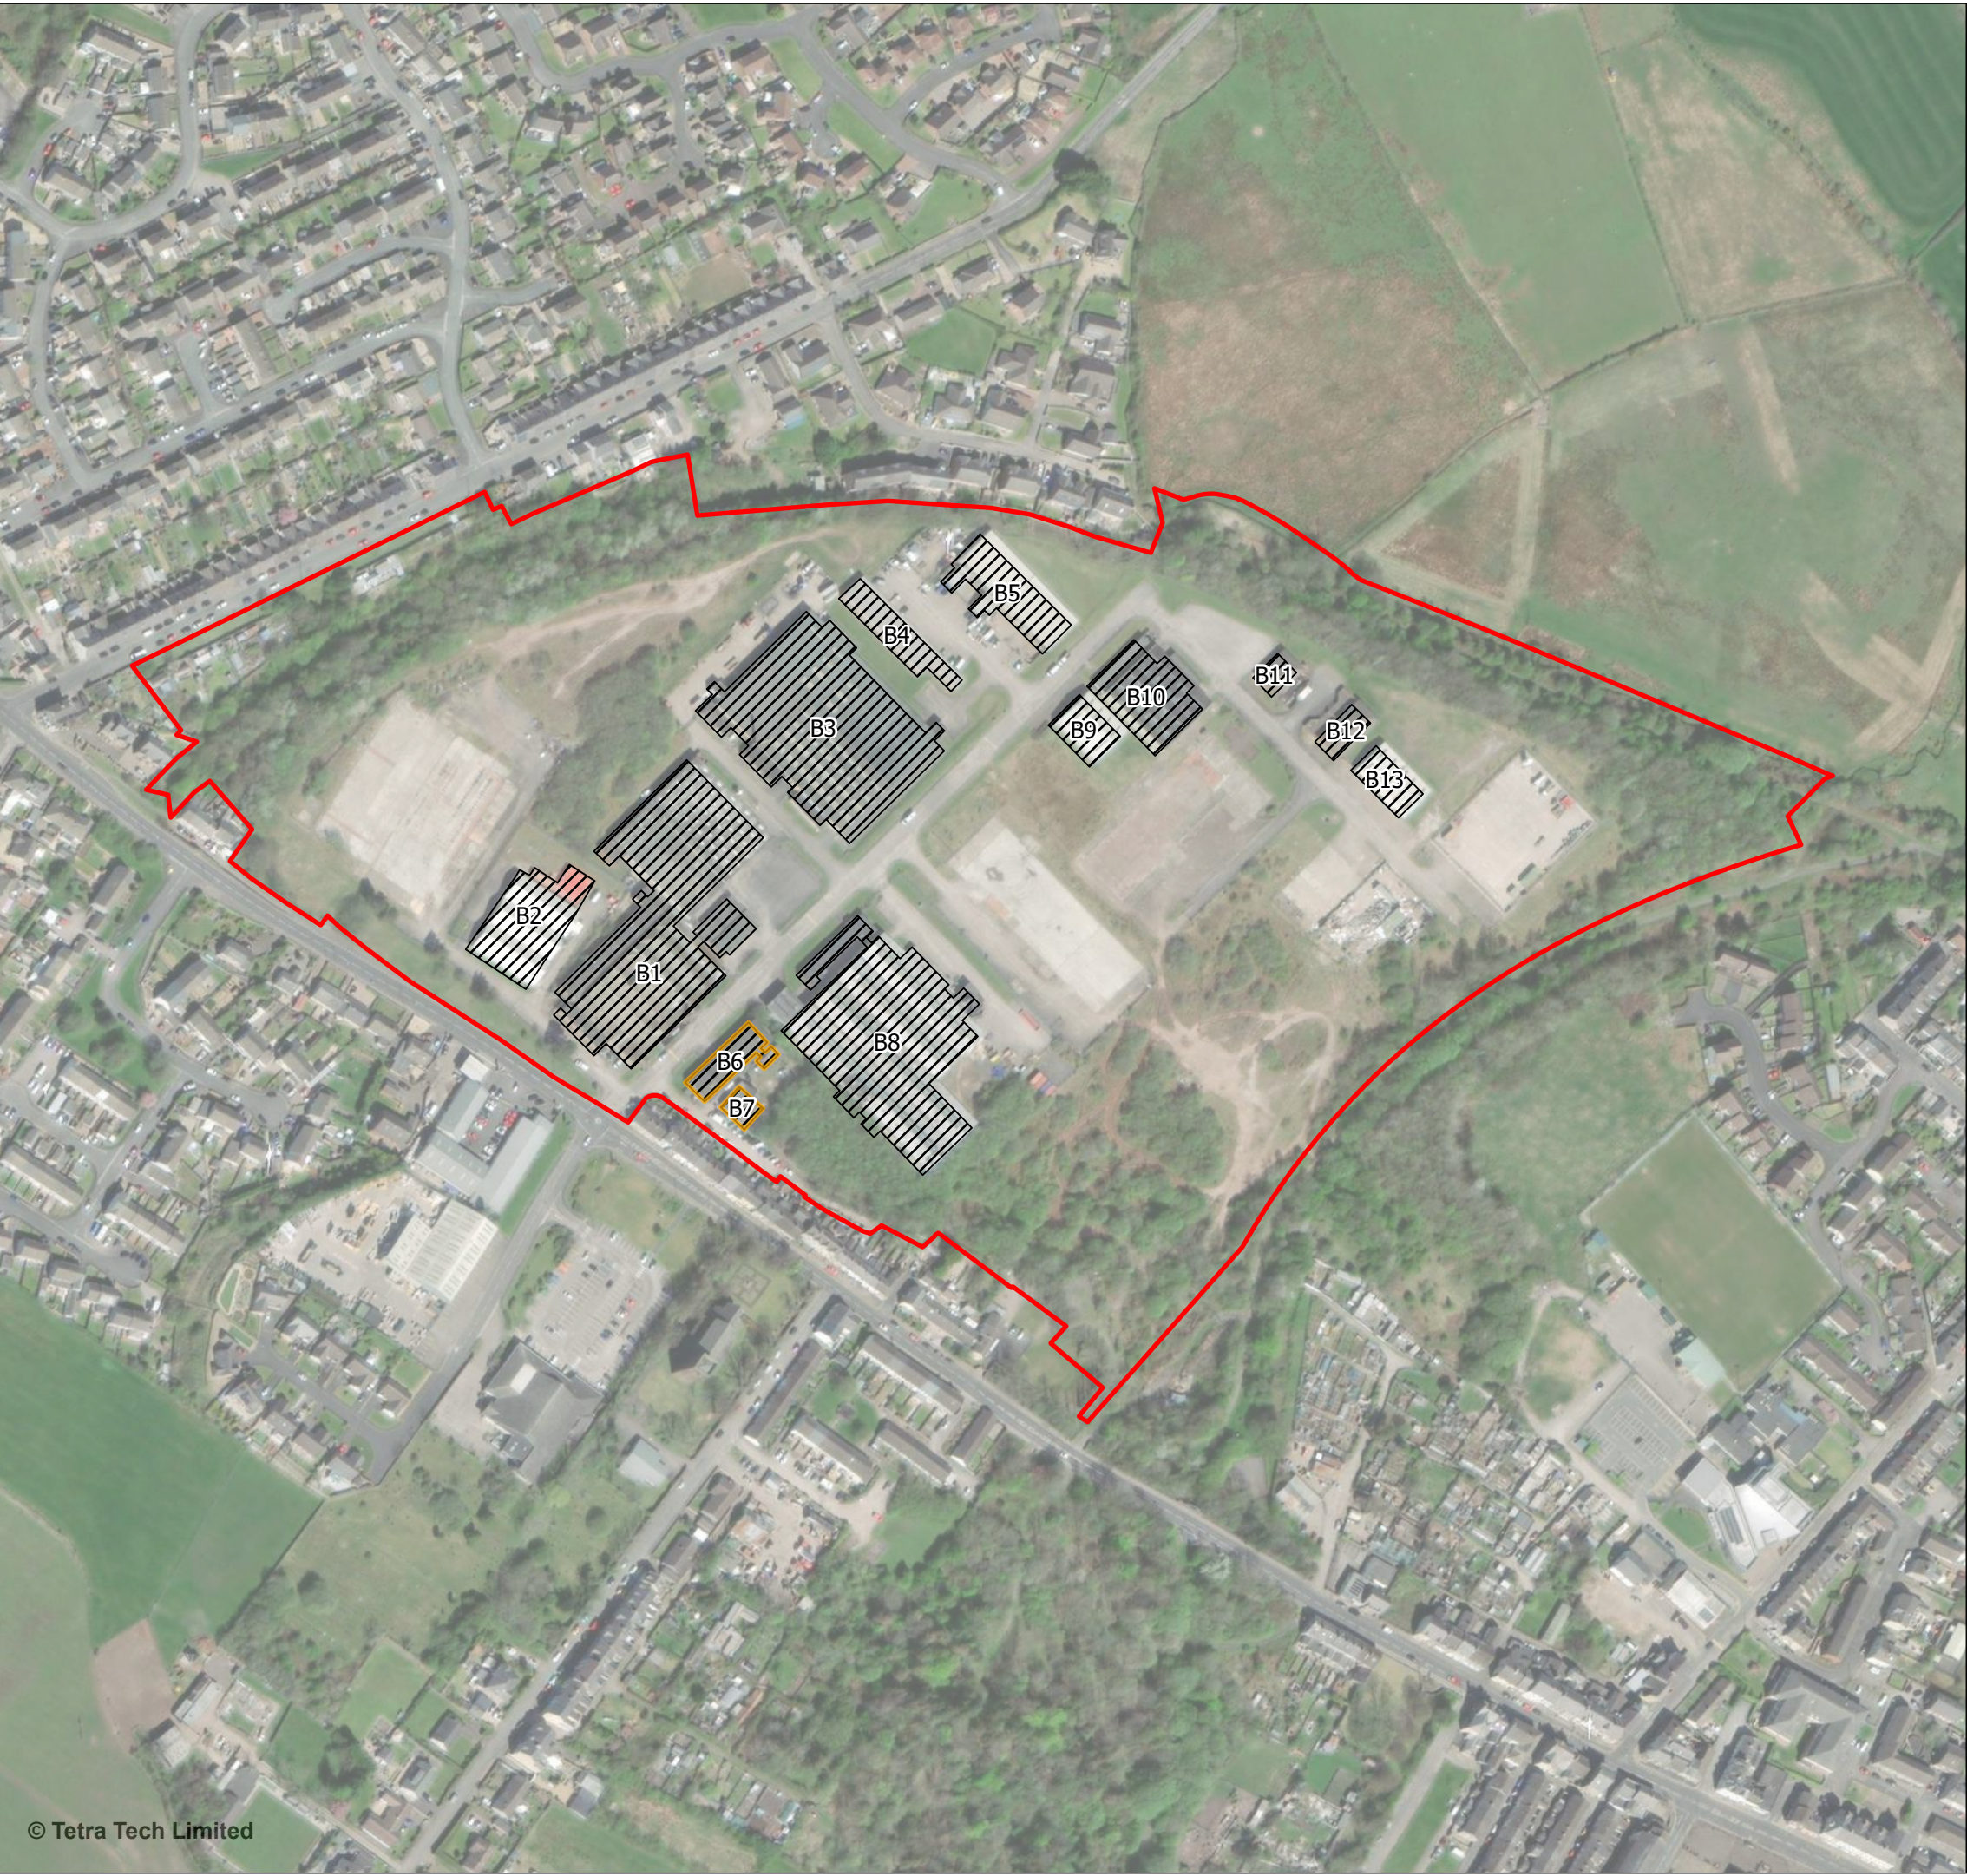
Figure No. 3  
Revision No. A

**Figure 3 – Bat Roost Summary Map**

# Location of the Surveyed Buildings

During the dawn re-entry survey a single common pipistrelle re-entered a gap along the southern corner of the roof of building B6 at 06:09 (12 minutes before sunrise). This was the same roost location as identified during the dusk emergence survey on 29<sup>th</sup> July (Figure 3, Roost R2).

- Roost R1 is located behind the PVC fascia board along western elevation of B1, with the single egress point through the gap between the brick wall and fascia board. A single common pipistrelle was observed using this roost on one occasion (during the dusk emergence survey on 22<sup>nd</sup> July 2021) (see Photograph 1 and Figure 3).
- Roost R2 is located at the southern roof corner to B6, with a single egress point gap between the brick wall top and the bitumen roof overlap. A single common pipistrelle was observed using this roost on two occasions (during the dusk emergence survey on 29<sup>th</sup> July 2021 and during the dawn re-entry survey on 10<sup>th</sup> September 2021) (see Photograph 2 and Figure 3).

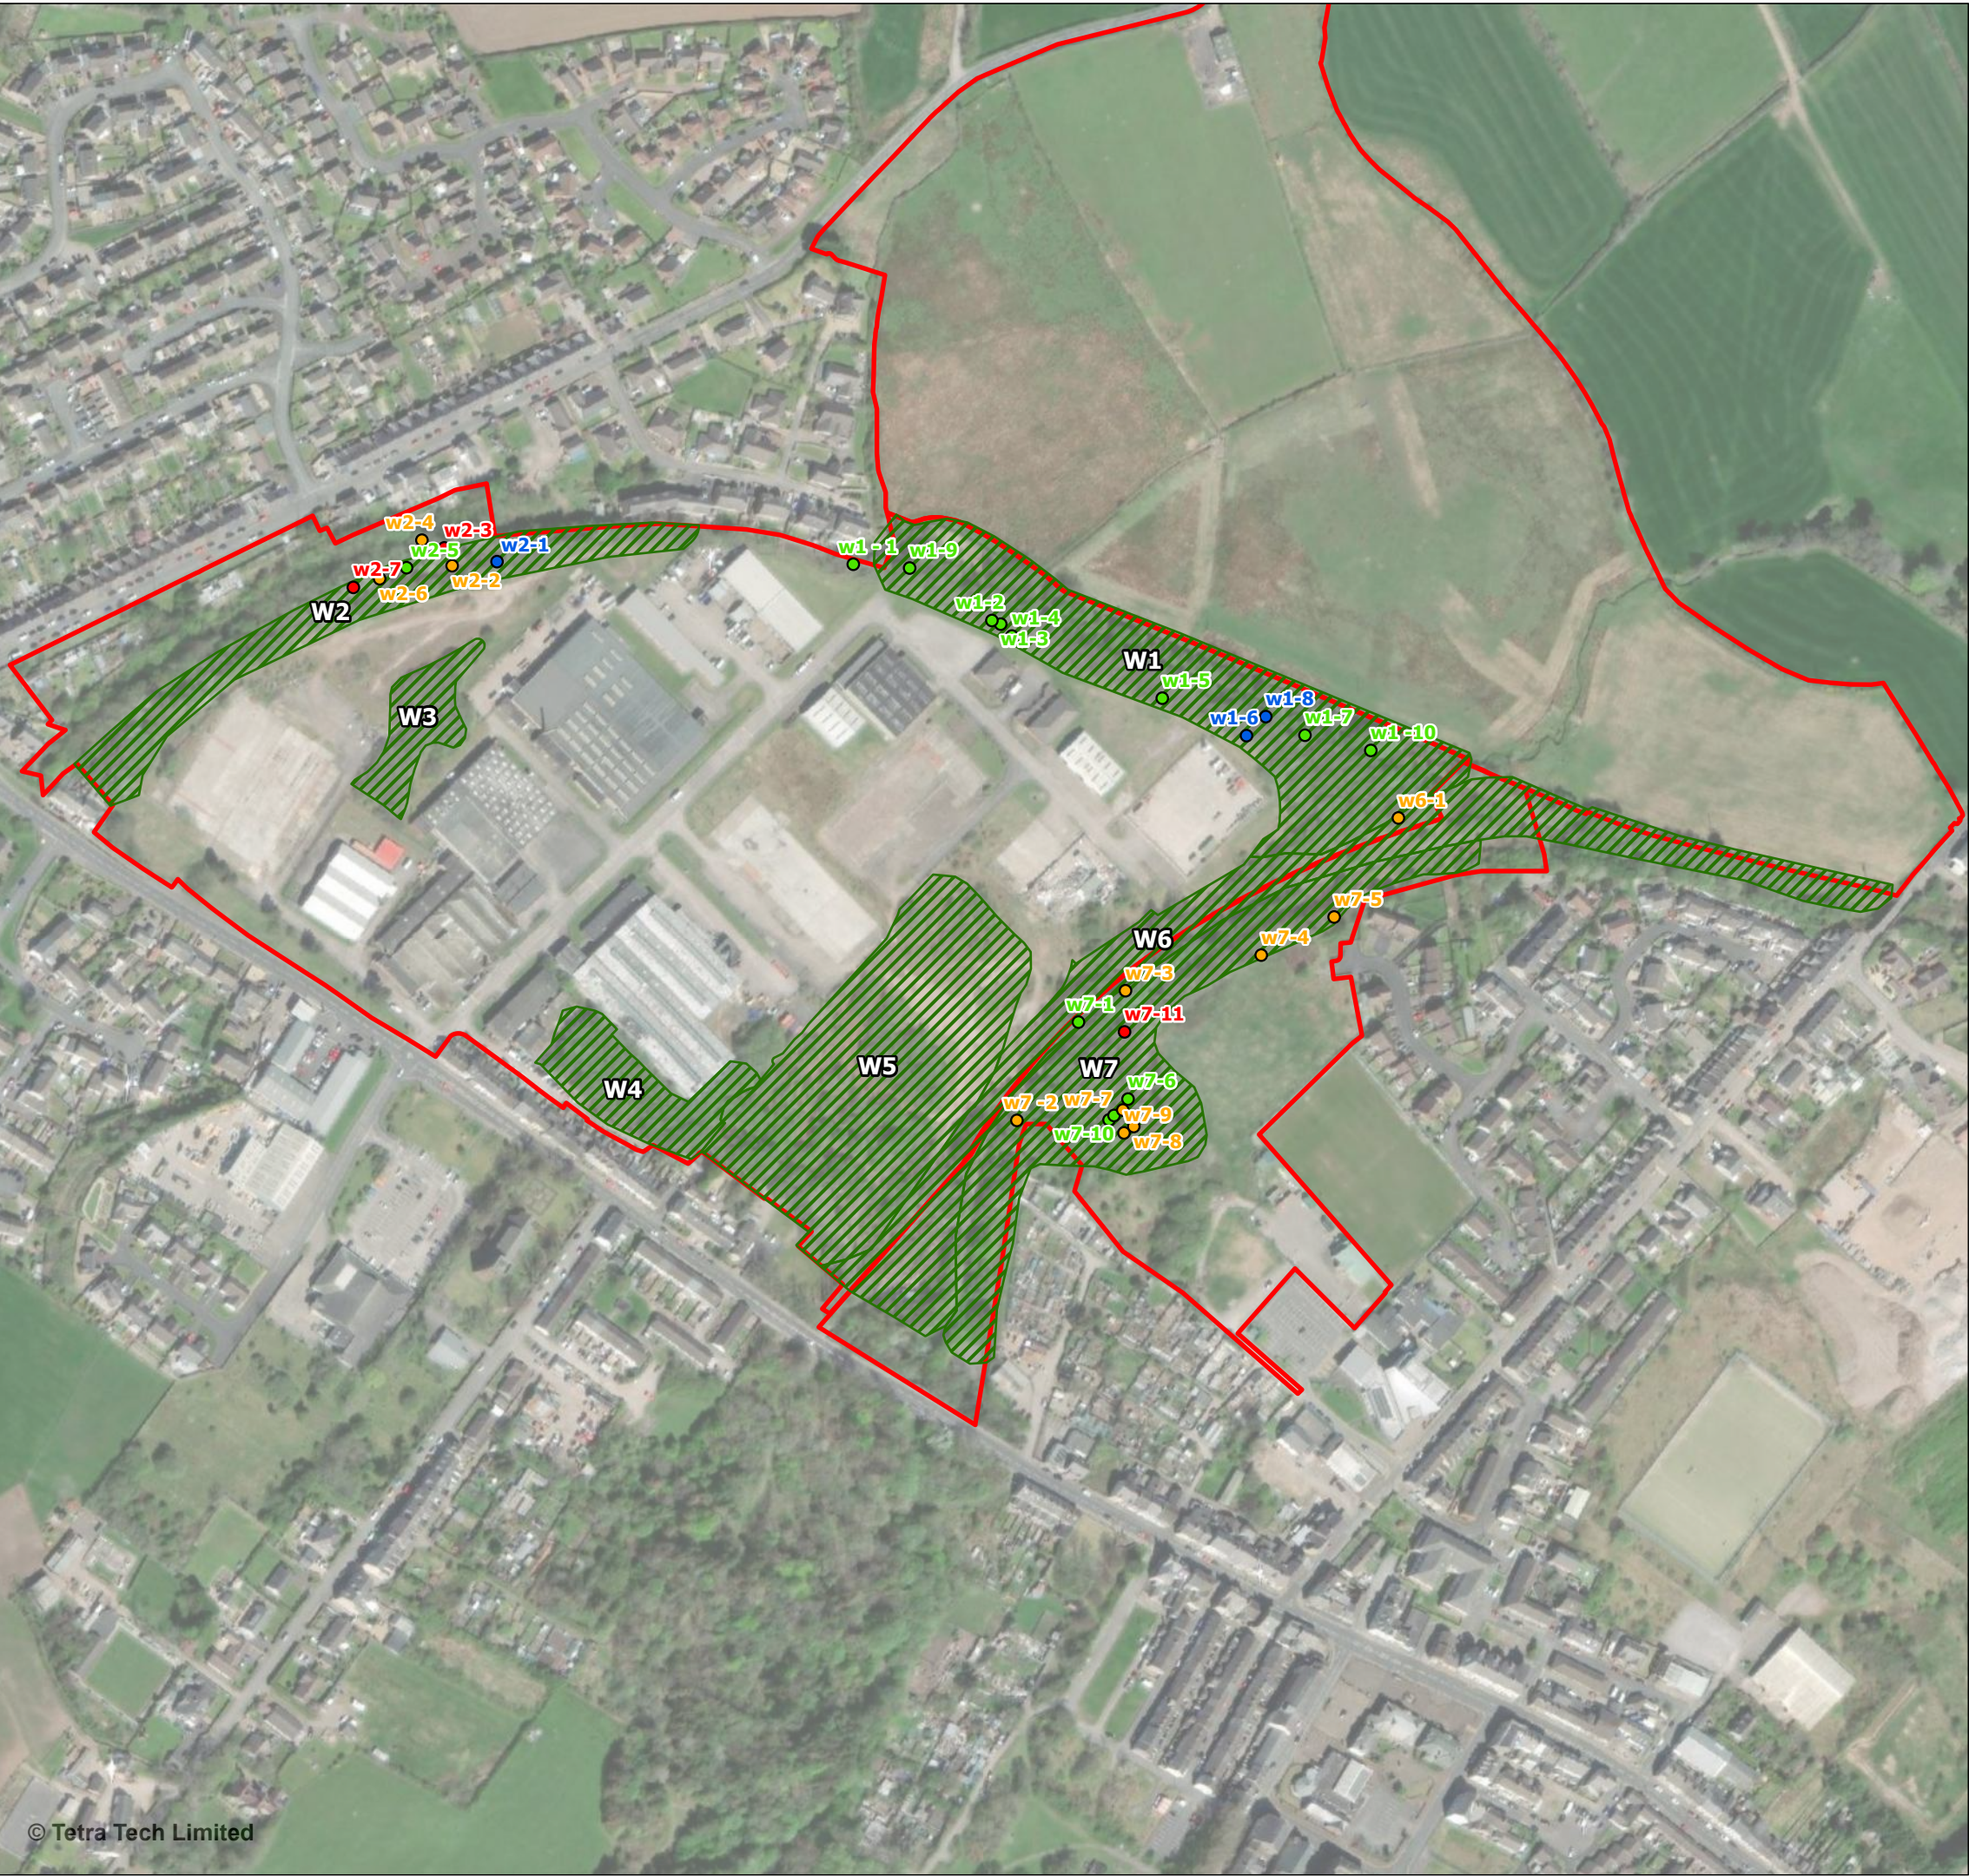
Figure No. 4  
Revision No. A

**Figure 4 – Ground Level Bat Tree Assessment Plan**

**Ground Level Bat Tree  
Assessment Plan**  
CLEATOR MOOR INNOVATION QUARTER  
Copeland Borough Council

All of the trees on site have been grouped into separate woodland blocks; trees within each block were assessed for their suitability for roosting bats. The results of the bat roost assessment survey have been summarised in the Table 9 below and are depicted in Figure 4. Detailed description of the trees providing suitability for roosting bats is included in Appendix D.

Three trees with high bat roost suitability were identified on site, these include W2-3, W2-7 and W7-11 (see Figure 4 and Appendix D).

Eleven trees with moderate bat roost suitability were identified on site; these include W2-2, W2-4, W2-6, W6-1, W7-2, W7-3, W7-4, W7-5, W7-7, W7-8, W7-9 (see Figure 4 and Appendix D). The CMIQ Masterplan (Appendix B) indicates that all trees with high and moderated will be retained within the woodland belt, as such no further survey to any of the trees is recommended.

Thirteen trees with low bat roost suitability were identified on site; these included W1-1, W1-2, W1-3, W1-4, W1-5, W1-7, W1-9, W1-10, W2-5, W7-1, W7-6, W7-10 and W7-12 (see Figure 4 and Appendix D). The CMIQ Masterplan (Appendix B) indicates that all of the above trees will be retained within the woodland belt, as such no further survey to any of the trees is recommended.

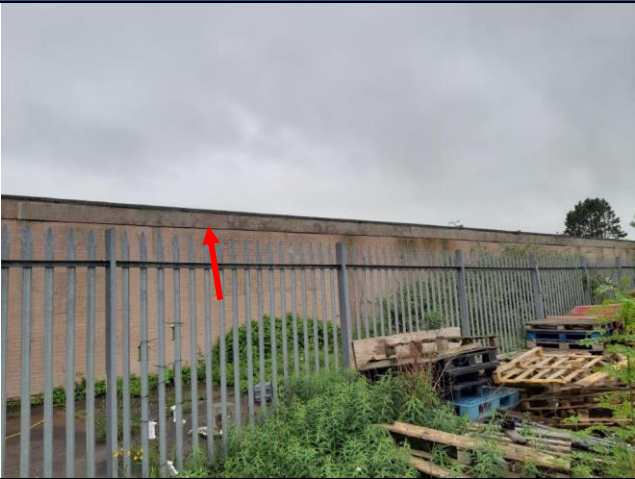
| Building Reference | Roosting Features / Description | Photo |
|---|---|---|
| B1 | Gaps behind wooden fascia boards – multiple elevations. <b>Low suitability.</b> | |

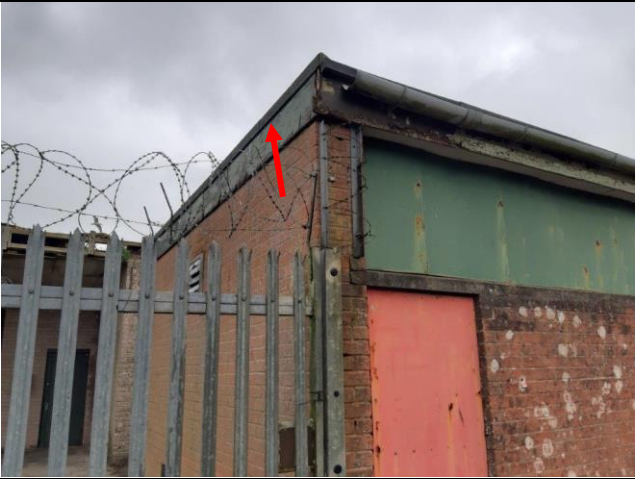
| Building Reference | Roosting Features / Description | Photo |
|---|---|---|
| B1 | Gaps behind bitumen roof overlaps – multiple elevations. <b>Low suitability.</b> | |

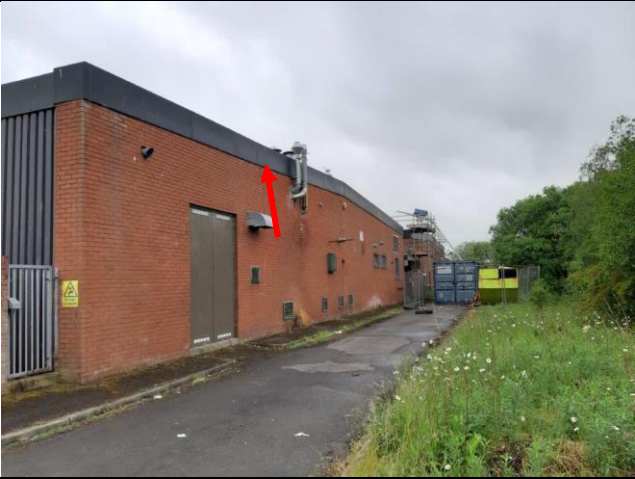
| Building Reference | Roosting Features / Description | Photo |
|---|---|---|
| B1 | Gaps behind PVC fascias – western and eastern of the northern warehouse. <b>Low suitability</b> | |

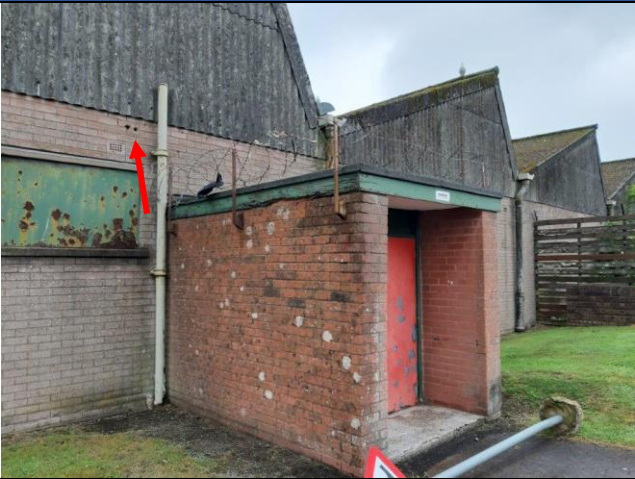
| Building Reference | Roosting Features / Description | Photo |
|---|---|---|
| B1 | Occasional gaps in the brickworks – all elevations. <b>Low suitability.</b> | |

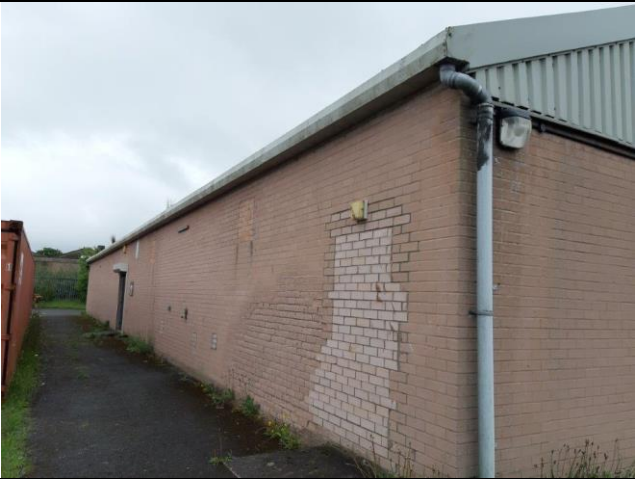
| Building Reference | Roosting Features / Description | Photo |
|---|---|---|
| B2 | Potential gaps in the brick at the wall tops (access gaps present under overhanging roof) – north elevation. <b>Low suitability</b> | |

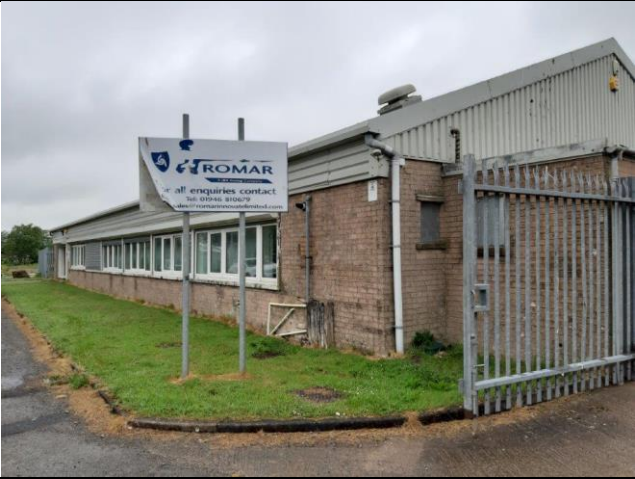
| Building Reference | Roosting Features / Description | Photo |
|---|---|---|
| B2 | Gaps behind steel roof overlaps, some boxed in. All elevations. <b>Low suitability</b> | |

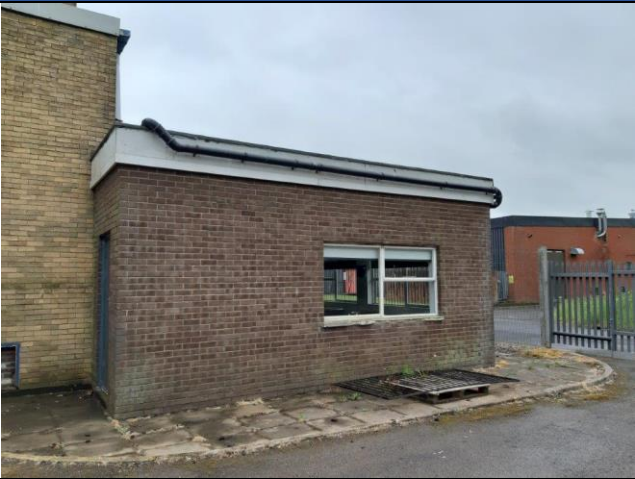
| Building Reference | Roosting Features / Description | Photo |
|---|---|---|
| B3 | Gaps behind the PVC fascia – lean-to structures adjacent western and southern elevations. <b>Low suitability.</b> | |

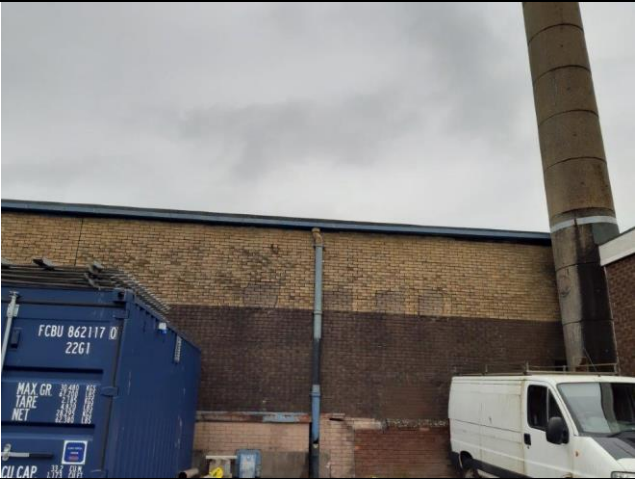
| Building Reference | Roosting Features / Description | Photo |
|---|---|---|
| B3 | Potential gaps at the wall tops, behind the steel roof overlap – southern elevation. <b>Low suitability.</b> | |

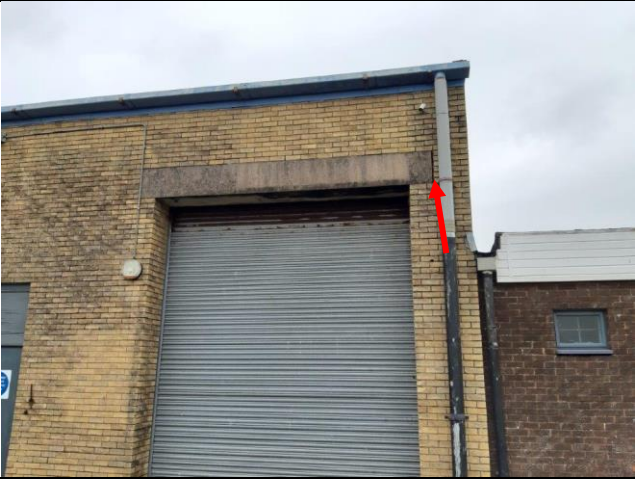
| Building Reference | Roosting Features / Description | Photo |
|---|---|---|
| B3 | Gap along the concrete lintel above the steel garage door – southern elevation. <b>Low suitability.</b> | |

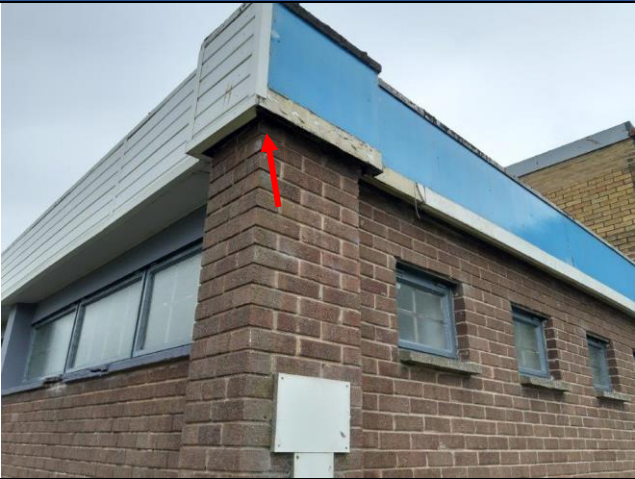
| Building Reference | Roosting Features / Description | Photo |
|---|---|---|
| B3 | Gaps behind the PVC fascias / soffits to the lean-to – eastern elevation. Gaps located predominate at the corners. <b>Low suitability</b> | |

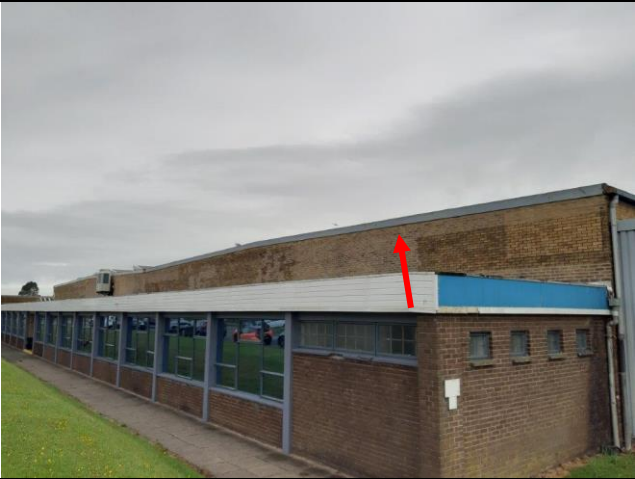
| Building Reference | Roosting Features / Description | Photo |
|---|---|---|
| B3 | Gaps behind the PVC fascia to the main building – eastern elevation; <b>Low suitability.</b> | |

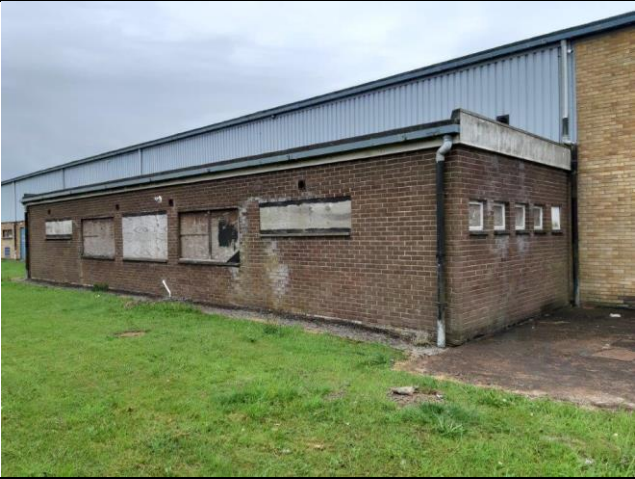
| Building Reference | Roosting Features / Description | Photo |
|---|---|---|
| B3 | Northern lean-to structure – gaps behind PVC fascia (predominantly at the corners) and gaps behind window boards. <b>Low suitability.</b> | |

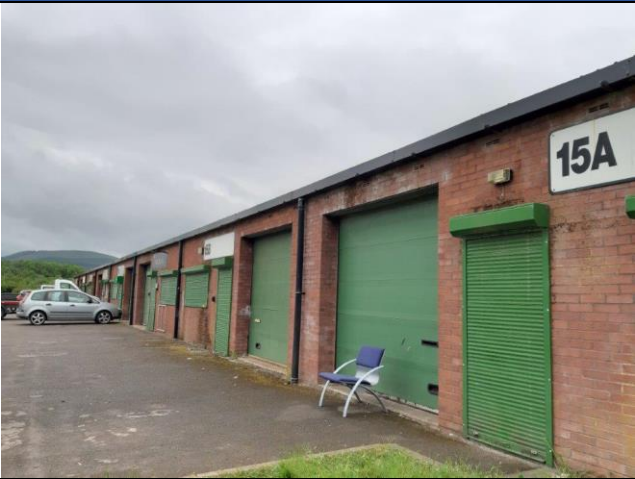
| Building Reference | Roosting Features / Description | Photo |
|---|---|---|
| B4 | Ventilation gaps and occasional gaps in the brickwork – all elevations. <b>Low suitability</b> | |

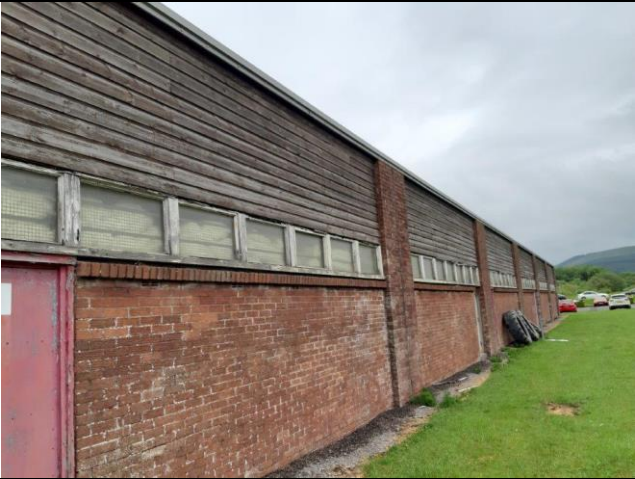
| Building Reference | Roosting Features / Description | Photo |
|---|---|---|
| B4 | Occasional gaps behind wood panelling and dilapidated window frames – southern elevations. <b>Low suitability.</b> | |

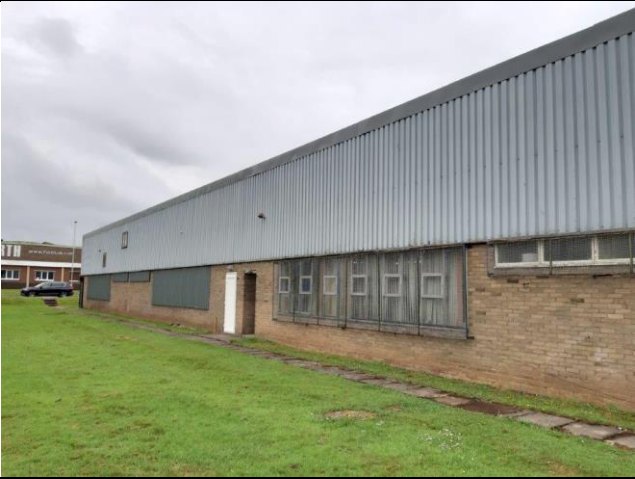
| Building Reference | Roosting Features / Description | Photo |
|---|---|---|
| B5 | Gap behind metal roof overlaps and occasional gaps in the brickwork – all elevations. <b>Low suitability.</b> | |

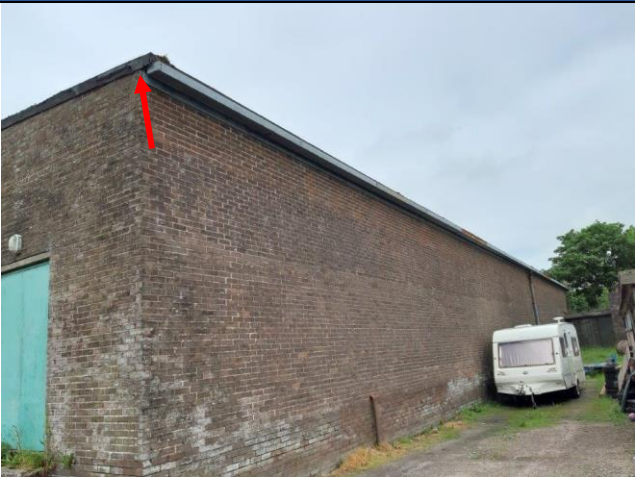
| Building Reference | Roosting Features / Description | Photo |
|---|---|---|
| B6 | Gaps behind wooden fascias and bitumen roof overlaps; occasional gaps in the brickwork – all elevations. <b>Low suitability.</b> | |

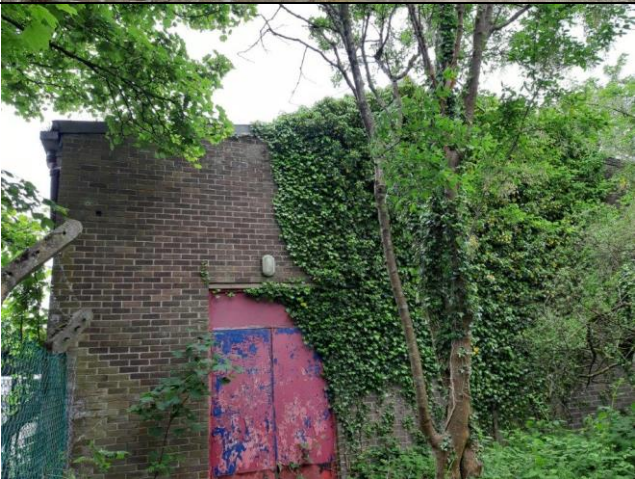
| Building Reference | Roosting Features / Description | Photo |
|---|---|---|
| B6 | Potential gaps in the brickworks / roof top concealed by ivy along the northern elevation. <b>Low suitability</b> | |

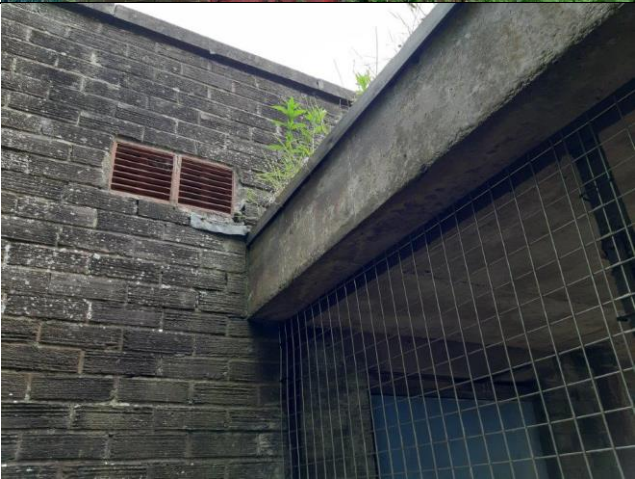
| Building Reference | Roosting Features / Description | Photo |
|---|---|---|
| B6 | Small extension to the east. Occasional gaps in the brickworks and above the doors; ventilation gaps and few areas with gaps behind flashing overlap. <b>Low suitability.</b> | |

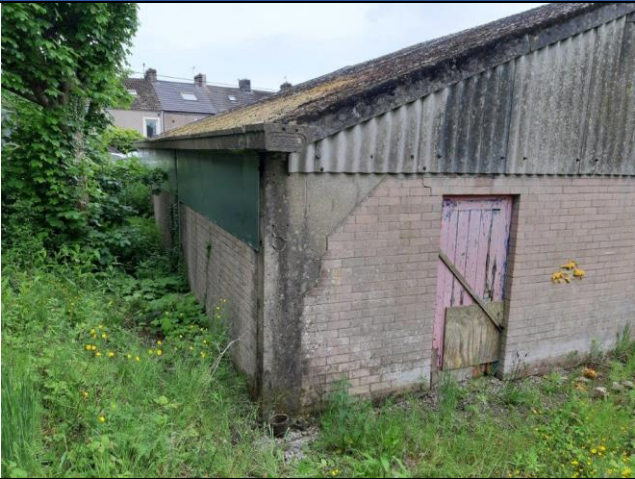
| Building Reference | Roosting Features / Description | Photo |
|---|---|---|
| B7 | Gaps in the brickwork (cavity appeared to be present in places, gaps behind metal boards, gaps behind asbestos roof overlaps – all elevations, <b>Low suitability.</b> | |

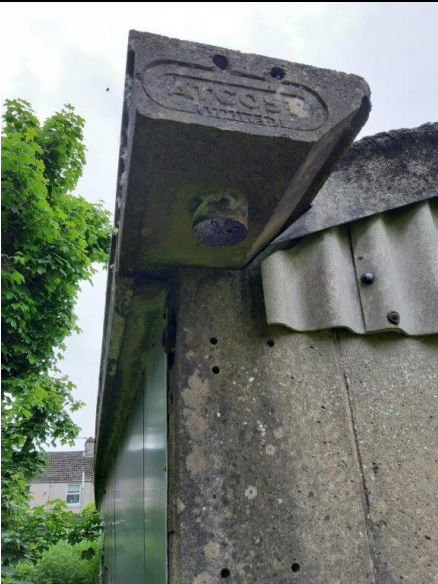
| Building Reference | Roosting Features / Description | Photo |
|---|---|---|
| B7 | Gaps around concrete wall tops and guttering at the corners – all elevations. <b>Low suitability.</b> | |
