# Cleator Moor Innovation Quarter

## BAT ROOST ASSESSMENT REPORT

784-B029668 Rev 2

Copeland Borough Council

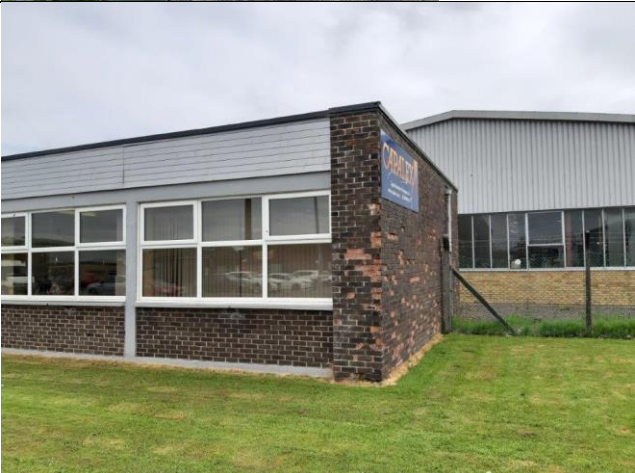
| Building Reference | Roosting Features / Description | Photo |
|---|---|---|
| B8 | Office extension along the east – gaps behind bitumen roof overlaps and metal facias / panelling at the front. Gap within the wood panelling above the main access door. Low suitability | |

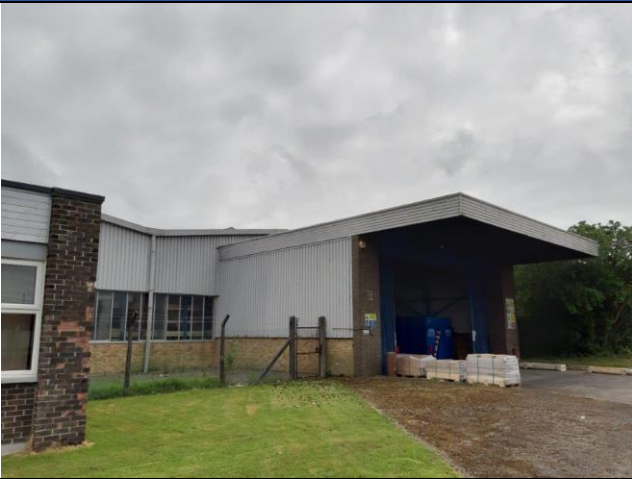
| Building Reference | Roosting Features / Description | Photo |
|---|---|---|
| B8 | Gaps underneath the porch to the warehouse access doors – eastern elevation. Low suitability. | |

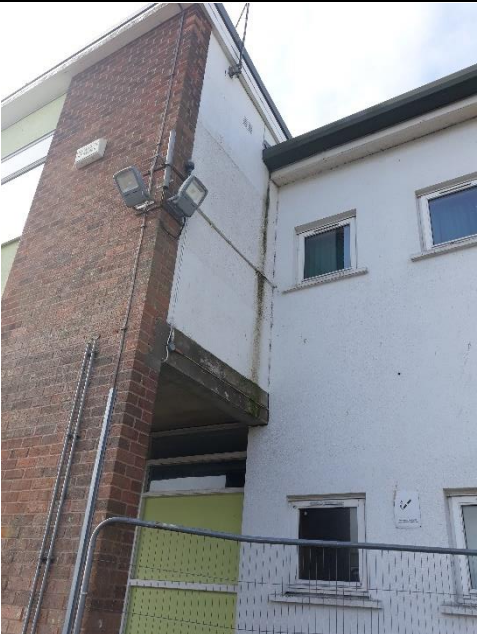
| Building Reference | Roosting Features / Description | Photo |
|---|---|---|
| B6 | Gaps within boxed-in soffits and around corner flashing; all elevations; <b>Low suitability</b> | |

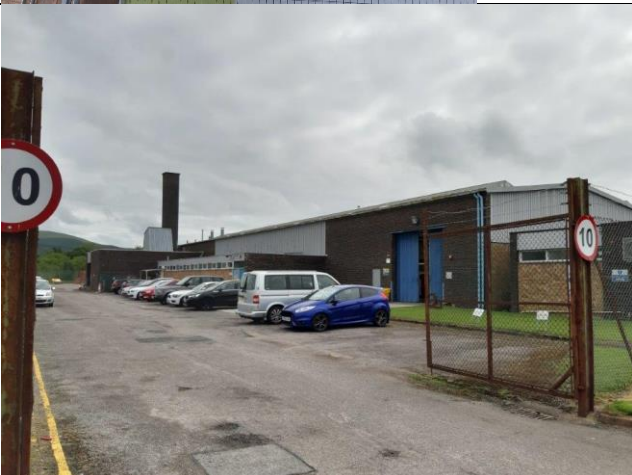
| Building Reference | Roosting Features / Description | Photo |
|---|---|---|
| B8 | Northern elevation with two brick lean-to structures. Potential gaps behind wooden fascias to the main warehouse, fascias and roof overlaps to the lean-to's and brickwork. <b>Low suitability.</b> | |

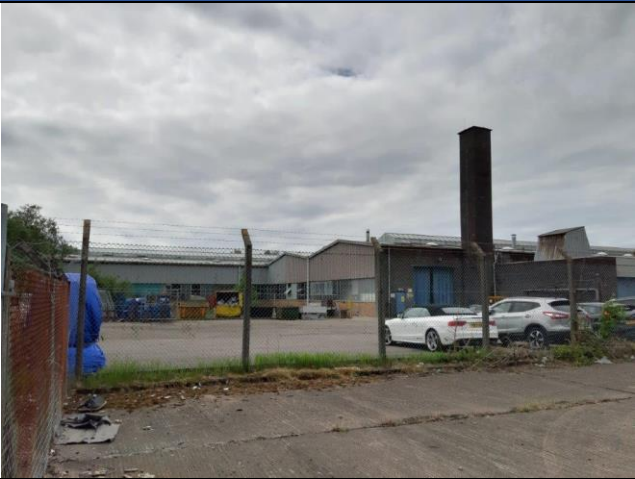
| Building Reference | Roosting Features / Description | Photo |
|---|---|---|
| B8 | Gaps in the brickworks around the chimney – north elevation. <b>Low suitability.</b> | |

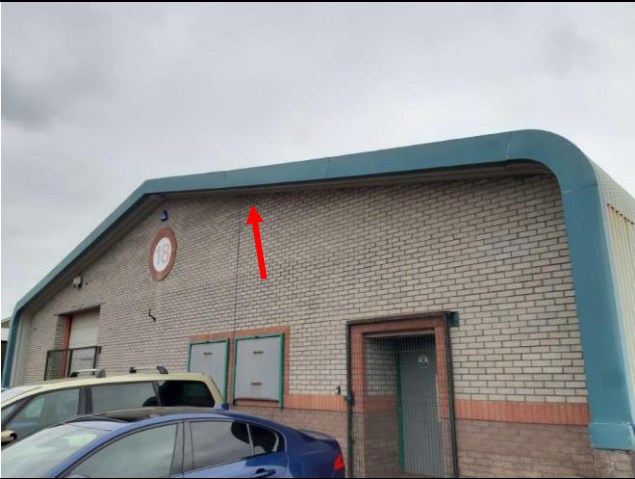
| Building Reference | Roosting Features / Description | Photo |
|---|---|---|
| B9 | Gaps behind the steel roof / shell overlap – eastern and western elevations. <b>Low suitability.</b> | |

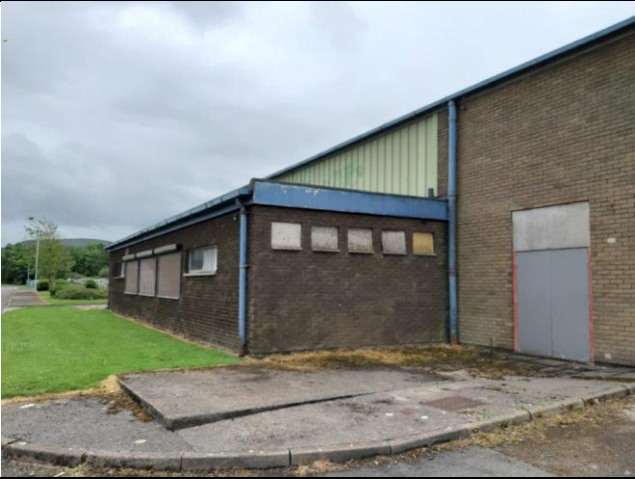
| Building Reference | Roosting Features / Description | Photo |
|---|---|---|
| B10 | Lean-to structure along the northern elevation – gaps behind wooden fascias / around the corners. <b>Low suitability.</b> | |

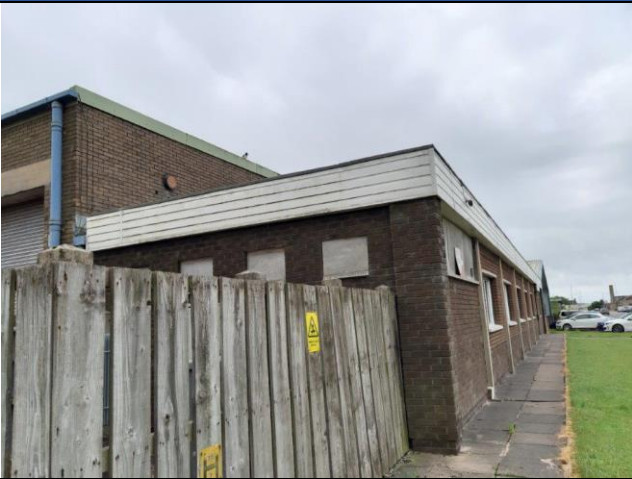
| Building Reference | Roosting Features / Description | Photo |
|---|---|---|
| B10 | Lean-to structure along the western elevations – gaps behind fascias / around the corners; gaps behind wooden window boards.<br><b>Low suitability.</b> | |

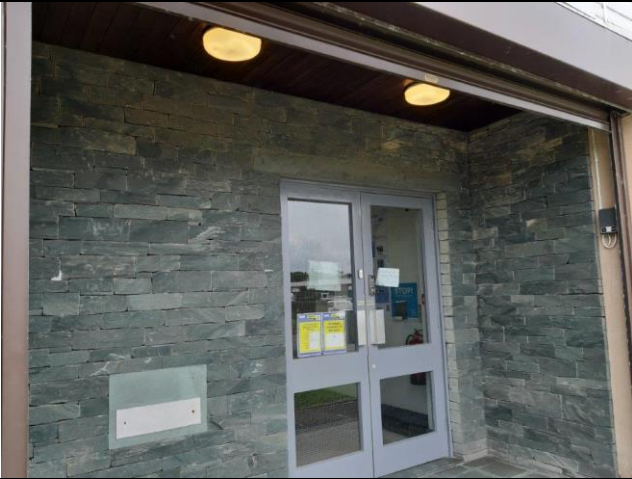
| Building Reference | Roosting Features / Description | Photo |
|---|---|---|
| B10 | Gaps between slate blocks around the main access door to the western lean-to.<br><b>Low suitability.</b> | |

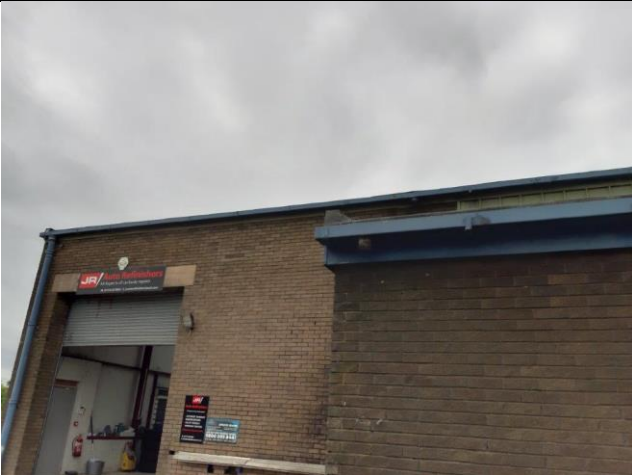
| Building Reference | Roosting Features / Description | Photo |
|---|---|---|
| B10 | Gaps behind steel wall top overlaps to the main building– northern and western elevation. <b>Low suitability.</b> | |

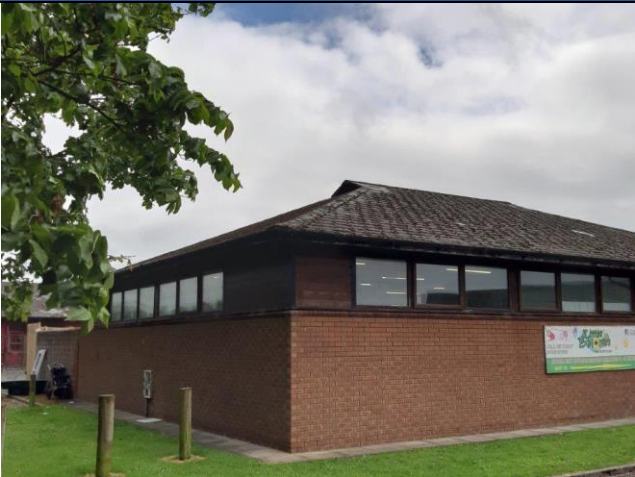
| Building Reference | Roosting Features / Description | Photo |
|---|---|---|
| B11 | <p>Roof areas – potential loft space within the roof. Gaps with access under ridges, tiles and ventilation gaps at the ridge ends. Wooden boxed-in soffits with occasional gaps – all elevations. <b>Moderate suitability.</b></p> | |

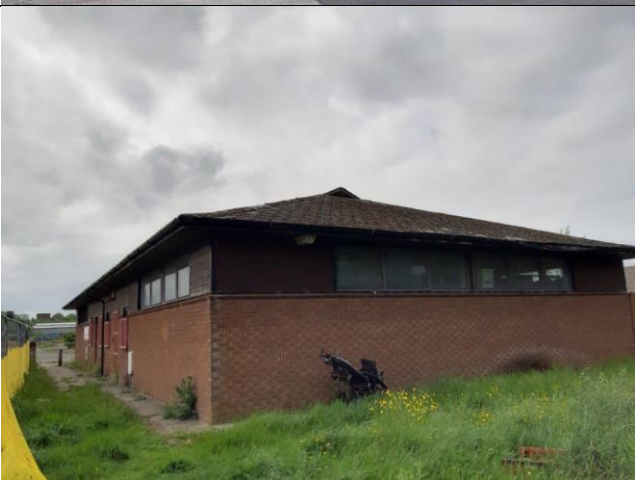
| Building Reference | Roosting Features / Description | Photo |
|---|---|---|
| B12 | <p>Roof areas – potential loft space within the roof. Gaps with access under ridges, tiles and ventilation gaps at the ridge ends. Wooden boxed-in soffits with occasional gaps – all elevations. <b>Moderate suitability.</b></p> | |

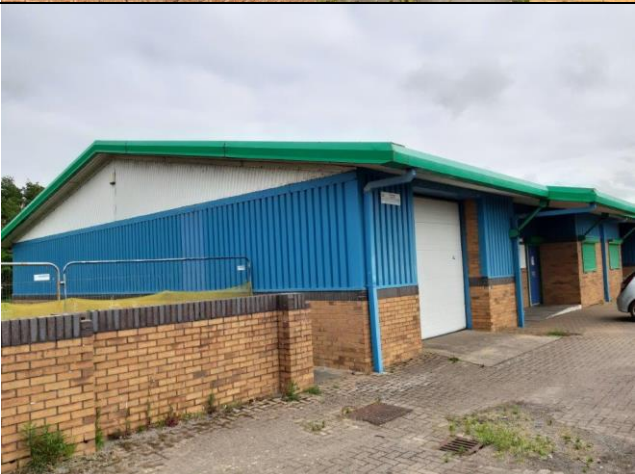
| Building Reference | Roosting Features / Description | Photo |
|---|---|---|
| B13 | Occasional gaps within the steel wall / roof overlaps. <b>Negligeble suitability.</b> | |

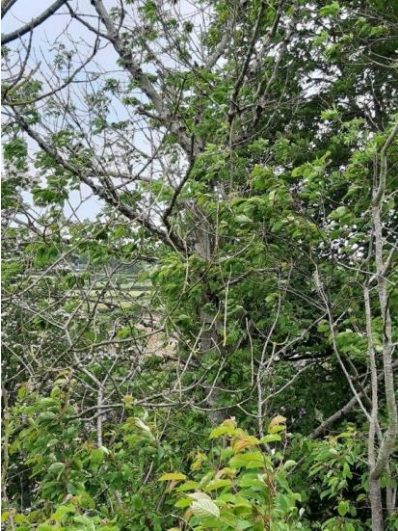
| Woodland Block | Tree Reference | Species | Grid Ref. (OSGB) | PRFs | Risk / Suitability | Photo |
|---|---|---|---|---|---|---|
| W1 | W1-1 | Ash | NY0166315666 | Shallow wounds and cankers on the stem | Low | |

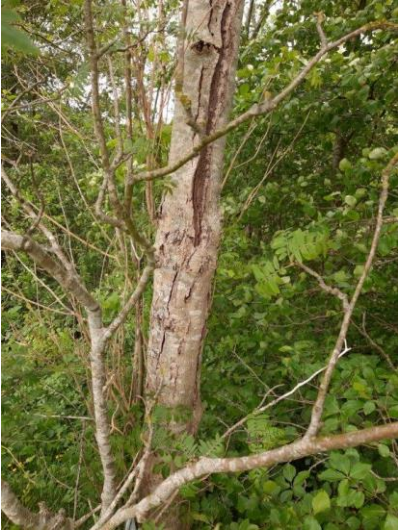
| Woodland Block | Tree Reference | Species | Grid Ref. (OSGB) | PRFs | Risk / Suitability | Photo |
|---|---|---|---|---|---|---|
| W1 | W1-2 | Ash | NY0173715636 | Shallow wounds and cankers on the stem | Low | |

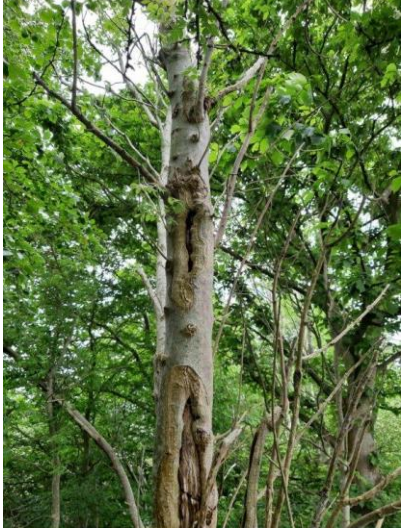
| W1 | W1-3 | Ash | NY0174215634 | Shallow tear out features on the main stem | Low | |

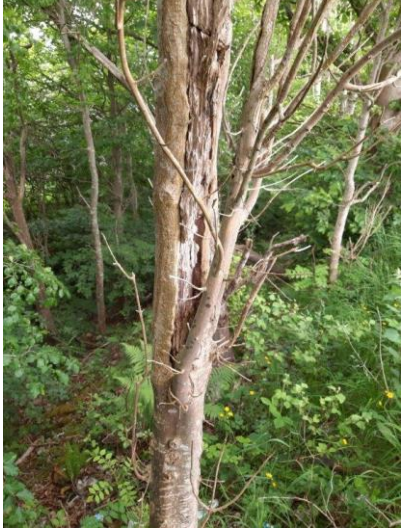
| W1 | W1-4 | Ash | NY0174815628 | Shallow wounds and cankers on the stem | Low | |

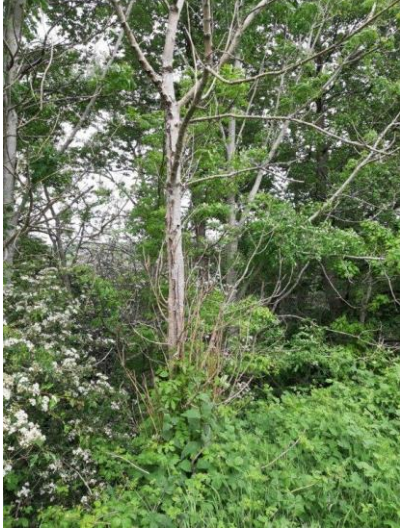
| W1 | W1-5 | Ash | NY0182815594 | Shallow wounds, cankers and flaking bark on the main stem | Low | |

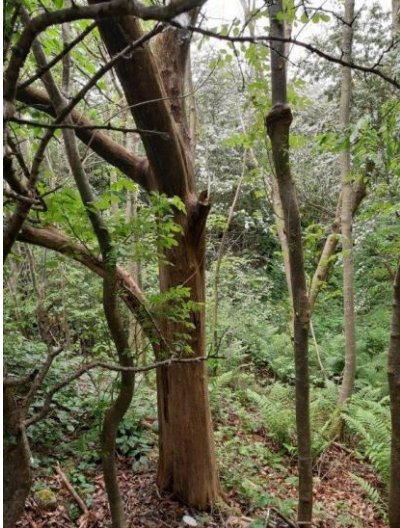
| W1 | W1-6 | Ash (Dead) | NY0187315574 | Shallow desiccation fissures within dead wood | Negligible | |

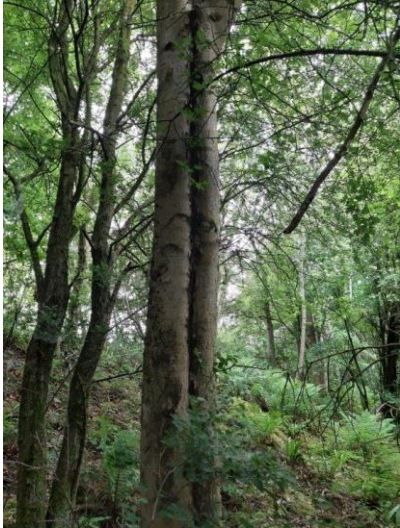
| W1 | W1-7 | Ash | NY0190415575 | Shallow lighting strike wound on the main stem. | Low | |

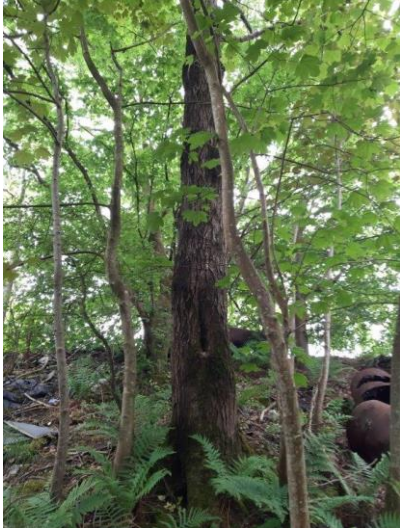
| W1 | W1-8 | Wych Elm | NY0188315585 | Shallow tear-out on the lower section of the stem. | Negligible | |

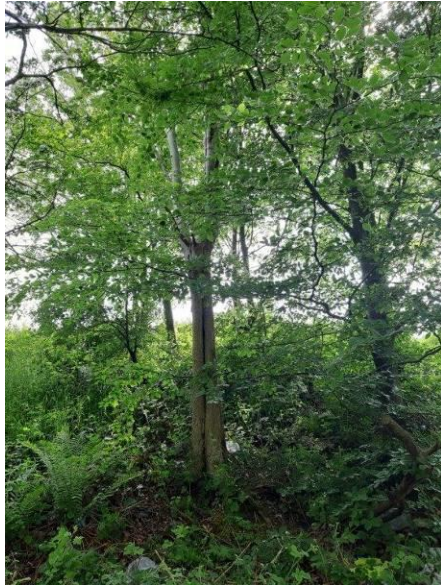
| W1 | W1-9 | Ash | NY0169315664 | A shallow lightning strike wound along the northern elevation, approximately 5m long towards the base. | Low | |

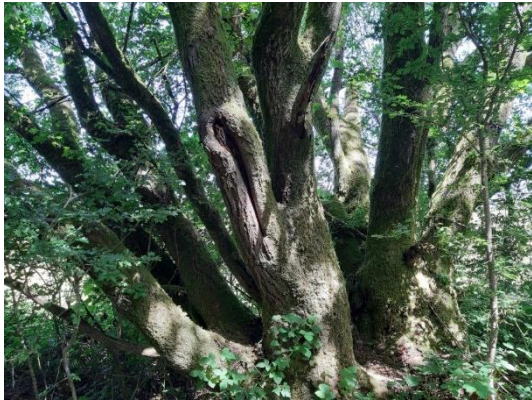
| W1 | W1-10 | Goat willow | NY0193915567 | Multistem with a tear out feature on the stem facing south – with a shallow crevice at the top of the feature. | Low | |

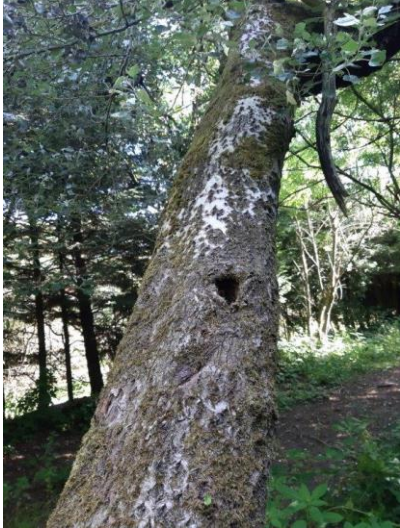
| W2 | W2-1 | White Poplar | NY0147315667 | A shallow hole in the north leaning stem. | Negligible | |

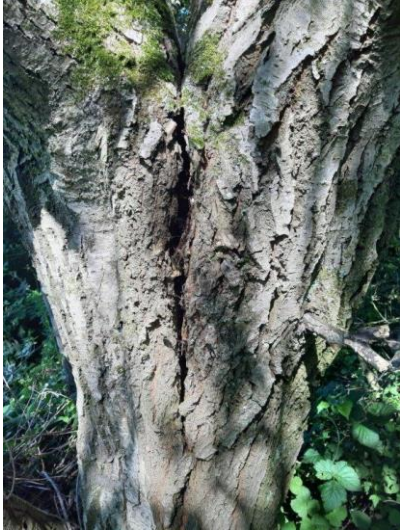
| W2 | W2-2 | Goat willow | NY0144915665 | A vertical split on the lower section of the main stem, east facing and approximately 10cm deep and 40cm long. | Moderate | |

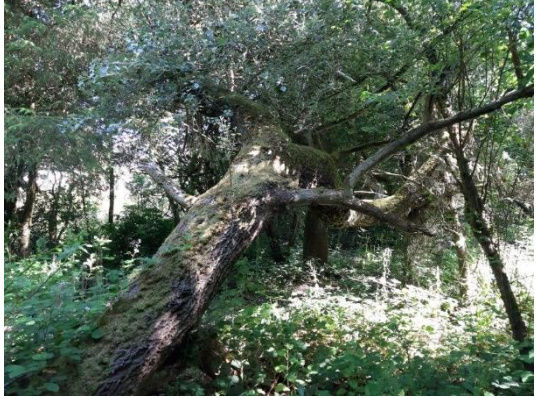
| W2 | W2-5 | White poplar | NY0142515664 | Desiccation fissures within dead branches | Low | |

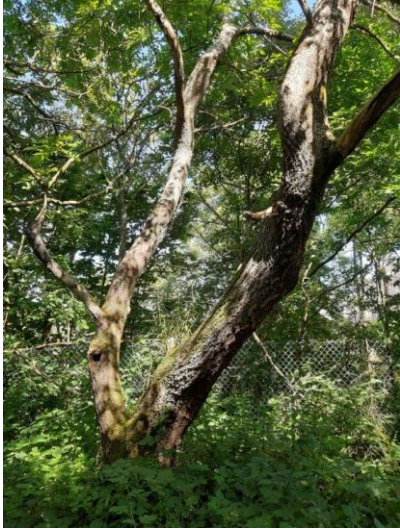
| W2 | W2-7 | White Poplar | NY0139715653 | <p>Large tear-out on the northeast stem, facing northeast, approximately 1m long starting at 1m up with a cavity extending 30-40cm upwards.</p> <p>Knothole at 1.5m up with a 7cm diameter and cavity extending up and facing east.</p> | High | |

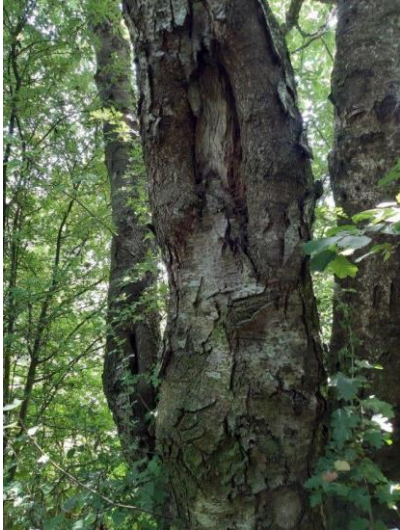
| W6 | W6-1 | White Poplar | NY0195415531 | <p>Two tear-outs, small gaps at the top on different stems with one being 2m up and the other being 1.5m facing northwest.</p> | Moderate | |

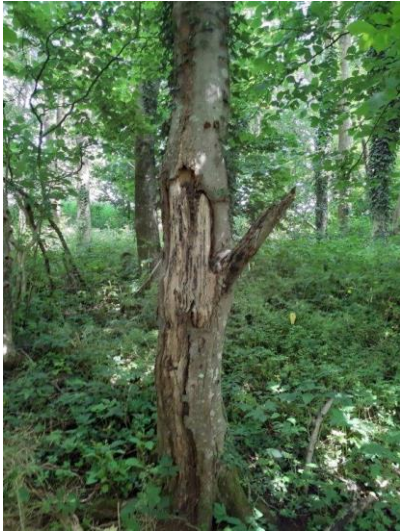
| W7 | W7-12 | Ash | NY0179915370 | <p>Dead wood/ rotten side with desiccation fissures.</p> <p>Very shallow cavity at the top of the tree.</p> | Low | |

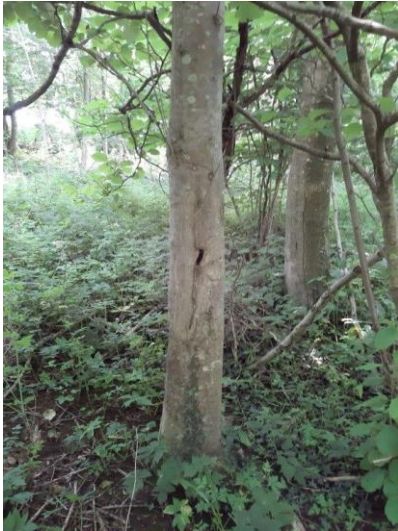
| W7 | W7-10 | Ash | NY0180215372 | Small tear-out with the gap extending upwards; 5cm long and 2cm wide. | Low | |

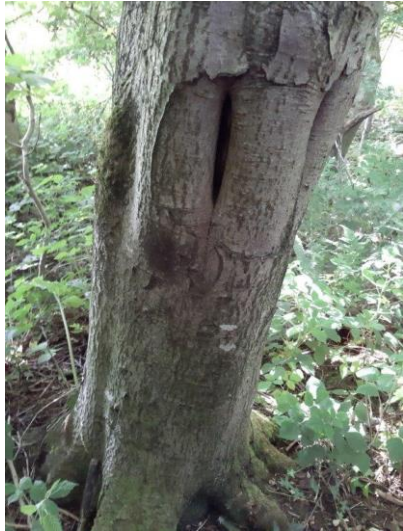
| W7 | W7-9 | Alder | NY0180715363 | Tear-out on the northern stem, 50cm up, with a fork at the same height. | Moderate | |

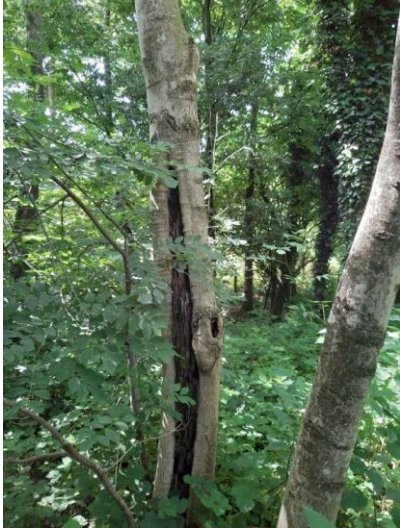
| W7 | W7-8 | Ash | NY0181315366 | Tear-out on the northeast face extends from the bottom upward by 2m, with a cavity of 5cm. | | |

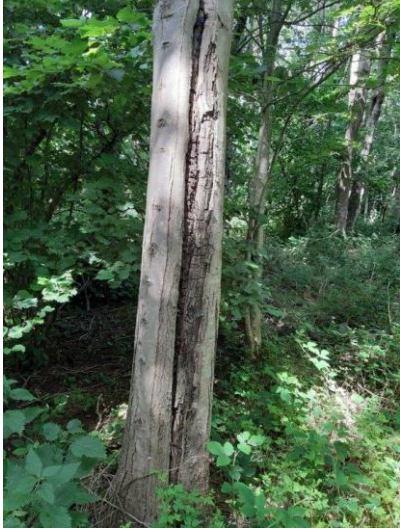
| W7 | W7-7 | Ash | NY0180715375 | Lightning strike on the east side which extends 3m upwards, with a cavity all the way up. | Moderate | |

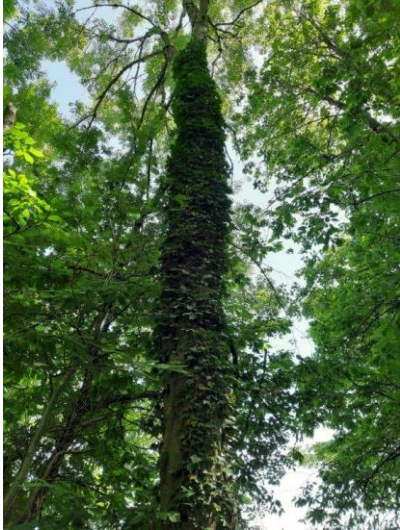
| W7 | W7-6 | Ash | NY0181015381 | <p>Trunk is ivy clad with stem diameters in excess of 50mm, may be obscuring potential features.</p> <p>Small tear-out on the south face approximately 4m up.</p> | Low | |

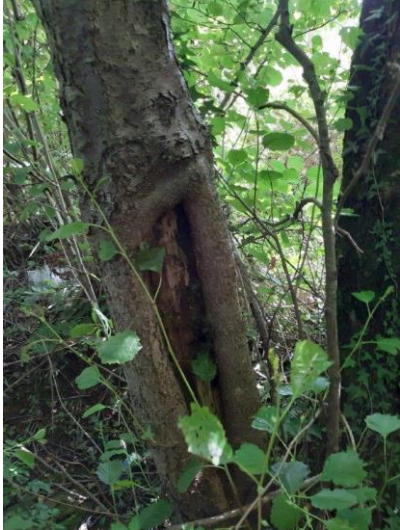
| | W7-5 | Alder | NY0191915478 | <p>Tear-out on the southwest face approximately 50cm long, with a very narrow cavity extending upwards.</p> | Moderate | |

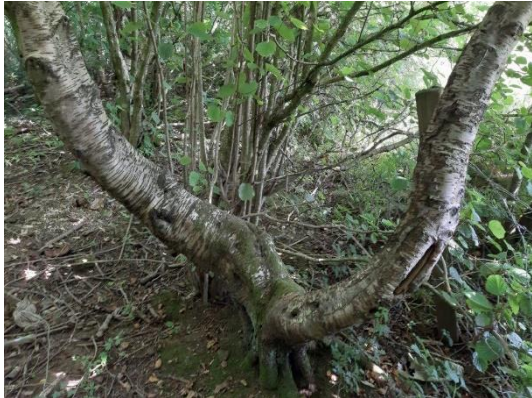
| W7 | W7-4 | Wild cherry | NY0188115457 | Tear-out on the south facing stem with a 20cm narrow cavity extending upwards. | Moderate | |

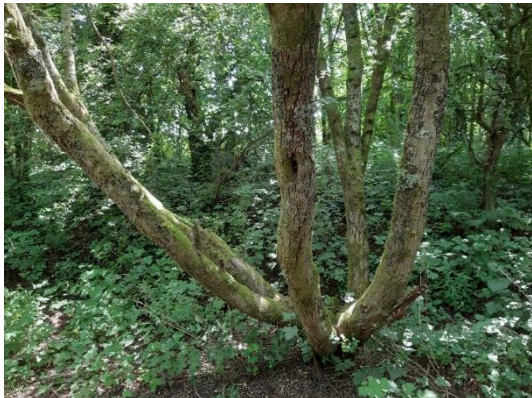
| W7 | W7-3 | Grey Willow | NY0180815438 | Tear-out facing up on the northwest stem extending upwards by 5cm, and is 20cm long. | Moderate | |

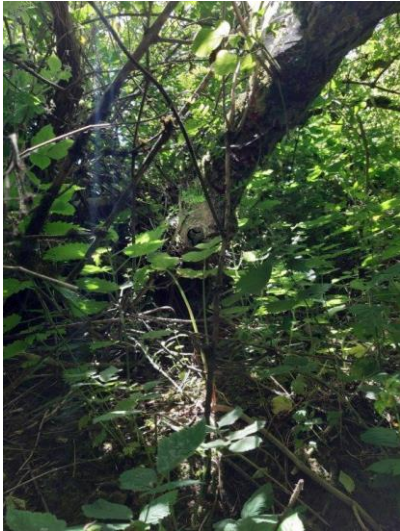
| W7 | W7-2 | Ash | NY0175015369 | Rot hole/ tear-out on the main stem (facing down) approximately 30cm from the ground, extending 15cm inside. | Moderate | |

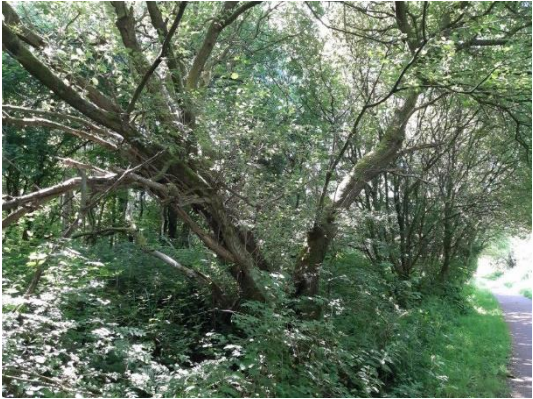
| W7 | W7-1 | Willow | NY0178315422 | Shallow desiccation fissures in dead wood. | Low | |
