This report has been produced to identify any protected species of animal in particular, bat, barn owl or any nesting bird from being disturbed in their roost, nest or feeding areas during the proposed work to be carried out on the property.

An application to Planning is being made to convert the stables into a dwelling, a bat and breeding birds survey is being commissioned for the application.

The stable sit on the east end of Calf Nook a converted barn south of Rottington Hall in the centre of Rottington, the roof is in the process of being replaced in blue slate on timber battens, rafters & purlin with timber fascia, barge boards & soffit, walls are cavity stonework with rubble fill, floors are concrete.

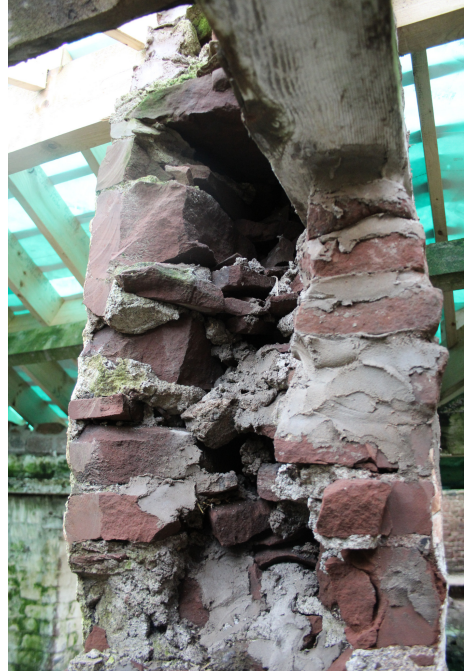
View south east over inner courtyard showing fascia & bargeboard boxing with bat roost potential

Allowing 15x25mm bat access created to fascia /eaves boxing on each elevation.

Bats will be encouraged on site by allowing them access to the building post-works into new fascia & barge boards and stone cavity walls, an activity survey on completion will confirm where bat roosts are being used.

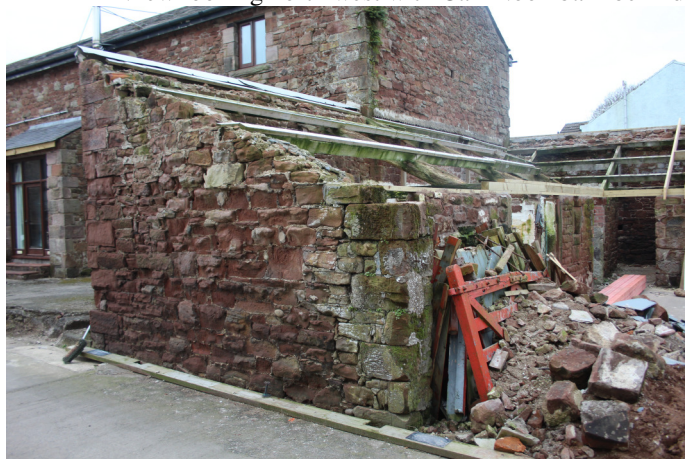
Timber wall sockets with possible roost cracks

There is potential for bats to be present in the areas that were inaccessible to the survey. These were in gaps around beam sockets & behind timber fascia & barge boards and in stone cavity wall gaps.

Extreme care must be taken when working on these areas. Crevices should be checked with a torch prior to pointing to ensure no bats are entombed, downward facing pvc tubes will allow any bats to escape, while mortar tubes will allow them escape and re-enter externally, where permitted.

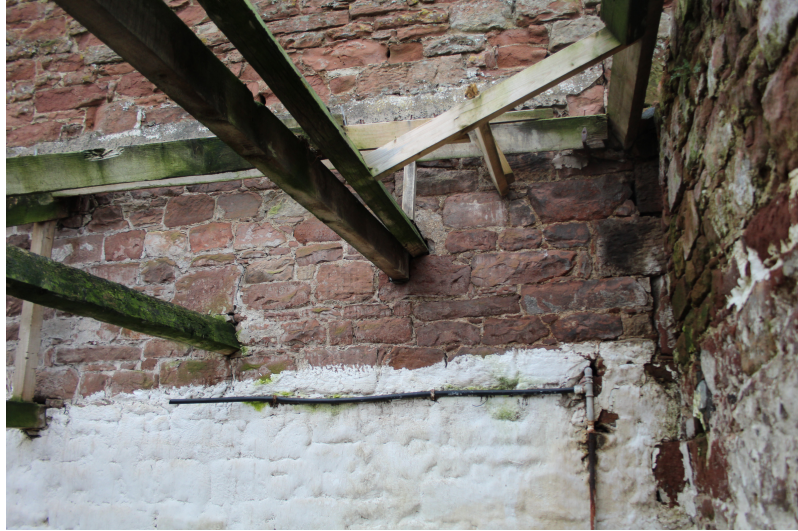
North wing looking west with new roof on existing truss
