## Bat Emergence and Re-Entry Surveys (BERS)

Sneckyeat Farm, Hensingham, Whitehaven, Copeland, Cumbria, CA28 8XZ

The conversion of the existing barn into a residential dwelling.

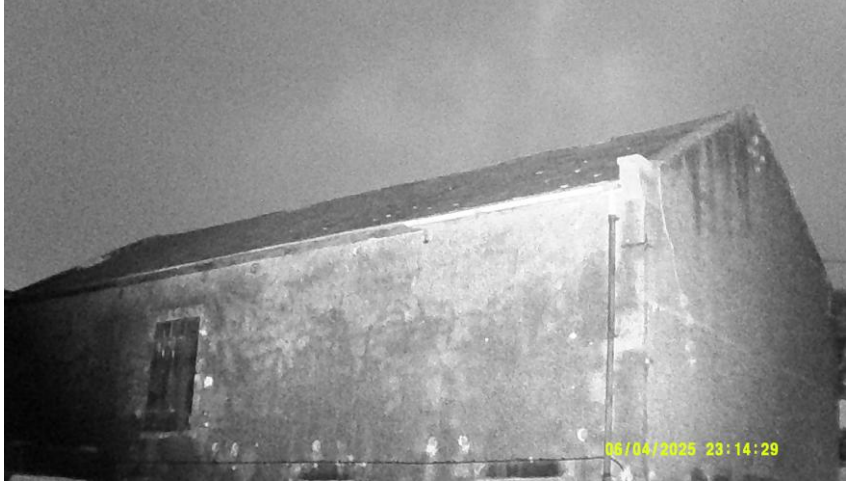
| Surveyor 1 | | <b>No emergence or re entries recorded</b><br>The first and only bat activity recorded was a heard but not seen (HNS) pass by a common pipistrelle (Cpip) at 22:14. | | | | |

| <i>IR position 1</i> | IR reflects surveyors position and notes. | An infrared (IR) photograph of a large, dark building at night. The building's roofline and walls are visible, with some lighter patches on the wall. A timestamp in the bottom right corner reads "06/04/2025 23:14:29". |

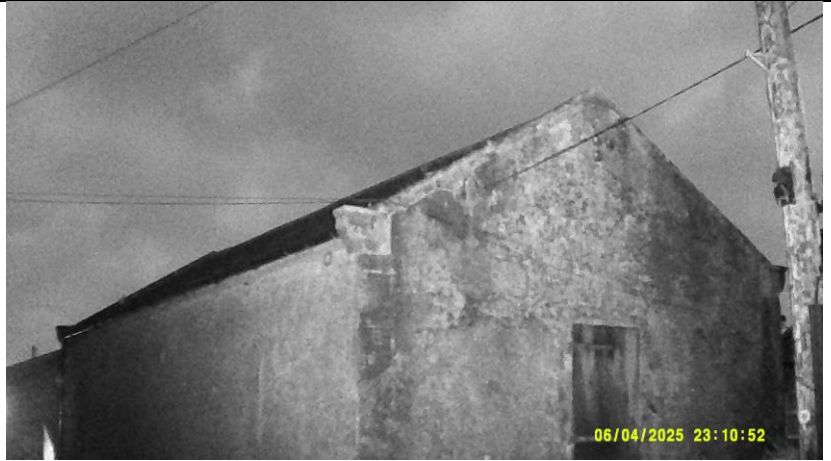
| <i>Surveyor 2</i> | <b>No emergence or re entries recorded</b><br>The first activity recorded was a HNS pass by a noctule (N).<br>At 22:06 and 22:14 HNS passes by Cpip's were recoded.<br>The final activity recorded was a pass by a Cpip at 22:46.<br>The bat was seen in a northern direction above the road which runs along the north eastern boundary of B1. | A daytime photograph of a large, weathered stone building with a gabled roof. A gravel driveway leads to the building, and a black car is parked nearby. A utility pole is visible on the right side of the frame. The sky is overcast. |

| <i>IR position 2</i> | IR reflects surveyors position and notes | |

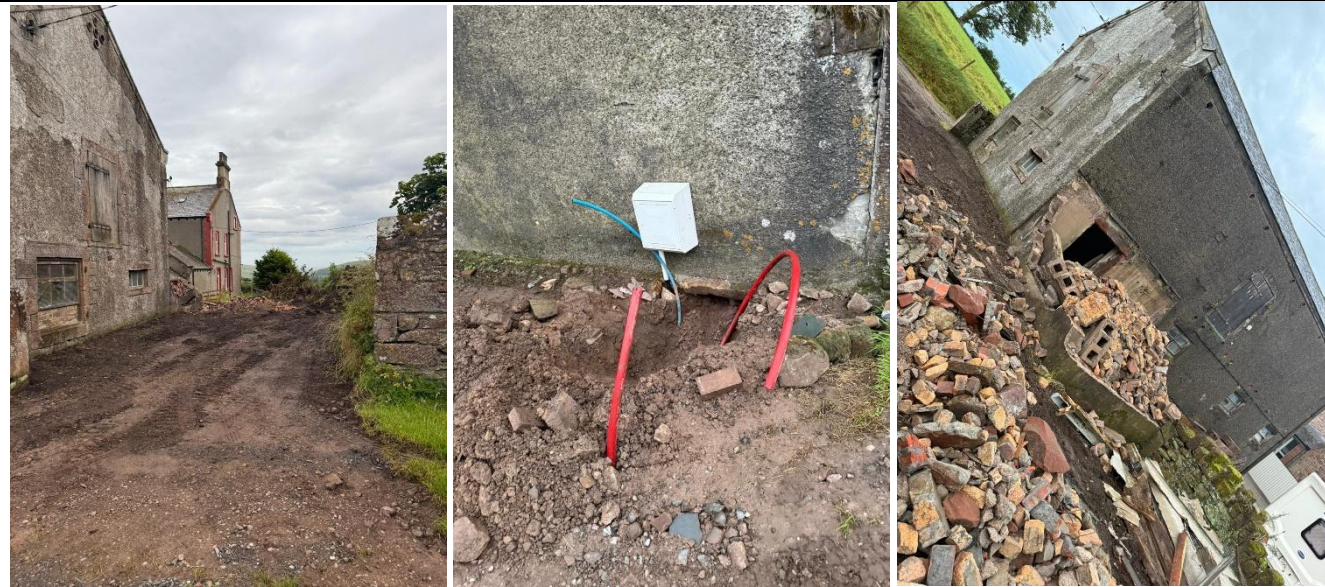
| <i>Building inspection prior to survey</i> | Demolition works to the single-storey, mono-pitched breeze block structure had been undertaken prior to the second survey and without Arbtech's knowledge. In addition, groundworks, including the laying of service pipes, had been carried out around the exterior of the building. While the full extent of the impact cannot be known with certainty, given the lack of bat activity during the proviso survey and sub-optimal features previously described on this section of building it is considered unlikely that the demolition works have negatively impacted bat use on the site. | |

Figures 1-3 above showing evidence of demolition and ground works on site.

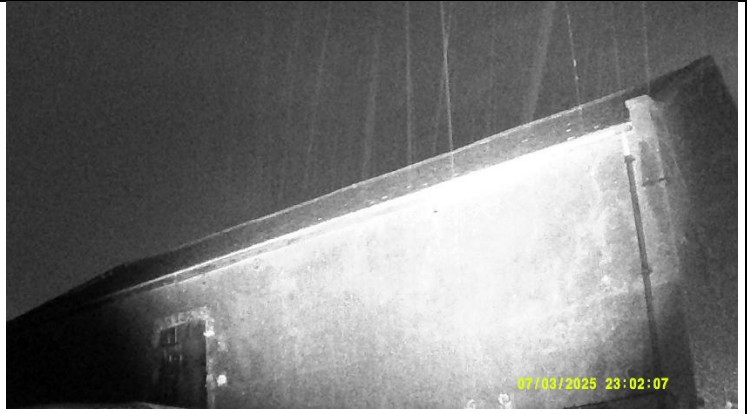
| Surveyor 1 | <b>No emergence or re entries recorded</b><br>The first activity recorded was a pass by a Cpip at 22:25. A bat was briefly seen passing along the road to the north east of B1. At 22:28, 22:31 and 22:32 HNS passes by Cpips were recorded. Further HNS calls by Cpip’s were recorded at 22:57, 23:02 and 23:04.<br>No further activity recorded. | | | |

| <i>IR position 1</i> | IR reflects surveyors position and notes | |

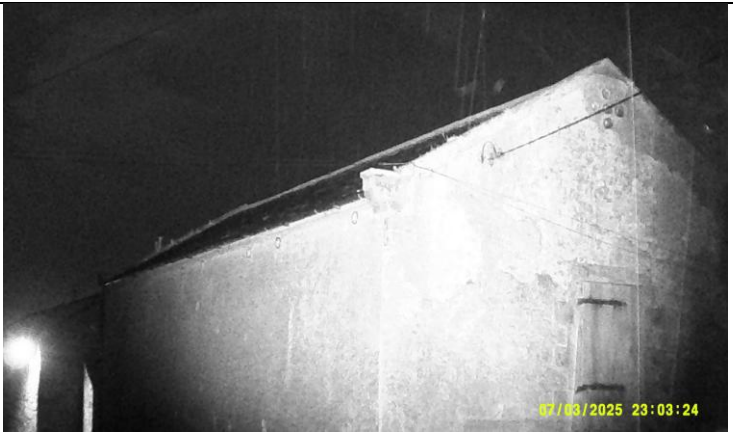
| <i>Surveyor 2</i> | <p><b>No emergence or re entries recorded</b></p> <p>The first activity recorded was a pass by a Cpip at 22:25. The bat was noted flying in a northern direction above the road which runs along the north eastern boundary of B1. At 22:27 a second bat followed the same flight path.</p> <p>At 22:31 and 22:33 a Cpip was recorded flying in a southerly direction and continued to the north of B1 following the boundary of the road and the adjacent fields.</p> <p>The final bat activity recorded was a HNS pass by a Cpip at 22:57.</p> | |

| <i>IR position 2</i> | IR reflects surveyors position and notes | |
