**Re: Calder Town End – Update Barn Owl Tyto alba Survey****Background**

A Preliminary Ecological Appraisal<sup>1</sup> (PEA) completed at Calder Town End (the 'site') identified a likely Barn Owl nest site within the 'Stone Barn' (a nest box), along with much evidence of recent presence (pellets/droppings/feathers).

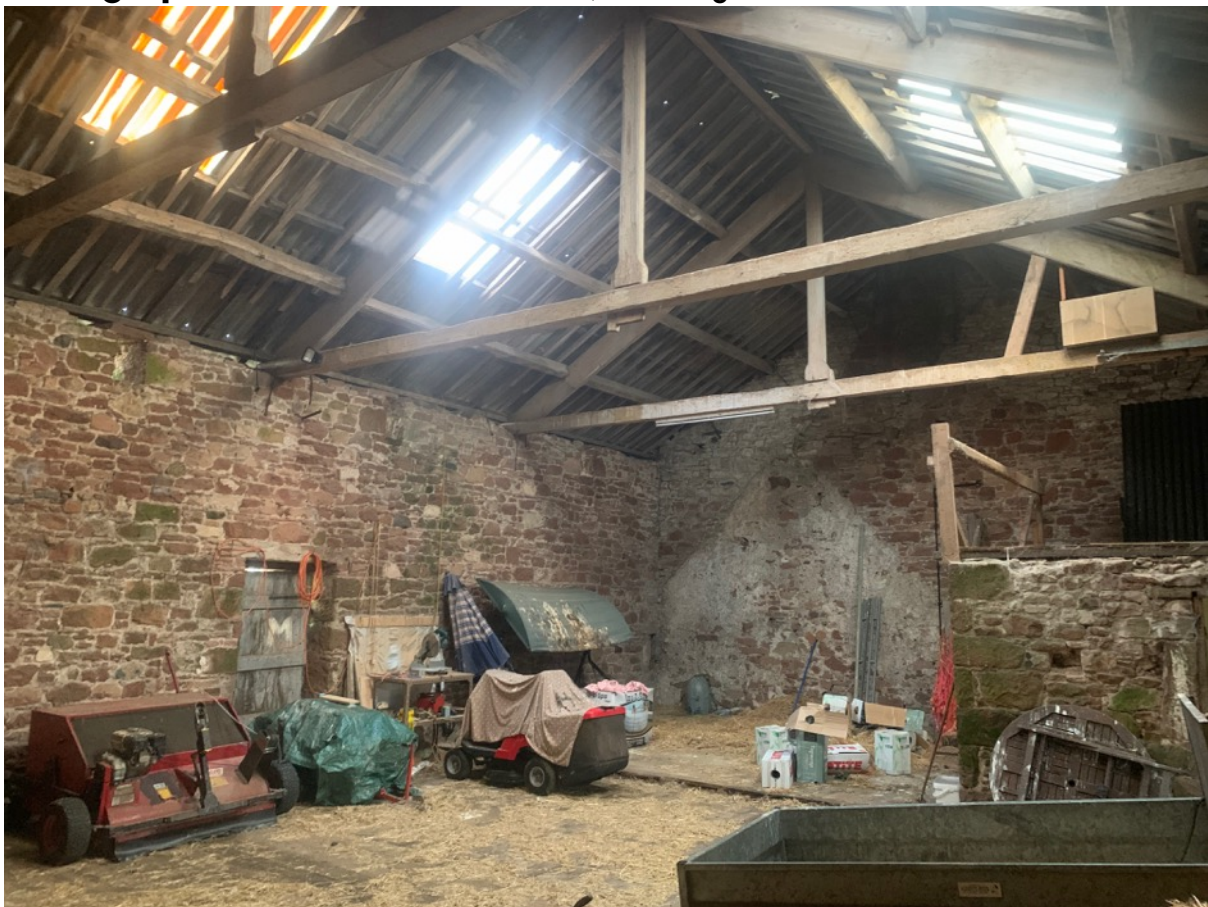
Within the barn, around 50 mixed-aged Barn Owl pellets were present although none appeared recent<sup>2</sup> (i.e. within the last eight months). Two Tawny Owl *Strix aluco* pellets were also present. Three Barn Owl feathers and much dropping evidence was also observed. No Barn Owls were present.

**Photograph 1.** Interior of 'Stone Barn', showing Barn Owl next box

Once these boxes are erected, the nest box present within the Stone Barn should be removed, and, if possible access to other potential nesting sites prevented (ensuring that no Barn Owls are harmed, i.e. through entrapment) .

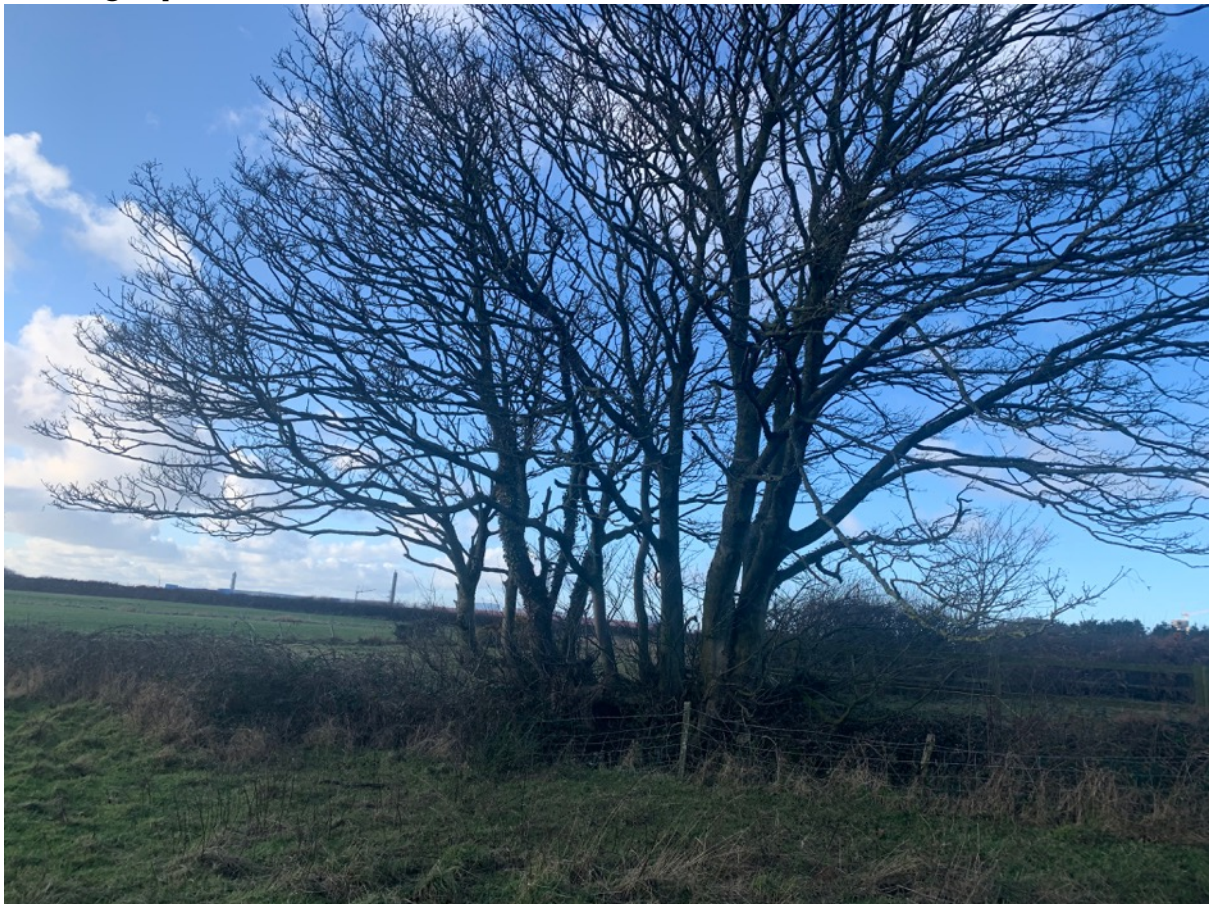
**Photograph 2.** Tree to south of site where a Barn Owl nest box should be sited

- on a tree located approximately 30m south of the Stone Barn (**Photograph 2**), and
- within a cowshed at Calder Town End Farm to the northwest of the site (**Photograph 3**), or, on the exterior south facing wall of Stangs Cottage (located to the south of Calder Town End Farm).

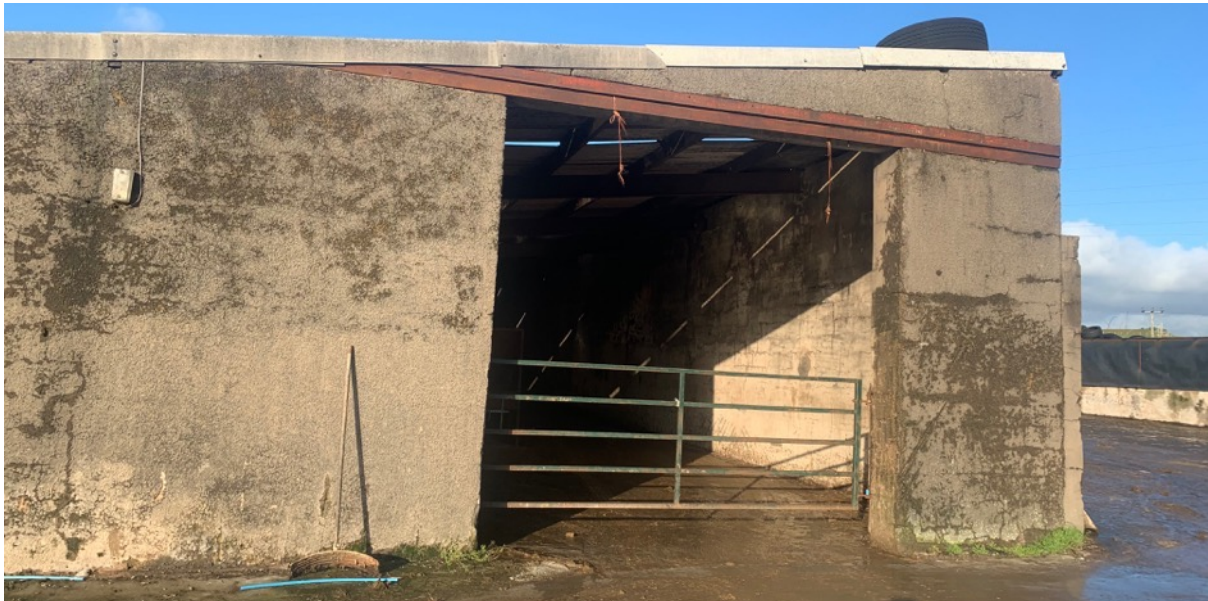
**Photograph 3.** Barn at Calder Town End Farm where a Barn Owl nest box could be sited
