The farmstead layout appears to conform to a range of buildings attached in a line. Single storey Buildings 1-3 probably form the earliest range, subsequently extended northwards with the addition of Buildings 4-6 that were of two stories.

The proposed scheme of demolition advocated by the client (planning application 2021/2255) has the potential to affect the character and appearance of a suite of buildings that represents a non-designated historic asset of special architectural and historic interest; in this case the demolition of a range of stone cottages and barns. The project lies within the curtilage of a plot synonymous with 18<sup>th</sup> and 19<sup>th</sup> century buildings

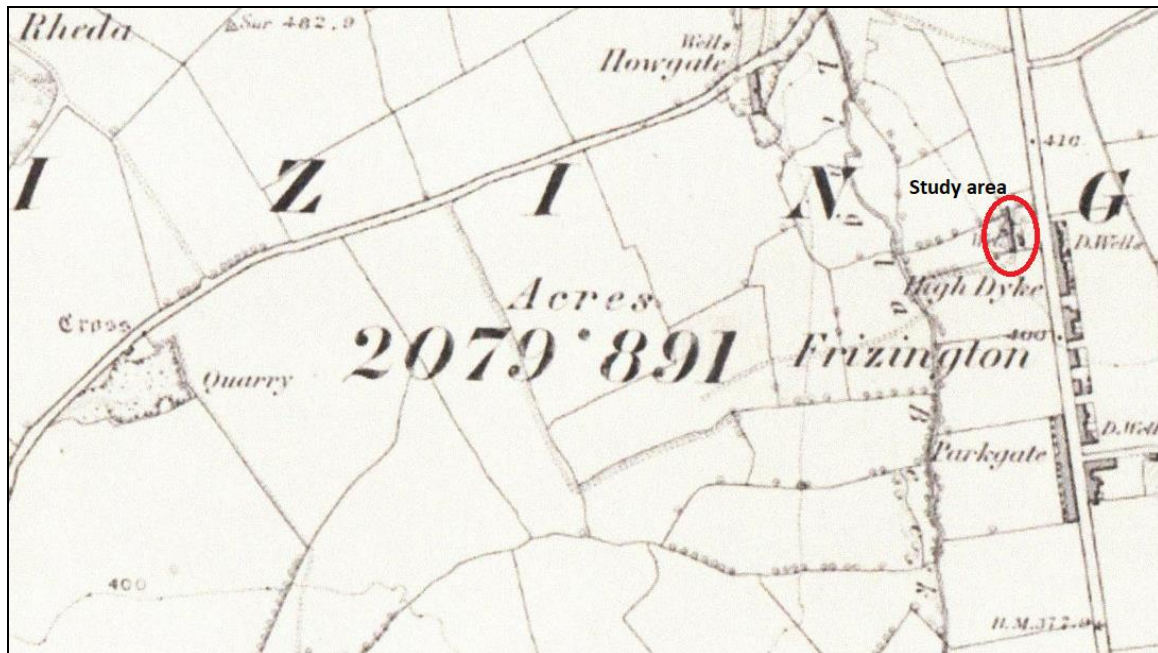
Figure 3. Ordnance Survey map of 1863

The first edition Ordnance Survey map surveyed in 1863 (figure 3) described the study area as High Dyke comprising a range of buildings forming a terrace that respected the main road. A map of 1860 (YBSC/21/2/15/1) describes the study building as Holly Dyke.

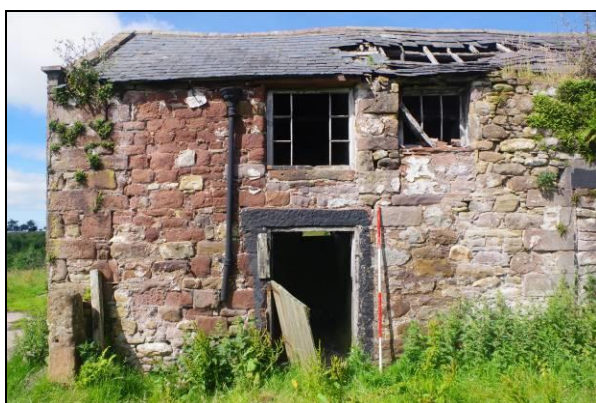
Figure 5. Eastern elevation of Building 1

Building 1 represented a stone byre with overhead accommodation and comprised two rooms (Rooms 1 and 2). The eastern elevation measured 3.10m in height to the north falling to 3.47m in height to the south and 11.78 in length. It was flanked by stone quoins (0.60m x 0.25m) at each end (twelve to the south, ten to the north), exposing random rubbles-stone courses of red sandstone (figure 5). Roughcast cement on the southern gable end measuring 5.33m in width masked any possible detail (figure 6). The slate roof was surmounted by a red sandstone ridge.

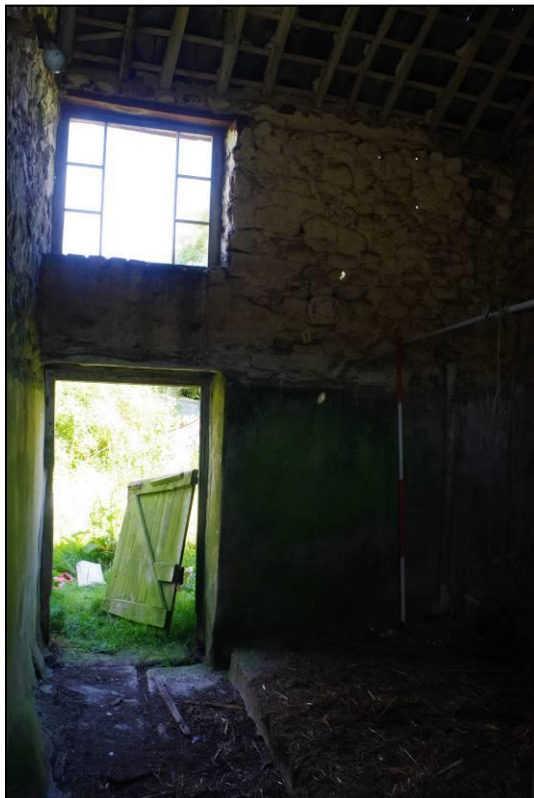
Figure 8. Room 1, Building 1

Room 1 measured 4.14m x 3.07m and stood to a height of 4.87m. The roof was formed from hand-made rafters and purlins with a slate covering, partly replaced by corrugated metal sheet (figure 8).

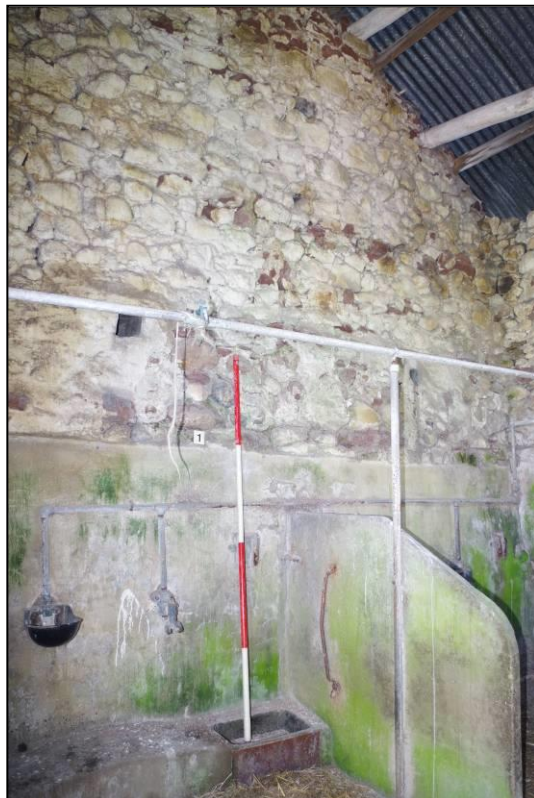
Figure 9. Cement stalls in the byre

There existed a later ground floor rear window measuring 0.86m in height and 0.83m in width. This action probably occurred with the later conversion to a byre. Two cement constructed stalls measuring 1.45m in height and 2.15m in width were present on the southern flank of Room 1 (figure 9). A trough was present within each stall (figure 10). The floor was formed from concrete.

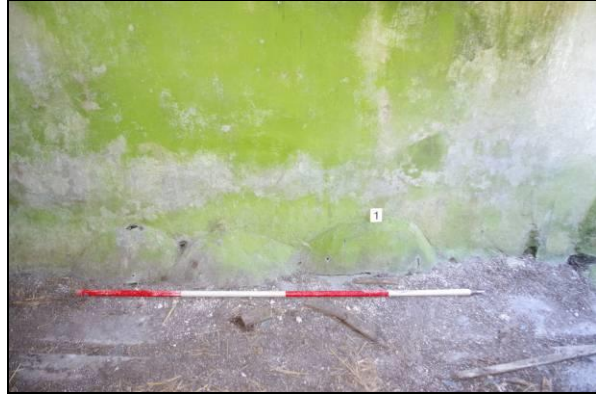
Figure 11. Stone plinth on northern wall

Beneath the northern wall were three rounded boulders forming a plinth or pedestal to Room 2. This may represent an earlier phase of building similar to the base of a clay dabbins structure, albeit distant from the Solway Plain where this typology is common (figure 11).

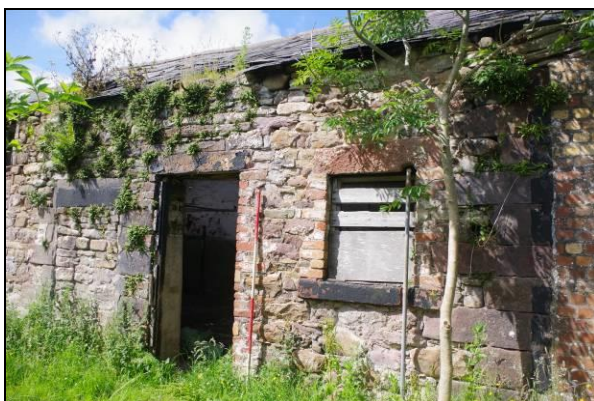
Figure 12. Elevation to Room 2

Room 2 has probably been remodelled and overlaps Buildings 1 and 2. In its later use, it served as a byre measuring 7.11m x 4.24m and 4.32m in height. The elevation identified the following architectural elements (figure 12):

- A stone-filled doorway measuring 1.12m in width and 1.85m in height formed from red sandstone quoins.
- A brick-outlined doorway, measuring 1.12m in width and 2.16m in height.
- A window with a brick surround, measuring 0.78m in width and 0.66m in height.

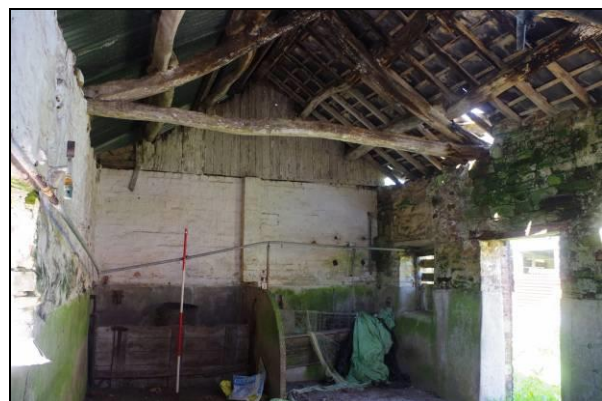
Figure 13. Interior to Room 2 looking north

The northern end wall with Room 3 was made of brick and had encroached into Building 2. The roof was formed from hand-made rafters and purlins with a slate covering, partly replaced by corrugated metal sheet. There existed two trusses lacking king posts (figure 13).

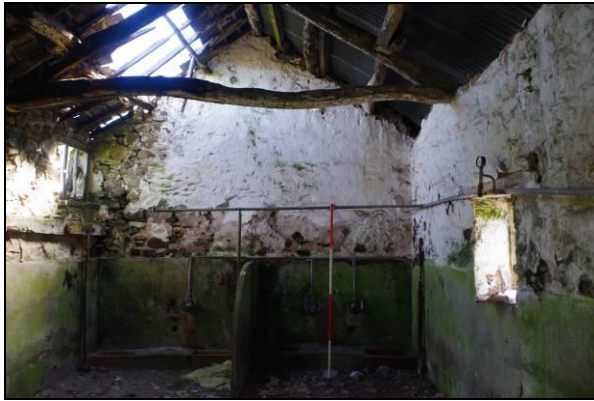
Figure 14. Southern end of Room 2, Building 1

A first floor window probably indicated a lost first floor. The room was white-washed with a cement render to the lower part of the wall fabric. The byre yielded two sets of cement-made stalls measuring 1.24m in height, 2.07m in width and a depth of 2.09m (figure 14). The floor was formed from concrete.

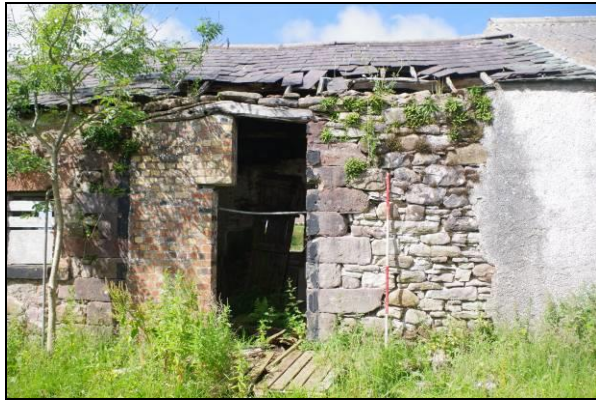
Figure 15. Entry to the threshing barn, Building 2

Building 2, a threshing barn was not immediately obvious as the central doorway had been partially infilled with brick (figure 15). The large central doorway measuring 2.83m in height and 2.14m in width and possessing a wooden lintel, yielded no jutting porch. Formed from ten dressed stone quoins, it was 2.40m south of Building 3 and it was a probable similar distance from Building 1, the partition now subsequently lost (figure 7). The eastern elevation measured at least 5.23m in length, most probably, approximately 7.63m in length. The roof was supported by a single truss.

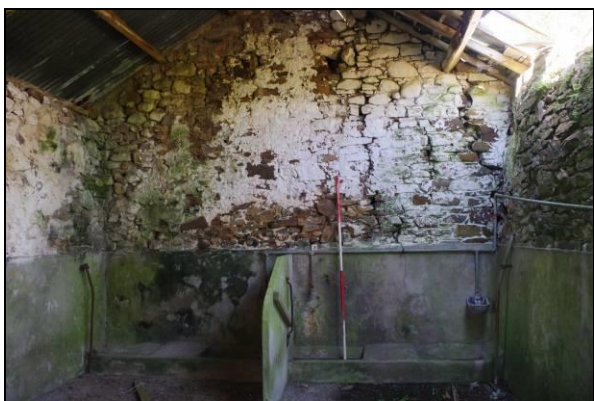
Figure 16. Northern end of Room 3, Building 2

Room 3 measuring 5.34m in length, 4.18m in width and 4.19m in height represented a later byre finished in white-wash. On the northern flank, two cement-built stalls had been inserted measuring 2.13m in width, 1.36m in height and 2.12m in depth (figure 16). The southern brick wall was plain with a door measuring 1.03m in width and 1.63m in height providing a backdraught for the former threshing barn. The floor was formed from concrete (figure 17).

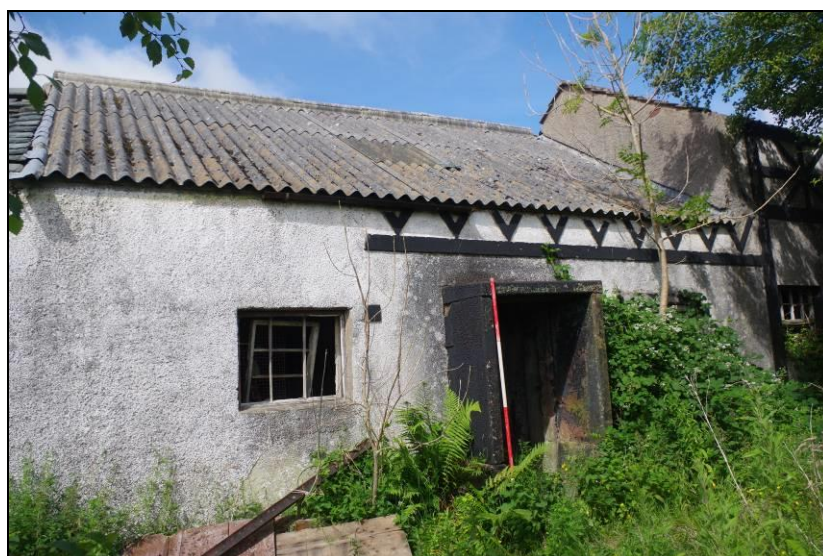
Figure 19. Facade of Building 3

The elevation identified the following architectural elements (figure 19):

- A porch with sides 0.11m in thickness surrounding a main door measuring 1.04m in width and 1.84m in height.
- A window measuring 0.90m in width and 0.77m in height.
- A window measuring 1.04m in width and 0.87m in height.

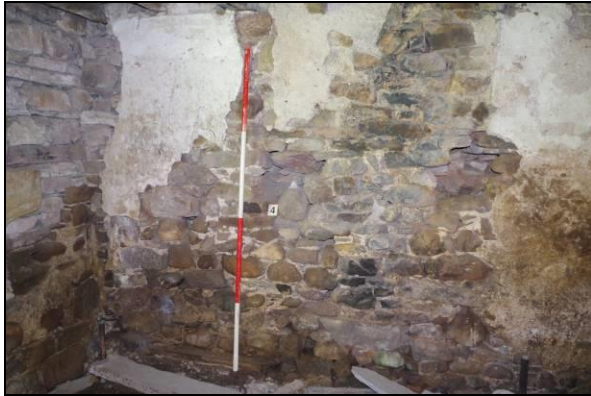
Figure 20. Room 4, the parlour, Building 3

Room 4 measuring 3.78m in length, 2.47m in width and 2.17m in height represented a parlour (figure 20). To the left off a cross passage behind a stone partition wall, the room was entered by a doorway measuring 1.01m in width and 1.83m in height (figure 21). The room was finished in white lime plaster and possessed a flagstone floor with a wooden ceiling. Illuminated by a single eastern window, there were no other remnant architectural features.

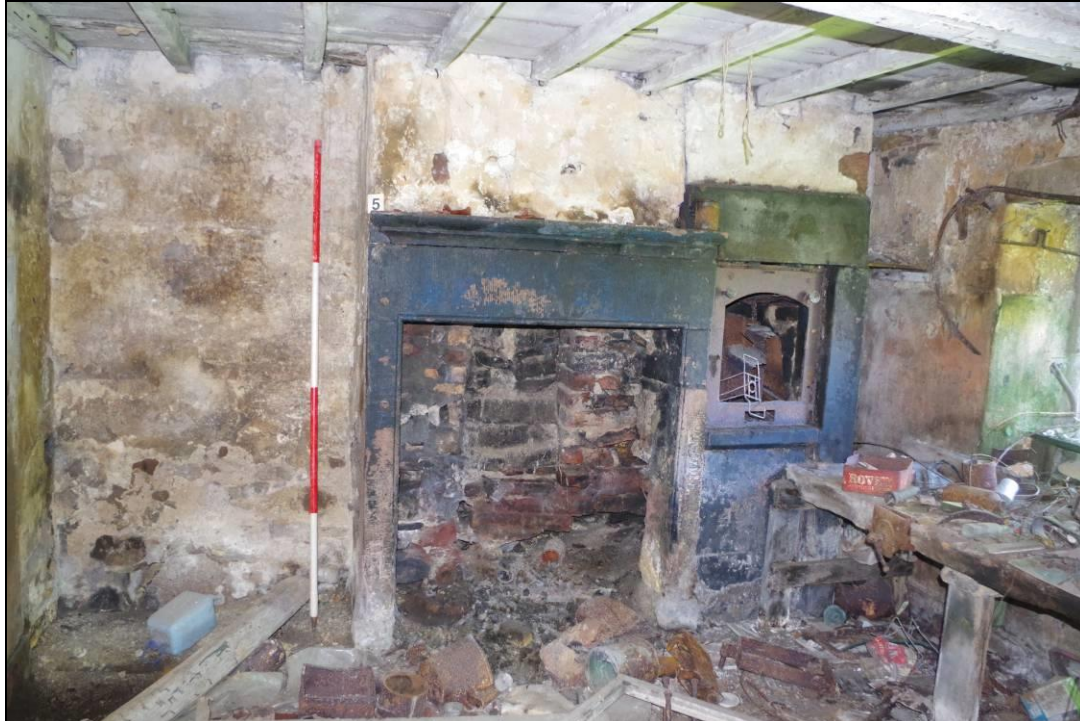
Figure 22. Room 5, the kitchen, Building 3

Room 5 measuring 4.11m in length, 3.68m in width and 2.24m in height represented a kitchen (figure 22). A range now removed would have filled a recess measuring 2.11m in width, 1.48m in height and 0.50m in depth and included a later bread oven. The room was finished in white lime plaster and possessed a flagstone floor with a wooden rafted ceiling. Illuminated by a single eastern window with a flanged rebate, there were no other remnant architectural features.

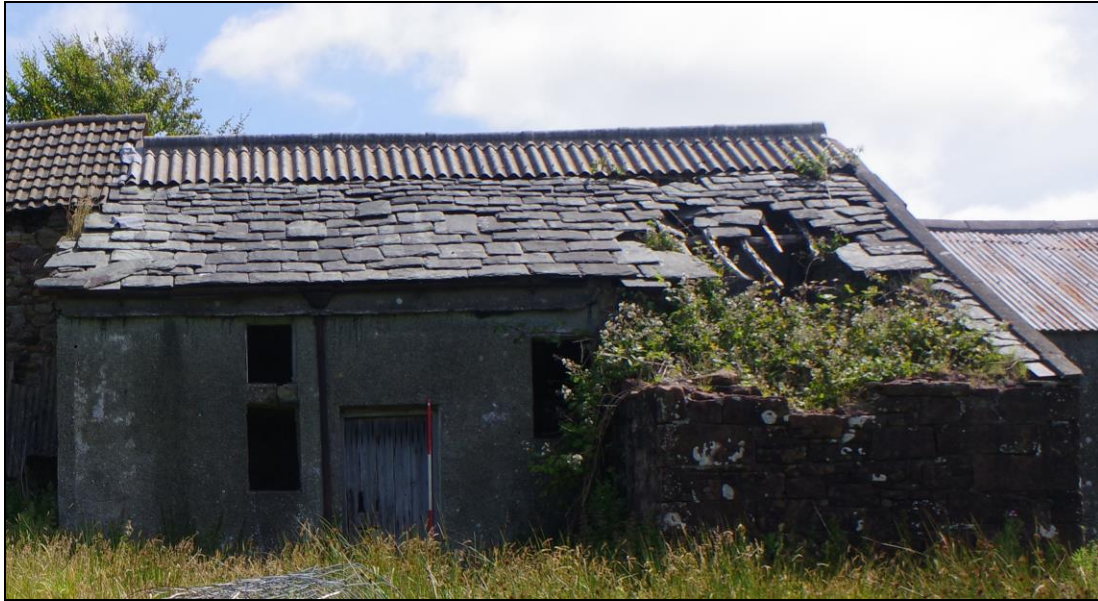
Figure 23. Outshut to Building 3

Room 7 measuring 3.01m in length, 1.76m in width and 2.00m in height represented a pantry, partly constructed in brick within a later outshut that was lit by a rear window, lacking a grille and measuring 0.47m in width and 0.77m in height. The outshut also possessed a back door measuring 0.88m in width and 1.94m in height (figure 23) and a flagstone floor

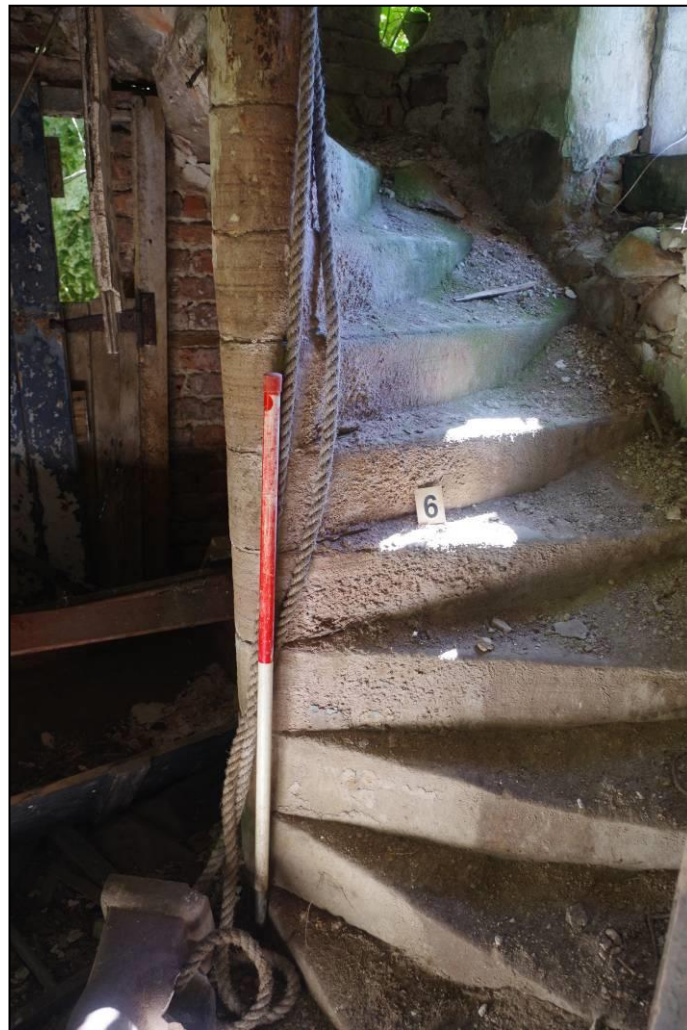
Figure 24. Spiral staircase, Room 6, Building 4

Room 6 measuring 2.14m in length, 2.02m in width and 1.91m in height represented a stairwell within a later outshut with a wall thickness of 0.50m that possessed a slate, cat-slide roof (figure 23). An extant spiral staircase possessed ten worn stone steps (figure 24) and was lit by a single window

measuring 0.58m in width and 0.89m in height in which two iron bars had formerly been held forming a grille.

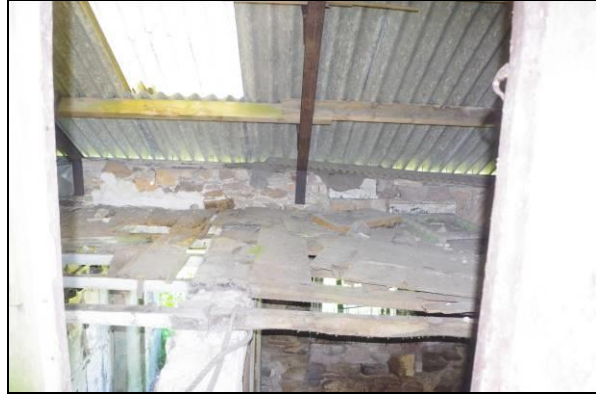
Figure 26. Room 8, a bedroom, Building 3

Room 8 was inaccessible and structurally dangerous. Formerly Room 8 had represented two separate bedrooms, seemingly lacking windows, although the corrugated roof was a relatively recent addition probably added following wall collapse (figure 26).

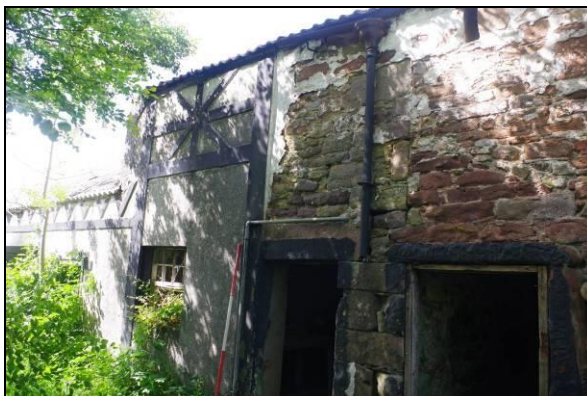
Figure 27. Elevation of Building 4

Building 4 represented a two storey extension to the cottage spread over two floors (Rooms 10 and 13). The roof was replaced with asbestos cement corrugated sheet. The elevation measured 4.30m in length (figure 18) and was framed by fourteen stone quoins on its northern gable end.

The red sandstone fabric was partly finished in roughcast with faux timber painted black cement relief forming a “union jack” pattern.

The elevation identified the following architectural elements (figure 27):

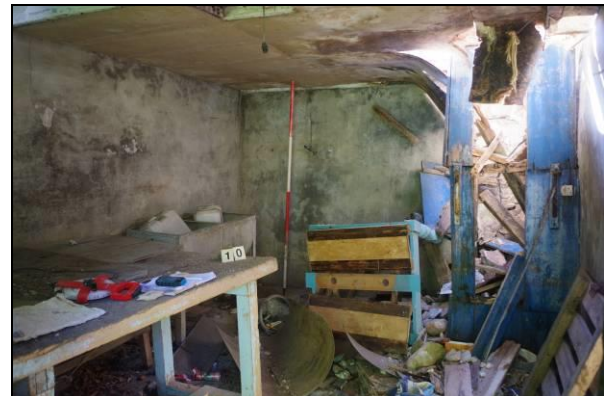
Figure 28. Room 10, a store, Building 4

Room 10 represented a store measuring 3.75m in length, 3.04m in width and 2.09m in height. It possessed cement rendered walls and a concrete floor (figure 28) and was surmounted by a hayloft above.

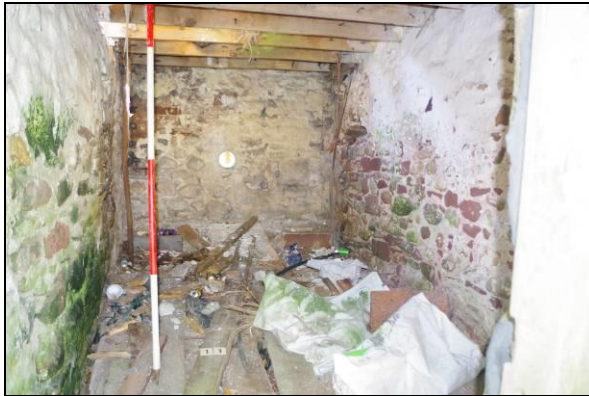
Figure 30. Room 11, a store, Building 5

Room 11 represented a store measuring 4.12m in length, 1.95m in width and 1.96m in height. It possessed white-washed walls and a concrete floor (figure 30) and was surmounted by a hayloft above.

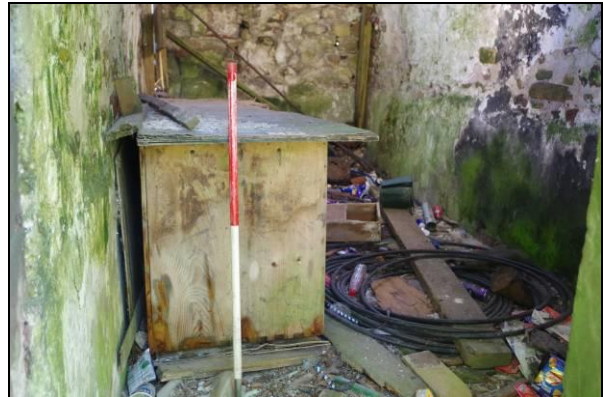
Figure 31. Room 12, a store, Building 5

Room 12 represented a store measuring 5.31m in length, 2.26m in width and 1.86m in height. It possessed white-washed walls and a concrete floor (figure 31) and was surmounted by a hayloft above. A door measuring 0.90m in width and 1.77m in height provided access into Room 14. Room 12 possessed a small outshut at the rear.

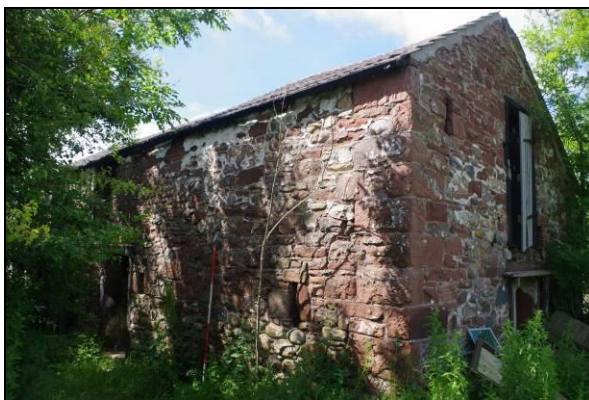
Figure 32. Elevation of Building 6

The elevation identified the following architectural elements (figure 32):

- An air vent measuring 0.13m in width and 0.50m in height formed from red sandstone slabs.

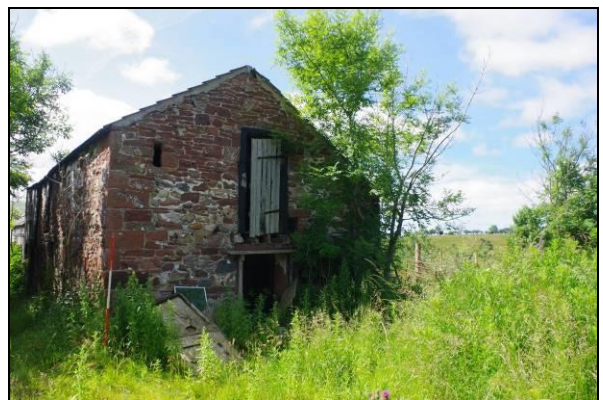
Figure 33. Northern gable end of Building 6

Building 6 represented a two storey barn extension spread over two floors (Rooms 13 and 14) formed from red sandstone rubble-stone. The roof was replaced with modern tiles. The elevation measured 3.73m in length (figure 29) and was framed by eleven stone quoins measuring 0.60m x 0.32m bonded by a white chalky mortar on its northern gable end (figure 33).

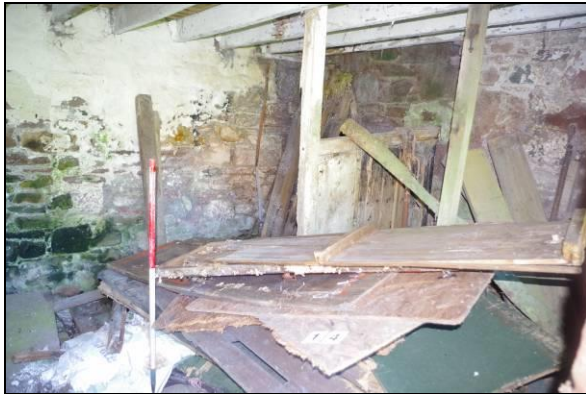
Figure 34. Room 14, a stable, Building 6

Room 14 represented a stable, measuring 5.11m in length, 3.30m in width and 1.94m in height. It possessed white-washed walls, a brick floor and two sets of wooden stalls on a raised dias (figure 34). Room 14 was illuminated by a single window measuring 0.68m in width and 0.53m in height.

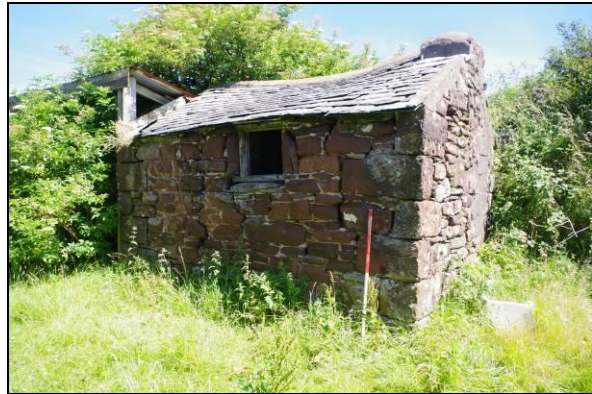
Figure 35. Stone outbuilding

A rectangular plan stone hut measuring 3.83m in length, 2.97m in width and 1.82m in height possessed a slate roof and a slighted chimney with a fireplace. Illuminated by a small window measuring 0.58m x 0.58m there was no access to the interior of the building (figure 35).

A small stone hut (figure 35) had no obvious function other than accommodation for workmen.

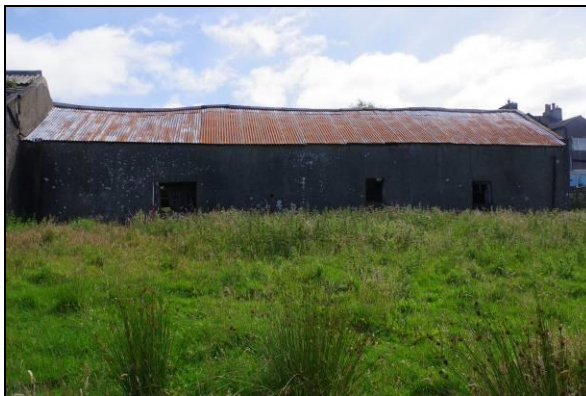
Figure 36. Western elevation Buildings 1 and 2

The western elevation illustrated the full range of the six study buildings. Buildings 1 and 2 appeared to possess a uniform roof-line replaced with corrugated metal sheet (figure 36). A cement render had been applied to Buildings 1 to 3. It is possible that originally Buildings 1-3 were part of a longhouse tradition whereby human habitation occurred at one end with animals kept within the same range.

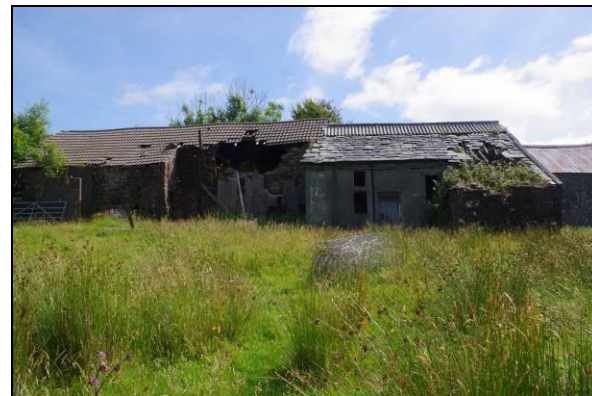
Figure 37. Western elevation Buildings 3 to 5

The western elevation depicted an outshut jutting out of Building 3. Inaccessible to the surveyor, and measuring around 2.50m x 3.00m and standing to a height of 1.80m, the outshut contained a window measuring 0.50m in width and 0.70m in height (figure 37).
