**REPORT C8049  
MARCH 2021**

**GEOENVIRONMENTAL APPRAISAL**

**Of land at  
CLEATOR MOOR ROAD, WHITEHAVEN, CUMBRIA**

**Prepared for  
GLEESON REGENERATION LTD**

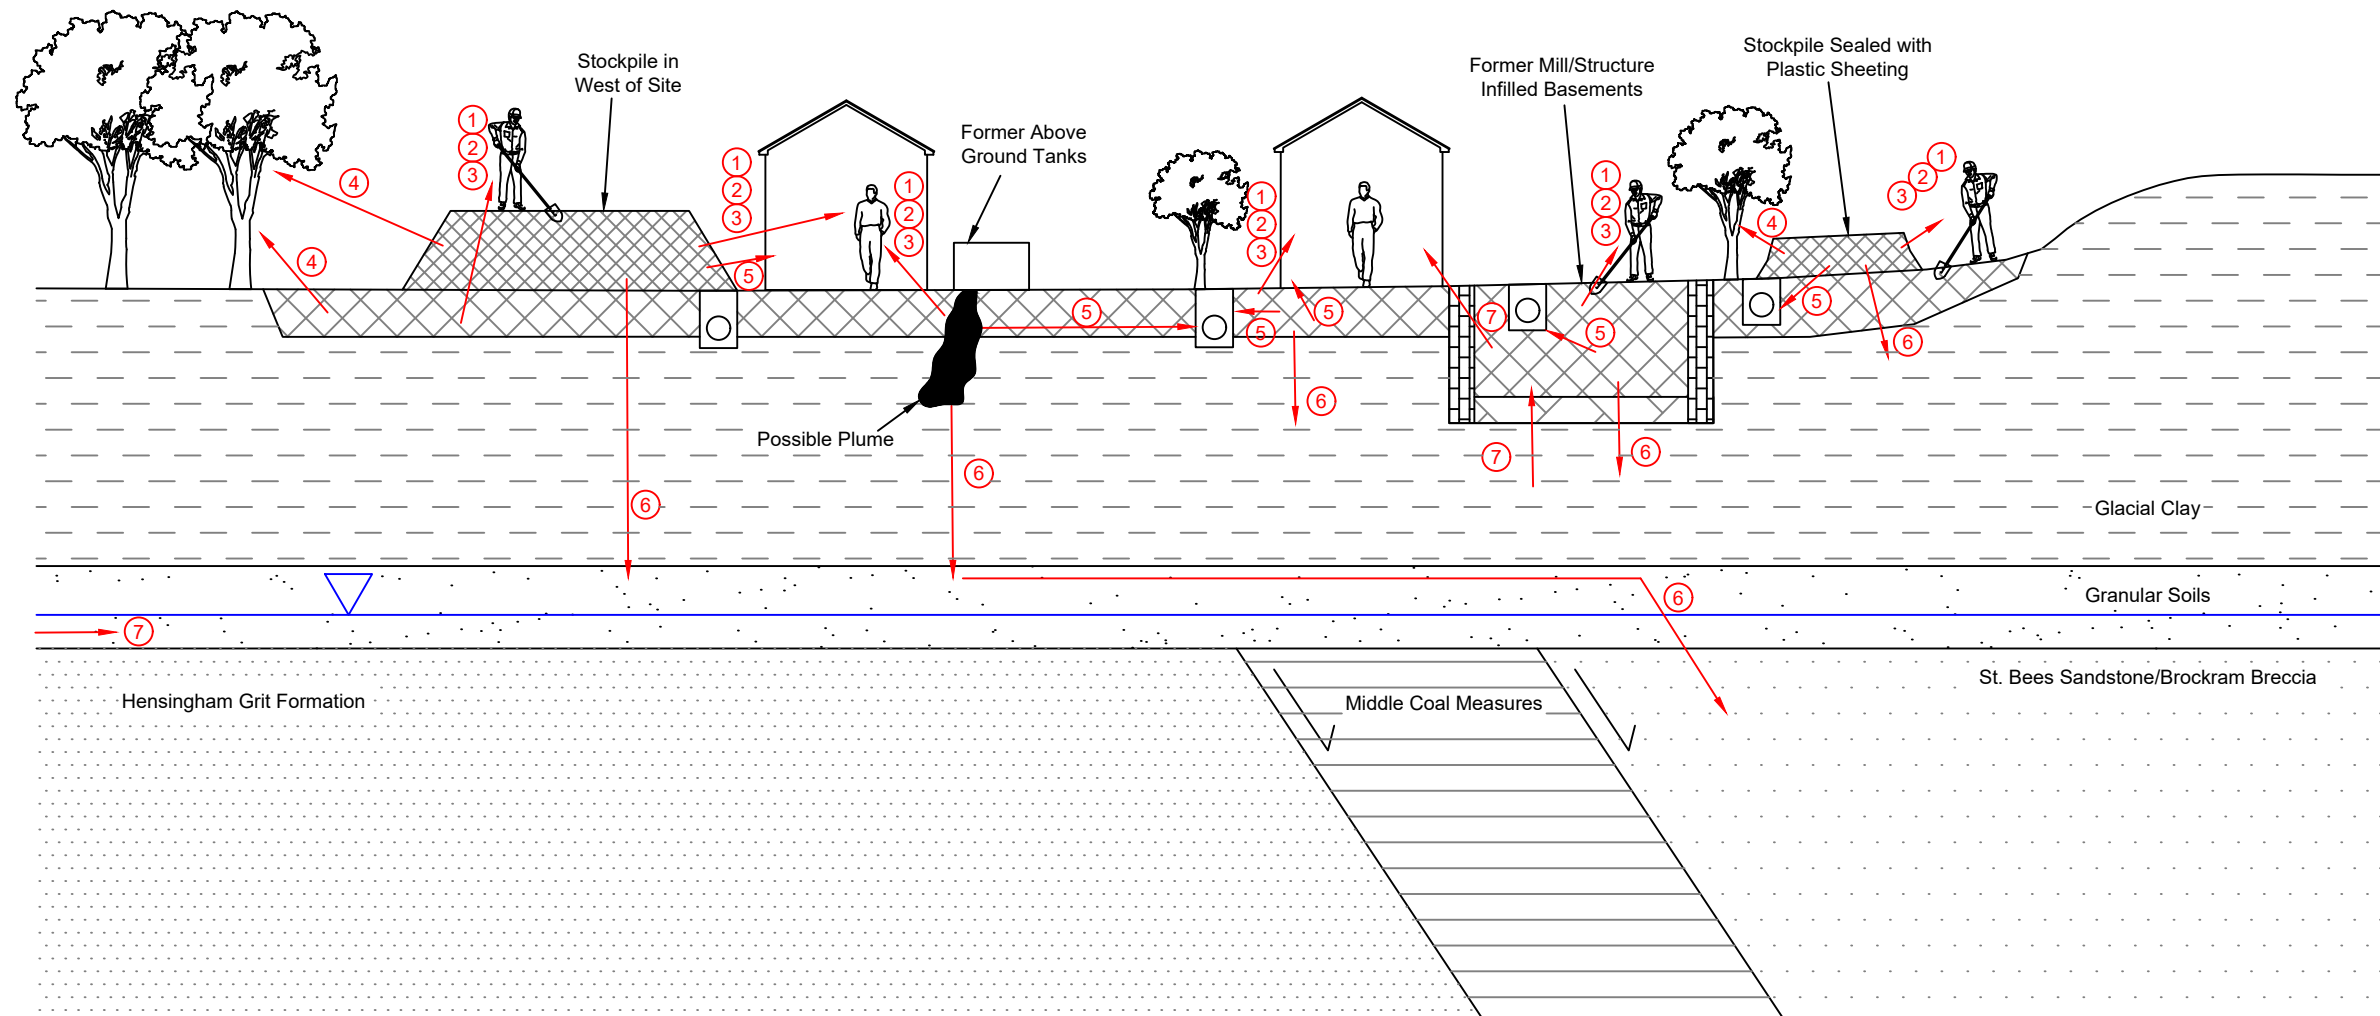
| Contamination Source | Contamination Pathways | Potential Receptors | Likelihood of Significant Pollutant Linkage |
| Metals, PAHs, organic and inorganic contaminants including asbestos in general <b>made ground</b> across site, including anticipated demolition filled basements, associated with previous use as a mill | 1. Direct and indirect ingestion | End users | Moderate |

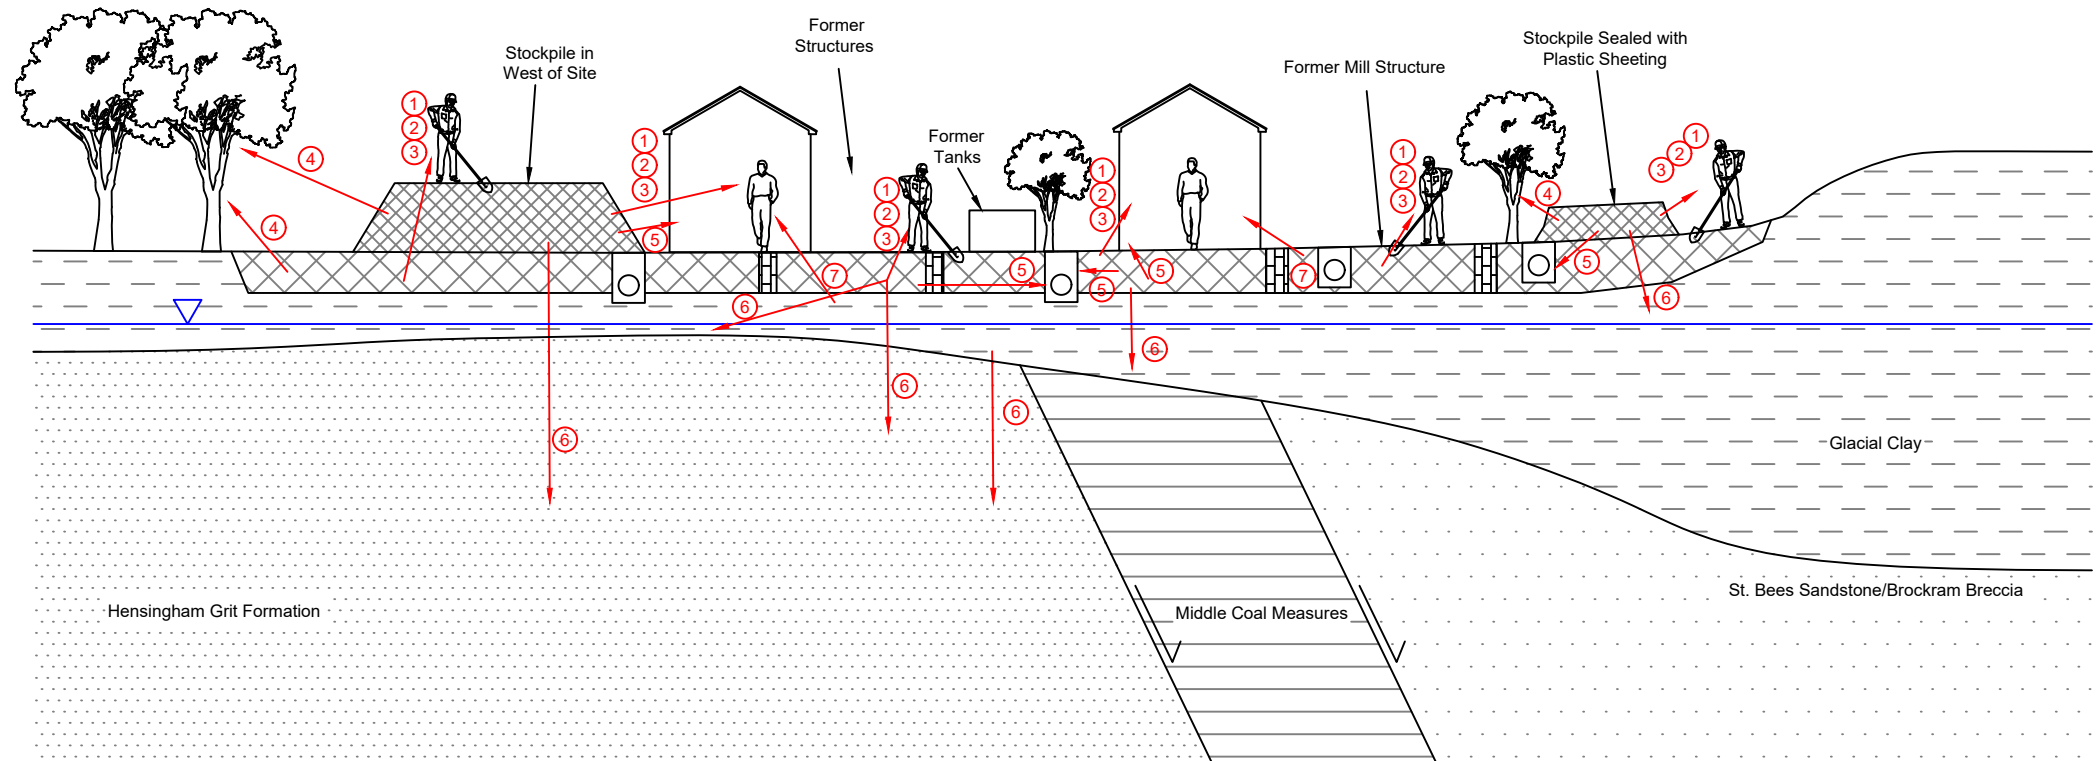
| Contamination Source | Contamination Pathways | Potential Receptors | Likelihood of Significant Pollutant Linkage |
| High (alkaline) pH values in general made ground across site. | 1. Direct and indirect ingestion | End users | Moderate |

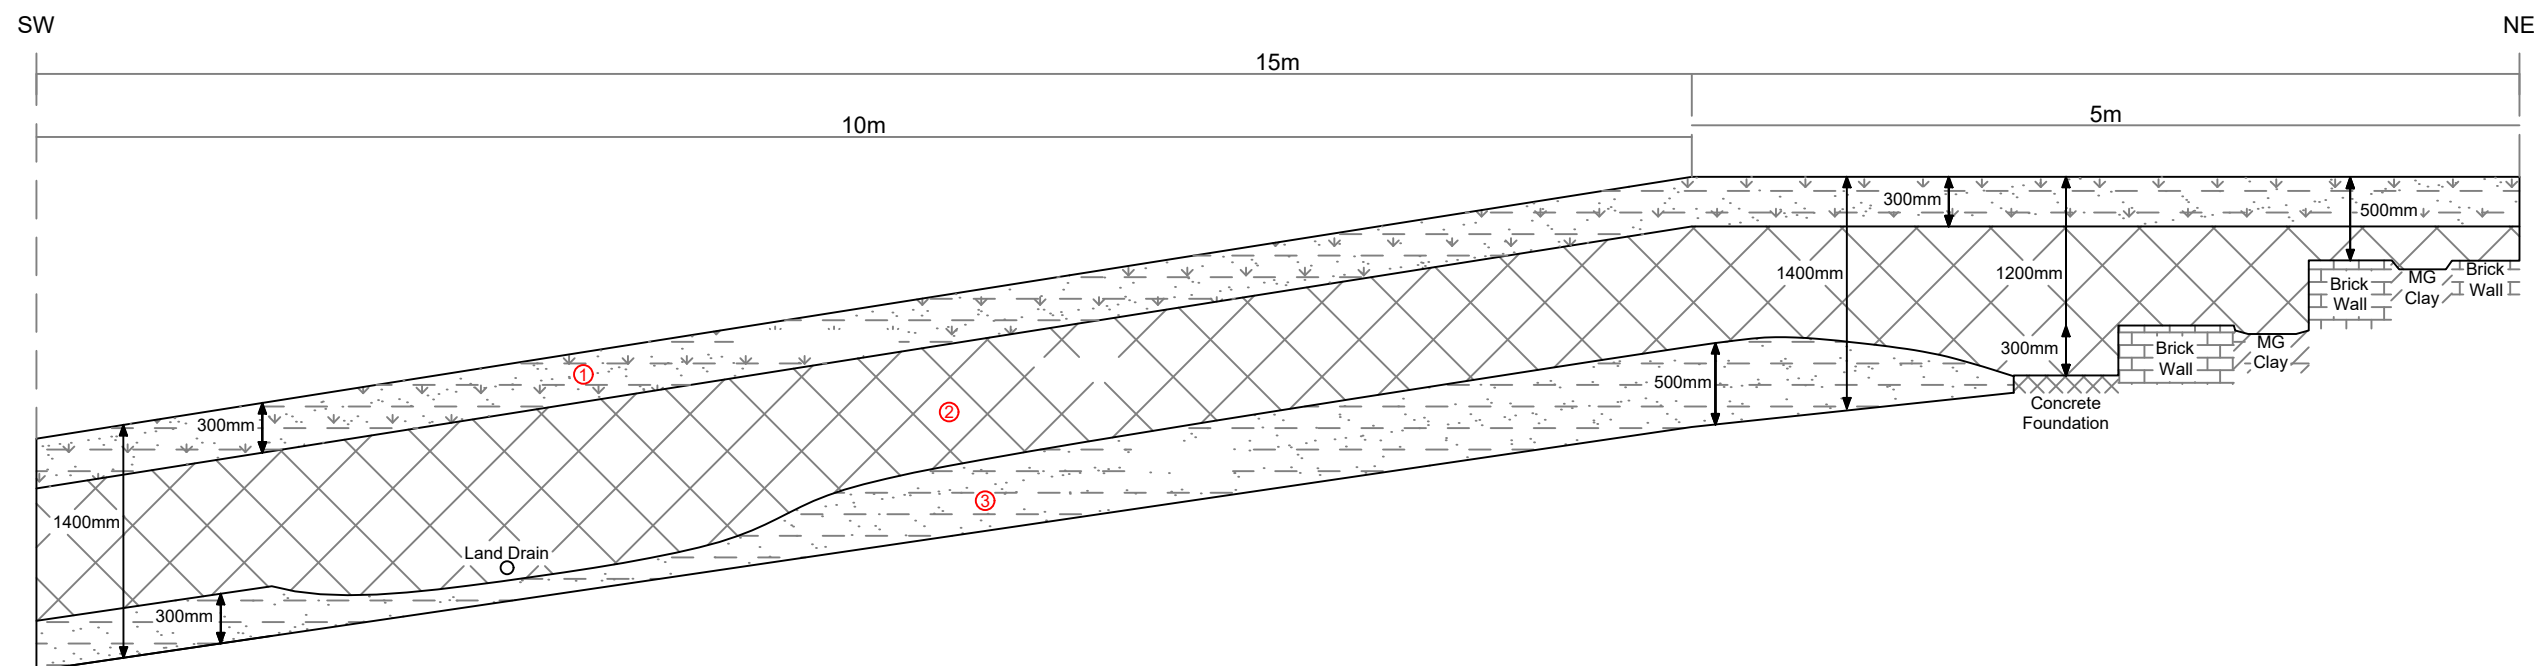
- ① MADE GROUND: Soft low strength orangish brown gravelly slightly sandy CLAY of low plasticity with rootlets. (Topsoil)
- ② MADE GROUND: Soft and firm friable brown sandy very clayey subangular to angular GRAVEL AND COBBLES
- ③ Firm to stiff medium strength orange brown mottled red and grey gravelly sandy CLAY.

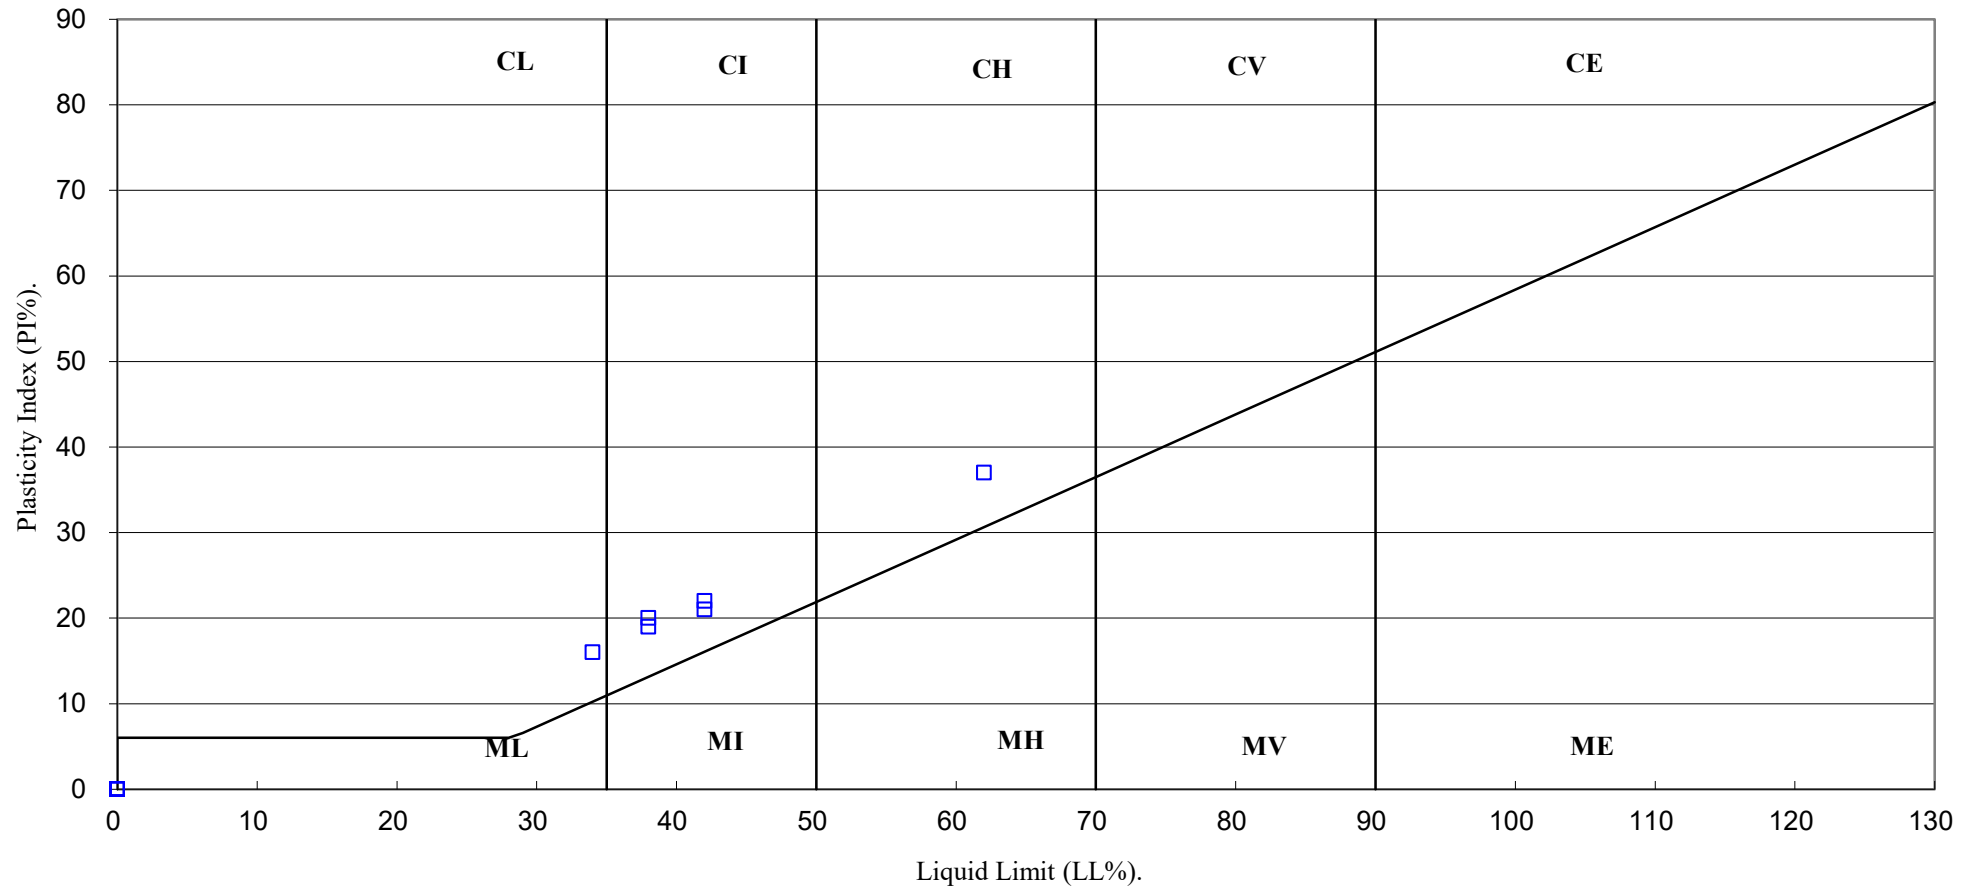
# PLASTICITY CHART FOR CASAGRANDE CLASSIFICATION.

Atterberg Limit determination undertaken on five samples indicate the material to be clay of low and intermediate plasticity, with liquid limits ranging from 34% to 41%, plastic limits ranging from 18% to 21%, and plasticity indices from 16% to 22%. The natural moisture content of the tested soils ranged from 13% to 26%.

A single sample of clay, recovered from beneath the stockpiled topsoil in TP8, indicates the shallow clay at that location to be of high plasticity with a liquid limit of 62%, plastic limit of 25% and plasticity index of 37%, with a natural moisture content of 37%. The variation noted in this sample may be as a consequence of the sample being recovered from relatively shallow depth below the natural ground surface (i.e. below the base of the stockpile) and some associated organic content as a consequence of proximity to the original surface.

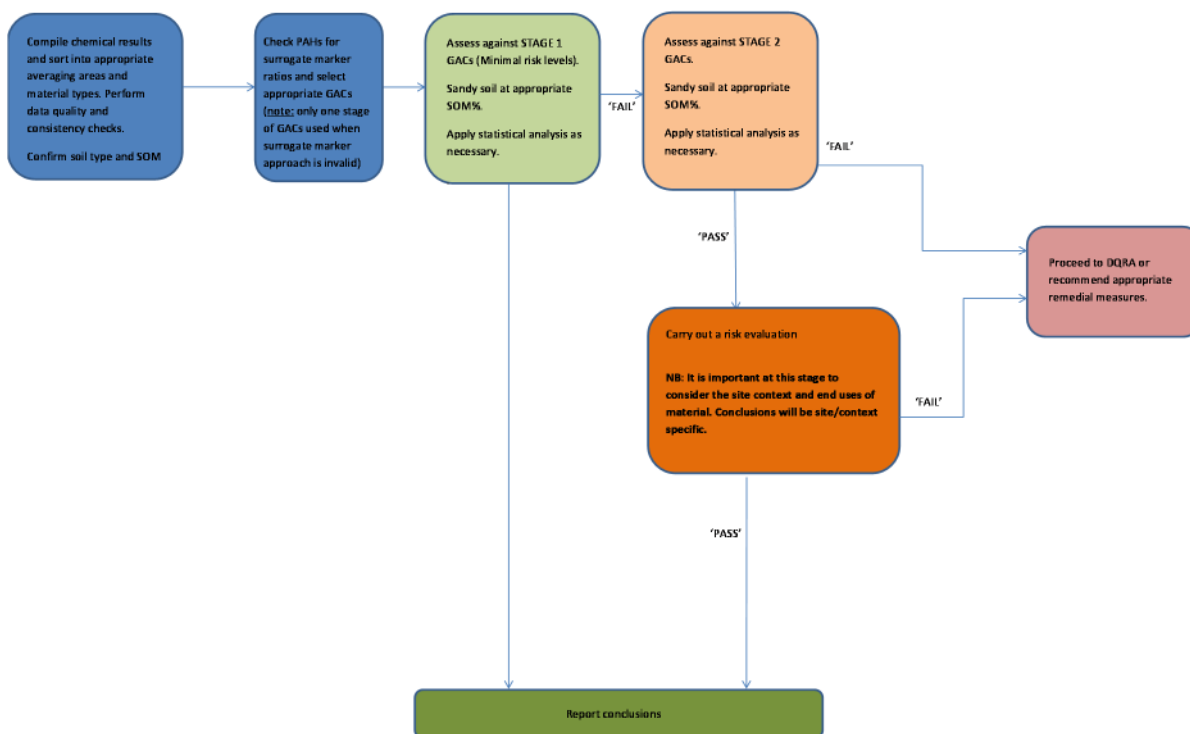
Figure 1. GQRA Process.

The first stage of GQRA comprises assessment of the data against GAC values derived using toxicological parameter values based on “minimum risk”. Any contaminants exceeding their GACs at this stage are further assessed against Stage 2 GACs, which have been derived using Low Level of Toxicological Concern (LLTC) criteria, where these are available.
