## **PHASE II: GROUND INVESTIGATION REPORT**

**PROPOSED RESIDENTIAL DEVELOPMENT OF  
LAND AT HARRAS DYKE FARM, HARRAS MOOR  
WHITEHAVEN, CUMBRIA**

**GENR8 NORTH LTD**

**Report Ref:** 2019-3889

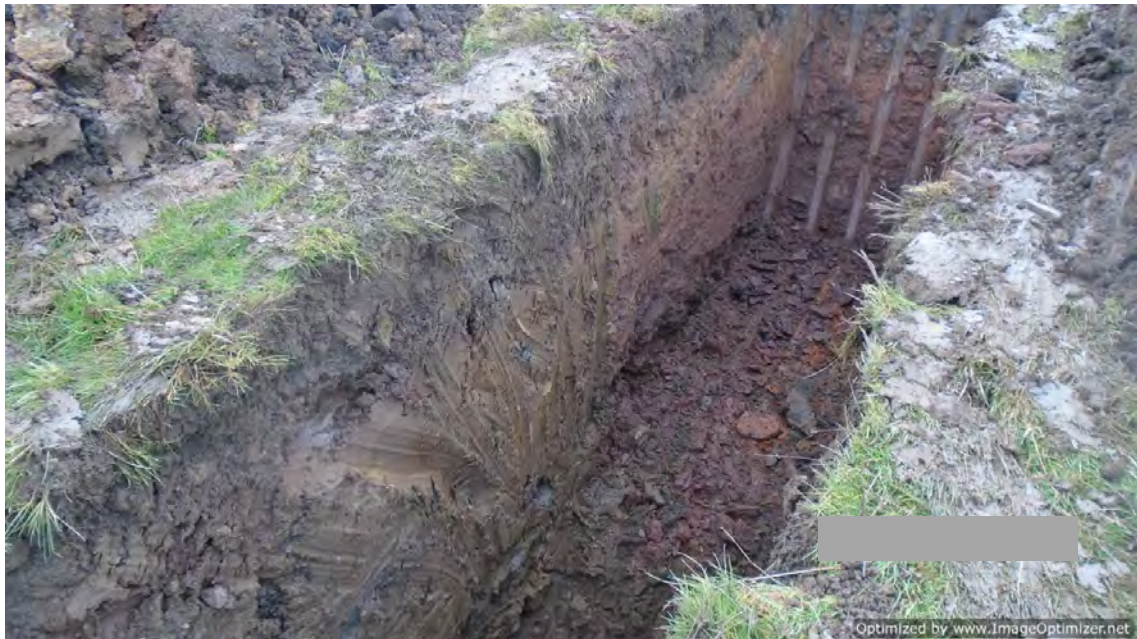
**GEO2019-3889: Harras Dyke Farm, Whitehaven – TT201 (Northern End)**

| Depth From (m) | Depth To (m) | Strata Description | Legend | Testing / Samples |
|---|---|---|---|---|
| | | Edge of Opencast noted at NGR: XXXX<br>Trial hole remained open and dry on completion.<br>Trial hole backfilled with arisings on completion. | | |

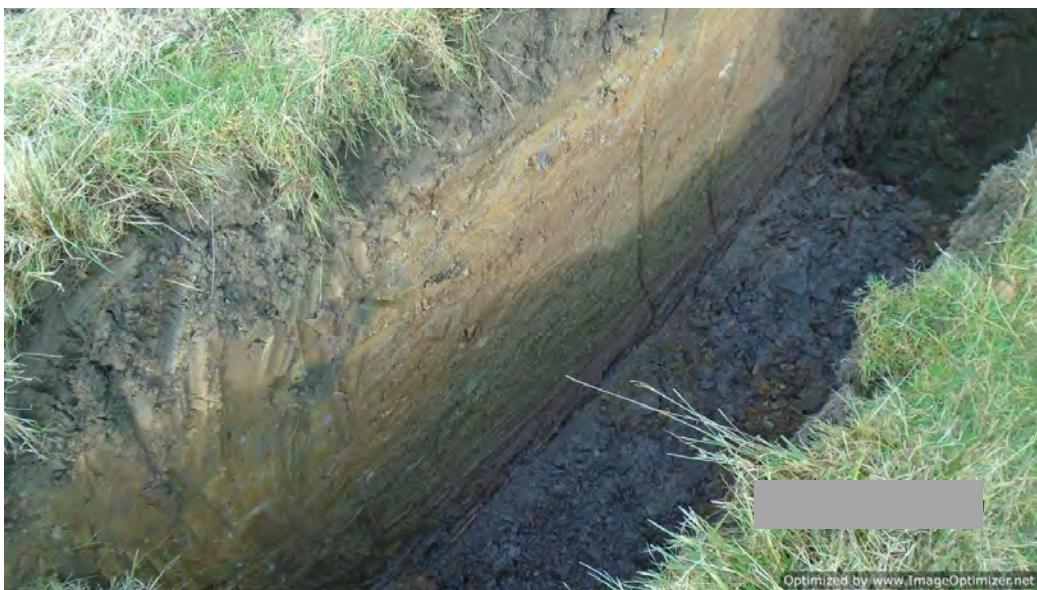
**GEO2019-3889: Harras Dyke Farm, Whitehaven – TT202 (Northern End)**

| Depth From (m) | Depth To (m) | Strata Description | Legend | Testing / Samples |
|---|---|---|---|---|
| | | Edge of Opencast noted at NGR: XXXX<br>Excavated as Trench (8.00m long).<br>Trial hole remained open and dry on completion.<br>Trial hole backfilled with arisings on completion. | | No samples retained. |

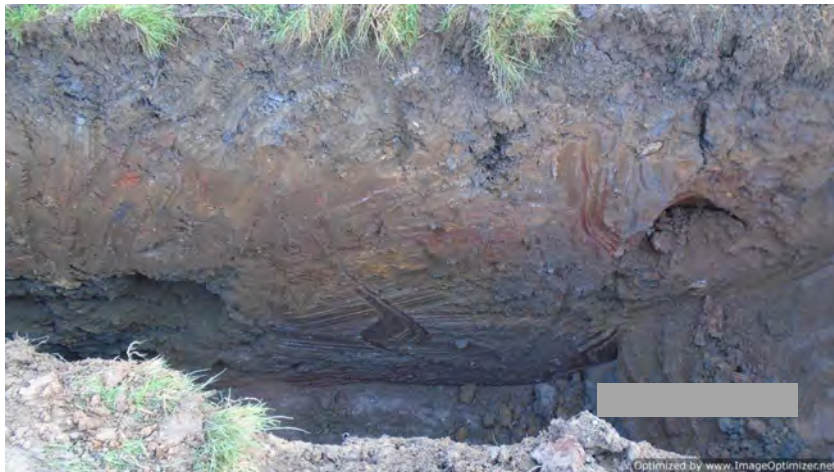
**GEO2019-3889: Harras Dyke Farm, Whitehaven – TT203 (Northern End)**

| Depth From (m) | Depth To (m) | Strata Description | Legend | Testing / Samples |
|---|---|---|---|---|
| | | Edge of Opencast noted at NGR: XXXX<br>Excavated as Trench (5.00m long).<br>Slight groundwater ingress at c.1.0m bgl.<br>Trial hole backfilled with arisings on completion. | | No samples retained. |

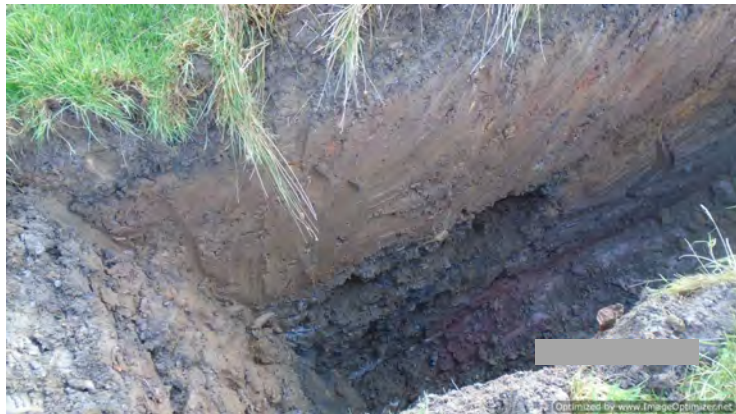
**GEO2019-3889: Harras Dyke Farm, Whitehaven – TT204 (Western End)**

| Depth From (m) | Depth To (m) | Strata Description | Legend | Testing / Samples |
|---|---|---|---|---|
| | | Edge of Opencast noted at NGR: XXXX<br>Excavated as trench (4.00m long).<br>Trial hole remained open and dry on completion.<br>Trial hole backfilled with arisings on completion. | | No samples retained. |

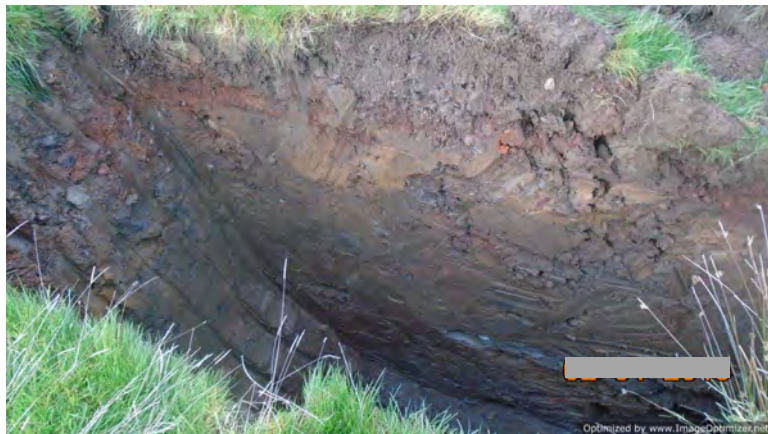
**GEO2019-3889: Harras Dyke Farm, Whitehaven – TT204 (Eastern End)**

| Depth From (m) | Depth To (m) | Strata Description | Legend | Testing / Samples |
|---|---|---|---|---|
| | | Edge of Opencast noted at NGR: XXXX<br>Excavated as Trench (4.00m long).<br>Trial pit was dry and stable on completion.<br>Trial hole backfilled with arisings on completion. | | No samples retained. |

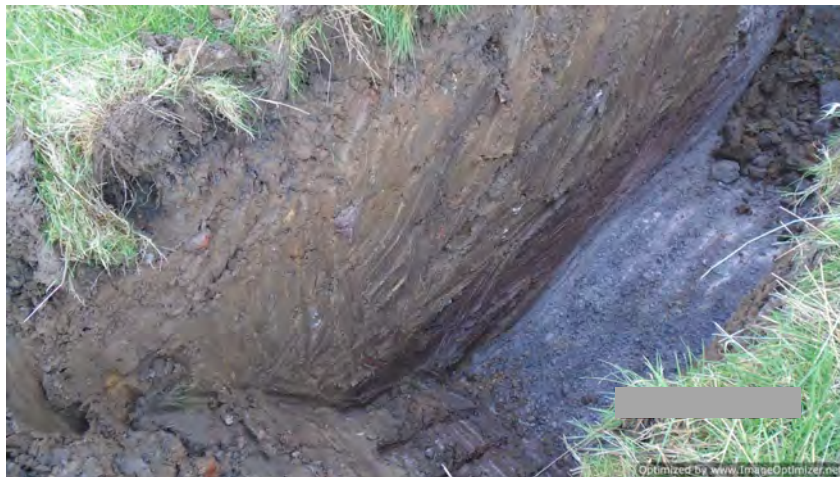
**GEO2019-3889: Harras Dyke Farm, Whitehaven – TT205 (Eastern End)**

| Depth From (m) | Depth To (m) | Strata Description | Legend | Testing / Samples |
|---|---|---|---|---|
| | | Edge of Opencast noted at NGR: XXXX<br>Excavated as Trench (8.00m long).<br>Trial pit was dry and stable on completion.<br>Trial hole backfilled with arisings on completion. | | No samples retained. |

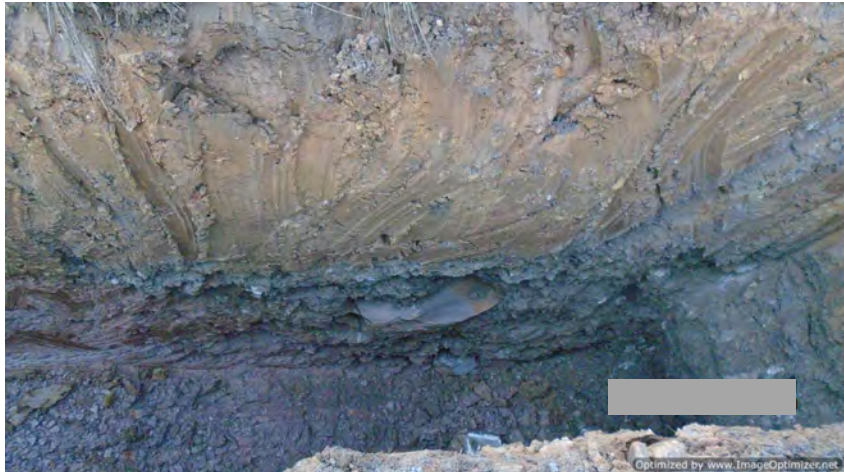
**GEO2019-3889: Harras Dyke Farm, Whitehaven – TP201**

| Depth From (m) | Depth To (m) | Strata Description | Legend | Testing / Samples |
|---|---|---|---|---|
| | | End of trial hole at 1.60m – Engineer Instruction.<br>Trial hole remained open and dry on completion.<br>Trial hole backfilled with arisings on completion. | | |

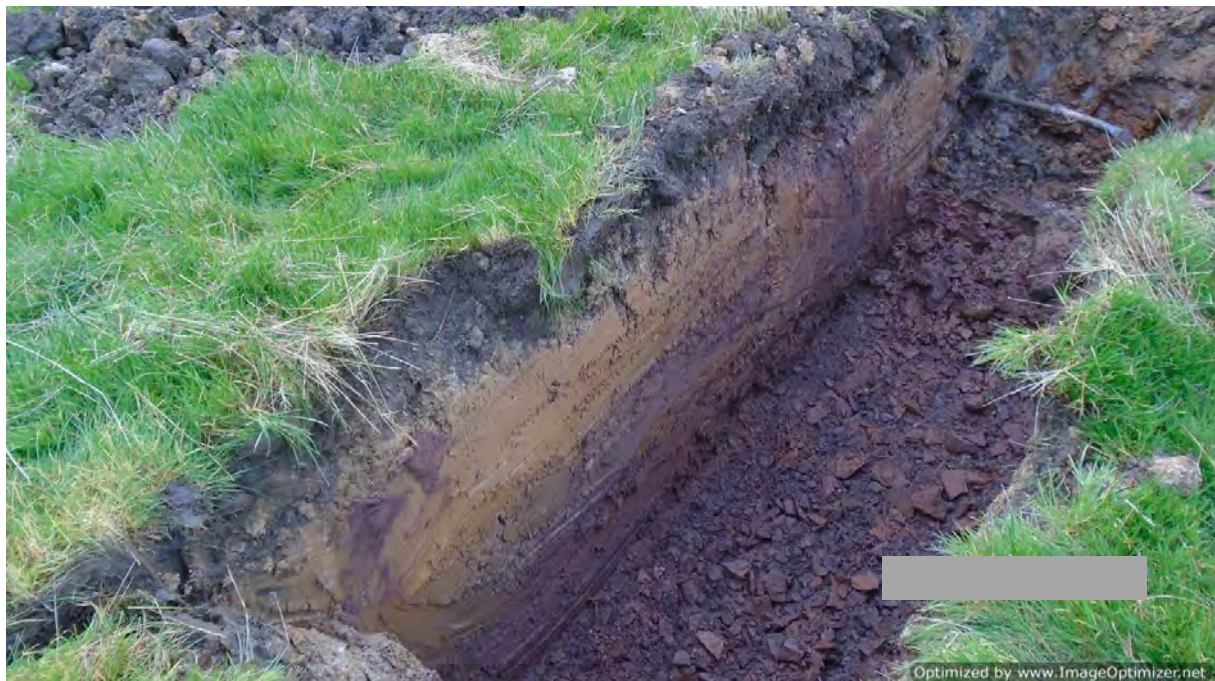
**GEO2019-3889: Harras Dyke Farm, Whitehaven – TP202**

| Depth From (m) | Depth To (m) | Strata Description | Legend | Testing / Samples |
|---|---|---|---|---|
| | | End of trial hole at 2.40m – Engineer Instruction.<br>Trial hole remained open and dry on completion.<br>Trial hole backfilled with arisings on completion. | | |

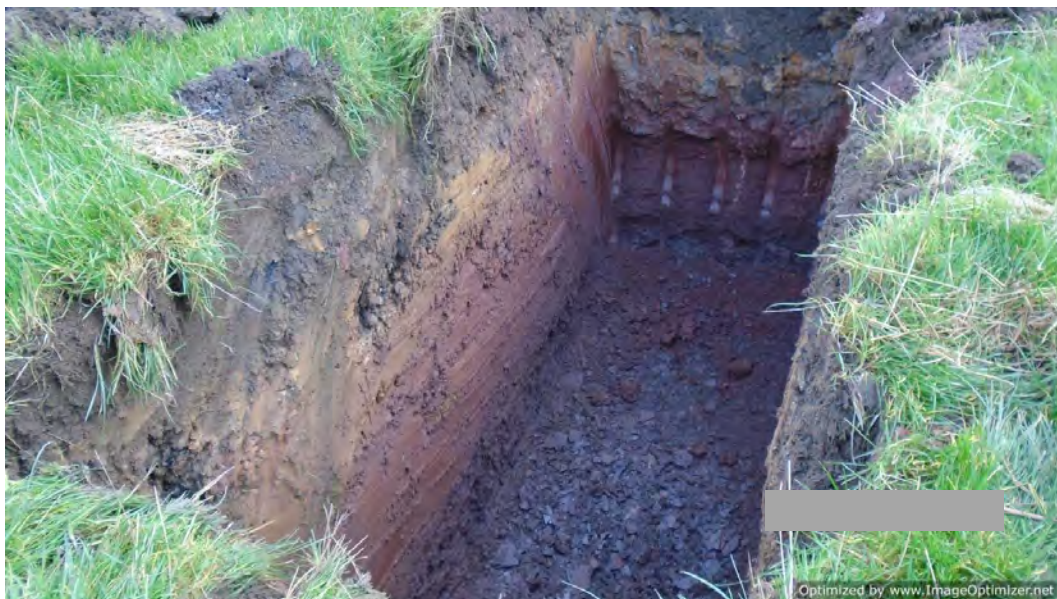
**GEO2019-3889: Harras Dyke Farm, Whitehaven – TP203**

| Depth From (m) | Depth To (m) | Strata Description | Legend | Testing / Samples |
|---|---|---|---|---|
| | | End of trial hole at 3.00m – Engineer Instruction.<br>Trial hole remained open and dry on completion.<br>Trial hole backfilled with arisings on completion. | | |

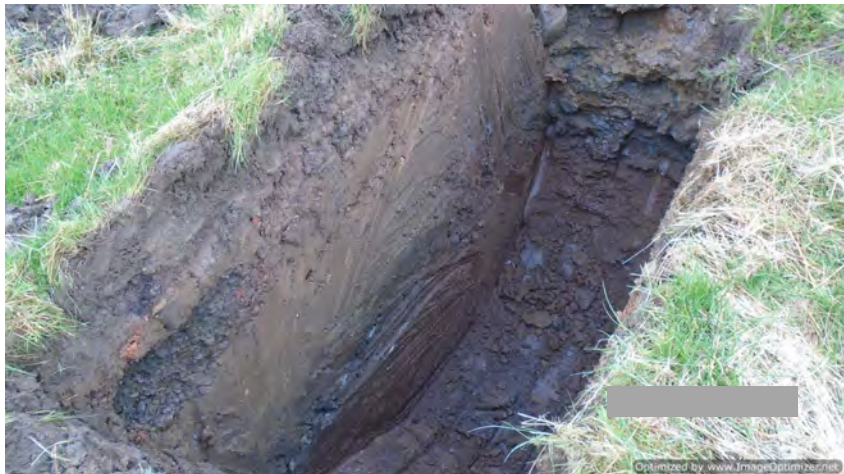
**GEO2019-3889: Harras Dyke Farm, Whitehaven – TP204**

| Depth From (m) | Depth To (m) | Strata Description | Legend | Testing / Samples |
|---|---|---|---|---|
| | | End of trial hole at 1.90m – Engineer Instruction.<br>Groundwater ingress from field drain at 0.70m bgl.<br>Trial hole backfilled with arisings on completion. | | |

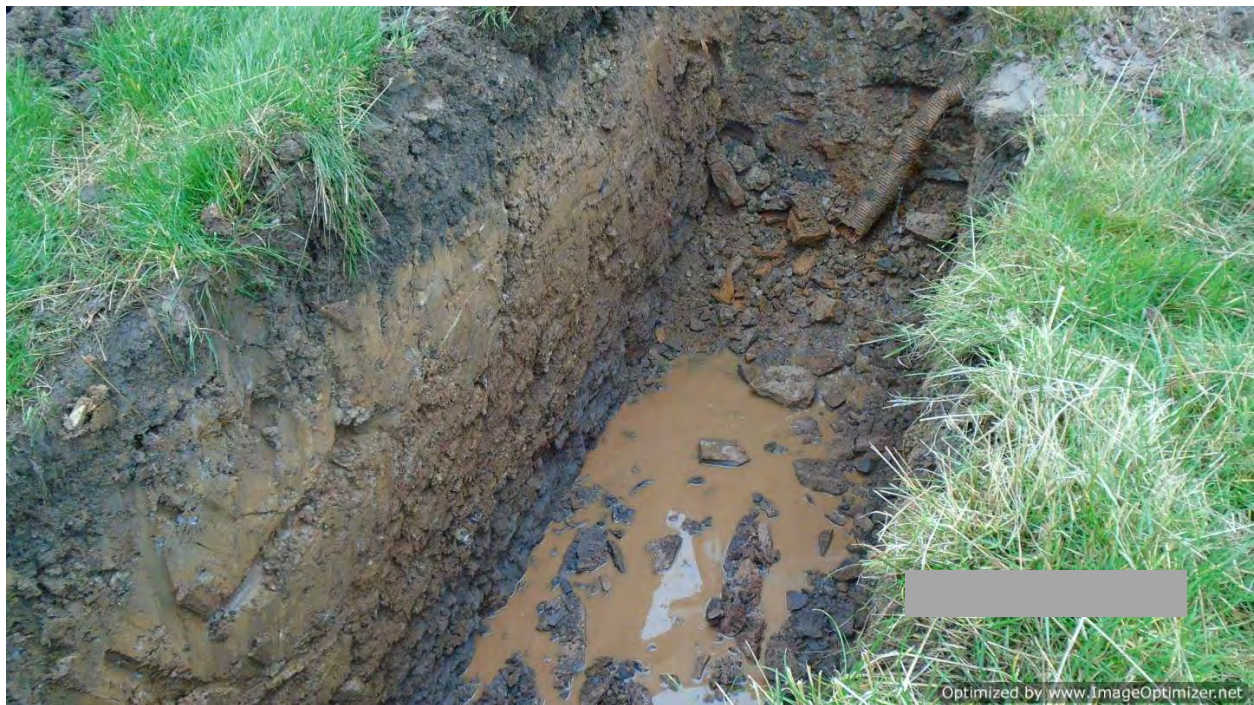
**GEO2019-3889: Harras Dyke Farm, Whitehaven – TP205**

| Depth From (m) | Depth To (m) | Strata Description | Legend | Testing / Samples |
|---|---|---|---|---|
| | | End of trial hole at 1.90m – Engineer Instruction.<br>Groundwater ingress from field drain at 0.70m bgl.<br>Trial hole backfilled with arisings on completion. | | |

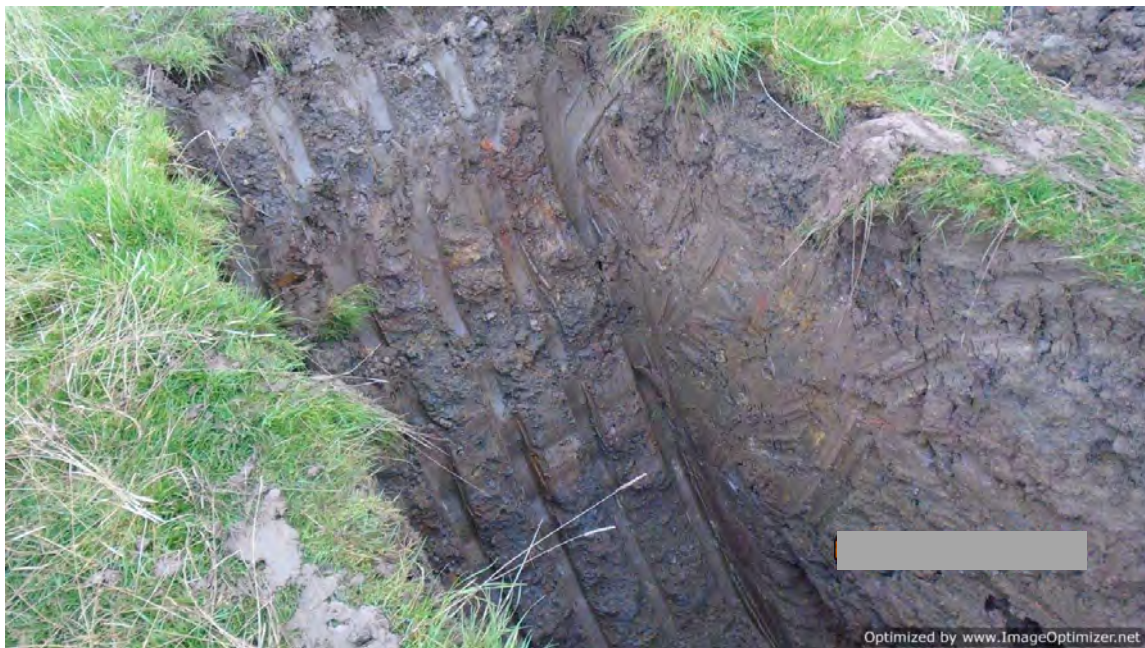
**GEO2019-3889: Harras Dyke Farm, Whitehaven – TP206**

| Depth From (m) | Depth To (m) | Strata Description | Legend | Testing / Samples |
|---|---|---|---|---|
| | | End of trial hole at 1.90m – Engineer Instruction.<br>Trial pit dry and stable on completion.<br>Trial hole backfilled with arisings on completion. | | |

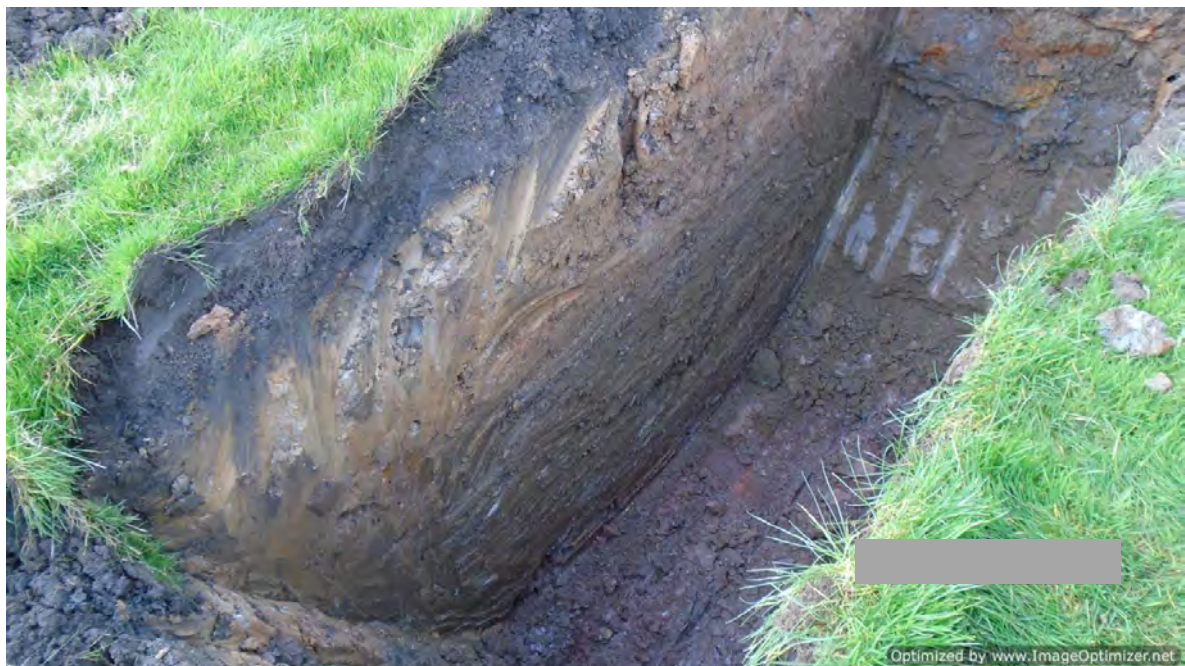
**GEO2019-3889: Harras Dyke Farm, Whitehaven – TP207**

| Depth From (m) | Depth To (m) | Strata Description | Legend | Testing / Samples |
|---|---|---|---|---|
| | | End of trial hole at 2.20m – Engineer Instruction.<br>Trial pit dry and stable on completion.<br>Trial hole backfilled with arisings on completion. | | |

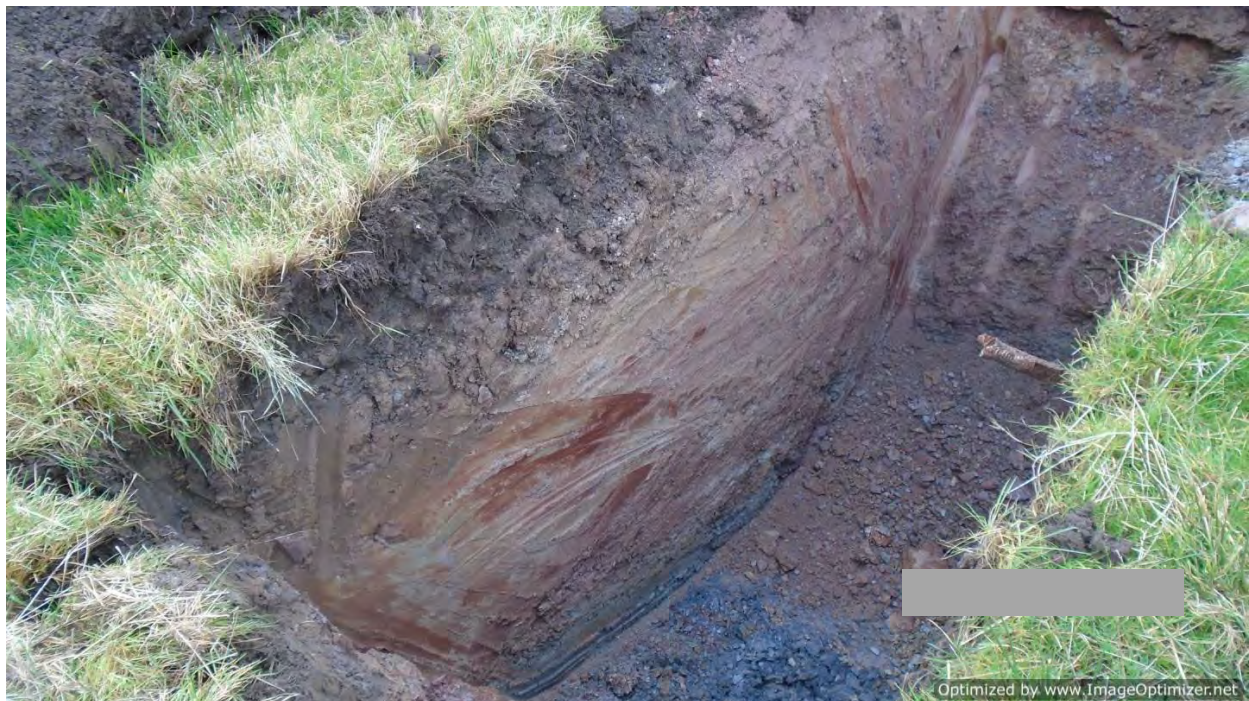
**GEO2019-3889: Harras Dyke Farm, Whitehaven – TP207B**

| Depth From (m) | Depth To (m) | Strata Description | Legend | Testing / Samples |
|---|---|---|---|---|
| | | End of trial hole at 2.20m – Pipe Encountered.<br>Pipe encountered at NGR: XXX (See EHLP).<br>Slight groundwater ingress at c.1.60m bgl.<br>Trial hole backfilled with arisings on completion. | | No samples retained. |

Made ground was also encountered in trial pit TP208 in the south east of the site associated with a buried pipe at c.2.20mbgl. This was initially recorded as an unrecorded utility, however, this may be associated with the drainage pipe connecting the field drains which cross the site. A copy of the plan indicating the layout of the field drains is included in the EES report. The fill material overlying the pipe was described as firm brown sandy gravelly clay over red brown silty sandy angular gravels and cobbles of siltstone and sandstone. The material was noted as very unstable and the sides walls collapsed on several occasions.

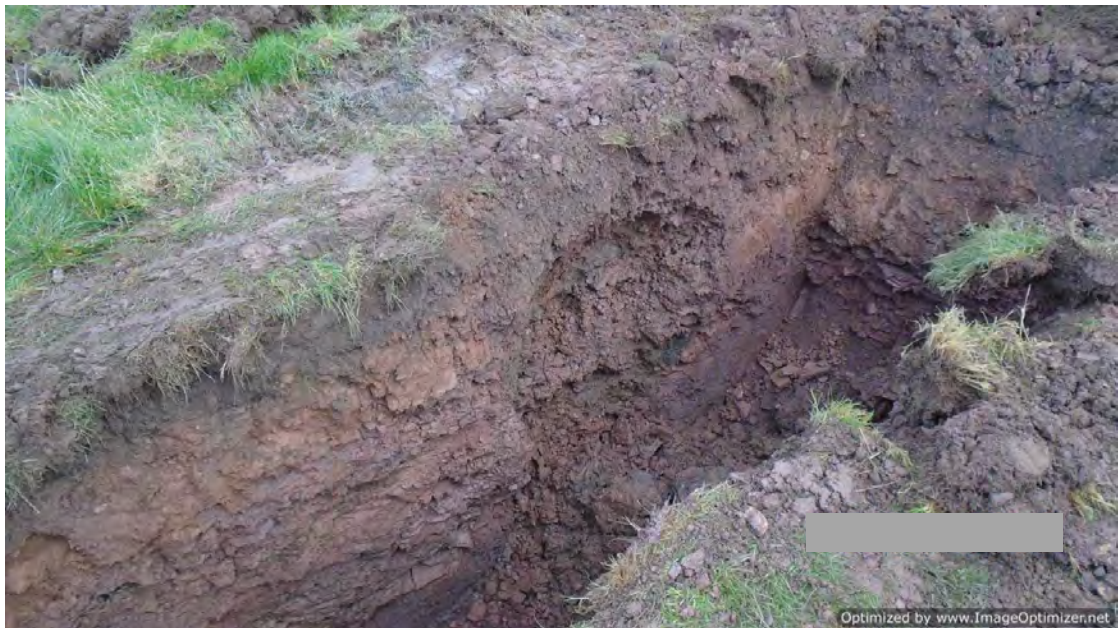
**GEO2019-3889: Harras Dyke Farm, Whitehaven – TP208**

| Depth From (m) | Depth To (m) | Strata Description | Legend | Testing / Samples |
|---|---|---|---|---|
| | | End of trial hole at 2.20m – Engineer Instruction.<br>Trial pit dry and stable on completion.<br>Trial hole backfilled with arisings on completion. | | |

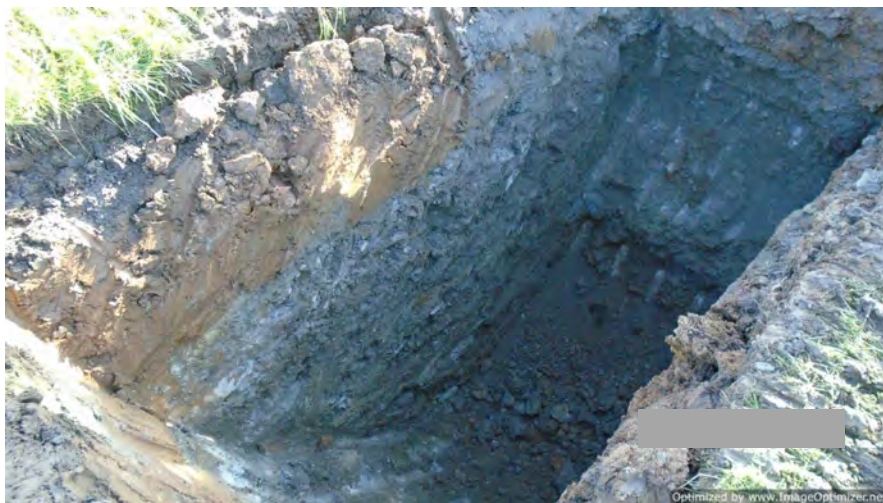
**GEO2019-3889: Harras Dyke Farm, Whitehaven – TP210**

| Depth From (m) | Depth To (m) | Strata Description | Legend | Testing / Samples |
|---|---|---|---|---|
| | | End of trial hole at 3.10m – Engineer Instruction.<br>Plate Load Test (PLT05) completed at 0.35m bgl.<br>Trial pit dry and stable on completion.<br>Trial hole backfilled with arisings on completion. | | |

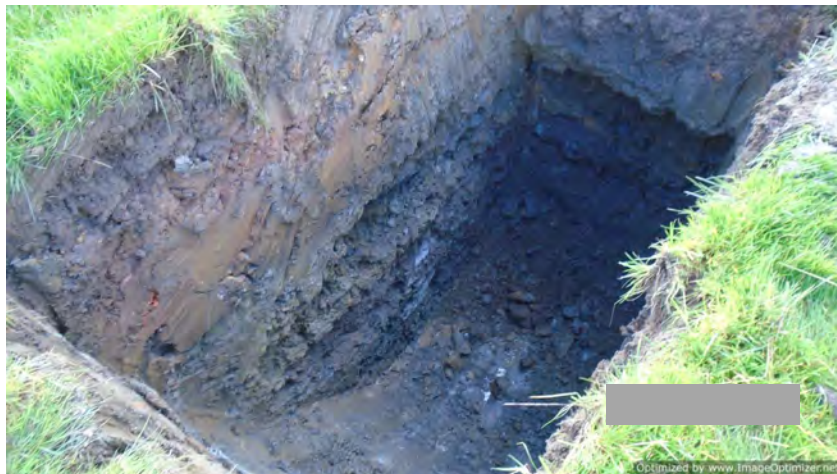
**GEO2019-3889: Harras Dyke Farm, Whitehaven – TP213**

| Depth From (m) | Depth To (m) | Strata Description | Legend | Testing / Samples |
|---|---|---|---|---|
| | | End of trial hole at 3.00m – Engineer Instruction.<br>Slight groundwater ingress at 2.30m bgl.<br>Trial hole backfilled with arisings on completion. | | |

The exploratory holes were typically dry except for a minor seepages noted in trial pits TP212 to TP215 in the east of the site at depths of between c.1.50m and c.2.00m bgl.

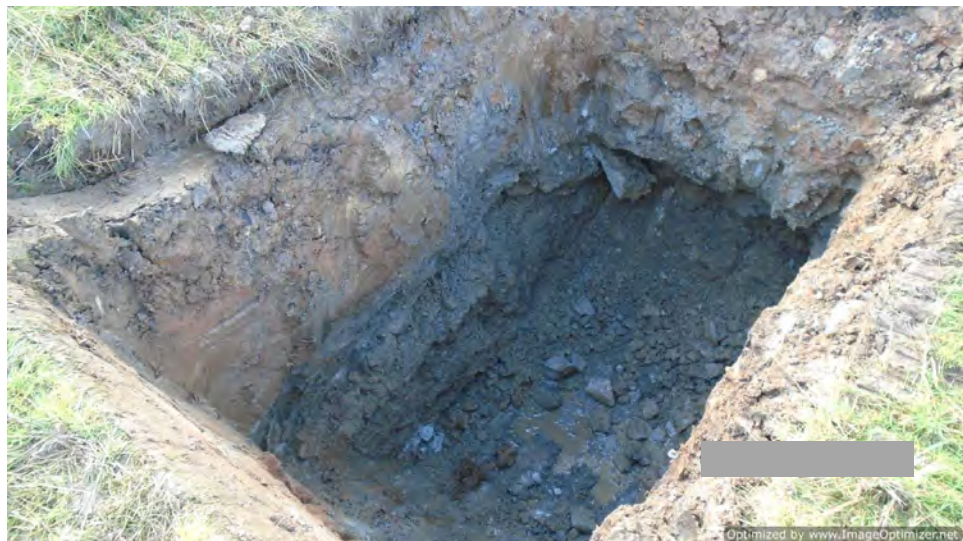
| Depth From (m) | Depth To (m) | Strata Description | Legend | Testing / Samples |
|---|---|---|---|---|
| | | End of trial hole at 2.60m – Engineer Instruction.<br>Plate Load Test - PLT09 completed at 0.30m bgl.<br>Slight groundwater ingress at 1.50m bgl.<br>Trial hole backfilled with arisings on completion. | | |

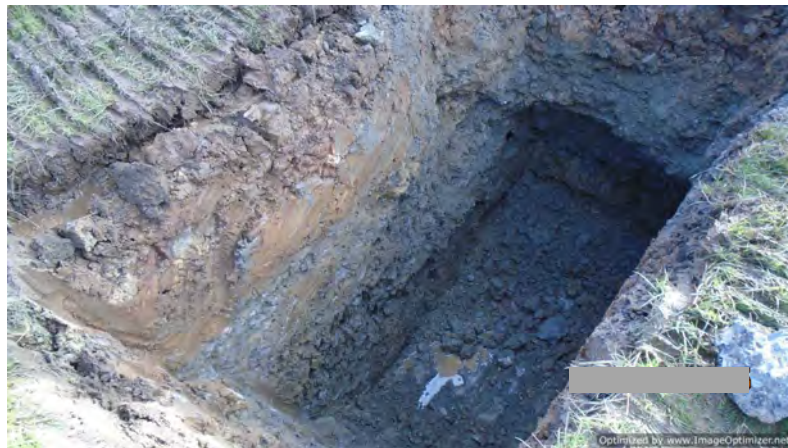
| Depth From (m) | Depth To (m) | Strata Description | Legend | Testing / Samples |
|---|---|---|---|---|
| | | End of trial hole at 2.60m – Engineer Instruction.<br>Plate Load Test - PLT06 completed at 0.30m bgl.<br>Slight groundwater ingress at 2.00m bgl.<br>Trial hole backfilled with arisings on completion. | | |

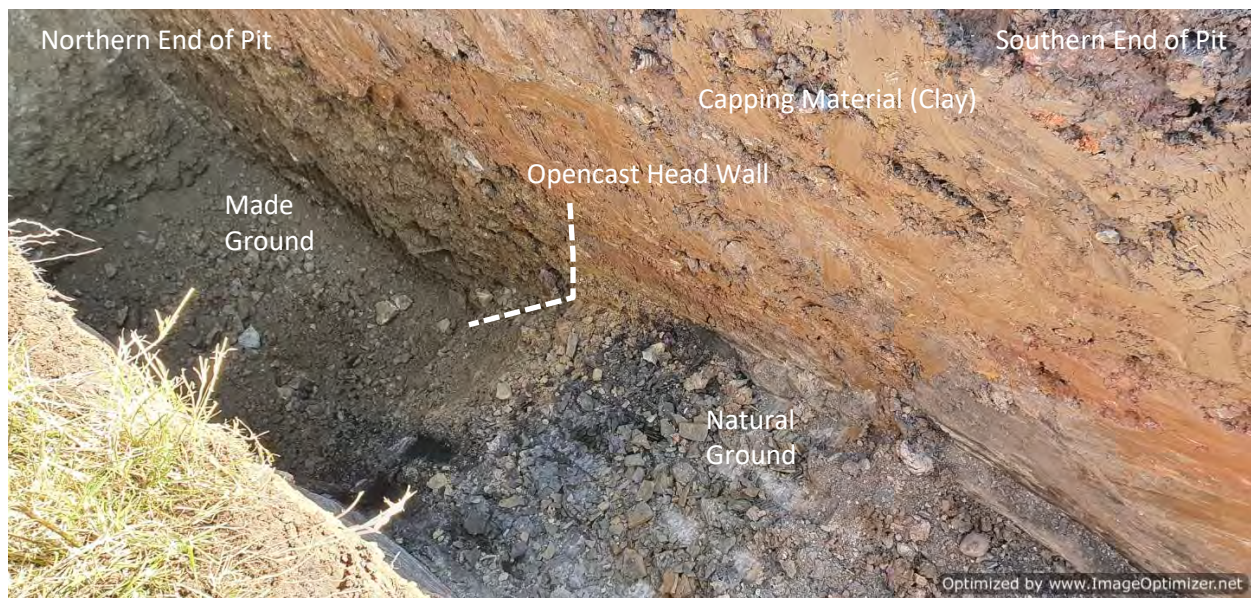
| Depth From (m) | Depth To (m) | Strata Description | Legend | Testing / Samples |
|---|---|---|---|---|
| 2.00 | 2.40 | SUSPECTED WEATHERED COAL SEAM. Recovered as dark grey to black silty fine to coarse angular GRAVEL of coal and carbonaceous siltstone. | | |

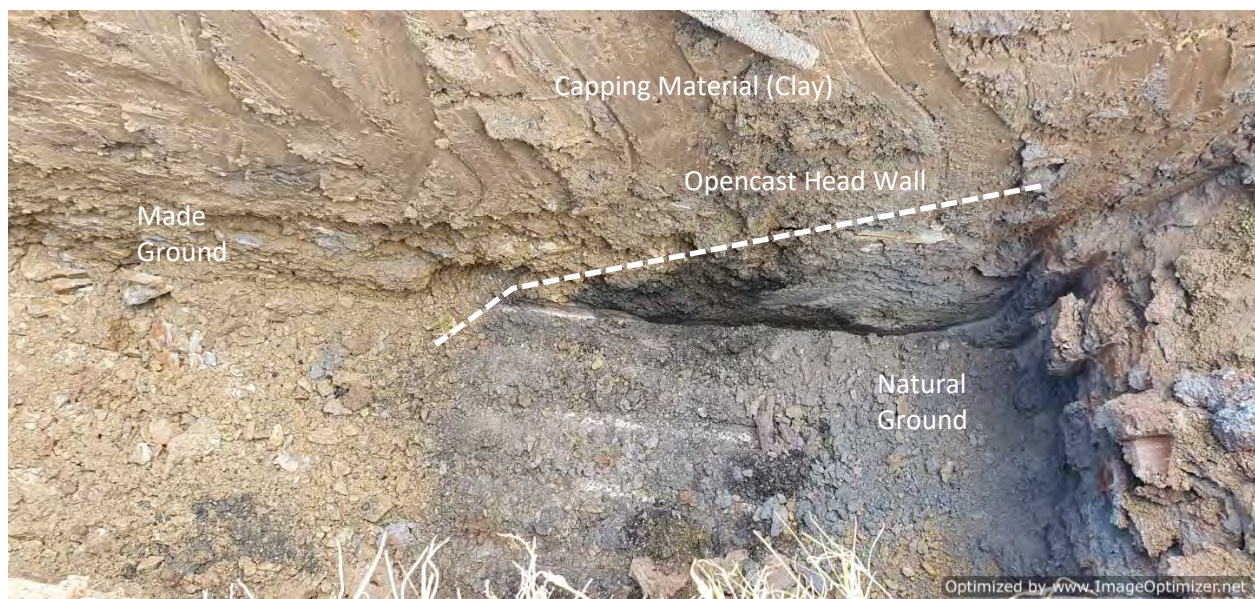
| Depth From (m) | Depth To (m) | Strata Description | Legend | Testing / Samples |
|---|---|---|---|---|
| 2.90 | 3.10 | SUSPECTED WEATHERED SILTSTONE: Recovered as grey sandy silty GRAVEL of weak siltstone. | | |

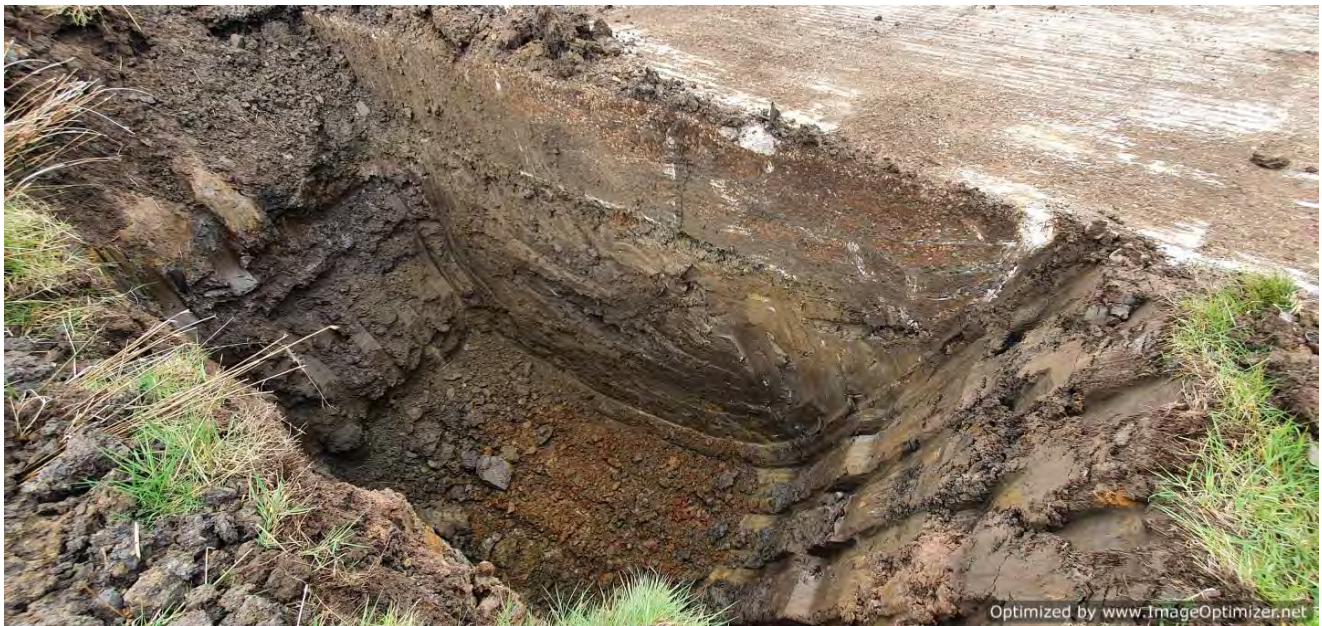
| Depth From (m) | Depth To (m) | Strata Description | Legend | Testing / Samples |
|---|---|---|---|---|
| 1.50 | 2.00 | SUSPECTED WEATHERED SILTSTONE: Recovered as grey sandy silty GRAVEL of weak siltstone. | | |

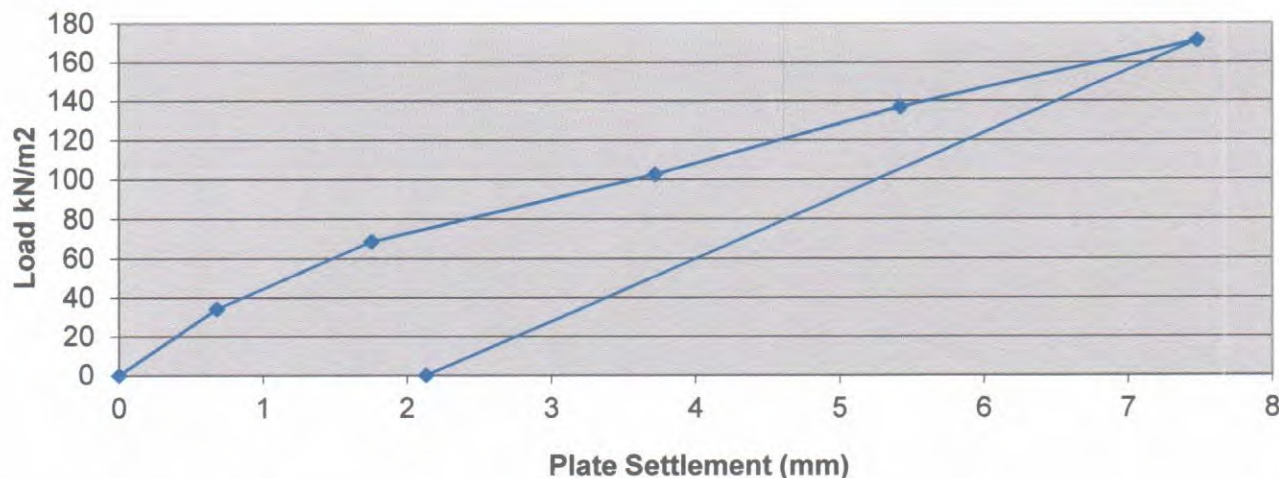
### Plate Bearing Test

Comments: CBR at 1.25mm estimated value  
Maximum Plate Settlement at  
Load Applied Maximum Load  
kN/m<sup>2</sup> mm  
Plate Test result 171 7.48  
K762 Factor 34620 kN/M<sup>2</sup>/M  
CBR @ 1.25mm 4.5  
Plate factor 0.8165  
Note: Plate factor and CBR calculated by IAN ;

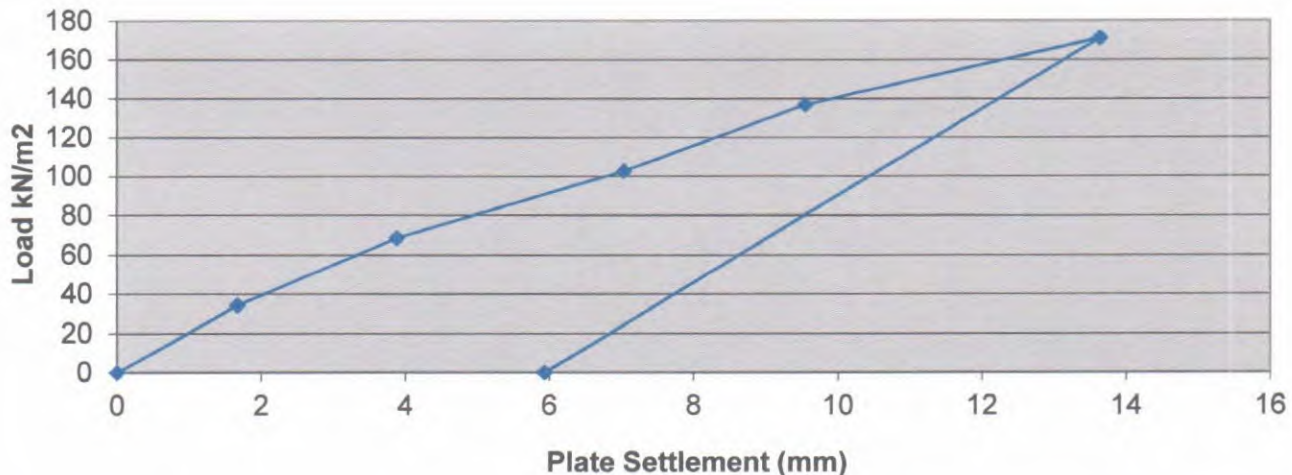
### Plate Bearing Test

Comments: CBR at 1.25mm estimated value  
Maximum Plate Settlement at  
Load Applied Maximum Load  
kN/m<sup>2</sup> mm  
Plate Test result 171 13.64  
K762 Factor 16983 kN/M<sup>2</sup>/M  
CBR @ 1.25mm 1.3  
Plate factor 0.8165

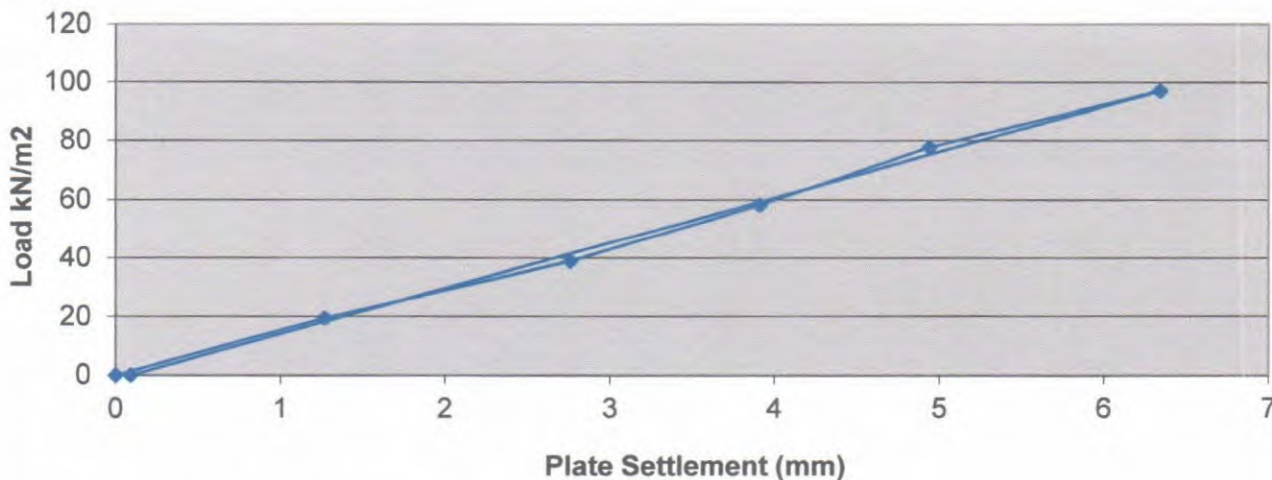
### Plate Bearing Test

Comments: CBR at 1.25mm estimated value  
Maximum Plate Settlement at  
Load Applied Maximum Load  
kN/m<sup>2</sup> mm  
Plate Test result 97 6.34  
K762 Factor 17740 kN/M<sup>2</sup>/M  
CBR @ 1.25mm 1.4  
Plate factor 1.1671  
Note: Plate factor and CBR calculated by IAN

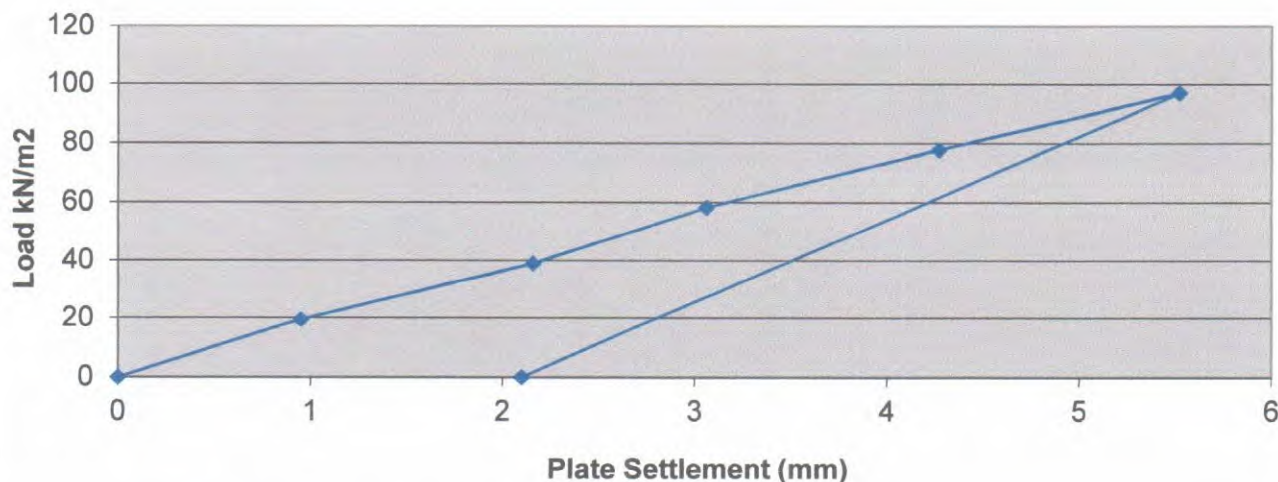
### Plate Bearing Test

Comments: CBR at 1.25mm estimated value  
Maximum Plate Settlement at  
Load Applied Maximum Load  
kN/m<sup>2</sup> mm  
Plate Test result 97 5.52  
K762 Factor 21475 kN/M<sup>2</sup>/M  
CBR @ 1.25mm 2.0  
Plate factor 1.1671

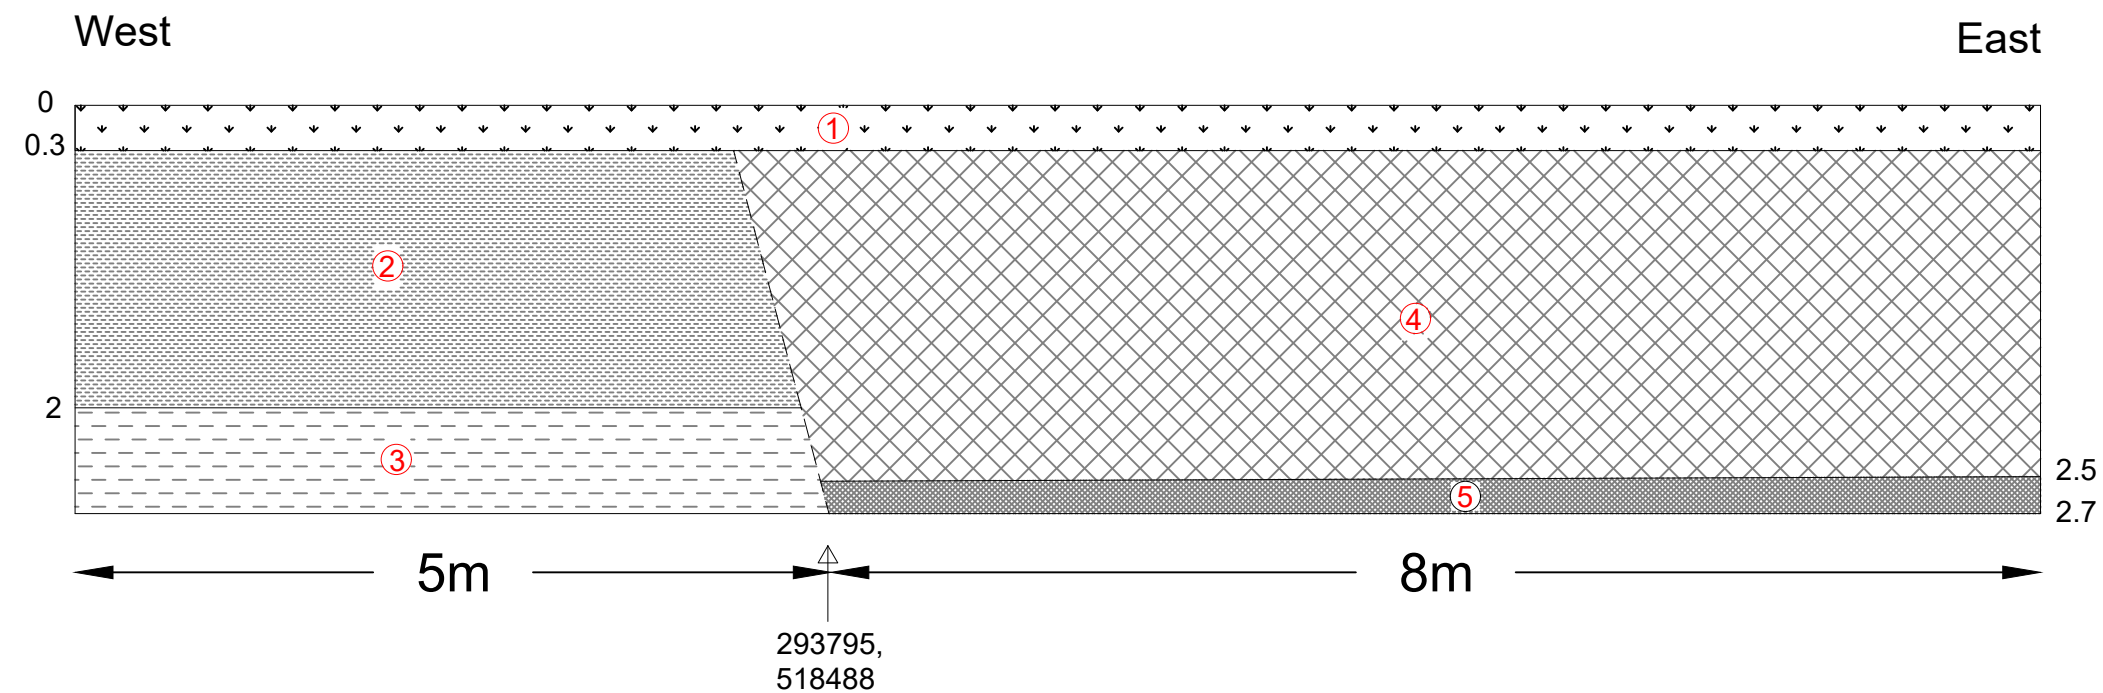
# TT01

- ① Topsoil: Brown sandy slightly gravelly CLAY.
- ② Firm to stiff orange, brown and brown sandy gravelly CLAY.
- ③ Stiff to very stiff red, brown sandy gravelly CLAY (weathered mudstone)
- ④ MADE GROUND: Firm to stiff brown, sandy, gravelly clay.
- ⑤ MADE GROUND; Grey, very clayey, sandy, gravel and COBBLES of mudstone and sandstone.

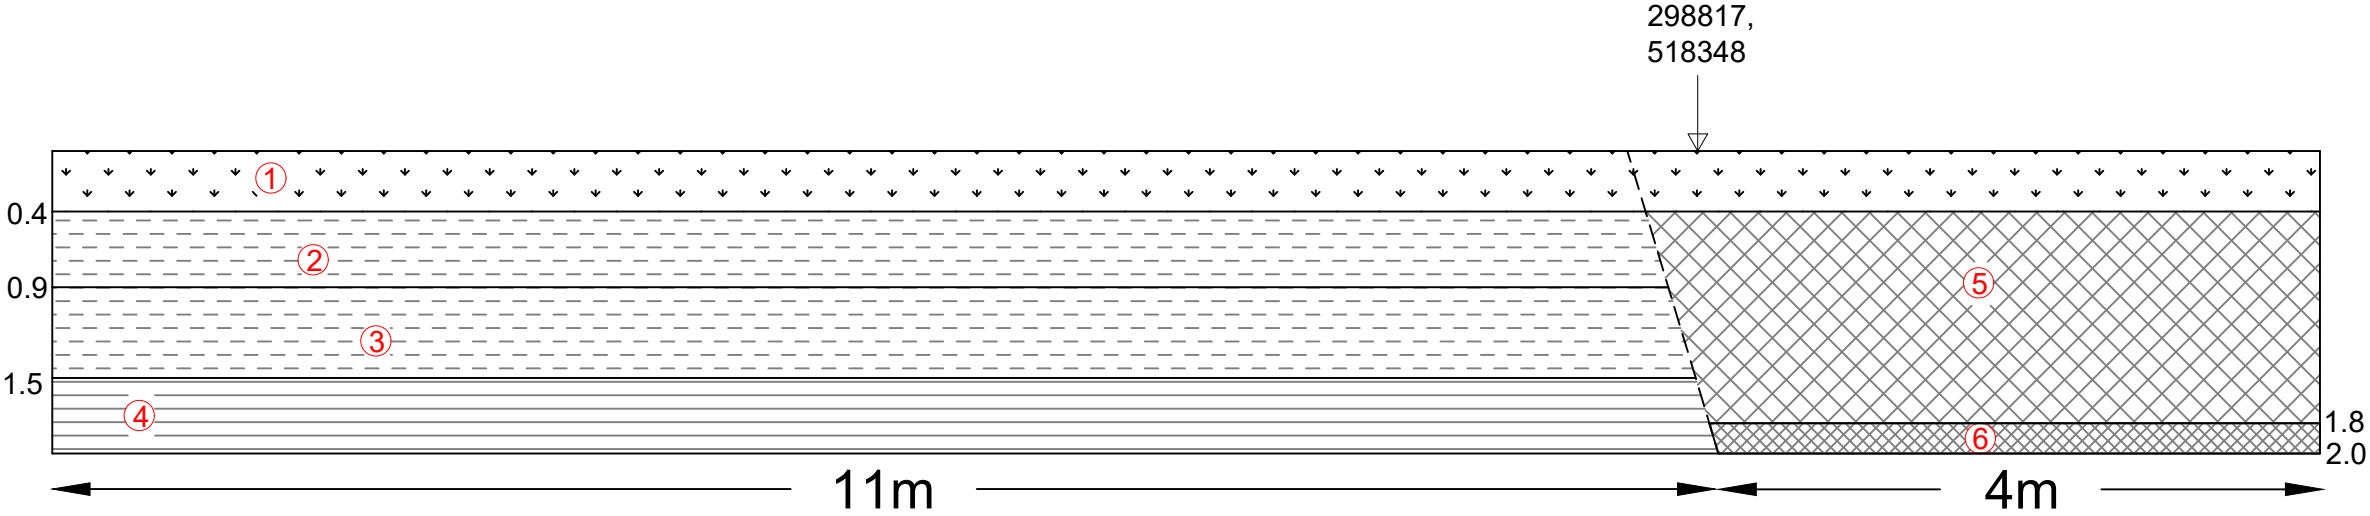
- ① Topsoil: Brown sandy slightly gravelly CLAY.  
② Firm to stiff orange, brown, mottled, grey, sandy, gravelly CLAY.  
③ Stiff red, brown, sandy, gravelly, friable CLAY.  
④ Grey, brown weathered SILTSTONE.  
⑤ MADE GROUND: Firm to stiff brown, sandy, gravelly clay.  
⑥ MADE GROUND; Grey, very clayey, sandy, GRAVEL and COBBLES of mudstone and sandstone.

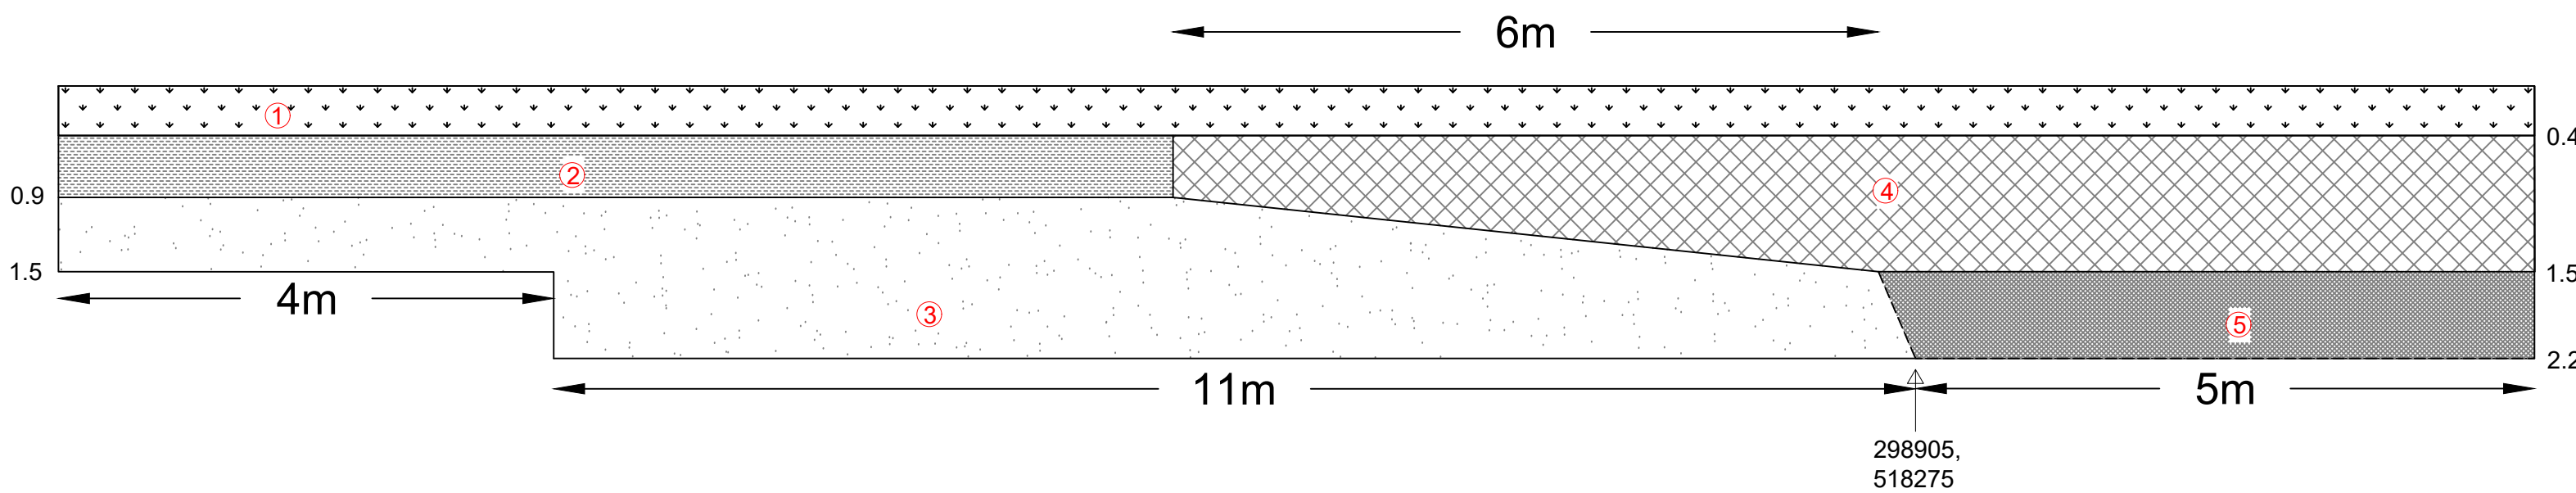
- ① Topsoil: Brown sandy slightly gravelly CLAY.
- ② Firm to stiff orange, brown and brown sandy gravelly CLAY.
- ③ Destructured red, brown silty sandstone
- ④ MADE GROUND: Firm to stiff brown, sandy, gravelly clay.
- ⑤ MADE GROUND; Grey, very clayey, sandy, gravel and COBBLES of mudstone and sandstone.

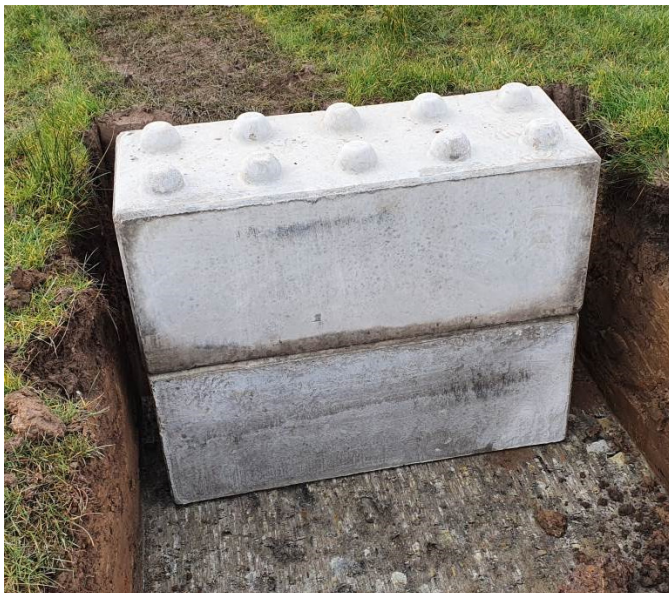
Figure 1: Blocks stacked directly on backfill
