## **PHASE II: GROUND INVESTIGATION REPORT**

**PROPOSED RESIDENTIAL DEVELOPMENT OF  
LAND AT HARRAS DYKE FARM, HARRAS MOOR  
WHITEHAVEN, CUMBRIA**

**GENR8 NORTH LTD**

**Report Ref:** 2019-3889

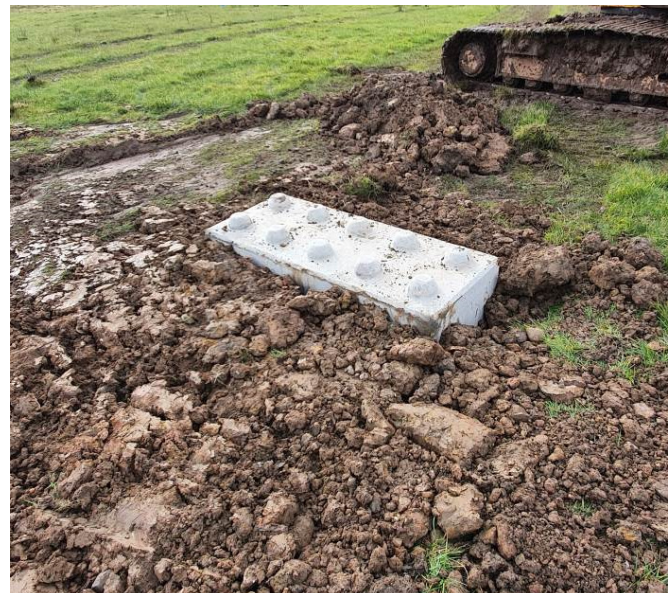
Figure 2: Arisings backfilled around blocks.

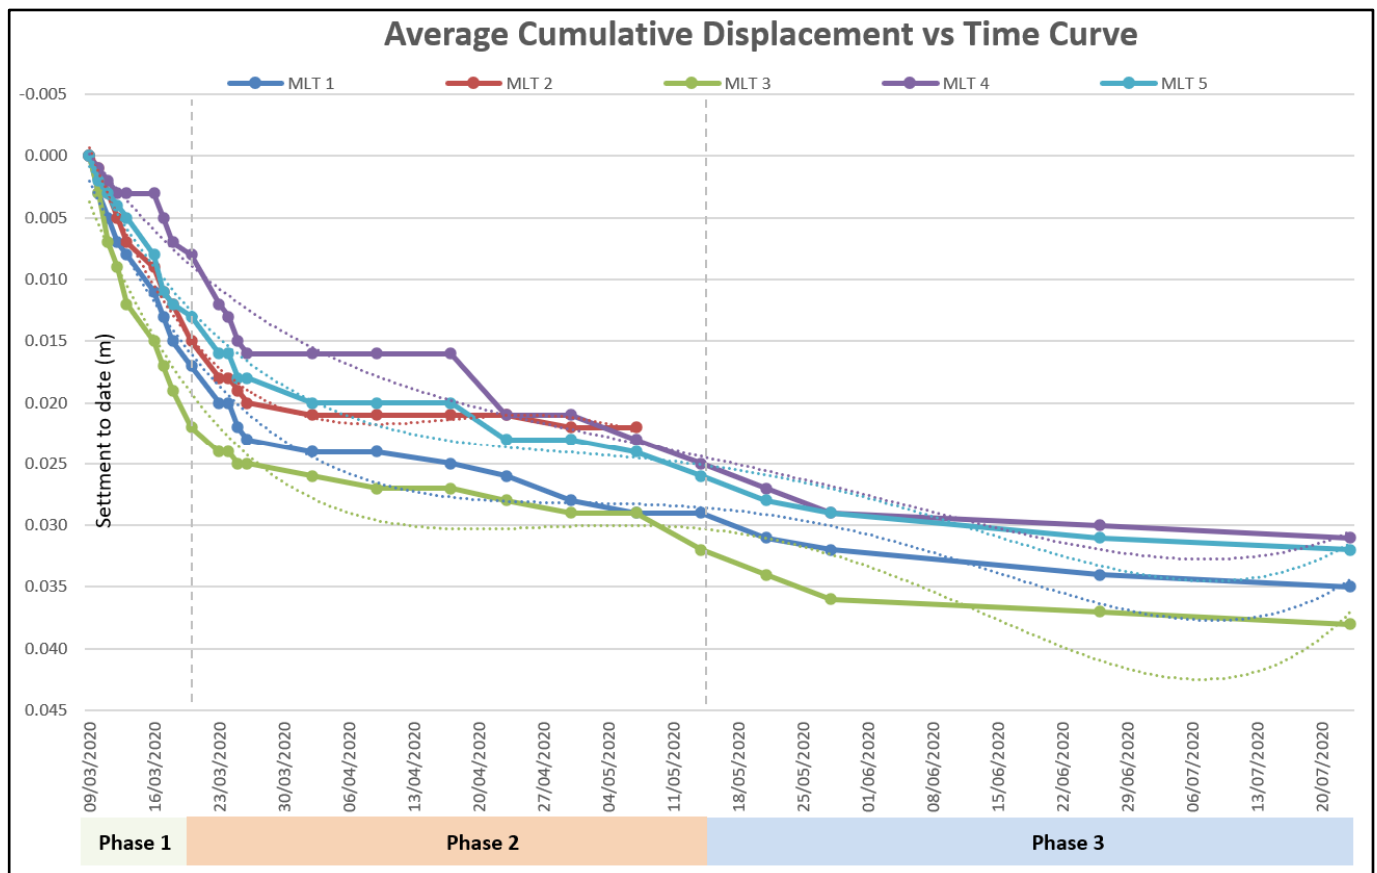
Graph 1: Average Cumulative Displacement Graph for each Test Location.

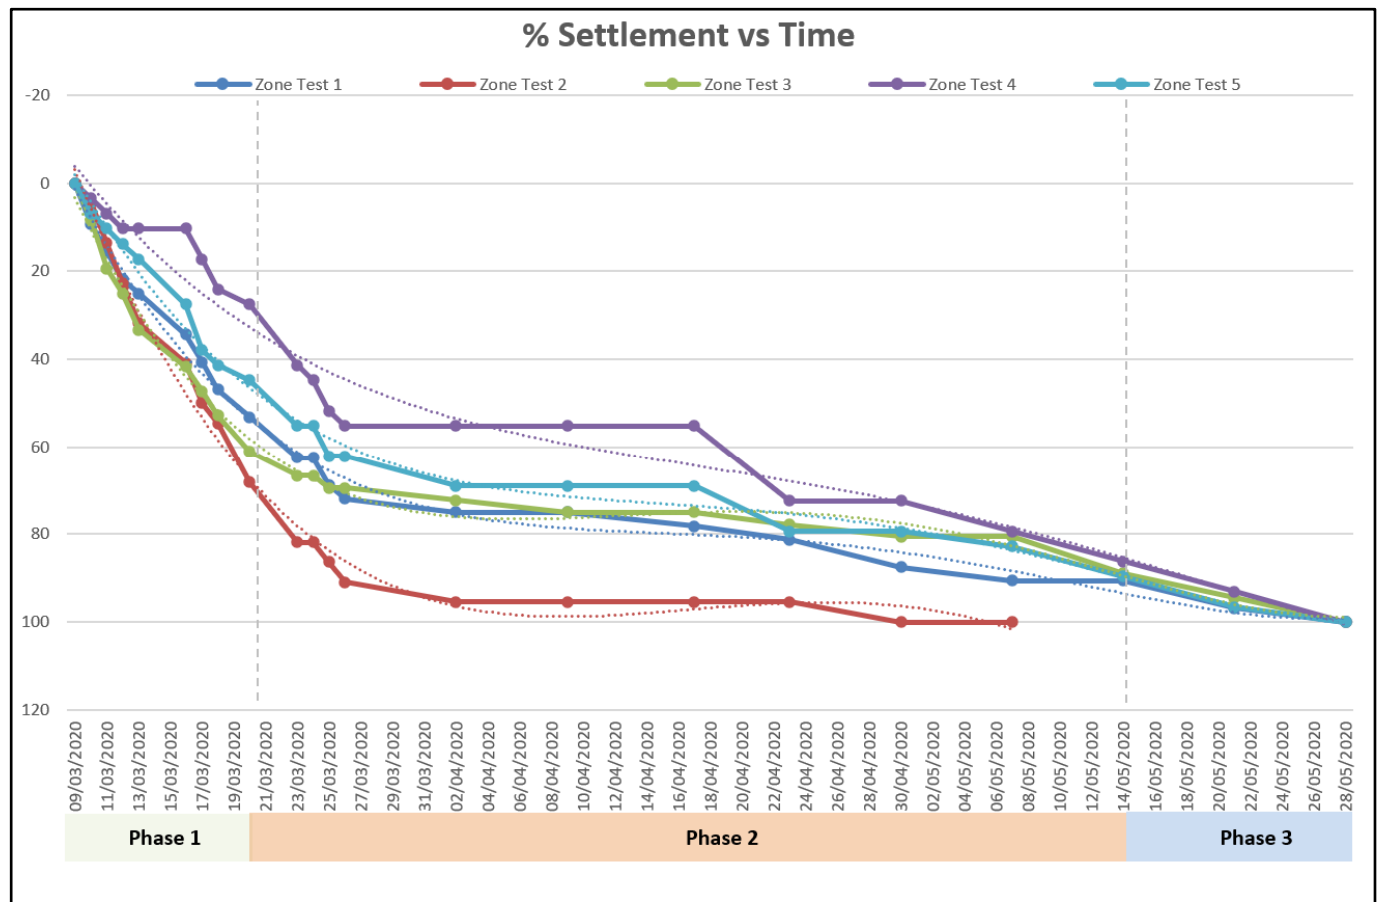
Graph 2: Percentage of Settlement to date at each Test Location.

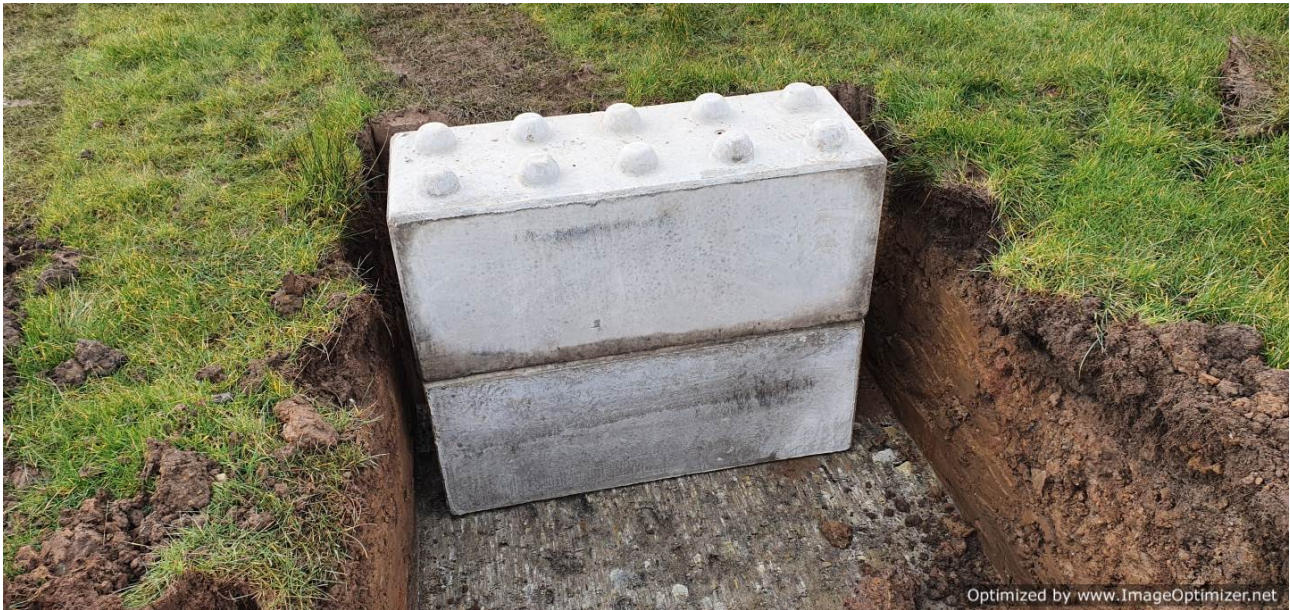
| Depth From (m) | Depth To (m) | Strata Description | Legend | Testing / Samples |
|---|---|---|---|---|
| | | Maintained Load test 1<br>2 x concrete blocks (1.5 x 0.60 x 0.60m) positioned in pit.<br>Pit dry on completion.<br>Pit backfilled around concrete blocks. | | No samples retained. |

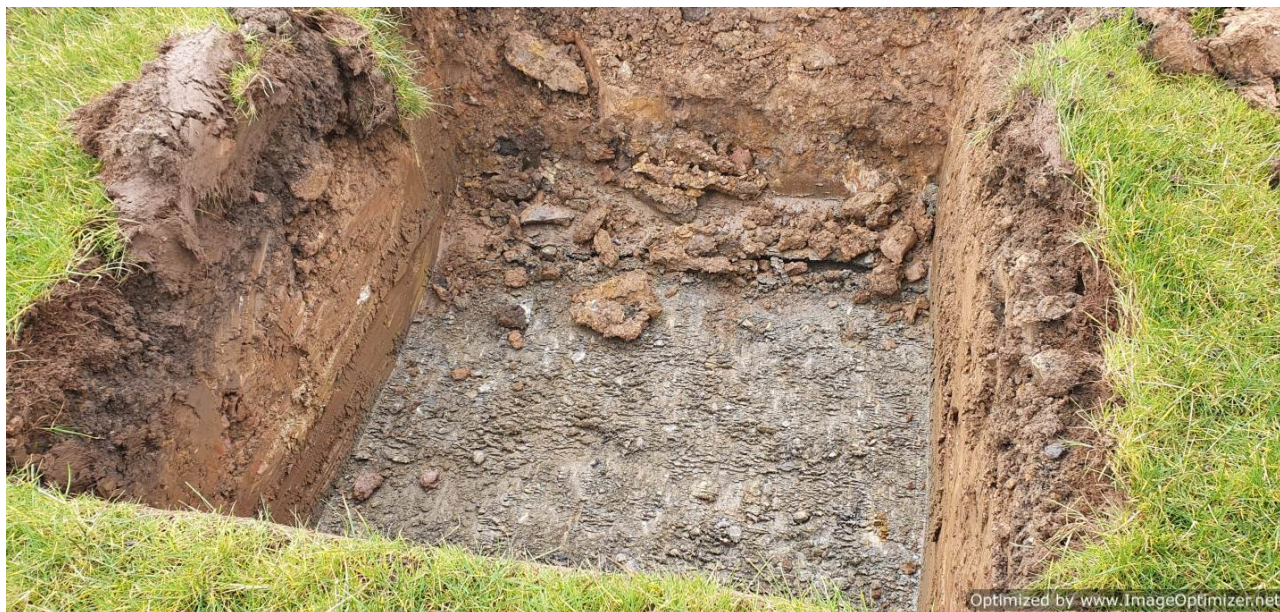
| Depth From (m) | Depth To (m) | Strata Description | Legend | Testing / Samples |
|---|---|---|---|---|
| | | Maintained Load test 2<br>2 x concrete blocks (1.5 x 0.60 x 0.60m) positioned in pit.<br>Pit dry on completion.<br>Pit backfilled around concrete blocks. | | No samples retained. |

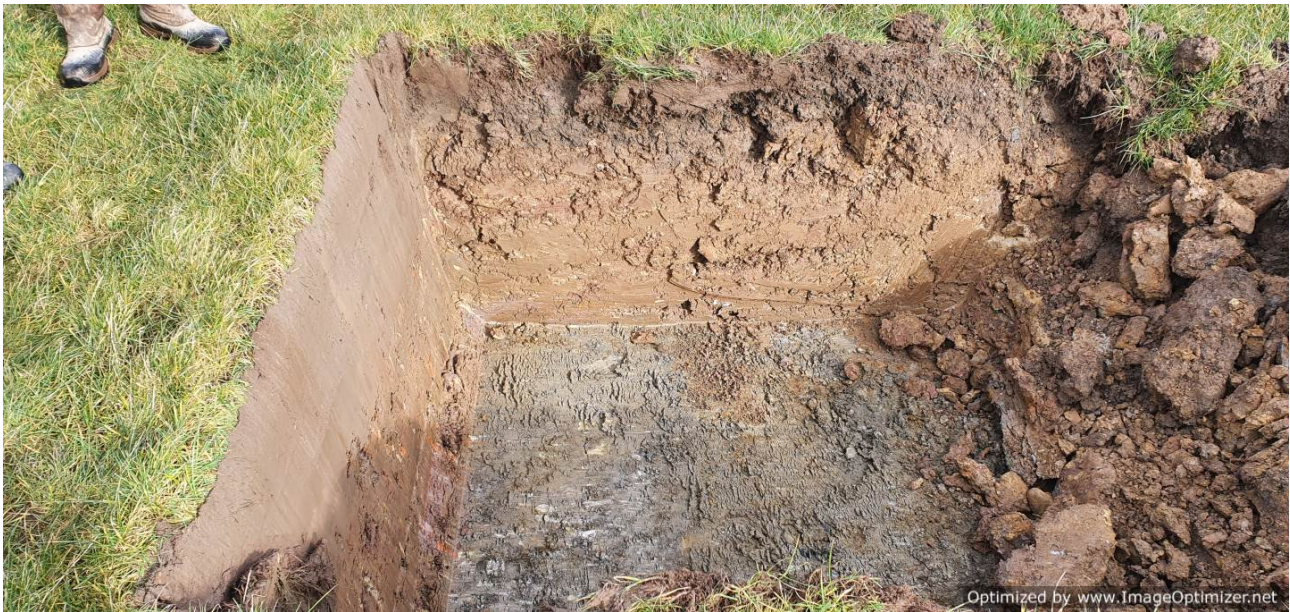
| Depth From (m) | Depth To (m) | Strata Description | Legend | Testing / Samples |
|---|---|---|---|---|
| | | Maintained Load test 3<br>2 x concrete blocks (1.5 x 0.60 x 0.60m) positioned in pit.<br>Pit dry on completion.<br>Pit backfilled around concrete blocks. | | No samples retained. |

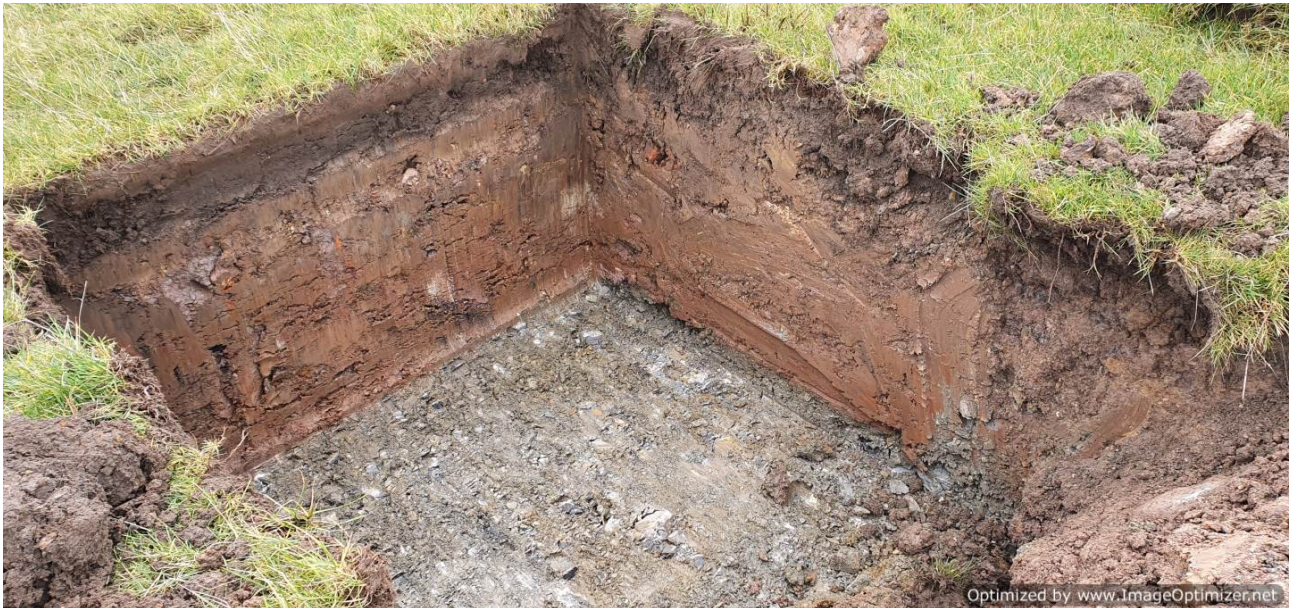
| Depth From (m) | Depth To (m) | Strata Description | Legend | Testing / Samples |
|---|---|---|---|---|
| | | Maintained Load test 4<br>2 x concrete blocks (1.5 x 0.60 x 0.60m) positioned in pit.<br>Pit dry on completion.<br>Pit backfilled around concrete blocks. | | No samples retained. |

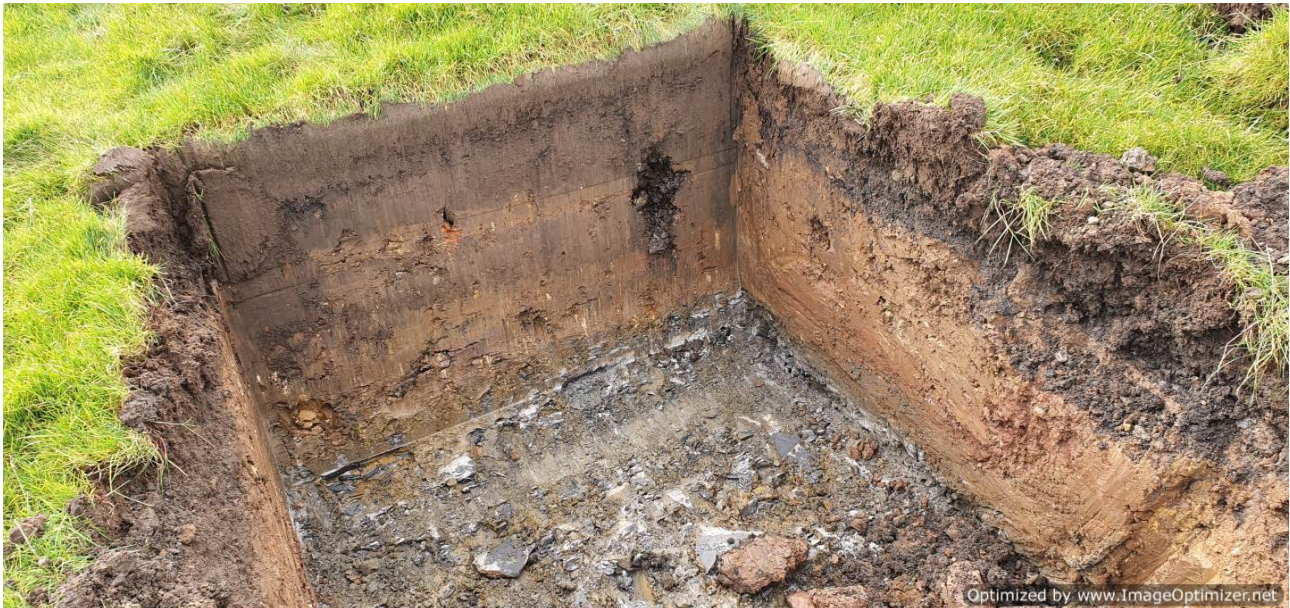
| Depth From (m) | Depth To (m) | Strata Description | Legend | Testing / Samples |
|---|---|---|---|---|
| | | Maintained Load test 5<br>2 x concrete blocks (1.5 x 0.60 x 0.60m) positioned in pit.<br>Pit dry on completion.<br>Pit backfilled around concrete blocks. | | No samples retained. |
