## **PHASE 2: GROUND INVESTIGATION REPORT**

**PROPOSED RESIDENTIAL DEVELOPMENT OF**

**LAND AT THORNLEA NEAR CARLETON**

**EGREMONT, CUMBRIA**

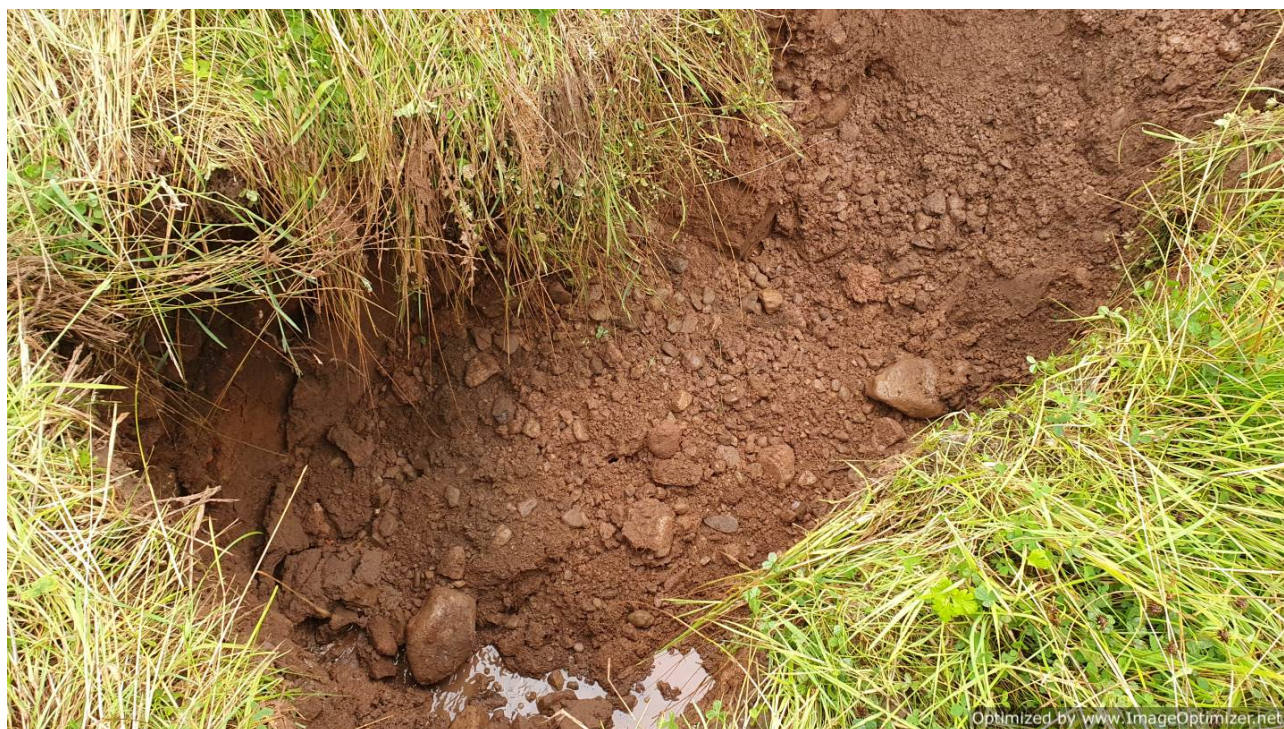
**GEO2021-4903: Land Adjacent to Thornlea, Carleton, Egremont, Cumbria – TP02**

During the test, the water level in trial pit TP02 was monitored over a duration of 199 minutes. During this time, the water level rose from 0.66m bgl to 0.63m bgl, possibly due to the ingress of groundwater. The test was classified as a fail.

| Depth From (m) | Depth To (m) | Strata Description | Legend | Testing / Samples |
|---|---|---|---|---|
| | | End of trial hole at 1.50m – Soil Infiltration Test Completed.<br>Groundwater ingress at 1.50m bgl.<br>Standing groundwater at 1.50m bgl on completion.<br>Trial hole backfilled with arisings on completion. | | |

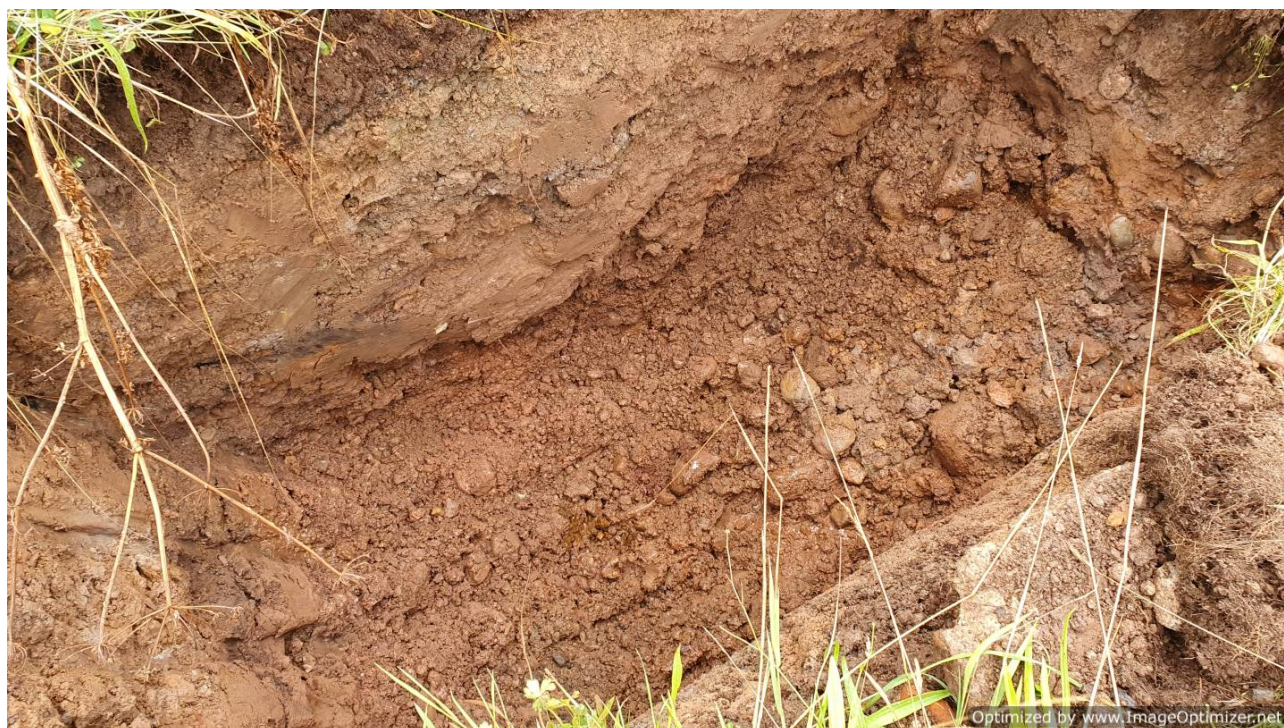
**GEO2021-4903: Land Adjacent to Thornlea, Carleton, Egremont, Cumbria – TP03**

| Depth From (m) | Depth To (m) | Strata Description | Legend | Testing / Samples |
|---|---|---|---|---|
| | | End of trial hole at 2.00m.<br>Groundwater ingress at 1.40m bgl.<br>Standing groundwater at 1.40m bgl on completion.<br>Trial pit collapsing during excavation.<br>Trial hole backfilled with arisings on completion. | | |

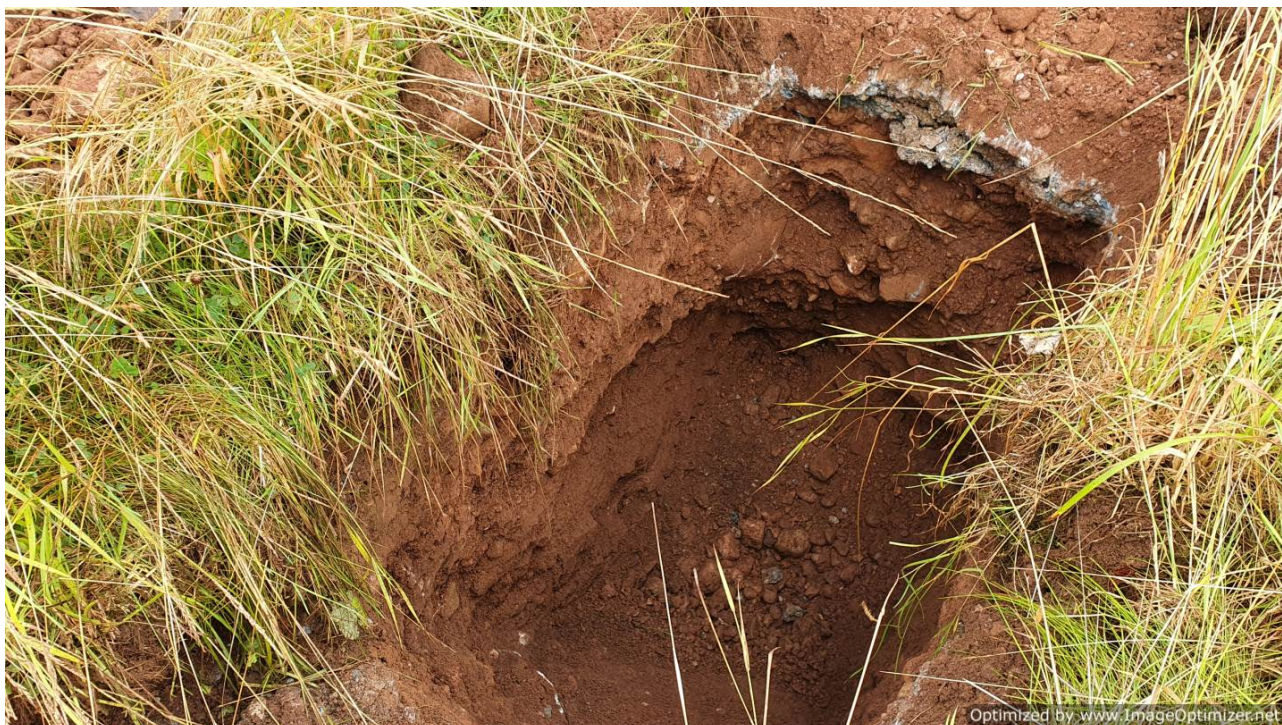
**GEO2021-4903: Land Adjacent to Thornlea, Carleton, Egremont, Cumbria – TP05**

Based on the Human Health risk assessment above, it can be seen that the concentration of lead in the made ground encountered in trial pit TP05 exceeds the assessment criteria for a residential end use where private gardens are proposed. The concentration of lead was over 13 times the assessment criteria value at 2659mg/kg. The made ground at this location comprised sandy gravel of mixed aggregate, slag and concrete. No obvious sources for the lead were noted.

There was nothing noted in trial pit TP05 to explain the elevated lead concentration. As such, it is possible that elevated lead may be present elsewhere on the site and it is recommended that further screening is undertaken to delineate the elevated lead. Alternatively, remediation or protection measures should be adopted for the site as a whole where gardens or soft landscaping are planned. As the made ground was generally not considered suitable for re-use within landscaped areas, this may be the preferable option.

Based on the ground investigation, it is likely that the most suitable form of remediation would be to excavate and remove the made ground (typically less than 0.50m thick) and replace with clean imported soils. The site will therefore require a Remediation Strategy.

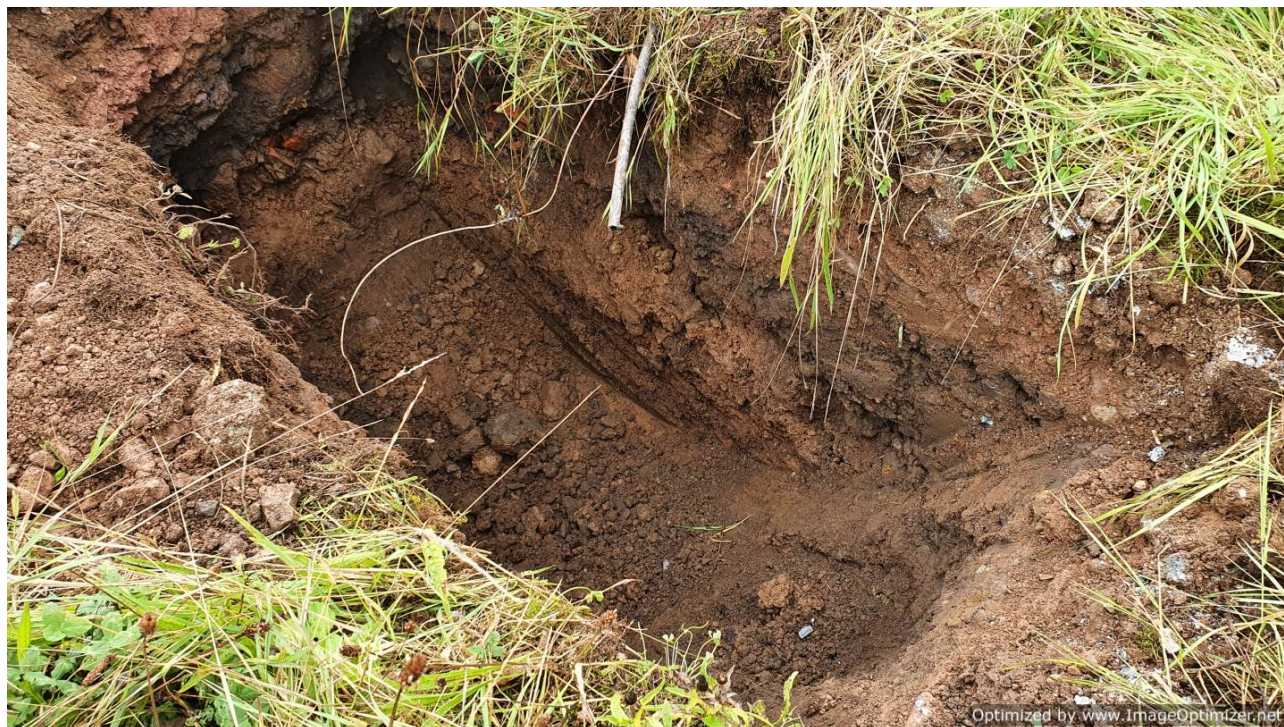
**GEO2021-4903: Land Adjacent to Thornlea, Carleton, Egremont, Cumbria – TP06**

Two infiltration tests were completed in trial pit TP06. The tests were run for a duration of 130 and 137 minutes respectively. The tests indicate soil infiltration rates of between  $2.3 \times 10^{-05} \text{m/s}$  and  $2.2 \times 10^{-05} \text{m/s}$ . It should be noted however, that groundwater ingress was recorded in trial pit TP06 prior to the infiltration tests at a depth of c.1.45m bgl. The groundwater levels should be taken into consideration when determining if soakaway drainage is appropriate for the site.

| Depth From (m) | Depth To (m) | Strata Description | Legend | Testing / Samples |
|---|---|---|---|---|
| | | End of trial hole at 1.80m – Soil Infiltration Test Completed.<br>Groundwater ingress at 1.45m bgl.<br>Trial hole backfilled with arisings on completion. | | |
