## **PHASE 2: GROUND INVESTIGATION REPORT**

**PROPOSED COMMERCIAL DEVELOPMENT OF LAND TO**

**SOUTH OF VALE VIEW, EGREMONT**

**Report Ref:** 2021-4760

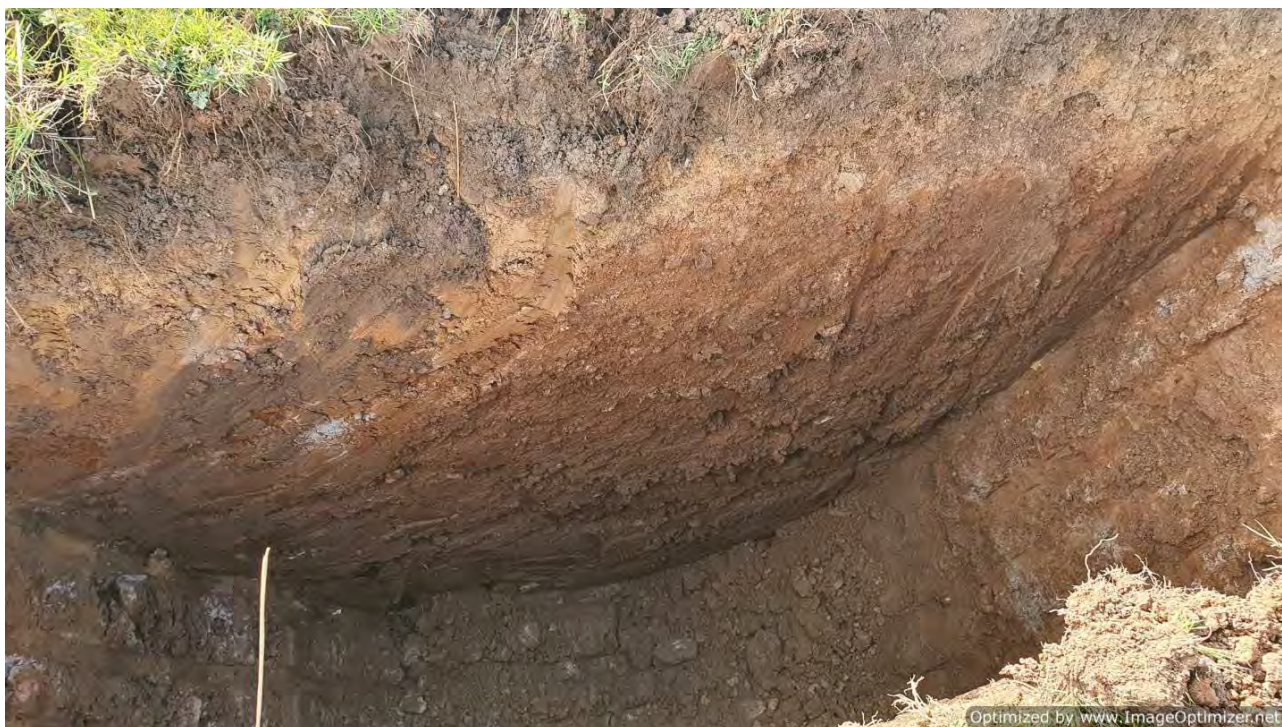
**GEO2021-4760: Vale View, Egremont – TP02**

| Depth From (m) | Depth To (m) | Strata Description | Legend | Testing / Samples |
|---|---|---|---|---|
| | | End of trial hole at 2.30m.<br>Trial hole remained open and dry on completion.<br>Trial hole backfilled with arisings on completion. | | |

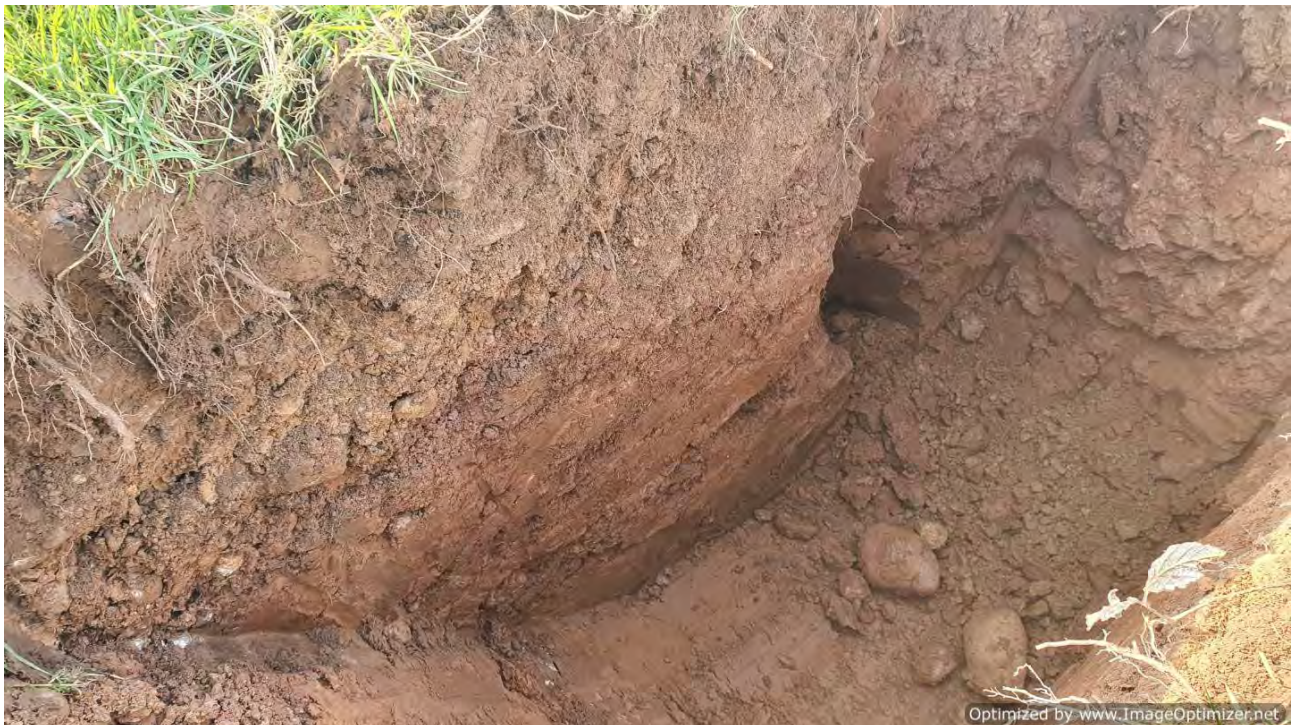
**GEO2021-4760: Vale View, Egremont – TP05 (On Mound)**

| Depth From (m) | Depth To (m) | Strata Description | Legend | Testing / Samples |
|---|---|---|---|---|
| | | End of trial hole at 2.20m.<br>Trial hole remained open and dry on completion.<br>Trial hole backfilled with arisings on completion. | | |

Historical records indicate that several mounds were present across the north east part of the site during the mid-1900s and remnants of these mounds are still present close to the site boundary. As such, made ground was anticipated in this area. The trial pits confirmed made ground (typically less than c.0.70m deep) comprising gravel, cobbles and boulders of aggregate within a loamy soil matrix. Trial pits TP's 05 and 06 were positioned on the mounds and encountered similar ground conditions.

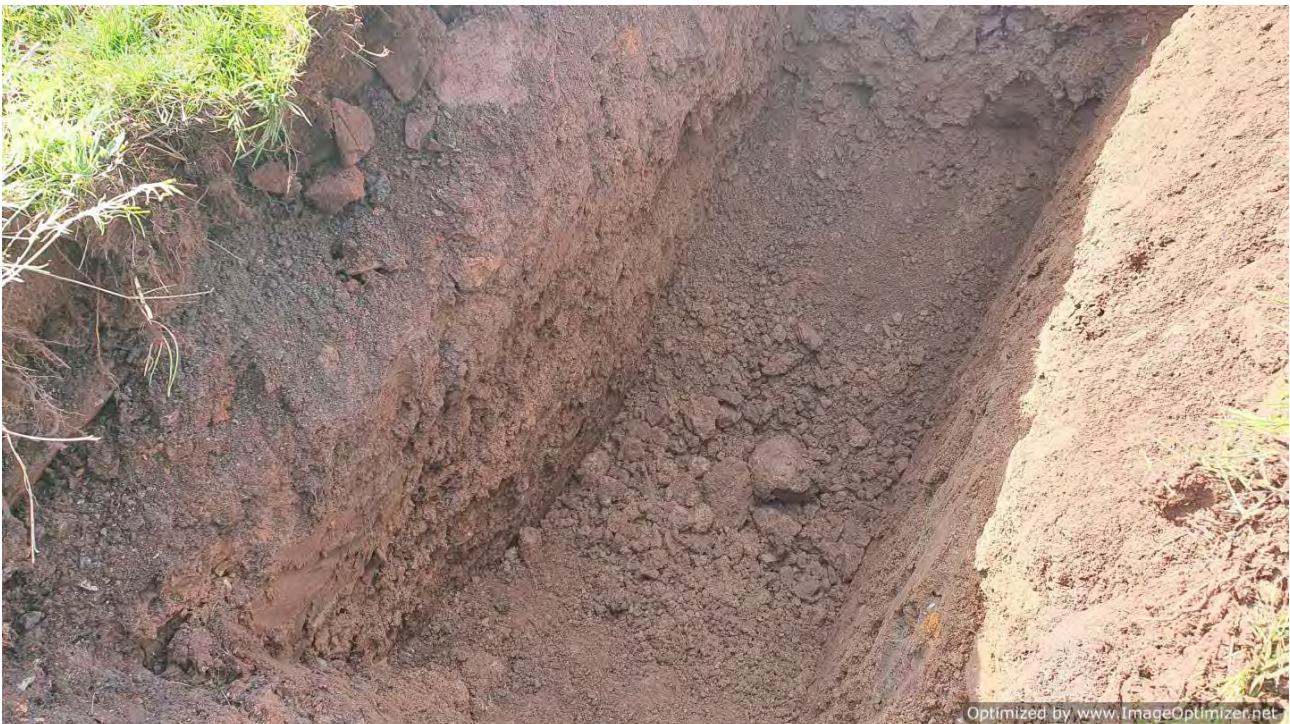
**GEO2021-4760: Vale View, Egremont – TP07**

| Depth From (m) | Depth To (m) | Strata Description | Legend | Testing / Samples |
|---|---|---|---|---|
| | | End of trial hole at 2.20m.<br>Trial hole remained open and dry on completion.<br>Trial hole backfilled with arisings on completion. | | |

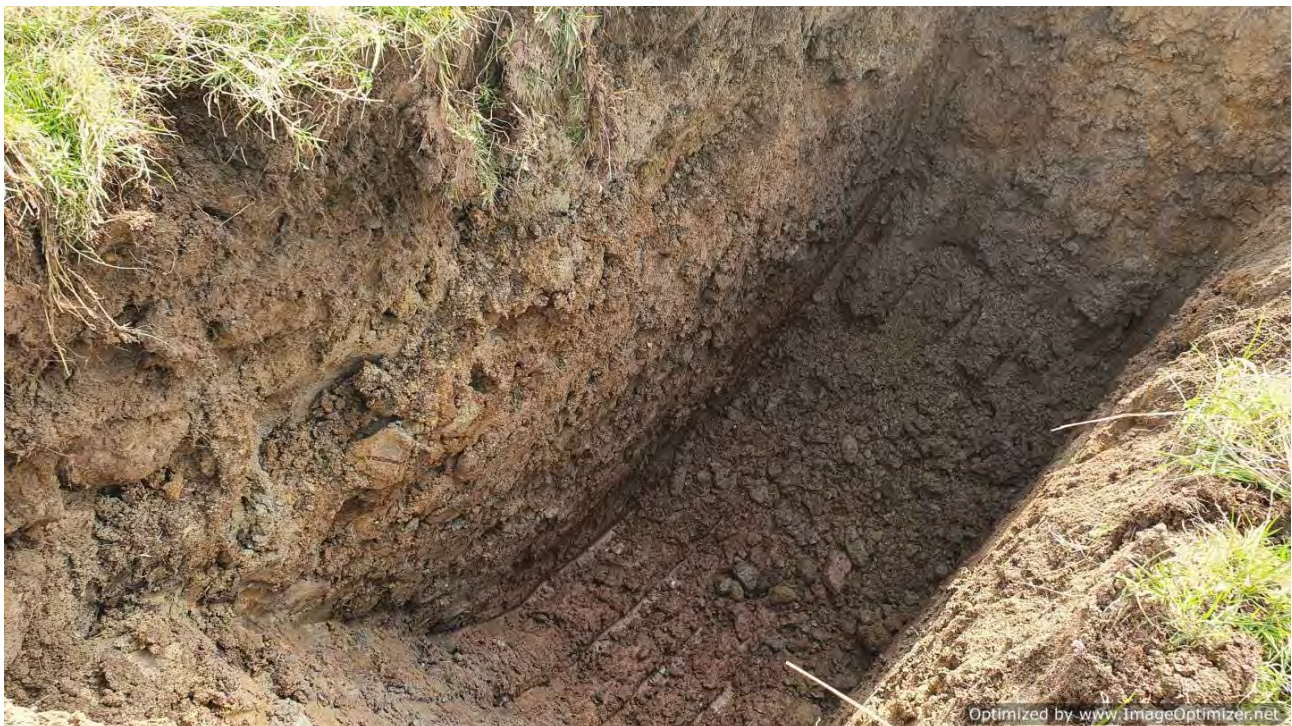
**GEO2021-4760: Vale View, Egremont – TP09**

| Depth From (m) | Depth To (m) | Strata Description | Legend | Testing / Samples |
|---|---|---|---|---|
| | | End of trial hole at 2.20m.<br>Occasional minor pockets of perched groundwater near base.<br>Trial pit remained stable during excavation.<br>Trial hole backfilled with arisings on completion. | | |

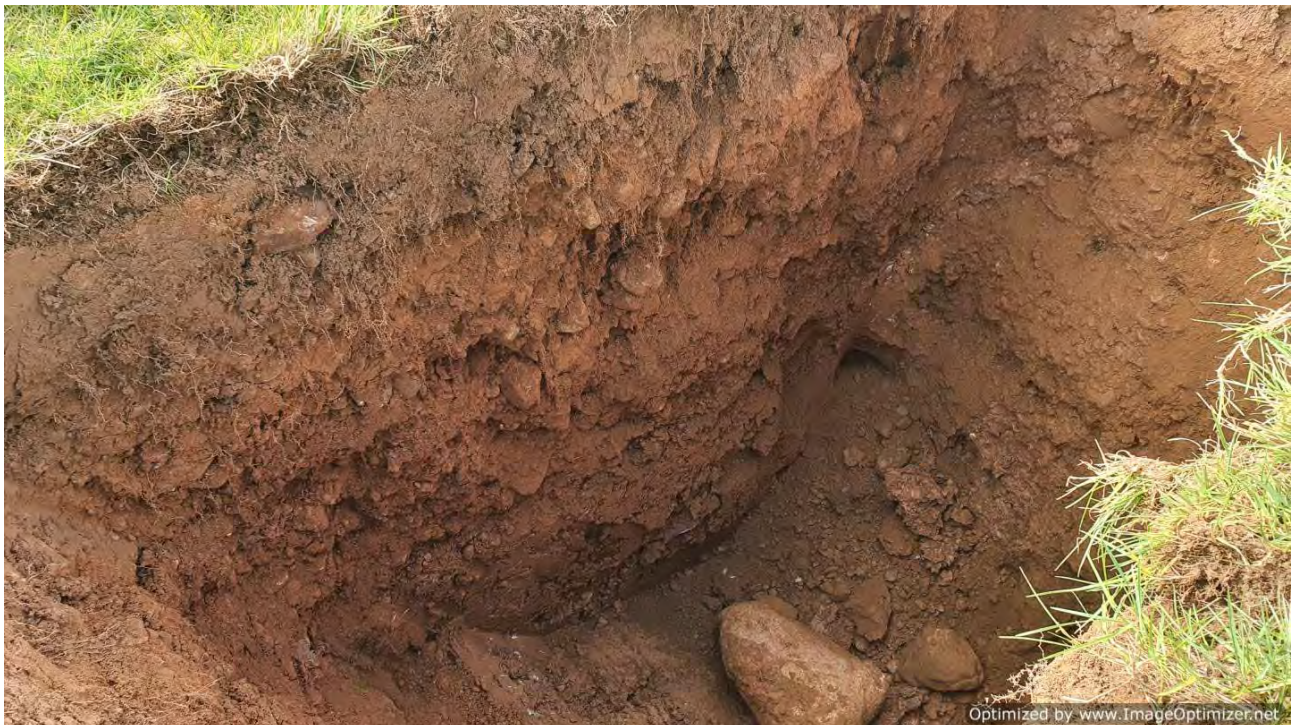
**GEO2021-4760: Vale View, Egremont – TP14**

| Depth From (m) | Depth To (m) | Strata Description | Legend | Testing / Samples |
|---|---|---|---|---|
| | | End of trial hole at 1.80m.<br>Trial pit remained stable during excavation.<br>Trial hole backfilled with arisings on completion. | | |

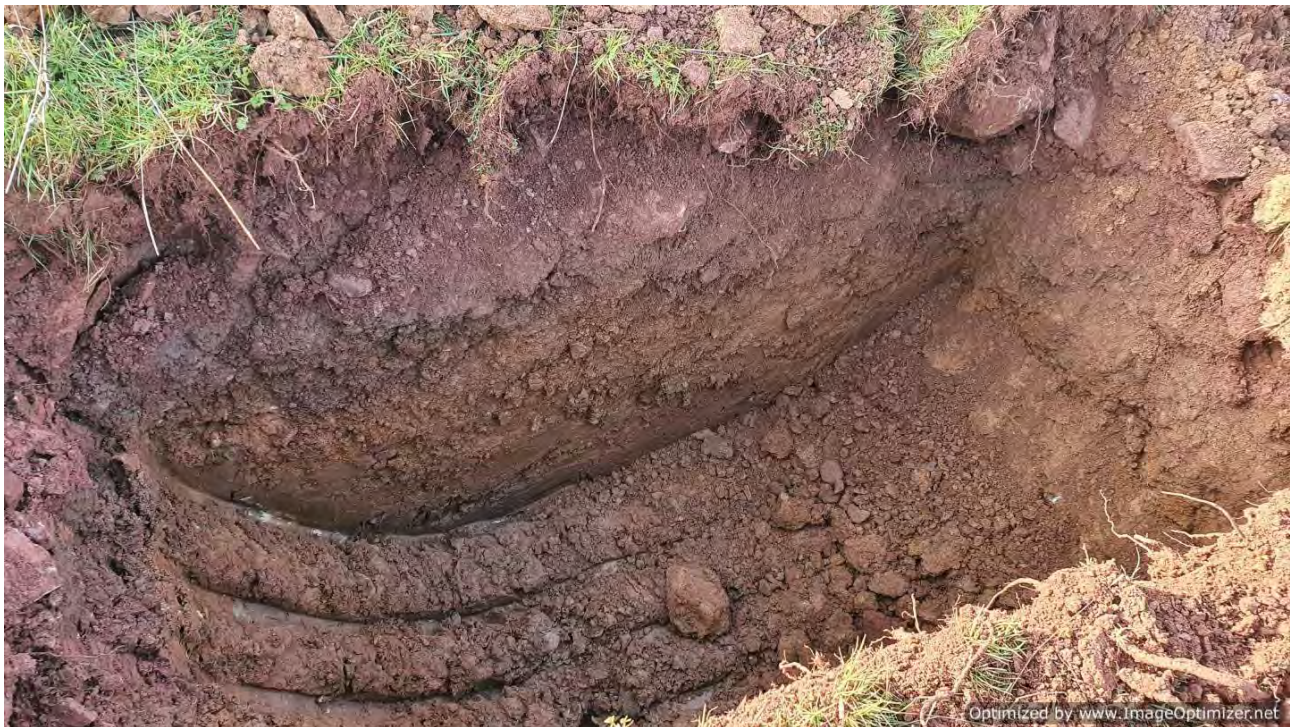
**GEO2021-4760: Vale View, Egremont – TP16**

| Depth From (m) | Depth To (m) | Strata Description | Legend | Testing / Samples |
|---|---|---|---|---|
| | | End of trial hole at 1.60m.<br>Trial pit remained stable during excavation.<br>Trial hole backfilled with arisings on completion. | | |

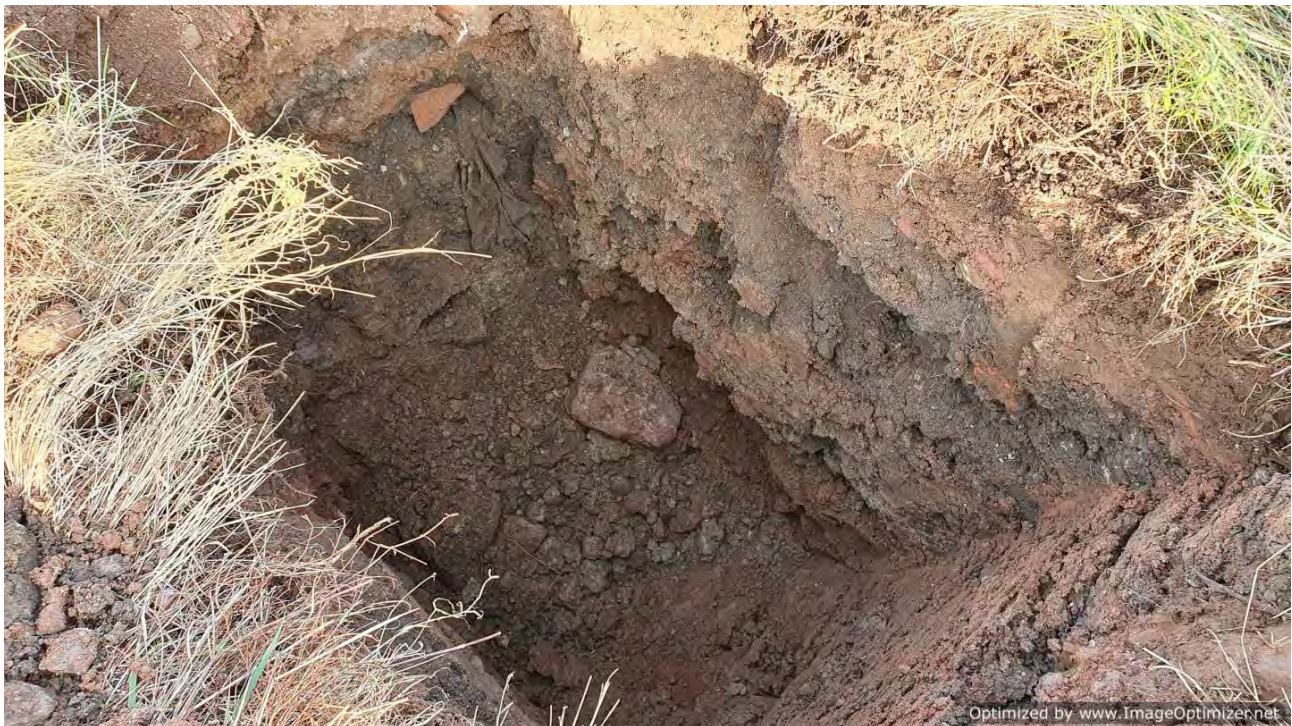
**GEO2021-4760: Vale View, Egremont – TP18**

| Depth From (m) | Depth To (m) | Strata Description | Legend | Testing / Samples |
|---|---|---|---|---|
| | | End of trial hole at 2.10m.<br>Trial pit remained stable during excavation.<br>Trial hole backfilled with arisings on completion. | | |

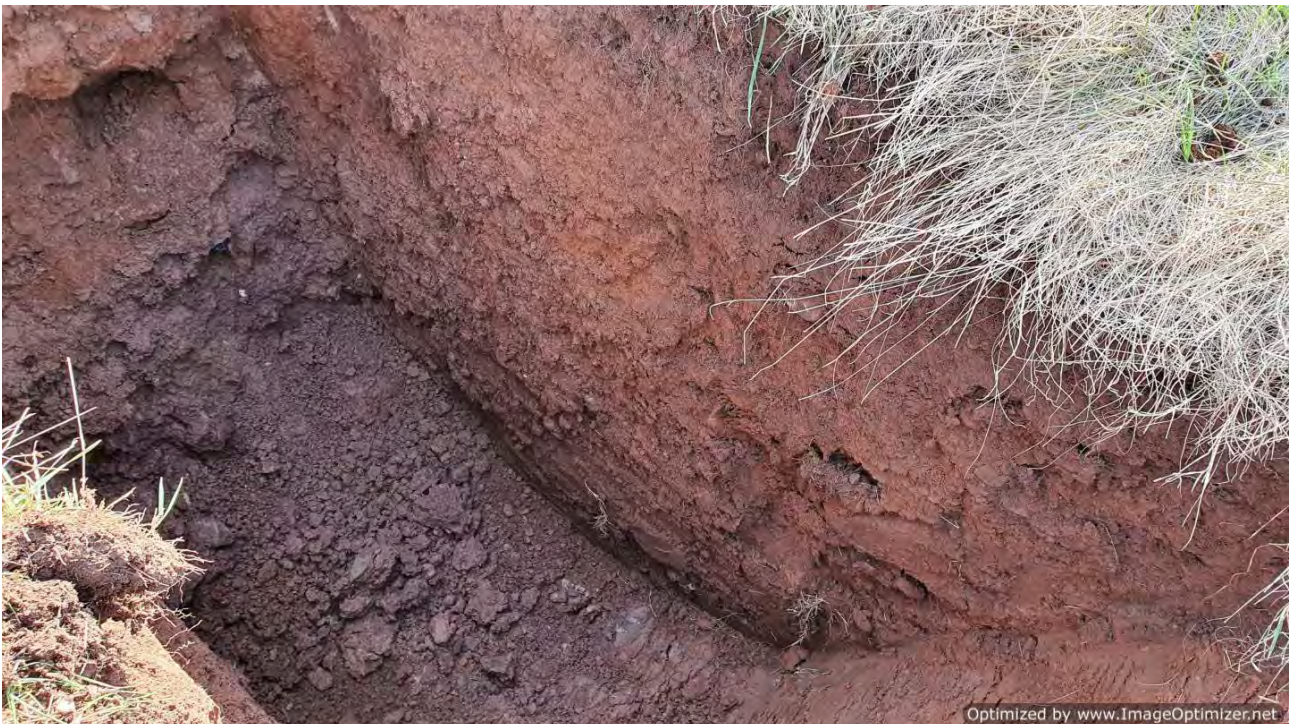
**GEO2021-4760: Vale View, Egremont – TP20**

| Depth From (m) | Depth To (m) | Strata Description | Legend | Testing / Samples |
|---|---|---|---|---|
| | | End of trial hole at 1.50m.<br>Trial pit remained stable during excavation.<br>Trial hole backfilled with arisings on completion. | | |

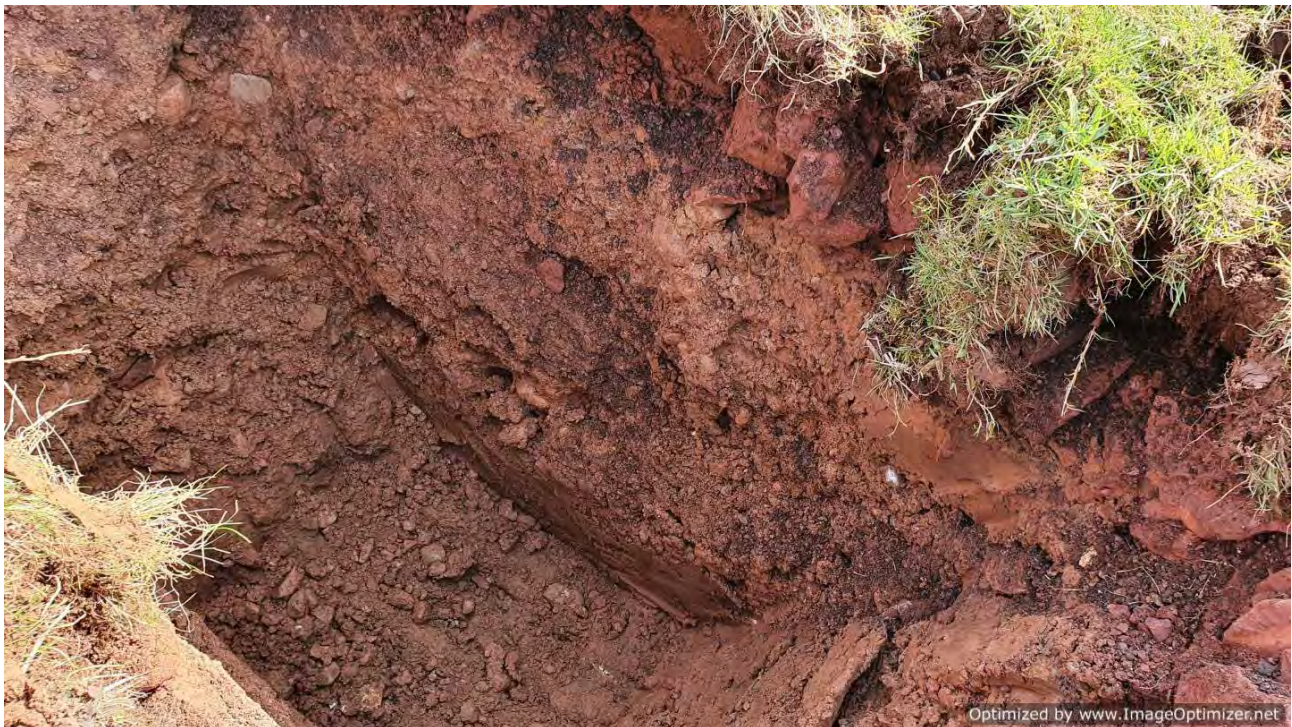
**GEO2021-4760: Vale View, Egremont – TP23**

| Depth From (m) | Depth To (m) | Strata Description | Legend | Testing / Samples |
|---|---|---|---|---|
| | | End of trial hole at 1.90m.<br>Trial pit remained stable during excavation.<br>Trial hole backfilled with arisings on completion. | | |

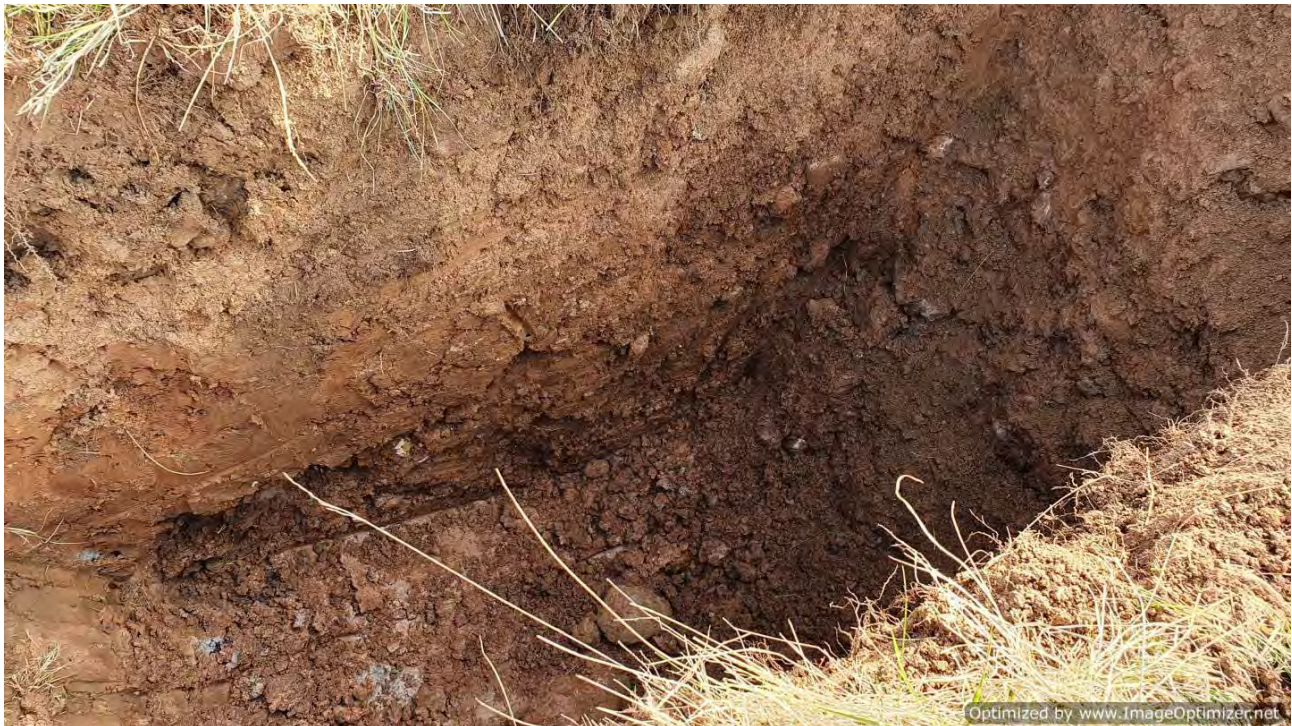
**GEO2021-4760: Vale View, Egremont – TP24**

| Depth From (m) | Depth To (m) | Strata Description | Legend | Testing / Samples |
|---|---|---|---|---|
| | | End of trial hole at 1.90m.<br>Trial pit remained stable during excavation.<br>Trial hole backfilled with arisings on completion. | | |
