## **PHASE 2: GROUND INVESTIGATION REPORT**

**PROPOSED RESIDENTIAL DEVELOPMENT OF**

**LAND OFF GRIFFIN CLOSE, FRIZINGTON**

**Report Ref:** 2023-5496

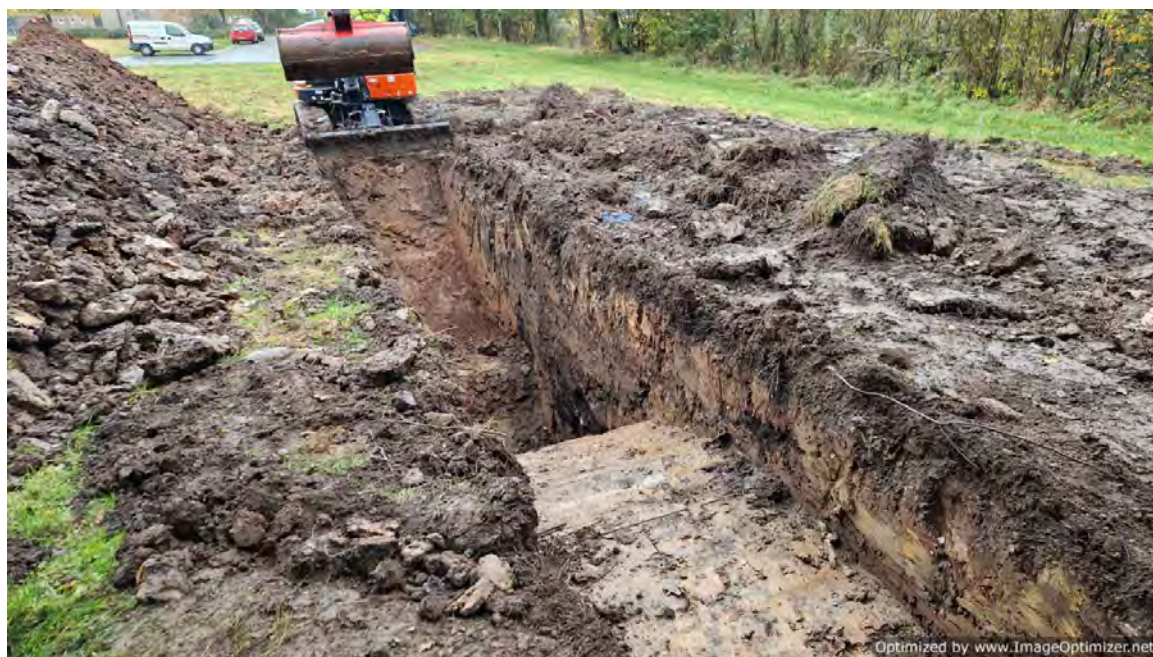
**GEO2021-5496: Griffin Close, Frizington – Trench 02**

| Depth From (m) | Depth To (m) | Strata Description | Legend | Testing / Samples |
|---|---|---|---|---|
| | | Base of trench varies 1.00m to 2.80m bgl.<br>Trench remained open and dry on completion.<br>Trench backfilled with arisings on completion. | | |

Three trenches were pulled across the area where the mine shaft is shown on The Coal Authority Plan. The trenches were c.1.60m wide and varied between 11.70m and 13.0m in length. The trenches encountered made ground which was typically less than c.1.30m deep, however, a localised pocket of made ground extending to c.2.70m bgl was noted in Trench 02. This comprised firm grey brown gravelly clay with occasional black organic silt (see photos on logs). No direct evidence of a mine shaft was encountered.

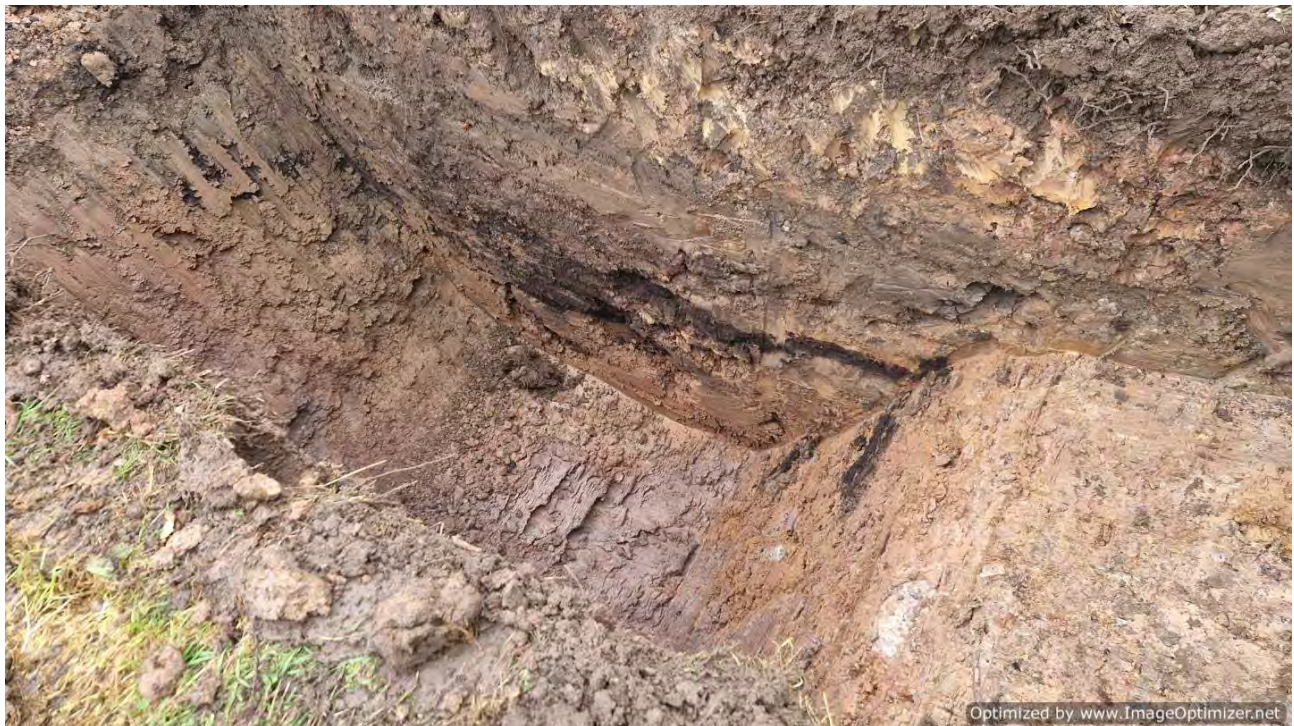
**GEO2021-5496: Griffin Close, Frizington – Trench 03**

| Depth From (m) | Depth To (m) | Strata Description | Legend | Testing / Samples |
|---|---|---|---|---|
| | | Base of trench varies 1.00m to 1.50m bgl in natural ground.<br>Trench remained open and dry on completion.<br>Trench backfilled with arisings on completion. | | |

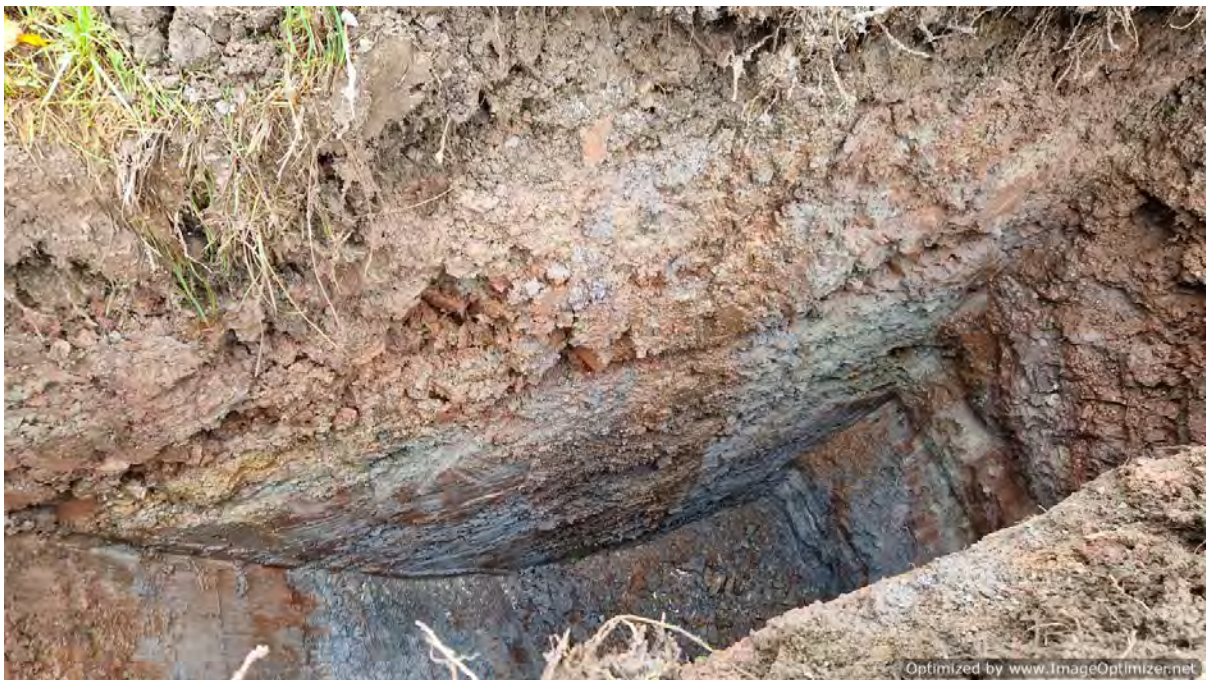
**GEO2021-5496: Griffin Close, Frizington – TP02**

| Depth From (m) | Depth To (m) | Strata Description | Legend | Testing / Samples |
|---|---|---|---|---|
| | | Trial pit terminated at 1.50m bgl.<br>Trench remained open and dry on completion.<br>Trial hole backfilled with arisings on completion. | | |

The clay in trial pits TP01 and 02 was noted as stiff to very stiff with gravel of angular mudstone. This was noted as possible heavily weathered bedrock.

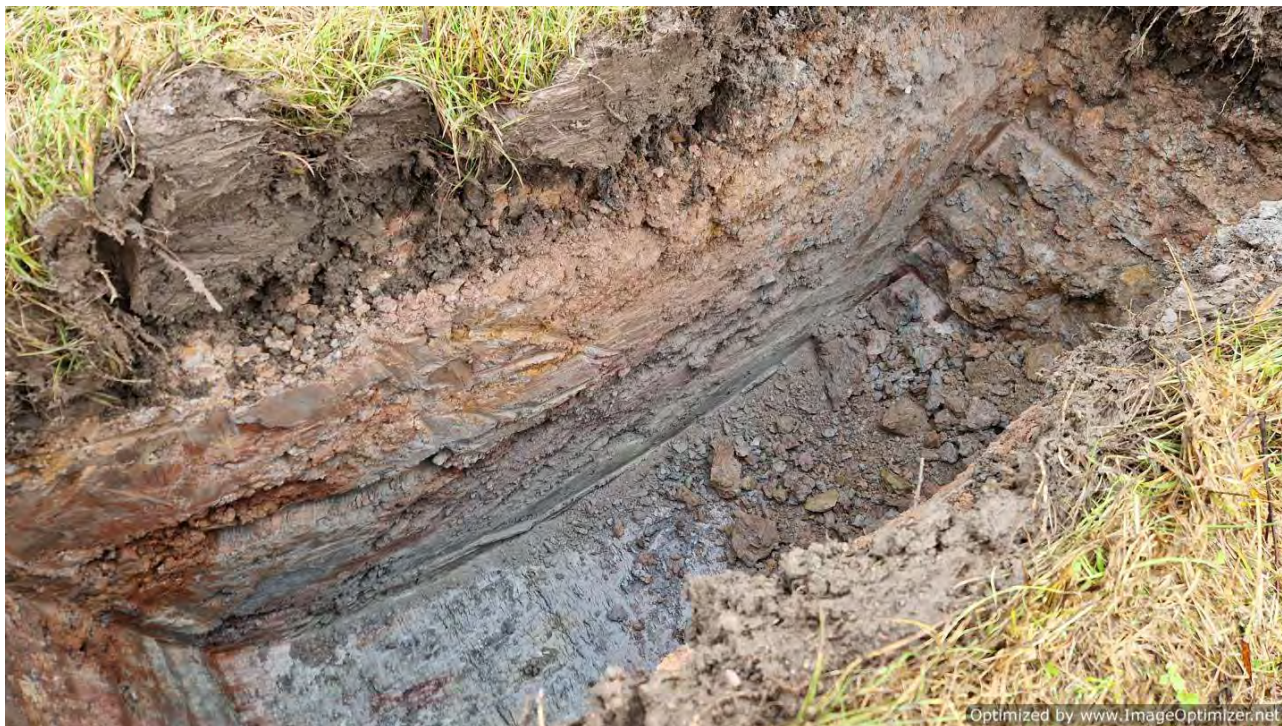
**GEO2021-5496: Griffin Close, Frizington – TP03**

| Depth From (m) | Depth To (m) | Strata Description | Legend | Testing / Samples |
|---|---|---|---|---|
| | | Trial pit terminated at 2.50m bgl.<br>Groundwater ingress (moderate) at 1.30m bgl.<br>Trial hole backfilled with arisings on completion. | | |

The exploratory holes were typically dry during the intrusive ground investigation works. However, significant groundwater ingress was noted in trial pit TP03 at c.1.30m bgl. This was noted as perched water within the made ground and the flow was noted to cease quickly.
