## **PHASE 2: GROUND INVESTIGATION REPORT**

**PROPOSED RESIDENTIAL DEVELOPMENT OF  
LAND OFF WINDERMERE ROAD & FELL VIEW AVENUE**

**WHITEHAVEN, CUMBRIA**

**HOME GROUP LTD & THOMAS ARMSTRONG**

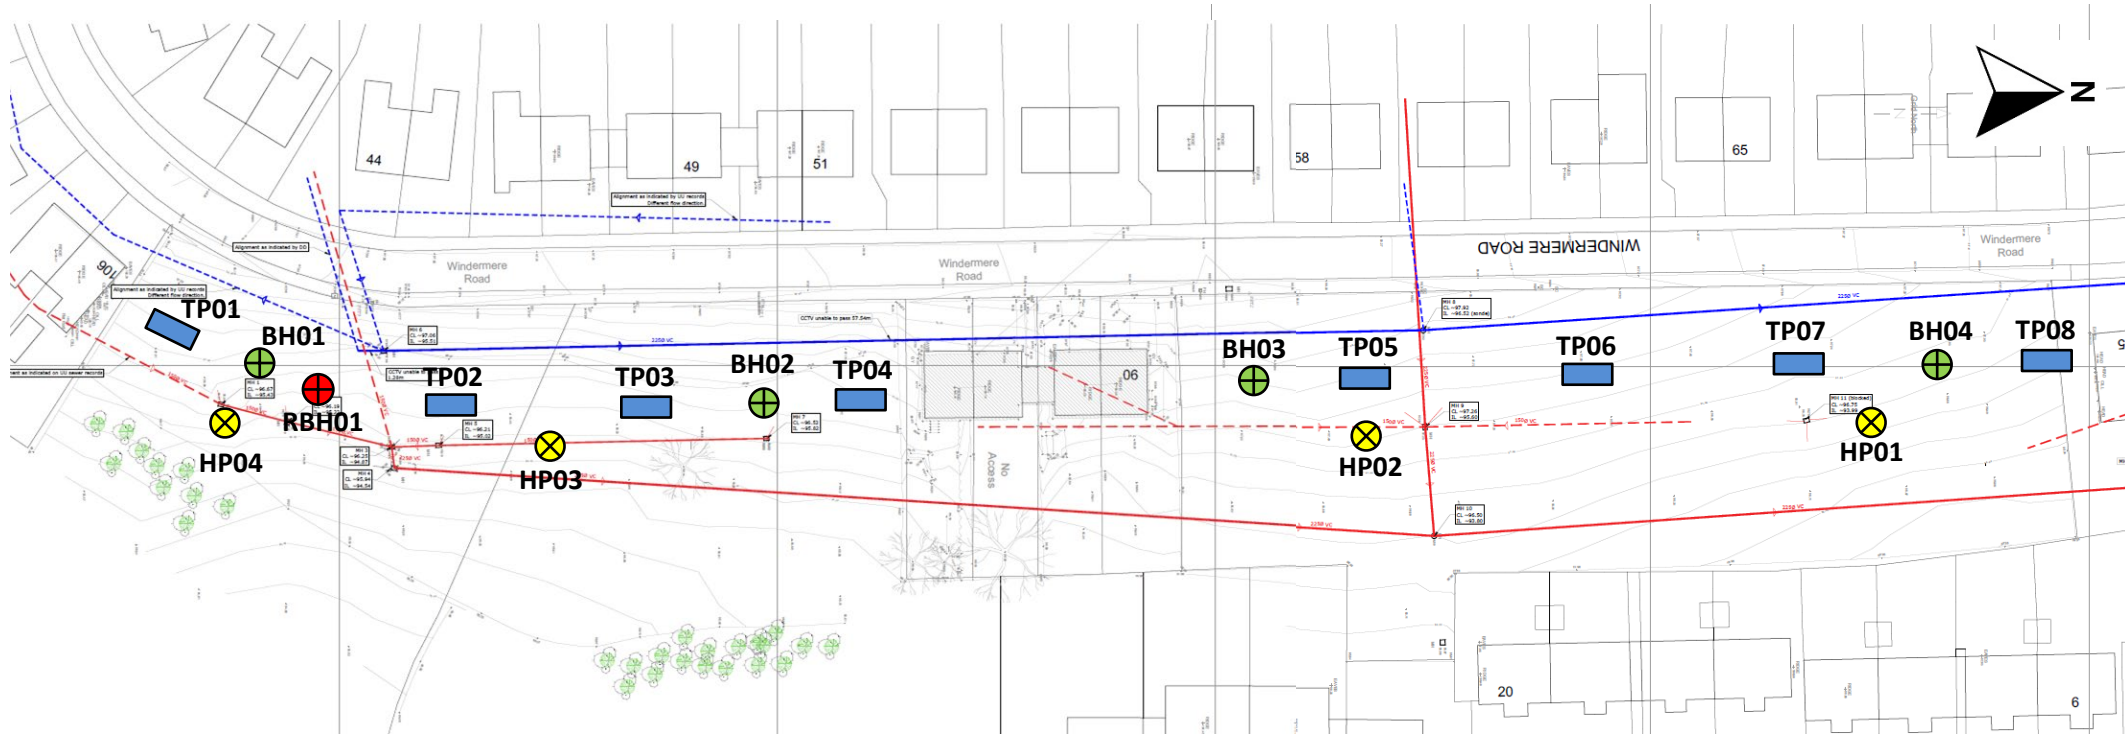
**GEO2022-5335: Windermere Rd, Whitehaven – Exploratory Hole Location Plans (Page 1 of 2)**

- Trial Pit Locations
- + Boreholes (Monitoring Wells Installed in BH01, BH02, BH03 and BH04)
- X Shallow Hand Dug Pits
- + Rotary Boreholes

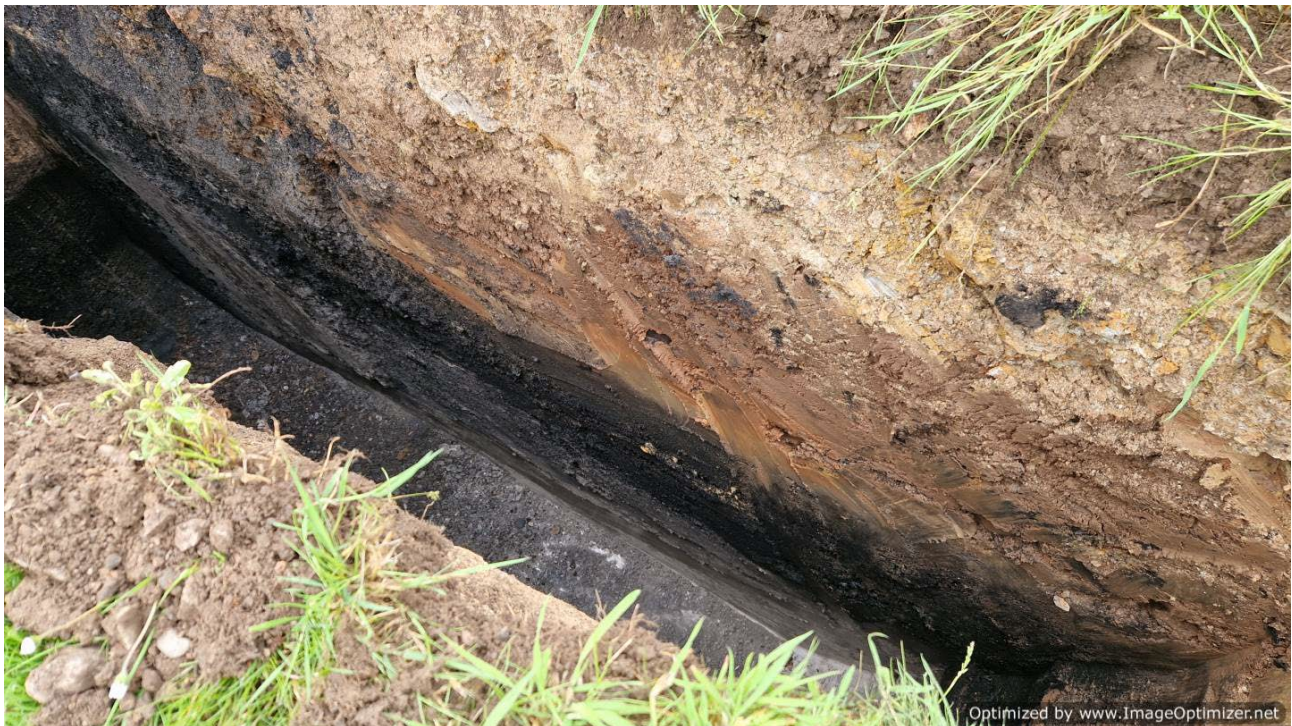
**GEO2021-5335: Windermere Rd & Fell View Avenue, Whitehaven – TP02**

| Depth From (m) | Depth To (m) | Strata Description | Legend | Testing / Samples |
|---|---|---|---|---|
| | | End of trial hole at 2.20m.<br>Trial hole remained open and dry on completion.<br>Trial hole backfilled with arisings on completion. | | |

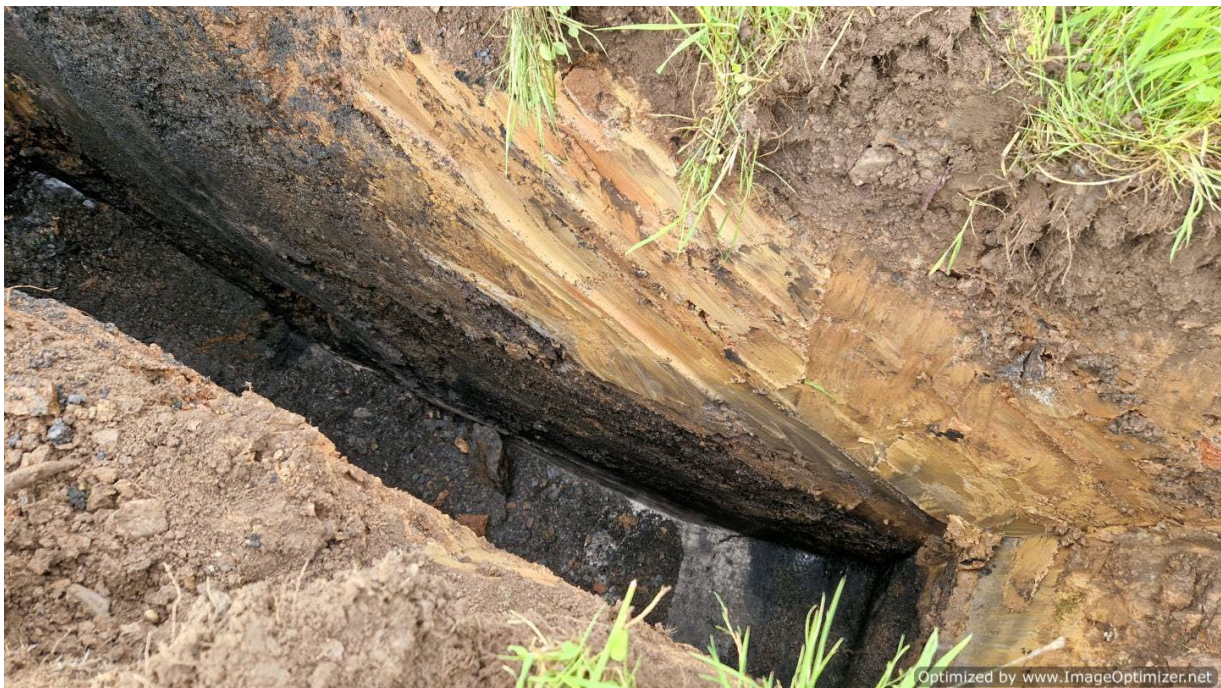
**GEO2021-5335: Windermere Rd & Fell View Avenue, Whitehaven – TP04**

| Depth From (m) | Depth To (m) | Strata Description | Legend | Testing / Samples |
|---|---|---|---|---|
| | | End of trial hole at 2.40m bgl.<br>Groundwater ingress (seep) from 1.50m bgl. Trial pit is stable.<br>Trial hole backfilled with arisings on completion. | | |

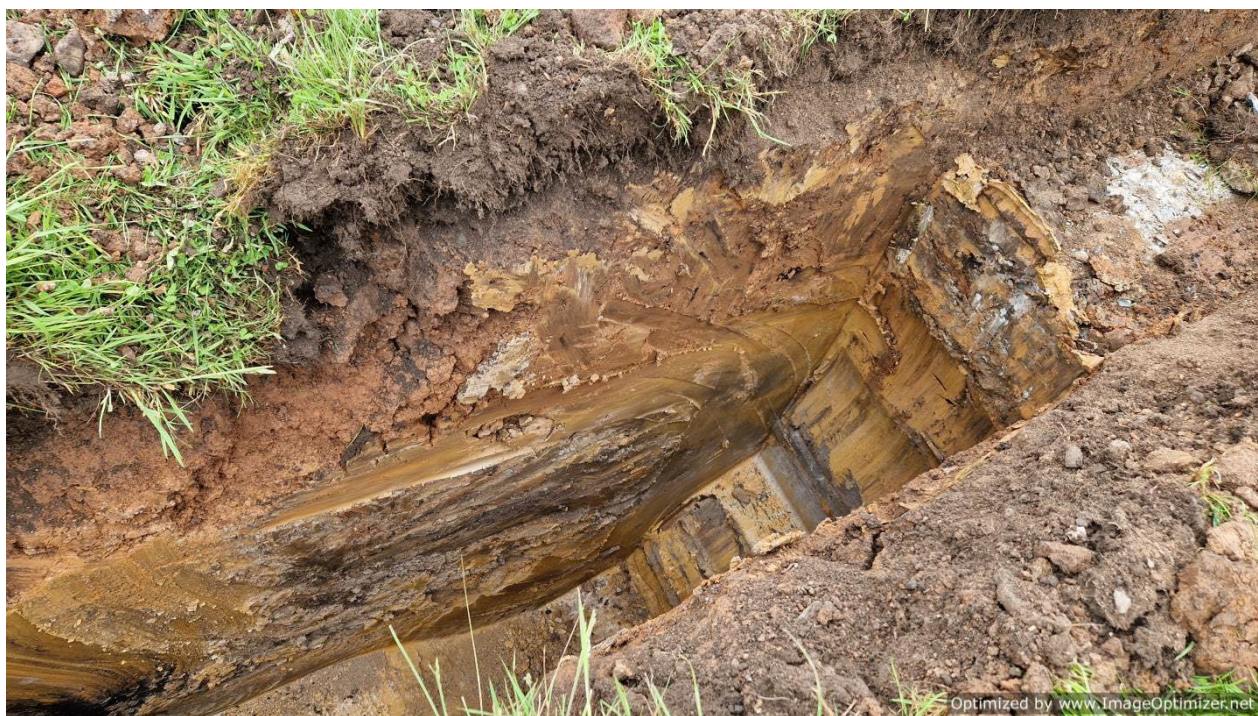
**GEO2021-5335: Windermere Rd & Fell View Avenue, Whitehaven – TP06**

| Depth From (m) | Depth To (m) | Strata Description | Legend | Testing / Samples |
|---|---|---|---|---|
| | | End of trial hole at 2.30m bgl.<br>Trial pit dry and stable on completion.<br>Trial hole backfilled with arisings on completion. | | |

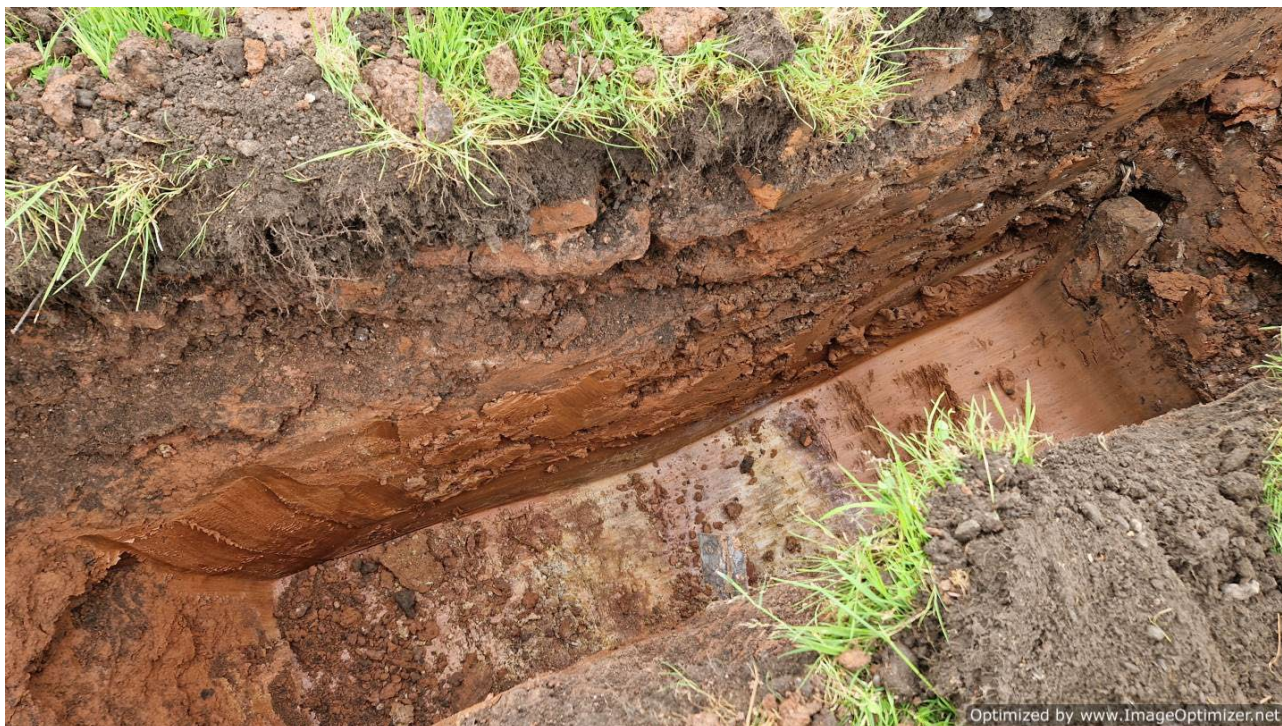
**GEO2021-5335: Windermere Rd & Fell View Avenue, Whitehaven – TP08**

| Depth From (m) | Depth To (m) | Strata Description | Legend | Testing / Samples |
|---|---|---|---|---|
| | | End of trial hole at 1.60m bgl.<br>Trial pit dry and stable on completion.<br>Trial hole backfilled with arisings on completion. | | |

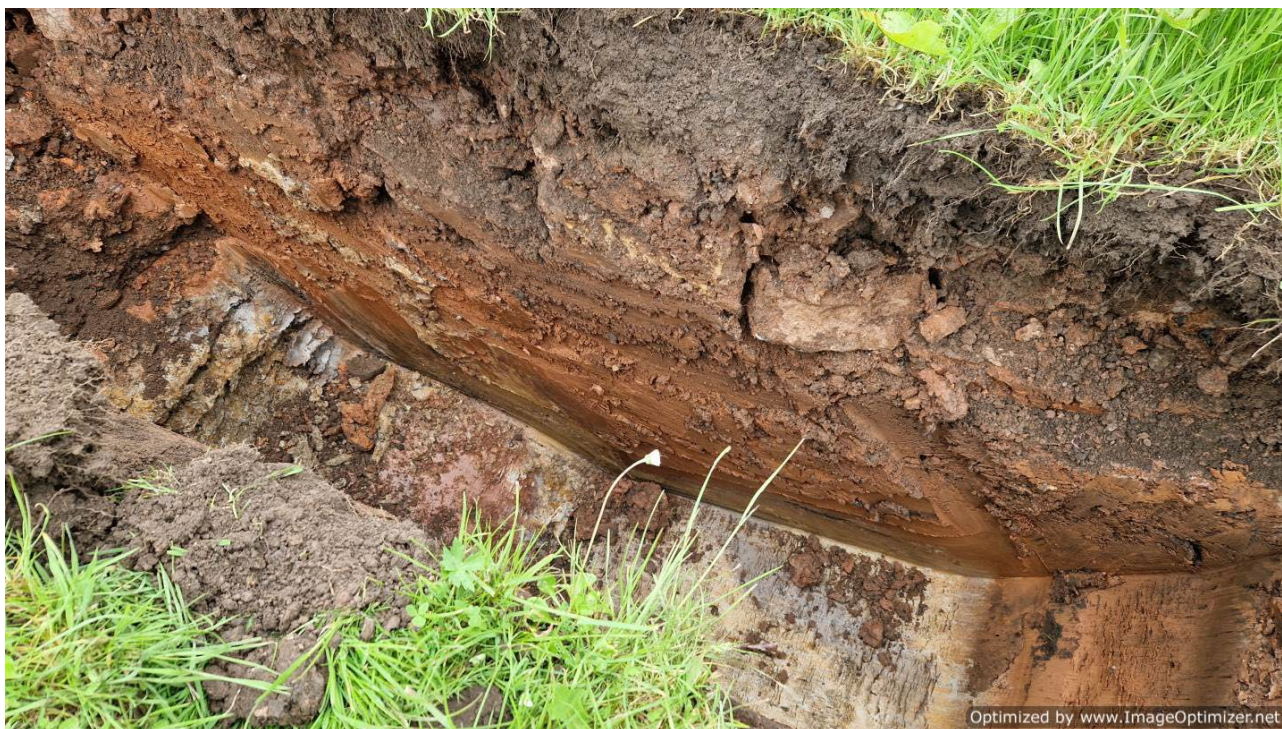
**GEO2021-5335: Windermere Rd & Fell View Avenue, Whitehaven – TP09**

| Depth From (m) | Depth To (m) | Strata Description | Legend | Testing / Samples |
|---|---|---|---|---|
| | | End of trial hole at 1.60m bgl.<br>Trial pit dry and stable on completion.<br>Trial hole backfilled with arisings on completion. | | |

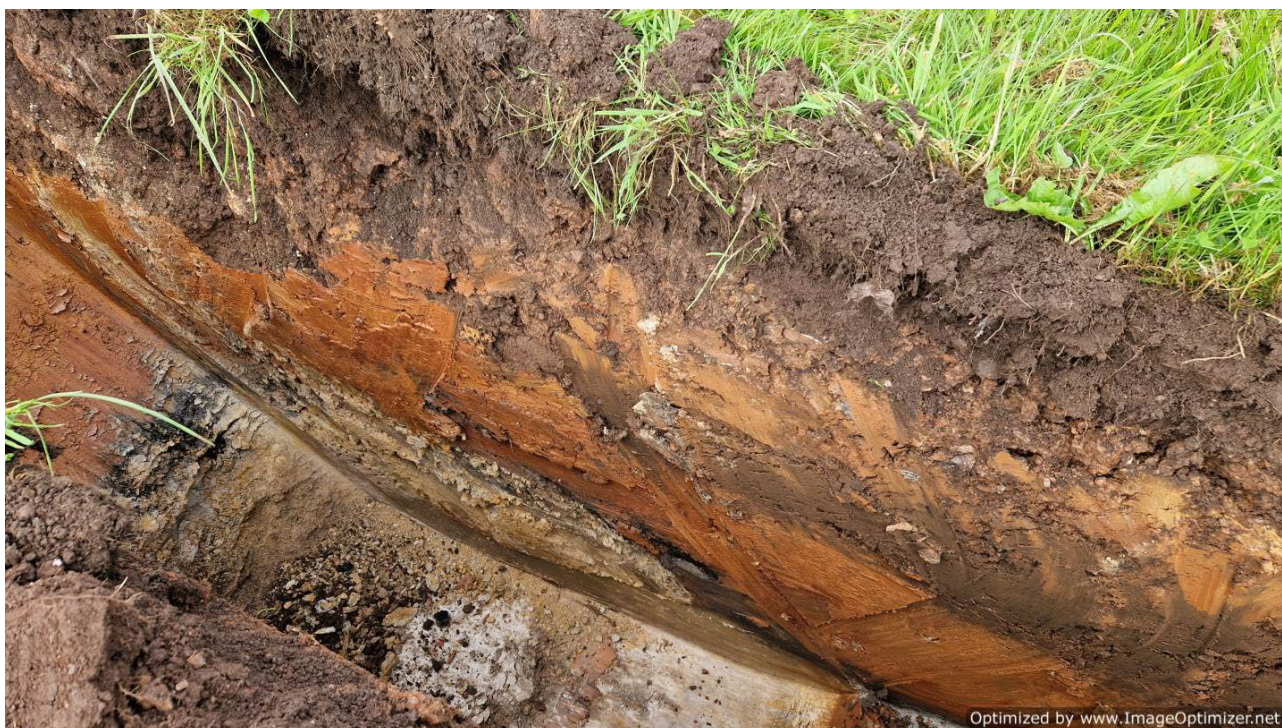
**GEO2021-5335: Windermere Rd & Fell View Avenue, Whitehaven – TP10**

| Depth From (m) | Depth To (m) | Strata Description | Legend | Testing / Samples |
|---|---|---|---|---|
| | | End of trial hole at 1.60m bgl.<br>Trial pit dry and stable on completion.<br>Trial hole backfilled with arisings on completion. | | |

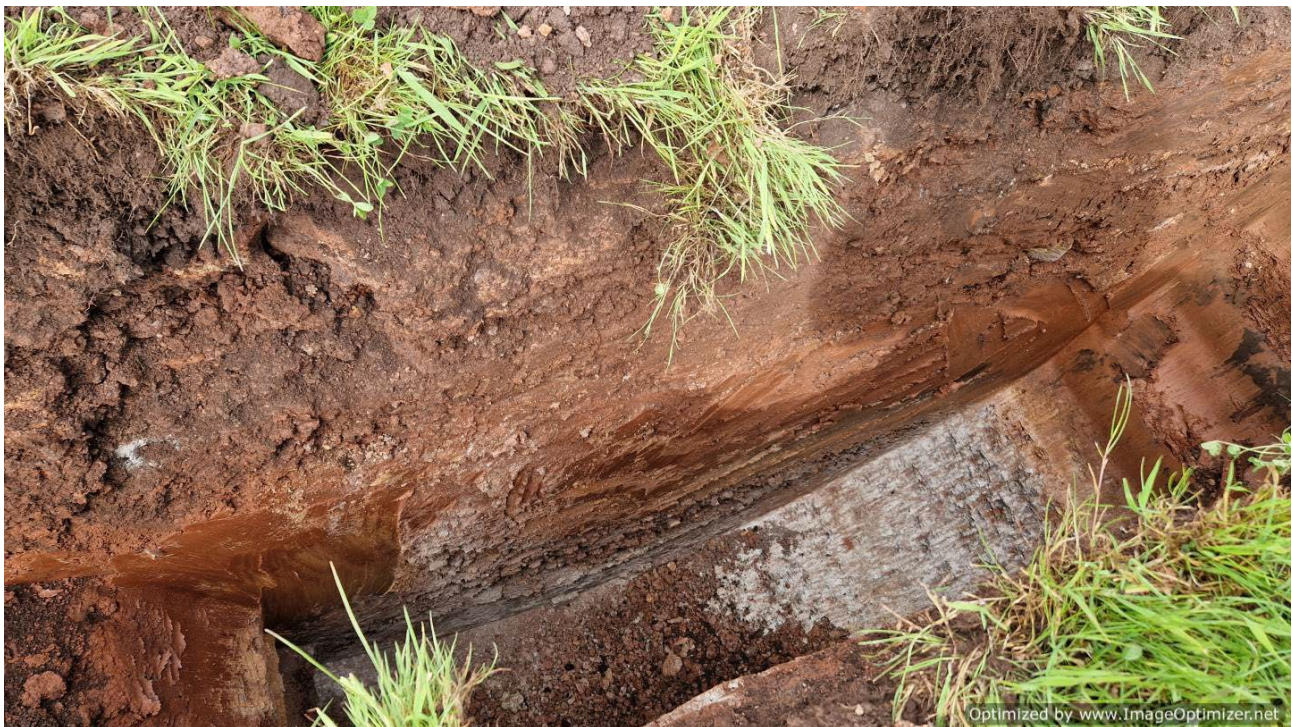
**GEO2021-5335: Windermere Rd & Fell View Avenue, Whitehaven – TP12**

| Depth From (m) | Depth To (m) | Strata Description | Legend | Testing / Samples |
|---|---|---|---|---|
| | | End of trial hole at 2.00m bgl.<br>Trial pit dry and stable on completion.<br>Trial hole backfilled with arisings on completion. | | |

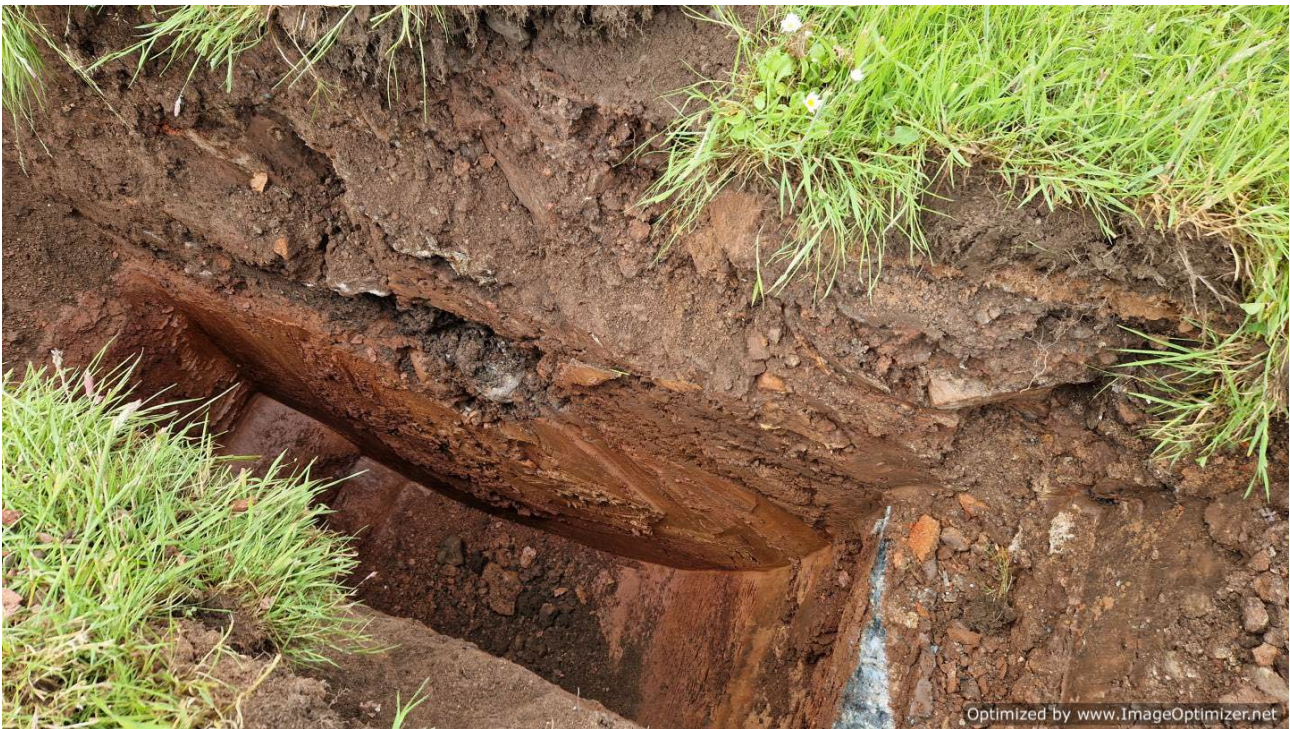
**GEO2021-5335: Windermere Rd & Fell View Avenue, Whitehaven – TP14 (Boggy Area)**

Trial pits TP14 and TP15 were located in the areas of dense vegetation at the request of the Consultant. The ground surface in these areas was noted as “very soft, wet and boggy”. The trial pits encountered made ground to a depth of between c.1.10m and c.1.20m bgl. The made ground comprised soft, locally very soft saturated dark grey to black gravelly silt with much organic material, brick (whole and part), sandstone, concrete and timber.

| Depth From (m) | Depth To (m) | Strata Description | Legend | Testing / Samples |
|---|---|---|---|---|
| | | End of trial hole at 2.00m bgl.<br>Groundwater ingress from surface and from made ground.<br>Trial hole backfilled with arisings on completion. | | |

During the intrusive ground investigation works the boreholes and trial pits were typically dry on completion with the exception of TP14 and TP15. These exploratory holes were located in an area of dense vegetation where the ground was noted to be "wet and boggy". Significant groundwater ingress was noted from the surface and from the made ground.

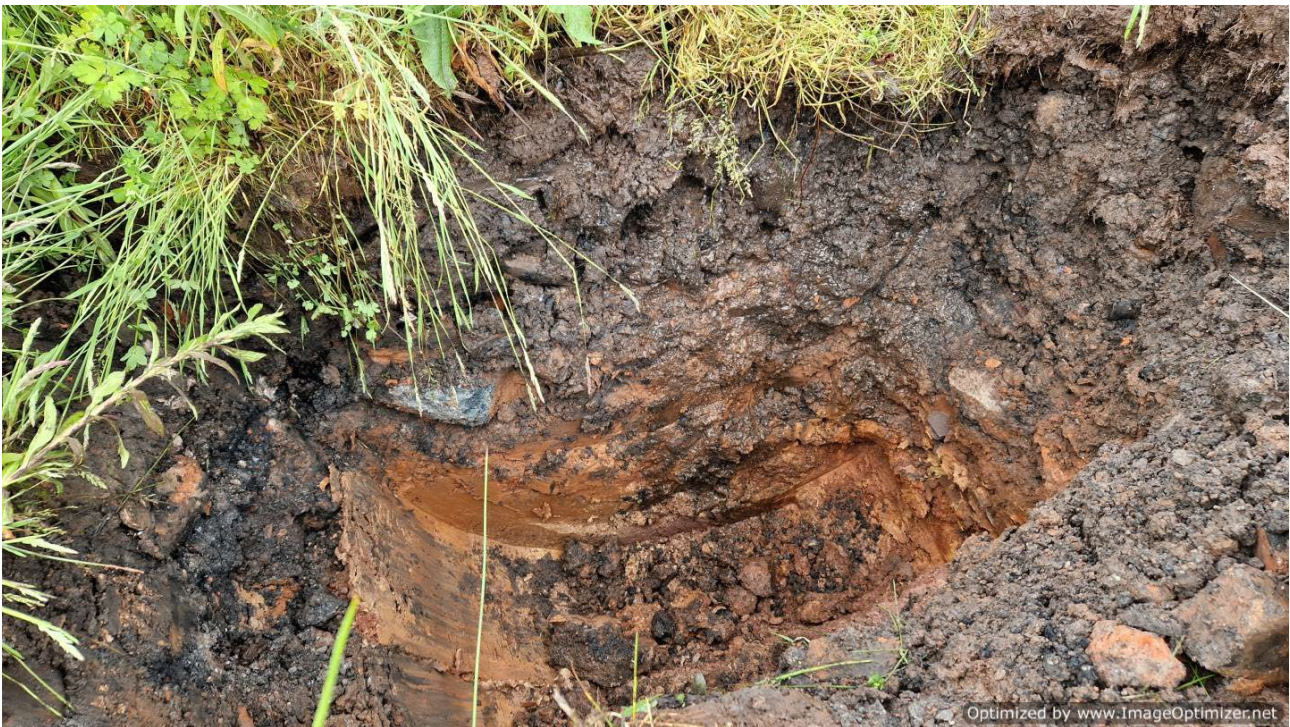
**GEO2021-5335: Windermere Rd & Fell View Avenue, Whitehaven – TP15 (Boggy Area)**

| Depth From (m) | Depth To (m) | Strata Description | Legend | Testing / Samples |
|---|---|---|---|---|
| | | End of trial hole at 1.90m bgl.<br>Groundwater ingress from surface and from made ground.<br>Trial hole backfilled with arisings on completion. | | |

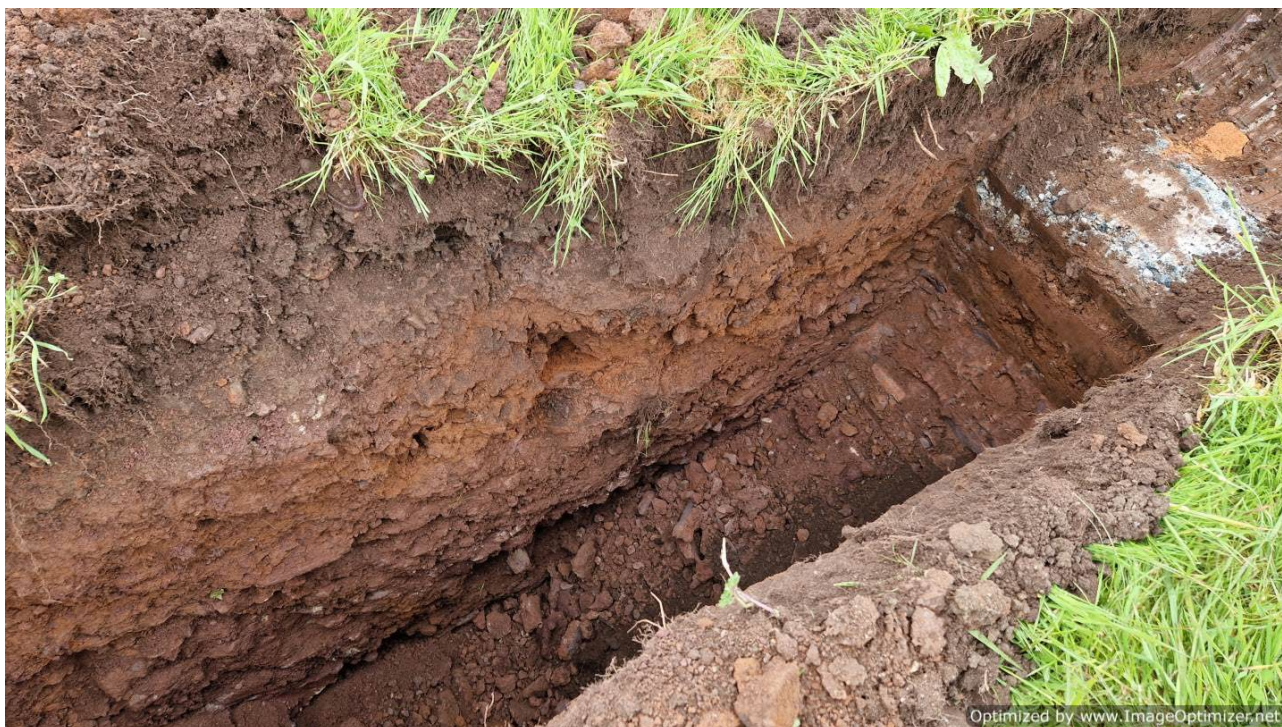
**GEO2021-5335: Windermere Rd & Fell View Avenue, Whitehaven – TP17**

| Depth From (m) | Depth To (m) | Strata Description | Legend | Testing / Samples |
|---|---|---|---|---|
| | | End of trial hole at 2.00m bgl.<br>Trial pit dry and stable on completion.<br>Trial hole backfilled with arisings on completion. | | |

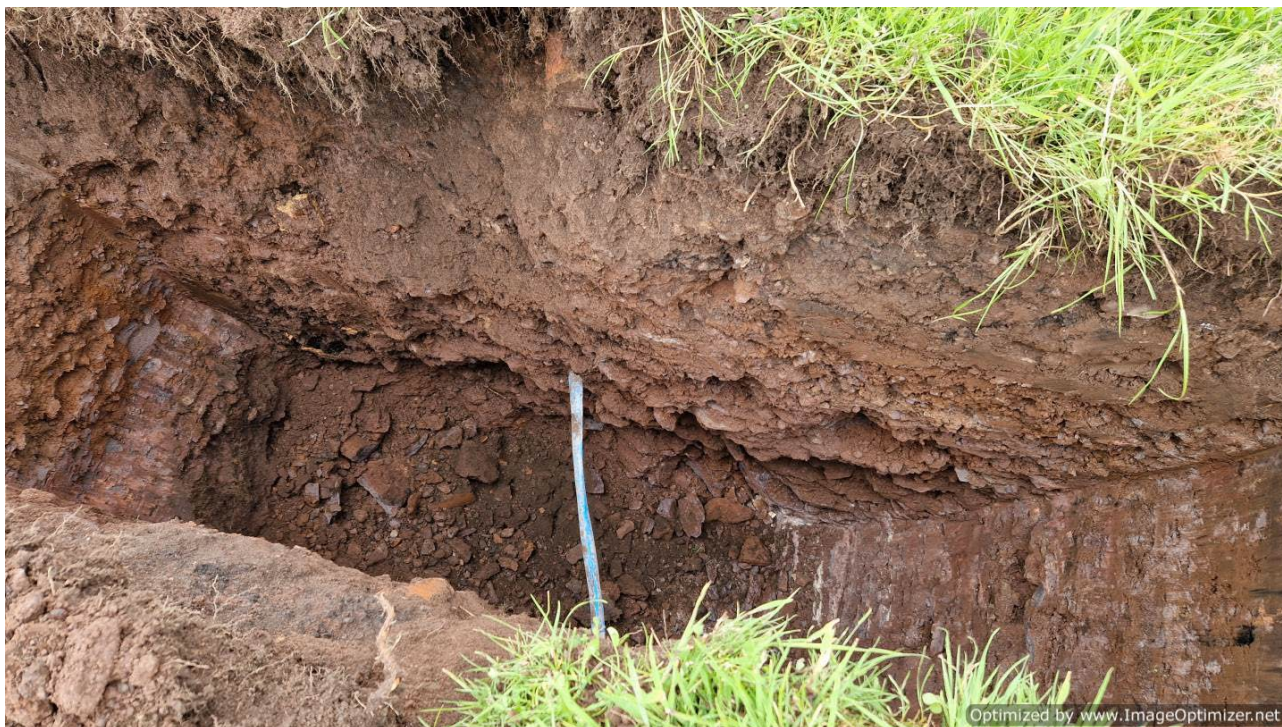
### GEO2021-5335: Windermere Rd & Fell View Avenue, Whitehaven – HP01

| Depth From (m) | Depth To (m) | Strata Description | Legend | Testing / Samples |
|---|---|---|---|---|
| | | End of trial hole at 1.90m bgl.<br>Trial pit dry and stable on completion.<br>Trial hole backfilled with arisings on completion. | | |
