**Project No:** GEO2024-6628

**Project Title:** Proposed Residential Development at Queens Park, Millom, Cumbria

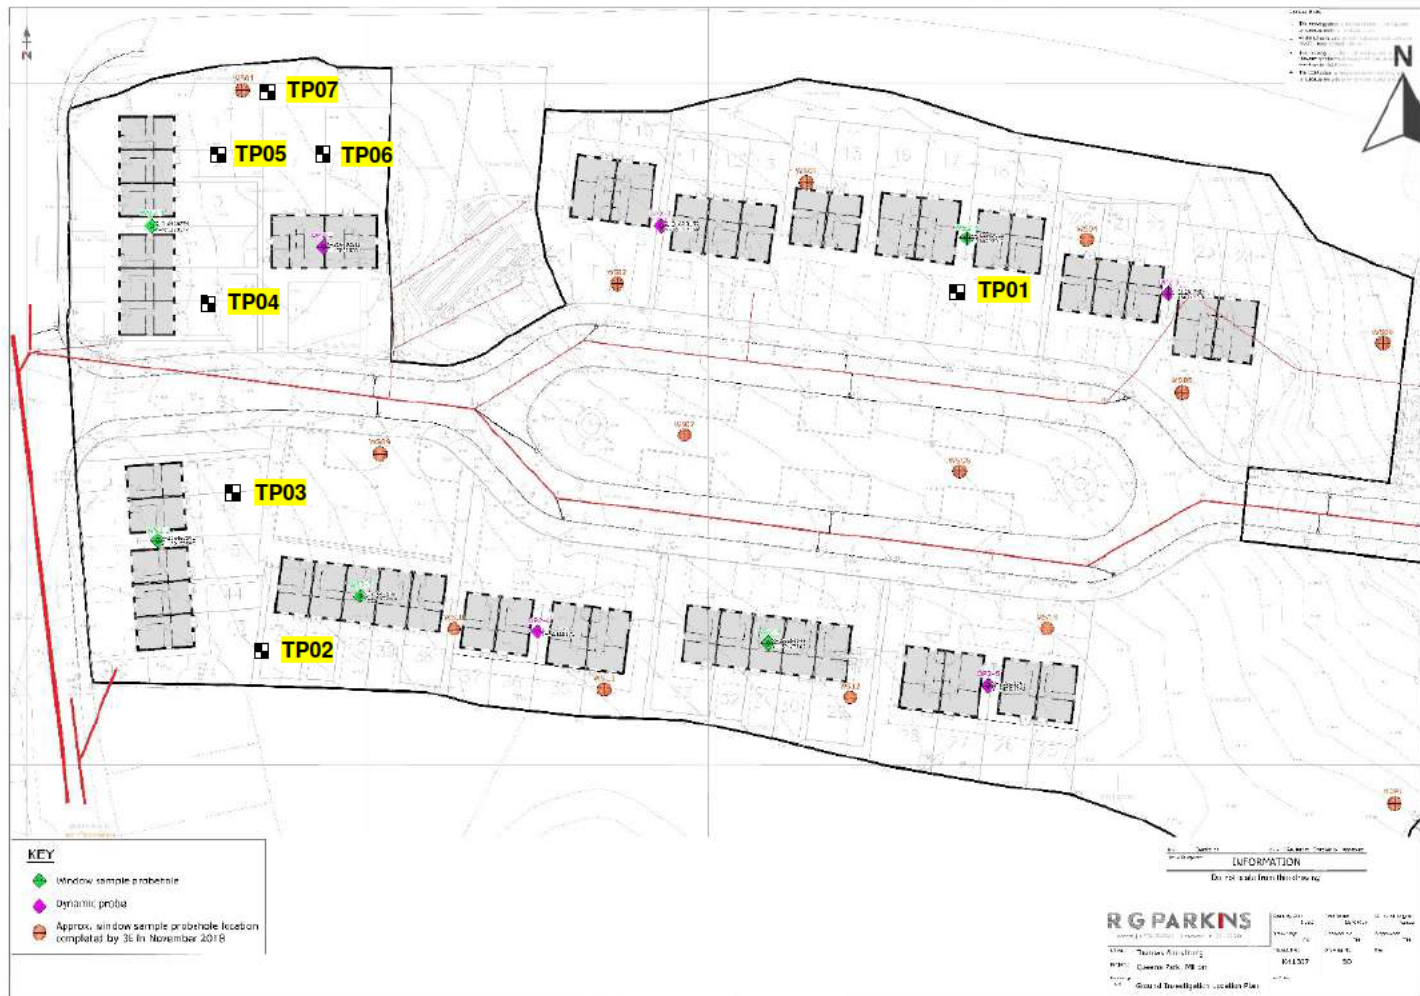
**GEO2024-6628: Queens Park, Millom, Cumbria**  
**Site Investigation Location Plan**

The positioning of the test locations was chosen by RG Parkins and were set out on site by GEO using the national grid co-ordinates provided. The investigation positions can be seen on the Site Investigation Location Plan in Appendix II.

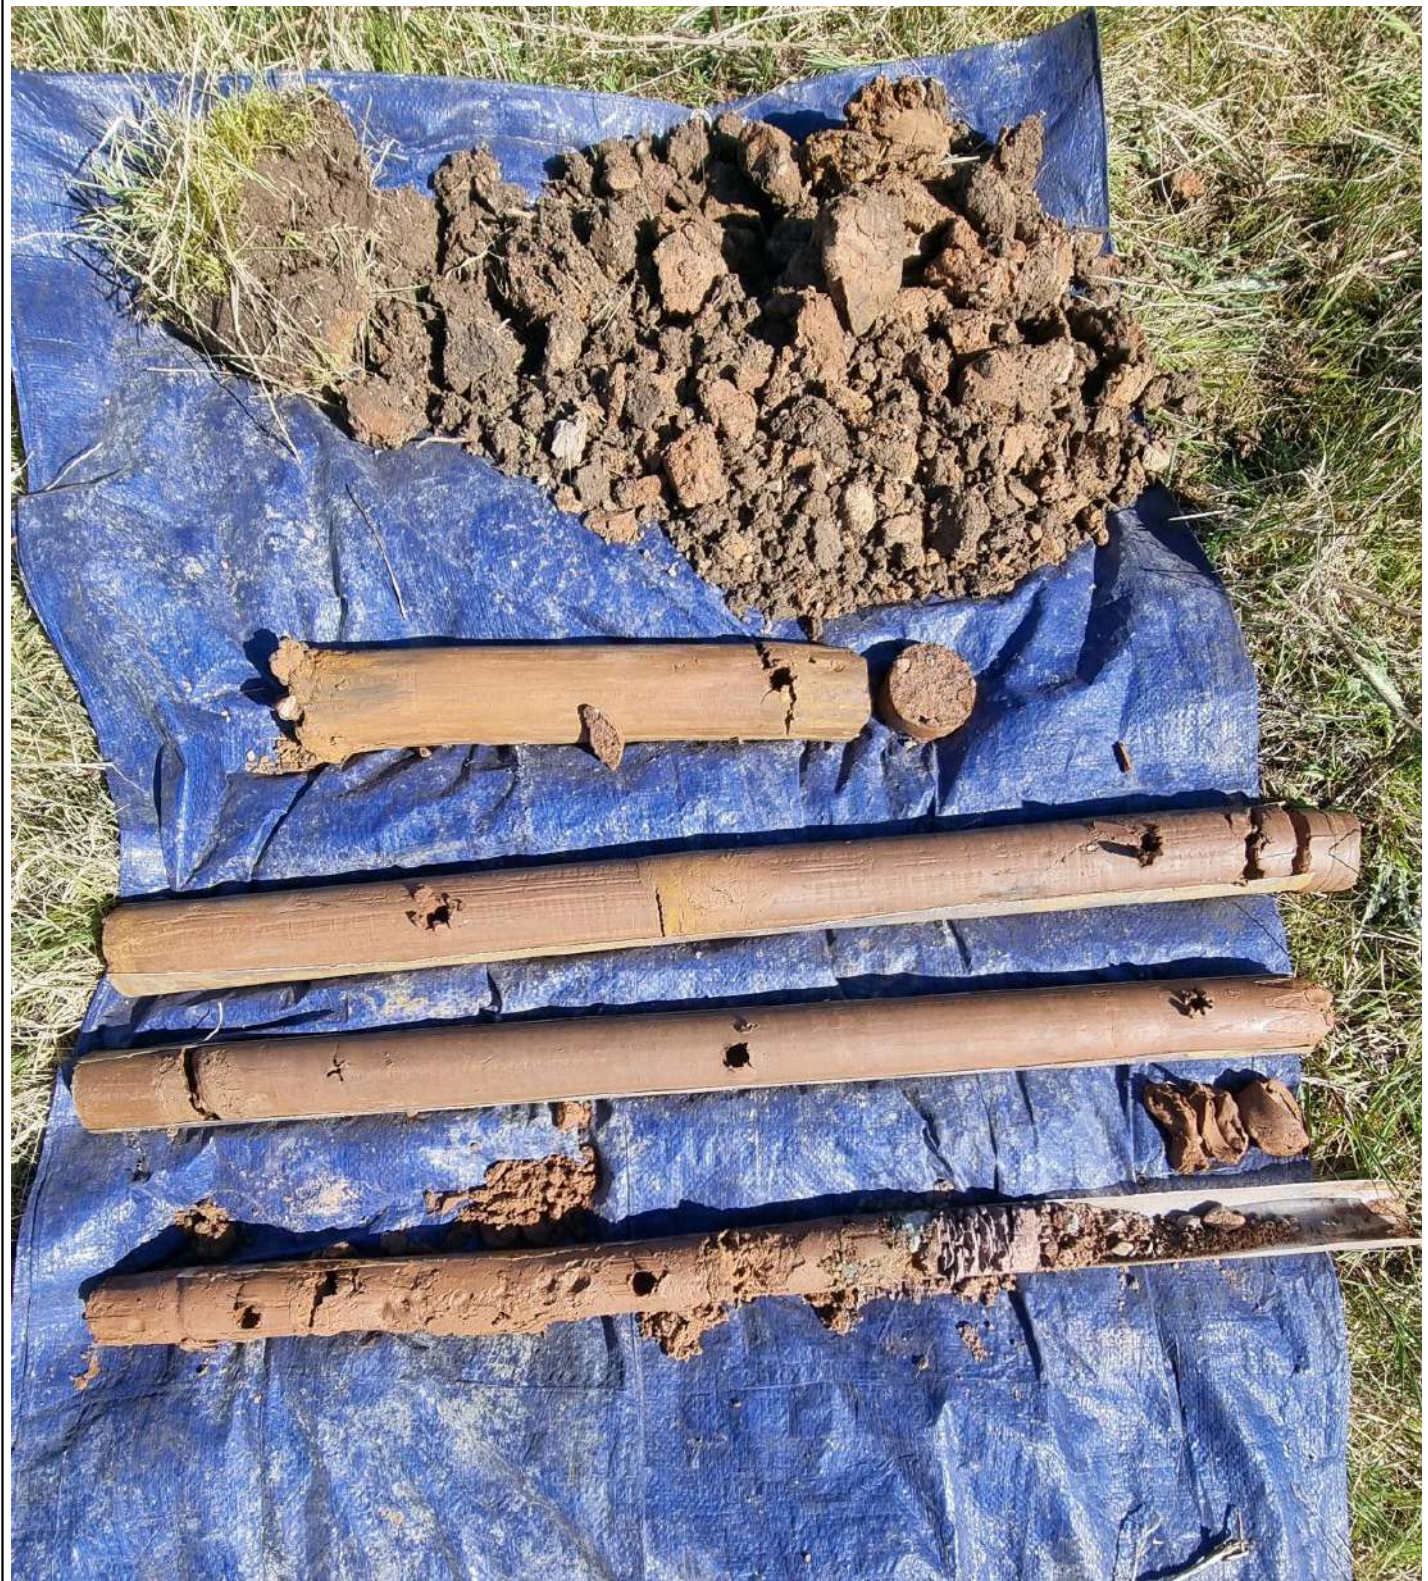
| Remarks | Method, Plant, Stability, Dimensions<br>0.00 - 4.35m    WLS Competitor Dart Rig | Logger<br>RS |

Detailed descriptions of the strata recorded at the borehole locations during the investigation works are presented on the borehole record sheets, copies of which can be seen in Appendix II.

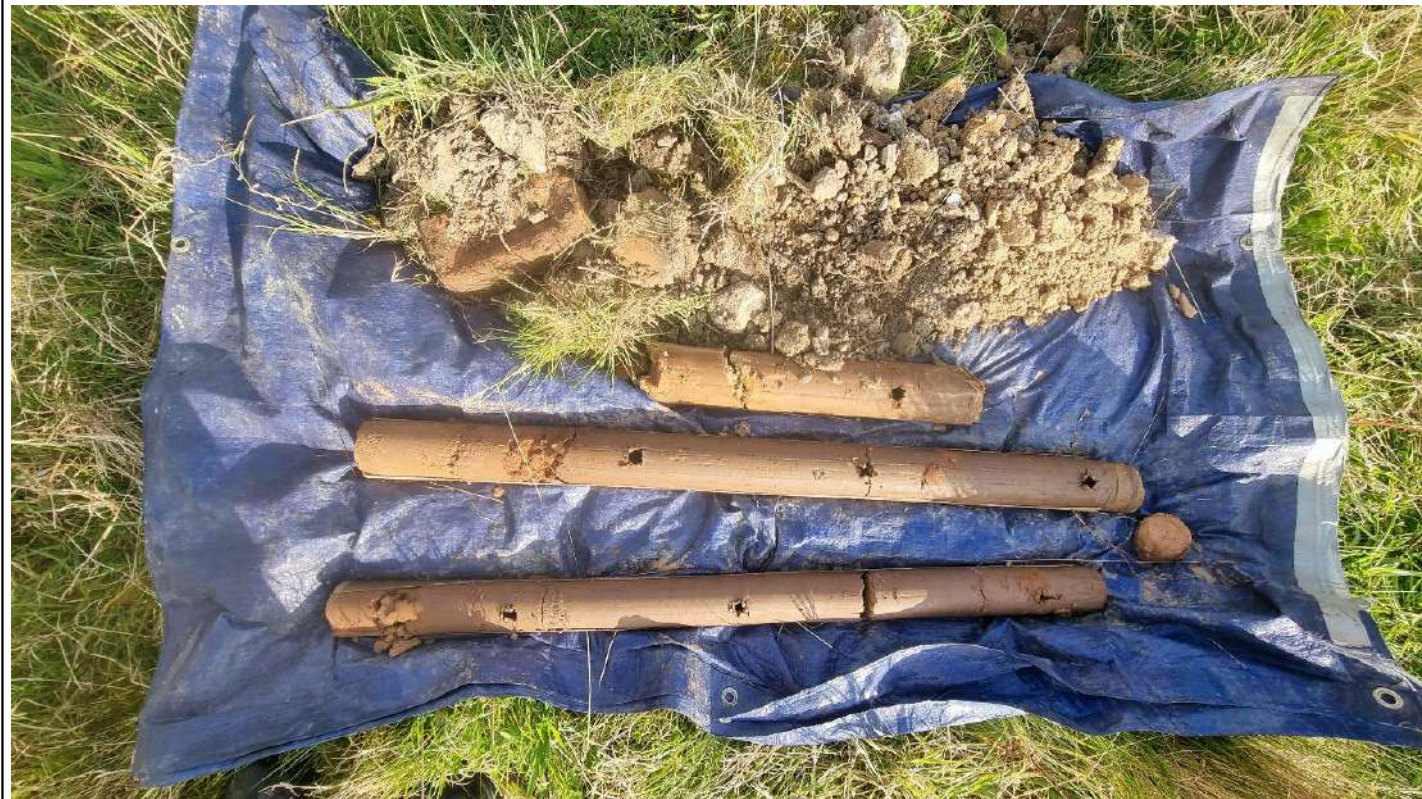
| Remarks | Method, Plant, Stability, Dimensions<br>0.00 - 3.00m    WLS Competitor Dart Rig<br>Borehole collapsed at 1.00m | Logger<br>RS |

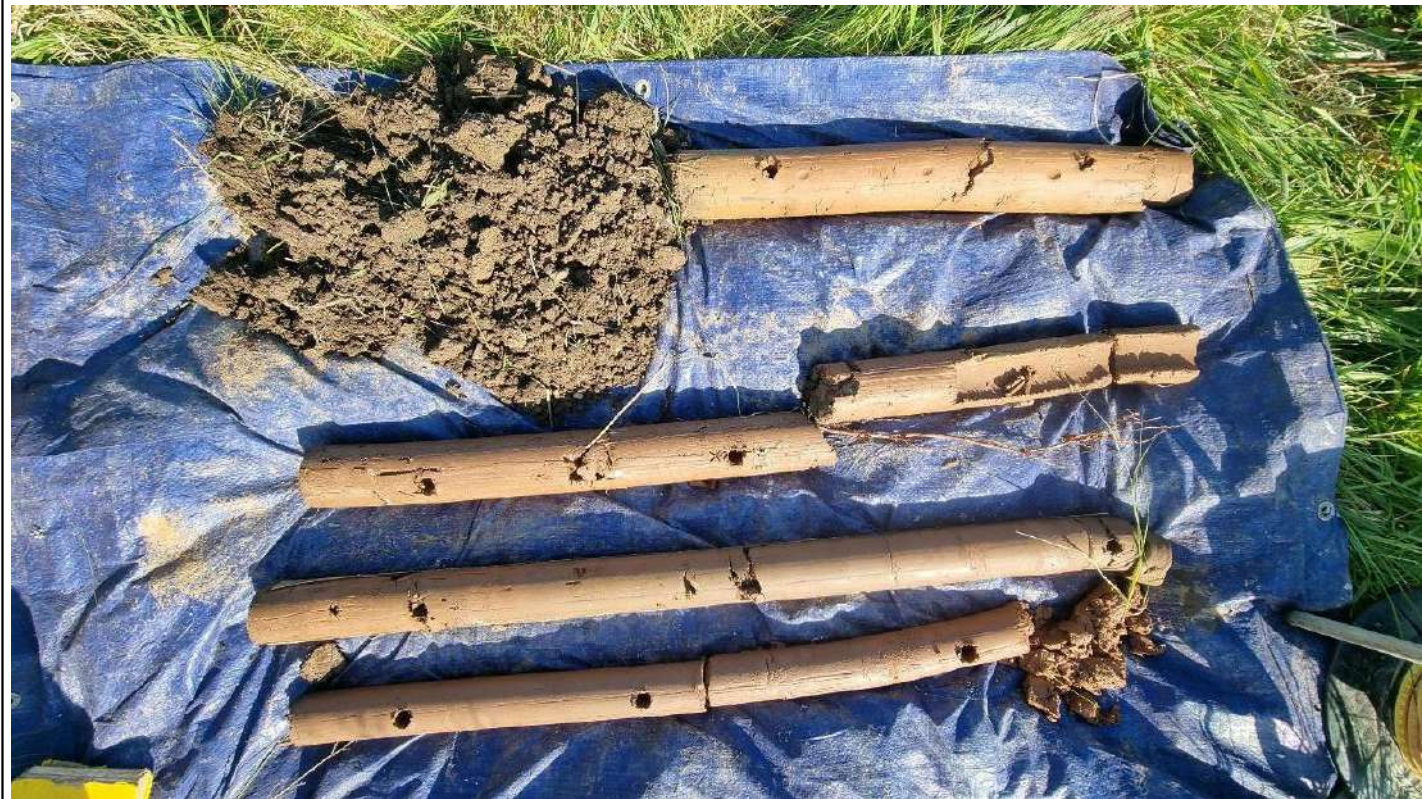
| Remarks | Method, Plant, Stability, Dimensions<br>0.00 - 4.33m    WLS Competitor Dart Rig | Logger<br>RS |

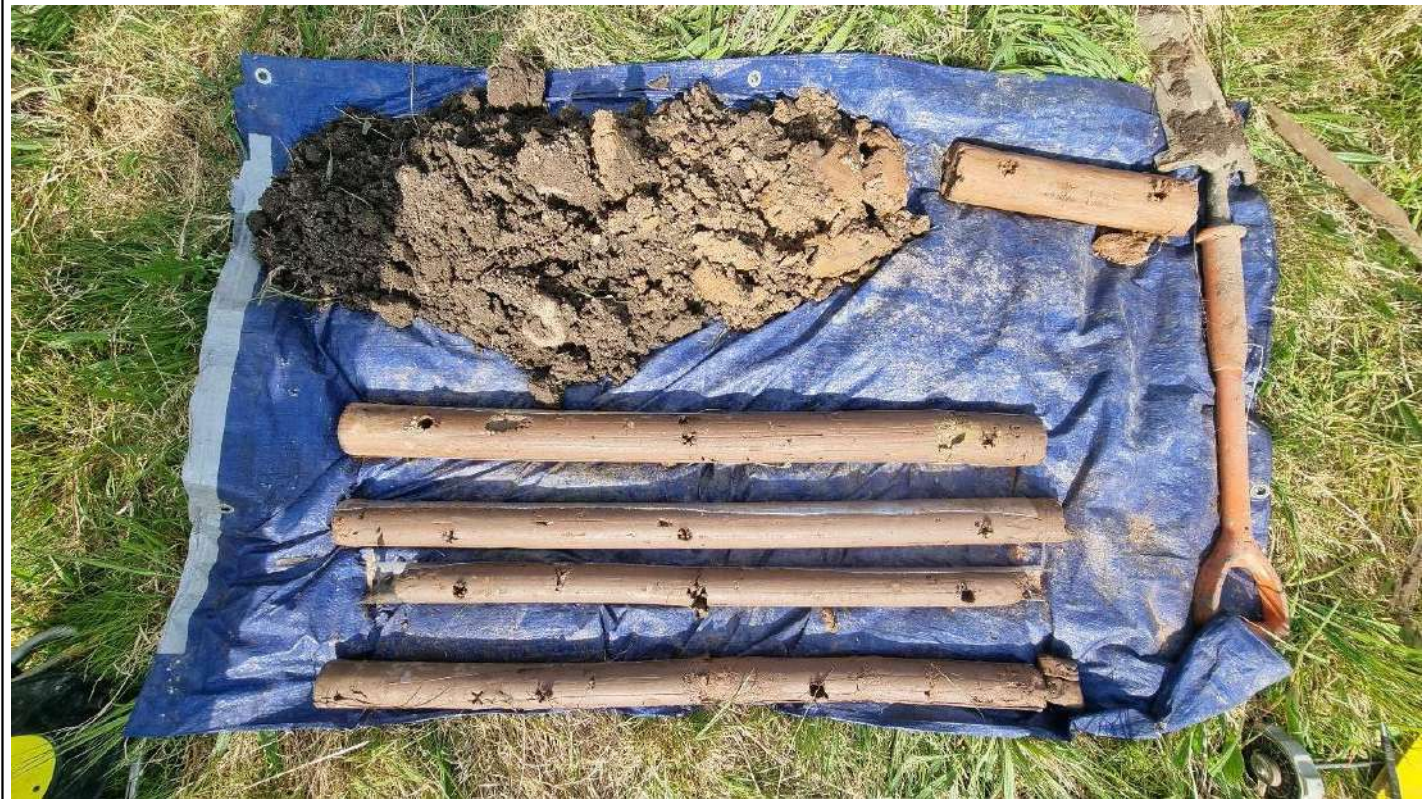
| Remarks | Method, Plant, Stability, Dimensions<br>0.00 - 5.00m    WLS Competitor Dart Rig | Logger<br>RS |

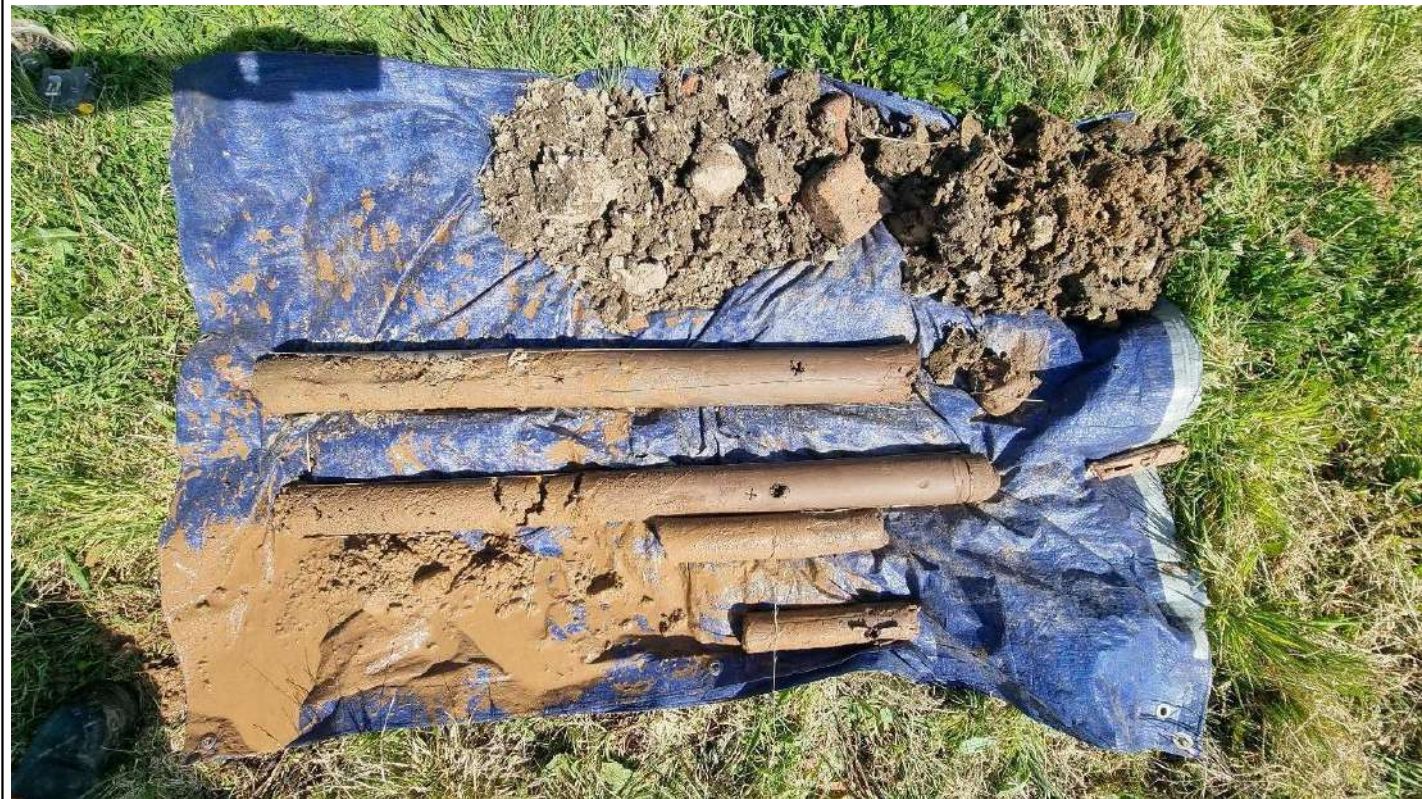
| Remarks | Method, Plant, Stability, Dimensions<br>0.00 - 5.00m    WLS Competitor Dart Rig | Logger<br>RS |
