## PHASE 2: GROUND INVESTIGATION REPORT

PROPOSED RESIDENTIAL DEVELOPMENT AT

COACH ROAD, WHITEHAVEN

Report Ref: 2025-7009

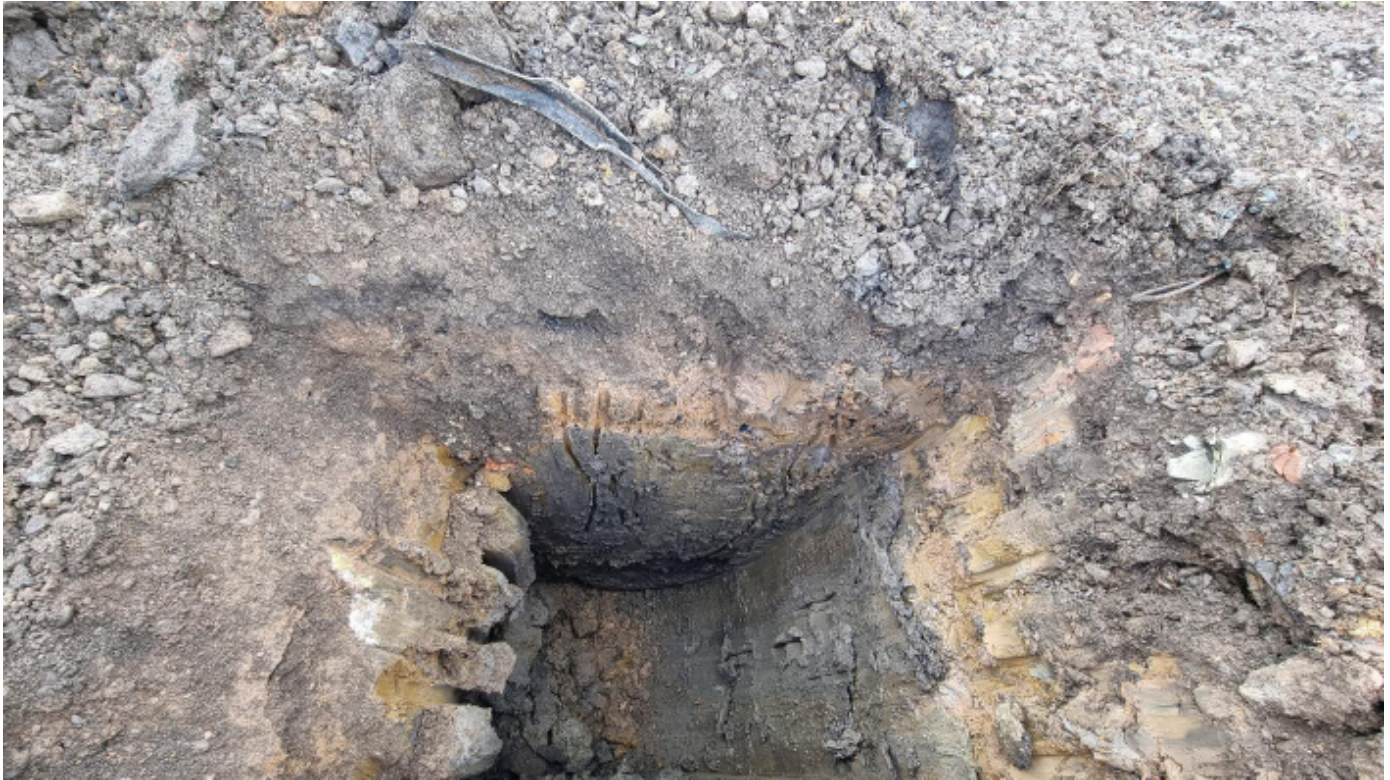
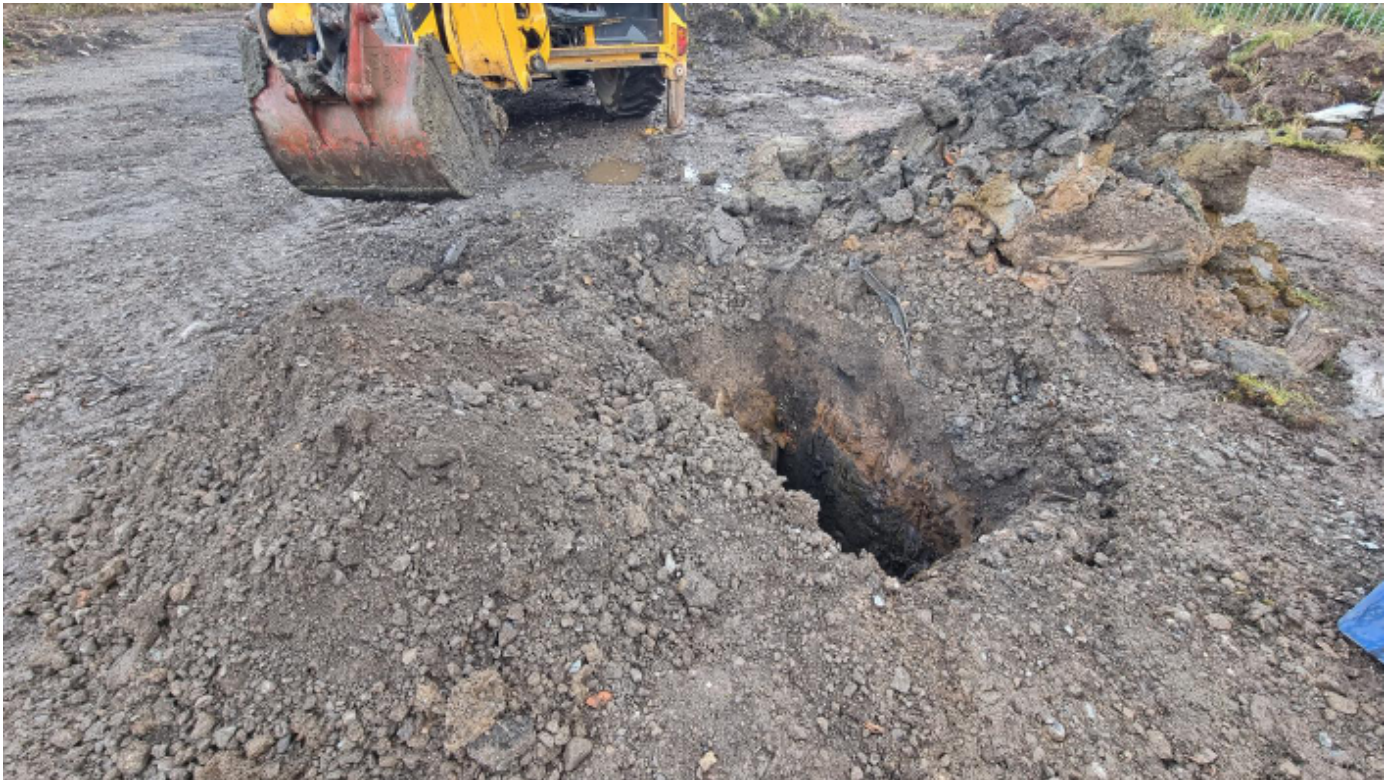
| <b>Remarks</b><br>No visible or olfactory evidence of hydrocarbon contamination noted. | <b>Method, Plant, Stability, Dimensions</b><br>0.00 - 2.25m TP JCB 3CX<br>Stable | <b>Logger</b><br>R Stripp |

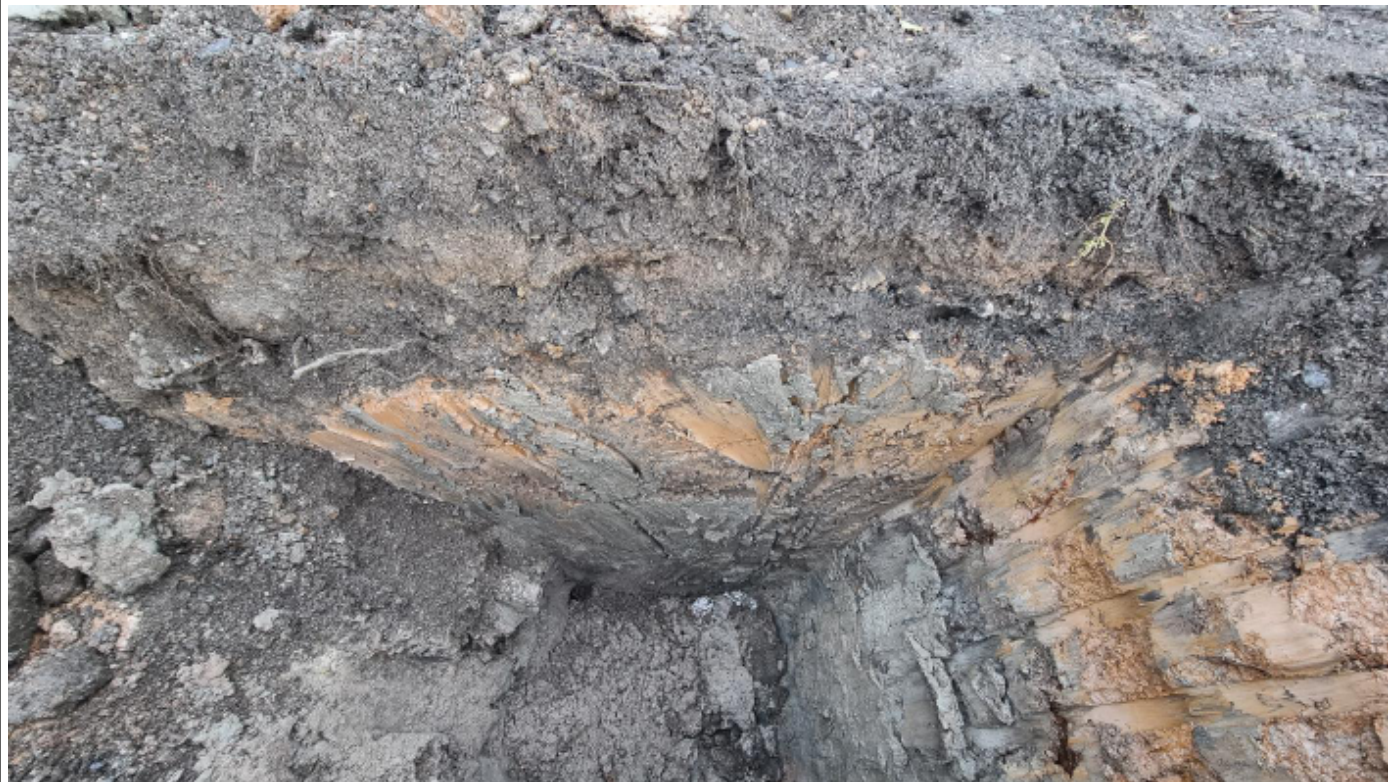
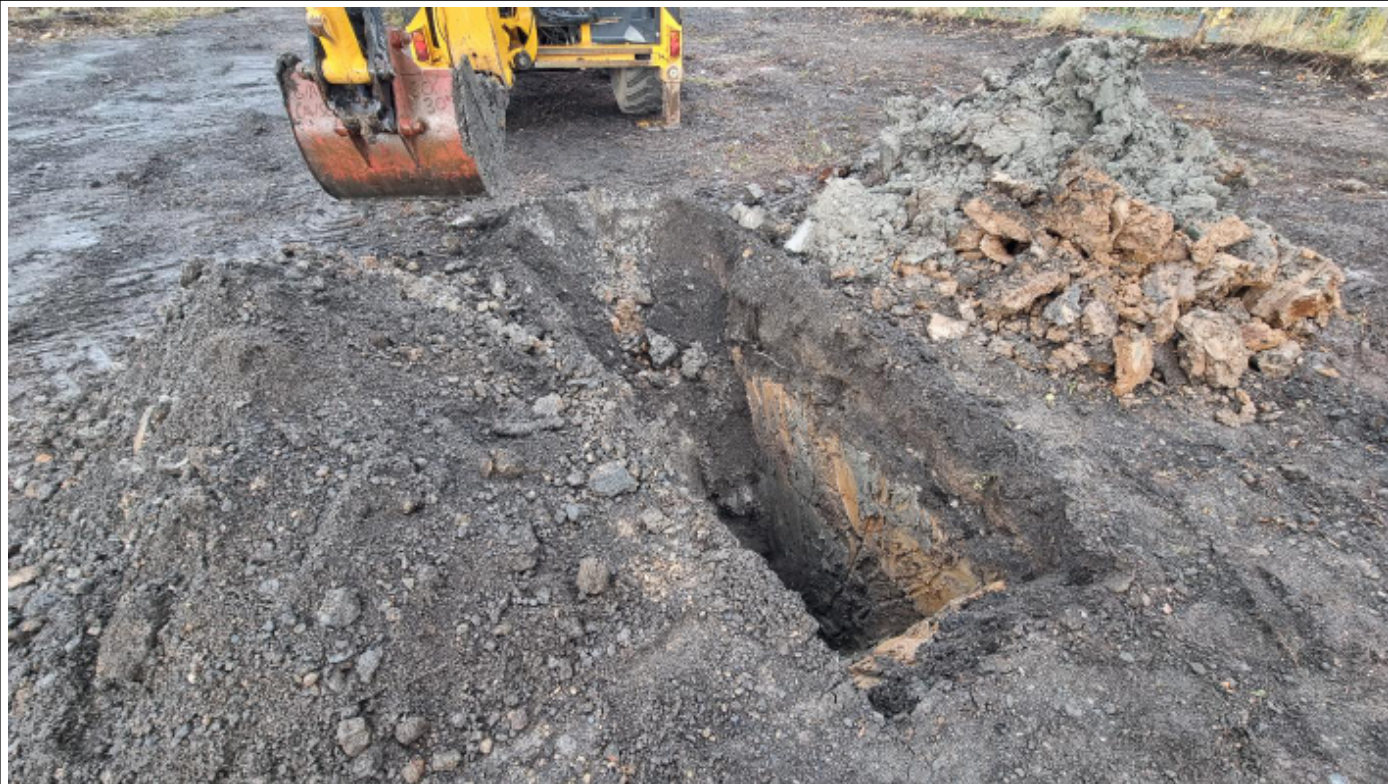
| <b>Remarks</b><br>No visible or olfactory evidence of hydrocarbon contamination noted. | <b>Method, Plant, Stability, Dimensions</b><br>0.00 - 2.00m    TP    JCB 3CX<br>Stable | <b>Logger</b><br>R Stripp |

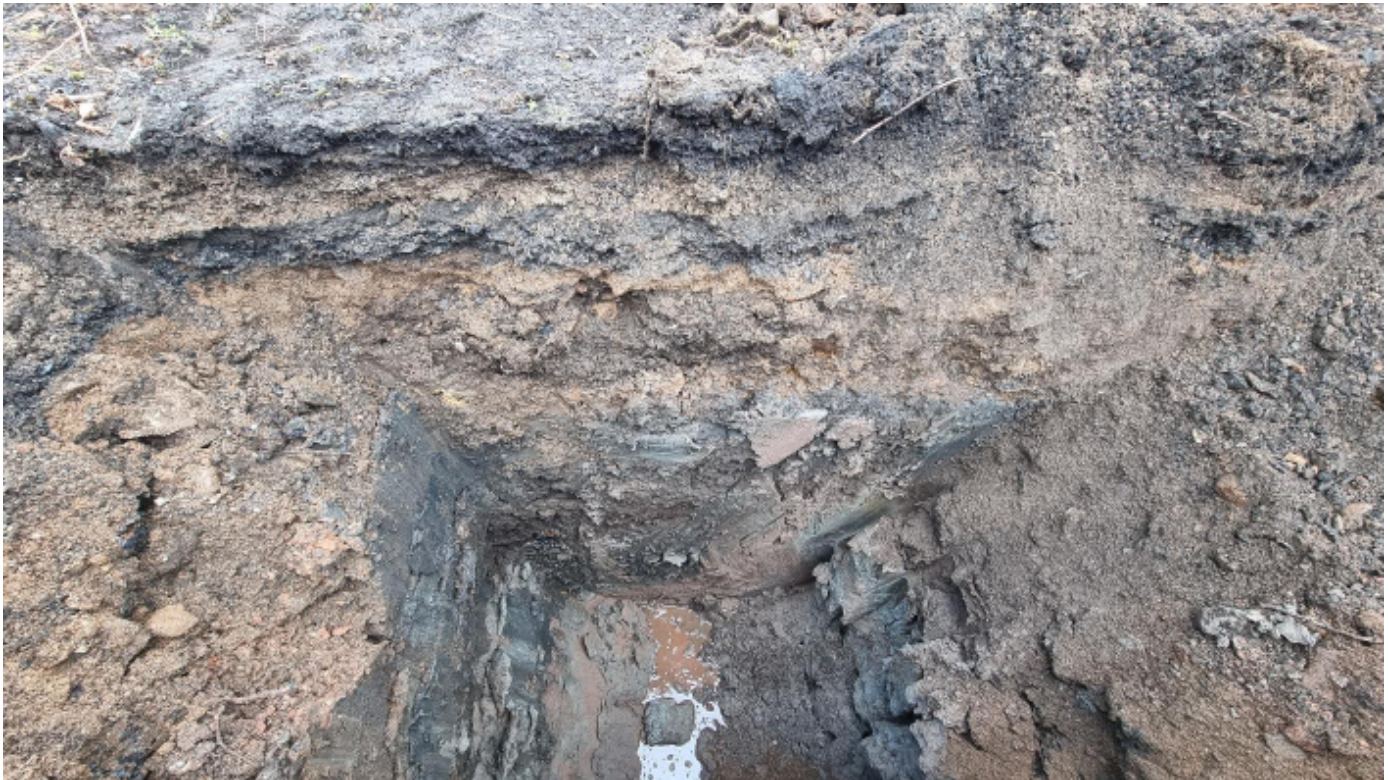
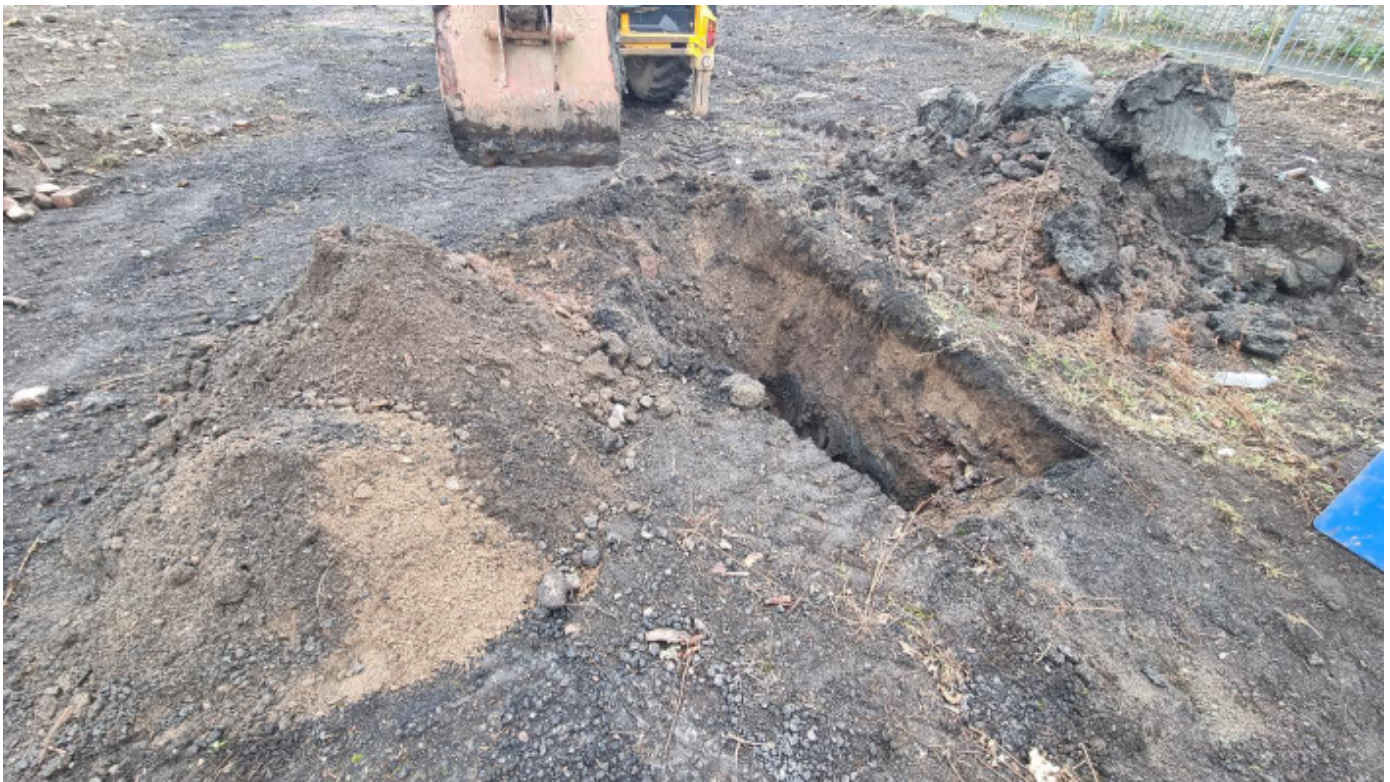
| <b>Remarks</b><br>No visible or olfactory evidence of hydrocarbon contamination noted. | <b>Method, Plant, Stability, Dimensions</b><br>0.00 - 2.25m TP JCB 3CX<br>Stable | <b>Logger</b><br>R Stripp |

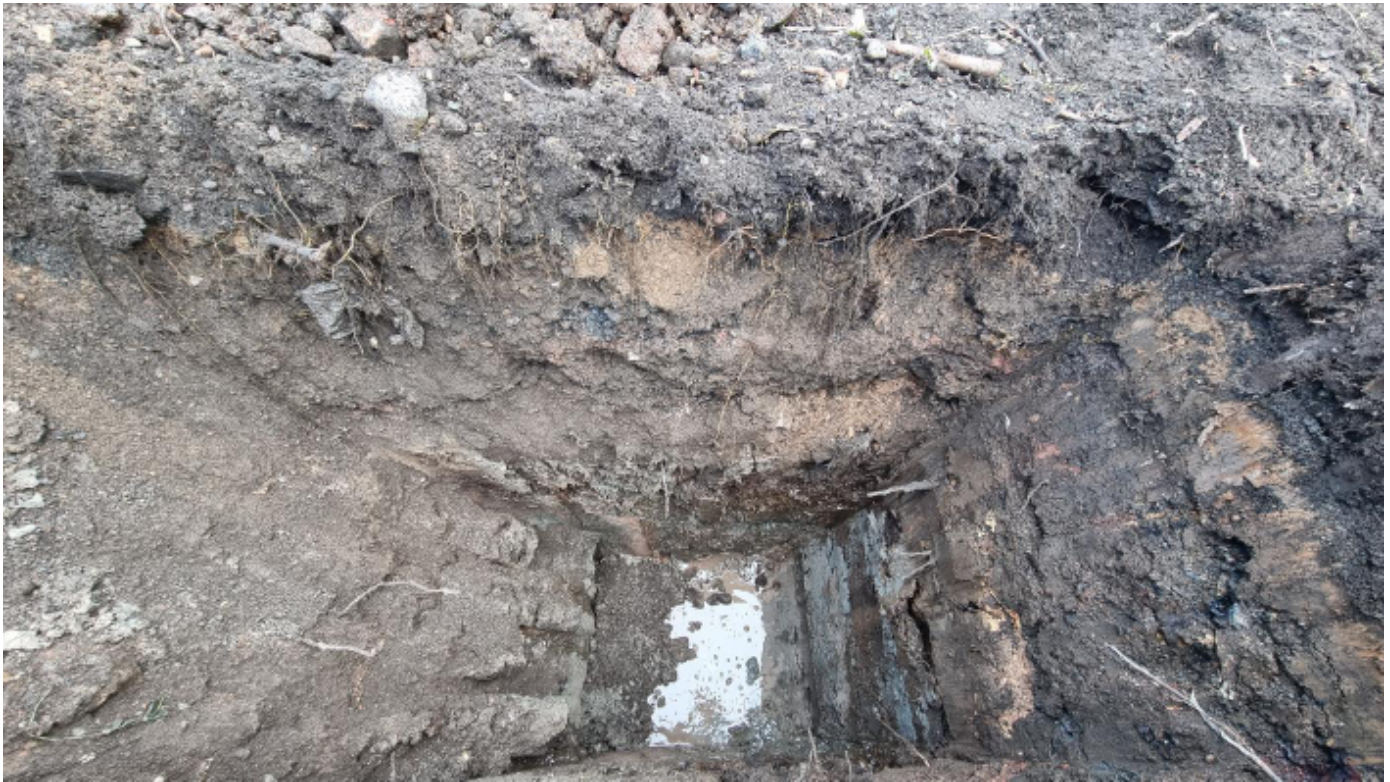
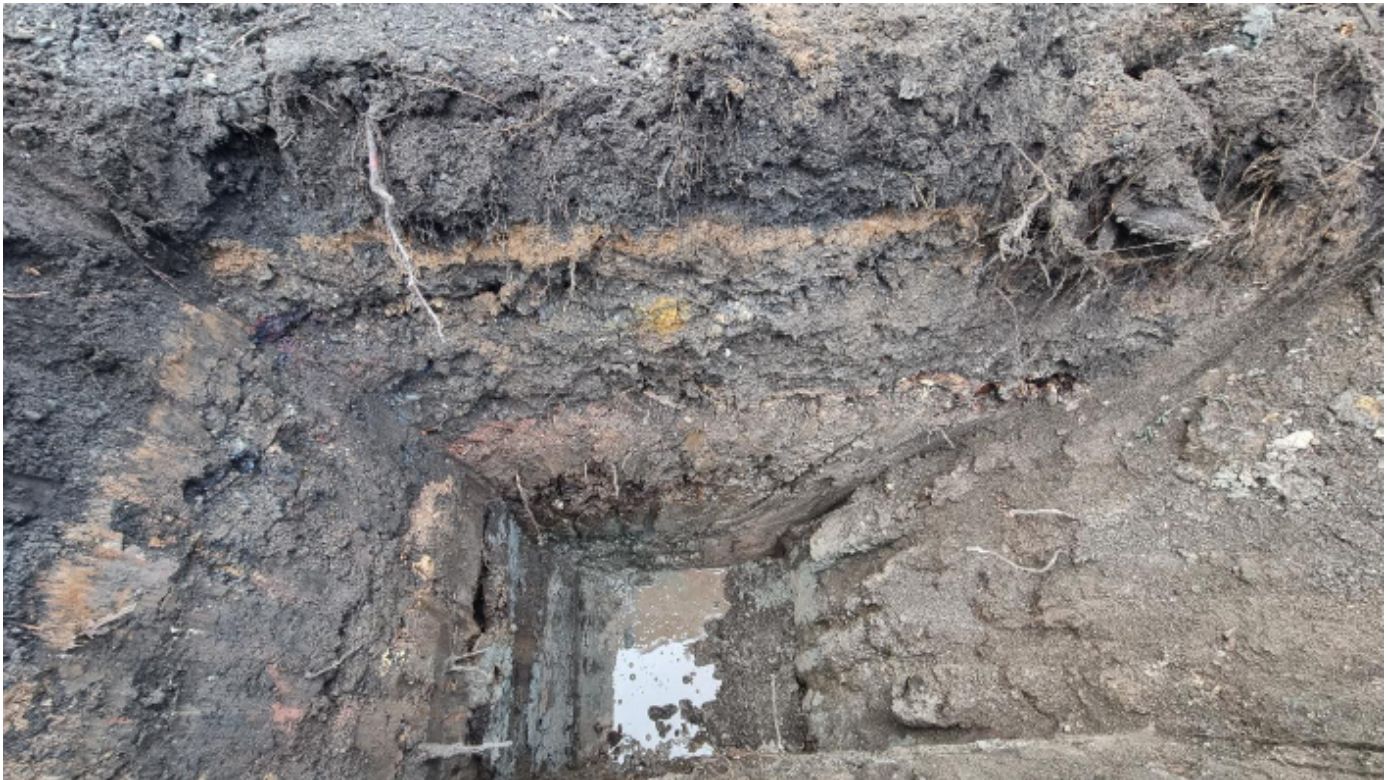
| <b>Remarks</b><br>No visible or olfactory evidence of hydrocarbon contamination noted. | <b>Method, Plant, Stability, Dimensions</b><br>0.00 - 2.30m TP JCB 3CX<br>Stable | <b>Logger</b><br>R Stripp |

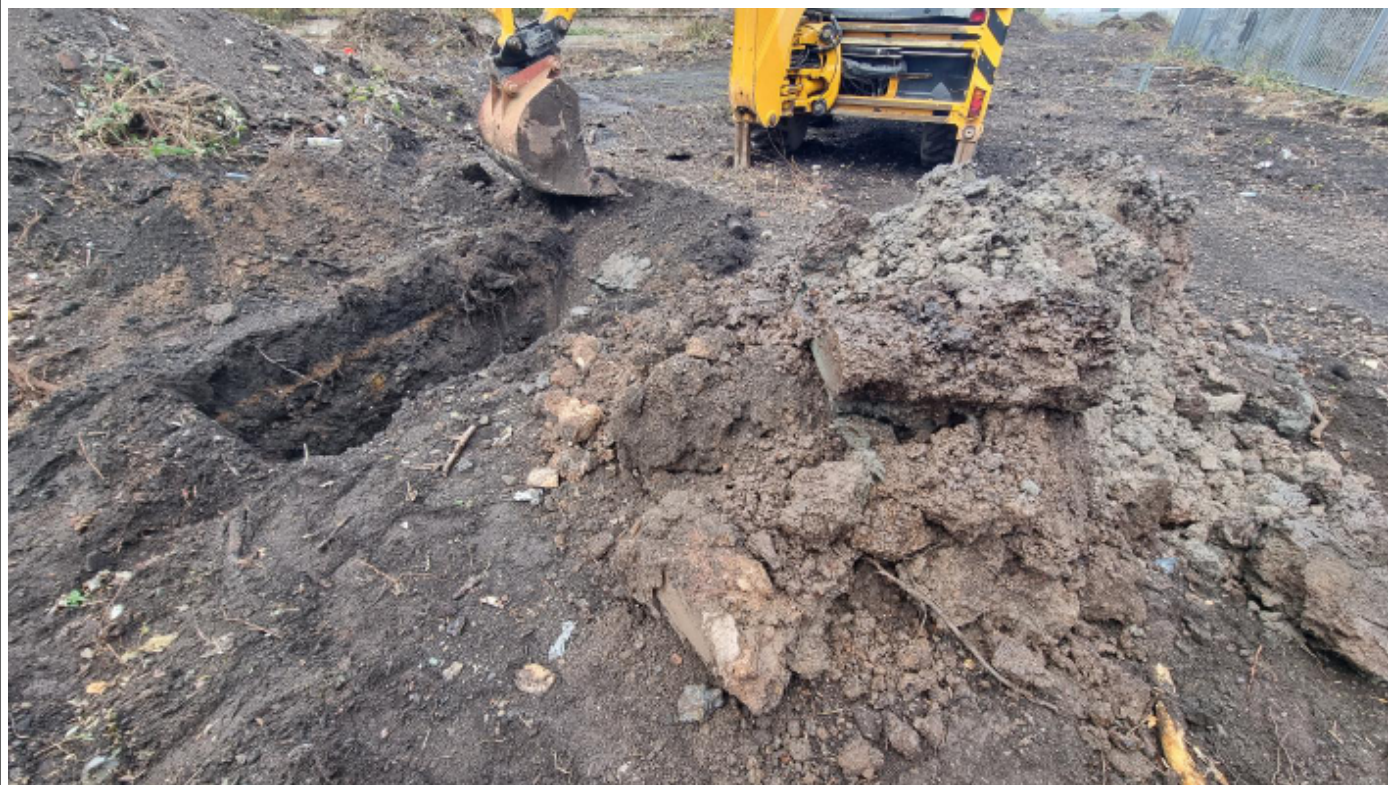
| <b>Remarks</b><br>No visible or olfactory evidence of hydrocarbon contamination noted. | <b>Method, Plant, Stability, Dimensions</b><br>0.00 - 2.30m TP JCB 3CX<br>Stable | <b>Logger</b><br>R Stripp |
