# BAT SURVEY REPORT

**Gill House Farm, Egremont**

**Preliminary Roost Assessment for Bats  
and Breeding Bird Survey**

**June 2026**

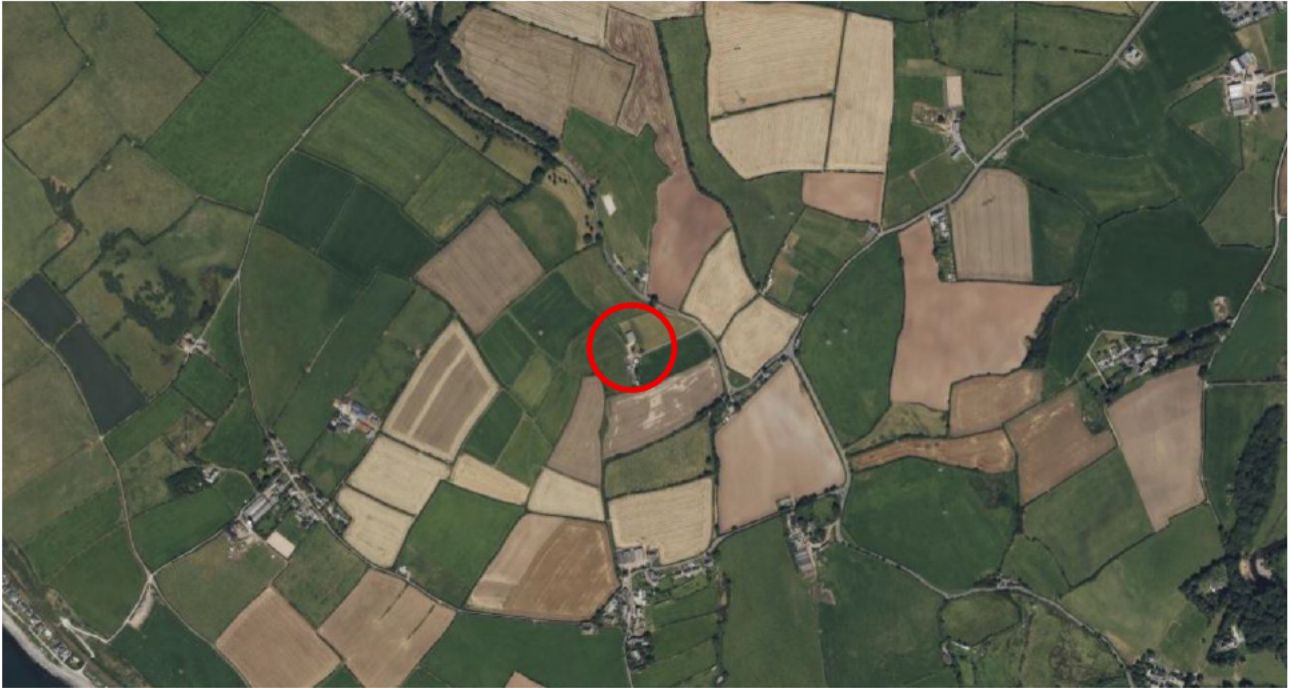
**Figure 3** *Habitat on and adjacent to the site*

The site is in an elevated and exposed location amongst open agricultural fields and in close proximity to the West Cumbrian coast. The surrounding landscape is a mosaic of pastoral and arable fields and whilst there are small hedgerows and scattered trees offering limited potential, there are no high quality foraging habitats or strong linear features for bats in close proximity.

The habitat on and adjacent to the site identified from satellite images was ground-truthed. Details of the habitats found on and adjacent to the site are detailed in Figure 3.

The site is in an elevated position amongst open agricultural land which offers very little foraging habitat for bats. A small residential garden to the South which adjoins a low hedgerow provides a potential commuting route for bats.

**The habitats on and adjacent to the site are assessed as being of low suitability for foraging and commuting bats, though there are areas of low suitability habitat in the wider area.**

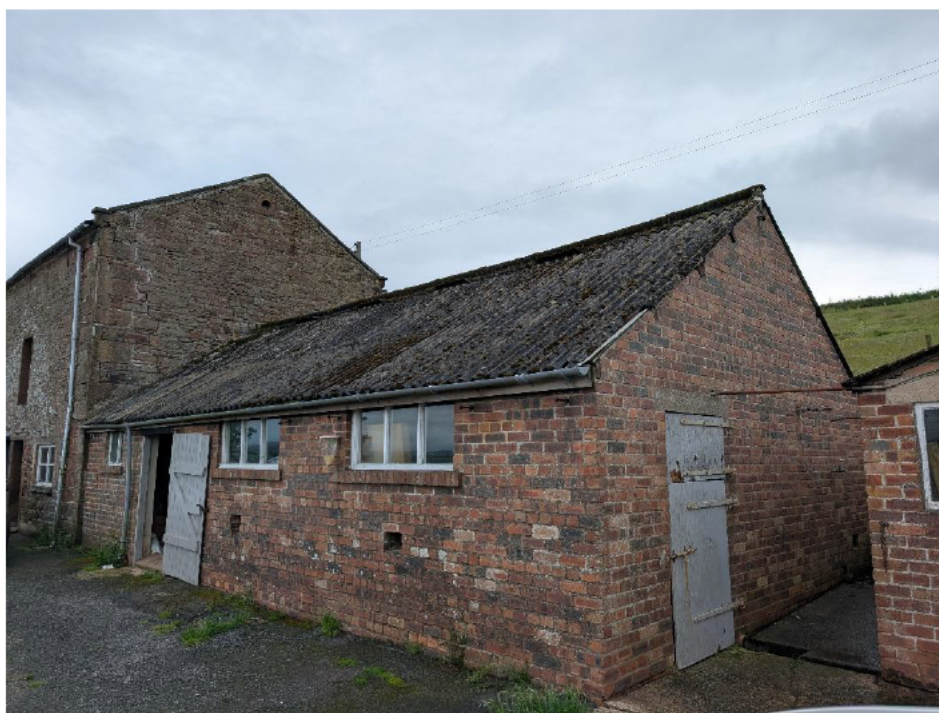
A single storey agricultural building formerly used as a milking shed. The building is single-storey and constructed of red brick, under a pitched, corrugated cement fibre roof. The surveyed building abuts a larger brick built agricultural barn to the South.

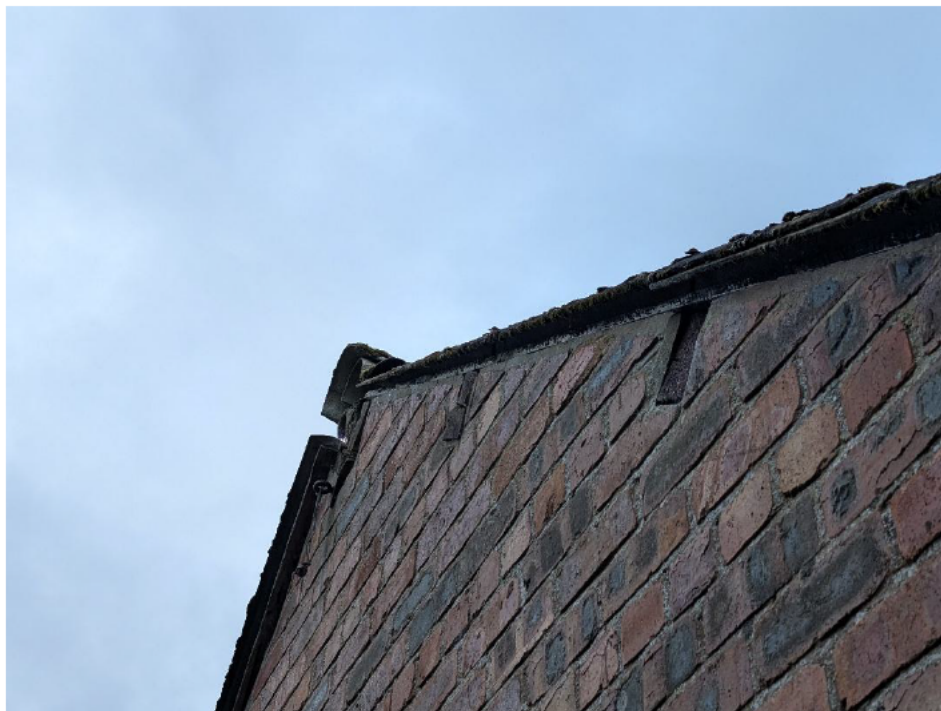
The building is built from red brick and is well pointed. Ventilation bricks are present low on the East facing elevation; these are obstructed and offer neither access points nor roosting opportunities. To the South, the building adjoins a larger red-sandstone barn.

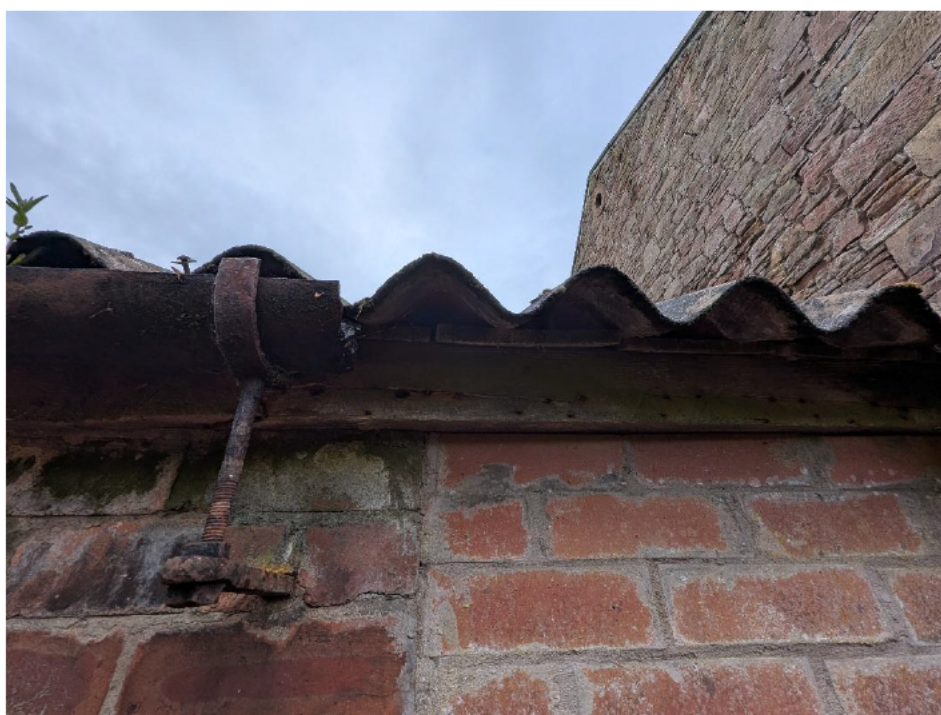
The roof verge on the North facing gable end has a low number of large gaps around the purlins. These are too open and exposed to be used by crevice dwelling bats but would allow access to the building interior. No droppings or other indications of the presence of bats were found in these areas.

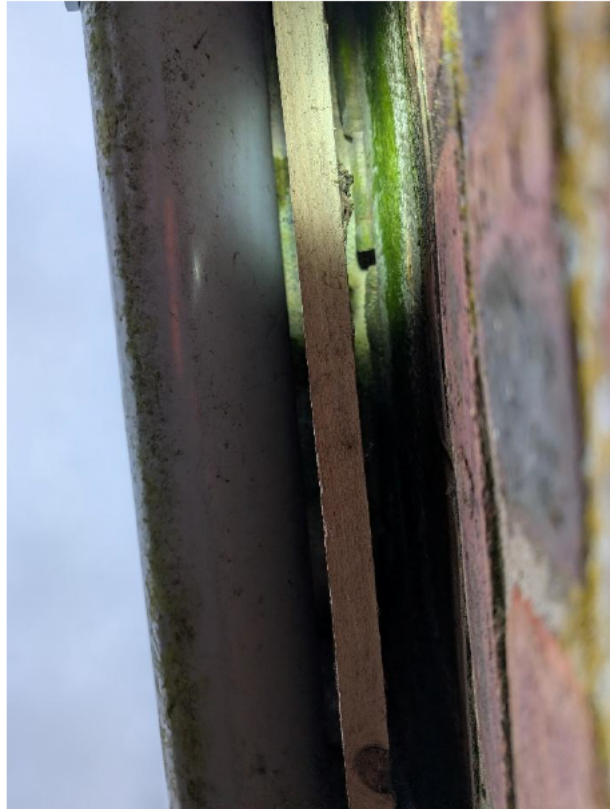
There are loosely fitted fascia boards at the eaves to the East and West, on which the gutters are mounted. The gaps between the fascias and the brickwork is c.750mm and too spacious to be suitable for use by bats. Due to the low height of the eaves, these areas could be thoroughly inspected which found no evidence of use.

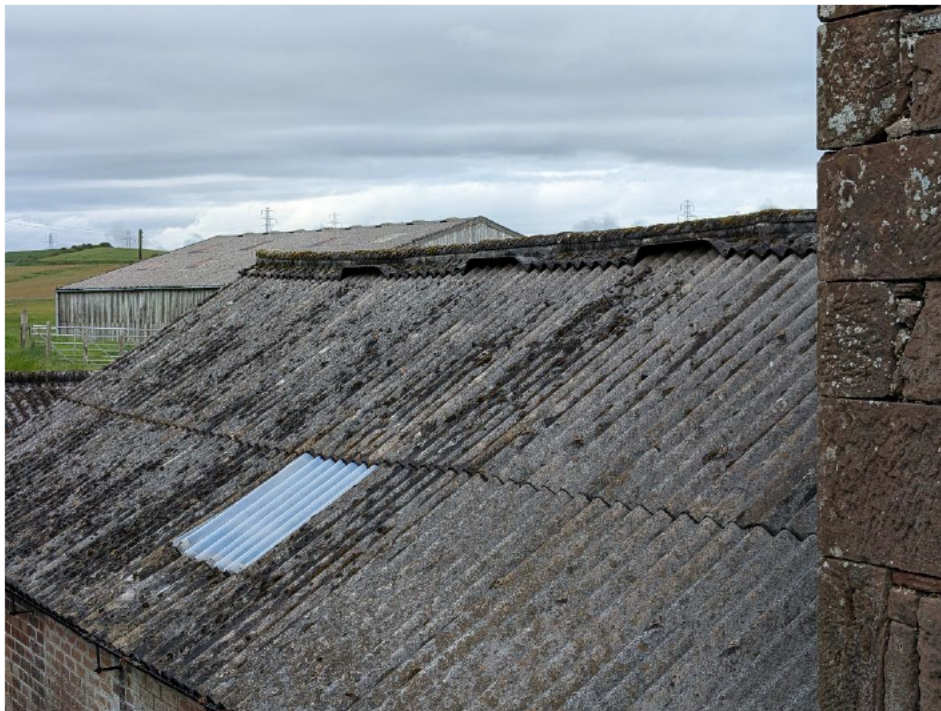
The roof of the building is pitched and made cement-fibre corrugated sheeting with corrugated plastic skylights. The corrugated sheets are fitted tightly and do not offer roosting potential. The sheets are fixed flush to the sarking in the furrows and the peaks sit too proud of the boards to provide suitable potential roost sites.

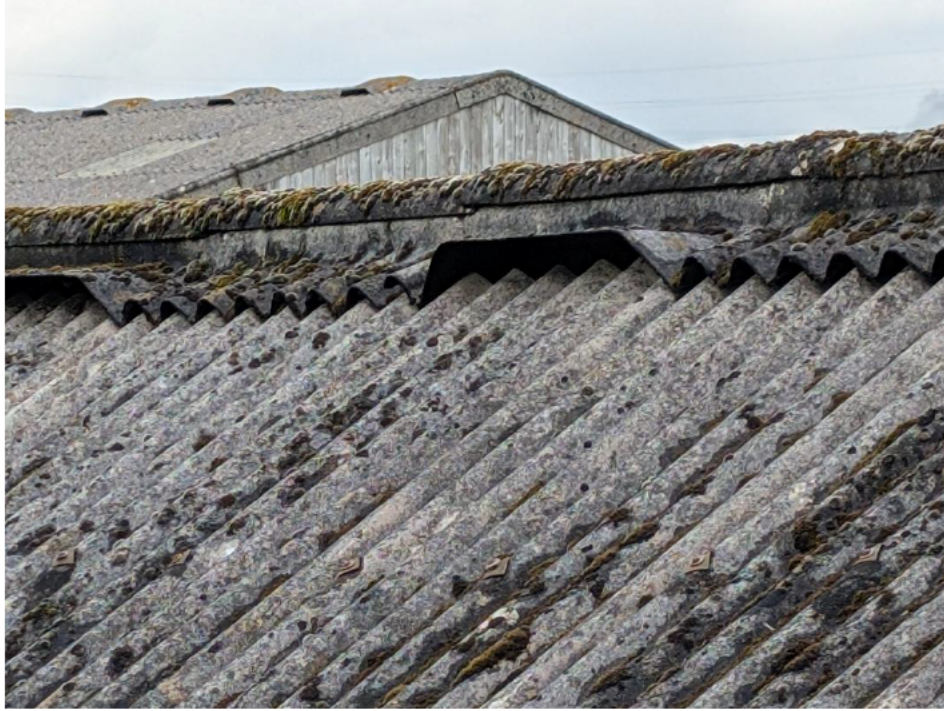
Large ventilation holes are present along the ridgeline. Whilst these would be potential access points, they are too large and exposed to be used as roost sites.

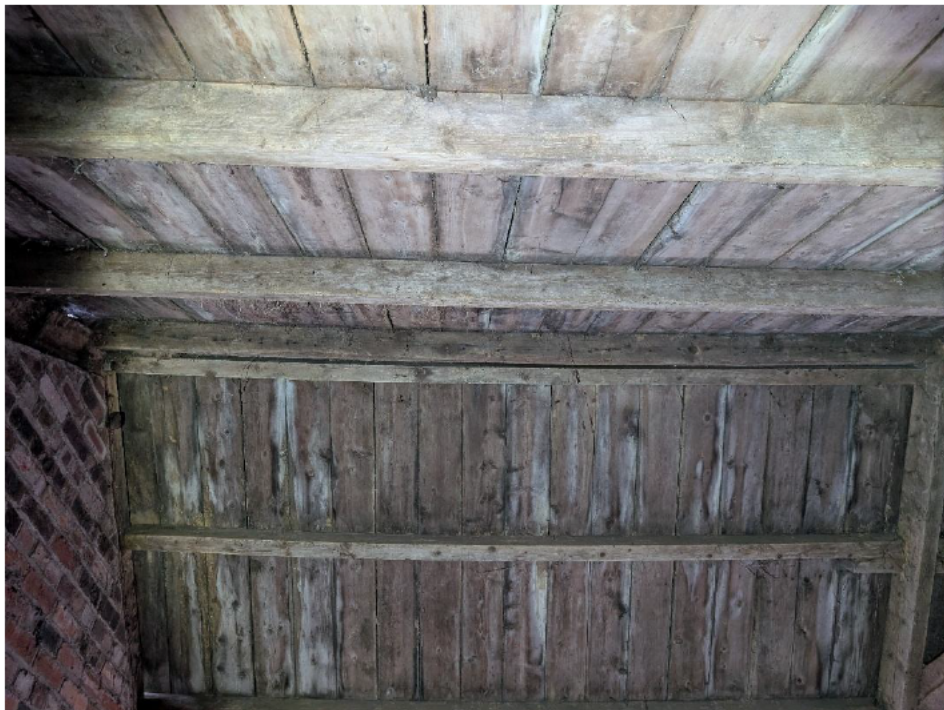
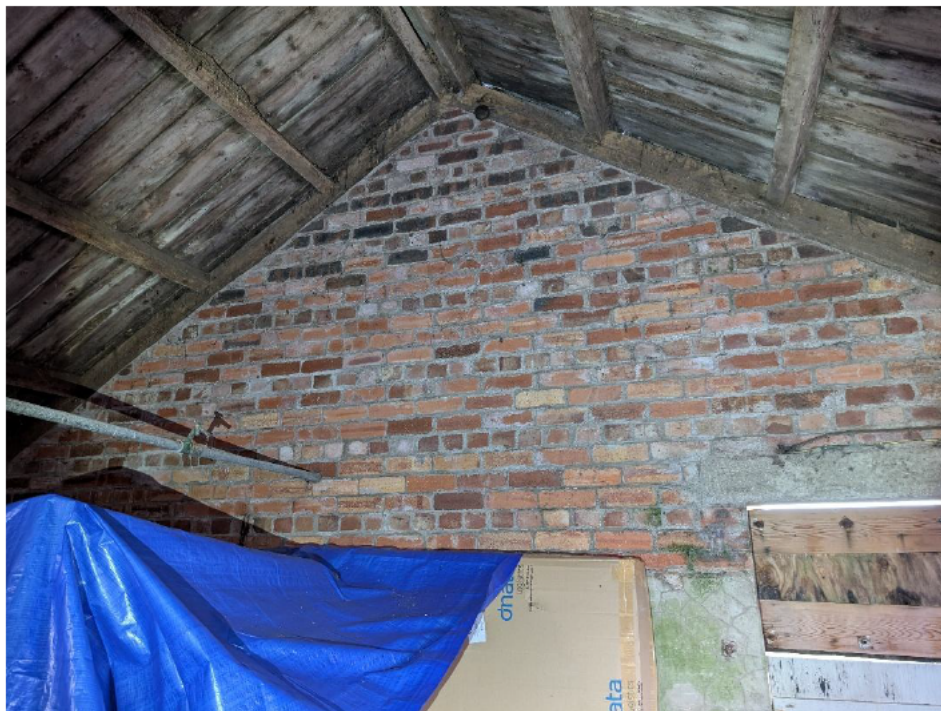
There are no enclosed voids in the building but the roof structure is exposed internally. There are wooden sarking boards beneath the corrugate sheets which is in good condition and free from rot or gaps which could be exploited by bats.

There roof timbers are also in good condition and do not contain any cracks, gaps or other features suitable for use by bats.

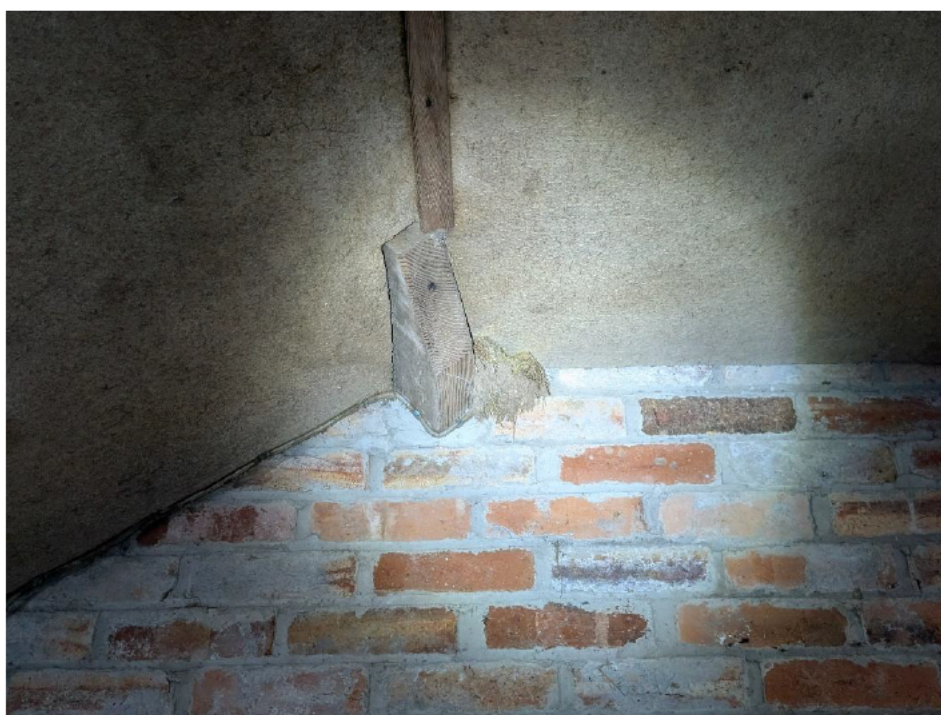
The internal space is open, exposed, and well illuminated by natural light. It is not considered likely that this space would be used by bats, though a low number of old Barn Swallow (*Hirundo rustica*) nests were noted. These did not show signs of recent use.

If works are required to commence during the breeding bird season then this must only be done after a thorough inspection. Contractors must be vigilant for signs of any active nests and pause works if active nests are seen or suspected.
