## **PROPOSED RESIDENTIAL DEVELOPMENT**

**HARRAS MOOR WHITEHAVEN CA286SZ  
TREE SURVEY REPORT**

**GLEESON HOMES LTD**

**Revision A 10.06.26**

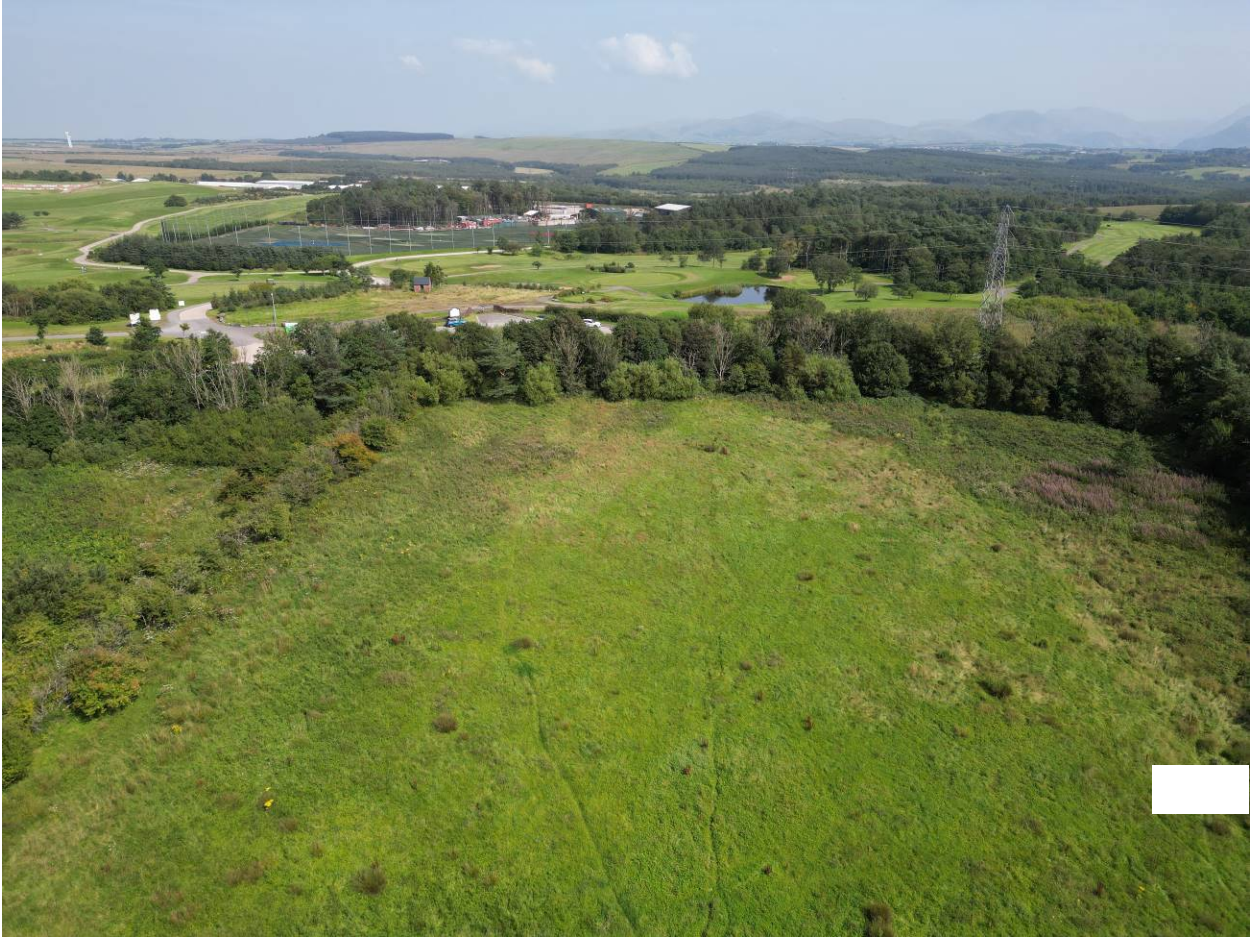
| Tree ID | Common Name | Botanical Name | Height (m) | Calc. / Actual Stem Dia. (mm) | Crown spread (m) | | | | Height (m) & Orientation of First Significant Branch | Avg. Canopy Height (m) | Life Stage | General Observations | Preliminary Recommendations | Estimated Remaining Contribution (Years) | BS5837: 2012 Category |
|---|---|---|---|---|---|---|---|---|---|---|---|---|---|---|---|
| G1 | Ash, black thorn, alder, hawthorn, silver birch, goat willow, cherry, crab apple | 150 | 16m | 250 | | | | | Middle aged | Roadside shelterbelt group with a diverse species mix. Large proportion of ash which is largely dead or dying from ash dieback. Ash dieback is noted throughout the locality. To the north where the group borders the footpath there is low branching over it. | Thin dead / dying ash out. Prune low branches over the footpath. | 10 - 20 | C | | |

1 Group 1

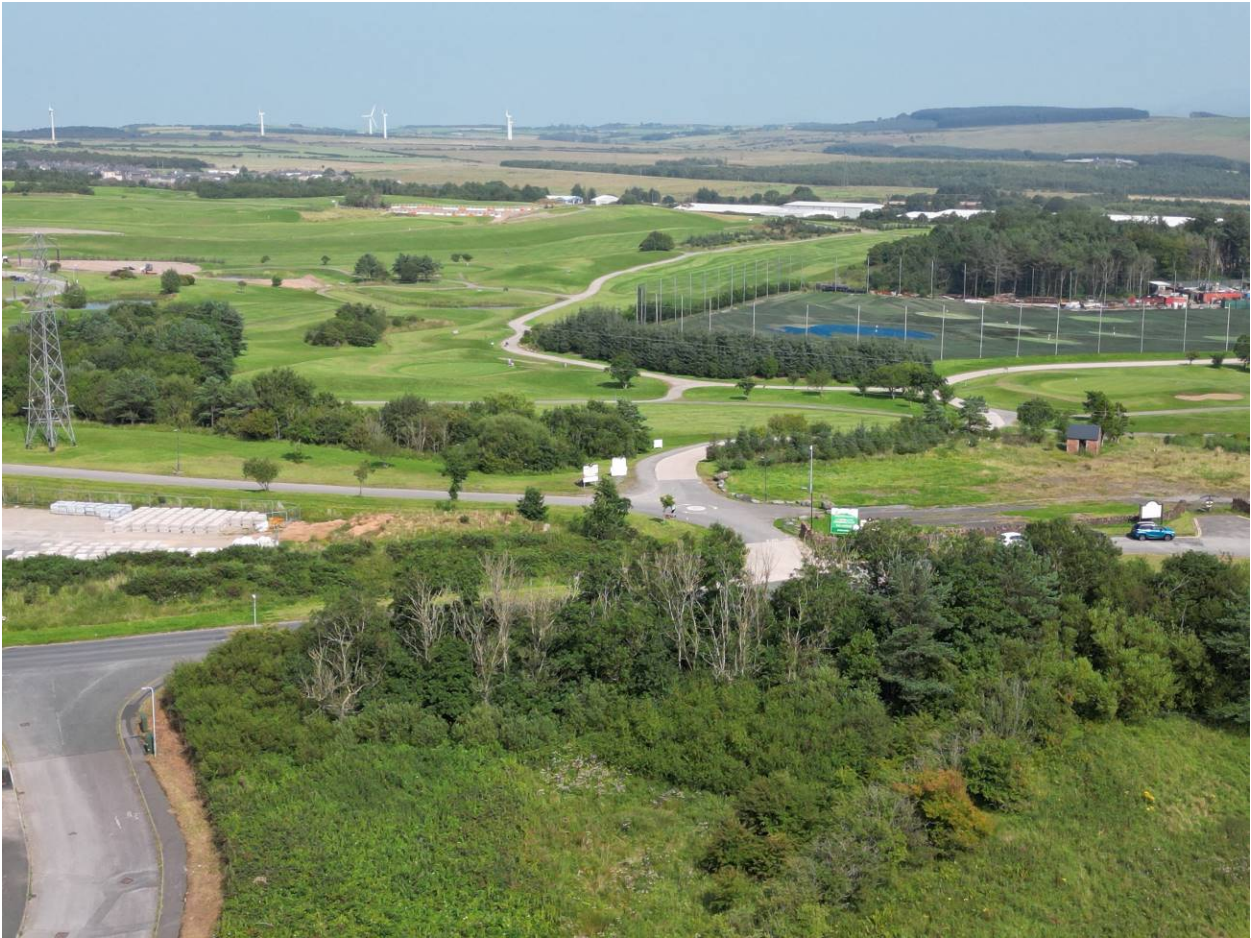
1. Main issue is ash dieback which is noted throughout the locality. Recommend removal of ash for safety as it looks poor throughout the site with the vast majority of ash trees either dead or dying. Didn't see any healthy ash trees. Recommend clearing ash trees in areas and replant with native species. Worst area G1, G3, G5 and G6.

2 Group 1 showing extensive diseased Ash

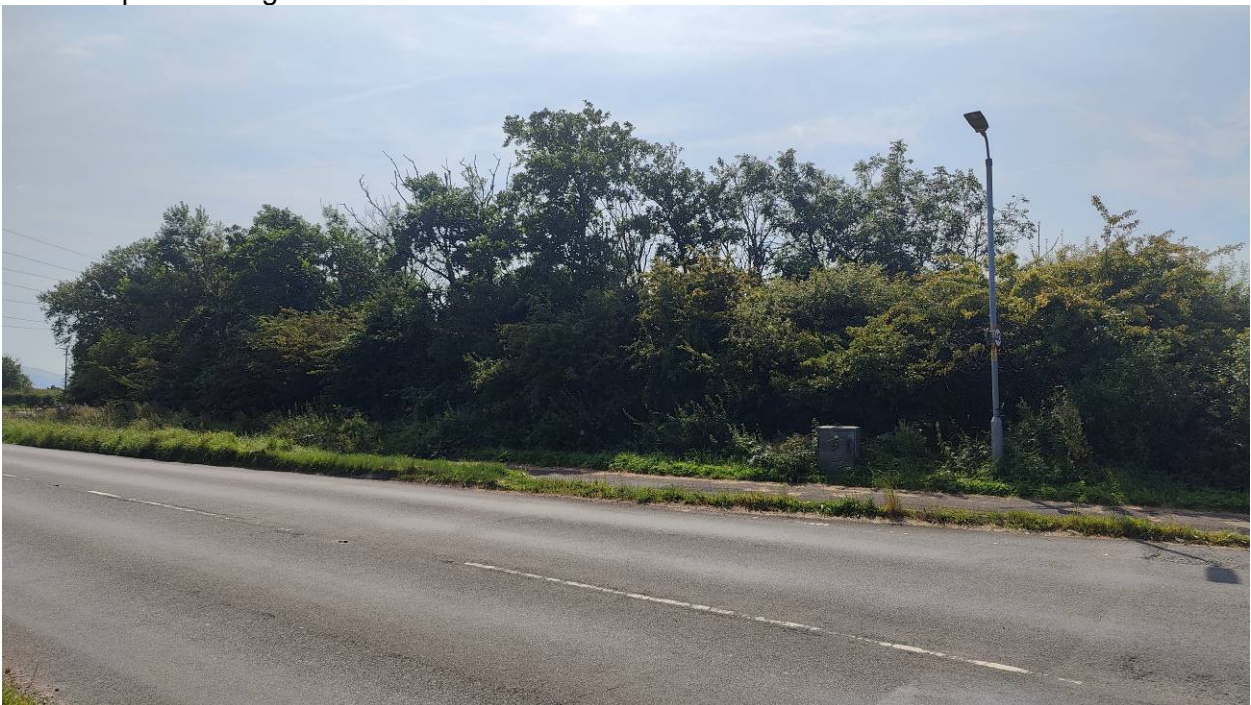
3 Group 1 from the roadside Harras Road

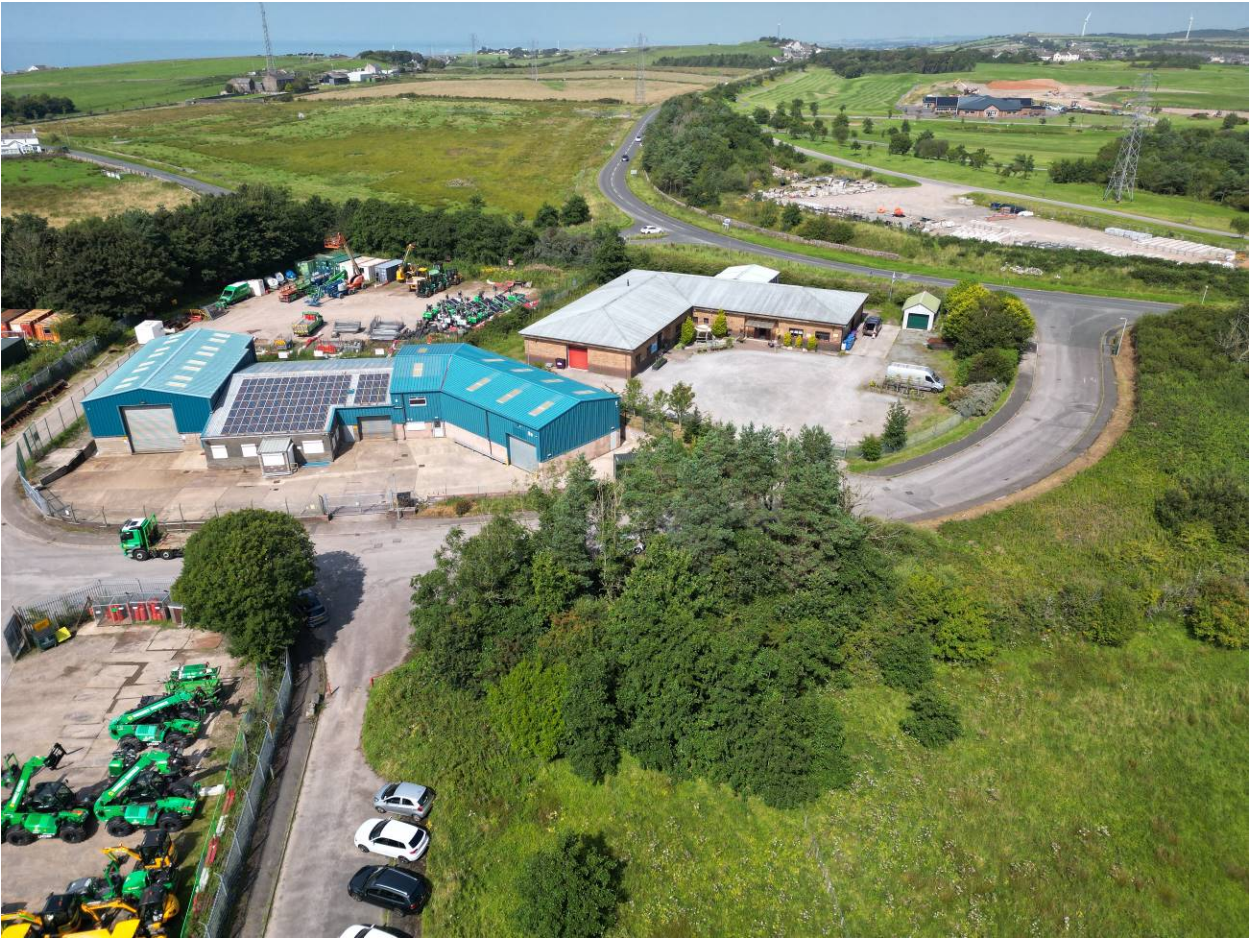
| Tree ID | Common Name | Botanical Name | Height (m) | Calc. / Actual Stem Dia. (mm) | Crown spread (m) | | | | Height (m) & Orientation of First Significant Branch | Avg. Canopy Height (m) | Life Stage | General Observations | Preliminary Recommendations | Estimated Remaining Contribution (Years) | BS5837: 2012 Category |
|---|---|---|---|---|---|---|---|---|---|---|---|---|---|---|---|
| G2 | Alder, ash, Scots pine, Oak, Elder | 30 | 15m | 300 | | | | | Middle aged | Small block of woodland in poor unmanaged condition, borders public road of industrial estate. Some dying ash trees have been previously paint marked. Many dead trees within incorporates a hedge to the east. | Thin dead ash trees prune back over the pavement. | 10 - 20 | C | | |

4 Group 2 to the south-east of the industrial estate.

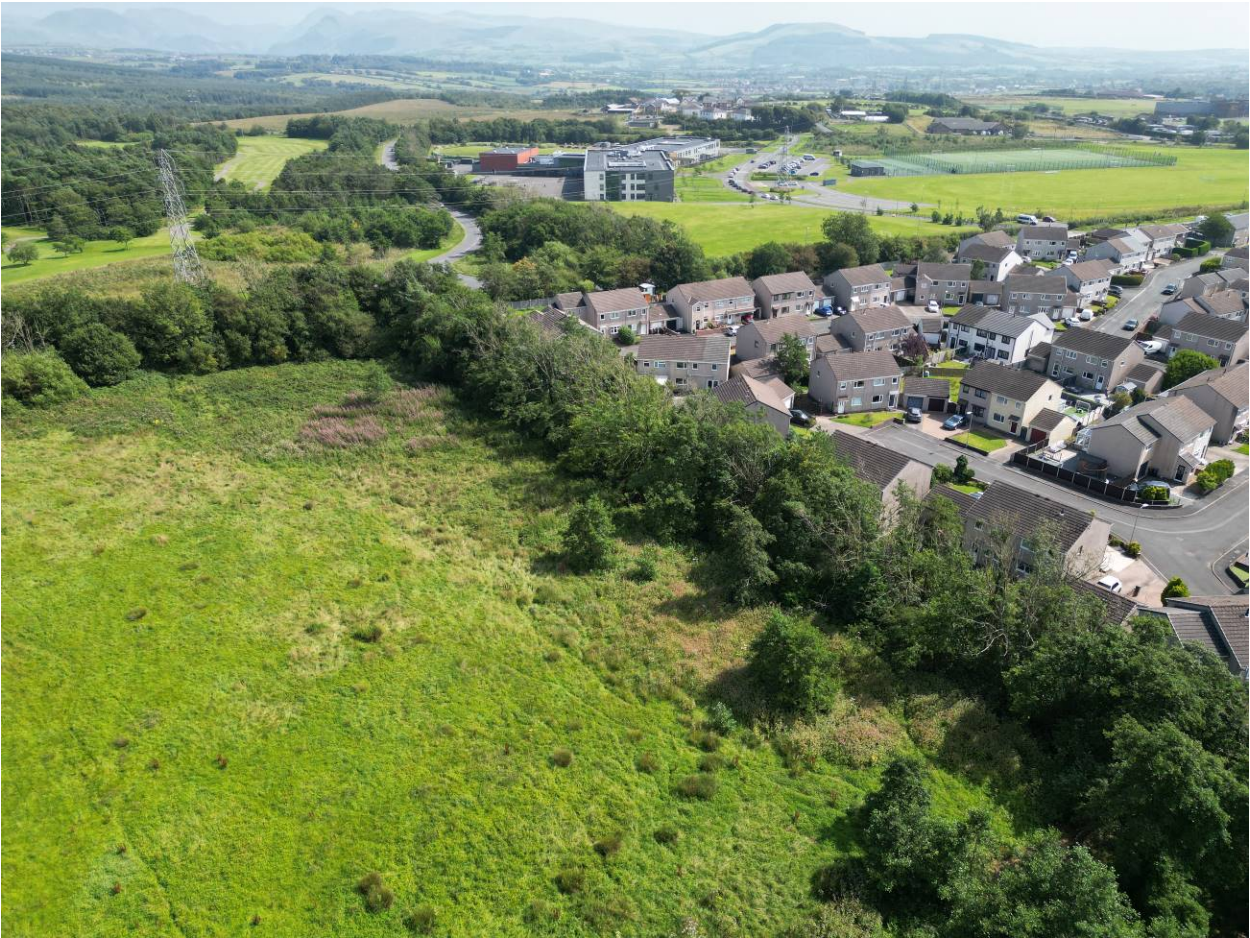
| Tree ID | Common Name | Botanical Name | Height (m) | Calc. / Actual Stem Dia. (mm) | Crown spread (m) | | | | Height (m) & Orientation of First Significant Branch | Avg. Canopy Height (m) | Life Stage | General Observations | Preliminary Recommendations | Estimated Remaining Contribution (Years) | BS5837: 2012 Category |
|---|---|---|---|---|---|---|---|---|---|---|---|---|---|---|---|
| G3 | Ash, sycamore, cherry, Scots pine, silver birch, elm | 100 | 16m | 250 | | | | | Middle aged | Tree group borders existing housing at Winchester Drive. Has a large amount of dead /dying ash trees. Long term tree safety needs to be factored in with many trees overhanging the adjacent properties gardens. Himalayan balsam noted on western edge. | As a priority fell dead / dying ash trees. Clear groups and replant. | 10 - 20 | C | | |

5 Group G3 at the southern boundary of the east section of the site.

- G3: Removal of the north-west section to accommodate the proposed access road and housing. The proposed road impedes within the RPA of the retained trees.

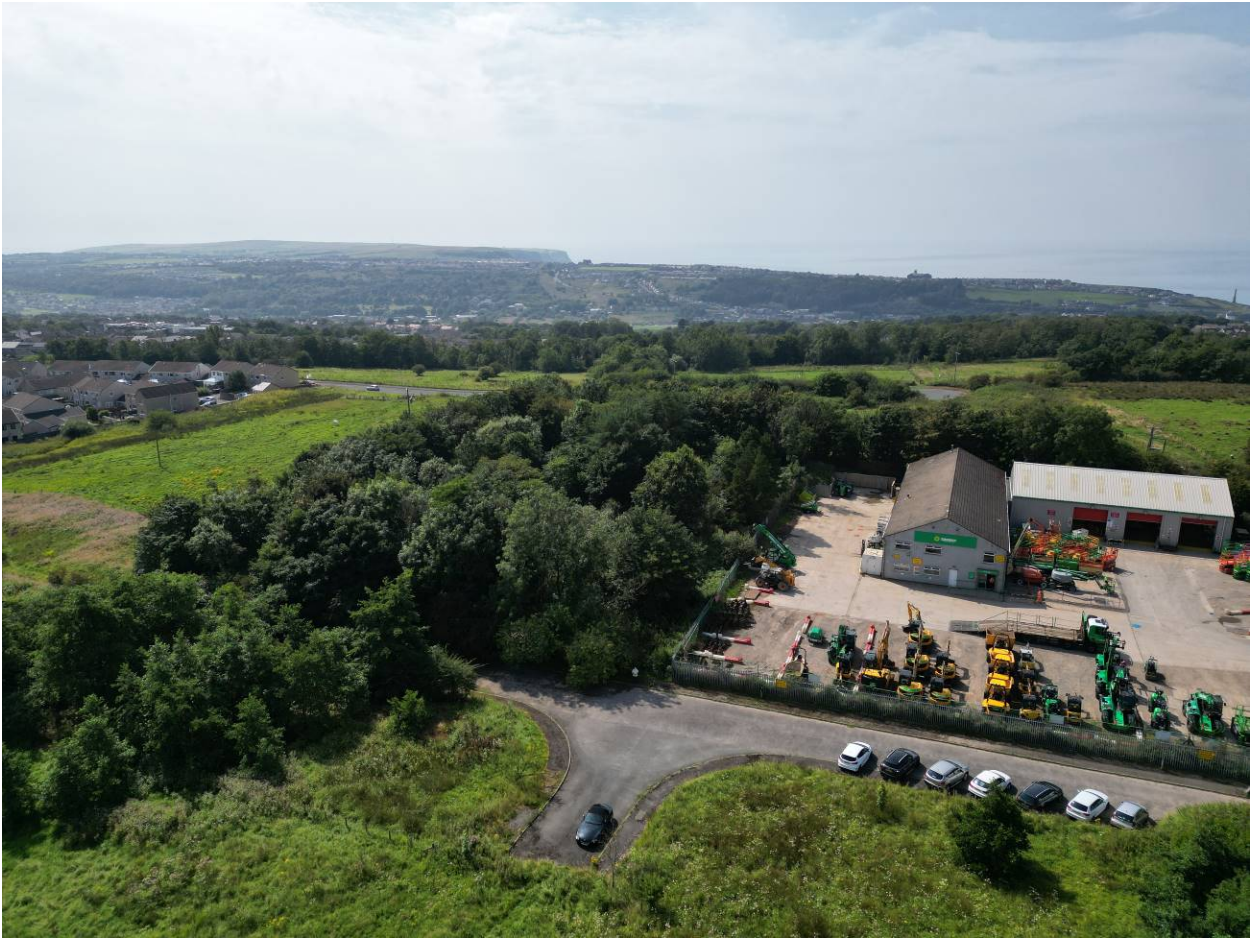
| Tree ID | Common Name | Botanical Name | Height (m) | Calc. / Actual Stem Dia. (mm) | Crown spread (m) | | | | Height (m) & Orientation of First Significant Branch | Avg. Canopy Height (m) | Life Stage | General Observations | Preliminary Recommendations | Estimated Remaining Contribution (Years) | BS5837: 2012 Category |
|---|---|---|---|---|---|---|---|---|---|---|---|---|---|---|---|
| G4 | Sycamore , beech, oak, hawthorn, aspen, alder, elder, elm | 150 | 16m | 350 | | | | | Middle aged | Tree group bordering Sunbelt Rentals depot. Some good quality trees within as well as some unmanaged. Some clearance has taken place as there are some open areas. Himalayan balsam noted. A few dead /dying ash trees. Would benefit from thinning.<br><b>Den/shelter noted.</b> | Remove dead ash trees and carry out selective thinning. Note there is a transformer at norther end. | 20 - 40 | B | | |

7. G4 – has a large well used den constructed within see photos.
8. G6 – has some sycamore trees recently felled - assumed for firewood.,
9. G10 – Crack willow have been cut badly.

6 Group G4 to the south boundary of the industrial estate.

- G4: Removal of the north-east section to accommodate the proposed access road and SUDS basin. The proposed road and SUDS impede within the RPA of the retained trees.

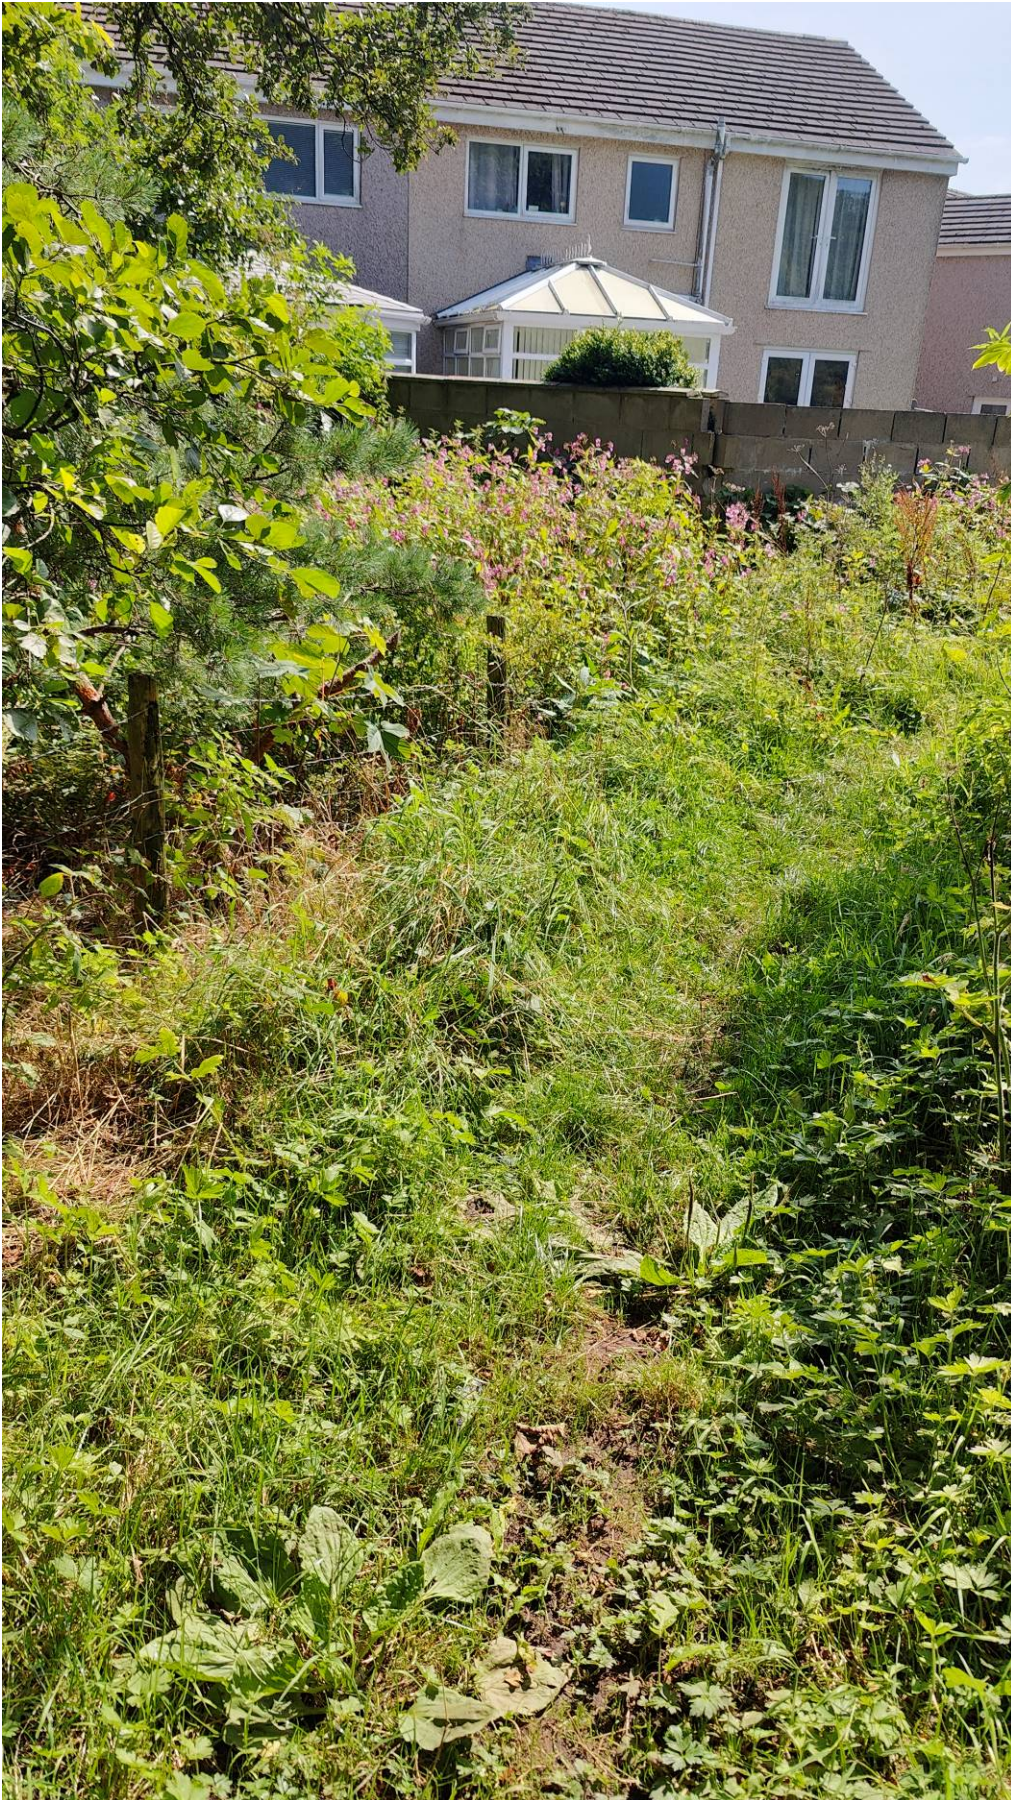
6. Himalayan balsam noted in several areas and control measures need to prevent further spread. Advise that areas are hand pulled in areas where development may take place in advance.

7 Himalayan Balsam to be controlled.

5.3. Eradicate Himalayan Balsam (eg margins to tree group G4)

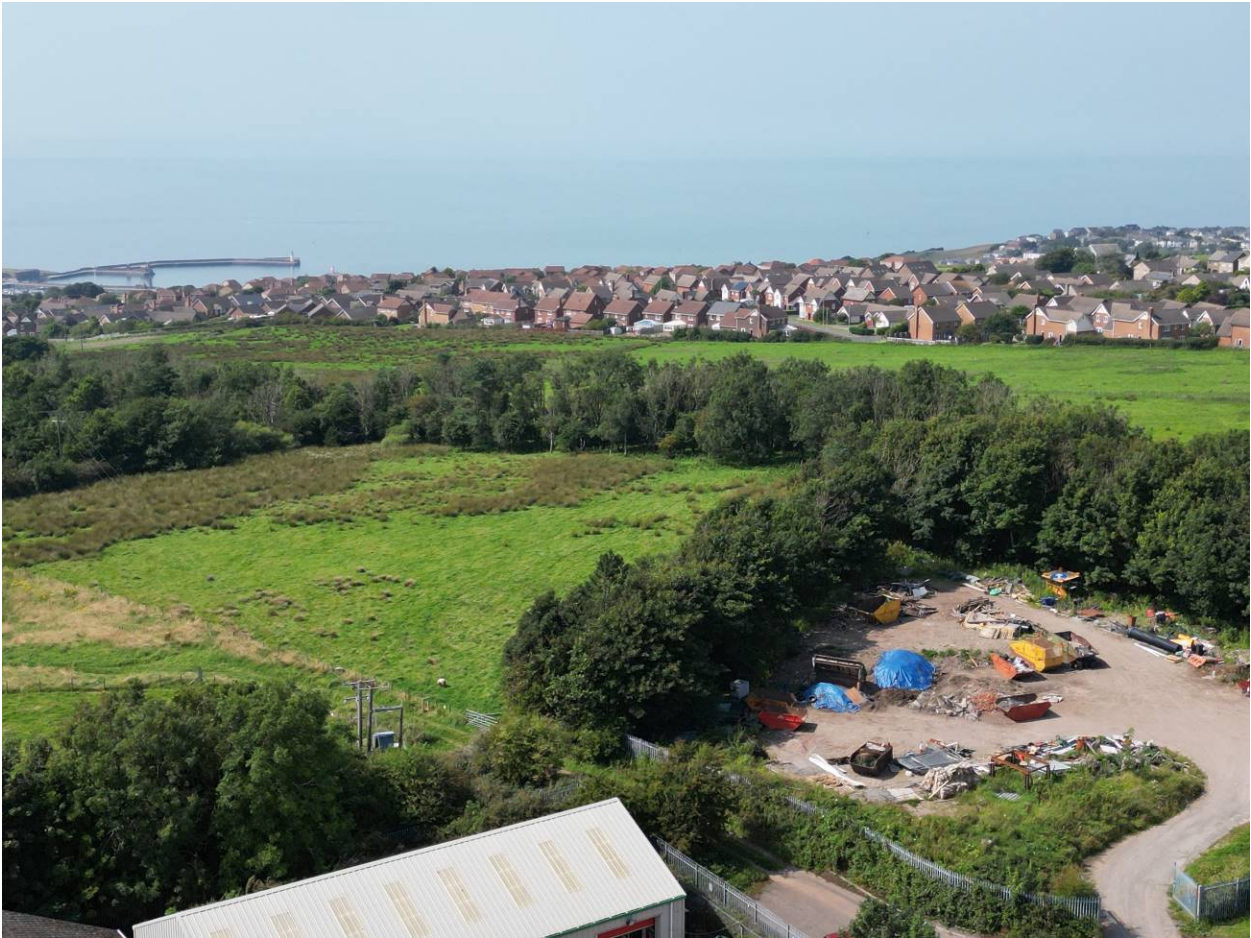
8 Groups G5 (right) and G6.

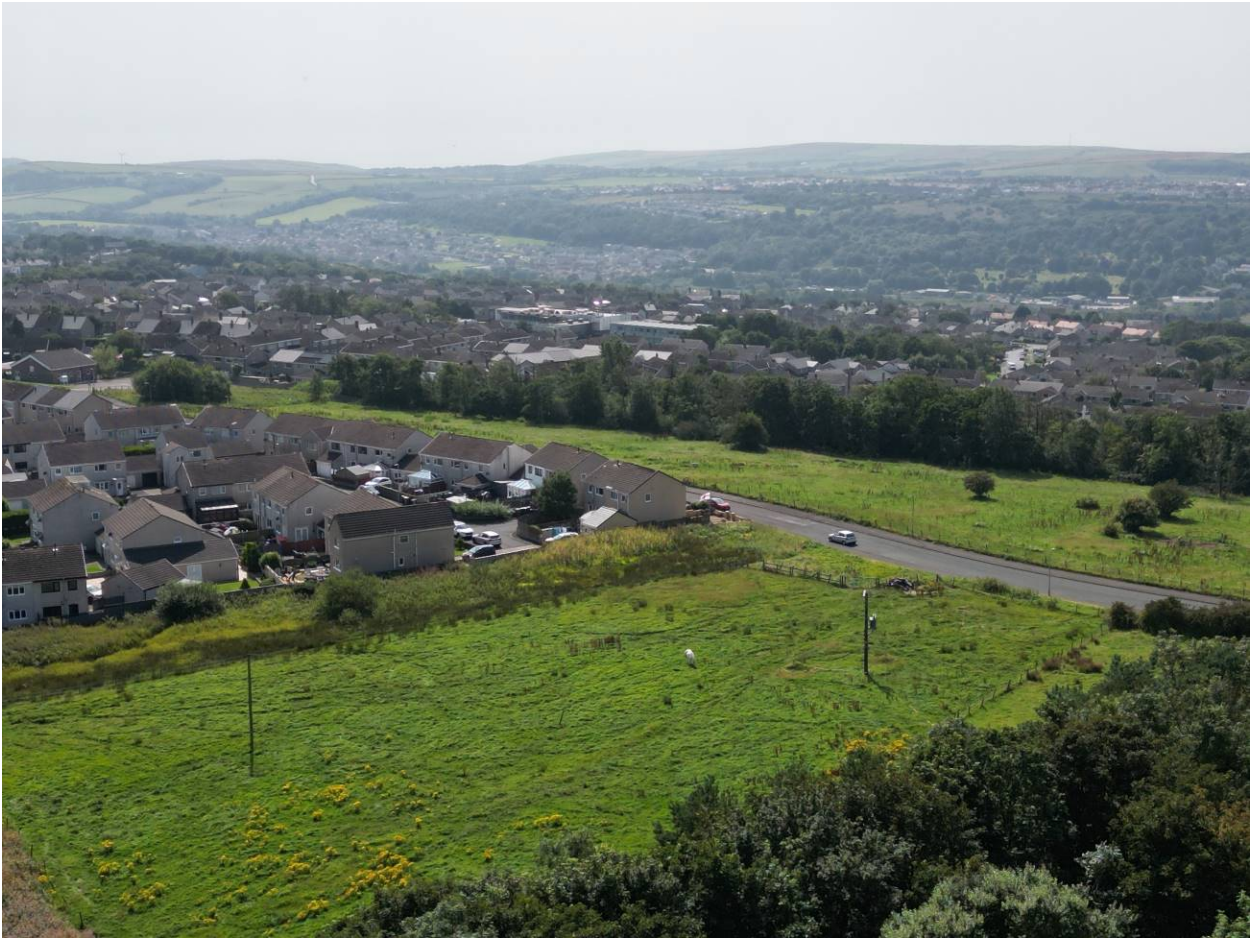
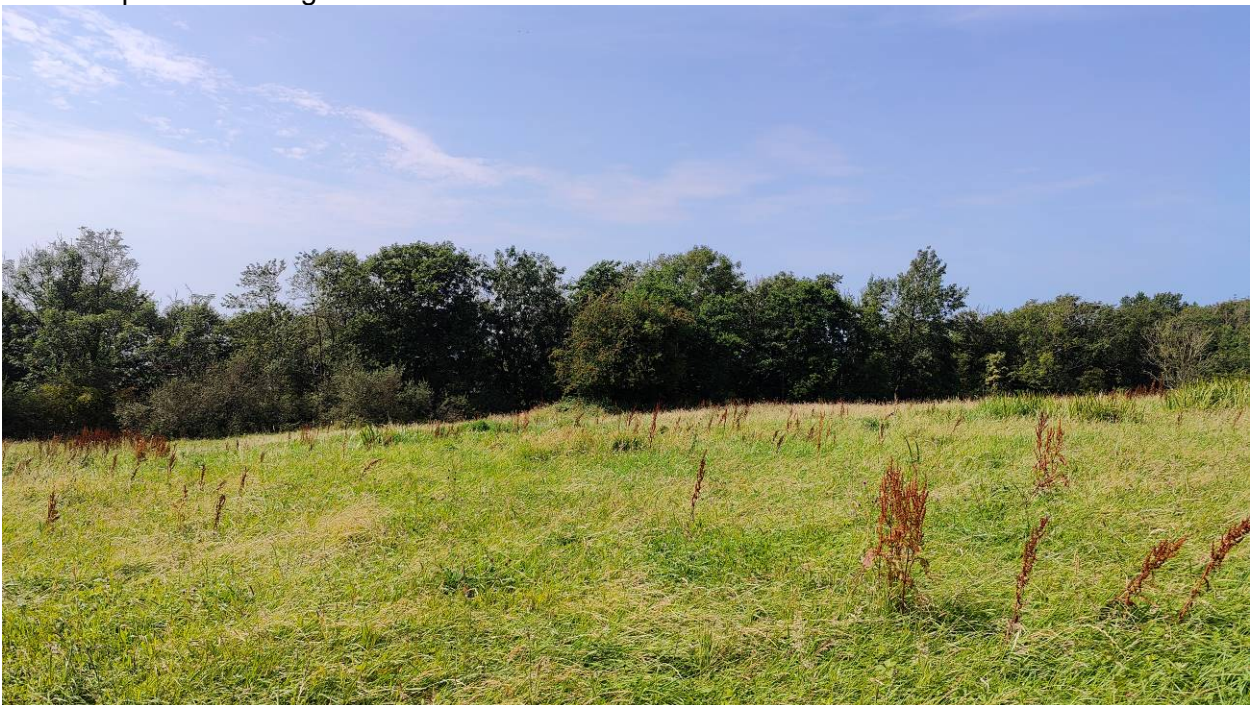
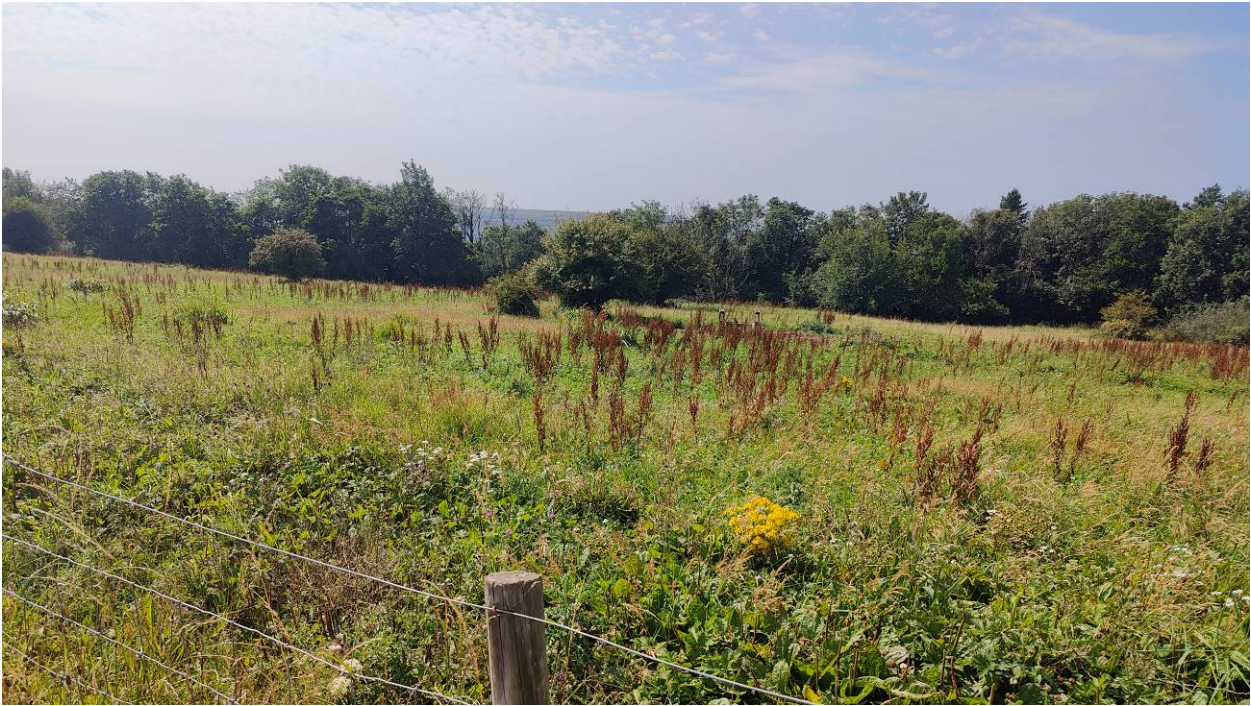
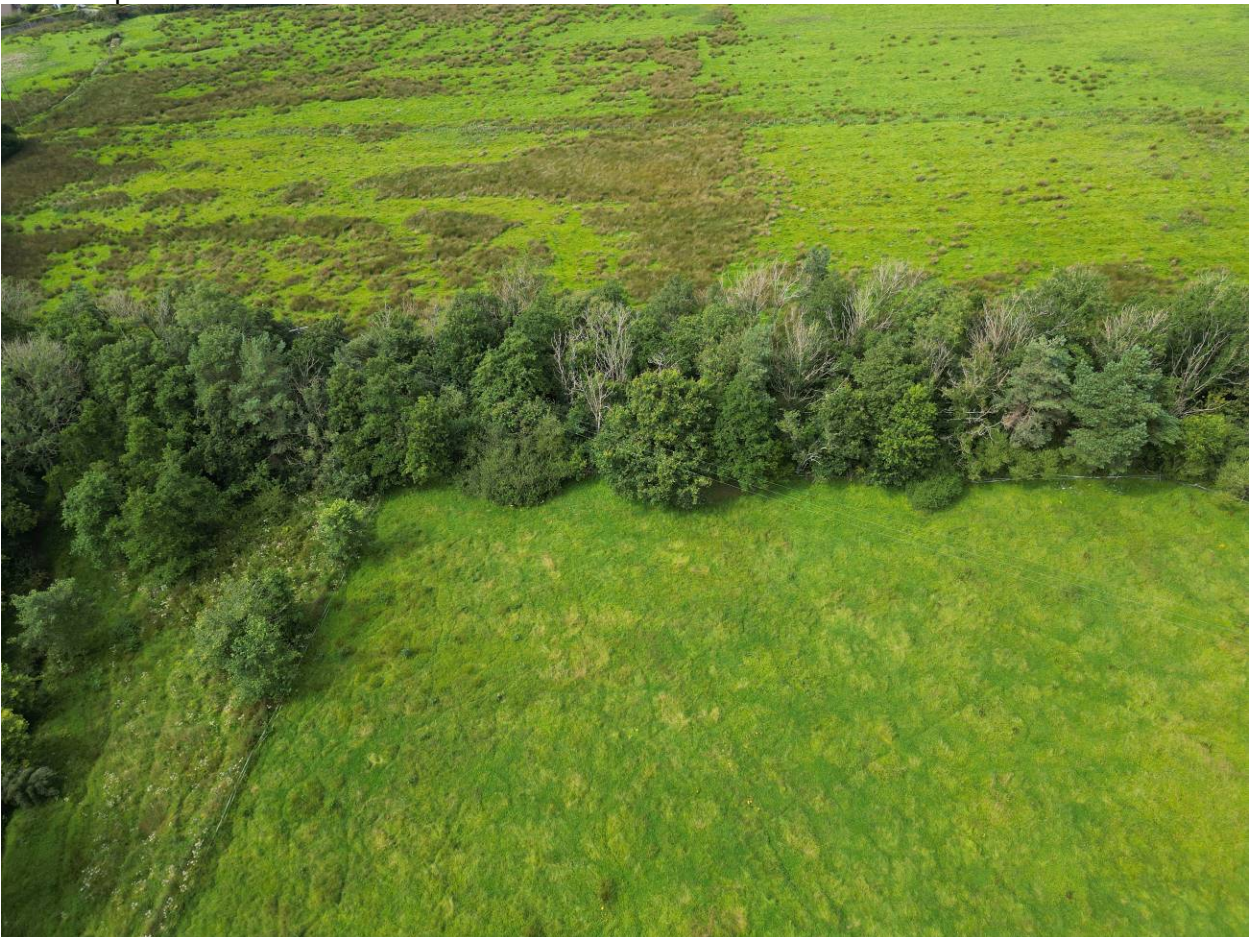
| Group ID | Common Names | Est. No. of Trees | Average Height (m) | Calc. / Actual Stem Dia. (mm) | Crown spread (m) | | | | Life Stage | General Observations | Preliminary Recommendations | Estimated Remaining Contribution (Years) | BS5837: 2012 Category |
|---|---|---|---|---|---|---|---|---|---|---|---|---|---|
| G6 | Ash, alder, oak, hawthorn, <del>sycamore</del> , <del>aspen</del> , Scots pine, holly, elder | 400 | 16m | 350 | | | | | Middle aged | Ash dieback throughout which needs removing and replanting. Some good trees within and provides excellent screen / wildlife corridor. Well used footpath through the block. Western side borders existing housing so tree safety needs to be considered. Himalayan balsam noted.<br><br><b>Note: 10x tree felled, unskilled felling so likely to be unauthorised I would expect. Near High Grove see photos.</b> | Remove large number of dead ash trees and replant. | 20 - 40 | B |

9 Group G6 bordering houses.

10. Group G6

12 Group G6

13 Group G6

- G6: Removal of areas for the proposed access road, footpath and SUDS. The proposed road and footpath impede within the RPA of the retained trees.
- G7: Complete removal of this small group to accommodate the proposed POS and roads.

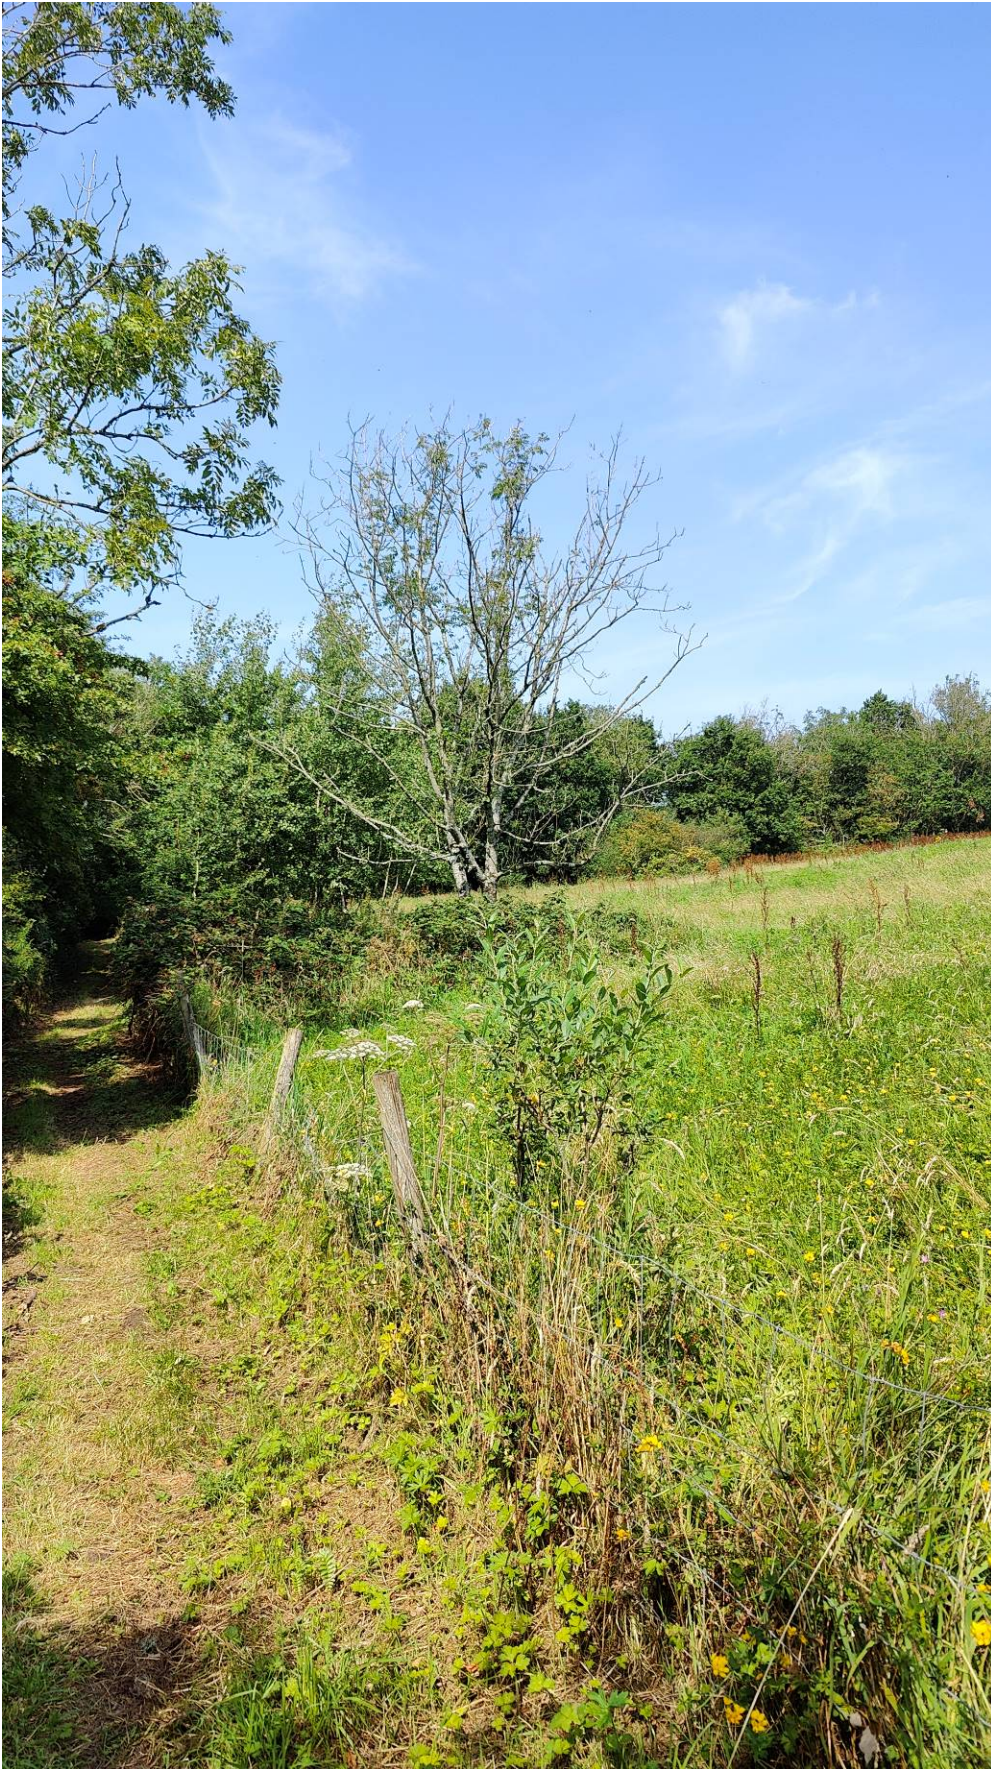
11 Group G6 dying Ash trees.

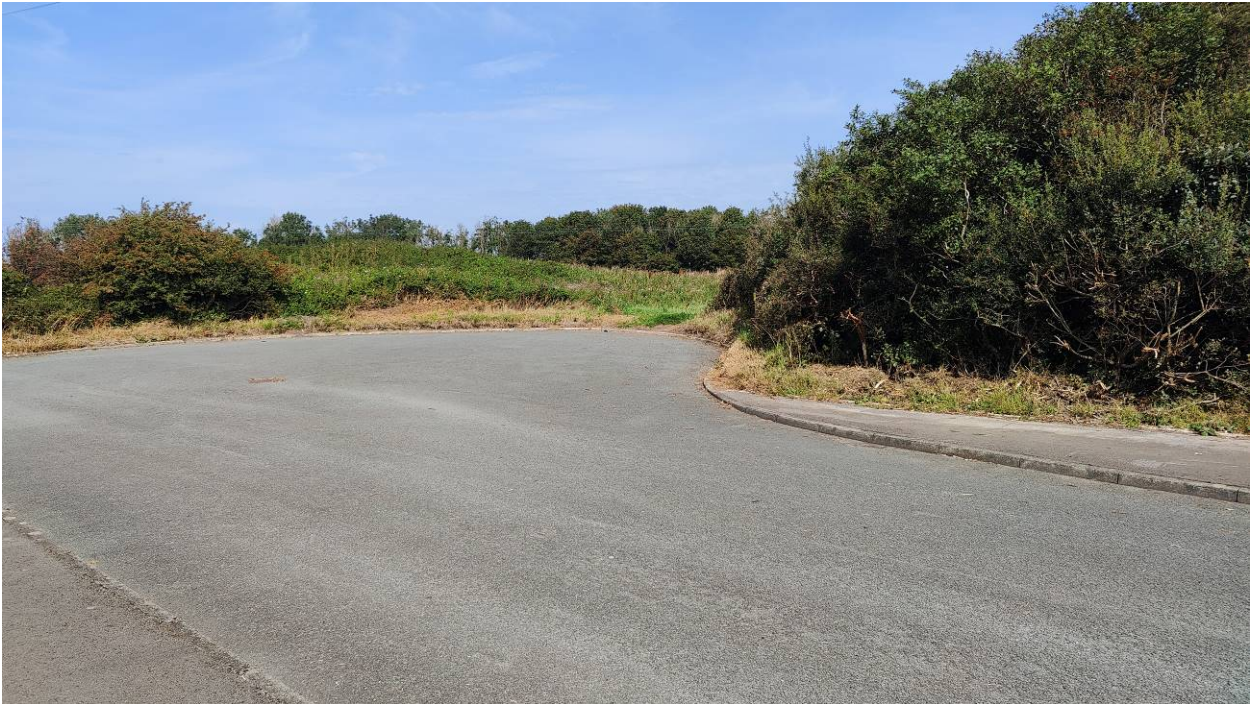
14 Groups G7 (left and G8 (right)

- G8: Complete removal of this small group to accommodate the proposed POS, housing and roads.
- G9: Removal of most of the group to accommodate the proposed houses and gardens at plots 268-275 leaving any trees beyond the boundary in suitable condition.

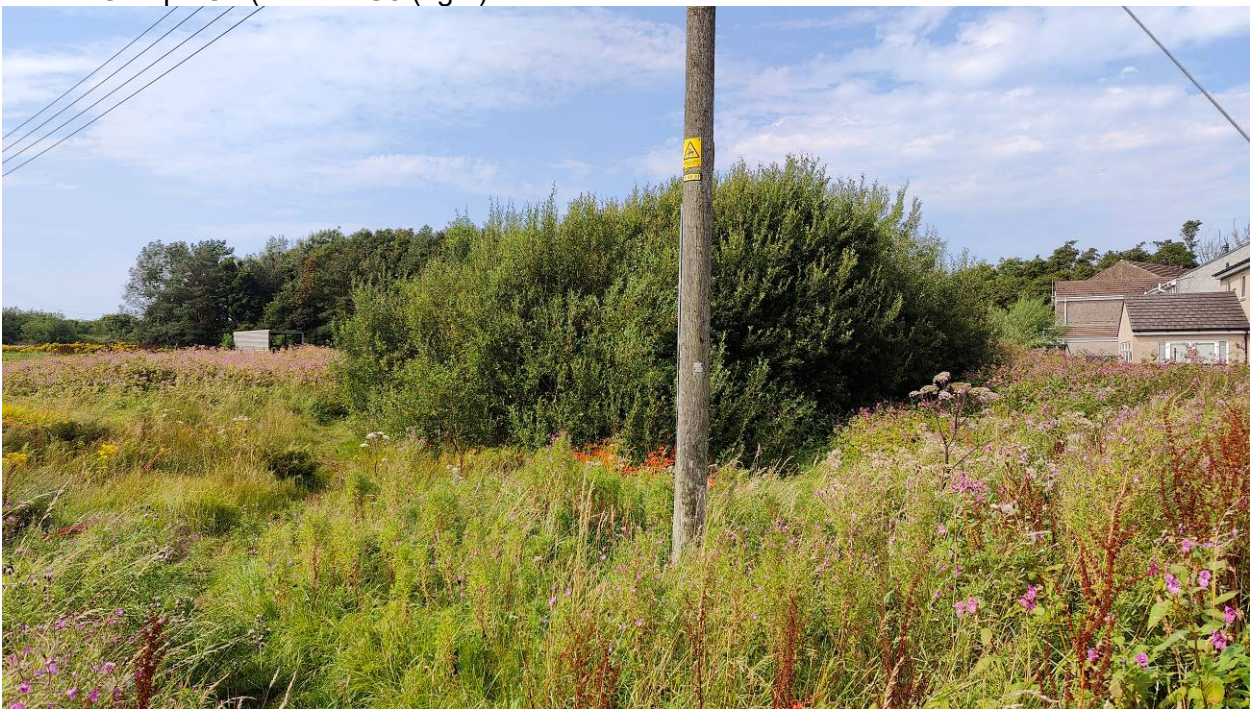
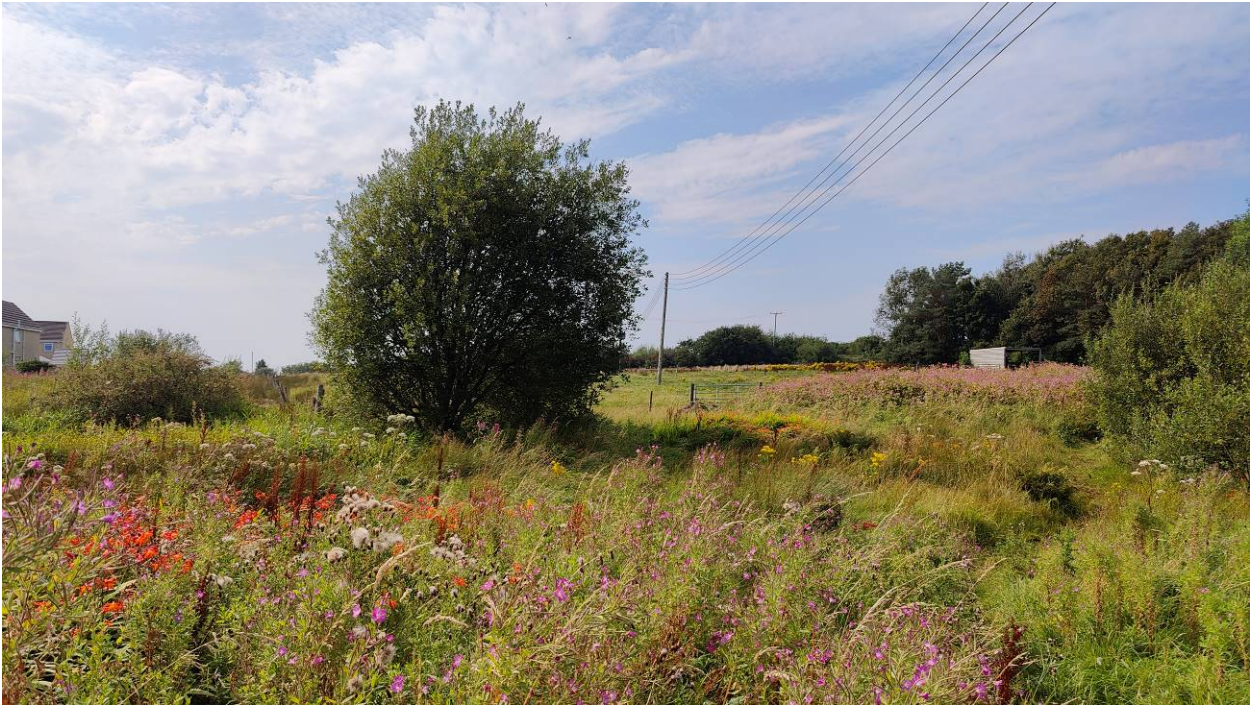
| Group ID | Common Names | Est. No. of Trees | Average Height (m) | Calc. / Actual Stem Dia. (mm) | Crown spread (m) | | | | Life Stage | General Observations | Preliminary Recommendations | Estimated Remaining Contribution (Years) | BS5837: 2012 Category |
|---|---|---|---|---|---|---|---|---|---|---|---|---|---|
| G9 | Goat willow, hawthorn, silver birch | 8 | 3m | 100 | | | | | Middle aged | Poor condition trees largely self-established. Large swath of Himalayan balsam noted. | No work required. | 10 - 20 | C |

15 Group G9

16 Group G9

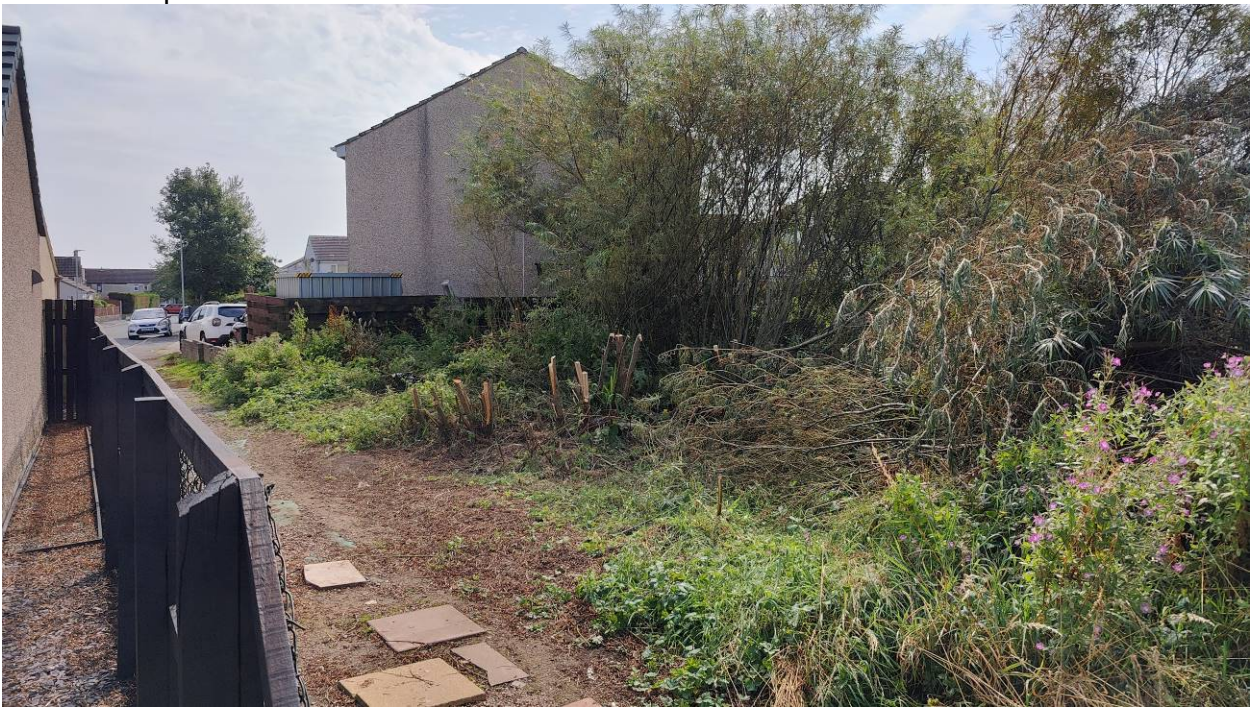
| Group ID | Common Names | Est. No. of Trees | Average Height (m) | Calc. / Actual Stem Dia. (mm) | Crown spread (m) | | | | Life Stage | General Observations | Preliminary Recommendations | Estimated Remaining Contribution (Years) | BS5837: 2012 Category |
|---|---|---|---|---|---|---|---|---|---|---|---|---|---|
| G10 | Crack willow | 10 | 3m | 40 | | | | | Middle aged | Spreading group of willows near to houses. Poor condition. Recently cut badly presumably by a neighbour see photos. | Remove to facilitate the development. | 10 - 20 | C |

17 Group G10

- G10: Removal of part of the group to accommodate the proposed house and garden at plot 267 leaving any trees beyond the boundary in suitable condition. The retained trees are outside the site boundary but may be affected by regrading to achieve the required levels.
