## **PROPOSED RESIDENTIAL DEVELOPMENT**

**HARRAS MOOR WHITEHAVEN CA286SZ  
TREE SURVEY REPORT**

**GLEESON HOMES LTD**

**Revision A 10.06.26**

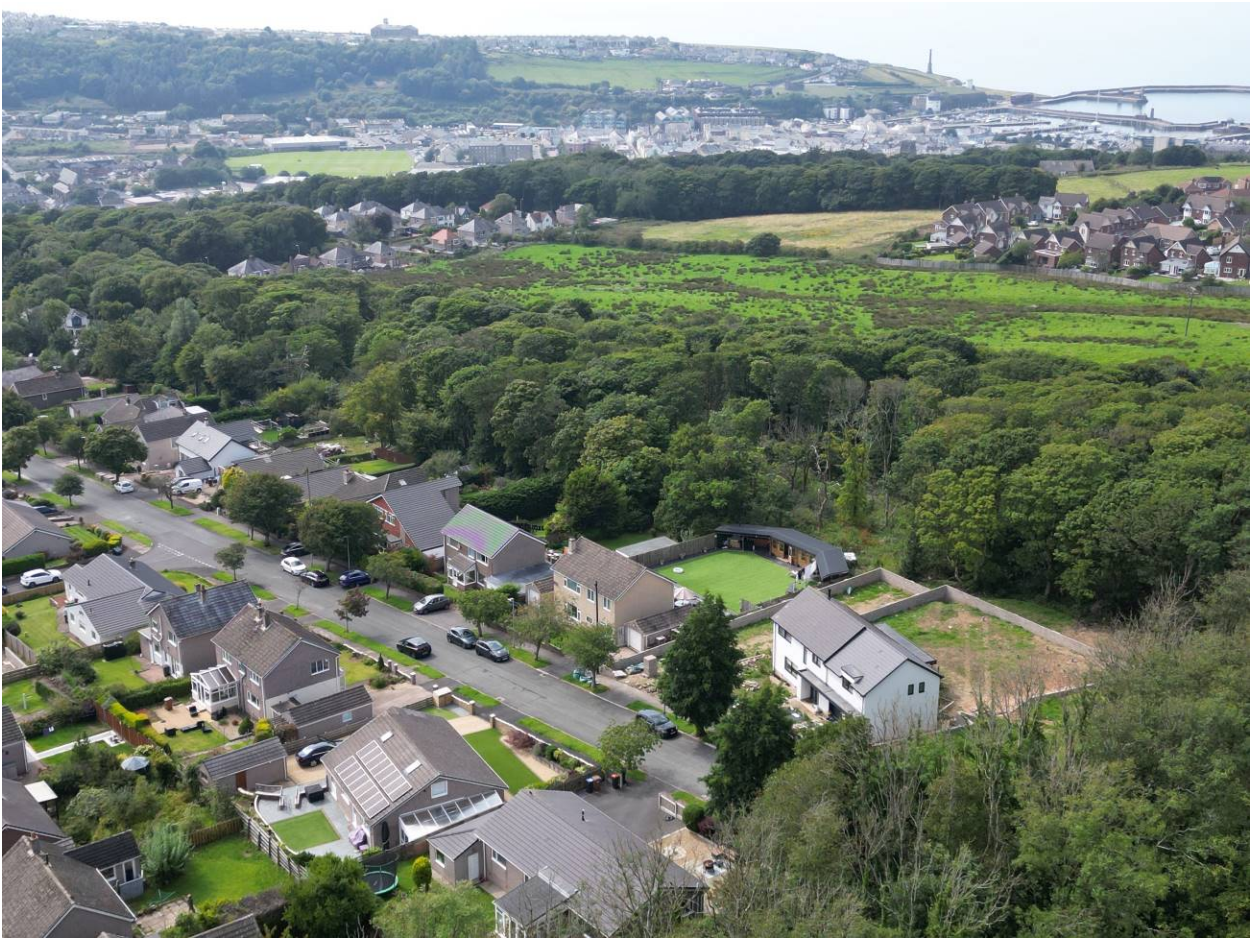
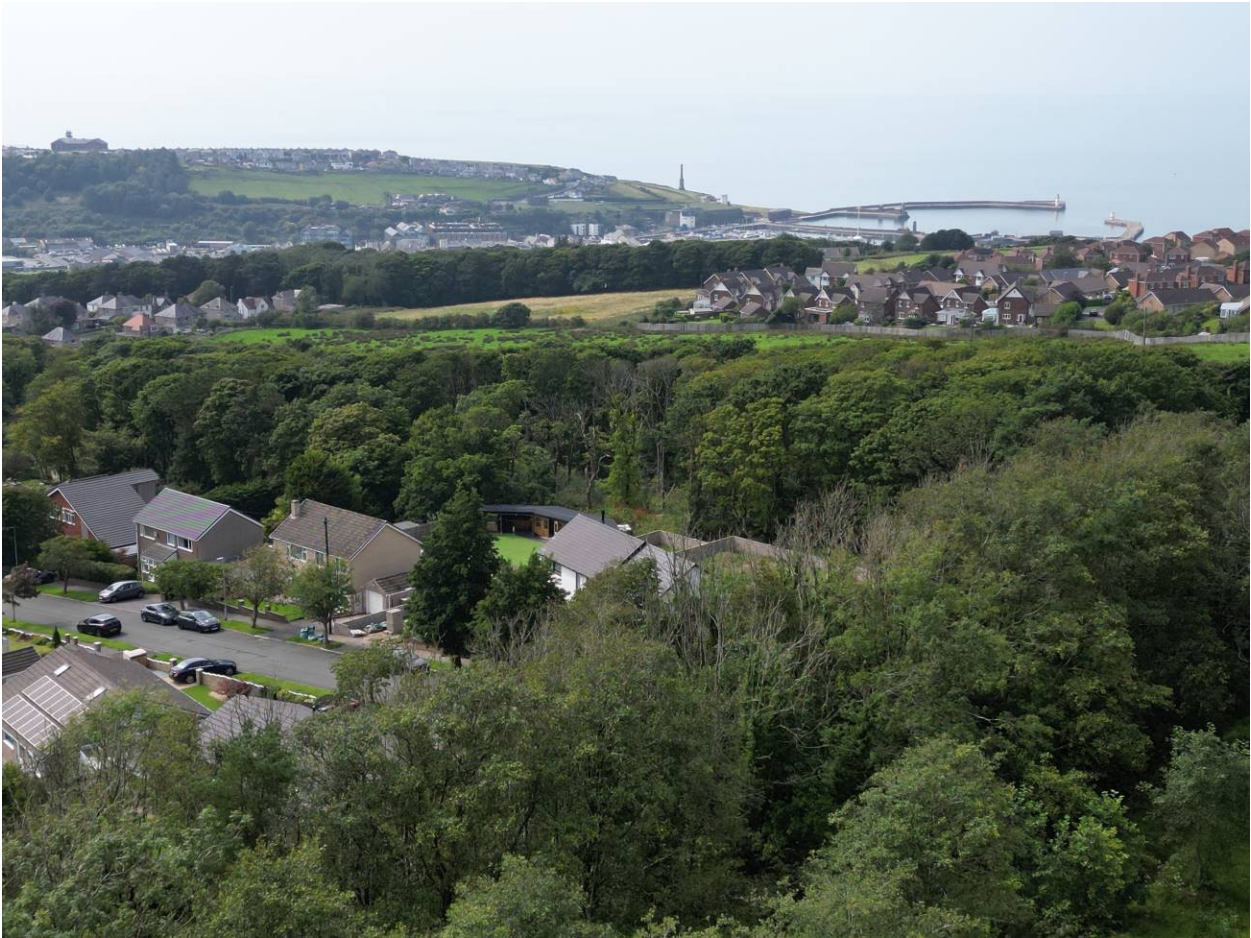
3.2. Woodland W1 Midgey Wood is of notable high value recognised by the designation of Ancient Woodland to the southern section. It is in reasonable condition except for the diseased Ash trees.

| Group ID | Common Names | Est. No. of Trees | Average Height (m) | Calc. / Actual Stem Dia. (mm) | Crown spread (m) | | | | Life Stage | General Observations | Preliminary Recommendations | Estimated Remaining Contribution (Years) | BS5837: 2012 Category |
|---|---|---|---|---|---|---|---|---|---|---|---|---|---|
| W1 | Oak, sycamore, holly, alder, ash, Silver birch | 400 | 18m | 450 | | | | | Mature | Good quality woodland classed as ancient semi natural woodland so an important habitat. Good mix of species and generally good condition except for the ash trees.<br><br>W1 is <del>cut</del> with the site ownership. High quality woodland but has some dead ash trees within. Some rhododendron noted likely to take over if left. | Protect during development.<br><br>Dead/ dying ash trees could be removed. Remove rhododendron. | 40+ | A |

18 Midgey Wood W1 part of which is an Ancient Woodland.

19 Midgey Wood W1

- Woodland W1 will be unaffected as this is beyond the application site boundary and the adjacent site area will not include any earthworks or ground level changes.

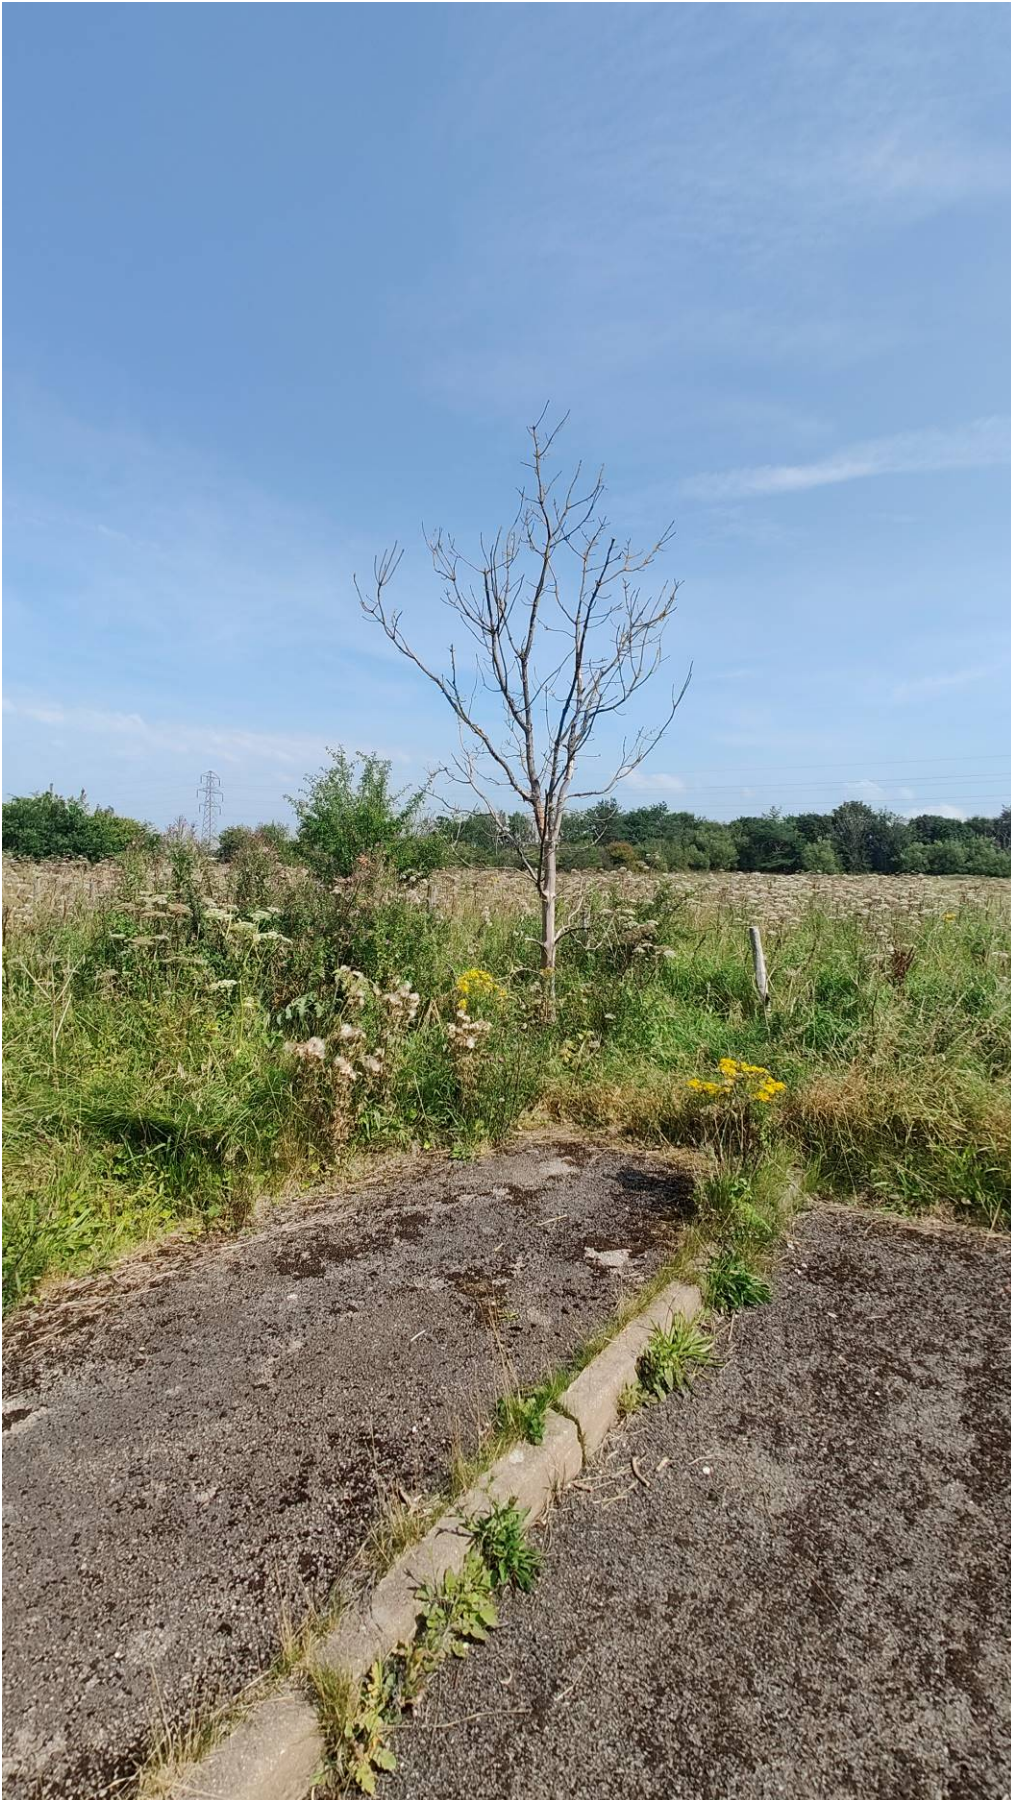
20 Tree T1 dead Ash

- Tree T1 is a dead Ash tree to be removed.
- Trees T2-T5 are all Category 'C' Hawthorn beyond the Application boundary and will be unaffected.

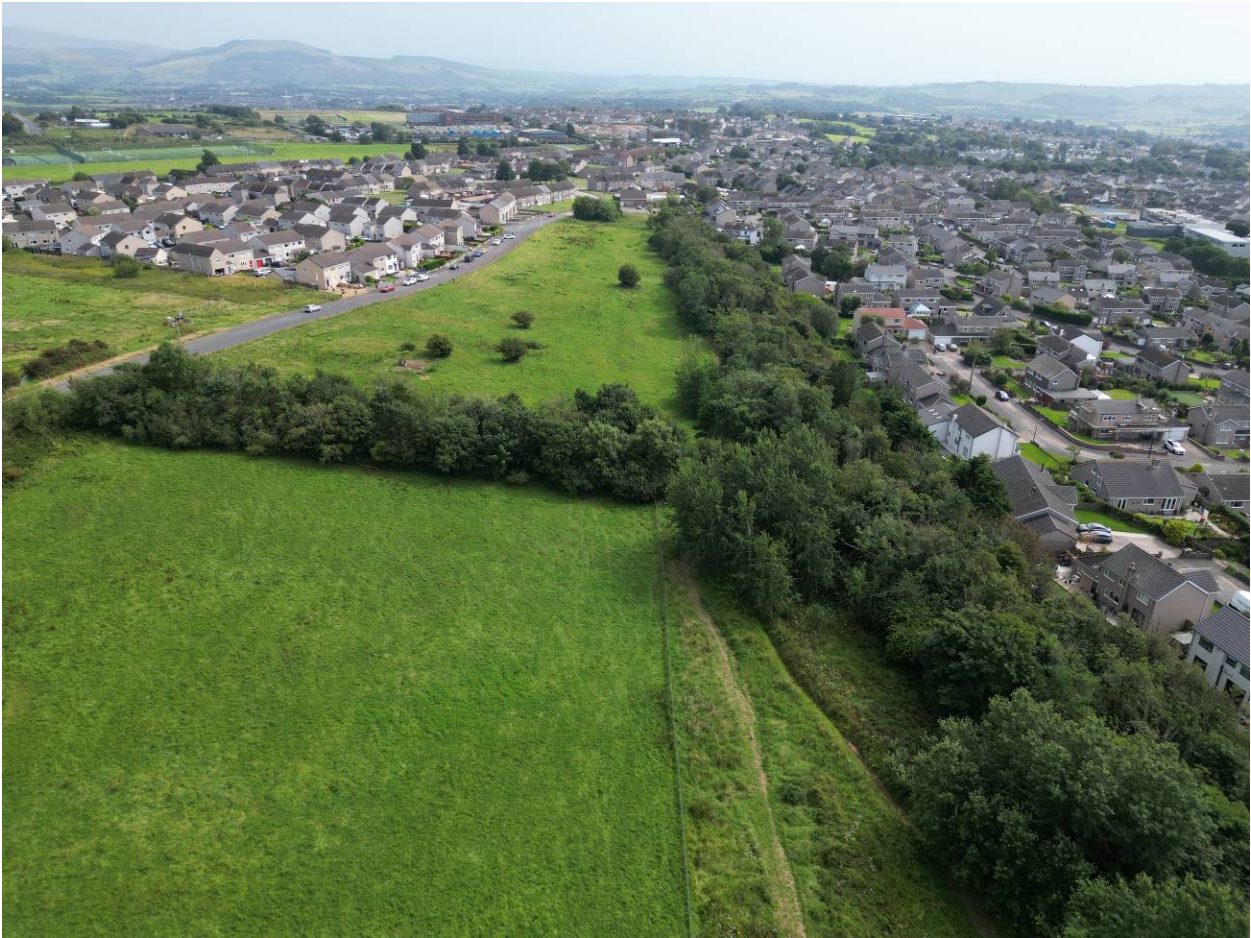
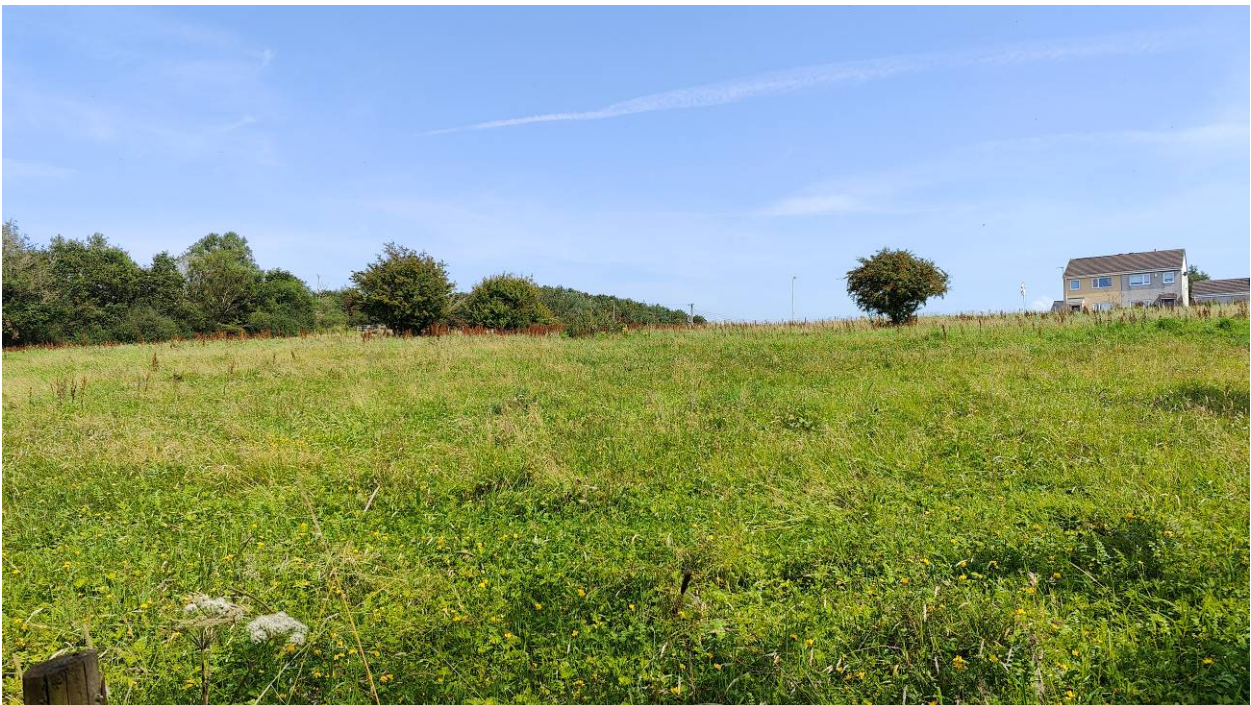
21 Trees T2-T5 scattered Hawthorn

22 Trees T2-T5 Hawthorn.

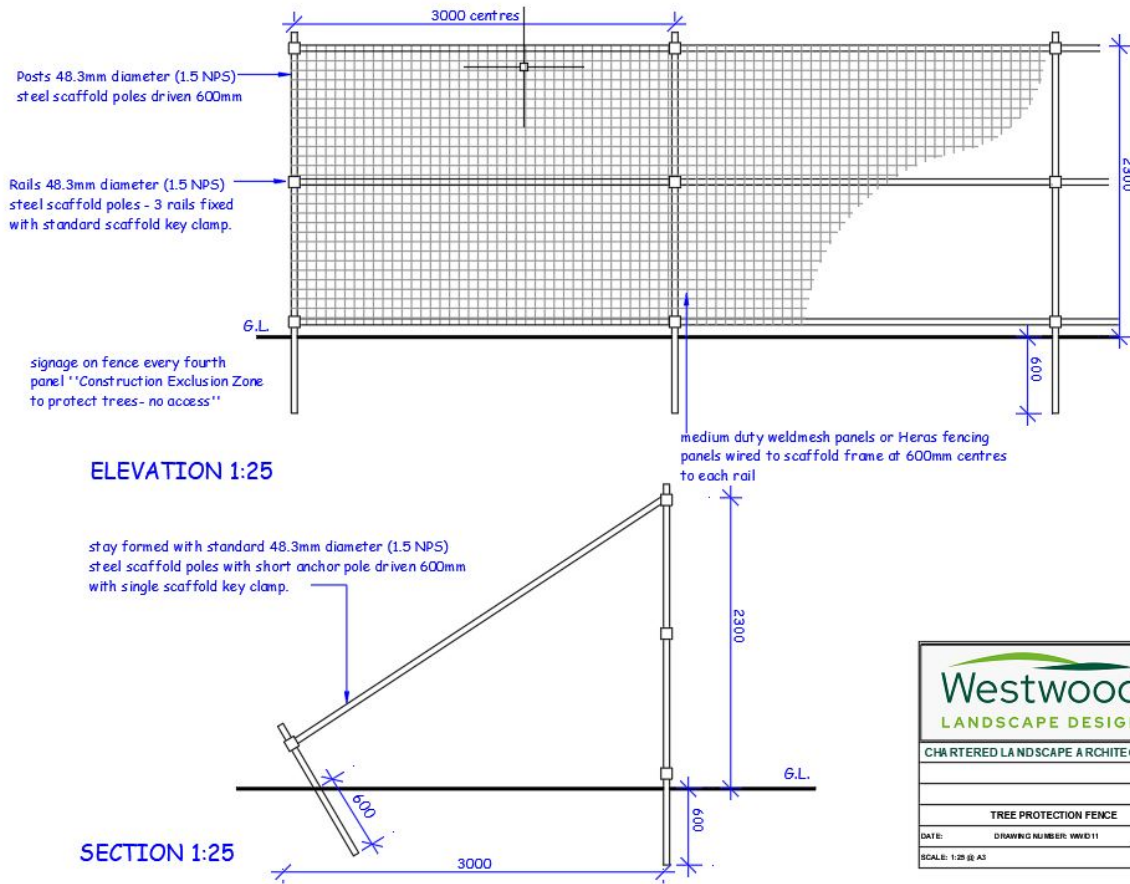
### Tree Protection Fence Detail

4.2 Protective fencing to be erected prior to the commencement of any other work to ensure that the trees and hedges are protected in accordance with British Standard 5837:2012 Trees in Relation to Construction. Such measures shall be retained for the duration of any approved works. Refer to detailed fencing drawing below in the Appendix.
