**COAL MINING RISK ASSESSMENT REPORT**

**HARRAS MOOR  
WHITEHAVEN  
CUMBRIA**

**Project No: EES16-199  
23<sup>rd</sup> December 2016**

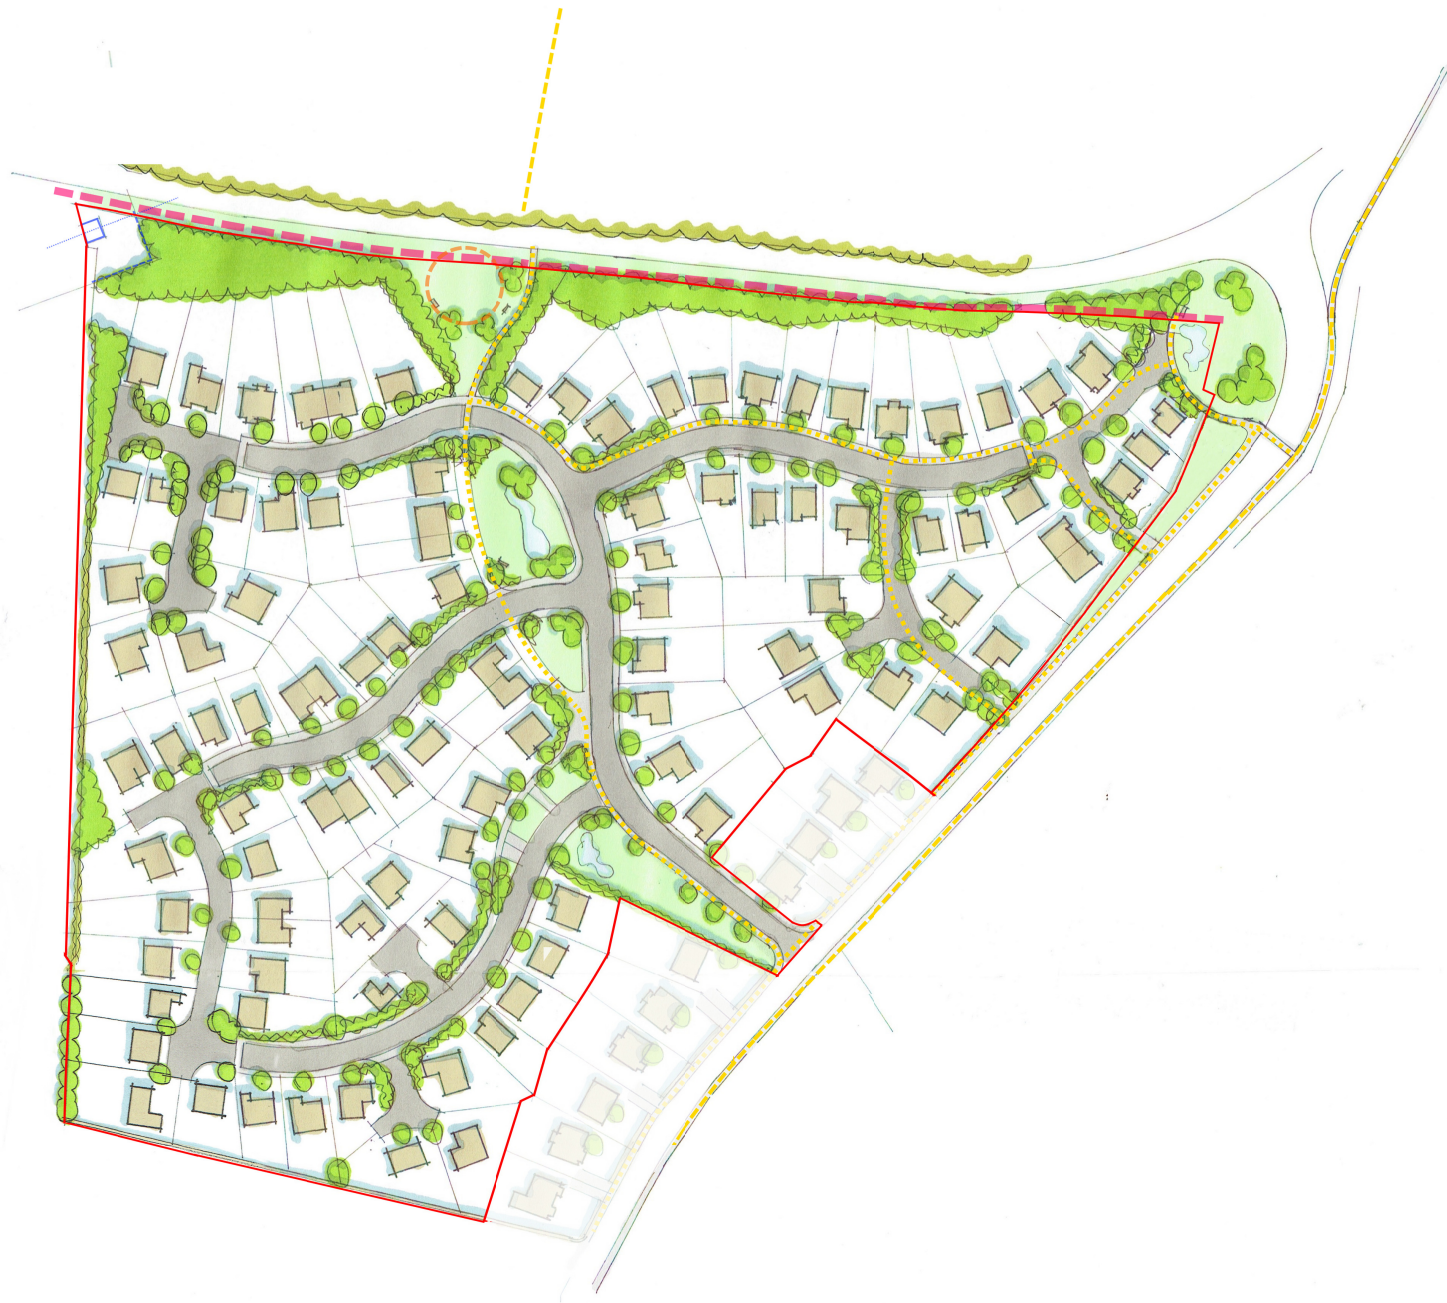
- Phase 2 Site boundary
- Phase 2 proposal
- Phase 1 proposal (shown later)
- Existing utility easements: avoid building over these
- Existing pylon and stand off area
- Existing mine shaft and stand off area
- Safeguarded area for potential Eastern Relief Road
- Existing footpaths
- Proposed or re-routed footpaths
- Proposed roads within site
- Proposed open space within site
- Proposed SUDs features
- Proposed planting
- Existing or relocated stone wall

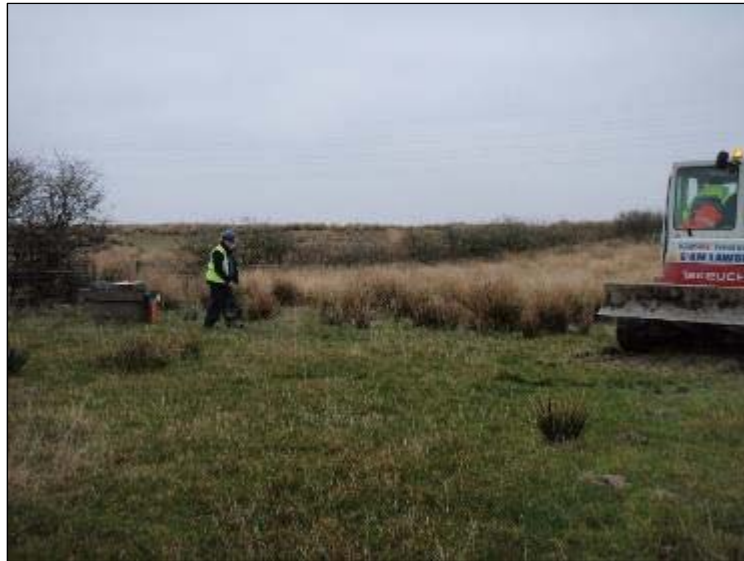
**Photo 4: TP1 located in the north west of the site.**

The infilled clay / subsoil averaged over 1.75m thick below 0.15 - 0.2m of topsoil and again was logged as compact stiff clay with occasional bricks, cobbles and boulders. The clay was wet in TP4, coinciding with the edge of a transient surface pond and stoniest in TP5. The breakline between the red / brown very stiff clay (natural ground) and the yellow / brown stiff clay (restored subsoil and clay backfill) was clearly visible in TP1.

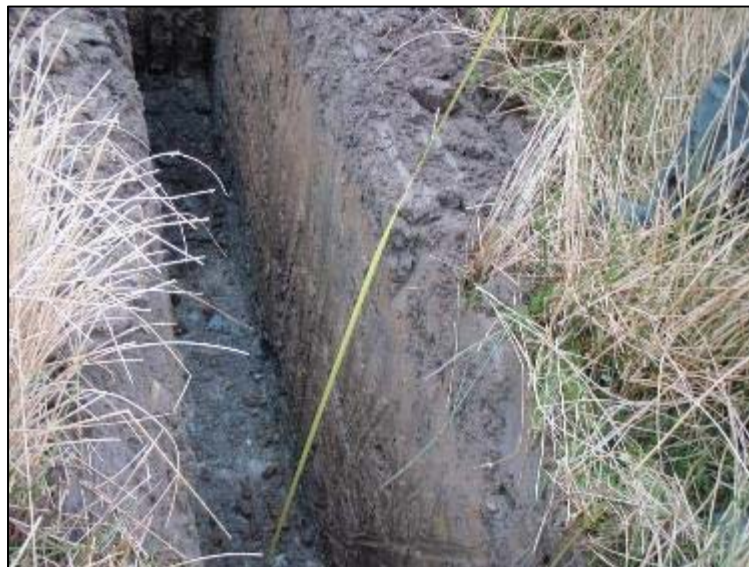
**Photo 5: TP1, compact disturbed subsoil over very compact grey shale overburden.**

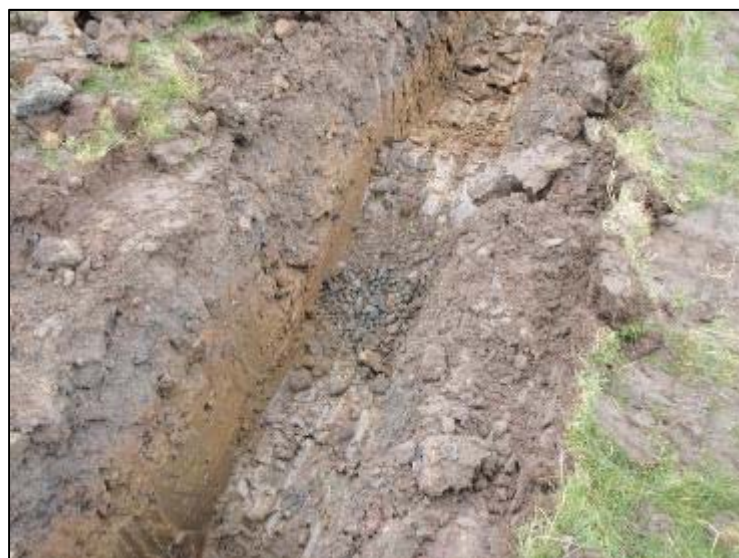
In all pits the field under-drainage was encountered, being identified by the gravel infill above the drains. In all cases the drains were avoided and not damaged during the investigation.

**Photo 6: TP1 exposed gravel indicating a field drain location below.**

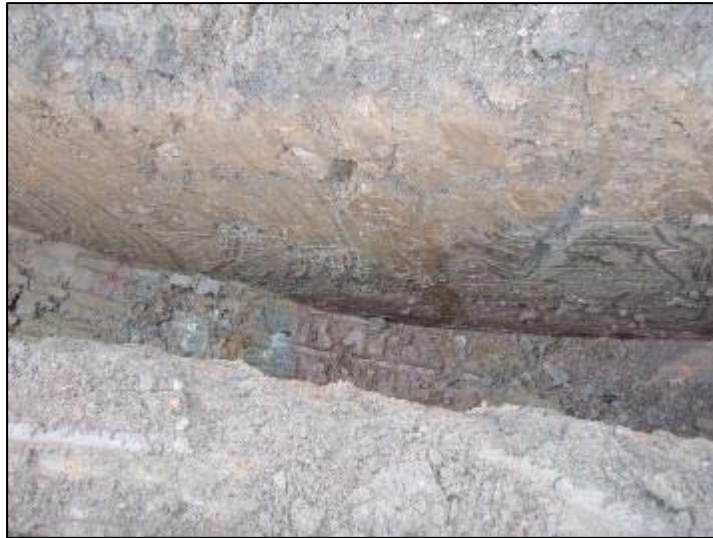
**Photo 7: TP1 boundary visible between the compact grey shale backfill on the left with the red / brown natural clay on the right.**

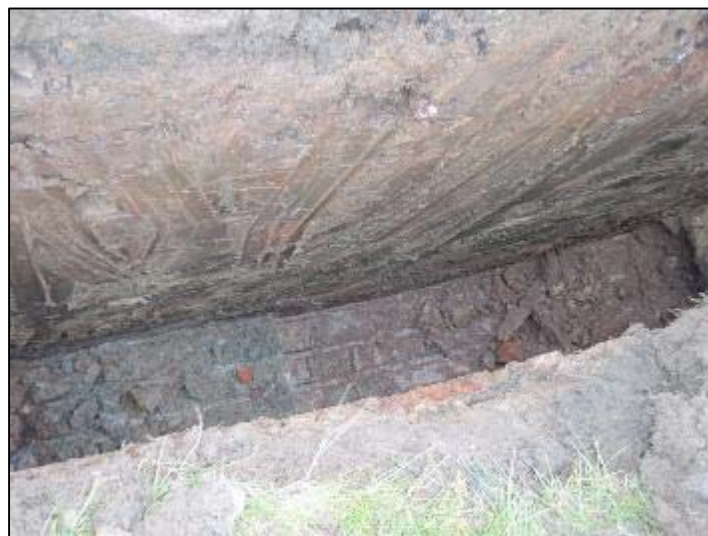
In all pits the edge of the overburden backfill was mapped and this information was used to plot the inferred line of overburden fill as shown on the Trial Pit Information and Proposed Development Plan in Appendix 6. An estimate of the position of the opencast limit of excavation was made using the thickness of infilled clay and from this a line was also plotted on the plan in Appendix 6 at a distance 2.6m to the south and west of the overburden fill line.

**Photo 9: TP2 exposed boundary between the grey shale opencast backfill on the left with the red / brown natural clay on the right.**

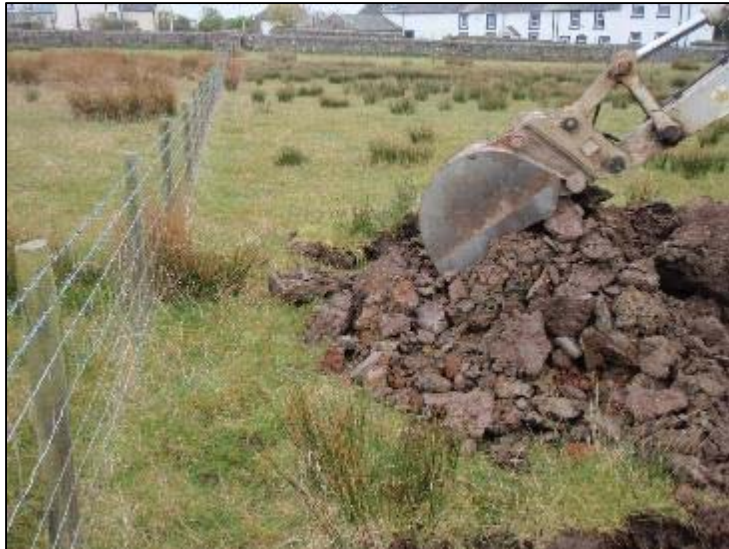
**Photo 10: TP3 located on the south west of the site. The trial pit trenches were dug on both sides of the fence.**

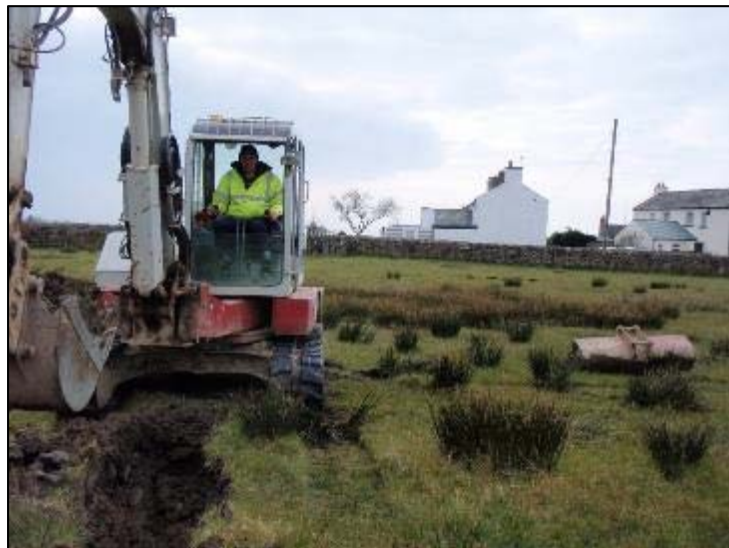
**Photo 11: TP4 located in the south of the site.**

In general the unworked ground was logged as stiff to very stiff clay with no sand, gravel, cobbles or boulders present. The base of the clay was only encountered in TP4 where at over 3.0m below surface it was underlain by red, weathered shale. This material is deemed to be of low permeability.

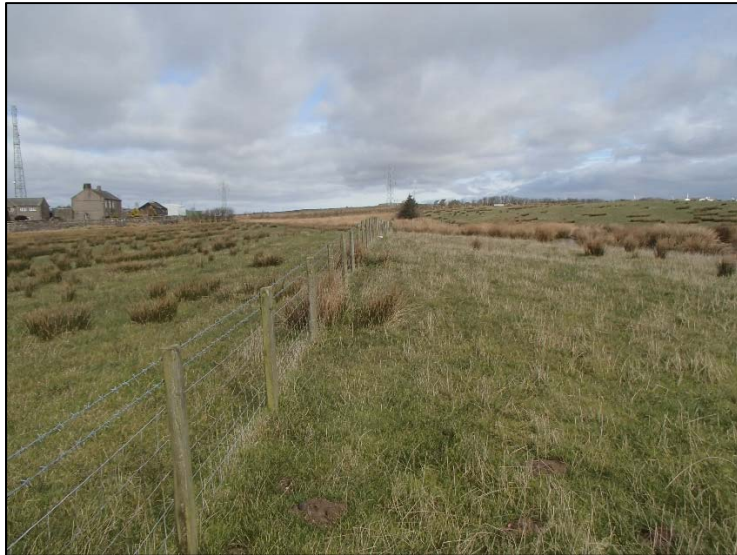
**Photo 12: TP5 located in the south east of the site.**

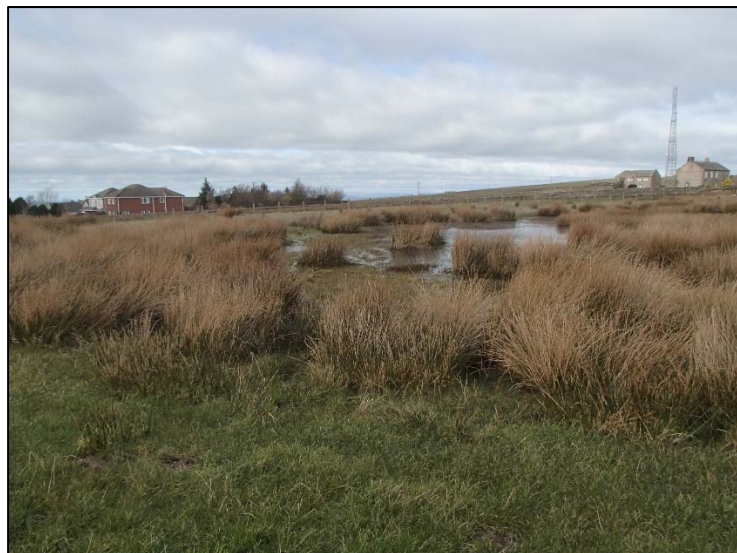
Examination of the area revealed a slight change in level and ground condition across the line of the supposed edge i.e. some settlement of the backfilled and restored ground has occurred.

**Photo 2: Confirmed SW corner of previous opencast excavated area looking north-west.**
