## THE IRON LINE, MILLOM REMEDIATION STRATEGY

**Curtins Ref:** 080874-CUR-XX-XX-T-GE-00008

Revision: P02

Site Address: The Iron Line, Millom, Cumbria, LA18 4LB

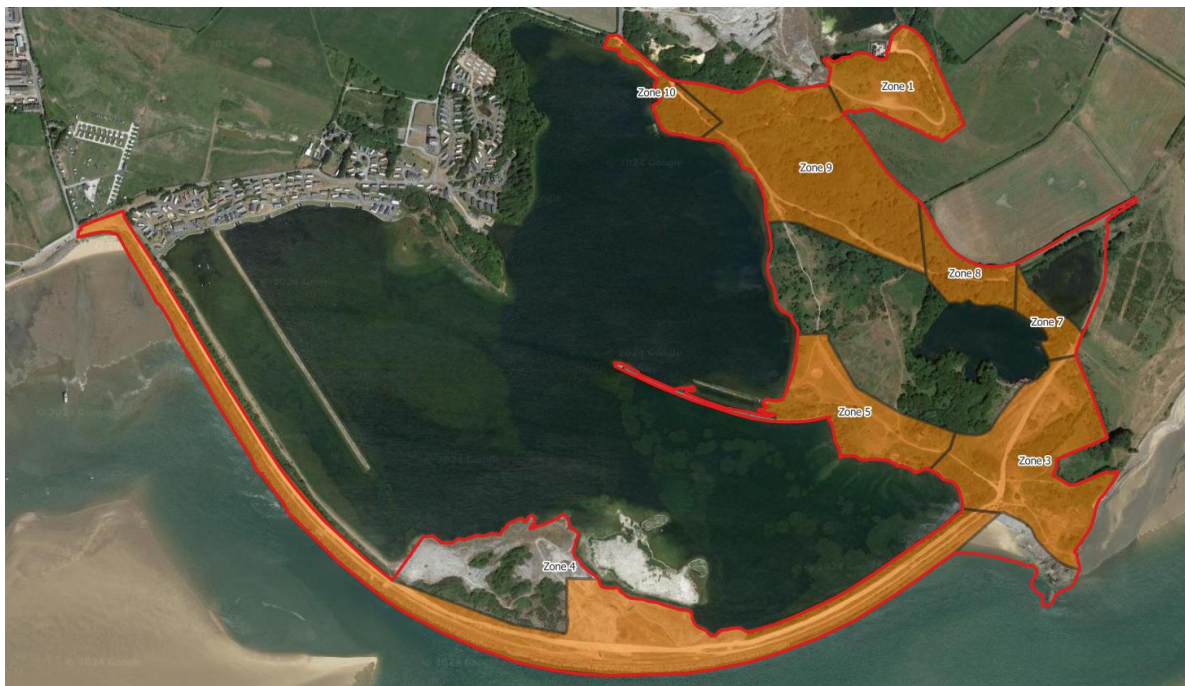
*Figure 1 – Site Location Plan with Development Zones, site boundary is shown in red.*

The main development is proposed in Development Zone 1, where a Visitor Centre building will be constructed. The remainder of the Development Zones will receive some development such as new roads, paths and hides. The locations of the Development Zones are illustrated in Figure 1.

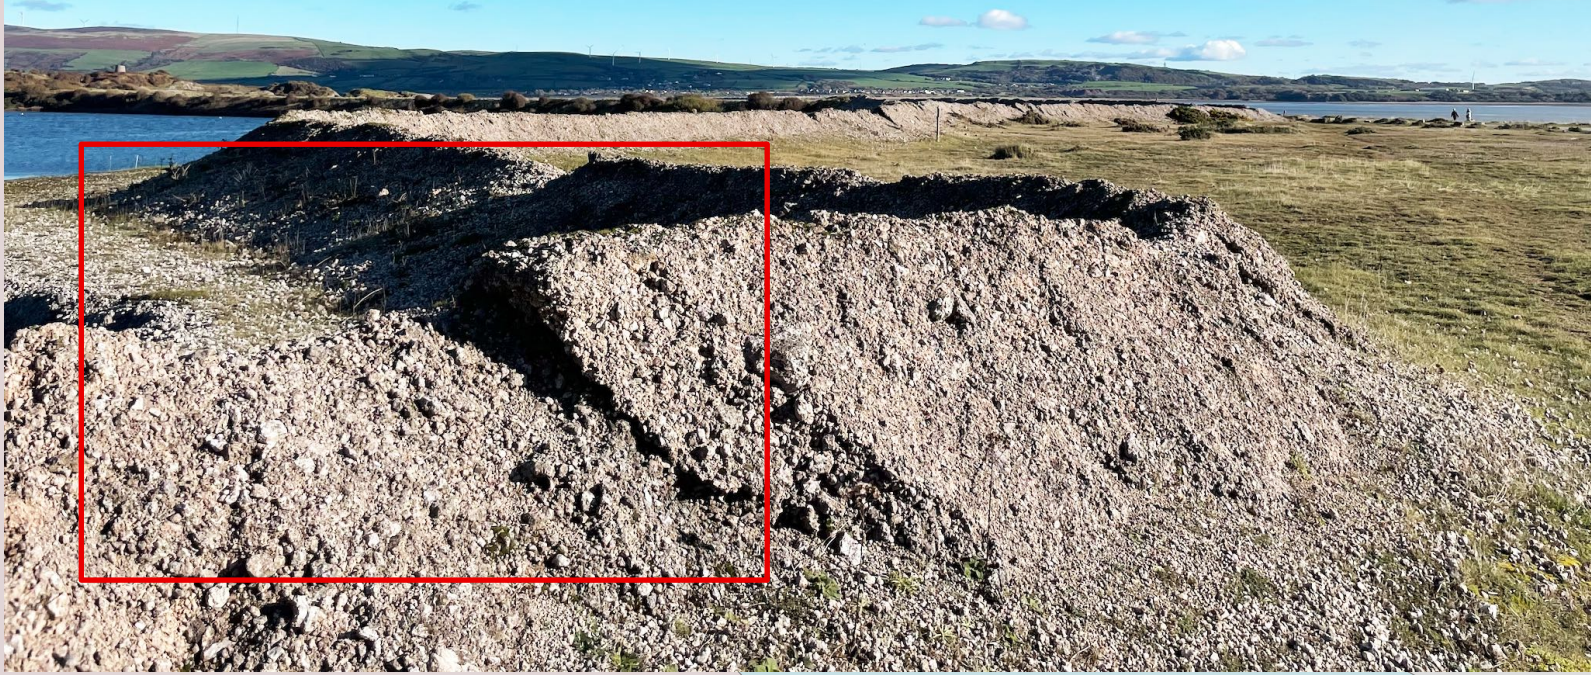
Bund to be infilled and raised to a maximum height of 1.5m in locations where it is has failed  
- **precise locations to be recorded and surveyed on site**
