## Phase 2: Site Investigation

ISH Building, Leconfield Industrial Estate

NE-26-021

## PHASE 2 SITE INVESTIGATION REPORT

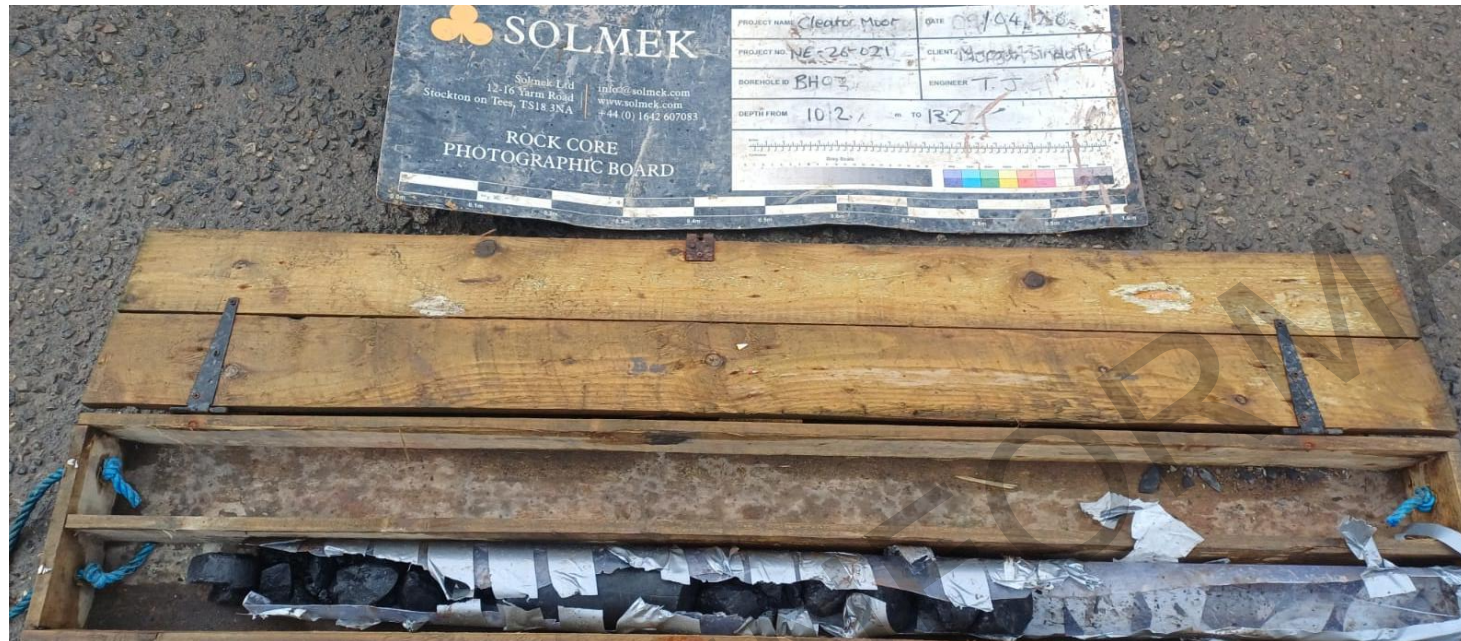
Figure 19: BH03 10.20-13.20m

Sandstone was noted within BH03 (13.20-13.80m & 14.70-15.30m), noted as medium strong.

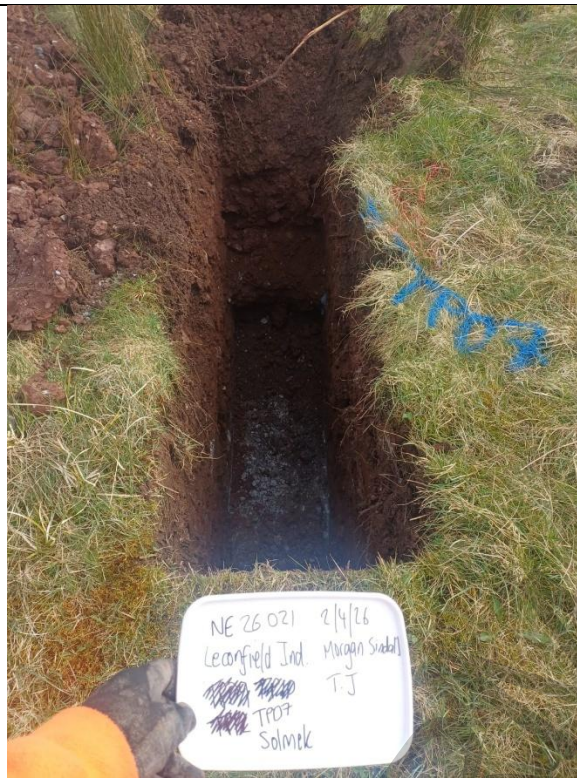
Figure 7: TP07

The fused slag deposits generally posed an obstruction to the excavator, with TPs 07-11 all terminating shallower than target depths, within slag materials. In addition, buried concrete was noted within TP12 (0.70-1.20m) resulting in termination at 1.20mbgl.
