## **Sella Park, Calder Bridge**

### **Preliminary Roost Assessment Survey and Presence / Likely Absence Surveys for Bats**

December 2023

**Project:** LE033 – Sella Park, Calder Bridge

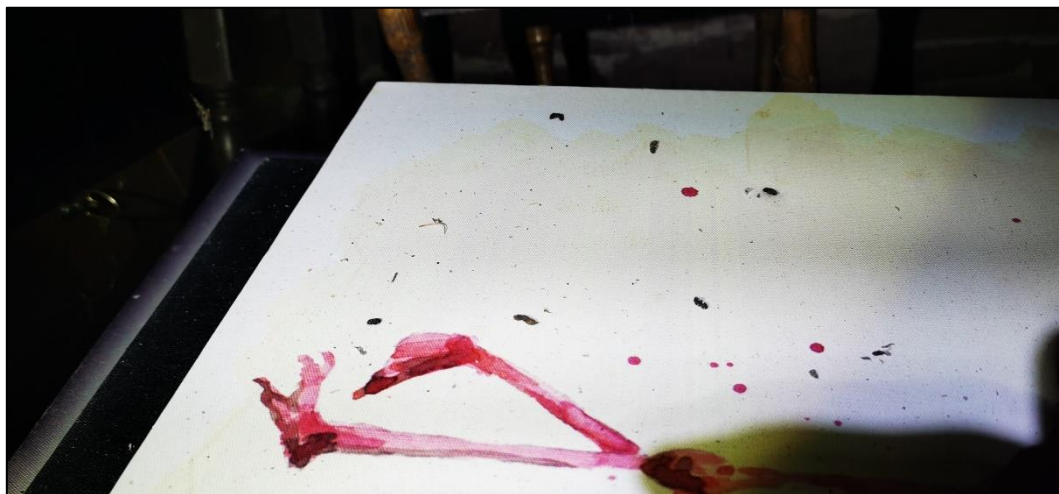
Multiple scattered bat droppings were found on the upper floor of the barn; these droppings appeared to be relatively fresh and included a mixture of larger and smaller droppings (see Figure 2 and Plate 1).

**Plate 1 – Mixture of large and smaller bat scattered throughout the upper floor of the barn.**

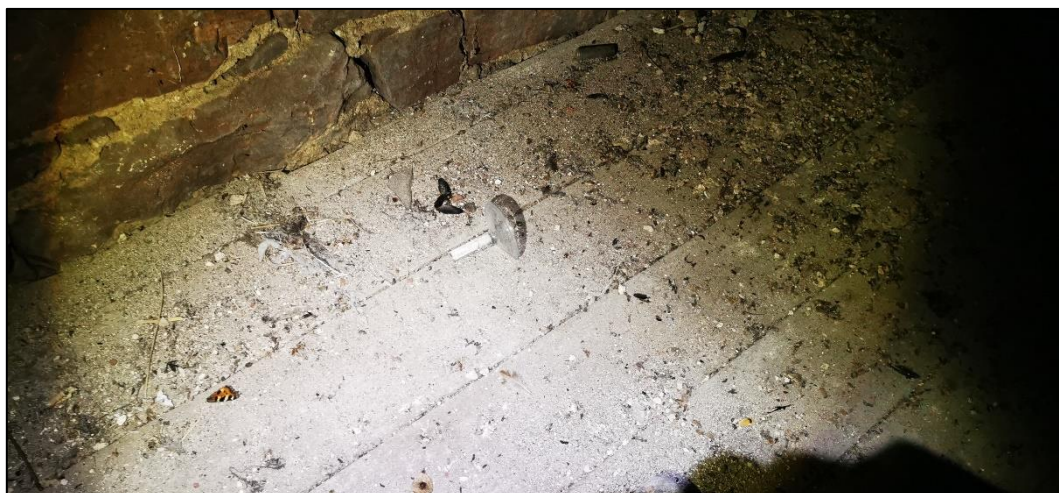
Furthermore, two piles (approximately 100 droppings) of larger droppings mixed with butterfly wings and insect feeding remains were discovered on the upper floor in the southern section of the barn. These piles were distributed under the ridge beam and near the gable end wall (see Figure 2 and Plate 2).

**Plate 2 – Accumulation of larger bat droppings mixed with feeding remains near the gable end wall on the upper floor of the southern section of the barn**

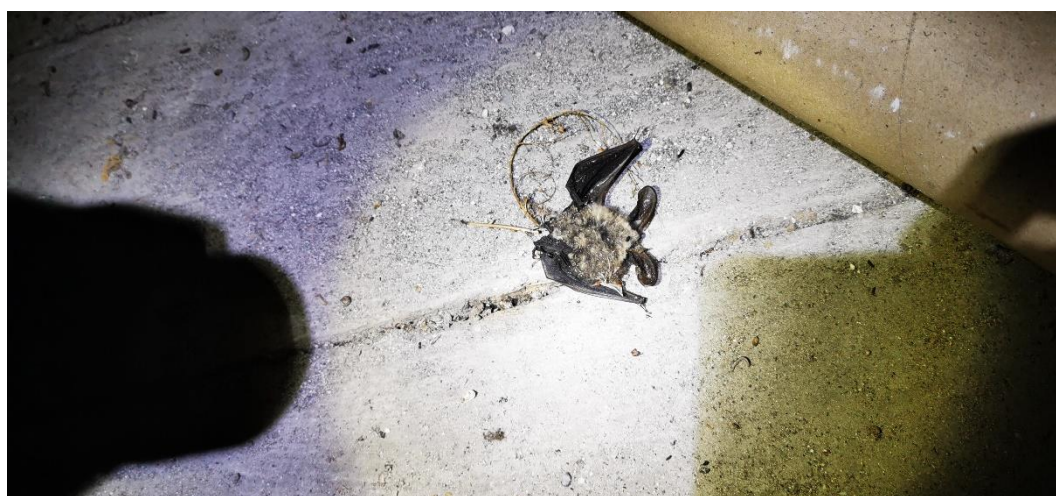
Additionally, a deceased adult male brown long-eared bat *Plecotus auritus* was noted within the upper floor of the southern section of the barn. The bat carcass was desiccated but appeared to be relatively fresh (estimated to have originated between one and three years ago) (see Figure 2 and Plate 3).

**Plate 3 – Brown long-eared bat carcass identified on the upper floor of the southern section of the barn**

As the brown long-eared bat roost identified within the interior of the barn during the Preliminary Roost Assessment is no longer active, no mitigation measures are required in relation to this roost. However, retaining the roosting provision for brown long-eared bats within the barn is recommended as part of the project. This would allow bats the opportunity to re-use this roosting space in the future.

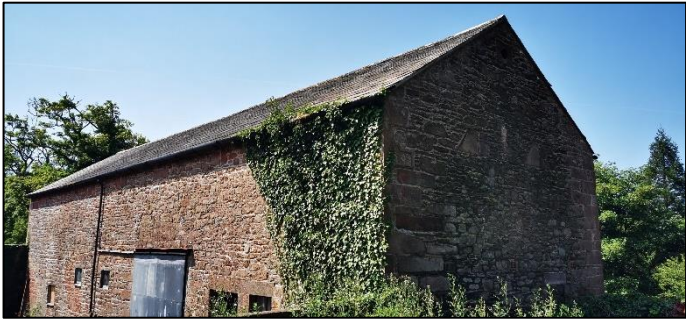
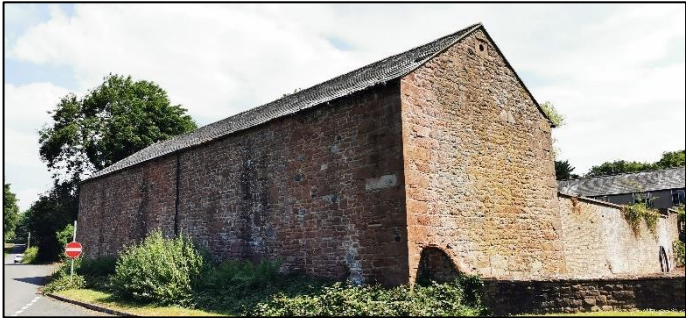
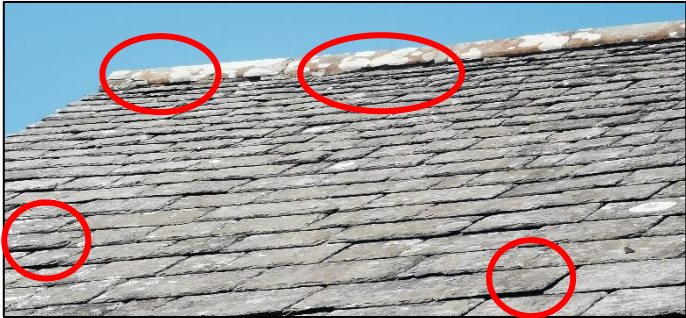
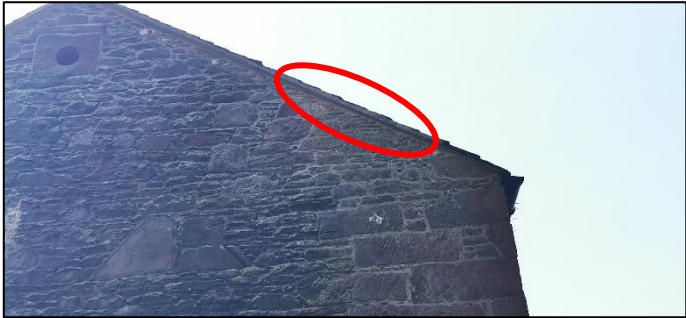
| Description | Potential Roosting Features | Bat Roost Suitability |
|---|---|---|
| <p>The building was a tall former agricultural sandstone barn located in the northwest of the site. Structurally, the barn was in very good condition, with no crevices within the external stonework.</p> | <ul style="list-style-type: none"> <li>Multiple gaps under slates and ridge tiles throughout the roof area – roosting potential between slates and internal felt lining.</li> </ul> <ul style="list-style-type: none"> <li>Gaps between the gable end coping flag tones and edge roof slates.</li> </ul> | <p>High</p> |

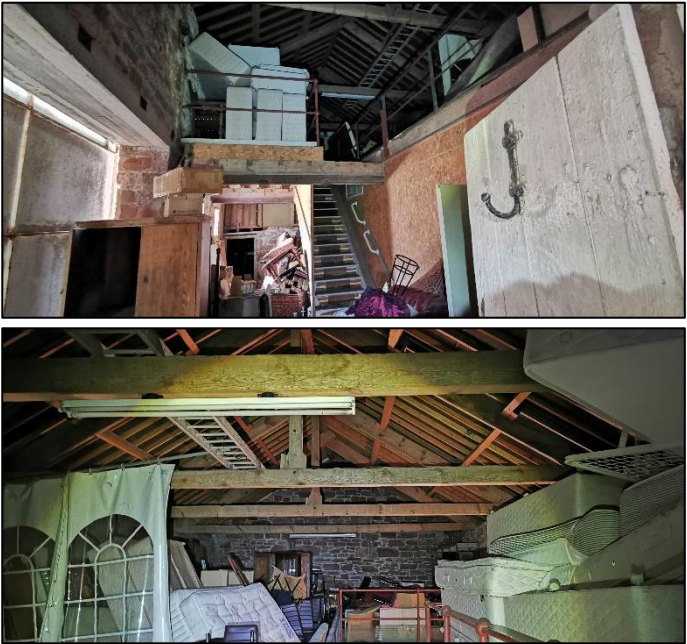
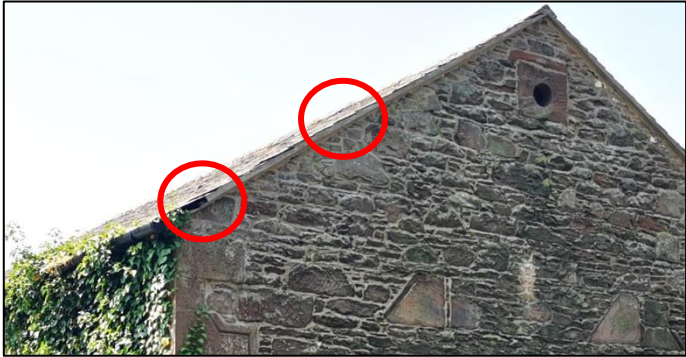
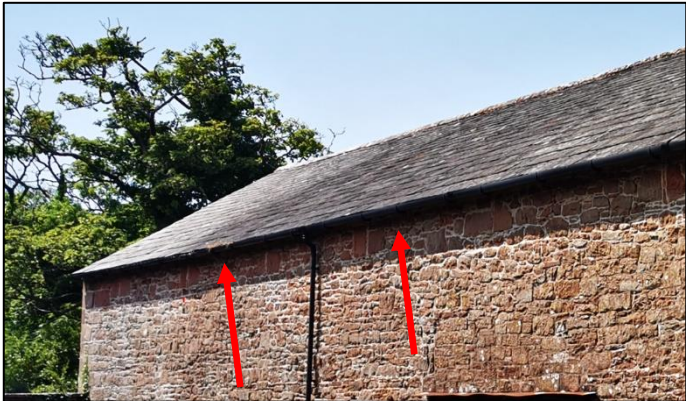
| Description | Potential Roosting Features | Bat Roost Suitability |
|---|---|---|
| <p>Internally, the barn consisted of a tall, open first-floor section that extended throughout the central and northern sections. The upper floor of the southern section was approximately 2 meters lower than the rest of the first-floor area. The ground floor of the barn was divided into three separate rooms / compartments, all connected to the open tall section near the main entrance to the barn. The primary use of the barn was for storage.</p> | <ul style="list-style-type: none"> <li>• Potential gaps at the wall tops – western and eastern elevation.</li> </ul> | |

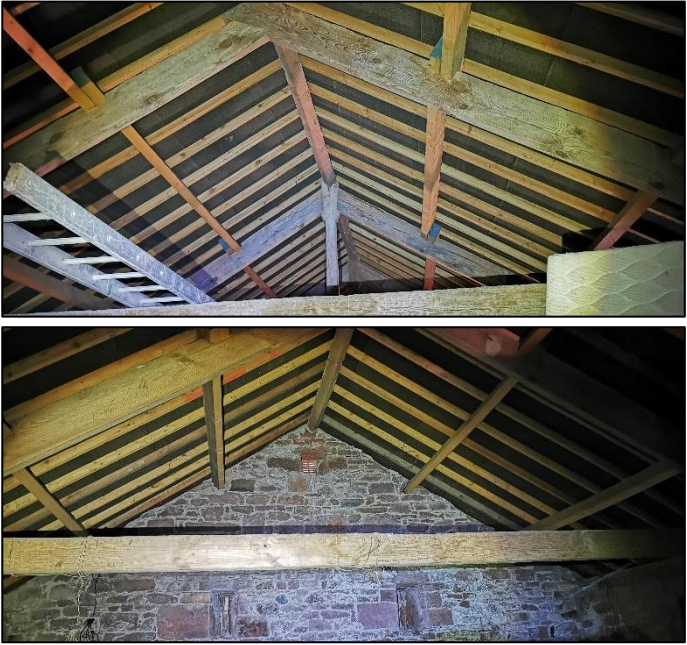
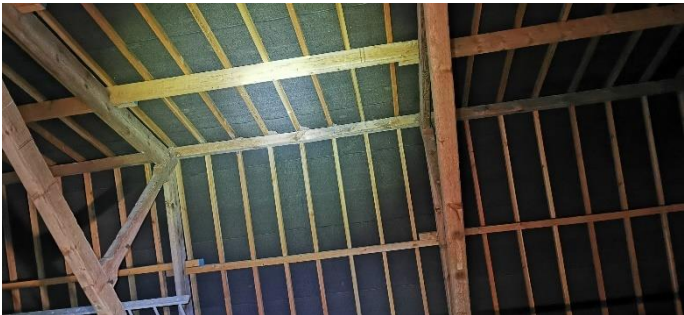
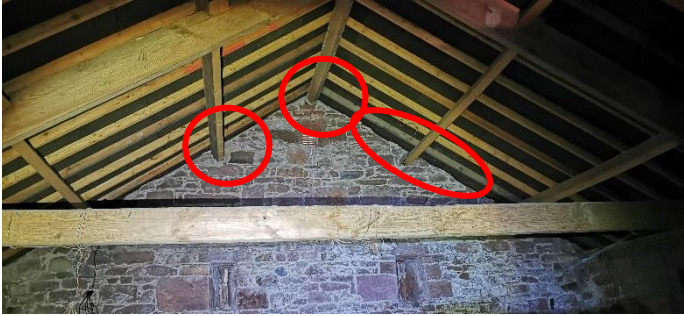
| Description | Potential Roosting Features | Bat Roost Suitability |
|---|---|---|
| <p>The barn had timber frame kingpost roof structure which was finished with slate tiles and lined with bitumen felt.</p> | <ul style="list-style-type: none"> <li>Internal roof timbers – void dwelling species. The upper interior of the barn was dark, with no window openings present. However, access to the interior seemed limited as owl holes, ventilation grills, or window openings were blocked off or boarded up.</li> </ul> <ul style="list-style-type: none"> <li>Few gaps within the internal stonework, particularly where the wooden purlins join the stone walls along the south and north gables. Gaps on top of the internal gable wall tops</li> </ul> | |

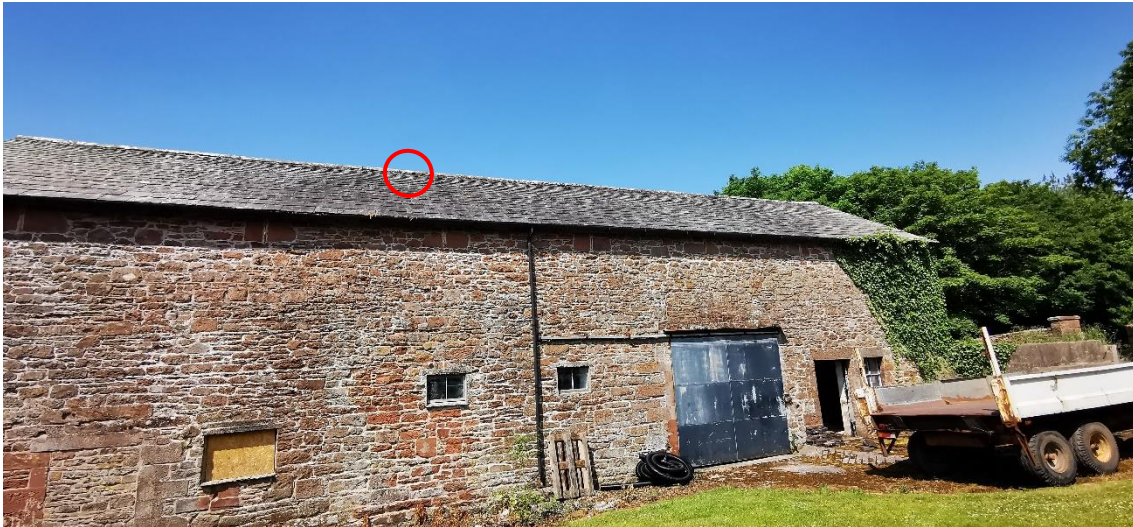
**At 21:25, an infrared camera and static detector deployed within the barn registered a brief light sampling activity of a myotis bat (considered to be Brandt's bat *Myotis brandtii* based on the sound analysis of the recorded call). At 21:45, a single myotis species of bat was recorded emerging from under the ridge tile in the middle section of the barn. Refer to Plate 4 and Figure 3 for the detailed location of the identified Brandt's bat roost.**

**Plate 4 – showing Brandt’s bat roost, used by a single bat located under the roof slates within the eastern pitch of the roof.**

- Roost R1 is located within a gap on top of the ridge beam / under the ridge tile in the central section of the barn. A single Brandt's bat was observed using this roost during the dusk emergence surveys on 01/08/23 and 17/08/23 (see Plate 4 and Figure 3). The roost is considered to be a day roost used by an individual / low number of bats.
- Roost R2 is located under the apex ridge tile of the northern gable wall of the barn. A single soprano pipistrelle bat was observed using this roost during the dusk emergence survey on 17/08/23 (see Plate 5 and Figure 3). The roost is considered to be a day / transient roost used by an individual / low number of bats.

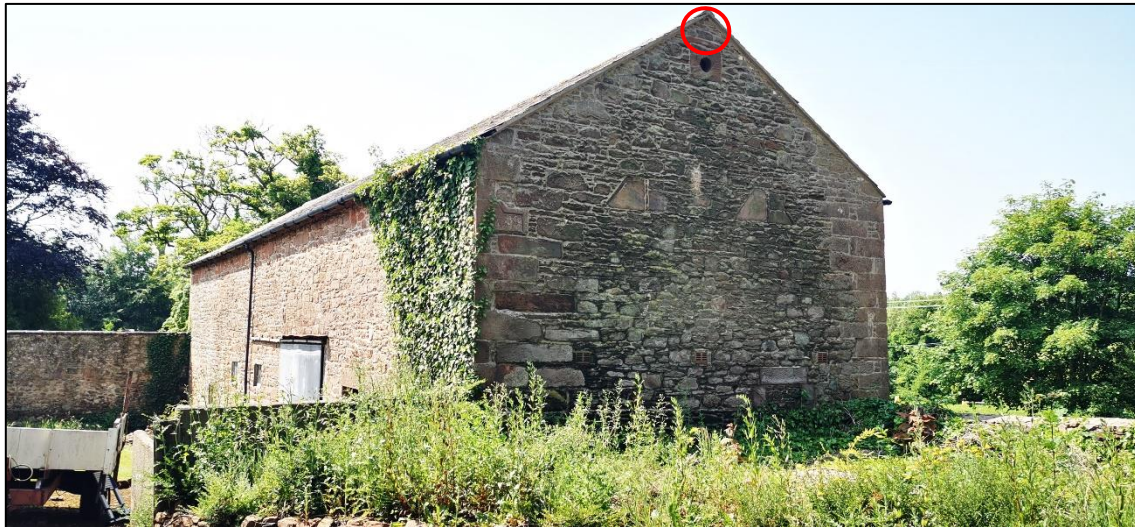
**During the third dusk emergence survey, a single soprano pipistrelle was observed emerging from the gap under the apex ridge tile of the northern gable wall at 20:54. Refer to Plate 5 and Figure 3 for the detailed location of the identified roost.**

**Plate 5 – showing soprano pipistrelle bat roost, used by a single bat located under the apex ridge tile of the northern barn gable.**

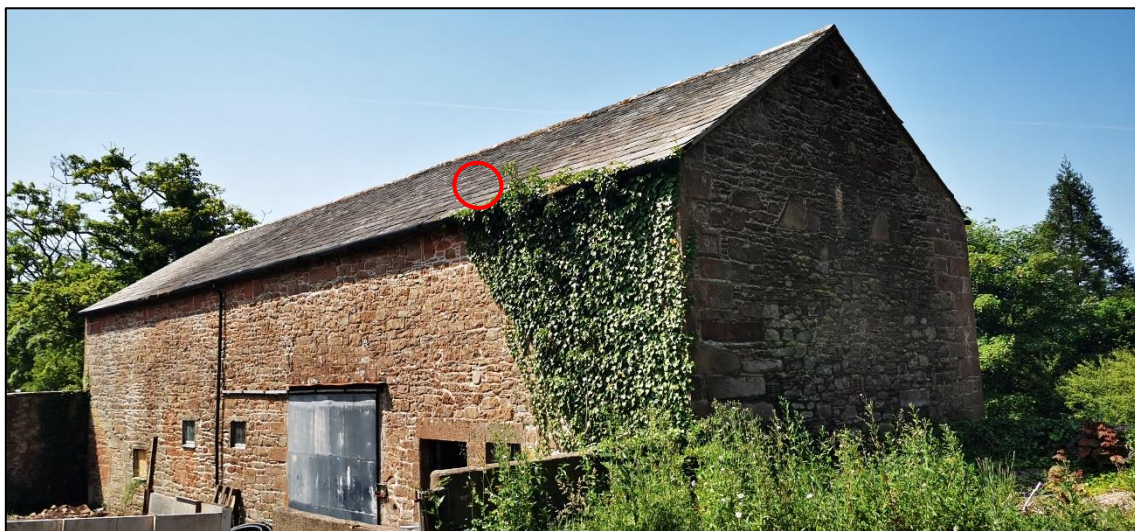
**Additionally, three Brandt's bats were observed emerging from under the roof slate tile of the eastern roof pitch of the northern section of the barn at 21:08, 21:14, and 21:18 respectively. Refer to Plate 6 and Figure 3 for the detailed location of the identified Brandt's bat roost.**

**Plate 6 – showing Brandt's bat roost, used by three bats located under the roof slates within the eastern pitch of the roof.**

- Roost R3 is located under the roof slates within the eastern pitch of the roof in the northern section of the barn. Three Brandt's bats were observed using this roost on 17/08/23 (see Plate 6 and Figure 3). The roost is considered to be a day roost used by a low number of bats.

The proposals to convert the barn and install the skylights will destroy / modify the identified day roost R3 used by low numbers of Brandt's bats. Without appropriate mitigation, the proposed works have the potential to cause a permanent loss of this roost.

As the proposed barn conversion works will remove / modify the roost used by a small number of Brandt's bats, an European Protected Species Mitigation (EPSM) Licence must be obtained from Natural England (NE) before works to the roof of the barn commence. The licence will place reasonable conditions on the development to ensure that the risk of harm and disturbance to bats is minimal and that the favorable conservation status of the species present is maintained.

- Any modified or destroyed bat roosts must be replaced after the works. This can be achieved by installing external bat boxes on the east elevation or northern gable of the converted barn.

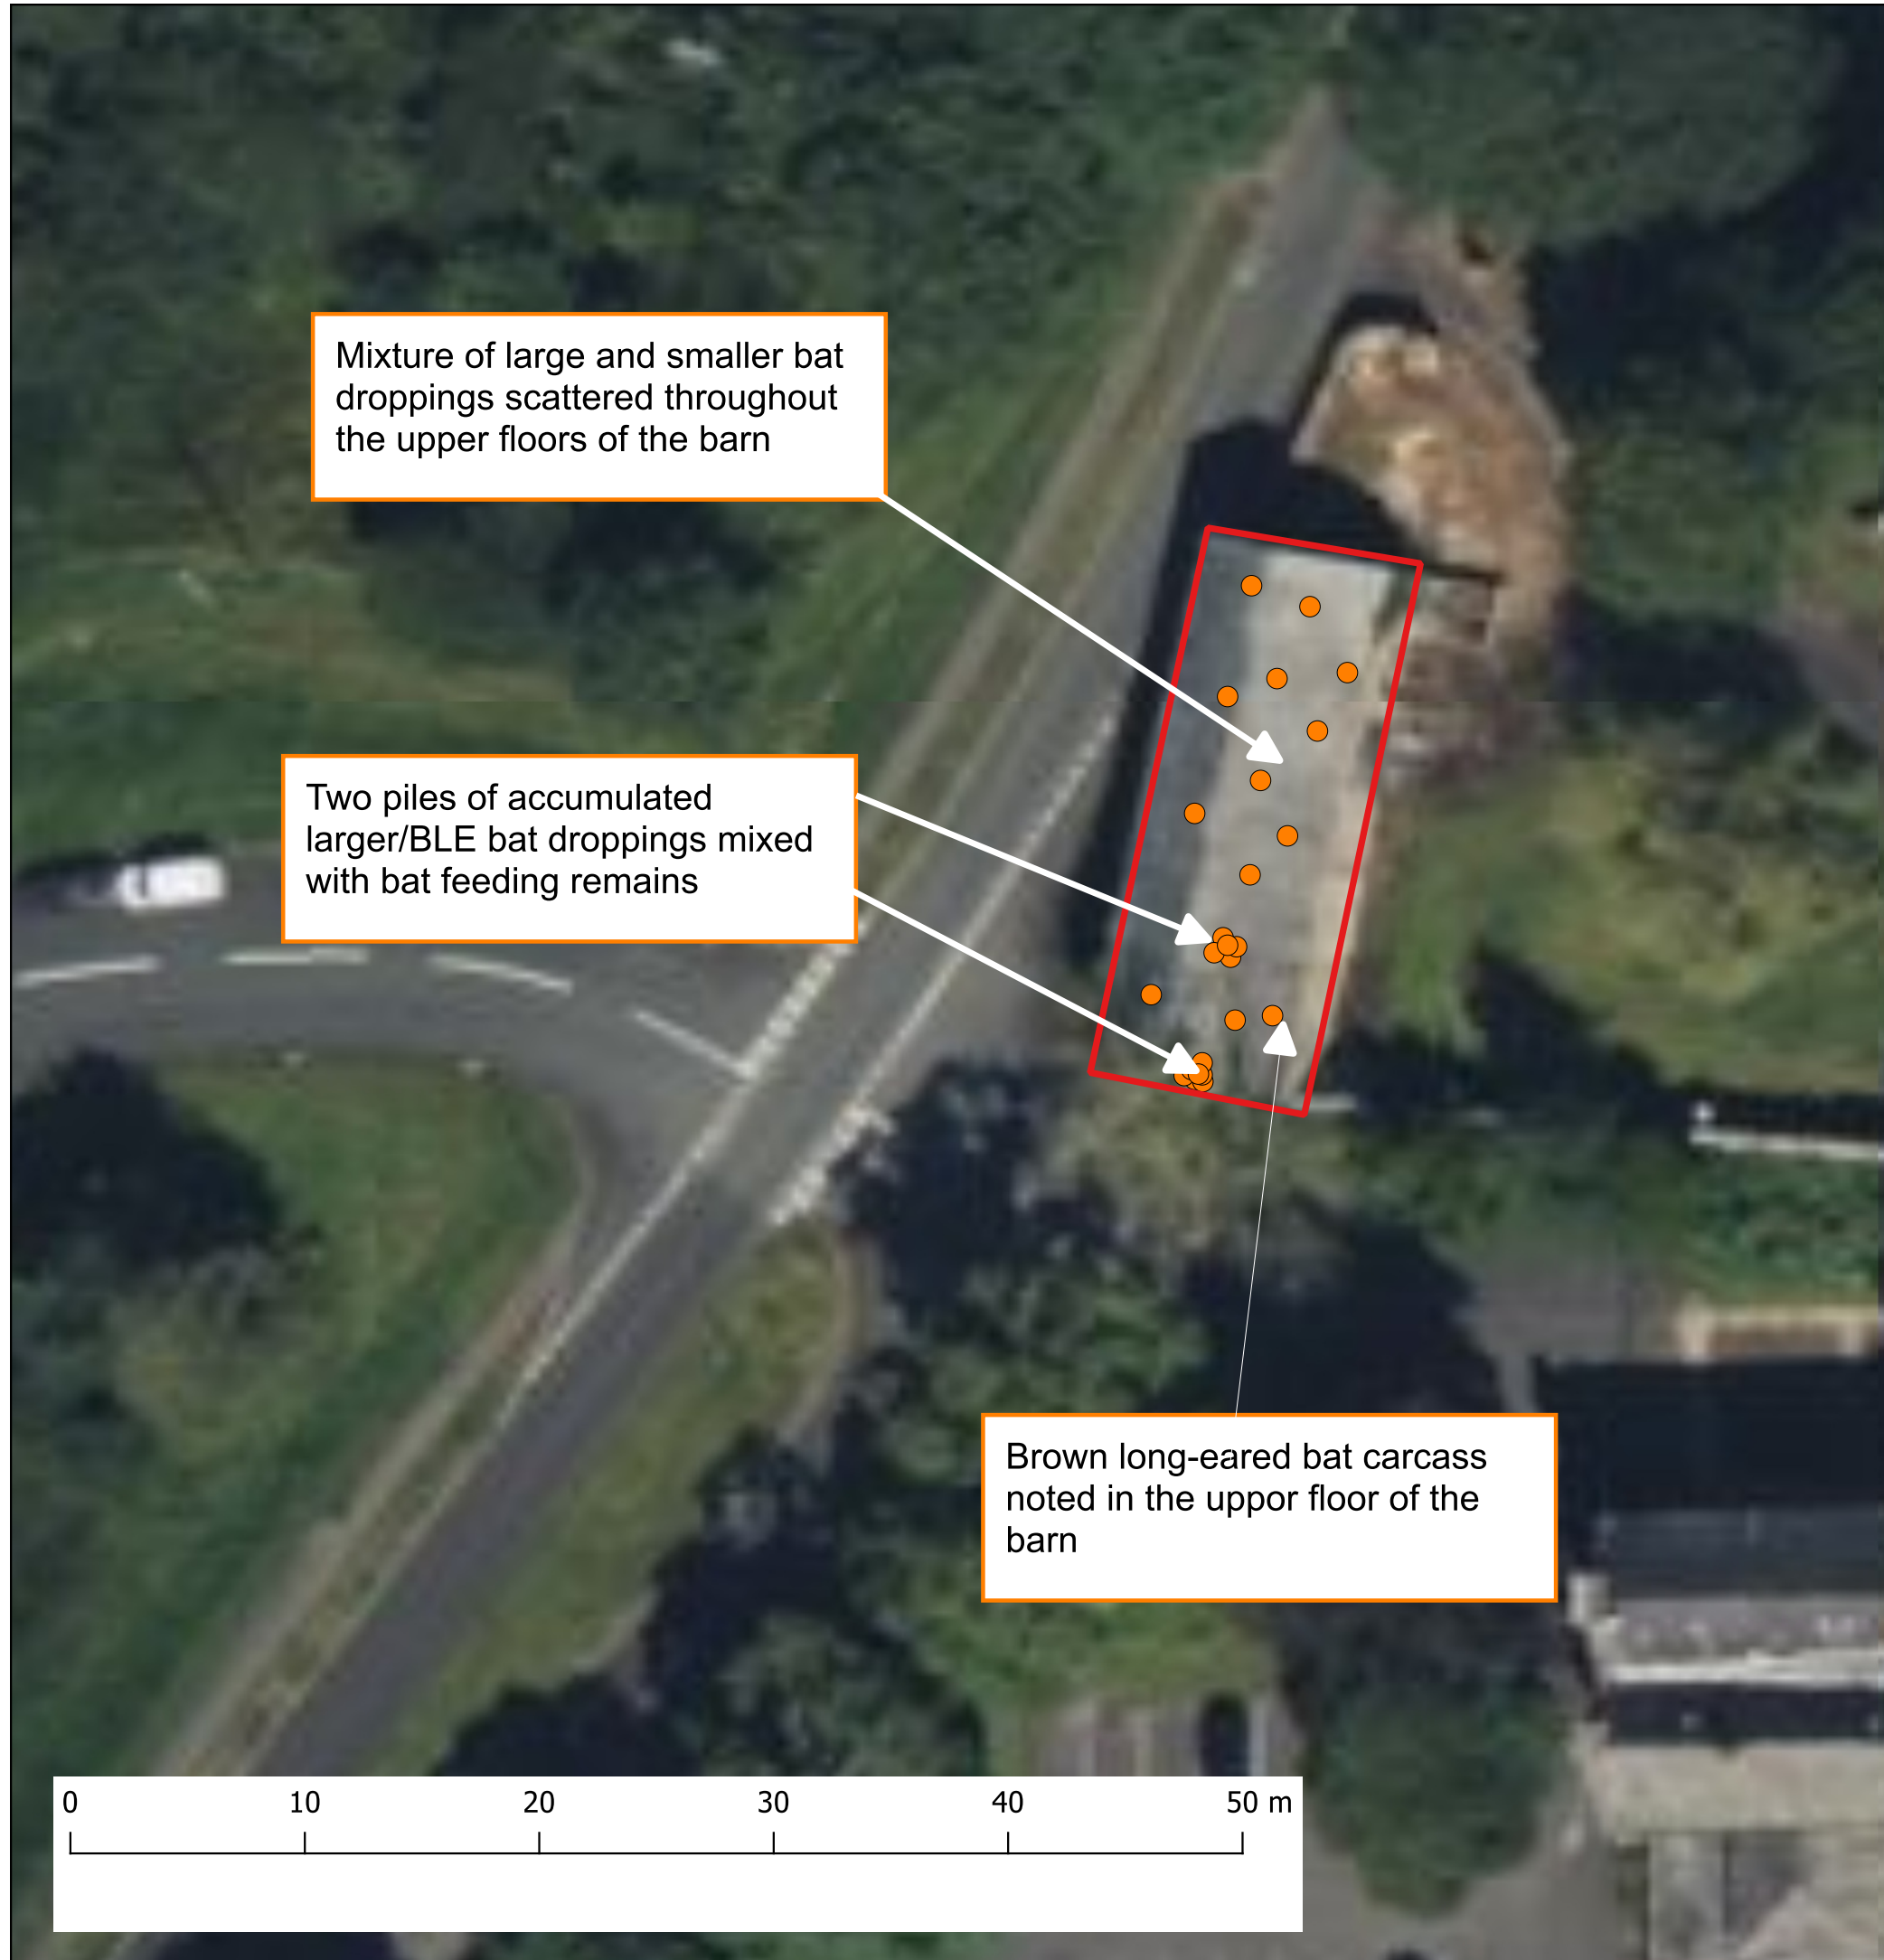
**Figure 2 – Site Plan with PRA Evidence**

Mixture of large and smaller bat droppings scattered throughout the upper floors of the barn

Two piles of accumulated larger/BLE bat droppings mixed with bat feeding remains

Brown long-eared bat carcass noted in the uppor floor of the barn
