# Cleator Moor Innovation Quarter

## Unit 1 Leconfield – Pre-Demolition Inspection Survey

**Curtins Ref: LUF-CUR-XX-XX-T-S-00001**

Issue Date: 28 November 2024

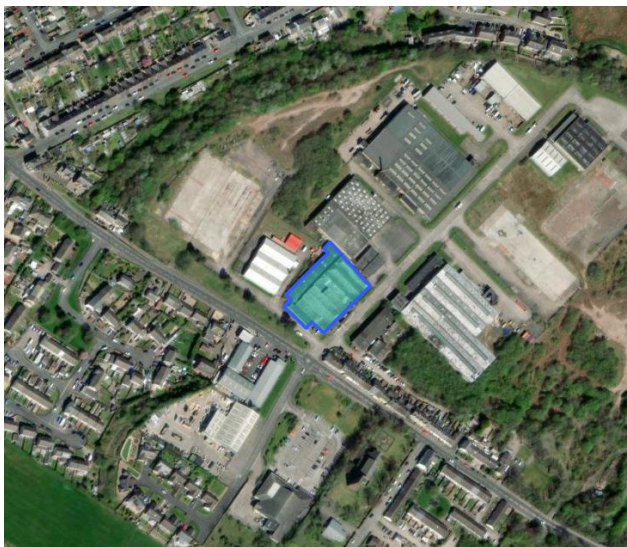
Figure 1.1 and Figure 1.2 – Former Iron Works site with overlay of current footprint

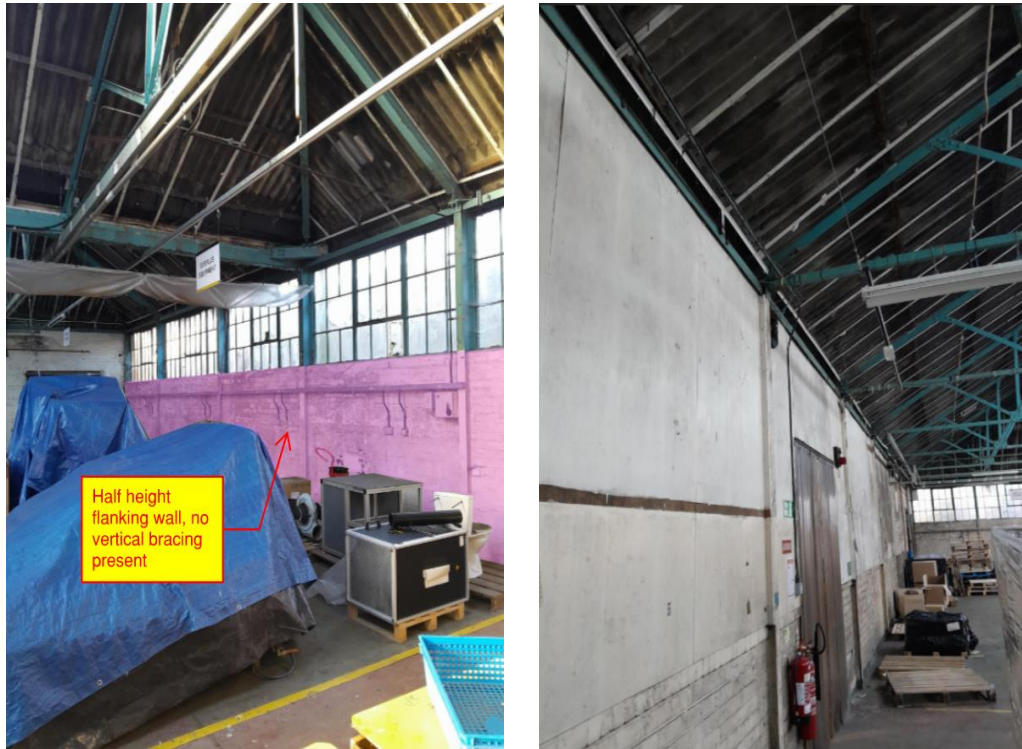
- 4.1.6 The roof trusses are not braced on plan at rafter level, nor at the bottom chord level. It is unclear to what extent the roof sheet cladding can serve as this bracing function. The columns supporting the roof trusses show no sign of being vertically braced. Lateral loads are resisted by the masonry flanking walls.

Figure 1.5 & Figure 1.6 – Zone 'A', half height flanking wall, and internal spine wall (right) to be retained

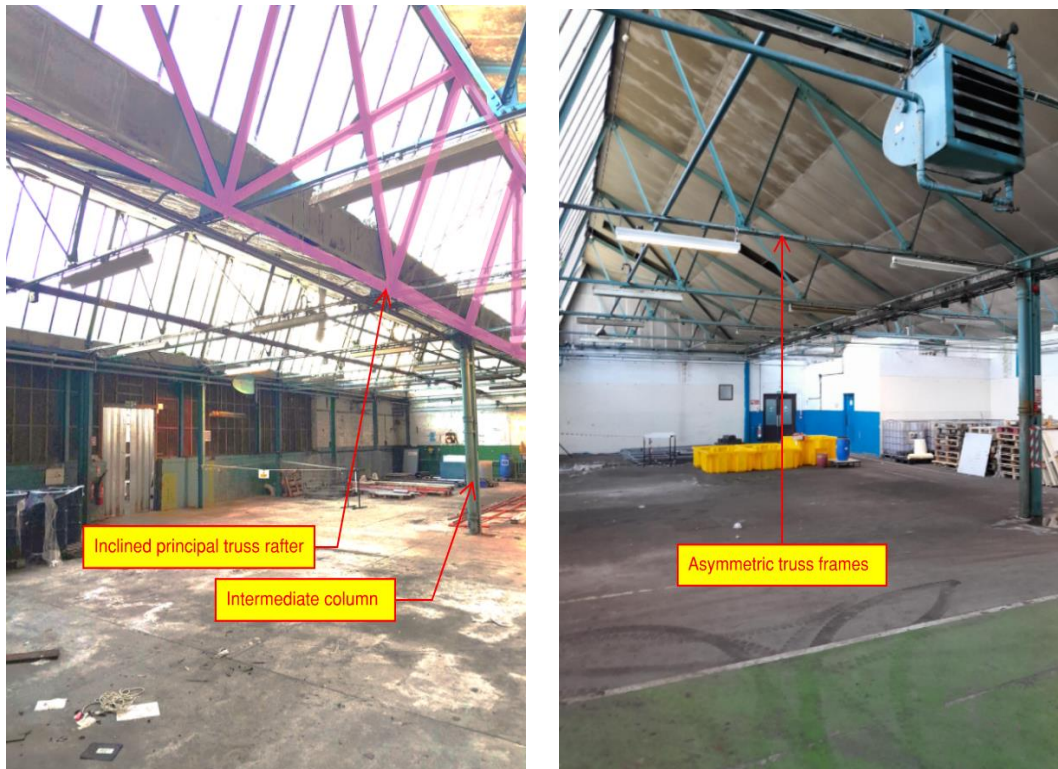
- 4.2.1 Zone 'B' consists of **four bays of multi-span asymmetric trussed frames**. Primary columns at regular centres form the principal vertical load-carrying element. The outer columns are built into the masonry walls.

Figure 1.7 & Figure 1.8 – Zone 'B', principal truss rafter and asymmetric truss, roof construction

- 4.2.2 The roof structure is of multi-span asymmetric form, early mild steel trusses at regular centres (ca. 3.8m crs) spanning bay widths of (ca. 7.5m CRS) onto intermediate columns. The trusses are of angle section, a combination of single and double (back-to-back) angles. Connection are via rivetted plates.

- 4.2.3 Two grid lines (blue lines shown on Figure 2.5) consist of an inclined wind girder truss that spans the width of Zone 'B,' supported by a single internal column that divides the span and shares the vertical load. Intermediate asymmetric trusses connect to the girder trusses and act as primary beams between the columns, supporting the ends of the trusses. **Due to the inclination of the truss, the destabilising load is supported by a combination of roof bracing and secondary trusses.**

- 6.1.1 Careful demolition phasing is required for the removal of the roof truss system due to the inclined nature of the principal trusses, which inherently introduce destabilizing forces within the structure.

- 7.1.5 Once the roof finishes and cladding have been removed, the roof trusses and purlins can be systematically dismantled or demolished. It is recommended to begin with the removal of the secondary trusses, ensuring that a sufficient number remain to provide support for the two main wind girder trusses. Alternatively, consideration could also be given to the temporary propping of the wind girder trusses during the removal of the secondary trusses. Several masonry flank walls (which may have hidden X-flat bracing) in Zone 'B' must remain in place to maintain stability during demolition and should only be removed after the roof has been fully dismantled.

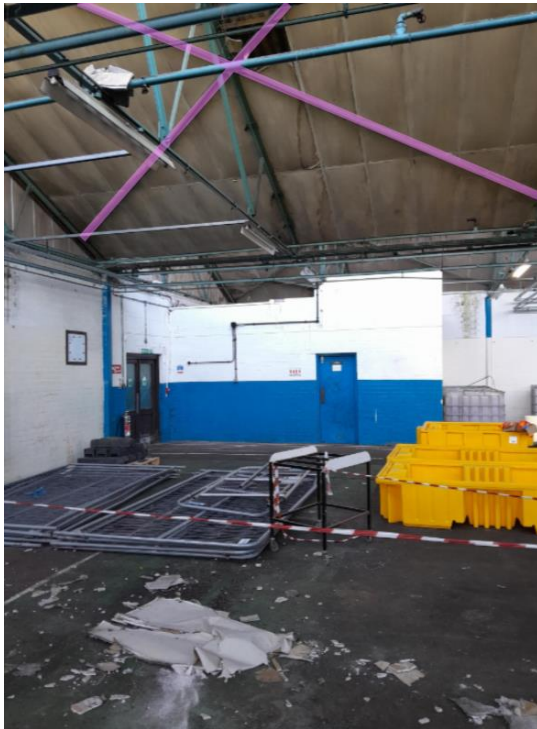
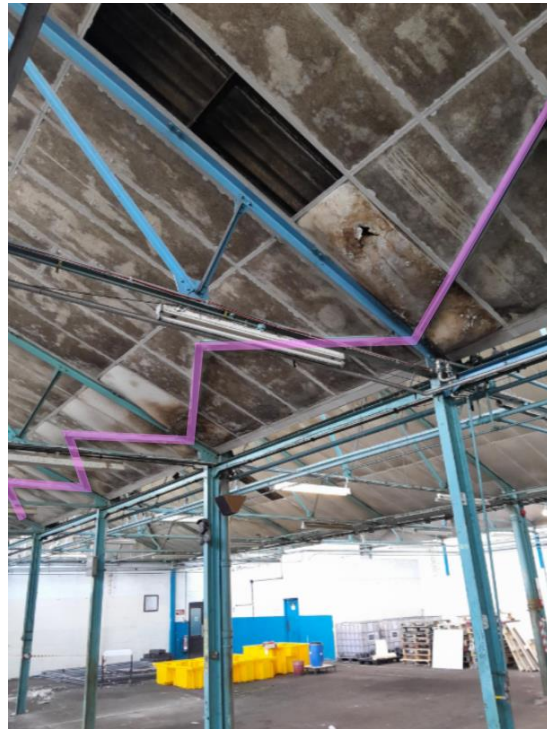
- 4.2.6 The roof trusses have plan bracing at rafter level, however not at the bottom chord level. Plan bracing occurs parallel to both flanking walls to the north-west elevation and south-east elevation.
- 4.2.7 Two secondary bracing systems run parallel to the retained demo line. The braces connect into the heads of the column and centrally to the roof purlin, forming k-braces on each 3.8m truss bay.

Figure 1.9 & Figure 2.0 – Zone 'B', main X-Angle bracing (left) and secondary K bracing (right)

- 4.2.12 Purlins are single hot rolled angle. Partial view can be seen through a missing soffit panel seen on Figure 2.0 above.

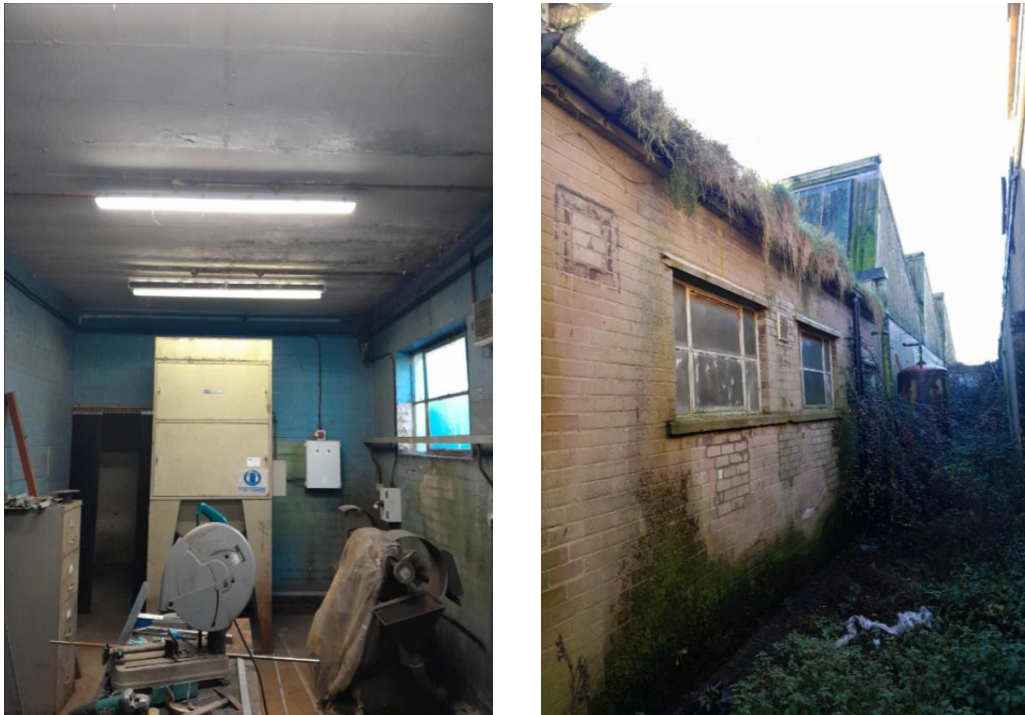
- 4.3.1 Zone 'B' comprises a single-story ancillary building featuring a flat concrete roof, specific type currently unknown.
- 4.3.2 The flat concrete roof is supported by a combination of load bearing masonry walls and downstand steel beams.

Figure 2.1 & Figure 2.2 – Zone 'C', single storey concrete slab soffit roof, load bearing masonry internal and external

- 4.3.3 Internal walls forming the perimeter of the ancillary building connect into the retained demo line. The walls act perpendicular, forming returns and are toothed in. Columns supporting roof trusses break the masonry panels either side, it is unclear if the wall is tied/fixed to the columns. See section 6.0, demolition interfaces for further information.
- 4.3.4 Ground floor construction comprises of a ground-bearing concrete floor slab.

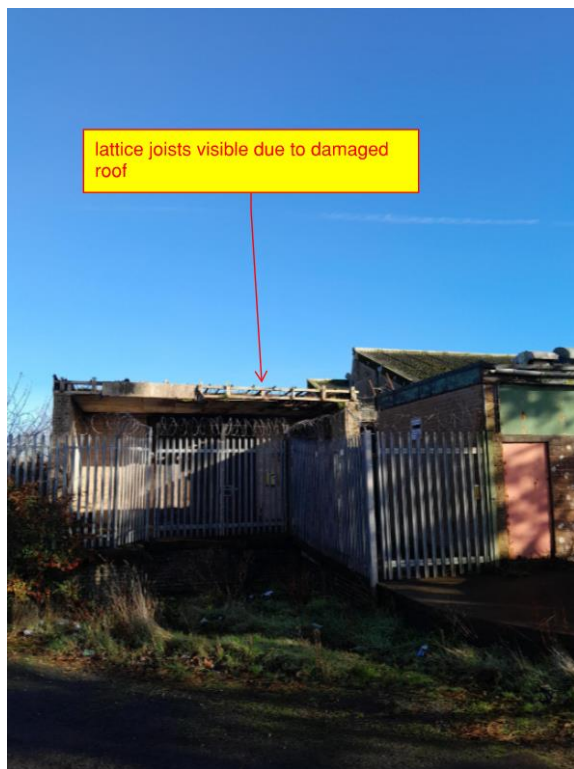
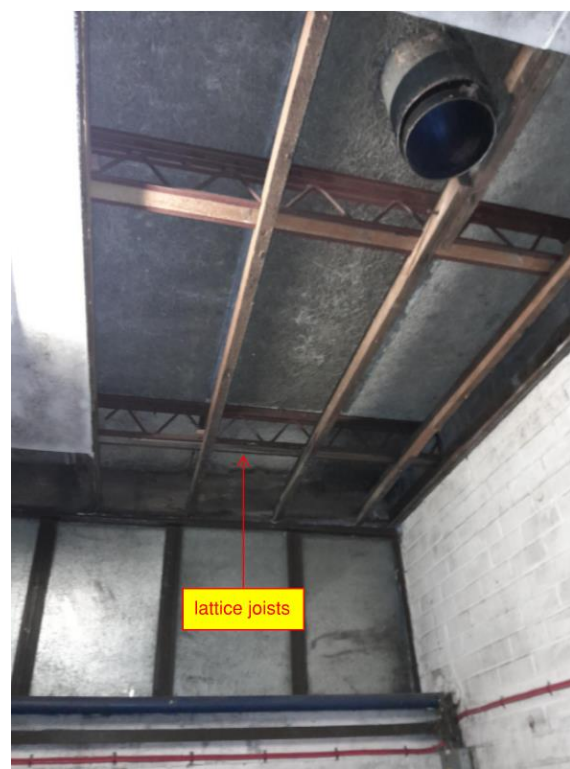
- 4.4.1 Zone 'D' consists of a single-story ancillary building with a flat roof made up by a fragile woodwall system, therefore no roof access is permitted. The roof is supported by a combination of lattice steel joists, which rest on load-bearing masonry walls. The lattice joists are fitted with timber plates on both the top and bottom flanges to facilitate roof and ceiling fixings. The lattice joists were typically used during the post-war period (1945-55) on Airey Houses.

- 4.4.3 The load bearing walls are two brick thick, solid wall with no cavity. Regular vertical cracks along the length of the flank walls suggests no movement joints have been allowed for. See figure 61 of Curtins photograph log.

Figure 2.3 & Figure 2.4 – Zone 'C', single storey concrete slab soffit roof, load bearing masonry internal and external

- 5.5.2 A length of Zone 'D' wall which is to remain will need support since post demolition the wall will act as freestanding, with only one return. A form of shoring, of buttress would need be implemented as indicatively shown on Architectural drawings. **Foundations for buttresses/shoring will be required, therefore intrusive ground investigations for this area will be required.**

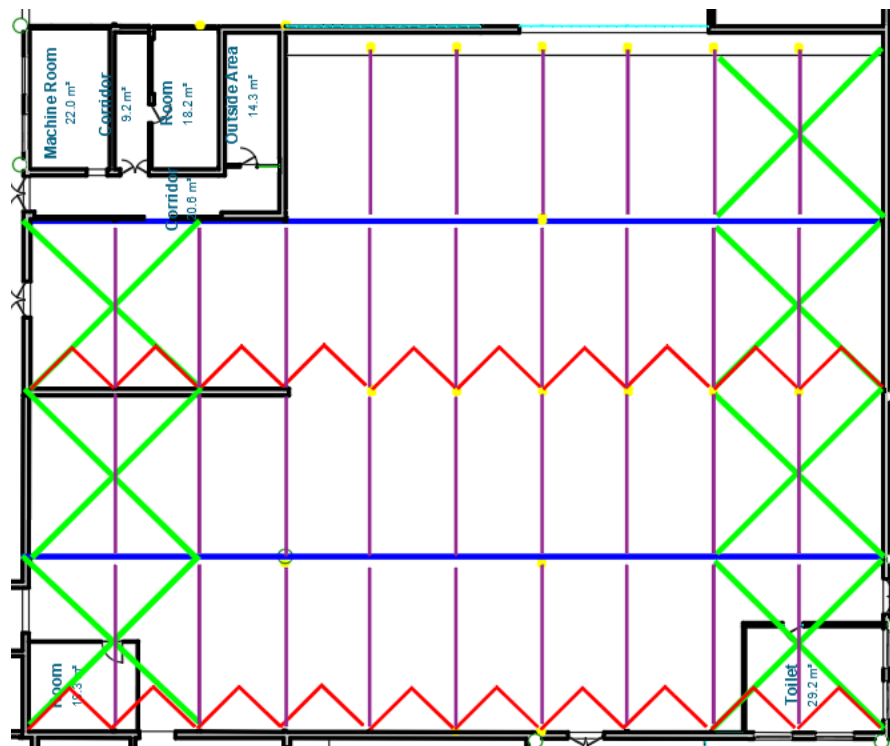
- 5.1.1 Green indicates main roof bracing comprising of a single angle connected into the top chord. Red shows the secondary K-bracing connecting into columns and purlin. **Blue, the main wind girder trusses**, and purple shows secondary trusses:

Figure 2.5 – Zone 'B' Roof Stability Systems

- 5.3.2 **Zone 'B' Horizontal Stability.** The half-height masonry perimeter walls are the primary elements responsible for transferring horizontal loads into the foundations. No moment / portal frames have been utilised since the columns are oriented in the strong axis and the head beam is not of significant size, see point 4.2.10. Roof bracing, highlighted as green and red above, resist wind load in both directions. **Careful consideration of the demolition of the roof should be carried out due to the inclined nature of the wind girder trusses, highlighted blue above, also see point 4.2.3.**
