**Preston Street, Whitehaven**

**Geo-environmental Appraisal  
& Coal Mining Risk Assessment**

**Aldi Stores Limited**

| Report Ref | Issue | Prepared by | Date |
|---|---|---|---|
| P18-351/GA | 1 | N Watson | 31.01.22 |

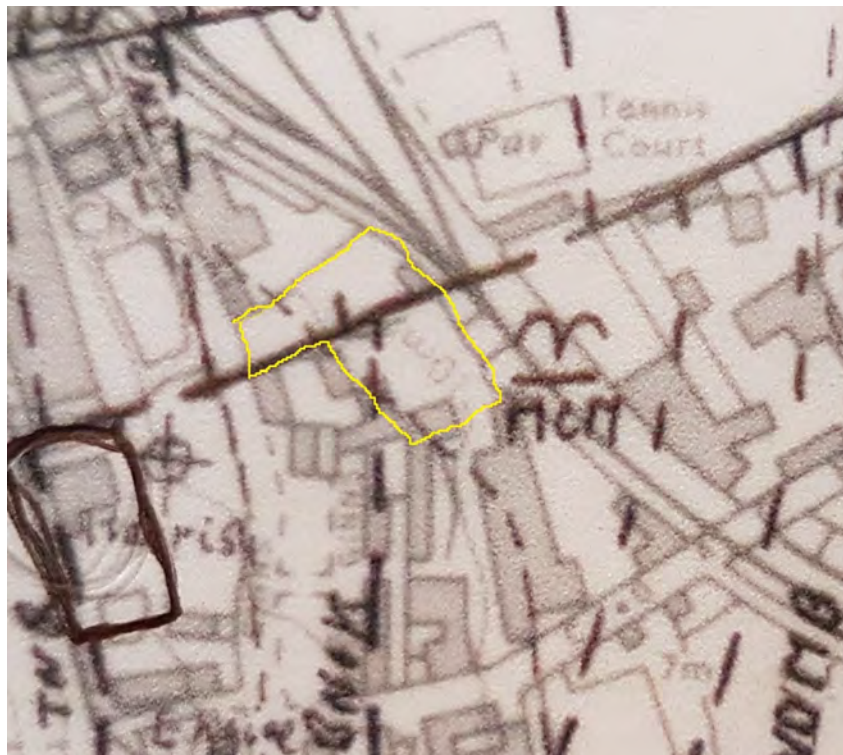
Extract of BGS Plan NX91NE with the general site area outlined in Yellow.

3.8 However, to further aid in determining ground conditions below the site, as part of this assessment a review has been made of BGS plan NX91NE, which also indicates the presence a fault within the bedrock deposits as potentially bisecting the central site area, trending generally east-west and down-throwing to the north. As a result of the localised faulting the Bannock Band is indicated to sub-crop at rock-head level below the southern site area, dipping to the west away from the site. For the northern site area the Bannock Band seam is shown to sub-crop around 100m west and potentially dips below the site at shallow depth. An extract of BGS Plan NX91NE is included below:

3.7 From BGS data reviewed as part of the Phase I report, the Bannock coal seam is noted as sub-cropping beneath the site, locally dipping to the south west. In addition, the Main coal seam is also noted as outcropping to the north west, dipping to the south-west below the development area.
