## **PHASE 2: GROUND INVESTIGATION REPORT**

**PROPOSED COMMERCIAL USE OF LAND AT:**

**THE FLAXWORKS (MILL BUILDING 1)**

**CLEATOR MILLS, CUMBRIA**

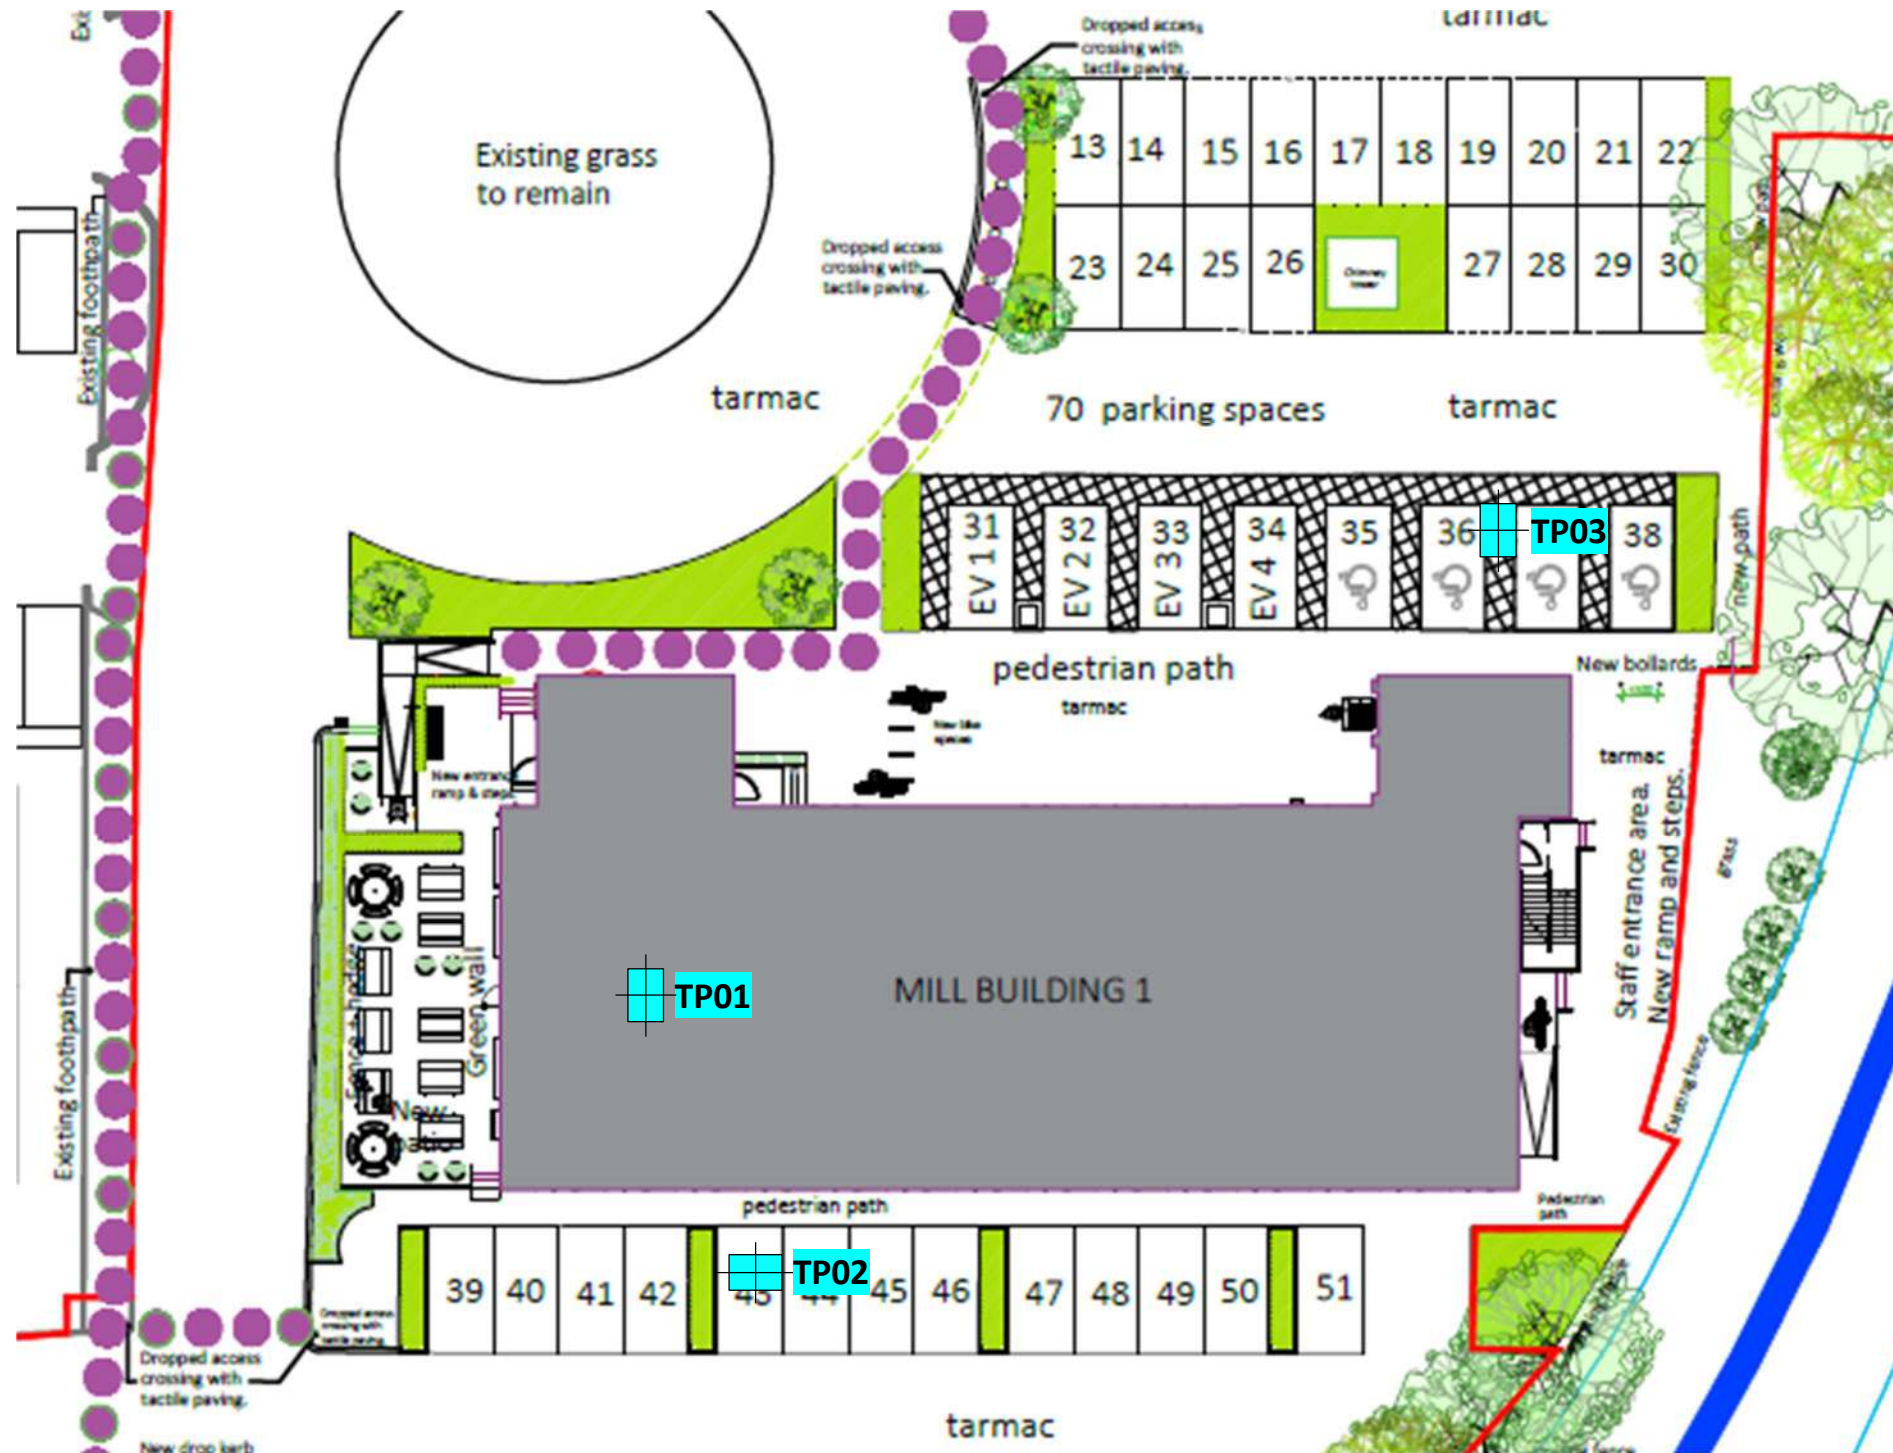
**GEO2025-6836– The Flaxworks (Mill Building 1), Cleator Mills (Exploratory Hole Location Plan)**

**Key:**  
**Mechanically Excavated Trial Pits**

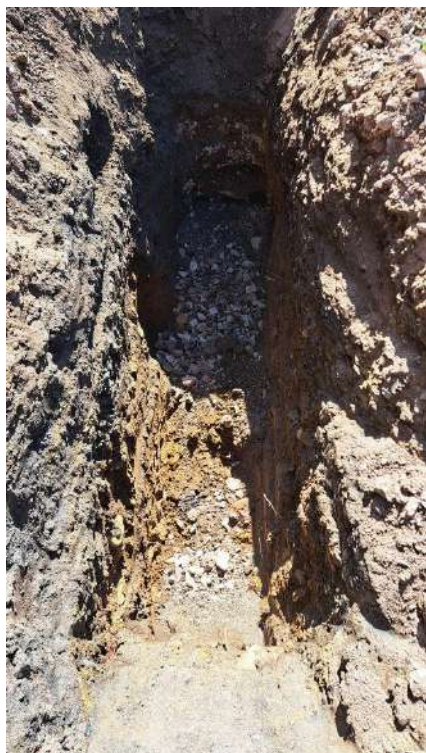
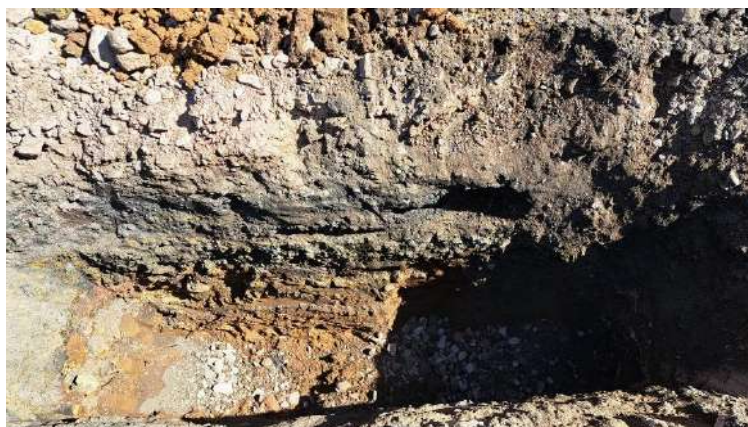
## GEO2025-6836: The Flaxworks (Mill Building 1), Cleator Mills, Cumbria – TP02 (External)

| Depth From (m) | Depth To (m) | Strata Description | Legend | Testing / Samples |
|---|---|---|---|---|
| 0.20 | 0.80 | MADE GROUND: "Compact" black / dark grey sandy fine GRAVEL of ash, coal and clinker.<br><br>Roots noted to c.0.80m. | | 0.60 JT |
| 0.80 | 1.10 | POSSIBLY DISTURBED: Firm brown / red brown slightly sandy silty CLAY with occasional subangular to subrounded fine to medium gravels. Occasional fine brick noted. | | 1.00 JT |

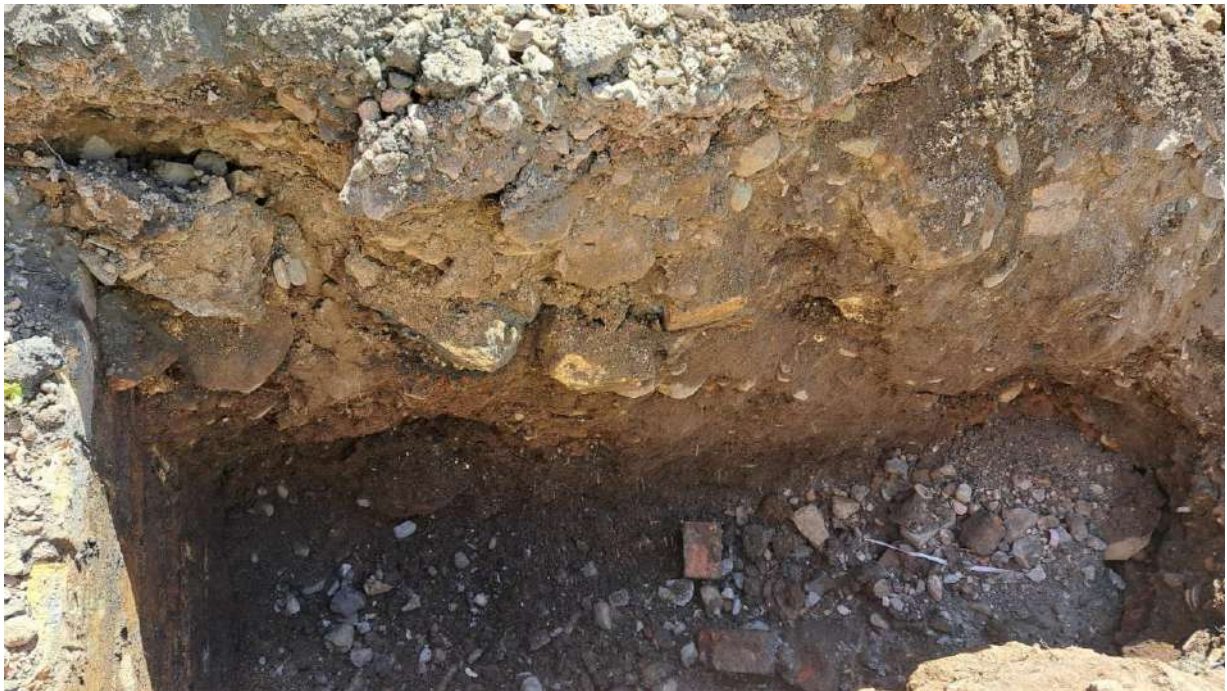
**GEO2025-6836: The Flaxworks (Mill Building 1), Cleator Mills, Cumbria – TP03 (External)**

The final location (TP03) was undertaken to the front and adjacent to the existing chimney. At this location, surfacing of sandy gravel to c.0.10m was underlain by “compact” gravelly clay with brick, mortar, ash and occasional coal to c.0.30m with “compact” black slightly gravelly sand with ash and soil lenses noted to c.0.40m. The base of the trial pit (between c.0.40m and c.1.25m) comprised sandy gravel and cobbles with bands of firm clay with abundant brick, sandstone cobbles, cloth, ash, clinker and slate.
