## **PHASE 2: GROUND INVESTIGATION REPORT**

**PROPOSED RESIDENTIAL DEVELOPMENT OF LAND AT**

**PARKSIDE ROAD, CLEATOR MOOR**

**GENESIS HOMES (NORTH) LIMITED**

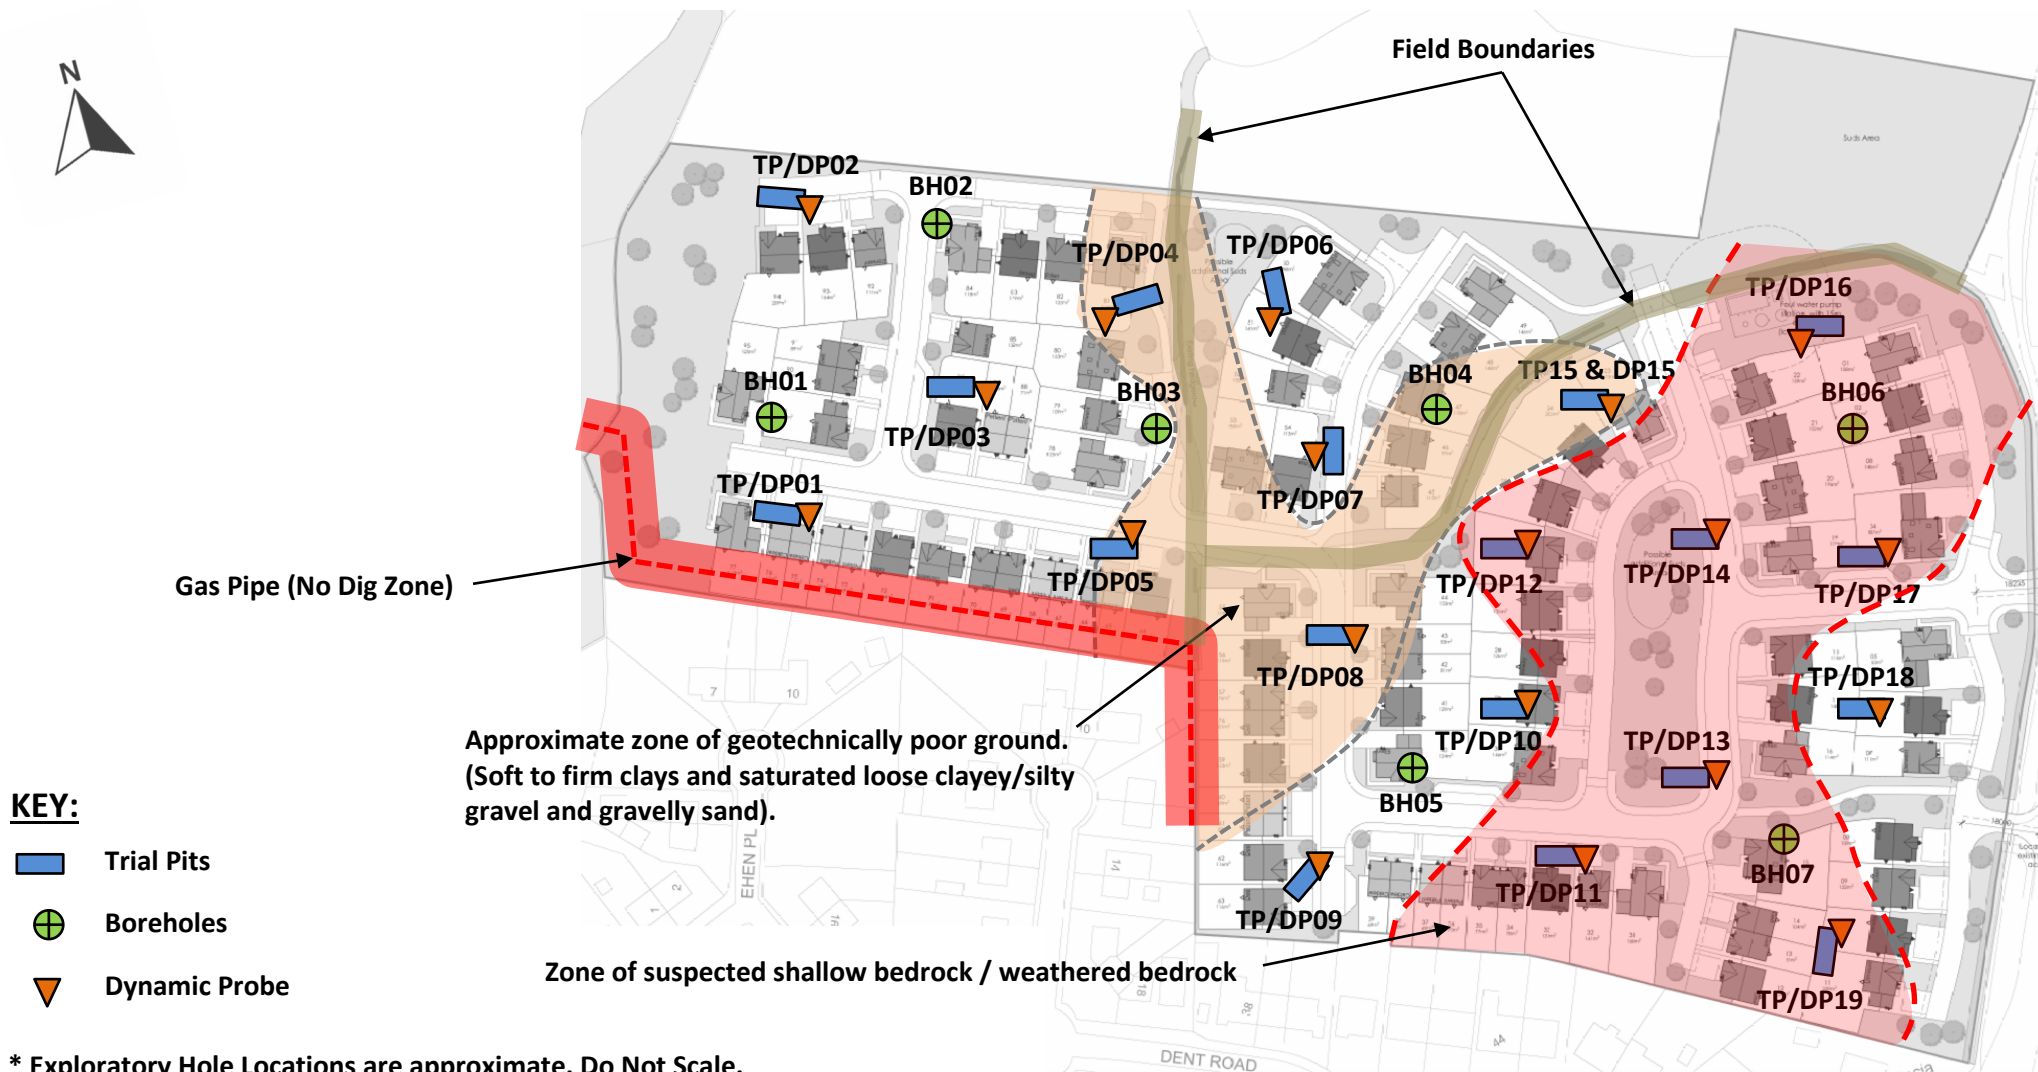
**GEO2024-6221: Parkside, Cleator Moor, Cumbria – Exploratory Hole Location Plan\***

\* Exploratory Hole Locations are approximate. Do Not Scale.

Across the central parts of the site, the firm orangey brown clay was underlain by clayey sandy gravel and silty gravelly sand (this area is indicated on the Exploratory Hole Location Plan in Appendix I). The deposits were noted as locally unstable with running sand and groundwater ingress. The granular deposits were not considered suitable for the conventional strip foundations.

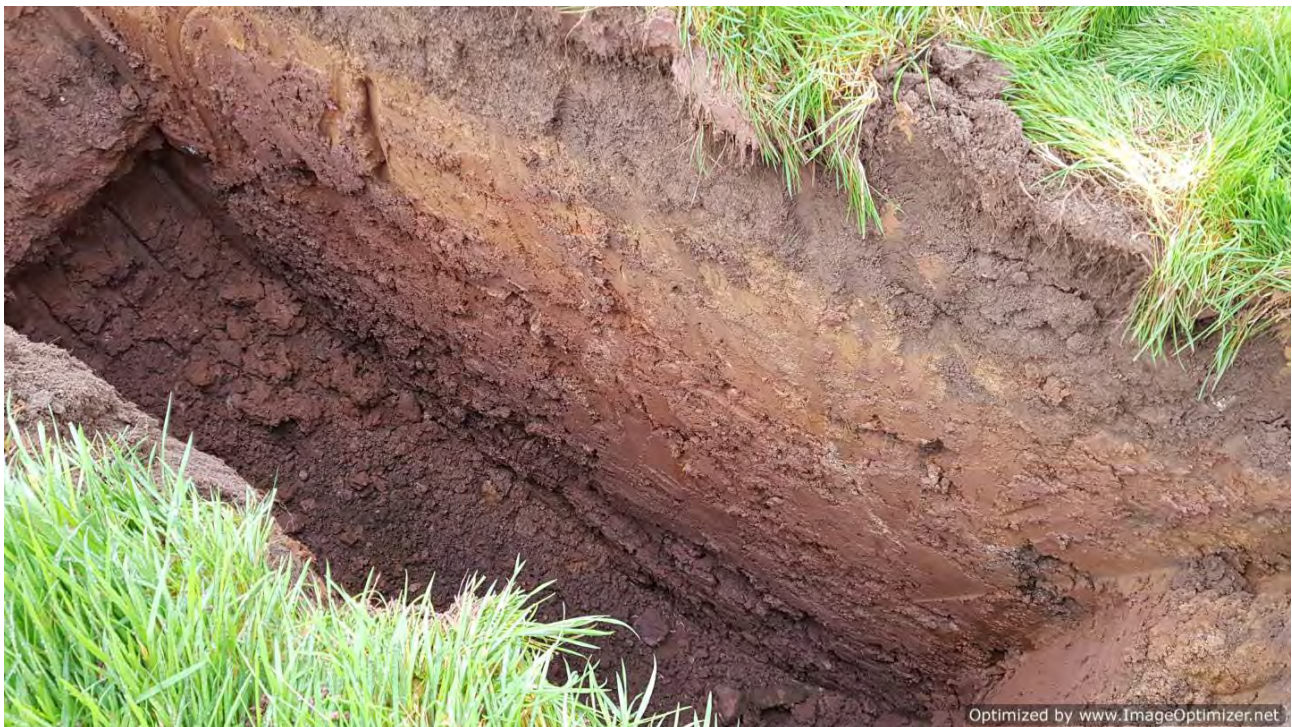
**GEO2024-6221: Parkside, Cleator Moor, Cumbria – TP08**

| Depth From (m) | Depth To (m) | Strata Description | Legend | Testing / Samples |
|---|---|---|---|---|
| | | End of trial hole at 2.60m – very unstable.<br>Collapse of both side walls between 0.60m and 2.30m bgl.<br>Groundwater ingress and running sand 1.00m to 2.30m bgl.<br>Trial hole backfilled with arisings on completion. | | Clay too gravelly for HSV tests.<br>Dynamic probe completed next to trial pit – see separate results sheet. |
