# THE IRON LINE, MILLOM (ZONES 3-10) PHASE 2 GROUND INVESTIGATION REPORT

**Curtins Ref:** 080874-CUR-XX-XX-T-GE-00007

**Issue Date:** 08 April 2025

**Client Name:** Cumberland Council

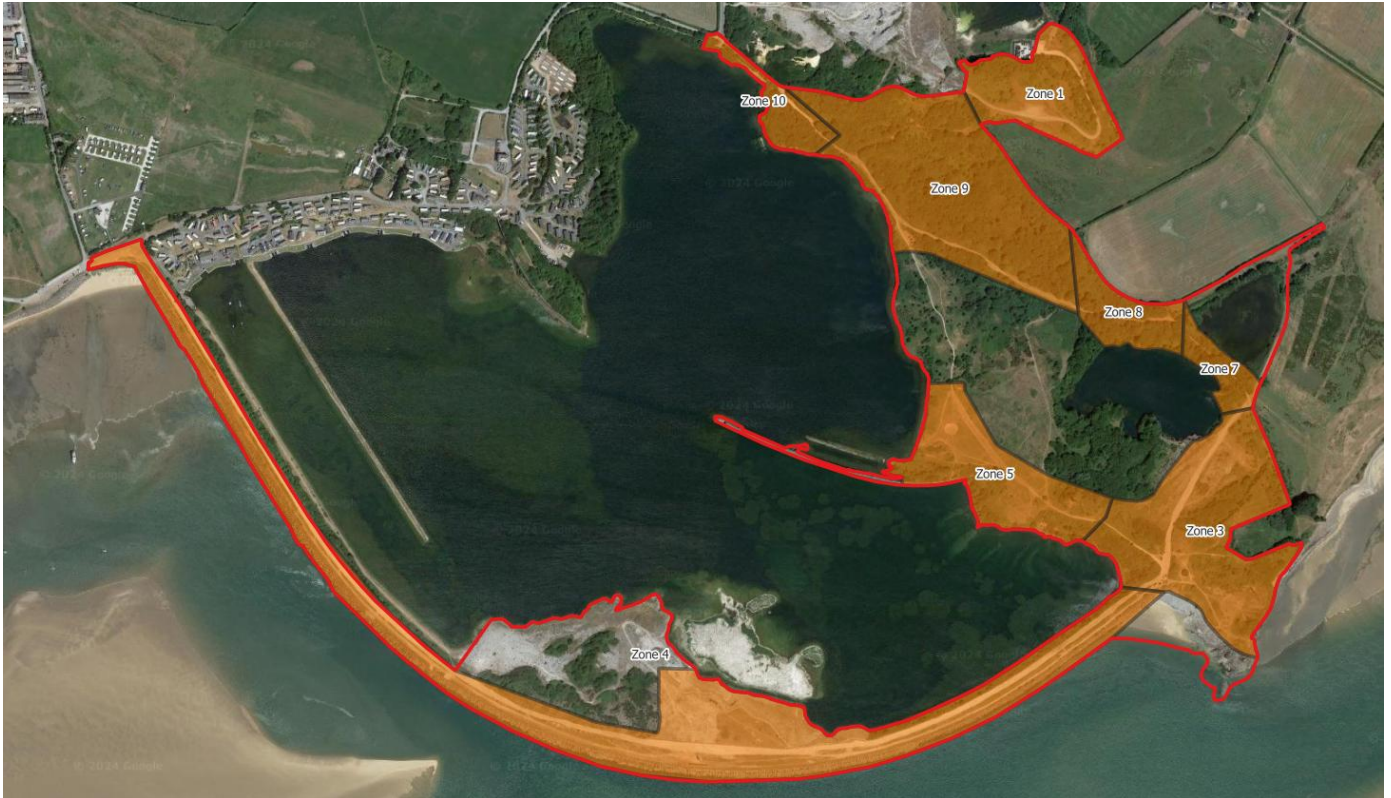
Figure 1 – Site Location Plan with Development Zones, site boundary shown in red.

The location and extent of the site is shown in *Figure 1* overleaf. The overall project comprises consolidation, repair and installation of interpretive sculpture to Towsey Hole Windmill; refurbishment of the existing Tern Island hide; new bird hides, pathways, gateway features and street furniture; enhancement of wildlife habitats; associated landscaping and drainage infrastructure; and maintenance of byway with restricted vehicular access.

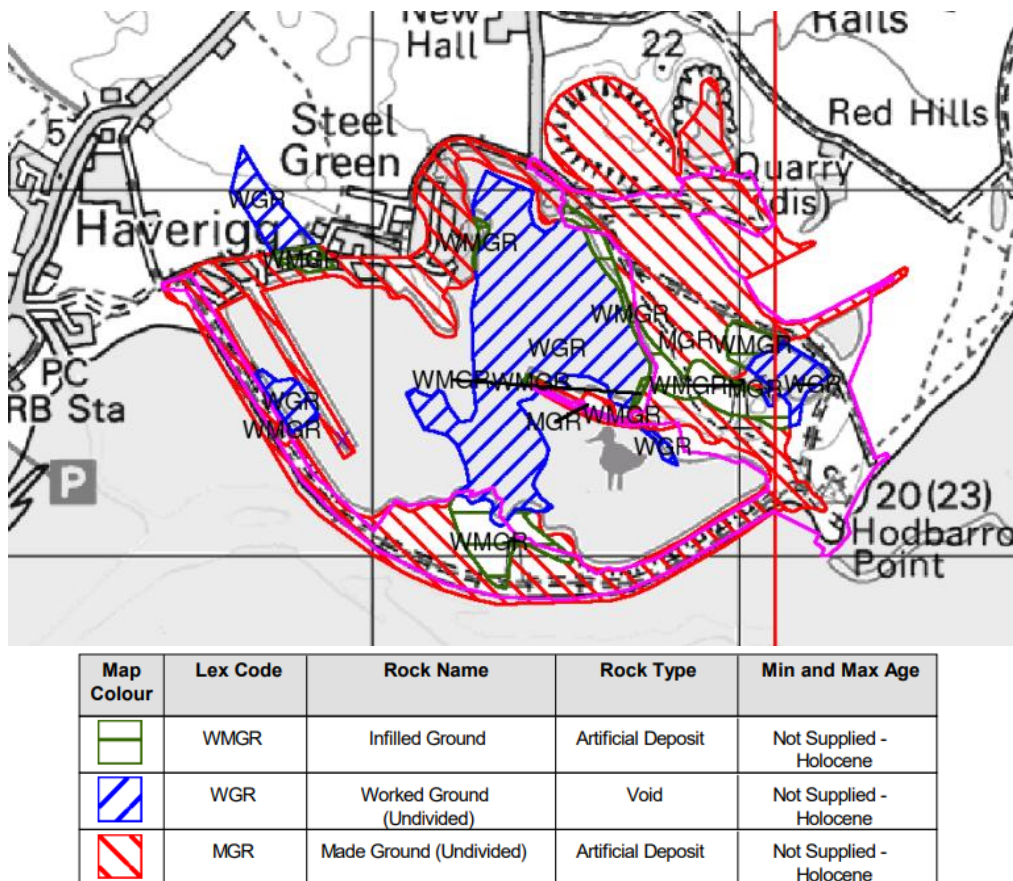
Figure 2 – Extract from BGS 1:50,000 mapping (Artificial Ground)

It is likely that the Made Ground will comprise the iron works process arisings.

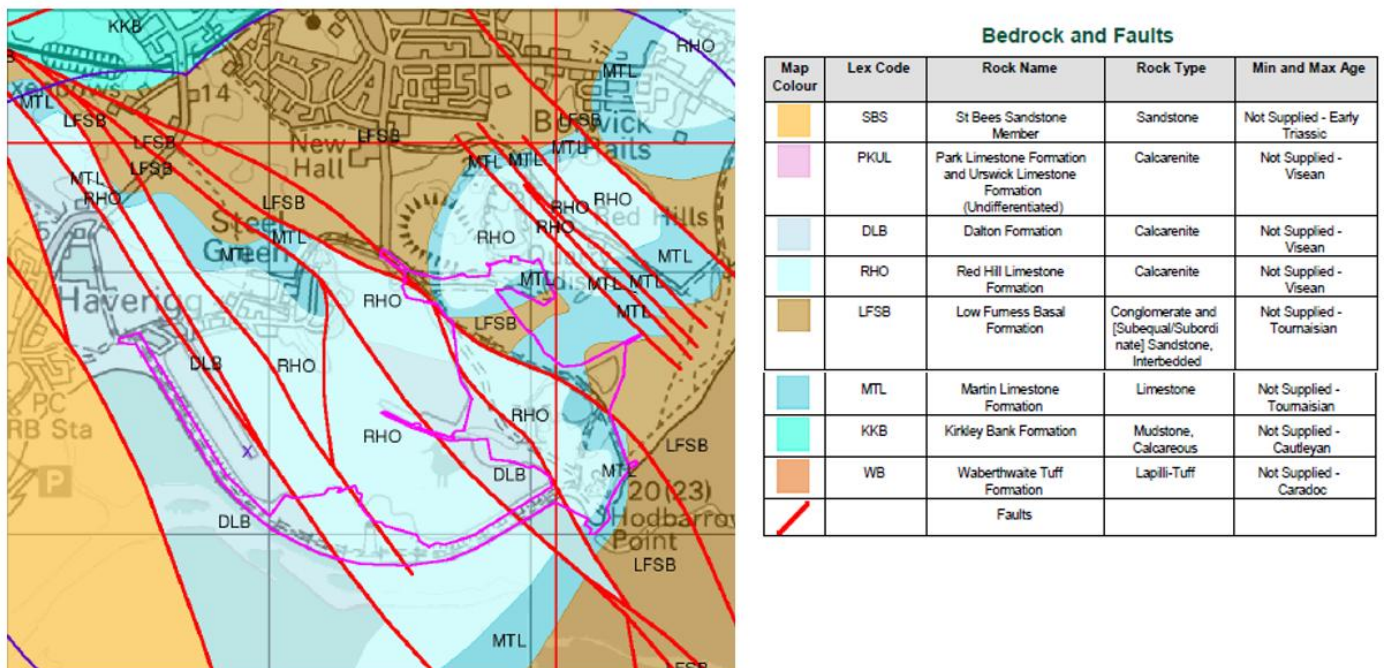
Figure 4 – Extract from BGS 1:50,000 mapping (Bedrock).  
Site outlined in purple.

The site and surrounding area are heavily faulted, with shallow dipping (5-15 degrees) SW and striking NW-SE cutting across all lithology types.

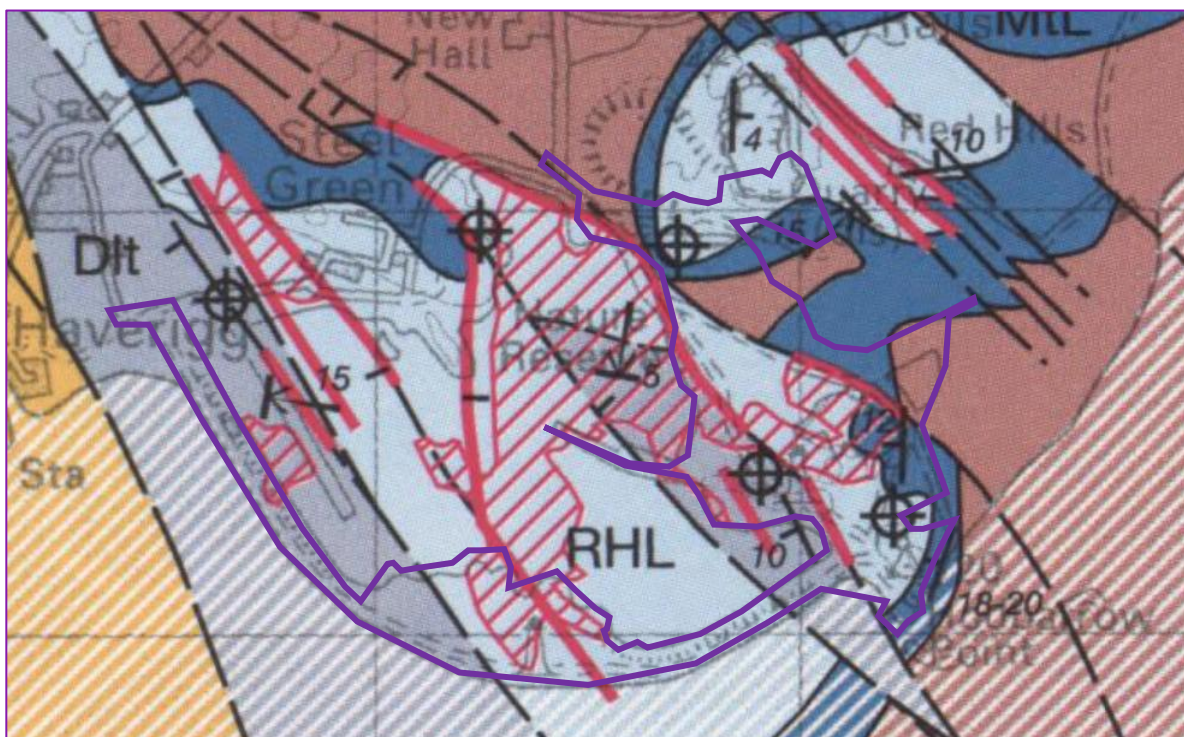
*Figure 5 – Extract from BGS 1:50,000 mapping (Bedrock)*  
*Approximate Site Boundary in Purple.*  
*Red lines showing haematite veins*  
*Red cross-hatched showing hematite deposits, worked at rockhead and at depth*  
*Black lines showing faults*  
*Black Crossed circles showing abandoned mine shafts.*

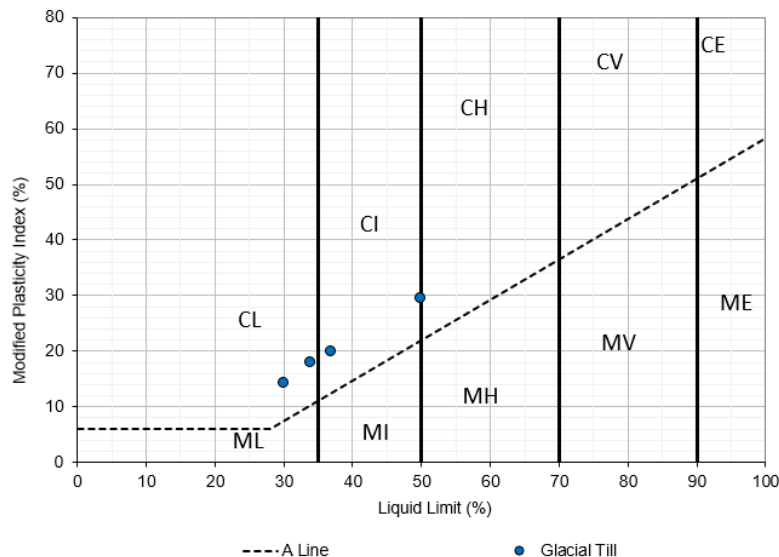
Figure 6 – Casagrande Chart

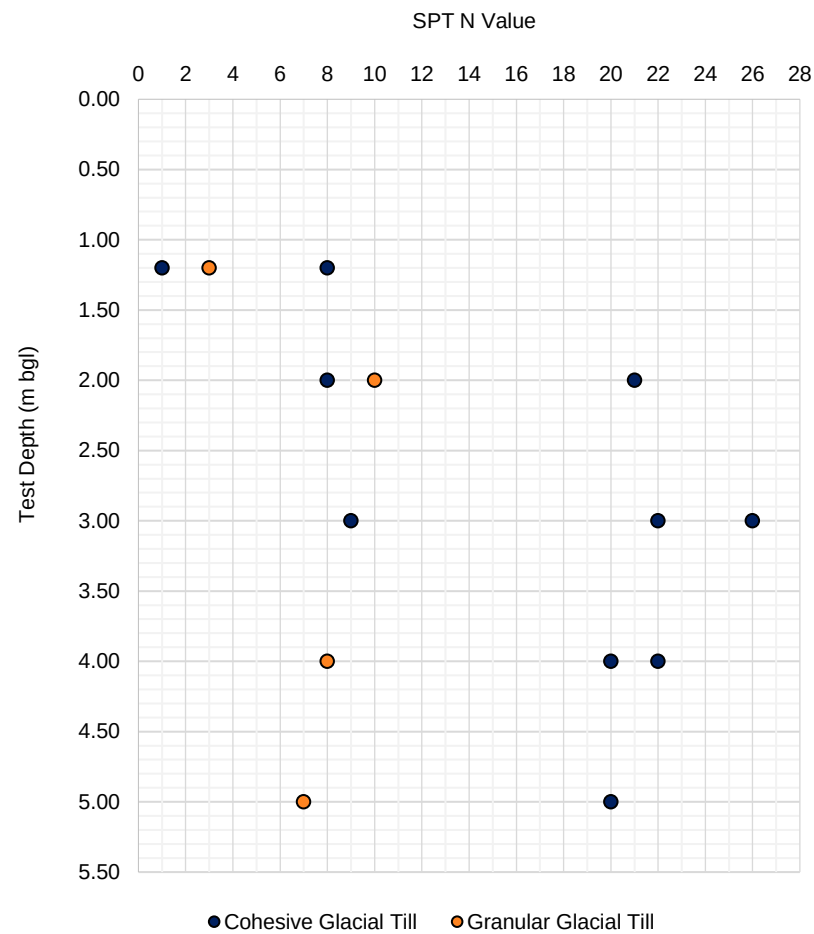
Figure 7 - SPT 'N' Value vs. Depth (m bgl) for Cohesive and Granular Glacial Till

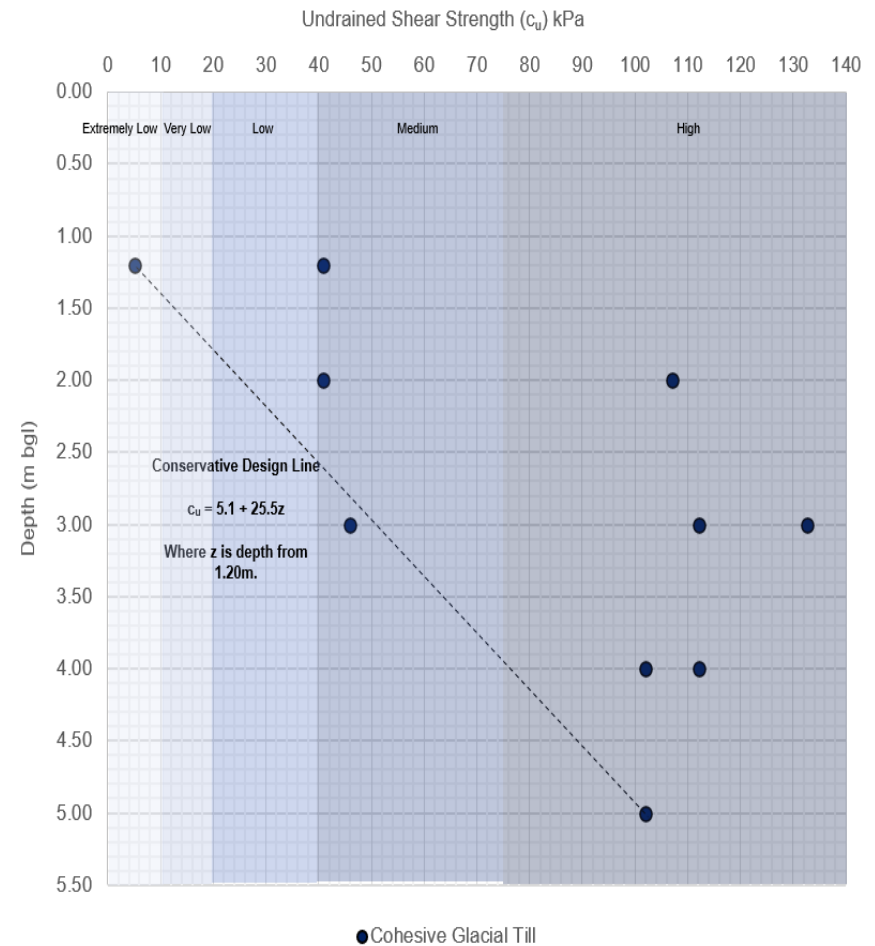
Figure 8 – Relationship between Undrained Shear Strength vs. Depth (m bgl)

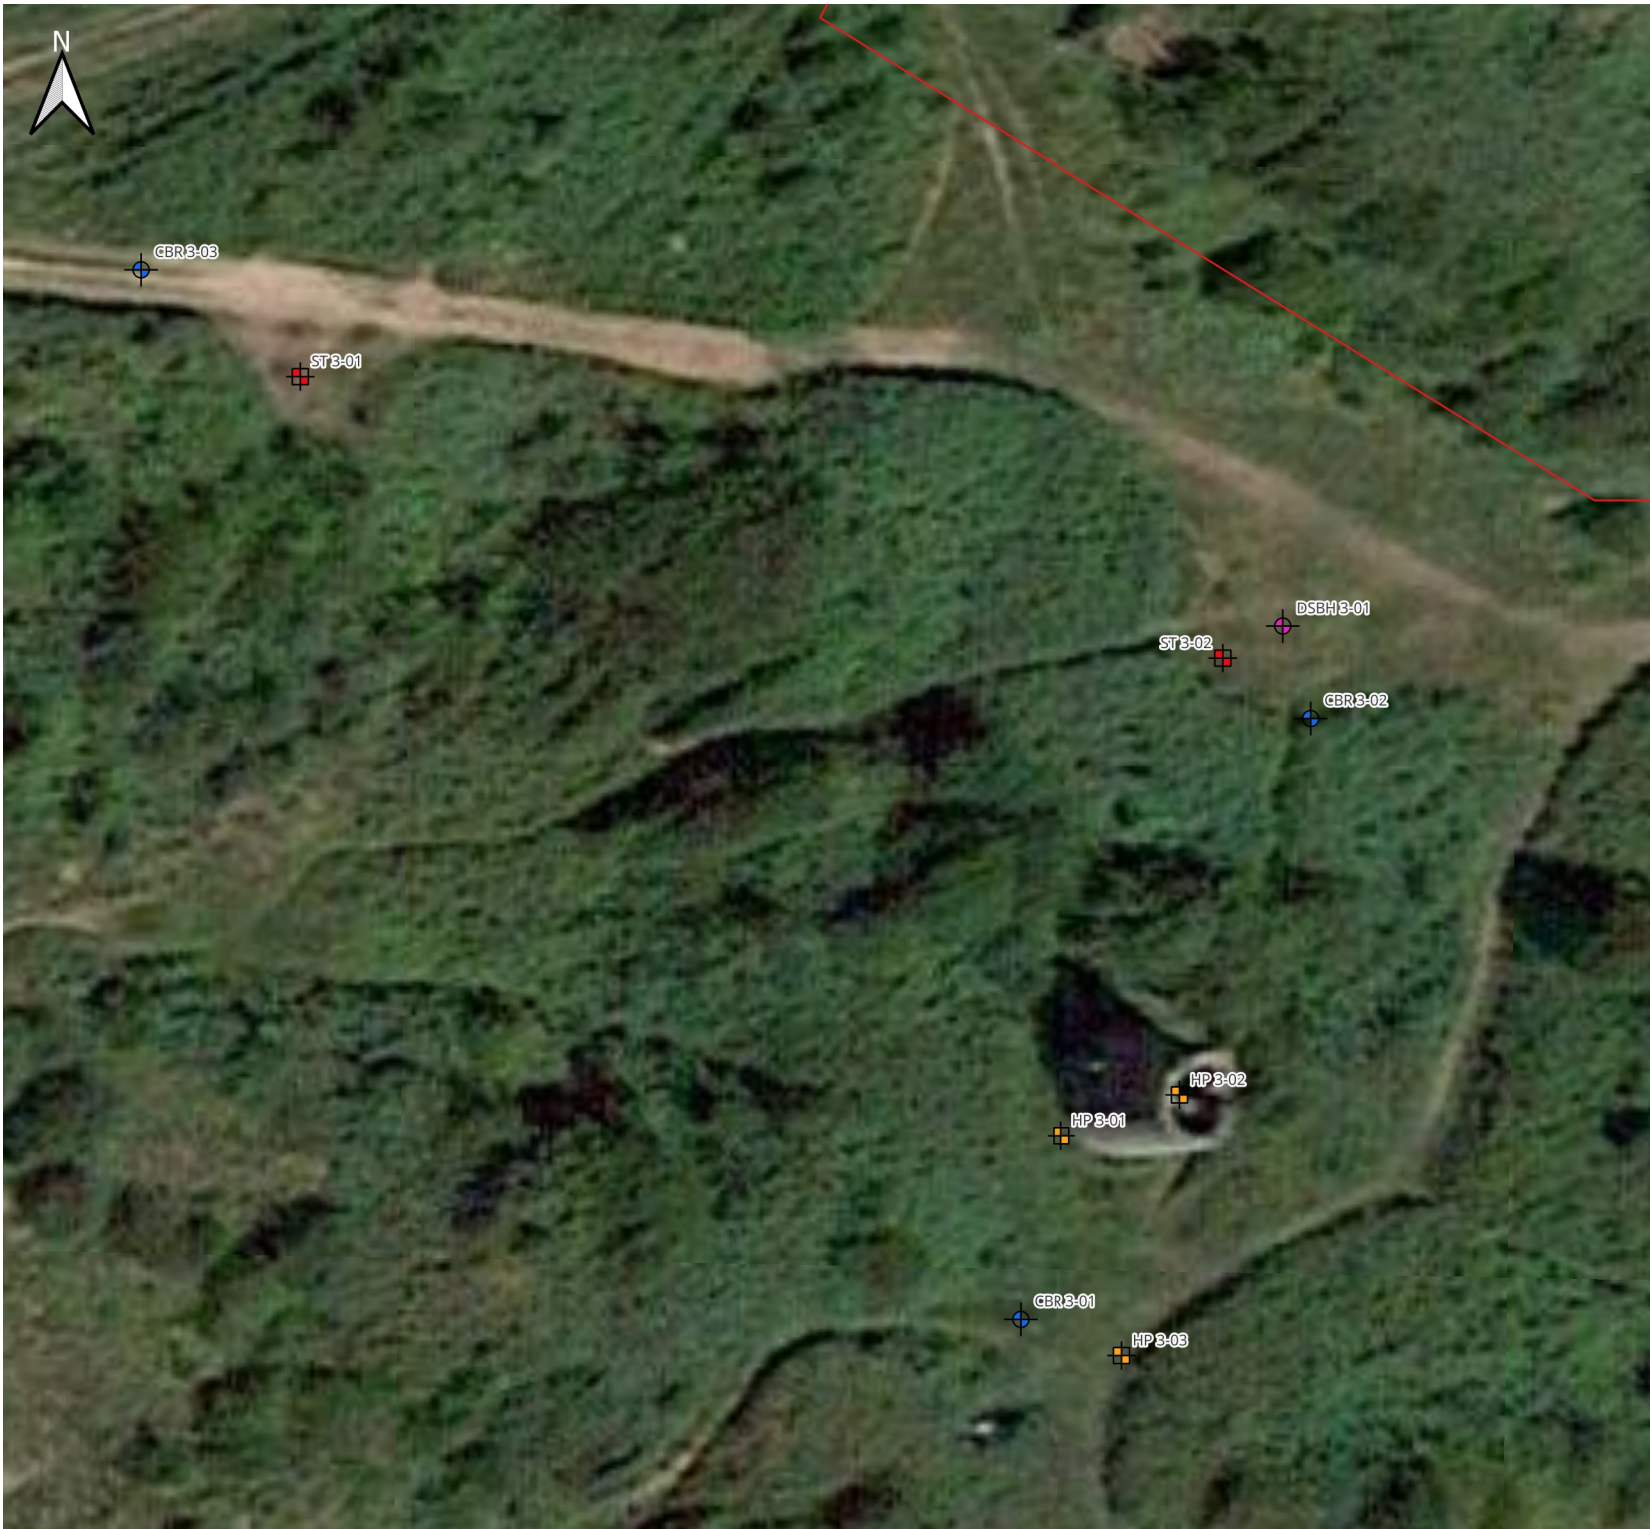
Proposed BH Locations

- CBR Test Location
- Hand Pit
- Rotary Open Borehole
- Soakaway Test
- Trial Pit
- Windowless Dynamic Sample Borehole
- Trial Trench
- Site Boundary

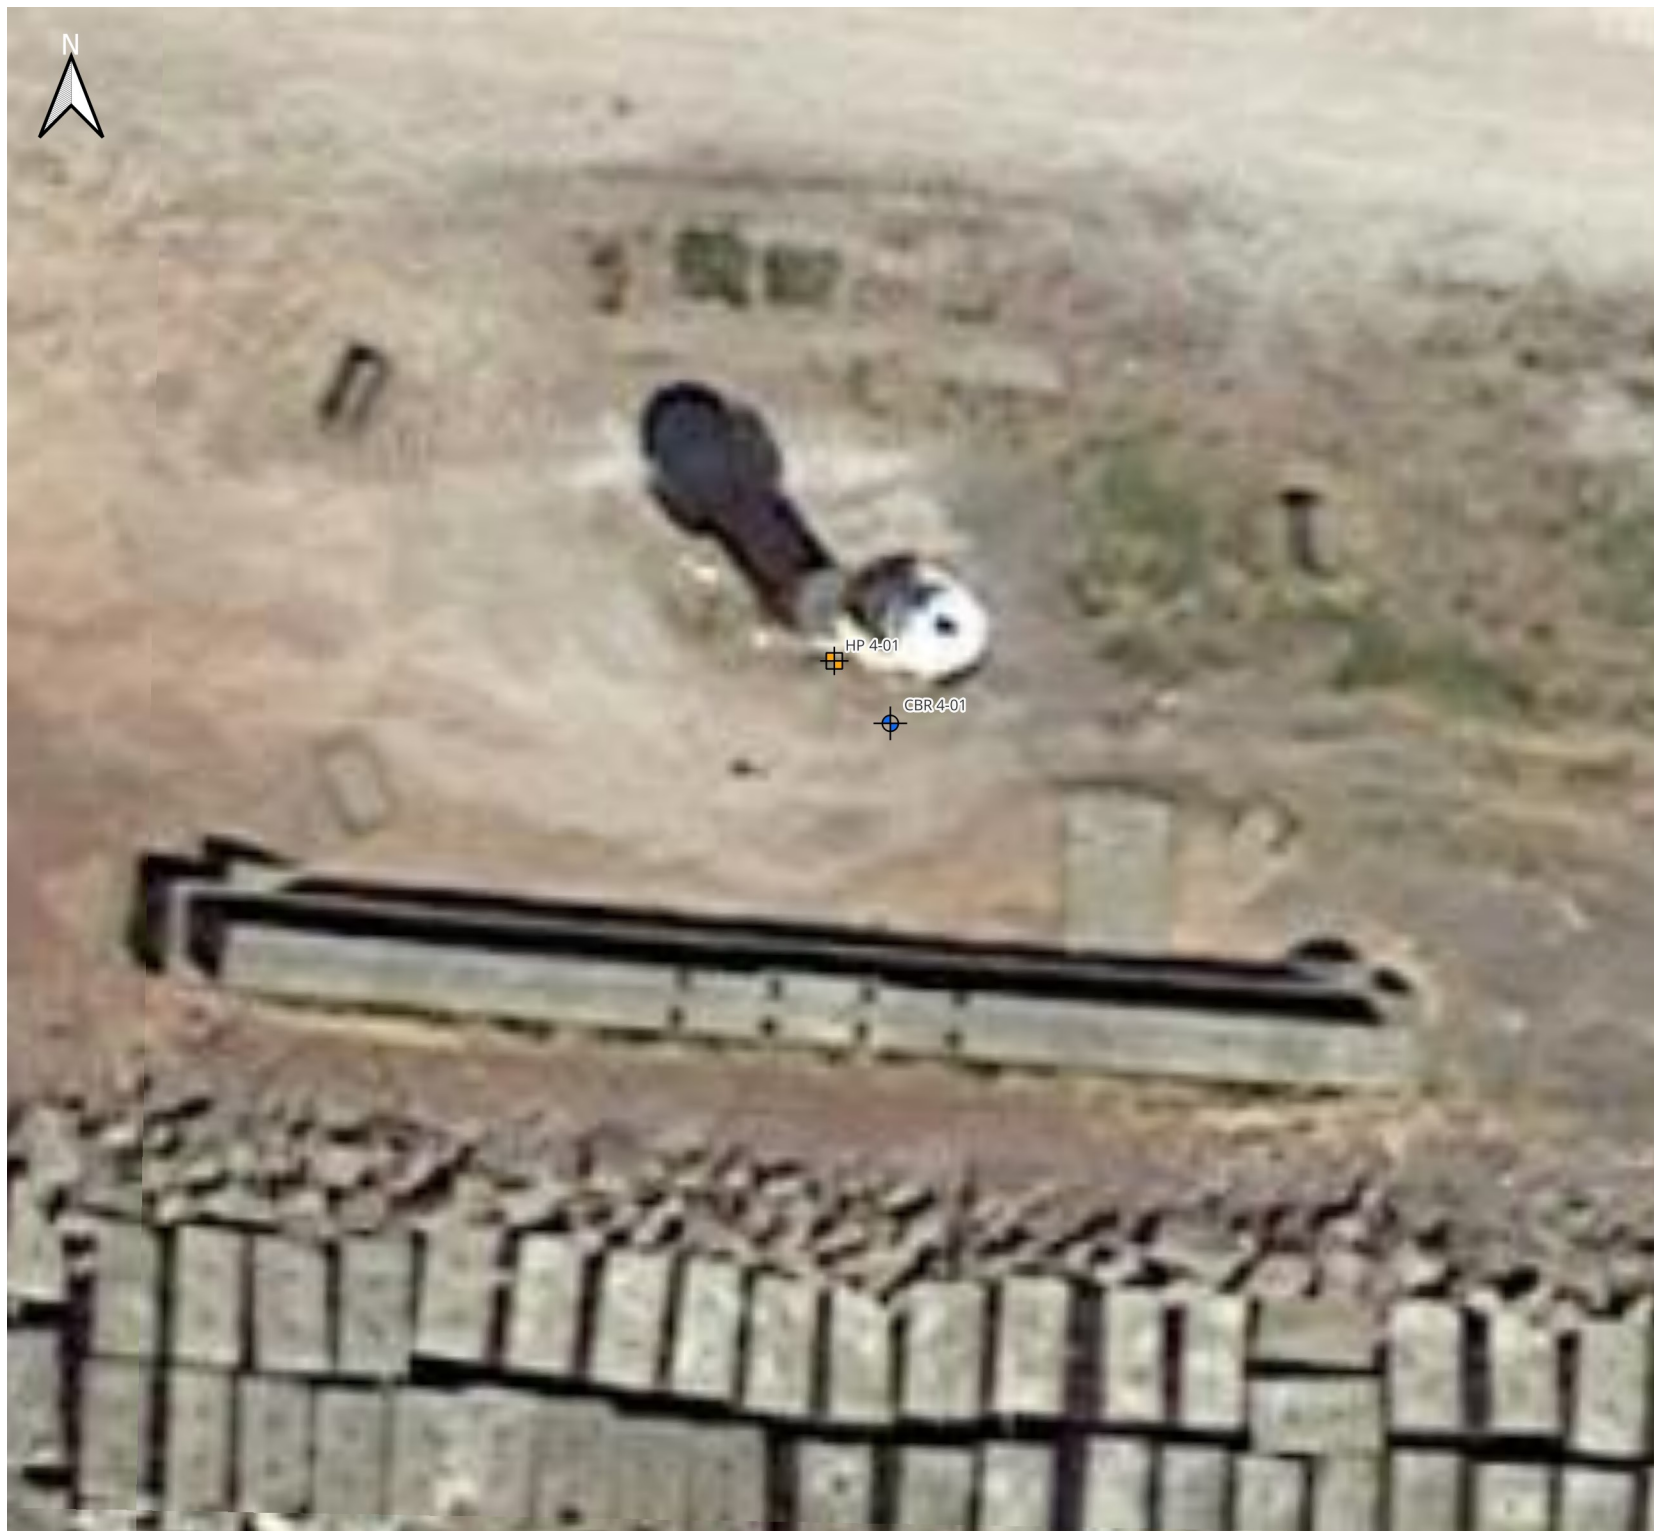
| Drg No: | 080874-CUR-XX-XX-DR-GE-80003 | Rev: | P0 |

-  CBR Test Location
-  Hand Pit
-  Rotary Open Borehole
-  Soakaway Test
-  Trial Pit
-  Windowless Dynamic Sample Borehole
-  Trial Trench
-  Site Boundary

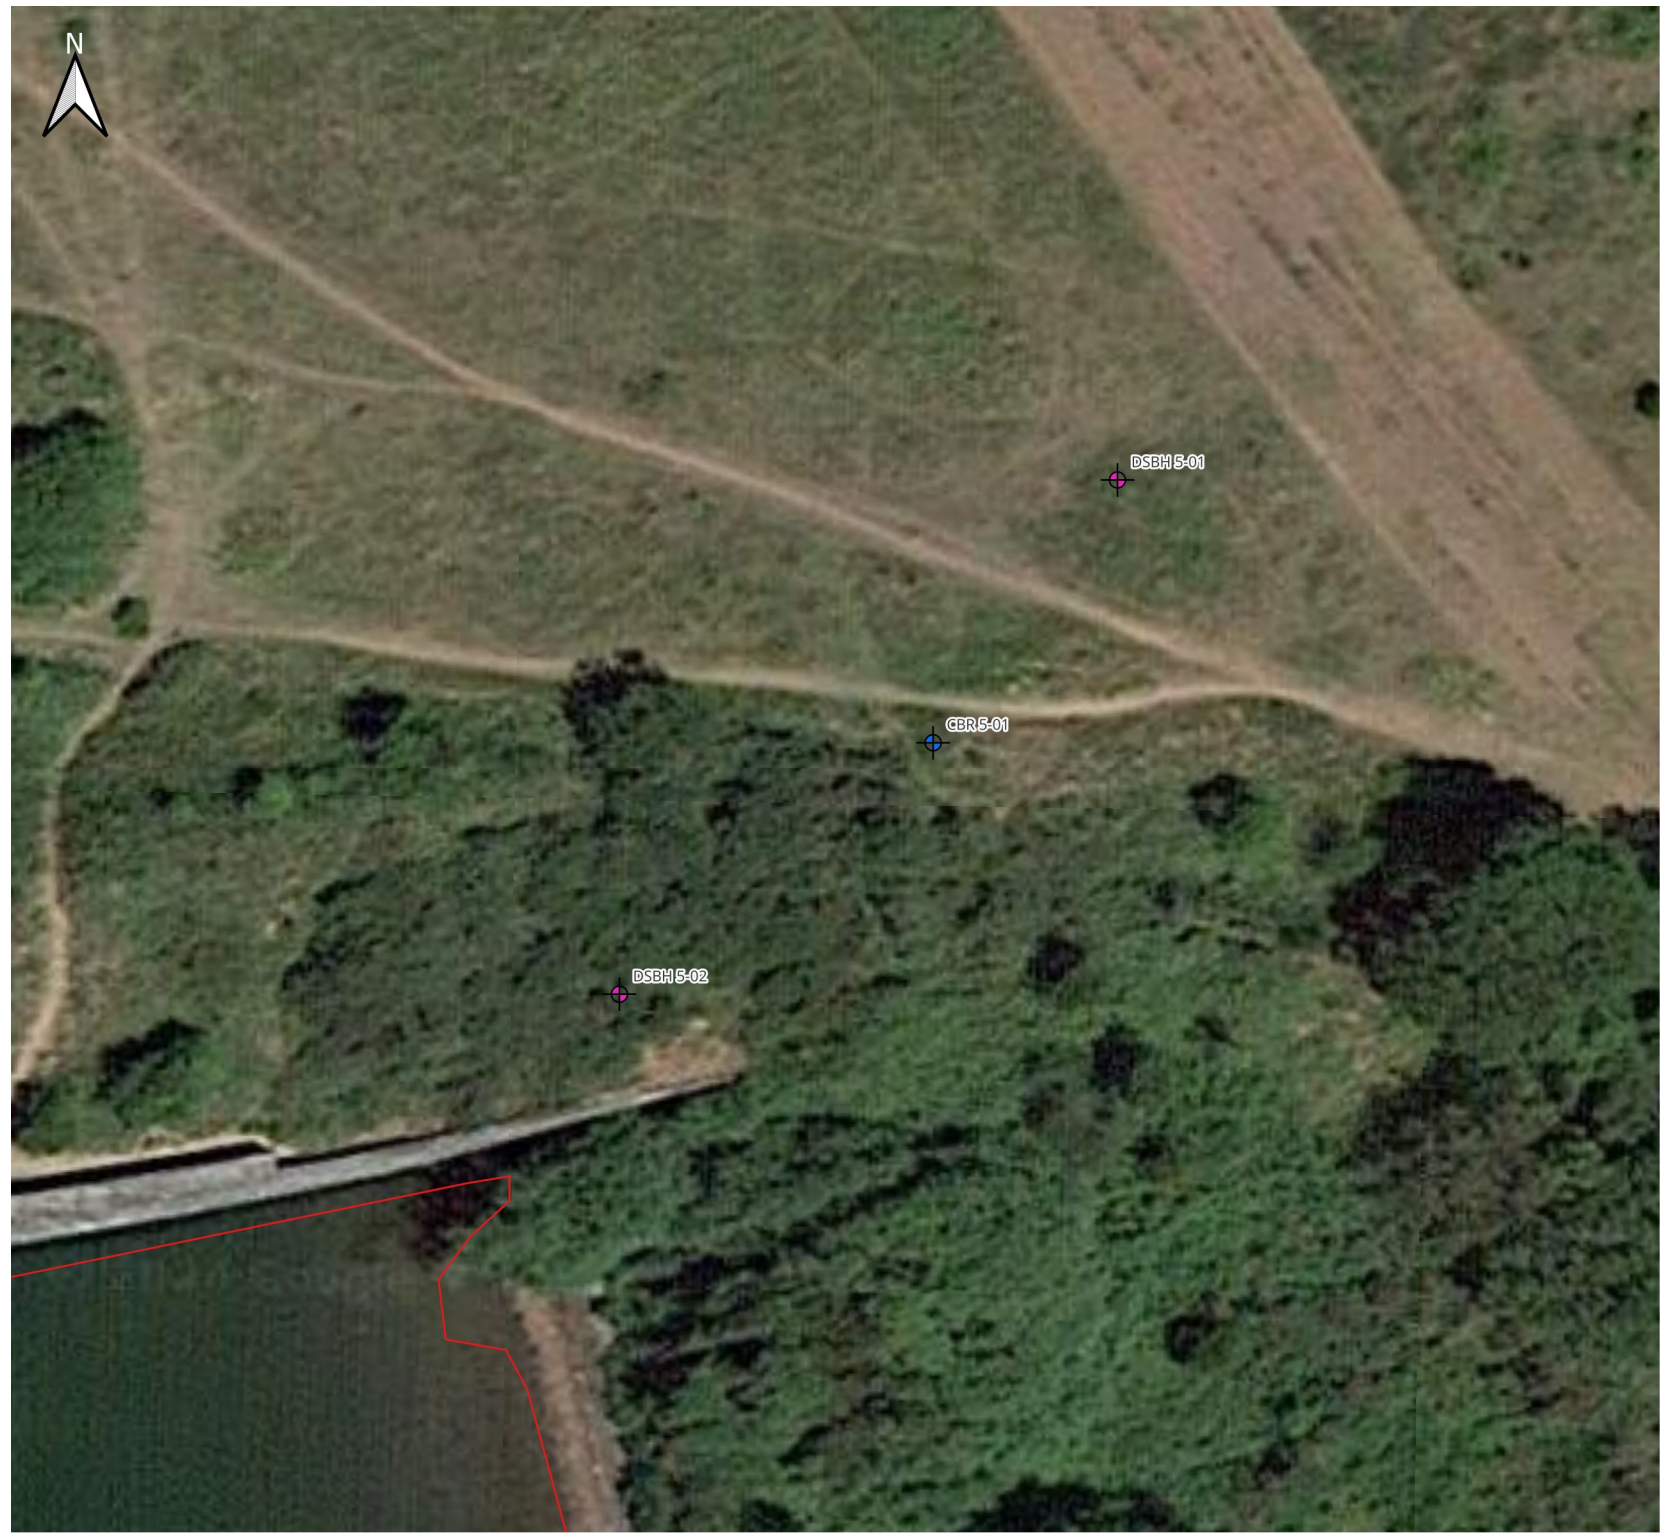
| Status INFORMATION | | | | |
|---|---|---|---|---|
| Drg No: <b>080874-CUR-XX-XX-DR-GE-80004</b> | | | | Rev: <b>P01</b> |

#### Proposed BH Locations

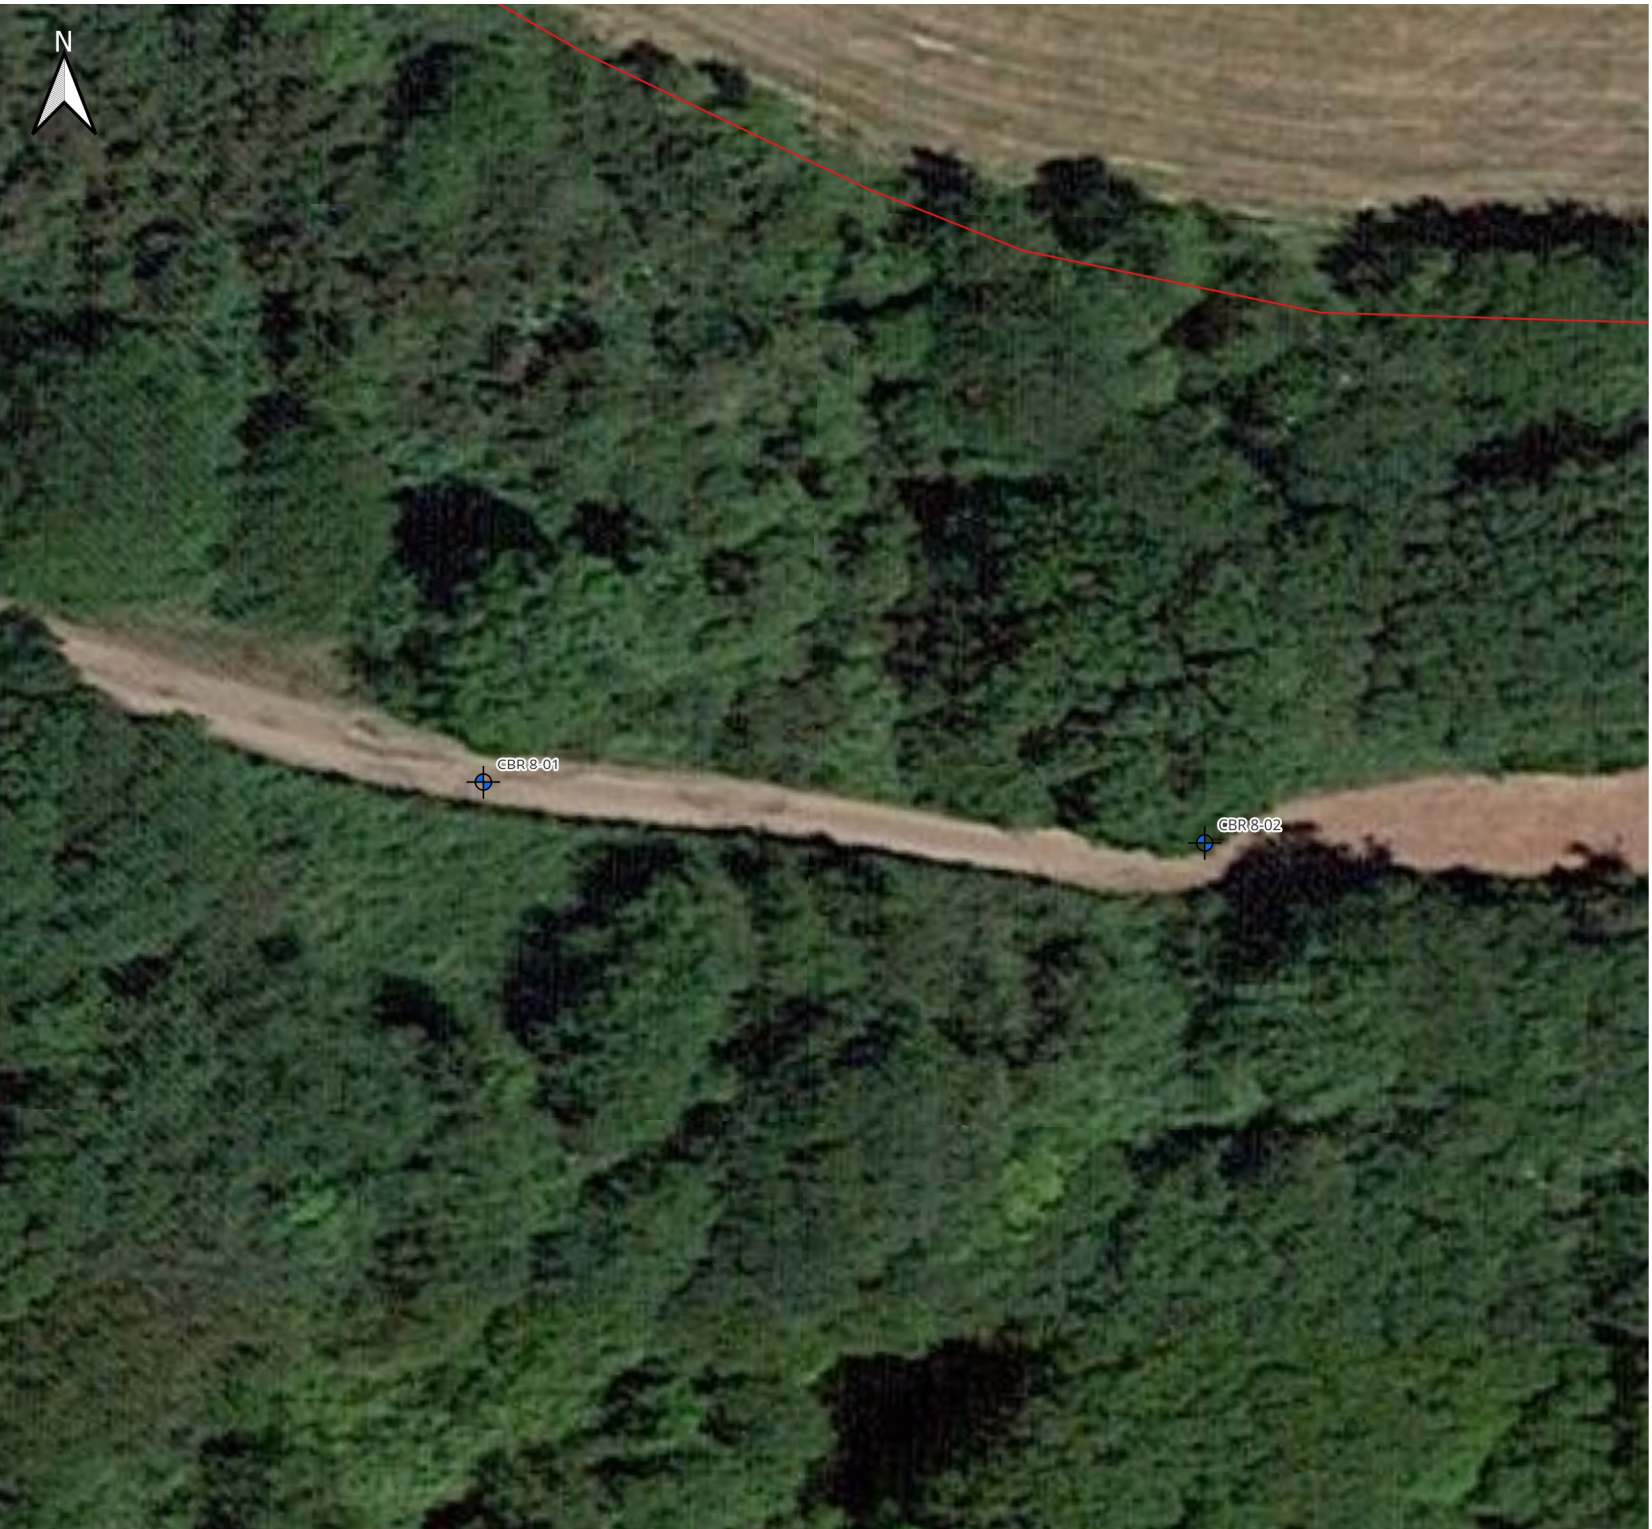
| 080874-CUR-XX-XX-DR-GE-80006 | | | | P01 |

Proposed BH Locations

- CBR Test Location
- Hand Pit
- Rotary Open Borehole
- Soakaway Test
- Trial Pit
- Windowless Dynamic Sample Borehole
- Trial Trench
- Site Boundary

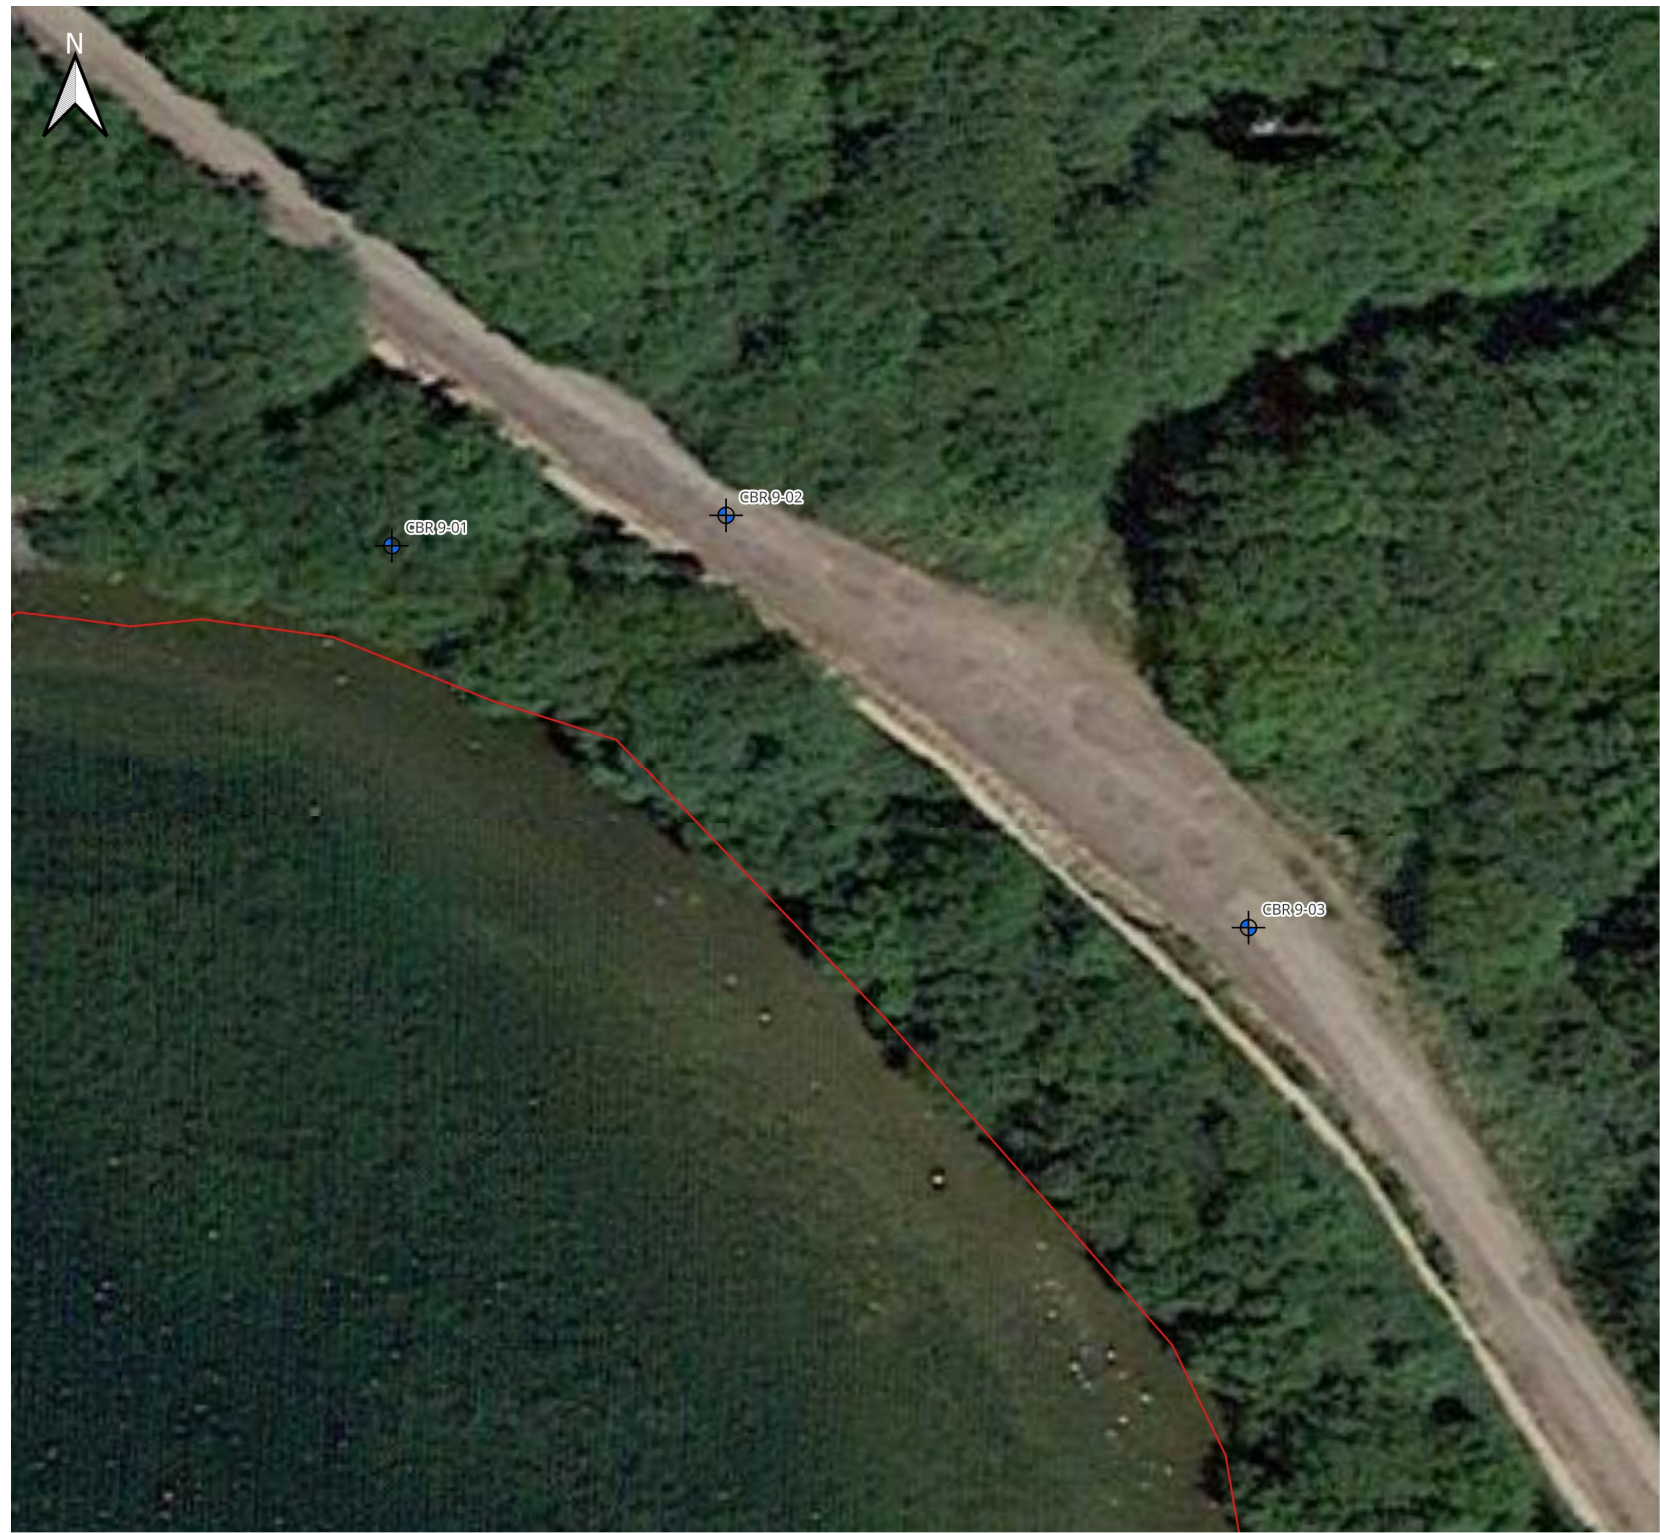
| 080874-CUR-XX-XX-DR-GE-80007 | | | | P01 |

#### Proposed BH Locations

- CBR Test Location
- Hand Pit
- Rotary Open Borehole
- Soakaway Test
- Trial Pit
- Windowless Dynamic Sample Borehole
- Trial Trench
- Site Boundary

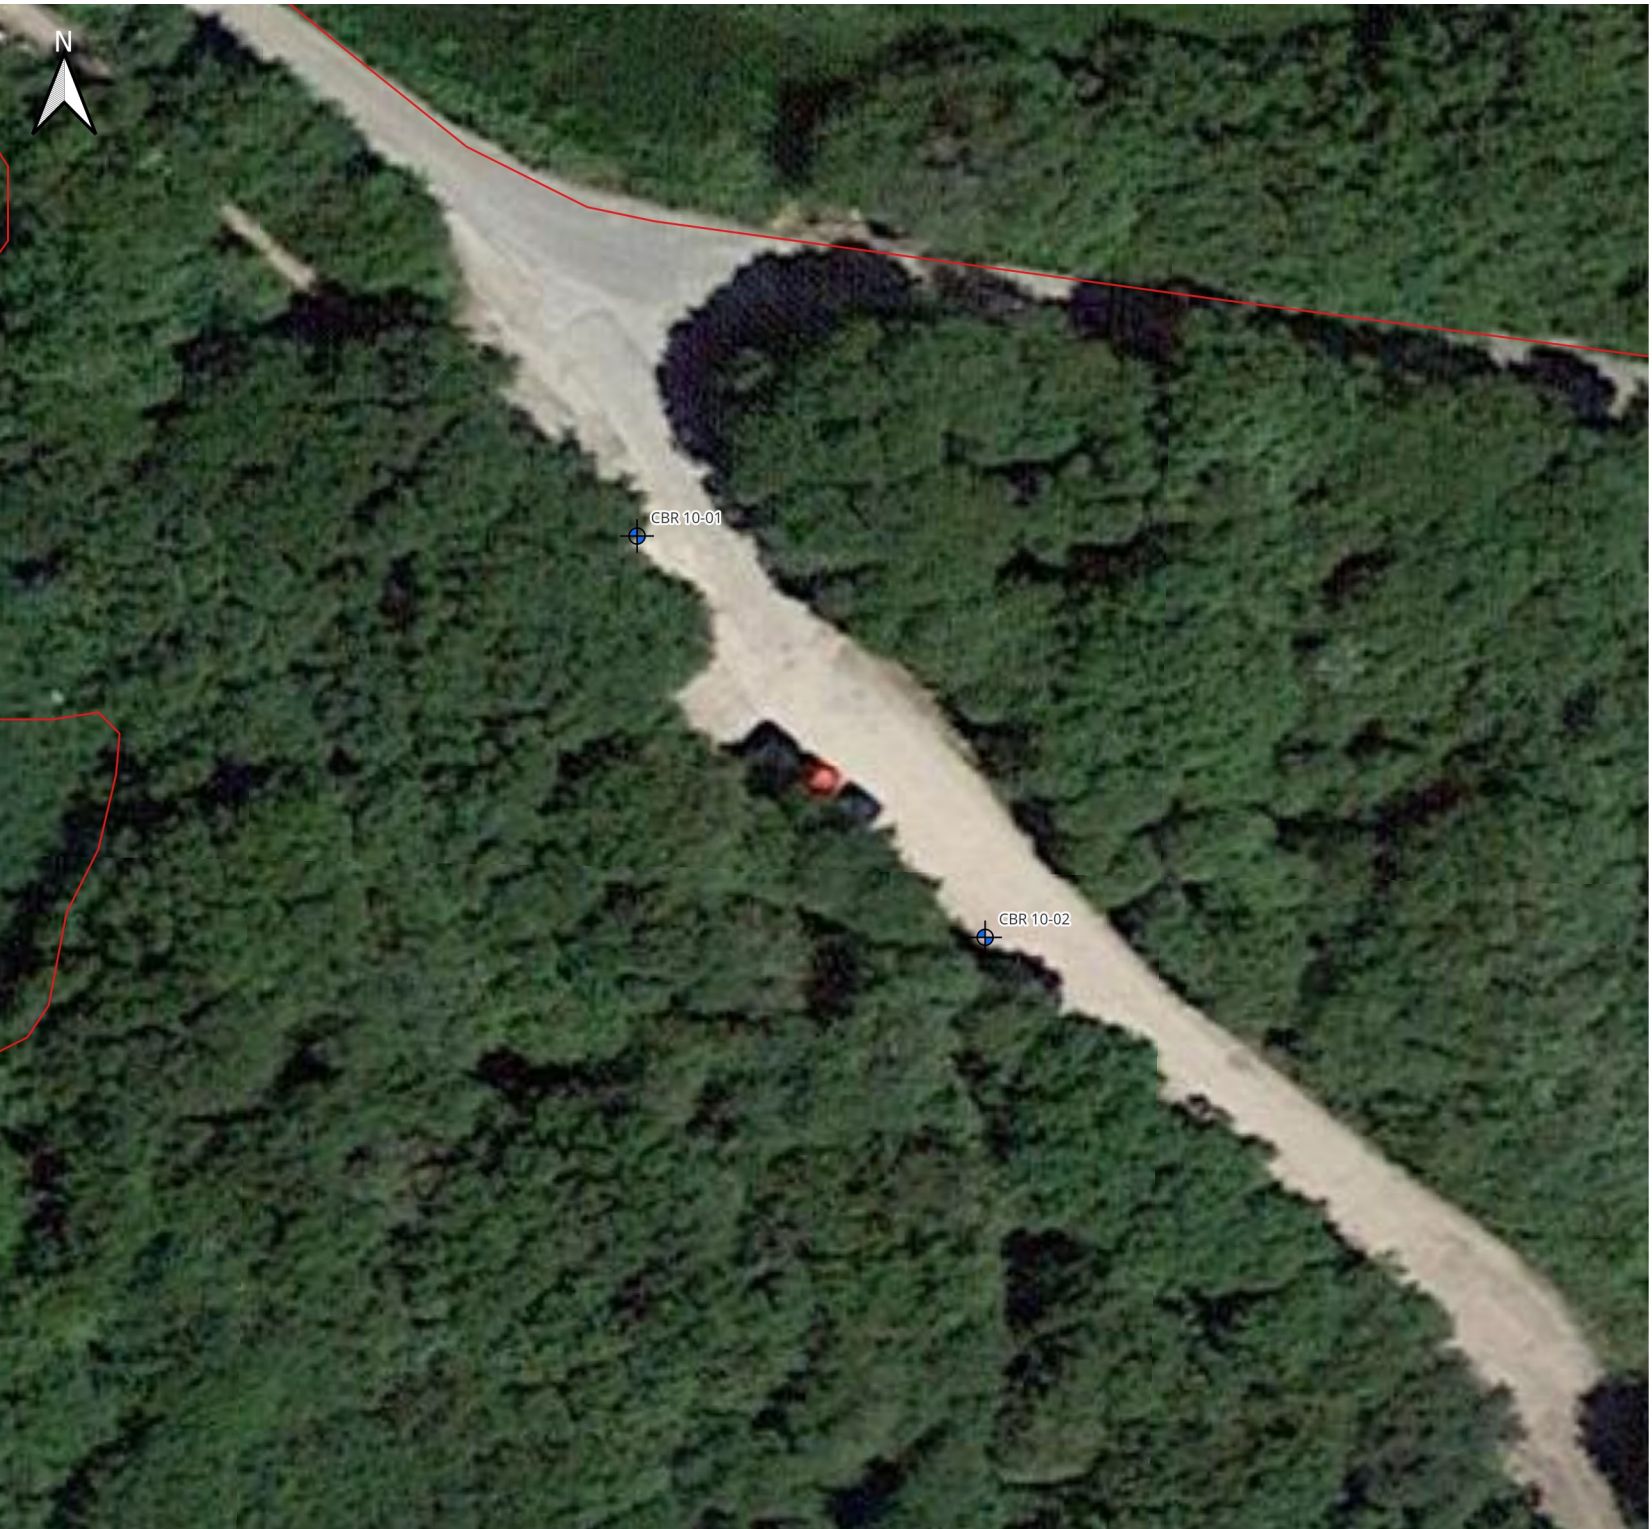
| 080874-CUR-XX-XX-DR-GE-80008 | | | | P01 |

Proposed BH Locations

- CBR Test Location
- Hand Pit
- Rotary Open Borehole
- Soakaway Test
- Trial Pit
- Windowless Dynamic Sample Borehole
- Trial Trench
- Site Boundary

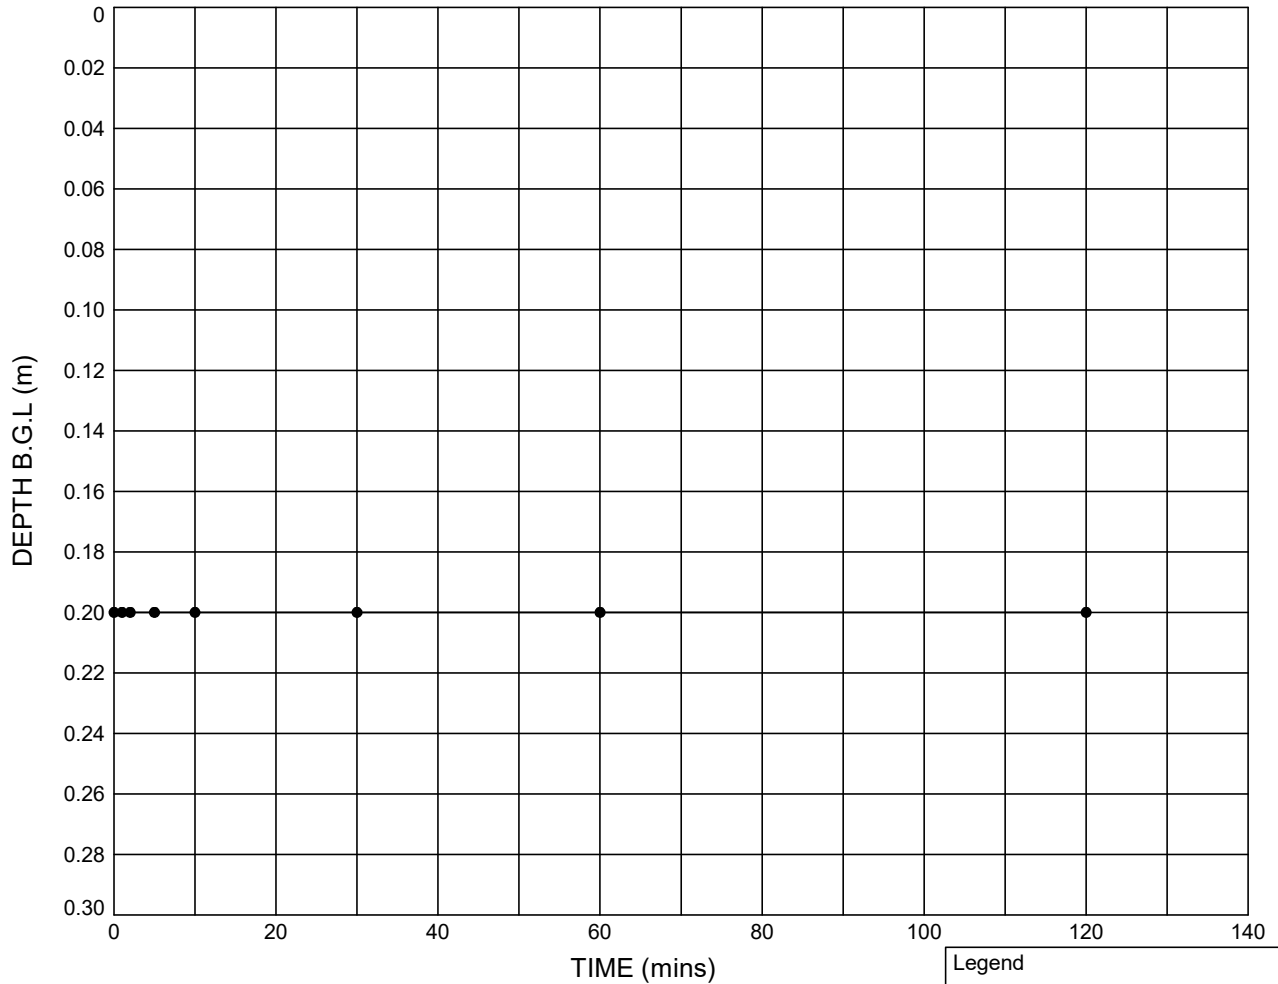
Test 1

## PLOT OF DEPTH OF WATER BELOW GROUND LEVEL AGAINST TIME

Pit start depth: = **0.30** m  
Pit final depth: = **0.30** m  
Effective depth,  $D_e$  = **0.10** m  
Effective storage volume,  $V_{p75-25}$  = **0.0450** m<sup>3</sup>  
Surface area,  $a_{s50}$  = **1.1100** m<sup>2</sup>  
Time,  $t_{p75-25}$  = **N/A** secs  
Infiltration rate,  $f$  = **N/A** m/s
