# THE IRON LINE, MILLOM (ZONES 3-10) PHASE 2 GROUND INVESTIGATION REPORT

**Curtins Ref:** 080874-CUR-XX-XX-T-GE-00007

**Issue Date:** 08 April 2025

**Client Name:** Cumberland Council

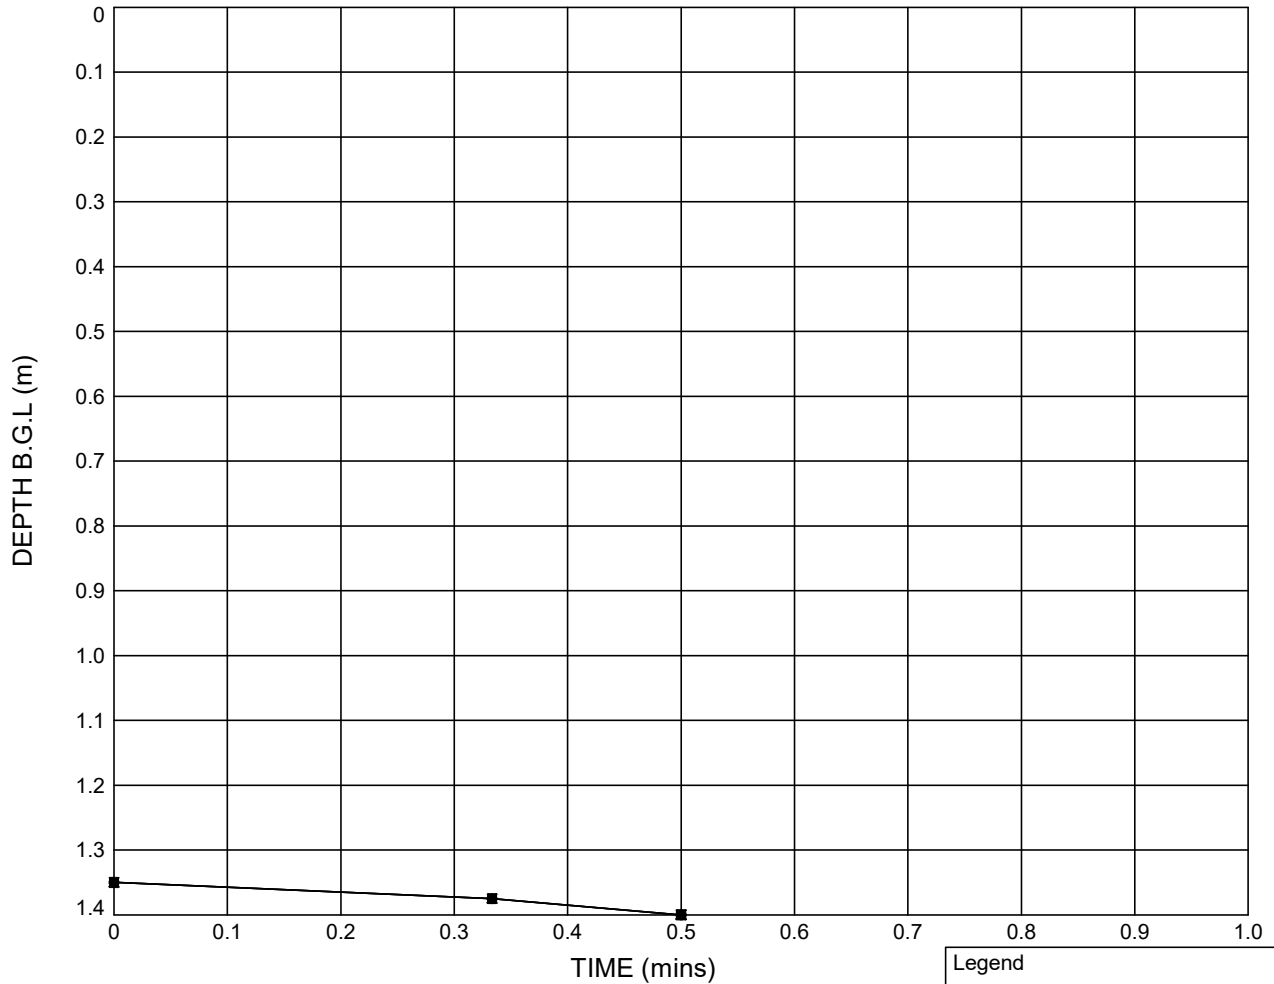
## Plot of Depth of Water Below Ground Level Against Time
