# **Combined Bat Roost Assessment and Activity report**

**Brimfull  
Haile  
Egremont  
CA22 2PD**

Prepared for: Mark and Helen Hunter  
Date: October 2025  
Reference: J123

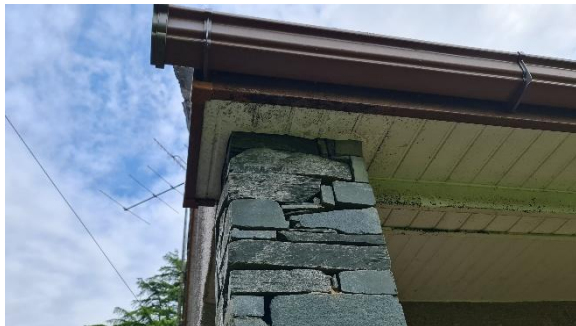
- 3.8 The walls are constructed of concrete pebble-dashed breeze block, and no gaps or crevices were evident. Soffit boxes are found the tops of the walls, on each aspect of the roof. However no obvious gaps or crevices were evident.

- 3.9 Decorative slate stone quoins are located at the two corners of what is the front of the building, on the western aspect. Two decorative slate stone pillars also form part of the entrance to the property. The slate stone facades provide minimal roosting opportunities for individual crevice dwelling species.

Photo 3: soffit and support pillar example

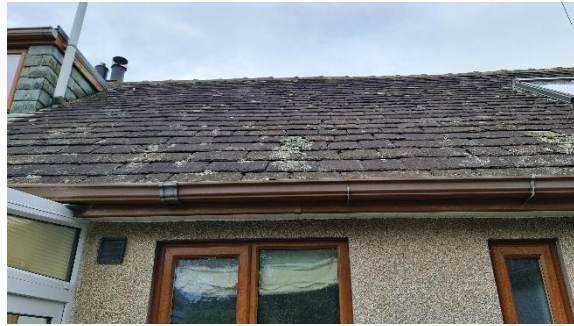
- 3.10 The roof is an open gable ended, pitched slate roof with two dormer windows on the west and a single double dormer window on the eastern side. The dormers are covered with hanging slate tiles. Gaps and crevices are noted all over the roof, providing multiple opportunities for individual bats to roost.

Photo 7: eastern roof example

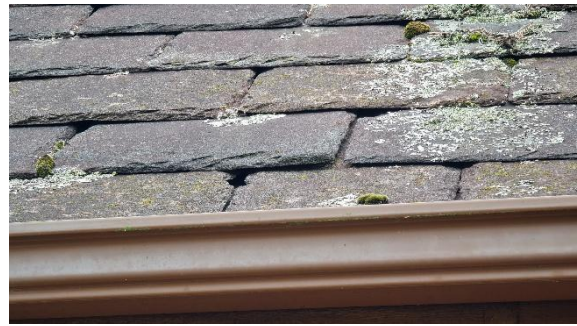
- 3.12 No bat droppings were found, and the small loft voids do not provide enough space or opportunities for void dwelling species to inhabit.
- 3.13 The greatest feature of the site is the slate roof, providing multiple opportunities for individual crevice dwelling species to roost.

Photo 8: gaps and crevices a plenty

- The best recommendation for all work involving the roof is for it to be carried out under an **Ecological Clerk of Works**.
- Due to the legal protection of bats in the UK, if any bats are unexpectedly discovered during works, all activities in that area should immediately cease and the advice of a licensed bat ecologist sought.

- As it has been found that breathable roofing membranes (BRM's) pose risk of entrapment to bats, they should not be used in locations where bats are likely to roost. Either Type 1F hessian reinforced bitumen felt should be used within the roof or measures must be taken to ensure that bats cannot come into contact with any BRM's.

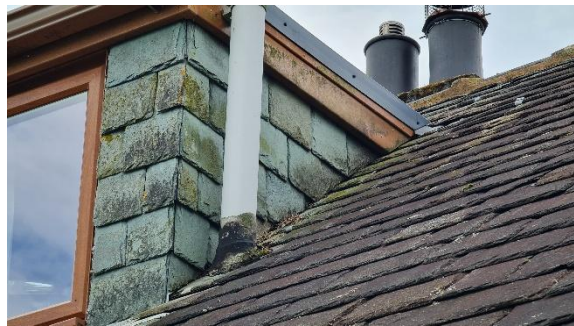
Photo 9: rear dormer window example

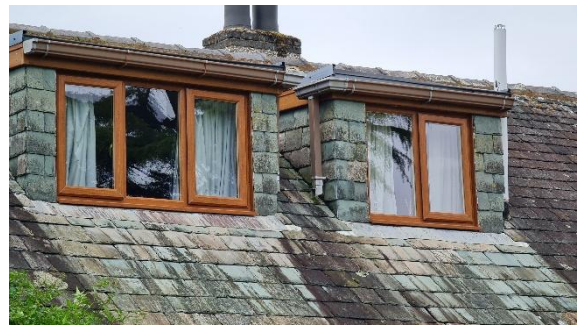
Photo 10: dormer windows

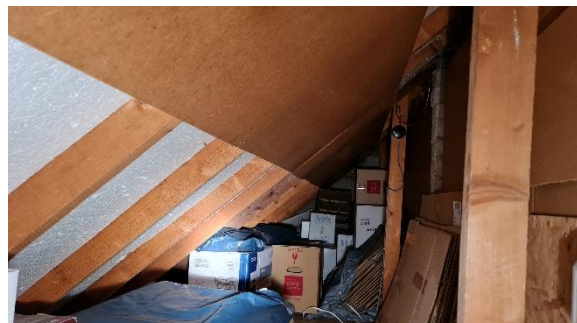
Photo 14: loft void example

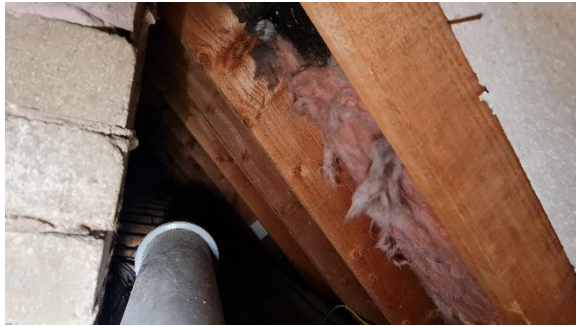
- 3.11 Internally the roof has been lined with polystyrene sheeting, held in place in a few locations with hardboard. Loft insulation has been wedged into other locations. Both types of insulation have been used to try to stop heat loss from the property.

Photo 15: insulation types

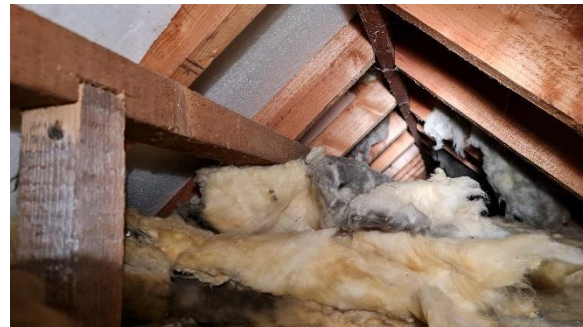
- 3.7 The survey site comprises of a two-storey bungalow, with the upper floor having been built into the loft void, leaving very small spaces set into the eaves and the apex of the roof as “attic” space.

Photo 16: apex loft void

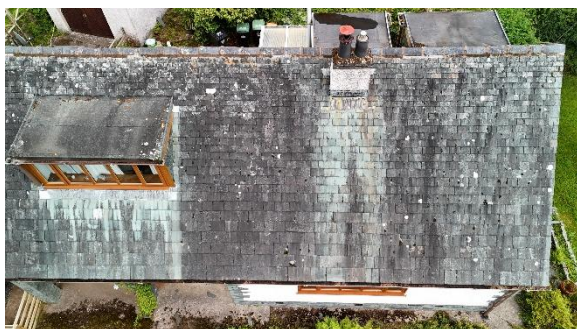
| Development Proposal | Development proposals include a single storey extension to the rear of the property, replacing the existing greenhouse, a larger full height dormer to replace the two rear singles, as well as extra sky lights and a potential solar array installed on the western roof. |

Photo 17: aera proposed for solar array

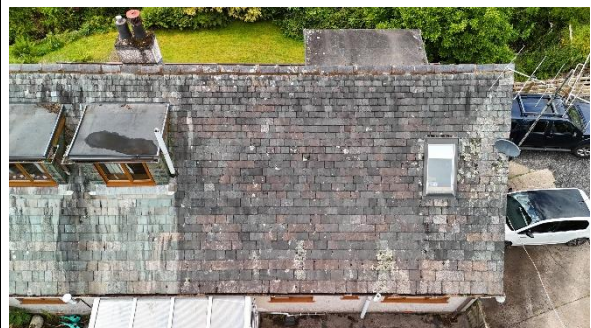
Photo 20: roofing section
