**PROPOSED HOUSING**

**QUEENS PARK MILLOM**

**TREE AND HEDGE SURVEY REPORT**

**19.03.26**

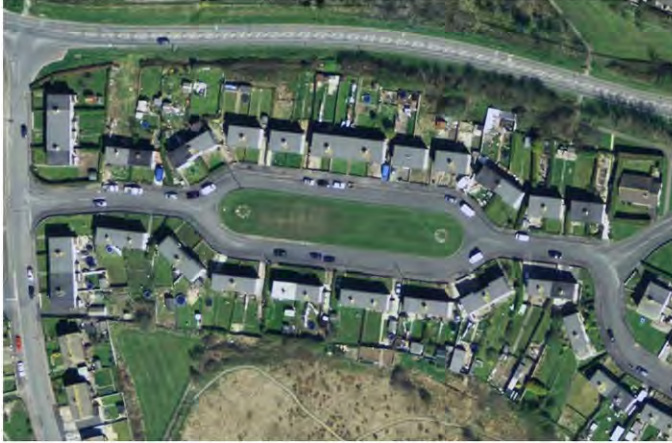
1. There are no high-quality trees on the site or adjacent to it.
2. The roadside tree group G5 encroaches onto the site ever so slightly to the south, so ownership will need to be established and there might be the need for some minor pruning to facilitate the proposals.
3. The site has previously been fully developed with houses but the vast majority have been cleared (only two remain to the north west). Aerial image below from 2010:

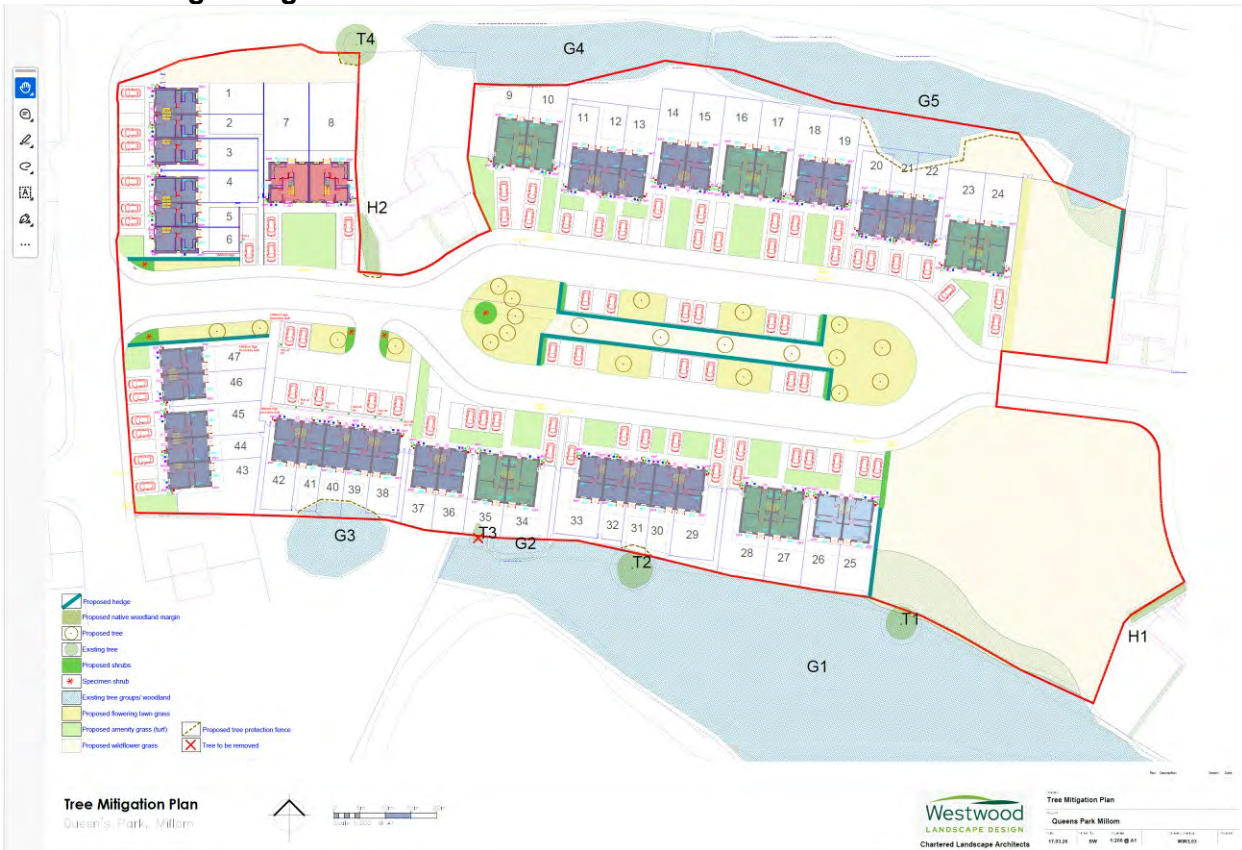
Tree and Hedge Mitigation Plan L03

4.1 Refer to Tree Mitigation Plan L03 for location of trees to be retained and extent of Root Protection Areas (RPA's) which form a Construction Exclusion Zone (CEZ).

7.2.5. Canopy obstruction: Some pruning to the tree group margins to groups G3 and G5 will be required to avoid obstruction and damage in the Construction Phase. Refer to the clearance areas indicated on the Tree Mitigation Plan L03.

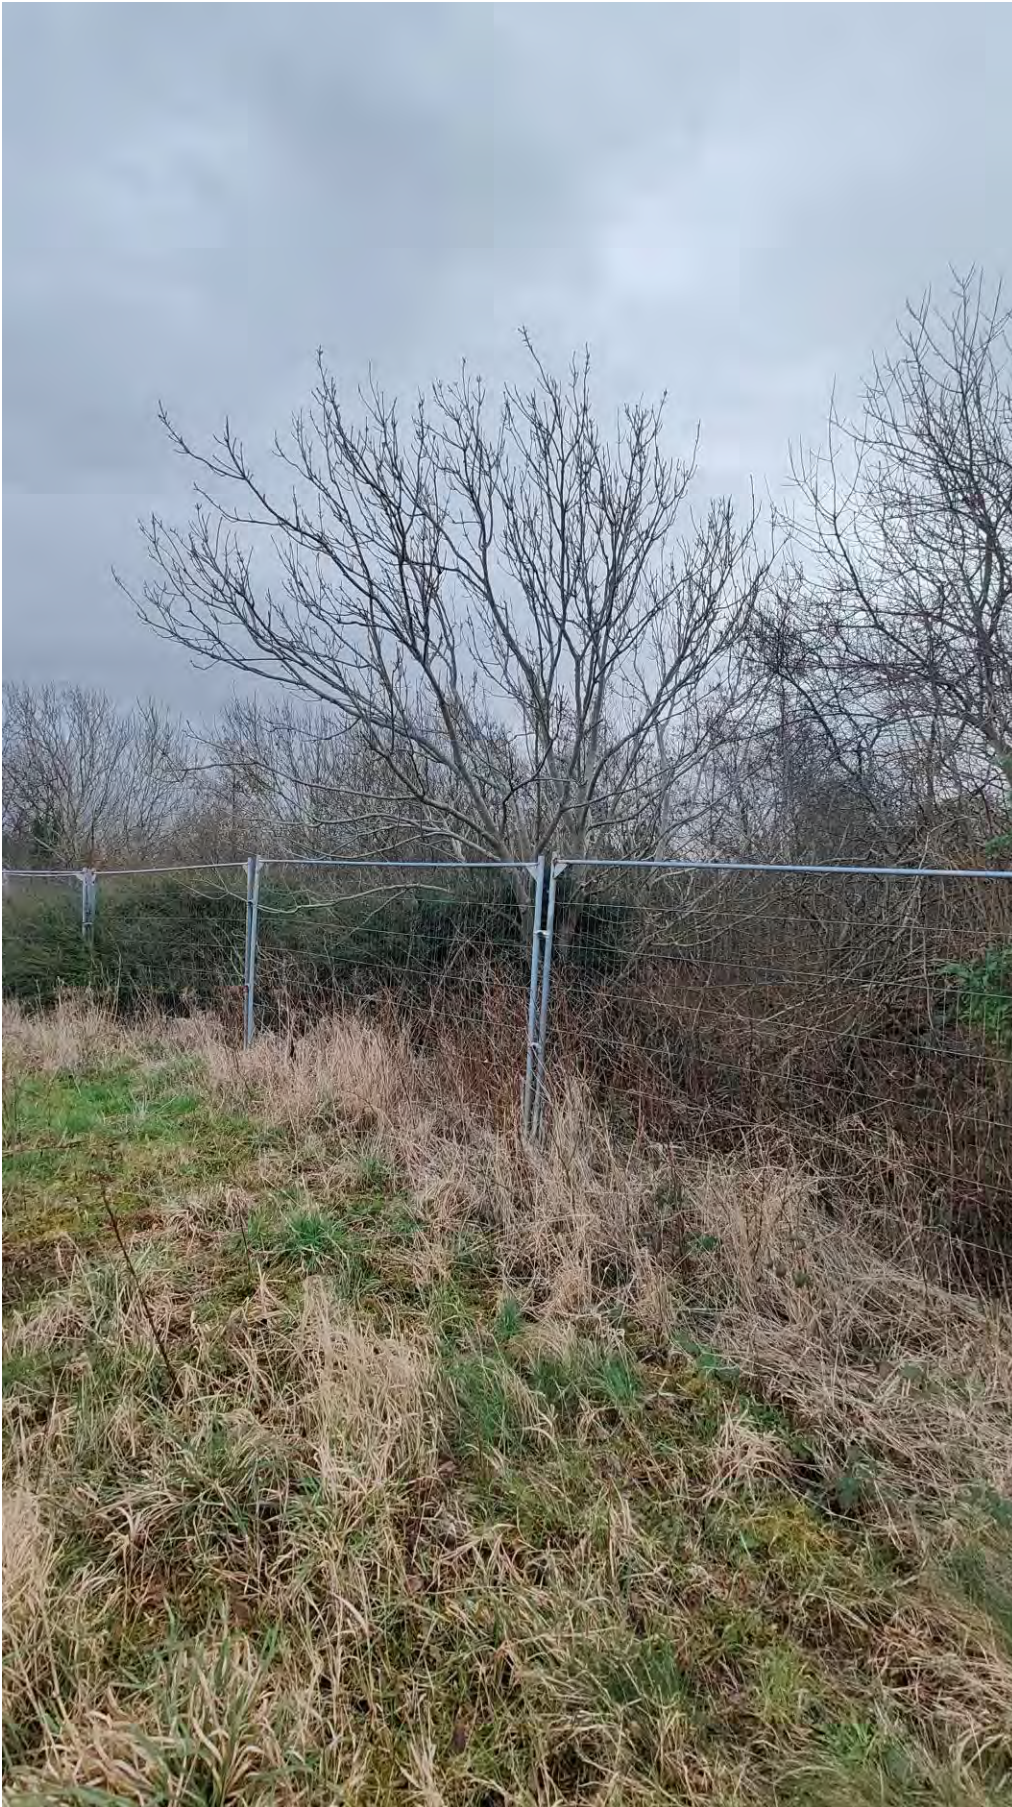
**1. Tree T1 Ash**

| Tree ID | Common Name | Botanical Name | Height (m) | Calc. / Actual Stem Dia. (mm) | Crown spread (m) | | | | Height (m) & Orientation of First Significant Branch | Life Stage | General Observations | Preliminary Recommendations | Estimated Remaining Contribution (Years) | BS5837: 2012 Category |
|---|---|---|---|---|---|---|---|---|---|---|---|---|---|---|
| T1 | Ash | <i>Fraxinus excelsior</i> | 8m | 220; 200; 150 | 3.5 | 3 | 3 | 3 | 0.5m East | Middle aged | On adjacent land, ash dieback class 2. | Monitor. | 10 - 20 | C |

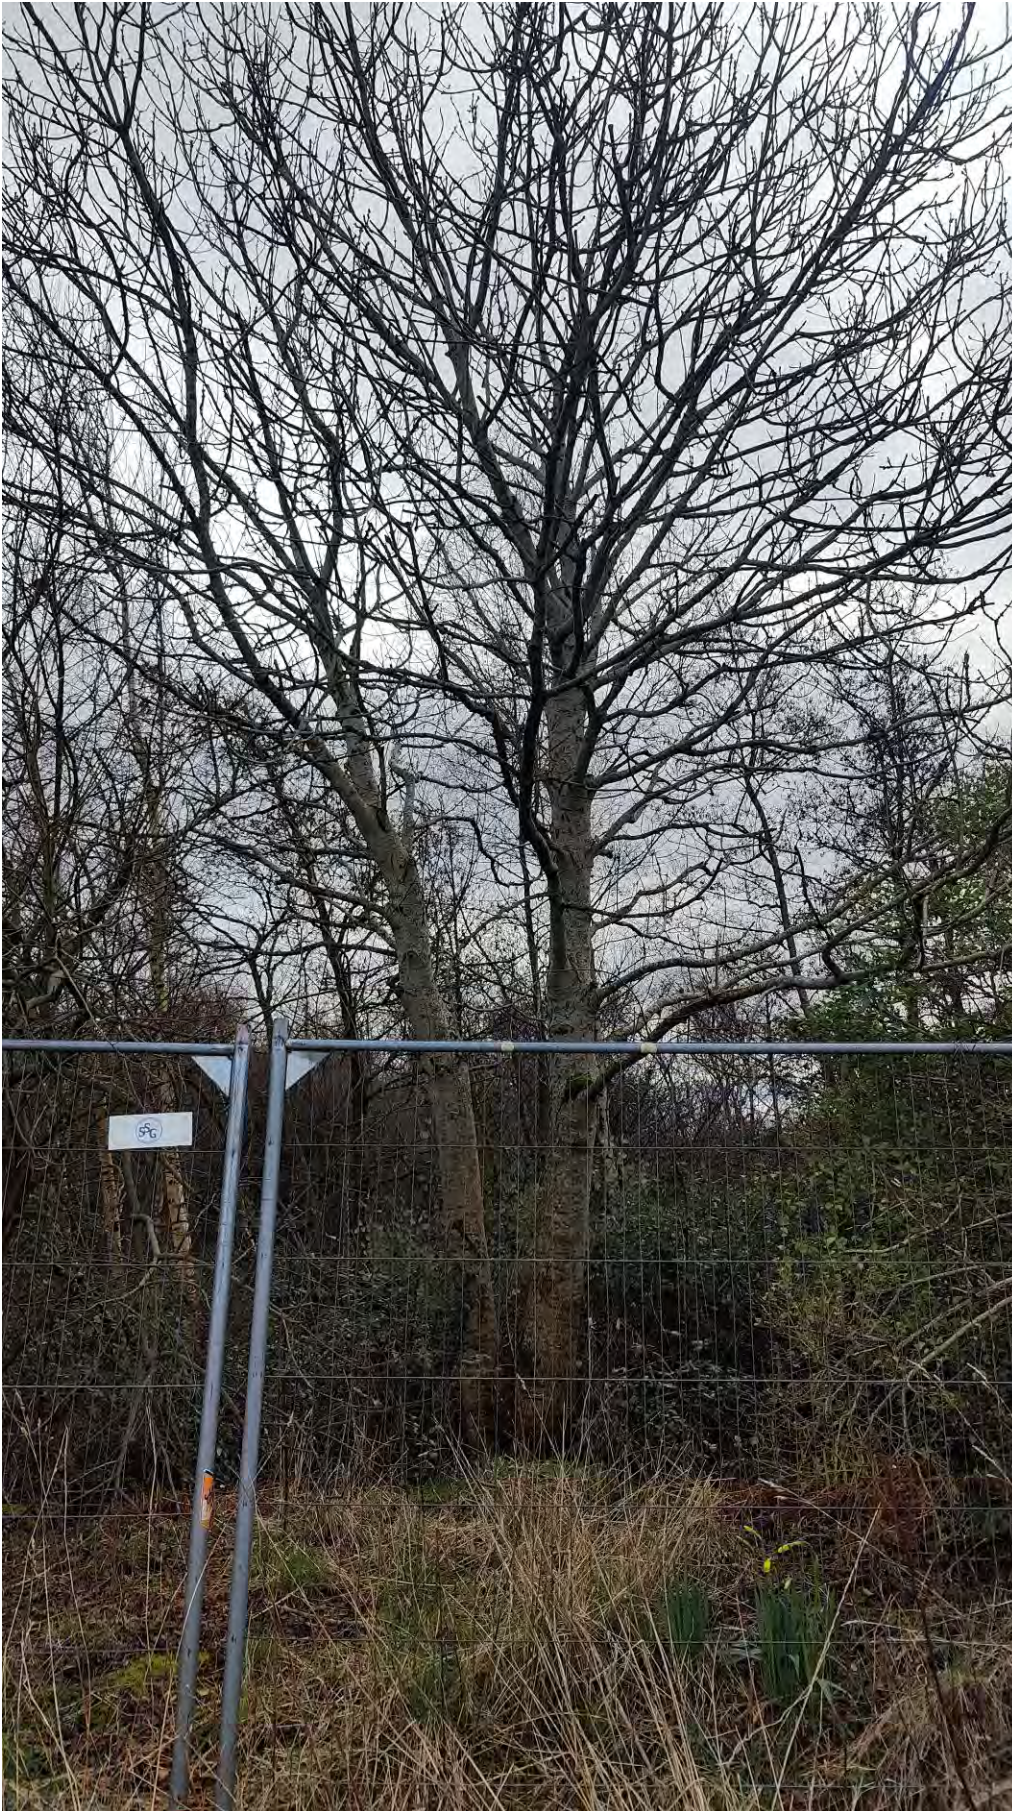
**2. Tree T2 Ash**

| Tree ID | Common Name | Botanical Name | Height (m) | Calc. / Actual Stem Dia. (mm) | Crown spread (m) | | | | Height (m) & Orientation of First Significant Branch | Life Stage | General Observations | Preliminary Recommendations | Estimated Remaining Contribution (Years) | BS5837: 2012 Category |
|---|---|---|---|---|---|---|---|---|---|---|---|---|---|---|
| T2 | Ash | <i>Fraxinus excelsior</i> | 6m | 350; 120 | 3 | 4 | 3 | 4 | 1.8m North | Middle aged | Twin stem tree on adjacent land, ash dieback class 2. | Monitor. | 10 - 20 | C |

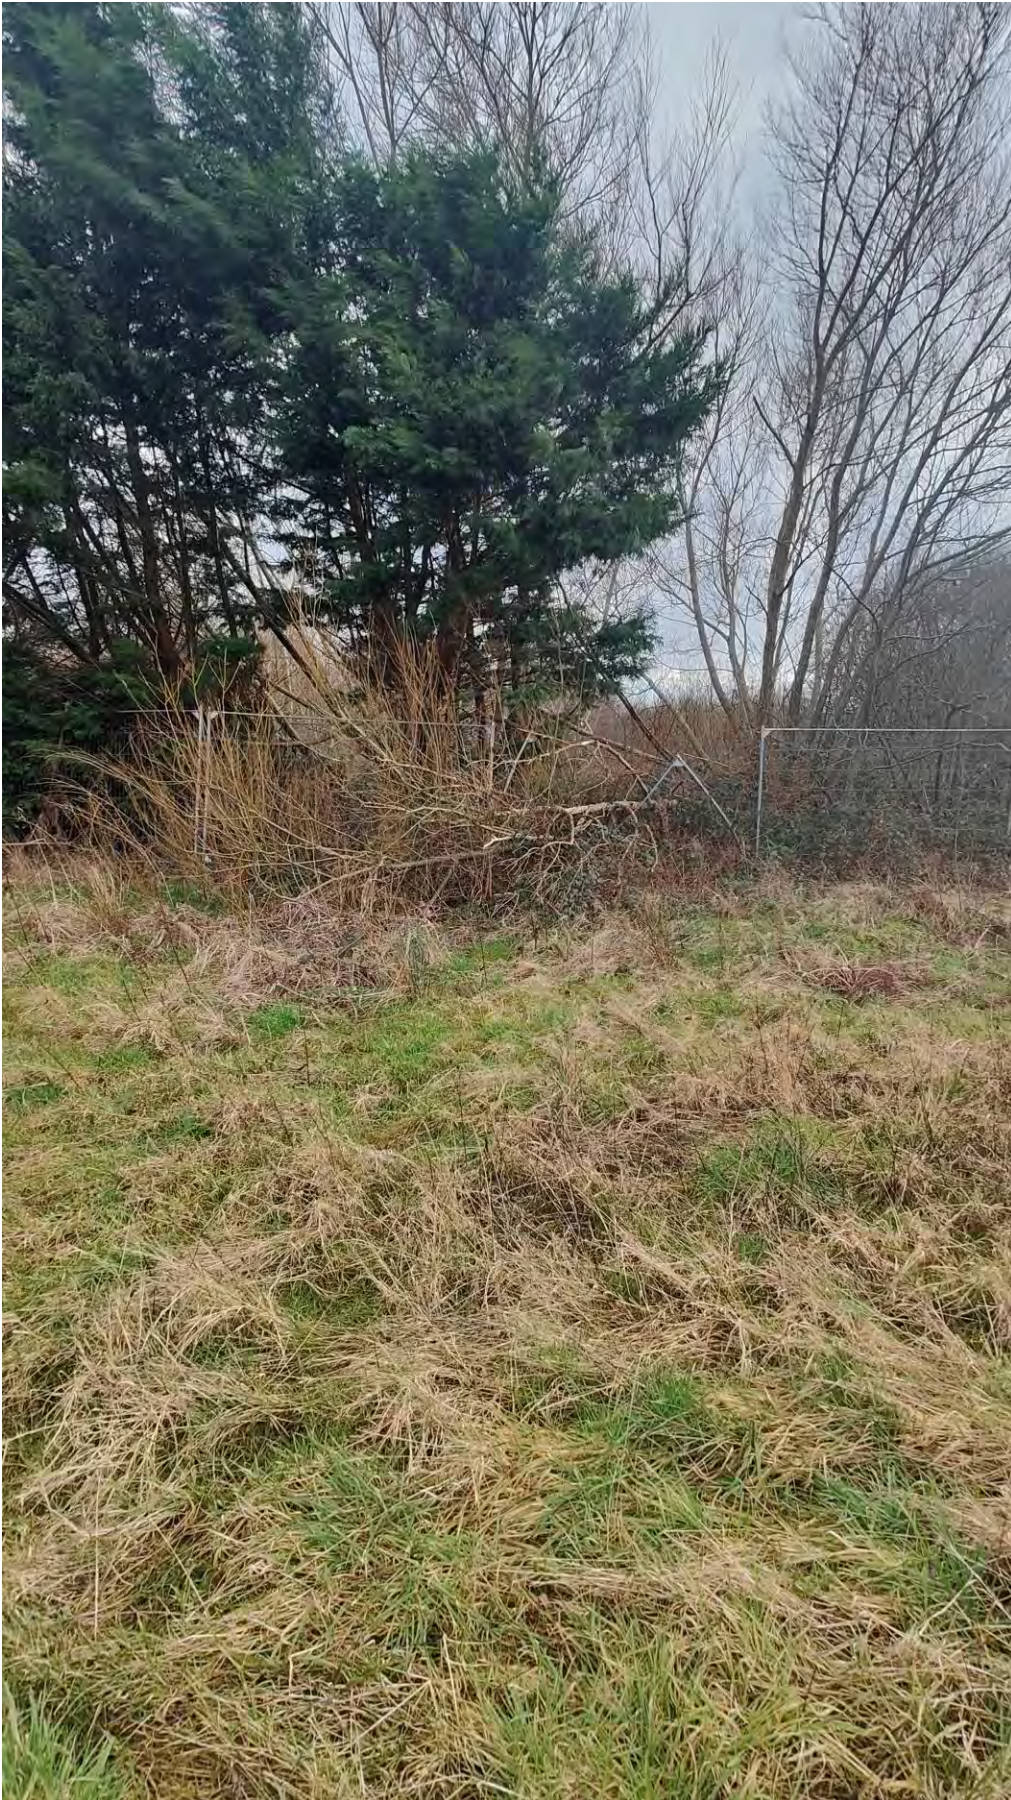
**3. Tree T3 Goat Willow fallen**

| Tree ID | Common Name | Botanical Name | Height (m) | Calc. / Actual Stem Dia. (mm) | Crown spread (m) | | | | Height (m) & Orientation of First Significant Branch | Life Stage | General Observations | Preliminary Recommendations | Estimated Remaining Contribution (Years) | BS5837: 2012 Category |
|---|---|---|---|---|---|---|---|---|---|---|---|---|---|---|
| T3 | Goat willow | <i>Salix caprea</i> | 6m | 150 | 3 | 1 | 0.5 | 1 | N/A | Dead | Windblown, dead tree. | Remove. | N/A | U |

- 2.3.1. Based on design layout in Appendix 2 the potential direct impact on the trees as a result of the proposed development will include:
- Removal of Category 'U' tree T3 which is dead
  - Pruning back the canopy of tree groups G3 and G5 to accommodate the proposed rear gardens and fencing work.
- 2.3.2. Refer to the Tree Mitigation Plan L03B which indicates an overlay of the provisional Layout Plan.

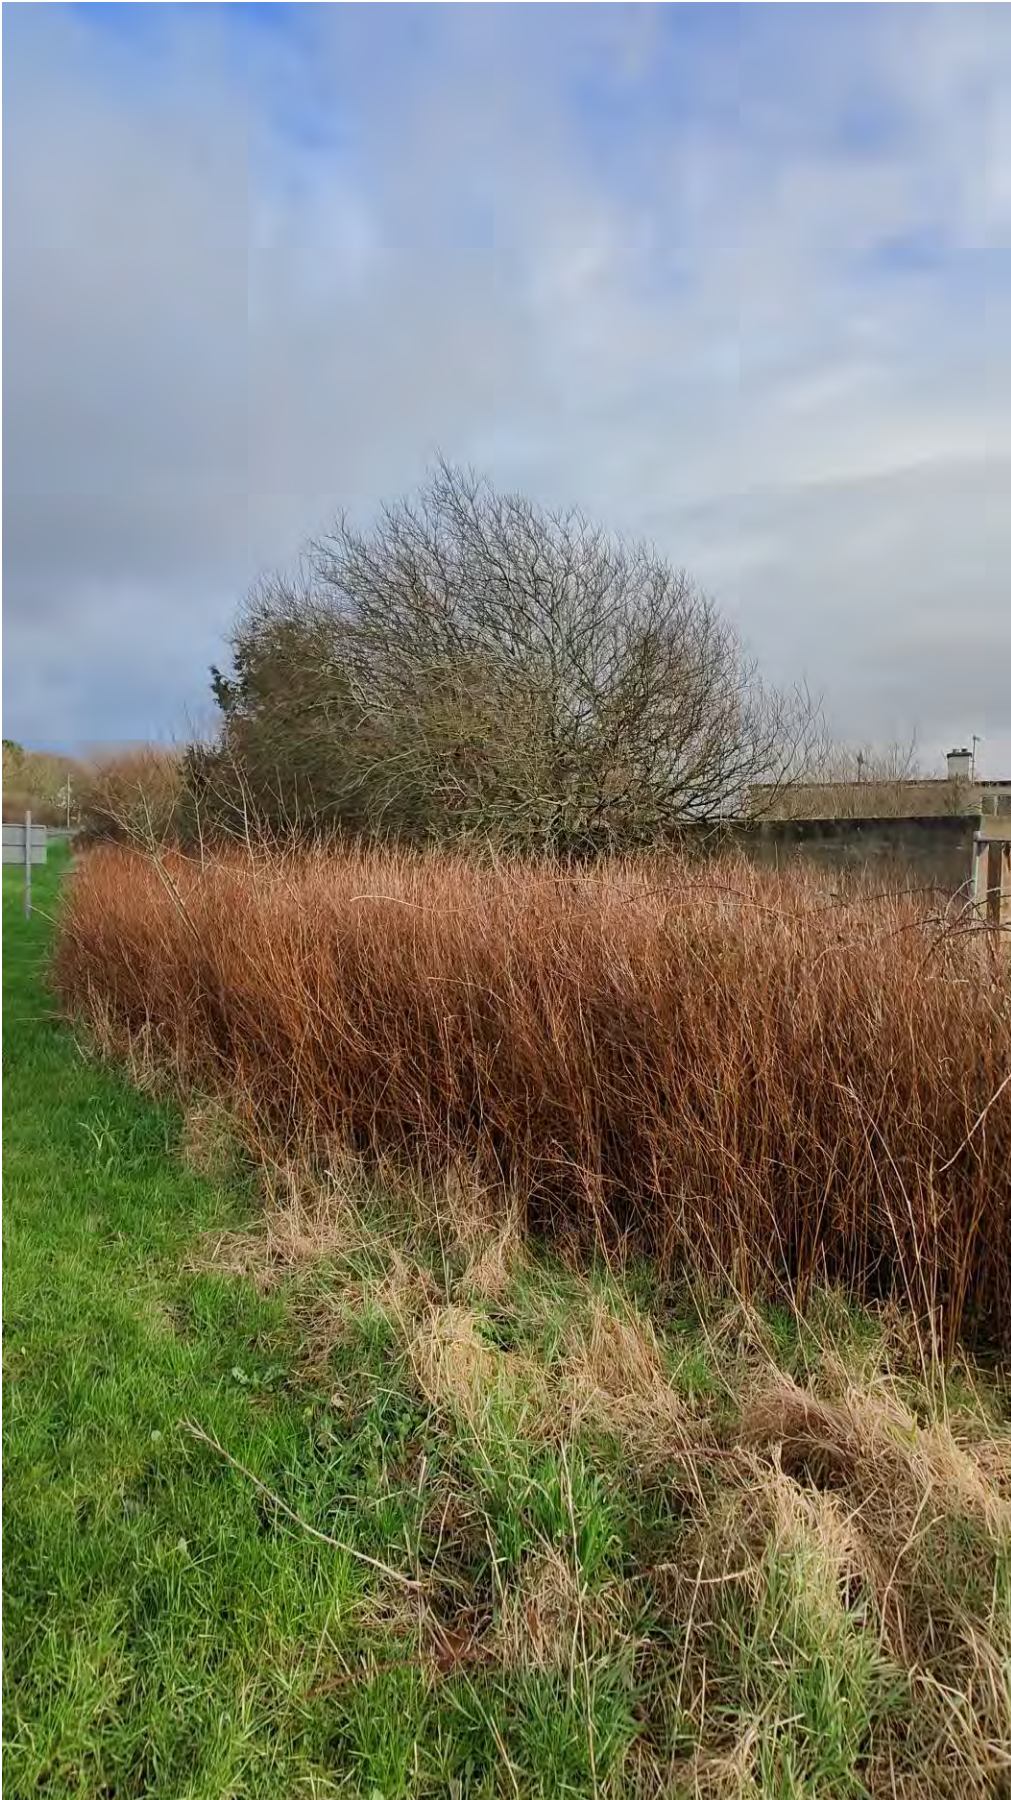
**4. Tree T4 Goat Willow**

| Tree ID | Common Name | Botanical Name | Height (m) | Calc. / Actual Stem Dia. (mm) | Crown spread (m) | | | | Height (m) & Orientation of First Significant Branch | Life Stage | General Observations | Preliminary Recommendations | Estimated Remaining Contribution (Years) | BS5837: 2012 Category |
|---|---|---|---|---|---|---|---|---|---|---|---|---|---|---|
| T4 | Goat willow | <i>Salix caprea</i> | 5m | 120; 100; 100; 90 | 4 | 4 | 4 | 4 | 1m North | Middle aged | Growing within highway verge. Multistem tree. | No work required. | 10 - 20 | C |

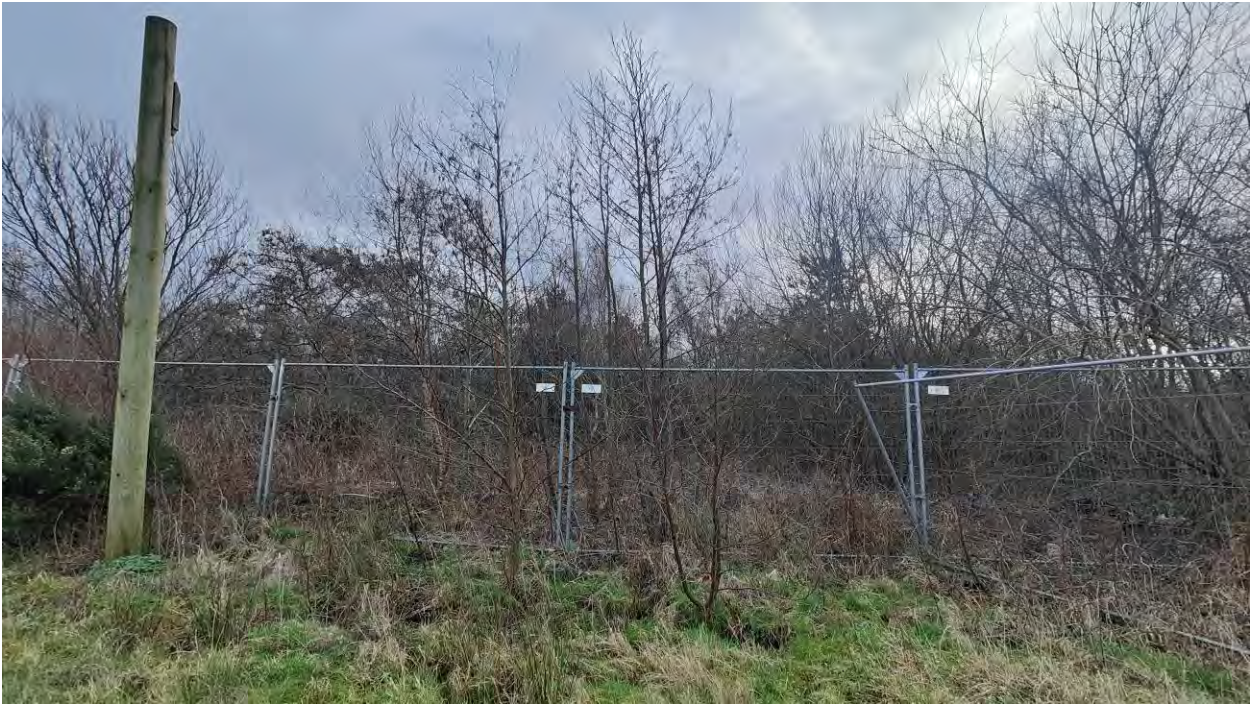
**5. Tree group G1**

| Group ID | Common Names | Est. No. of Trees | Average Height (m) | Calc. / Actual Stem Dia. (mm) | Crown spread (m) | | | | Life Stage | General Observations | Preliminary Recommendations | Estimated Remaining Contribution (Years) | BS5837: 2012 Category |
|---|---|---|---|---|---|---|---|---|---|---|---|---|---|
| G1 | Alder, ash, silver birch, goat willow, privet, hawthorn | 100 | 8m | 250 | | | | | Middle aged | Some fallen trees within, looks largely self-established with some plantings within. No evidence of recent management. Ownership unknown but outside of development area. | No work required. | 10 - 20 | C |

4. A number of ash trees are present with G1 and these are showing signs of ash dieback disease. Whoever owns G1 will need to monitor and proactively manage these trees.
5. Tree protection measures will need to be adequately set out and managed during construction.

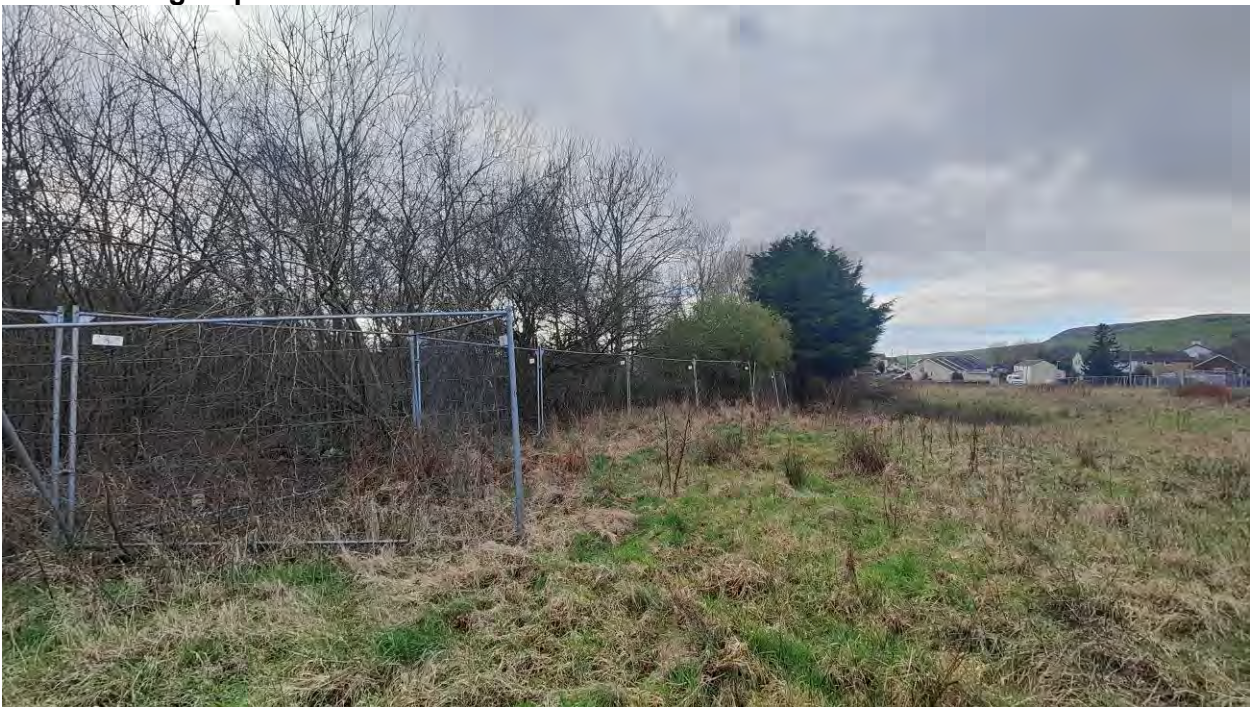
**6. Tree groups G1 and G2 Leylandii**

| Group ID | Common Names | Est. No. of Trees | Average Height (m) | Calc. / Actual Stem Dia. (mm) | Crown spread (m) | | | | Life Stage | General Observations | Preliminary Recommendations | Estimated Remaining Contribution (Years) | BS5837: 2012 Category |
|---|---|---|---|---|---|---|---|---|---|---|---|---|---|
| G2 | Leyland cypress | 7 | 14m | 400 | | | | | Middle aged | Established group of Leyland cypress on boundary, several snapped limbs and generally poor form and quality. Ownership unknown but outside of development area. | Consider removal. | 10 - 20 | C |

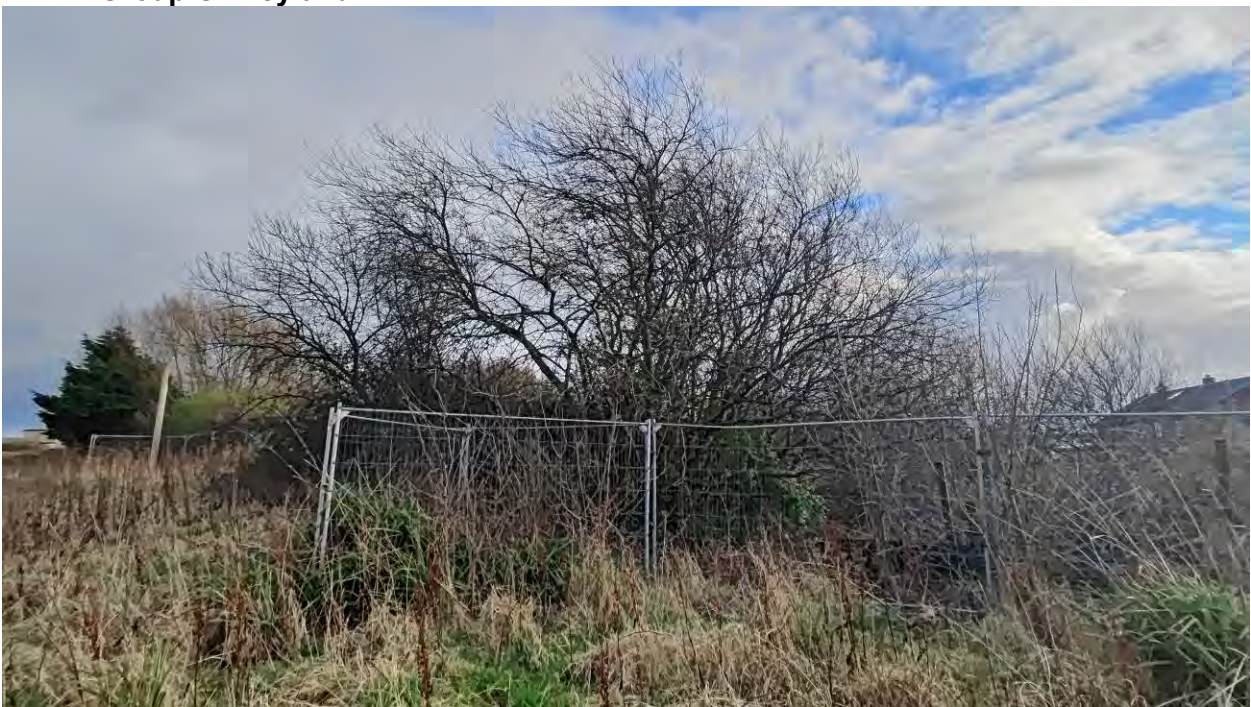
**8. Tree group G3 Goat Willow**

| Group ID | Common Names | Est. No. of Trees | Average Height (m) | Calc. / Actual Stem Dia. (mm) | Crown spread (m) | | | | Life Stage | General Observations | Preliminary Recommendations | Estimated Remaining Contribution (Years) | BS5837: 2012 Category |
|---|---|---|---|---|---|---|---|---|---|---|---|---|---|
| G3 | Goat willow | 3 | 6m | 250 | | | | | Middle aged | Group of three multistem goat willow trees on adjacent land. In future could be coppiced. | No work required. | 10 - 20 | C |

3.7. The pruning to tree groups G3 and G5 to accommodate the development will cause a negligible reduction in landscape and amenity value although the integrity of the field boundaries and tree groups will be maintained.

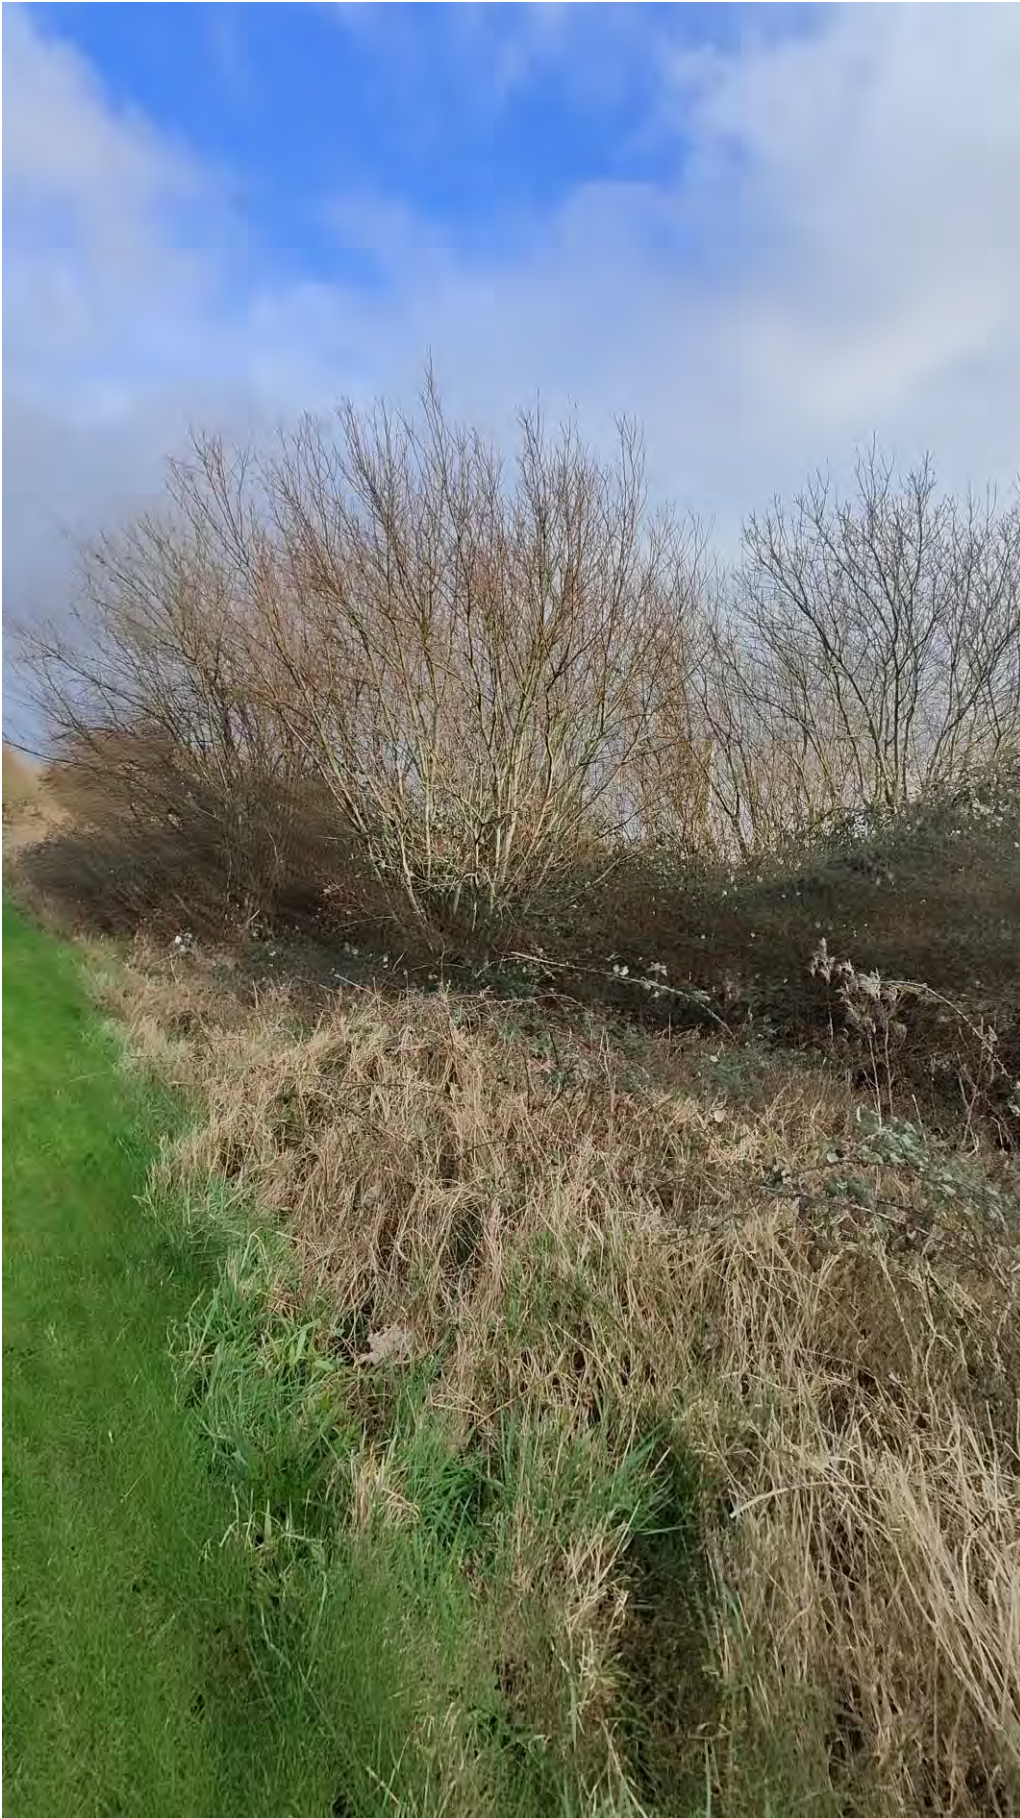
**9. Tree group G4**

| Group ID | Common Names | Est. No. of Trees | Average Height (m) | Calc. / Actual Stem Dia. (mm) | Crown spread (m) | | | | Life Stage | General Observations | Preliminary Recommendations | Estimated Remaining Contribution (Years) | BS5837: 2012 Category |
|---|---|---|---|---|---|---|---|---|---|---|---|---|---|
| G4 | Goat willow | 10 | 4m | 60 | | | | | Young | Roadside group of multistem trees. | No work required. | 10 - 20 | C |

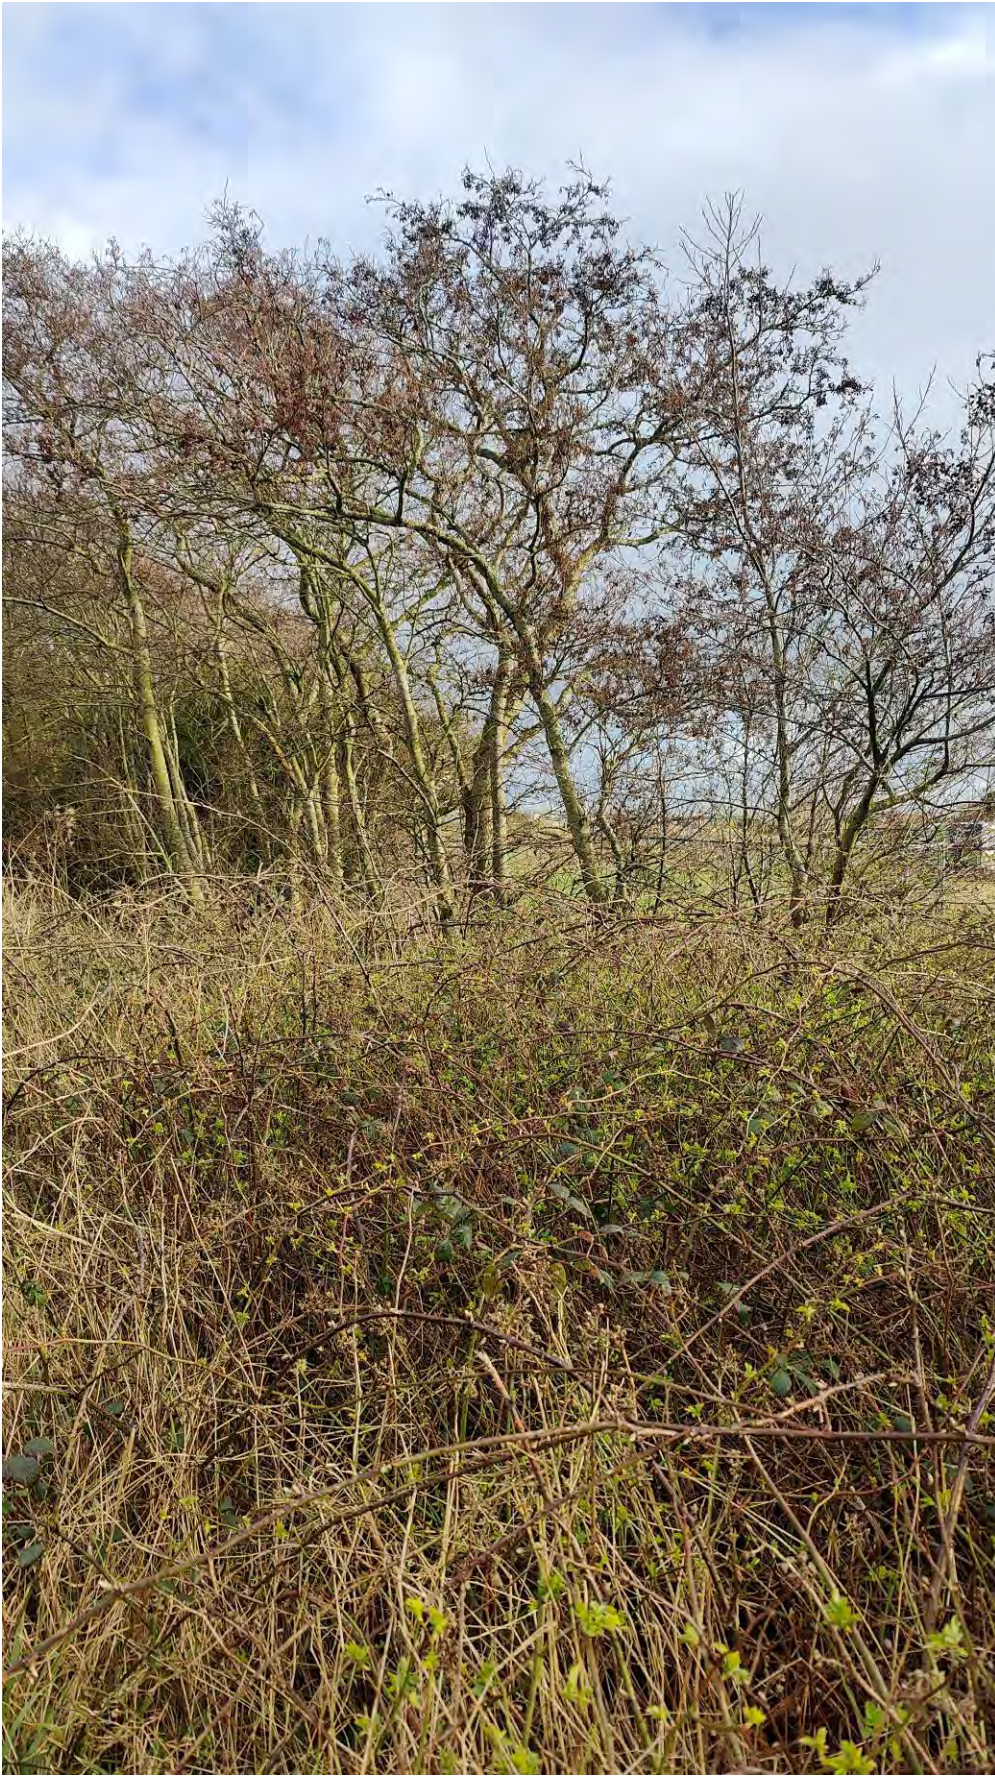
**10. Tree group G5**

| Group ID | Common Names | Est. No. of Trees | Average Height (m) | Calc. / Actual Stem Dia. (mm) | Crown spread (m) | | | | Life Stage | General Observations | Preliminary Recommendations | Estimated Remaining Contribution (Years) | BS5837: 2012 Category |
|---|---|---|---|---|---|---|---|---|---|---|---|---|---|
| G5 | Alder 90%, sycamore, goat willow | 30 | 12m | 300 | | | | | Middle aged | Roadside shelterbelt planting of largely alder trees. Largely outside of development site, small area may require pruning. | Assess if pruning is required to facilitate development. | 10 - 20 | C |

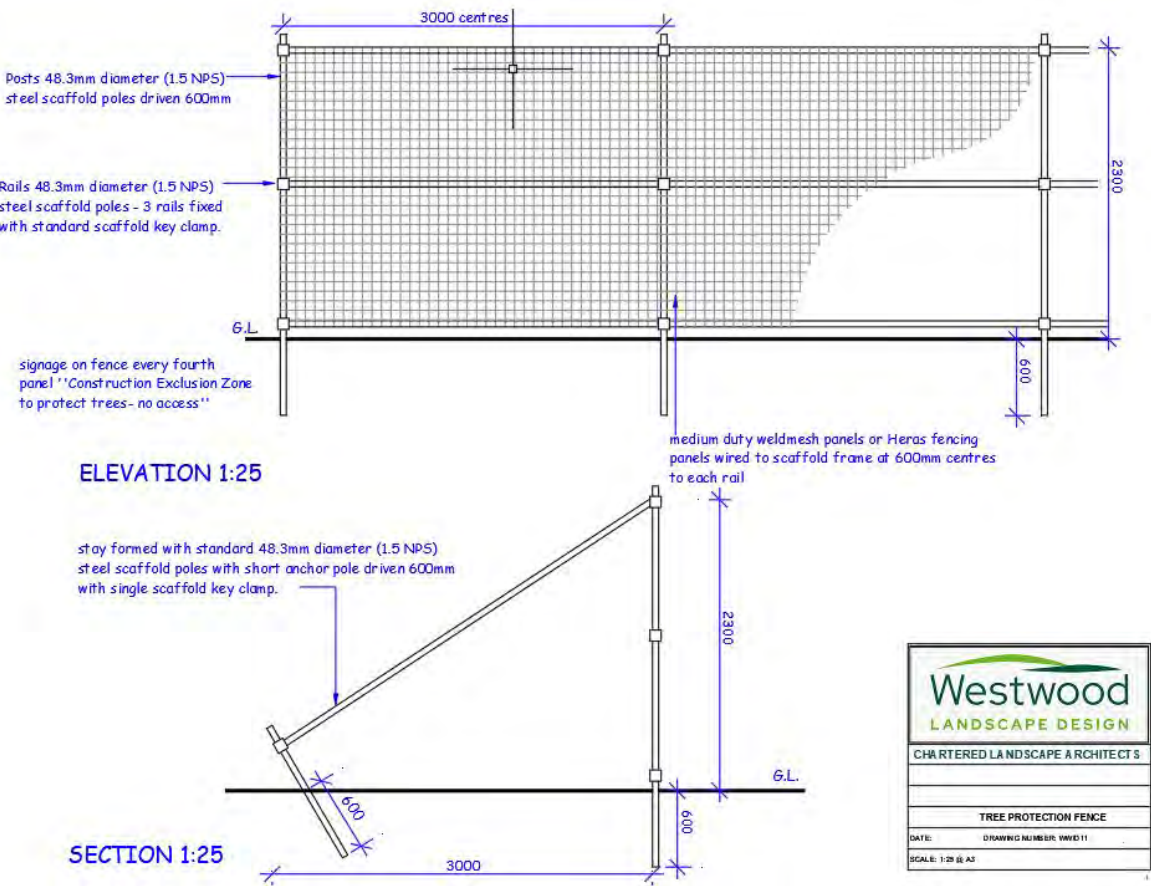
**APPENDIX 4**  
**Tree Protection Fence Detail**

4.2 Protective fencing to be erected prior to the commencement of any other work to ensure that the trees and hedges are protected in accordance with British Standard 5837:2012 Trees in Relation to Construction. Such measures shall be retained for the duration of any approved works. Refer to detailed fencing drawing below in the Appendix.
