**VERIFICATION REPORT  
FOR THE  
TREATMENT OF MINESHAFT  
271515-008**

**PHASE 4 EDGEHILL PARK,  
WILSON PIT ROAD,  
WHITEHAVEN**

**Prepared for  
STORY HOMES LIMITED**

**Report No. 4046-G-R035**

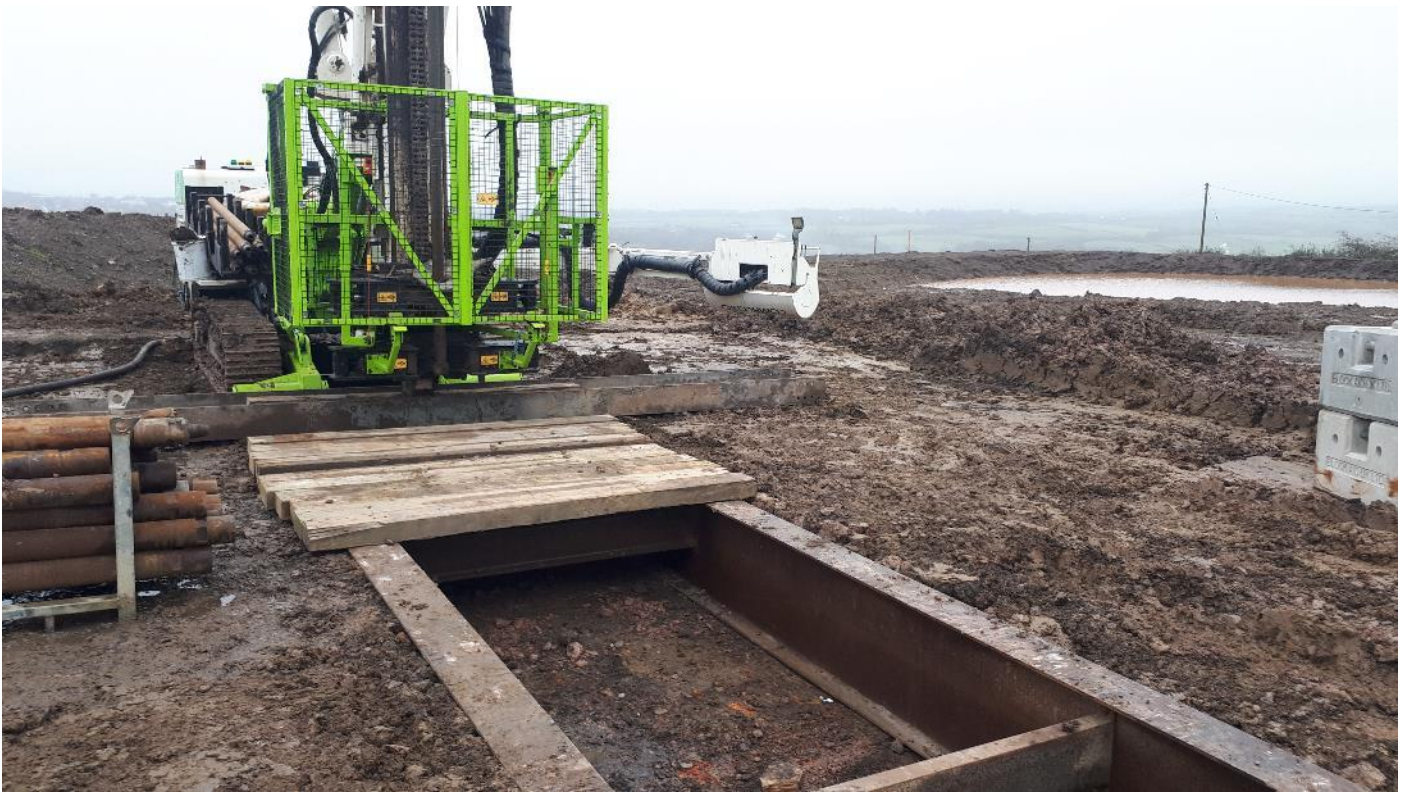
Photograph 1: Rig setup over shaft using shaft safety platform.

- 4.1.1 The contractor, Sirius mobilised to site on Monday 19<sup>th</sup> February 2024.
- 4.1.2 A steel safety platform shall was established centrally over the recorded position of the shaft, on which the drilling rig was positioned.

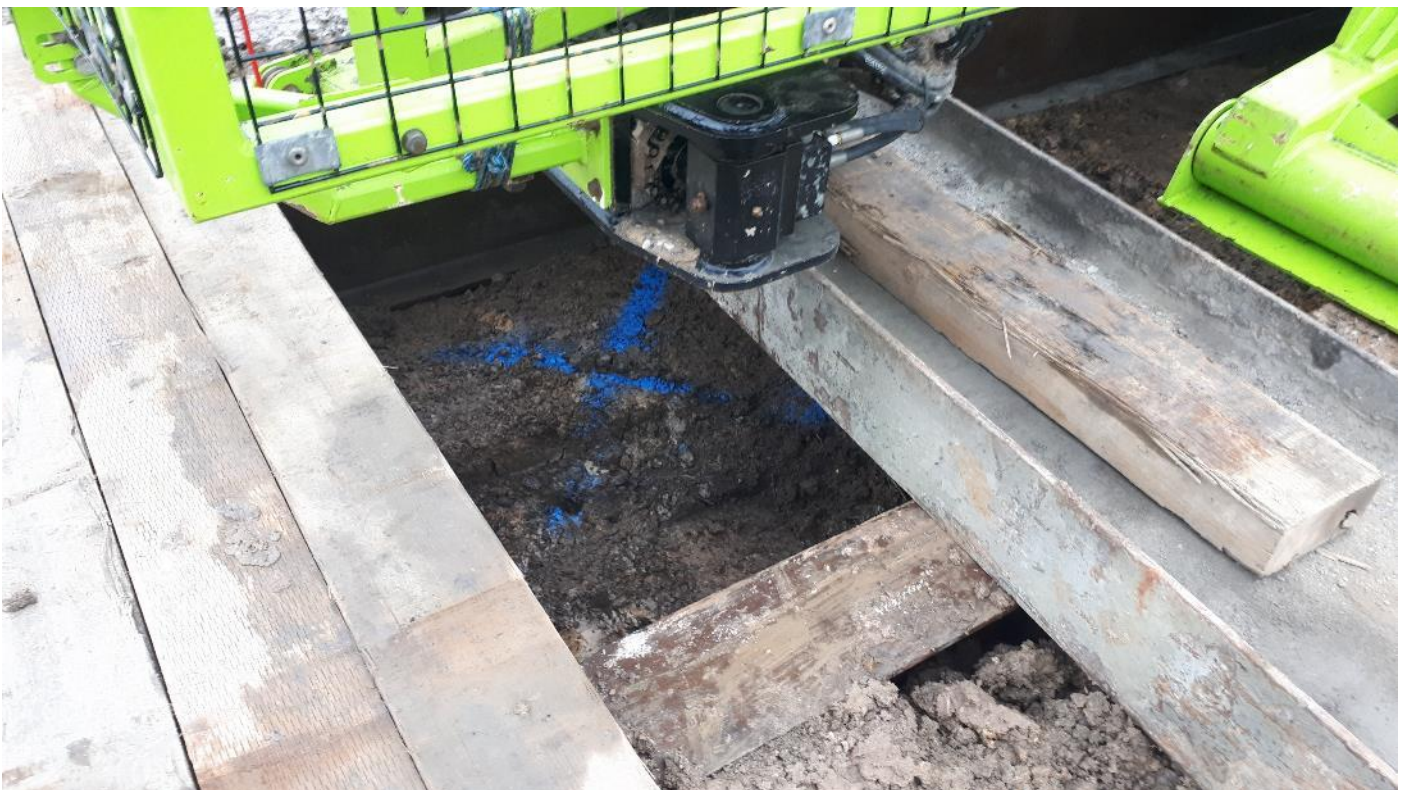
Photograph 2: Survey Position of centre of shaft.

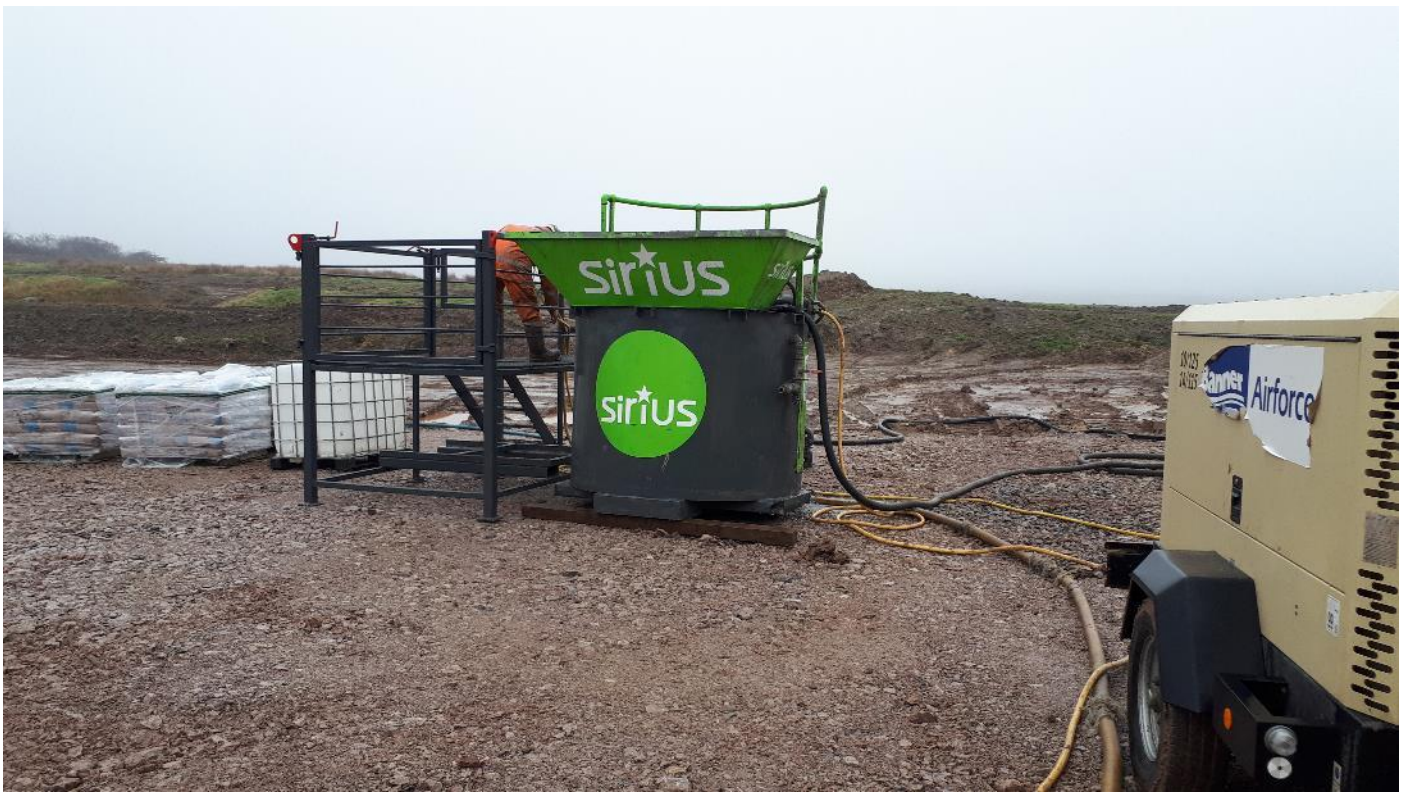
Photograph 3: Grout mixer, platform, compressor and OPC stockpile.

- 5.3.1 Grout was mixed at a ratio of 9:1 (PFA:OPC) using a small 4 tonne mixing plant with separate grout pump.

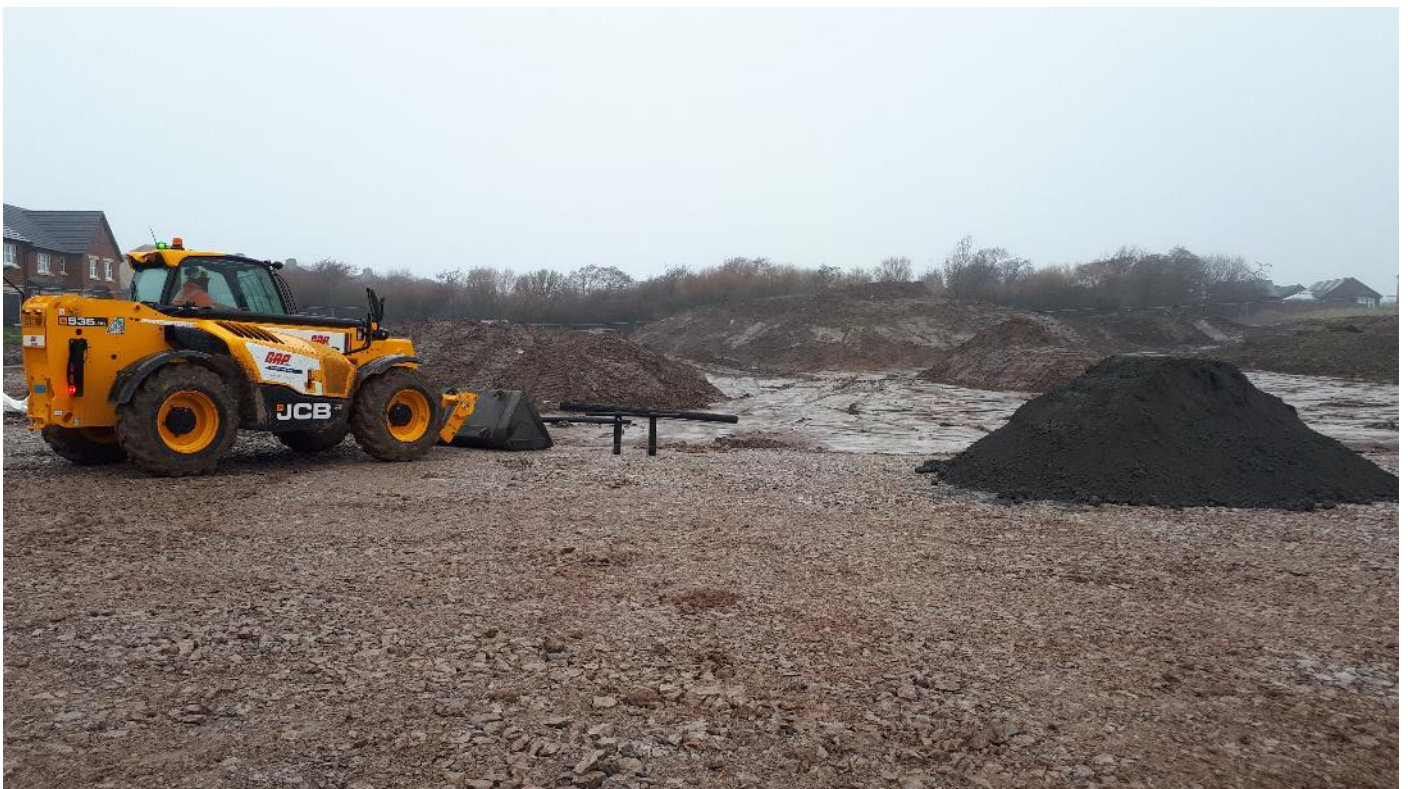
Photograph 4: Telescopic loader and delivery 1 of PFA.

- 5.2.1 Ninety-three tonnes of pulverised fuel ash (PFA) was delivered in bulk to the site on 19<sup>th</sup> and 21<sup>st</sup> February 2024.

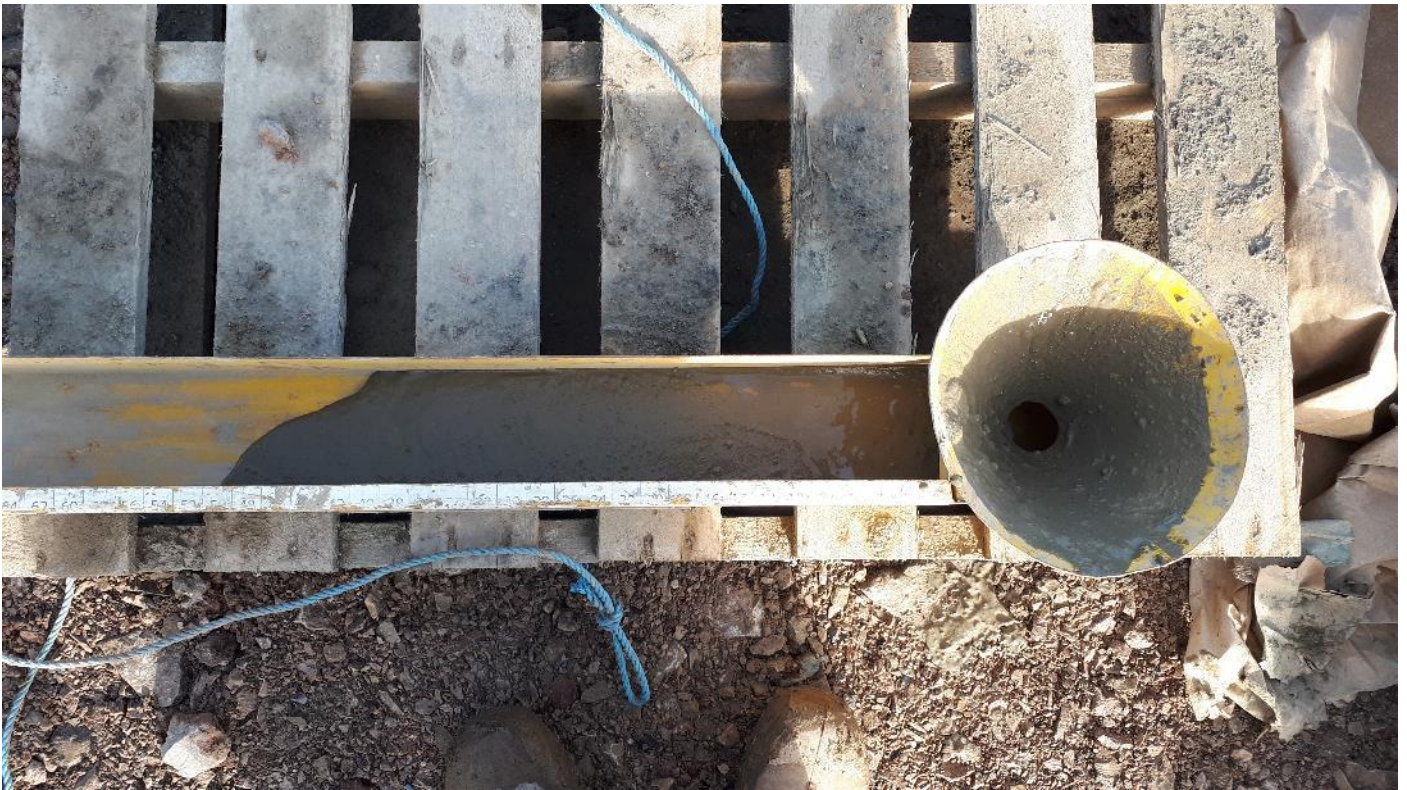
Photograph 5: Flow test.

- 5.4.1 Flowability tests were undertaken on samples tested using a Colcrete flow meter. Flow test results of 400mm to 500mm are indicated on the drillers logs.

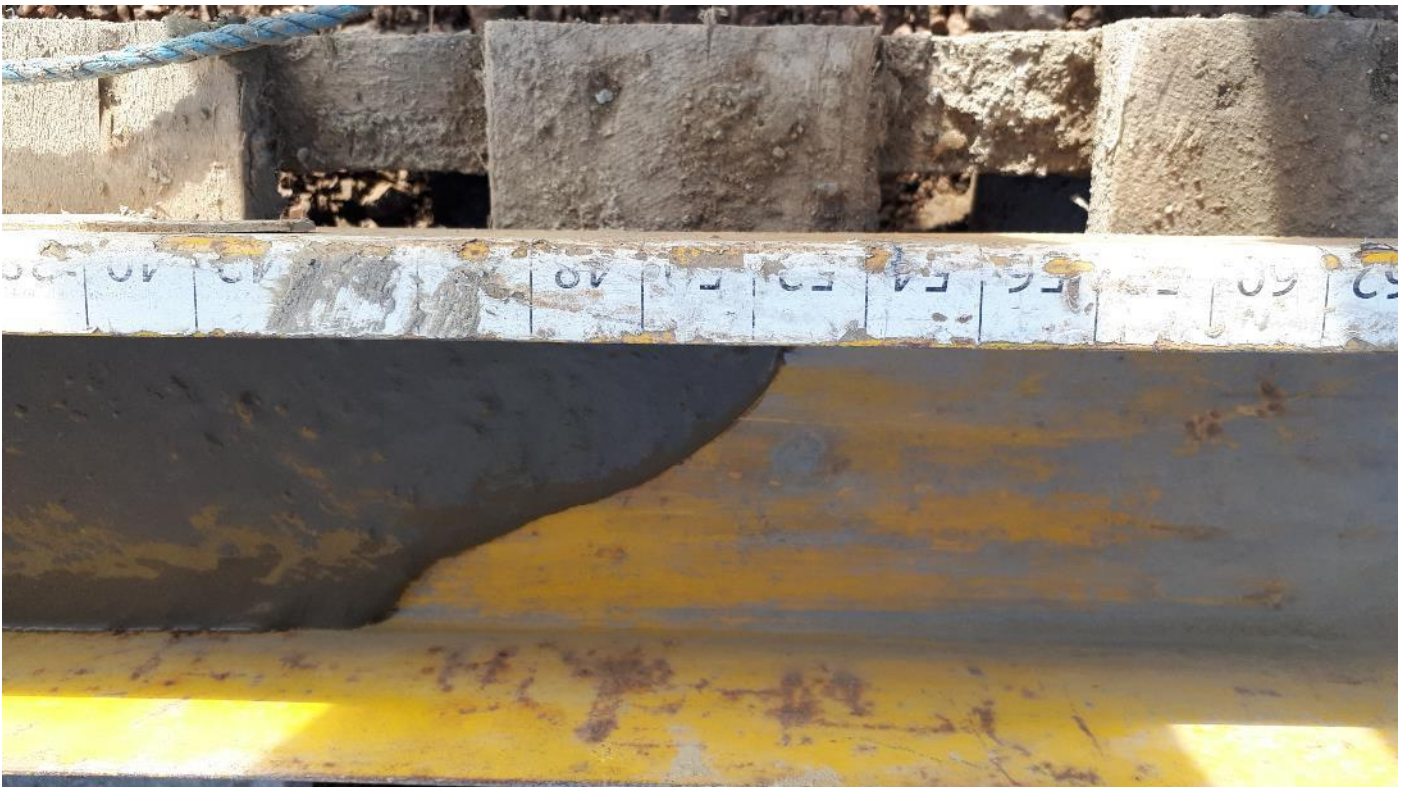
Photograph 6: Flow test at approximately 450mm.

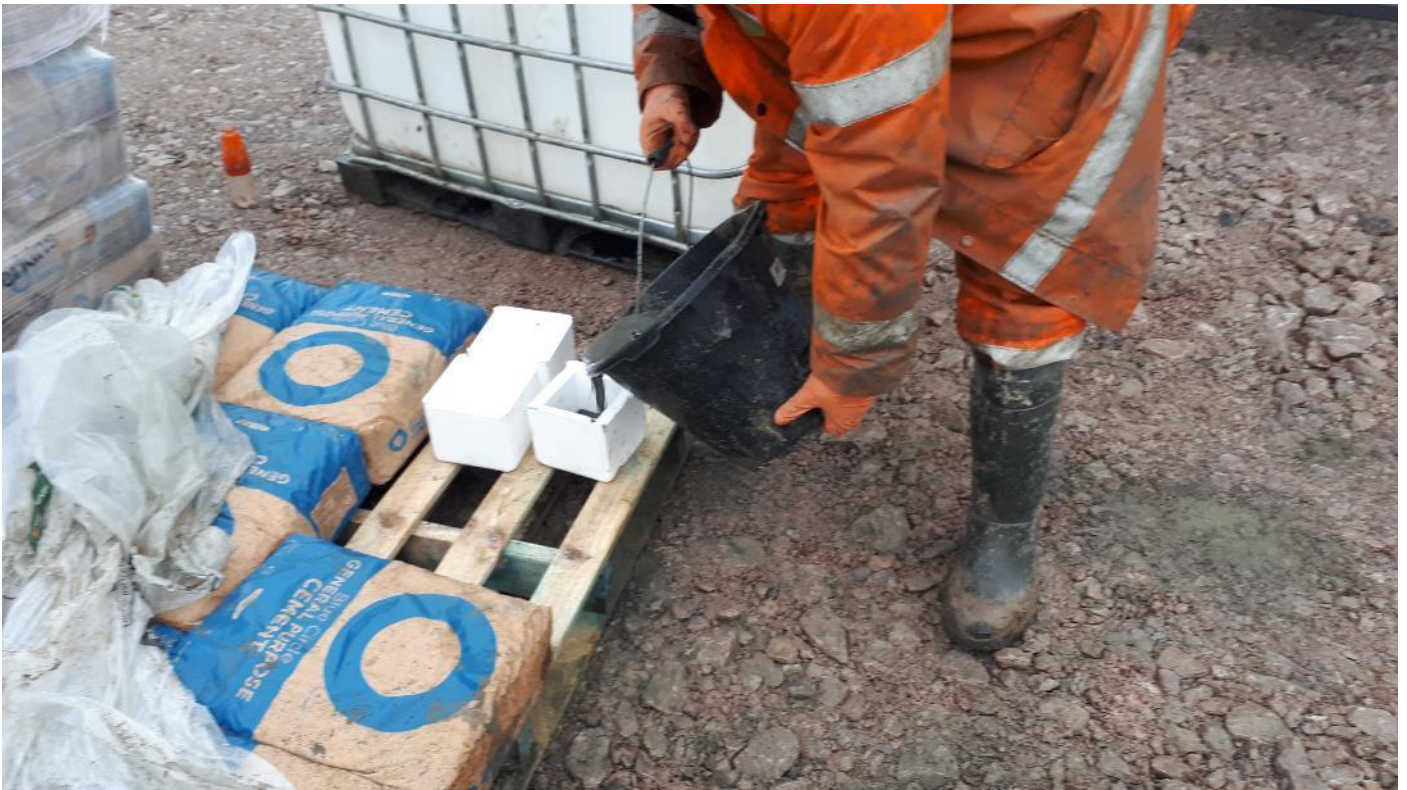
Photograph 7: Set of three grout cubes being cast.

- 5.4.2 Bleed tests were conducted with a range of 1% - 3% bleed recorded on each test as indicated on drillers logs.
- 5.4.3 The Contractor prepared three sets of 3 test cubes on 20<sup>th</sup>, 21<sup>st</sup> and 26<sup>th</sup> February 2024. The Contractor arranged for 3 samples to be tested by crushing at 7 days and three at 28 days in accordance with BS1881. Test results undertaken by an independent laboratory are presented in Appendix E. 7-day strength tests (actually 8-9 days) range from 0.5 N/mm<sup>2</sup> (0.5 MN/m<sup>2</sup>) to 1.0 N/mm<sup>2</sup> (1.0 MN/m<sup>2</sup>) which are all in excess of the minimum interim strength of 0.4 MN/m<sup>2</sup> stated in the specification. 28-day strength tests range from 1.5 N/mm<sup>2</sup> (1.5 MN/m<sup>2</sup>) to 2.8 N/mm<sup>2</sup> (2.8 MN/m<sup>2</sup>) which are all in excess of the minimum strength of 0.7 MN/m<sup>2</sup> stated in the specification.

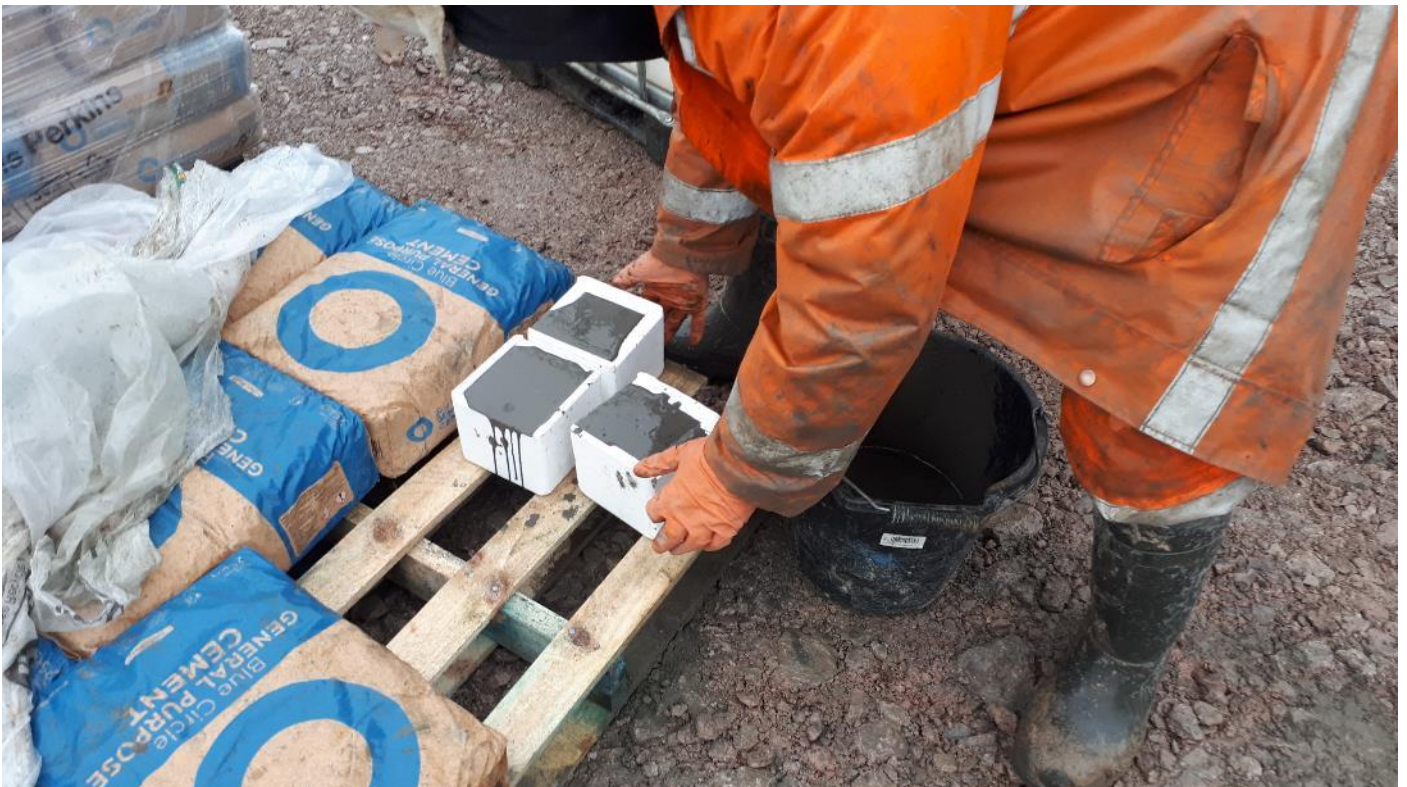
Photograph 8: Set of three grout cubes.

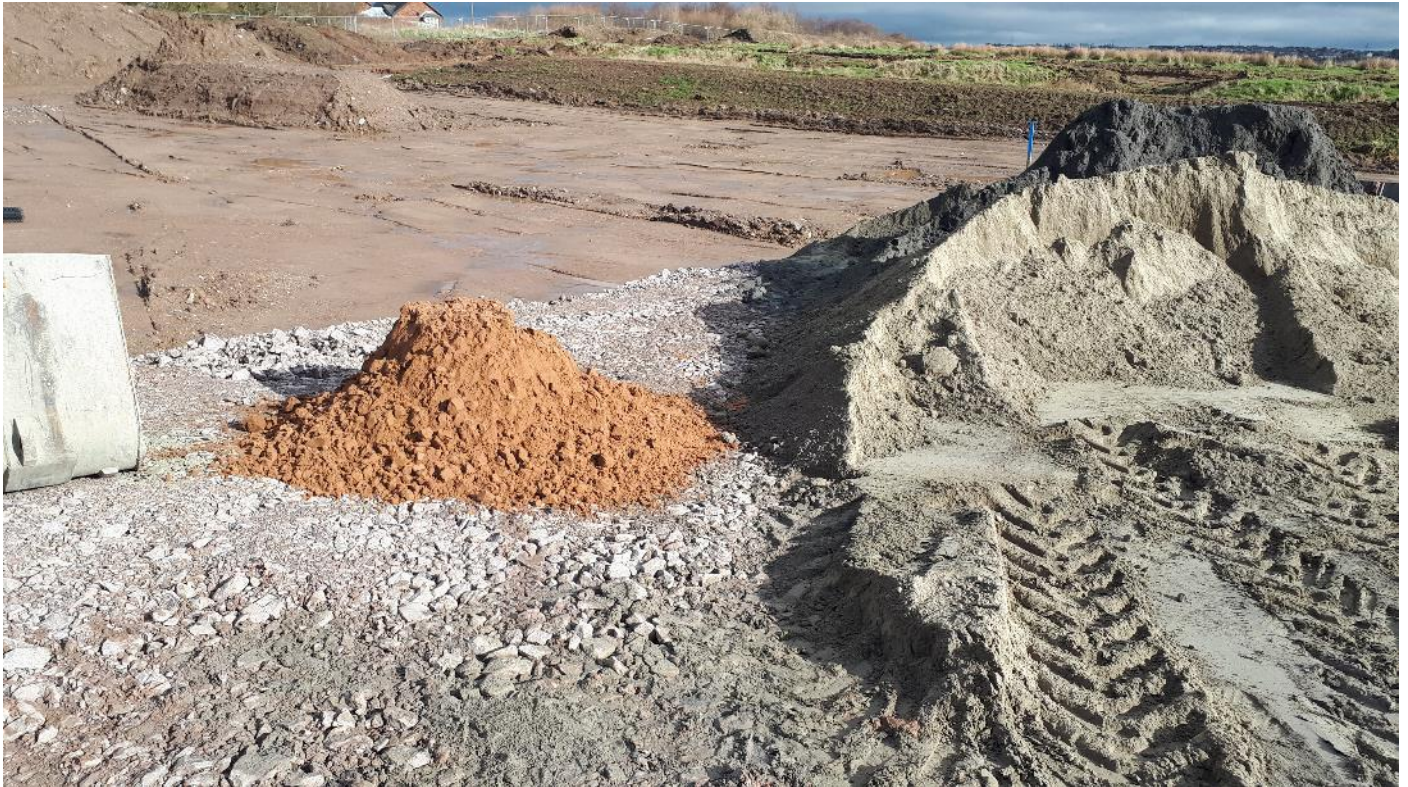
Photograph 9: Sand addition to grout mix.

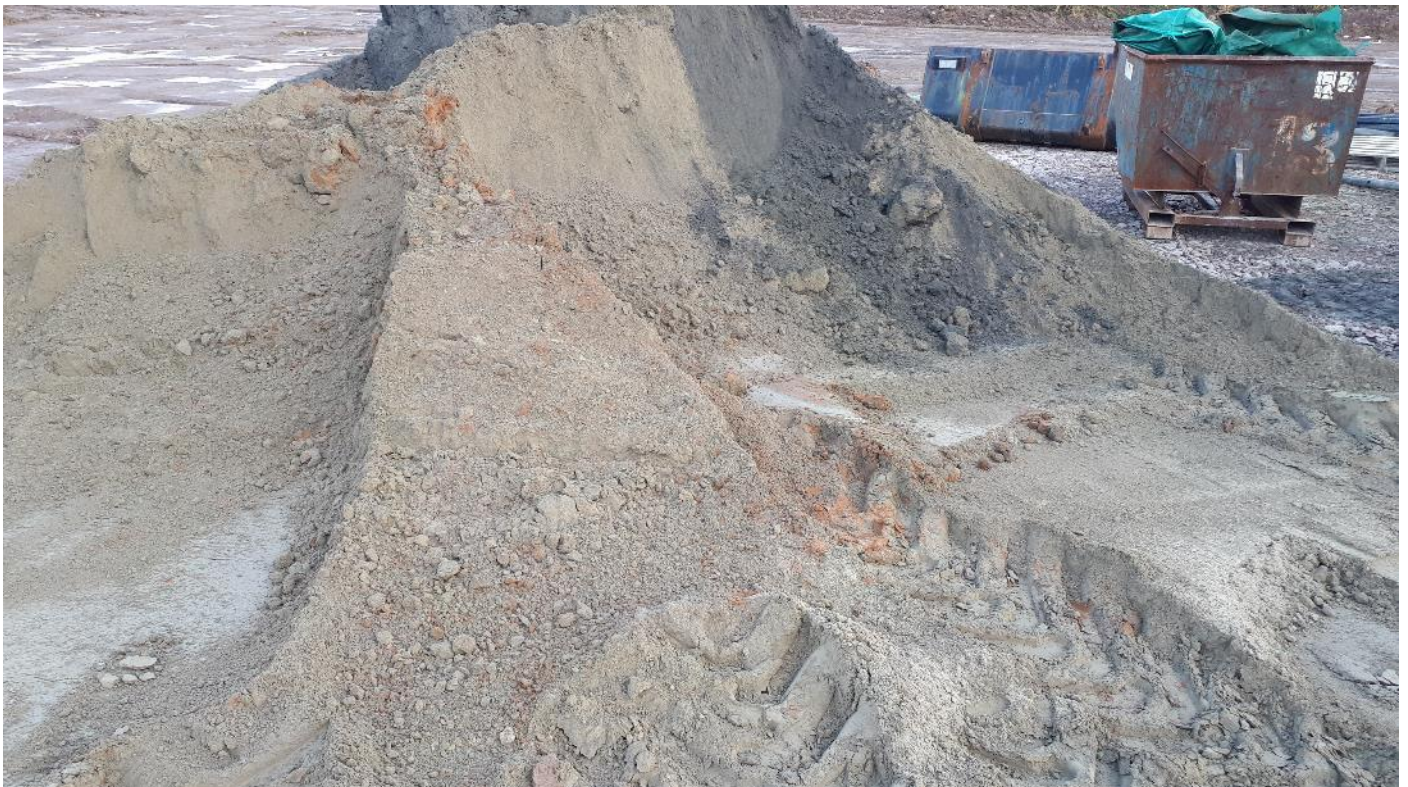
Photograph 10: Sand pre-mixed into PFA.
