## **Second Percolation tests - Former Grove Court Hotel, CA23 3DT**

Date: 17/09/2025

Carried out by F Scott Builders LTD

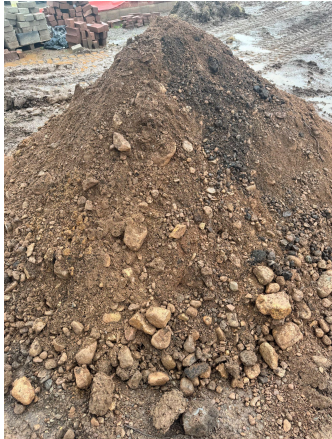
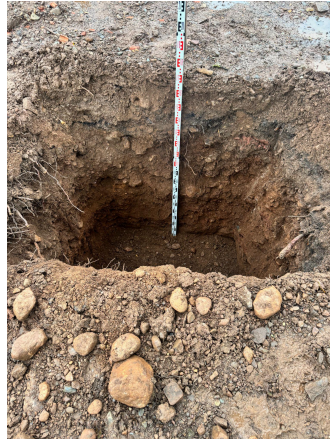
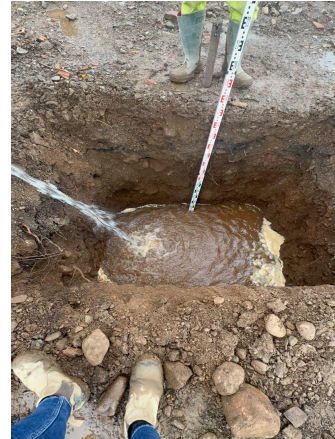
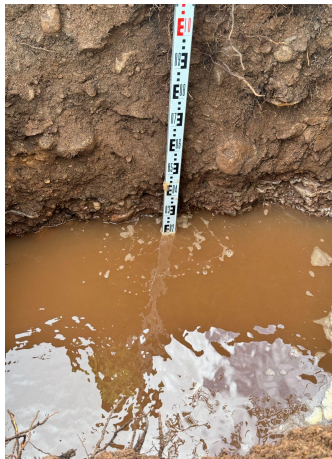
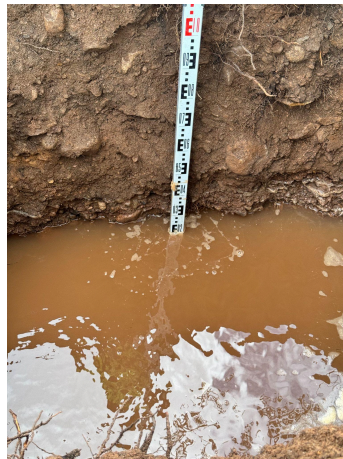
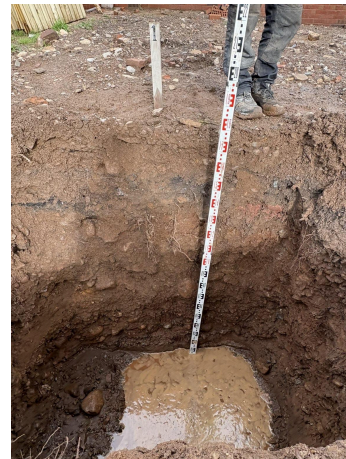
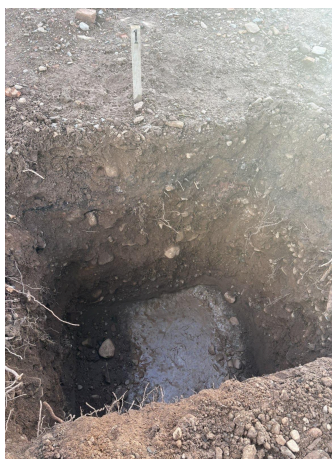
## Hole 1:

1000 litres input.

The water level did not go above 450mm.  
Over 200mm of water drained within 20 minutes  
Picture 6 shows water level after 3 hours  
Picture 7 shows water level after 5 hours

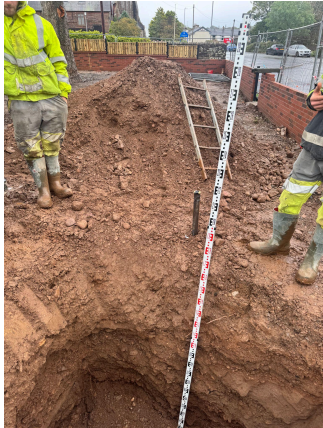
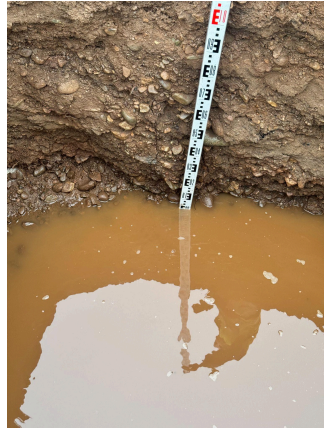
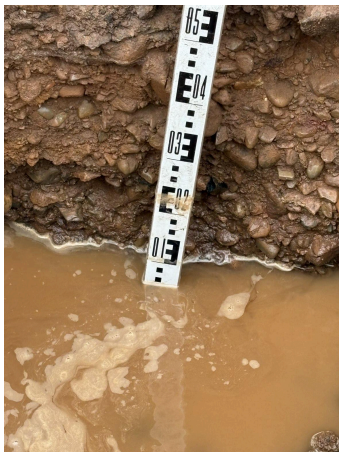
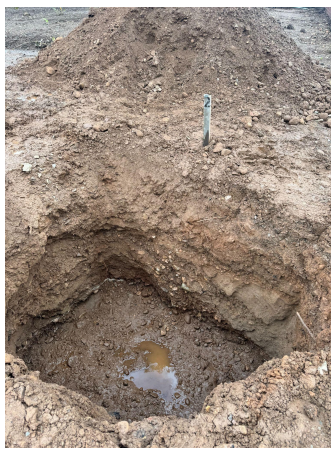
## Hole 2:

1000 litres input.

The water level did not go above 200mm

Pictures 2,3,4, show water level drained to 55mm within 'Lap 4' time.

Picture 5 shows water level after 1 hour 30.

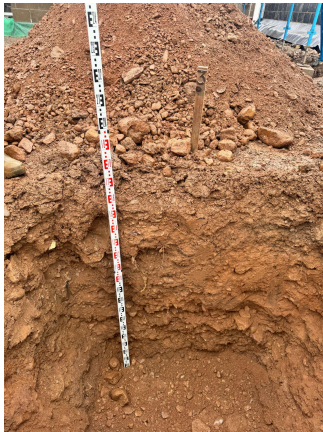
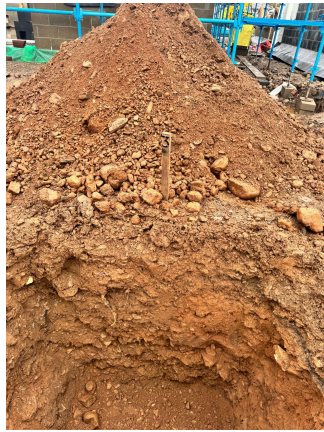
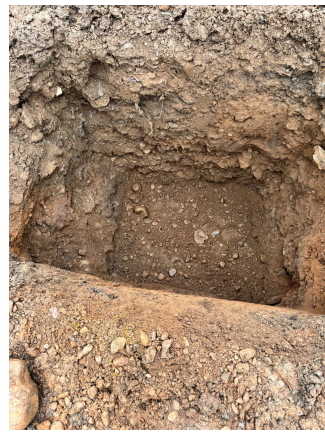
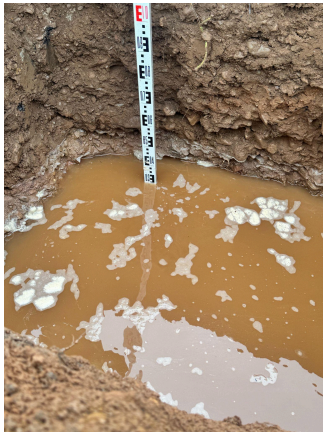
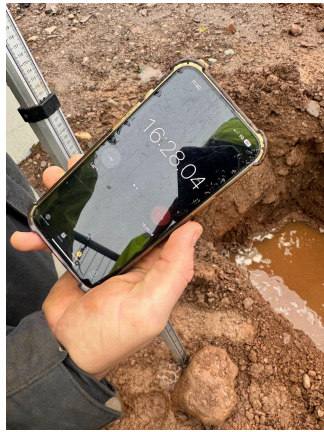
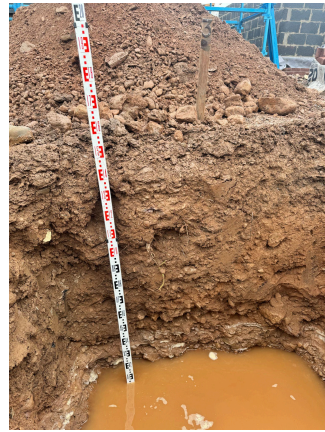
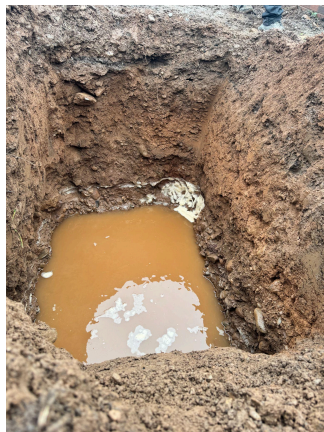
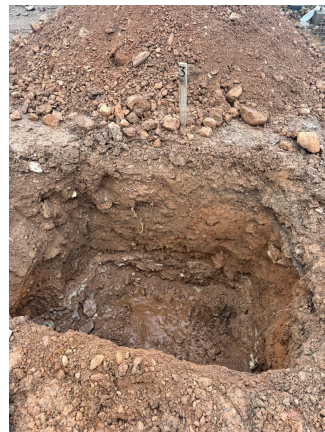
### Hole 3:

1000 litres input.

The water level did not go above 350mm  
Over 200mm of water drained within 30 minutes  
Picture 8 shows water level after 45 minutes.  
Picture 9 shows water level after 1 hour 30.

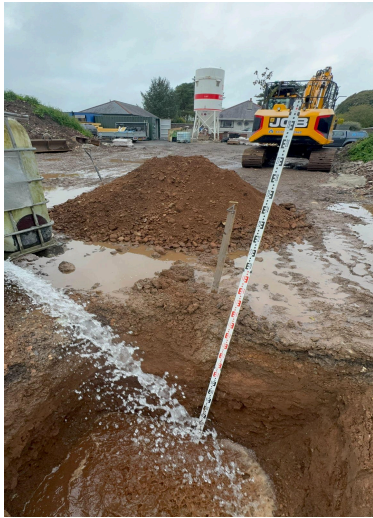
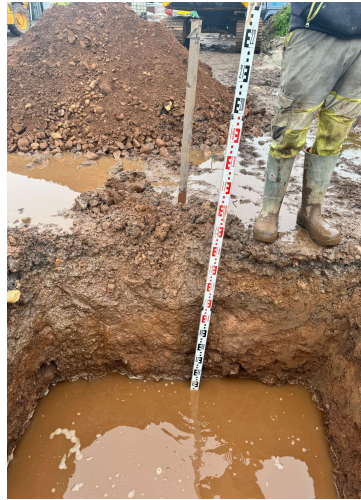
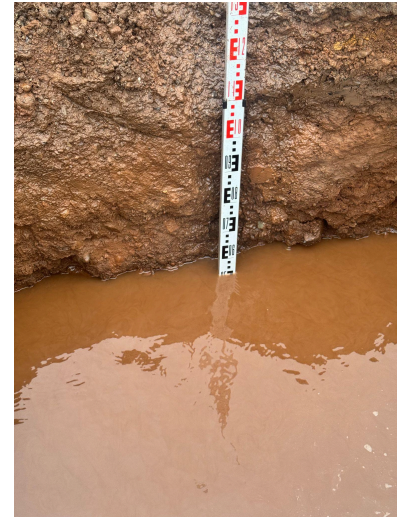
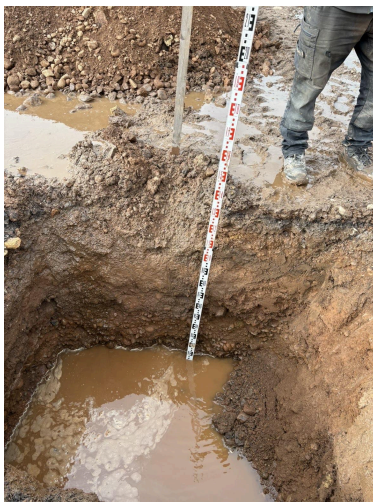
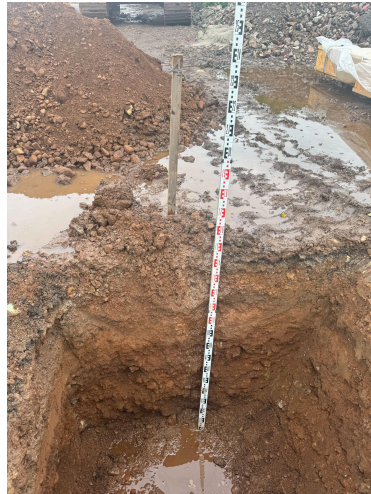
#### Hole 4:

1000 litres input.

The water level did not go above 500mm  
Picture 4 shows drainage within 1 hour  
Picture 5 shows drainage within 3 hours.

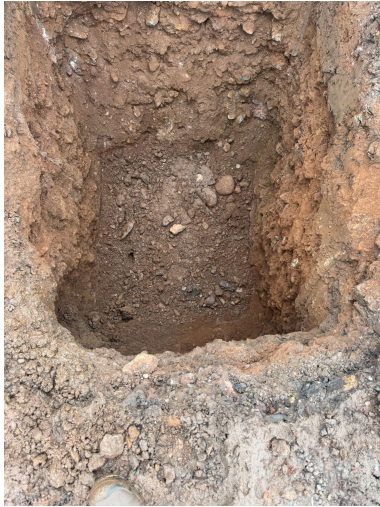
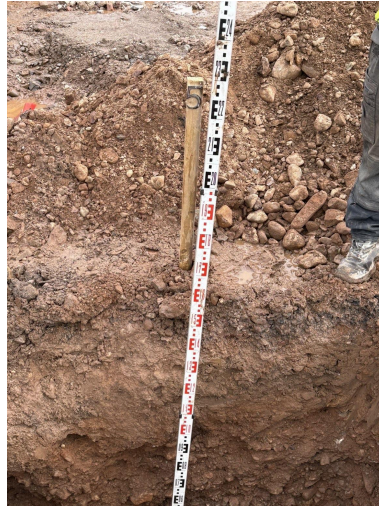
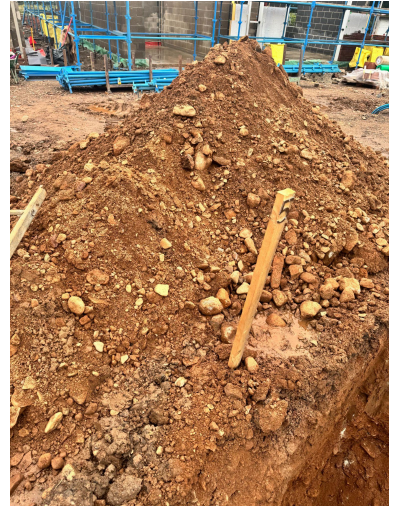
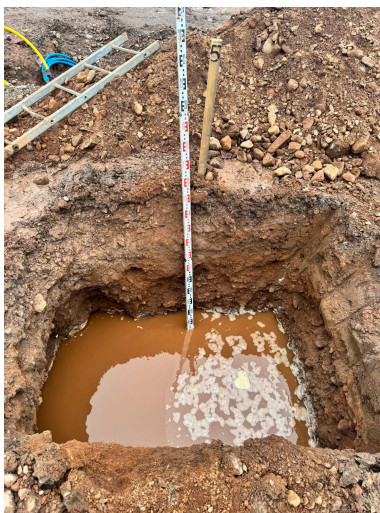
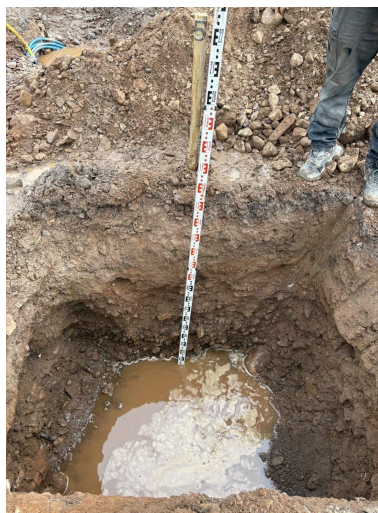
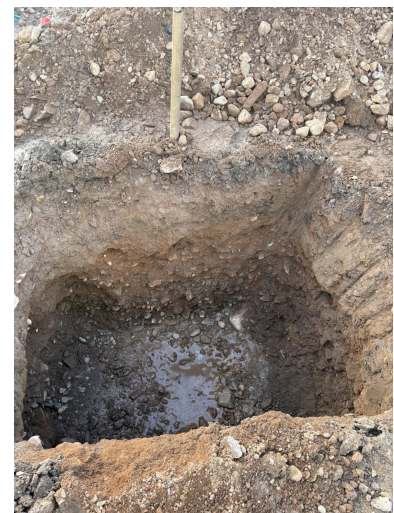
## Hole 5:

1000 litres input.

The water level did not go above 500mm

50mm dropped within 30 mins

Picture 5 shows the water level after 3 hours.

Picture 6 shows the water level after 5 hours.
