**Date:** 06.08.2024  
**Project No:** GEO2024-6310  
**Project:** Griffin Close, Frizington  
**Report Title:** Soil Infiltration Tests

Geo Environmental Engineering Ltd (GEO) were commissioned by the Consultant, RG Parkins & Partners Ltd, on behalf of the Client, Home Group to carry out soil infiltration tests to aid the drainage design for the proposed residential development.

## GEO2024-6310: Griffin Close, Frizington – Soil Infiltration Test Results

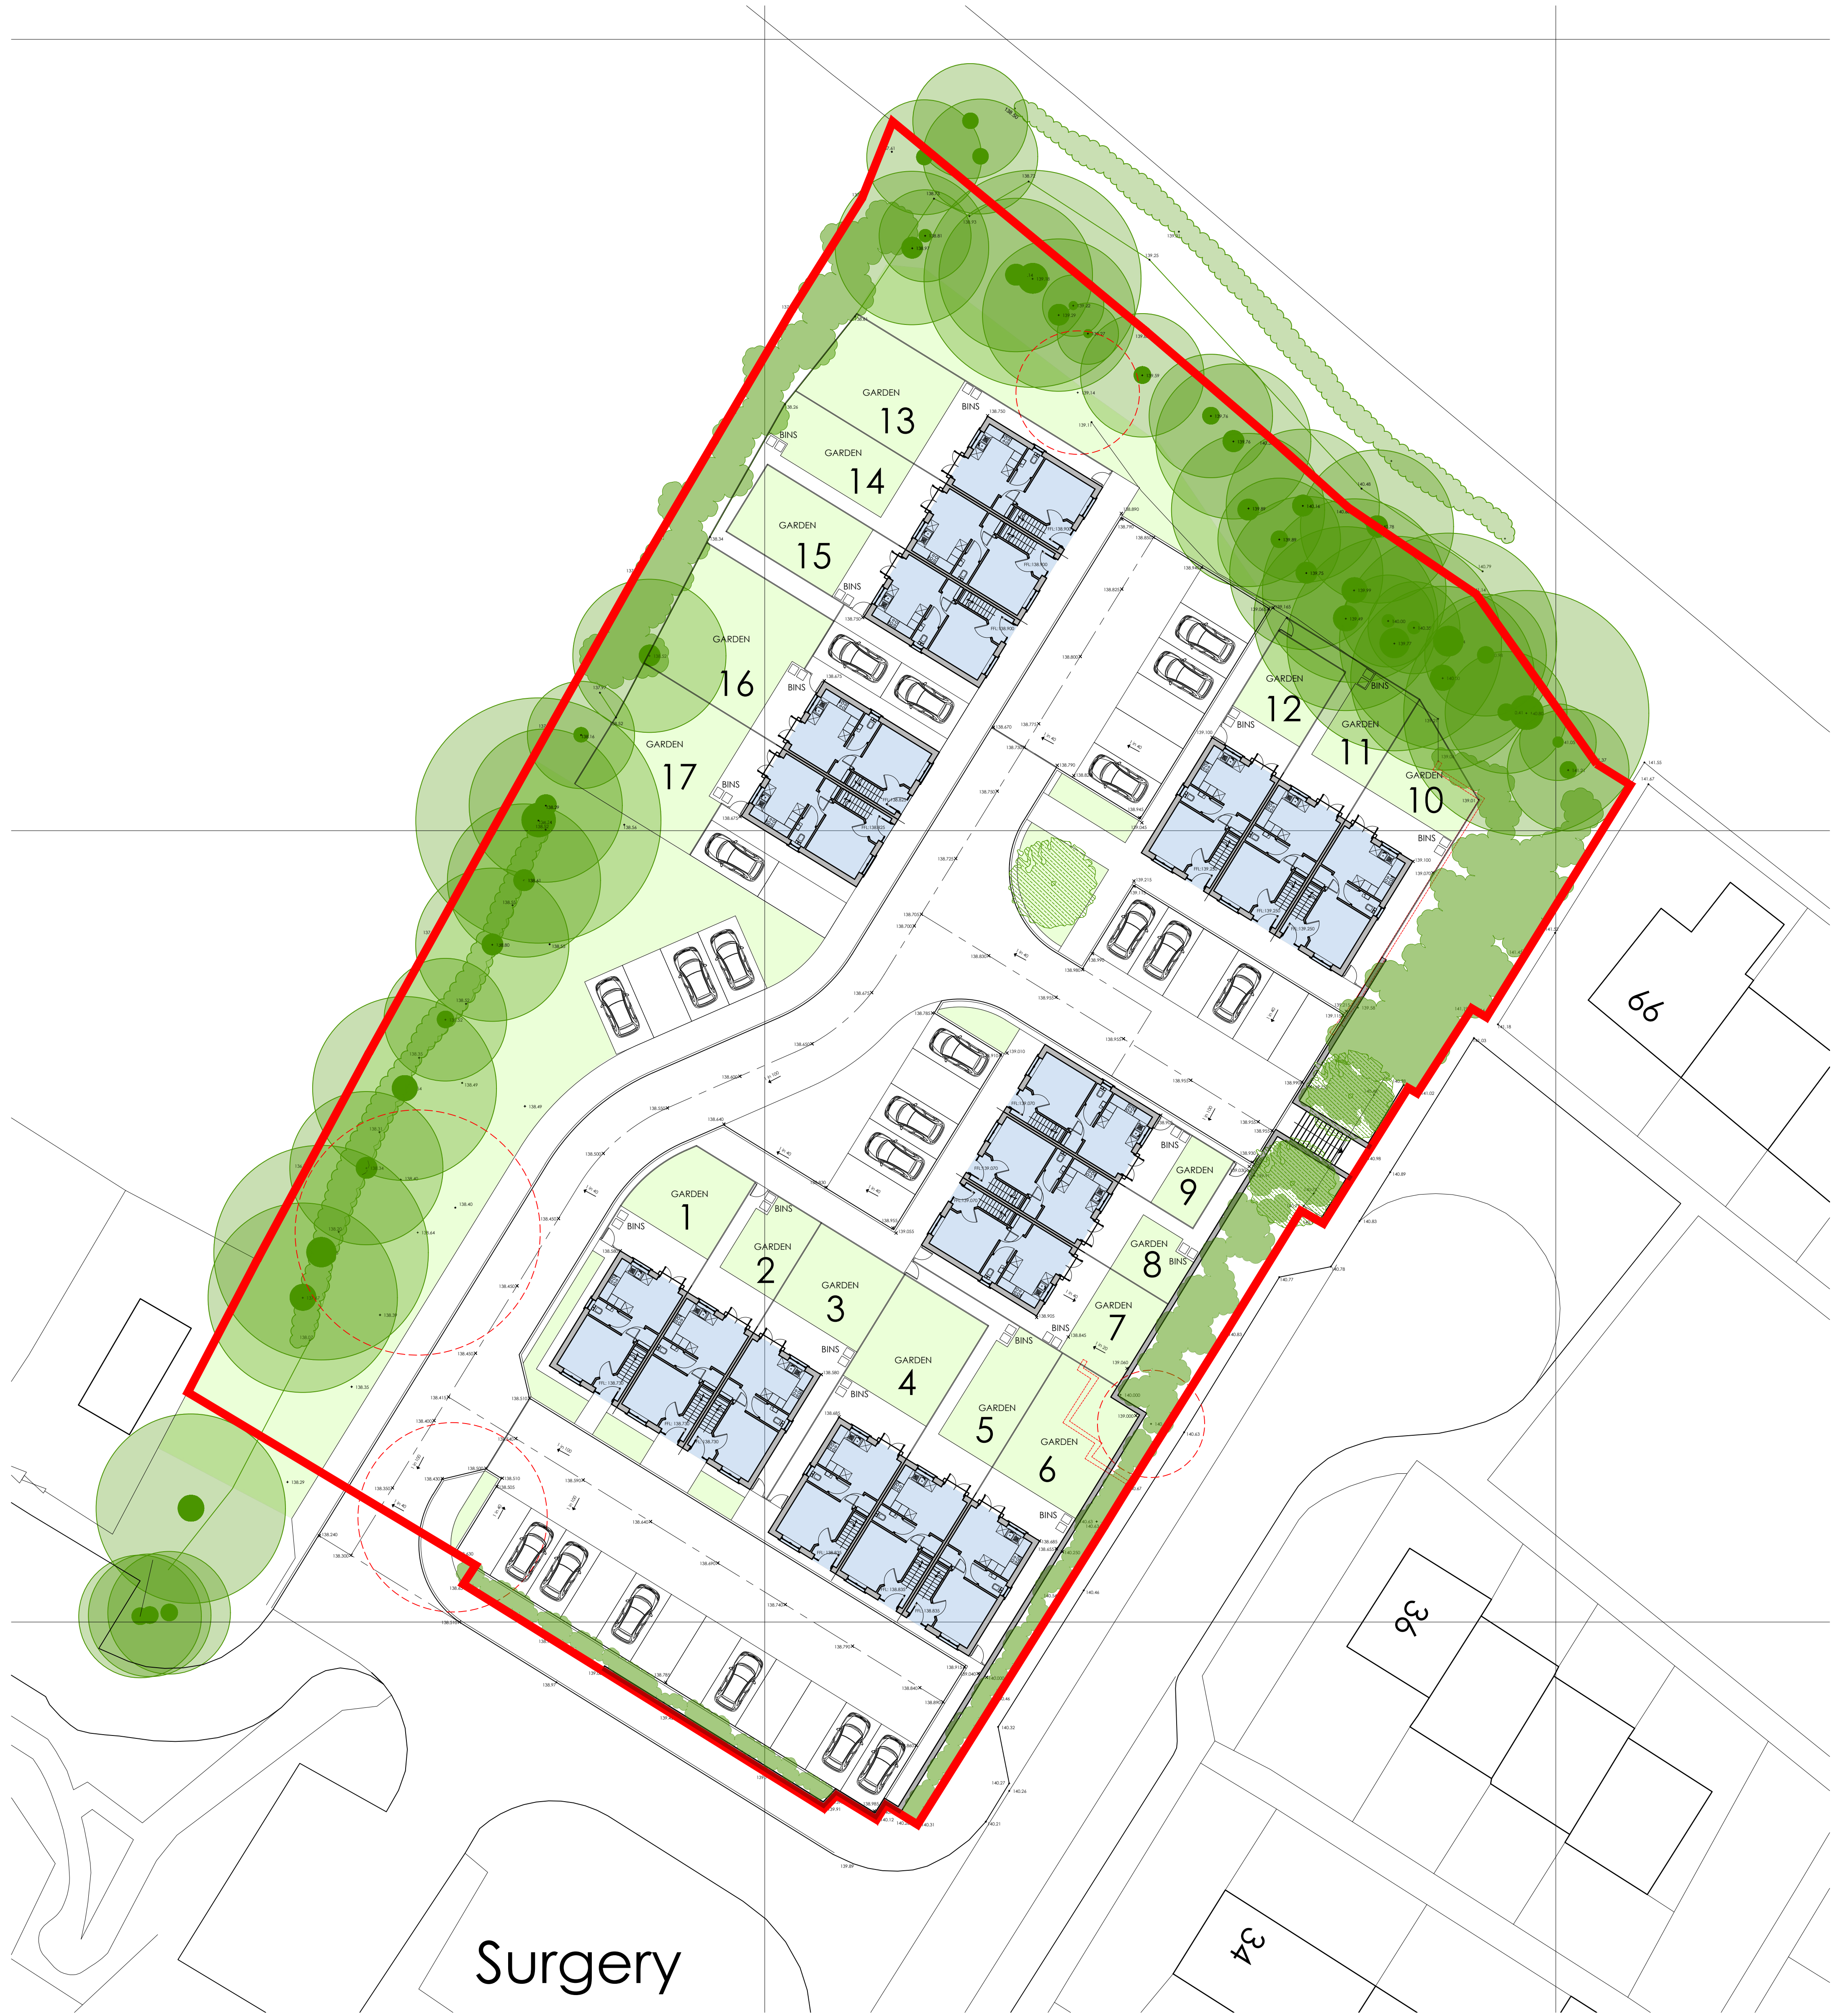
**GEO2024-6310: Griffin Close, Frizington - Exploratory Hole Location Plan**

The soil infiltration tests were completed on the 30<sup>th</sup> July 2024. The works comprised two trial pits (SA01 and SA02) to depths of between 2.00m and c.2.20m bgl. The trial pits encountered made ground to depths of between c.1.00m and c.1.70m bgl respectively. This comprised clayey gravel of dolomite, brick, timber and concrete in SA01 and reworked gravelly clay with brick, concrete and sandstone in SA02.

Soil Infiltration Test Locations

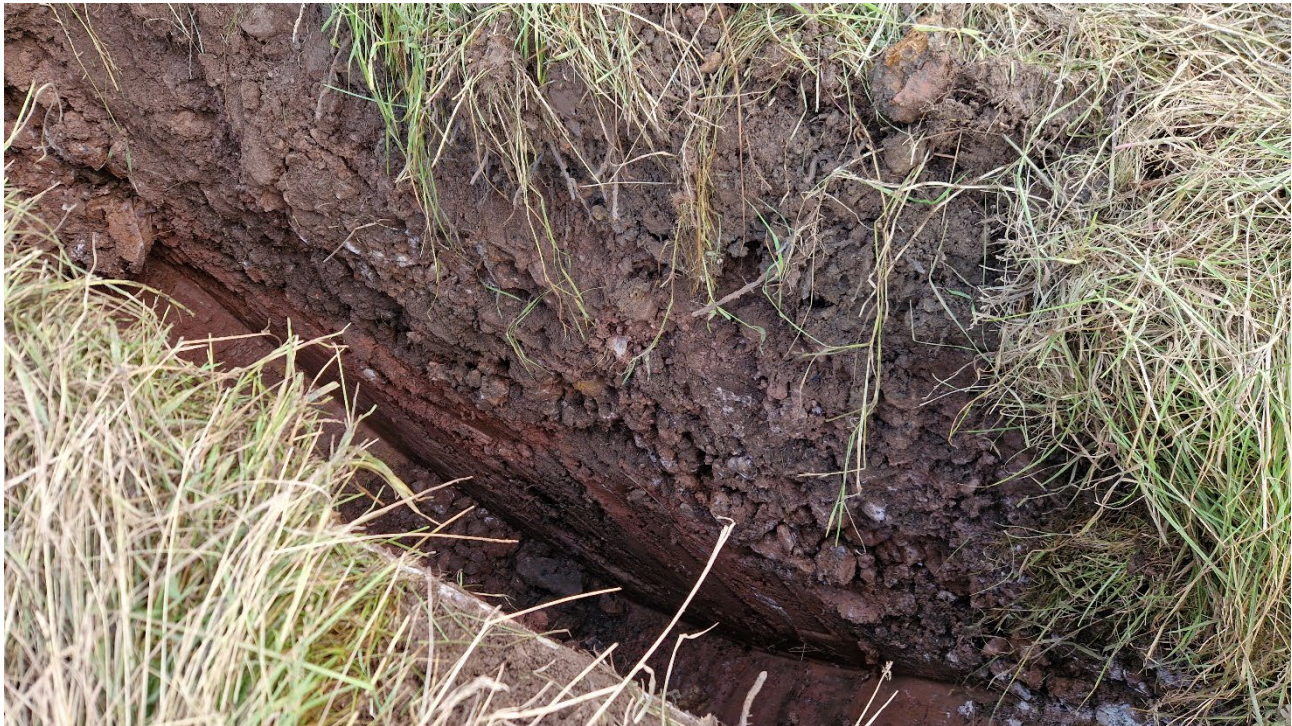
**GEO2024-6310: Griffin Close, Frizington, Cumbria – SA01**

| Depth From (m) | Depth To (m) | Strata Description | Legend | Testing / Samples |
|---|---|---|---|---|
| 0.00 | 0.26 | TOPSOIL: Dark brown sandy gravelly LOAM. | | |
| 0.26 | 1.00 | MADE GROUND: Grey very silty/clayey fine to coarse angular GRAVEL of dolomite, brick, timber and concrete. | | |
| 1.00 | 2.00 | Stiff dark brown gravelly CLAY. | | |
| | | End of trial hole at 2.00m – Soil Infiltration Test Completed.<br>Trial hole remained dry on completion.<br>Trial hole backfilled with arisings on completion. | | |

During the tests, the water in both trial pits dropped 4cm and 1cm respectively. The results suggest that the natural soils are practically impermeable (as would be expected given the presence of clay deposits) and the tests are considered as a fail.

Based on the ground conditions encountered during this and the previous investigations, and the results of the soil infiltration tests, the ground beneath the site is not considered suitable for soakaways and an alternative drainage solution should be sought.

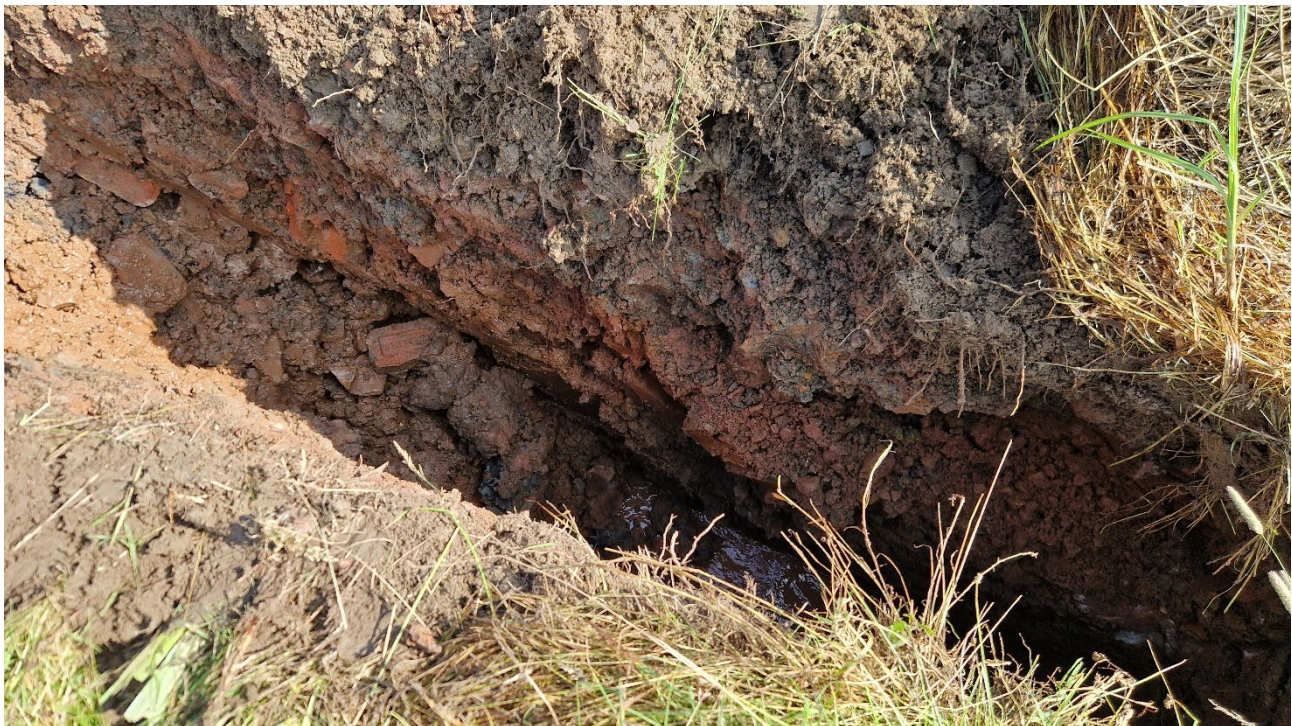
**GEO2024-6310: Griffin Close, Frizington, Cumbria – SA02**

| Depth From (m) | Depth To (m) | Strata Description | Legend | Testing / Samples |
|---|---|---|---|---|
| 0.00 | 0.22 | TOPSOIL: Dark brown sandy gravelly LOAM. | | |
| 0.22 | 1.70 | MADE GROUND: Soft to firm dark brown very gravelly clay with much brick, concrete, sandstone. | | |
| 1.70 | 2.20 | Stiff dark brown gravelly CLAY. | | |
| | | End of trial hole at 2.20m – Soil Infiltration Test Completed.<br>Perched groundwater ingress from base of made ground.<br>Trial hole backfilled with arisings on completion. | | |
