**SUBJECT: DESIGNER'S RESPONSE TO STAGE 1 RSA AT STATION YARD, MOOR  
ROW**

Project Name  
**FORMER STATION YARD, MOOR ROW**

Sheet Title  
**ACCESS ARRANGEMENTS**

Stage 1 Road Safety Audit

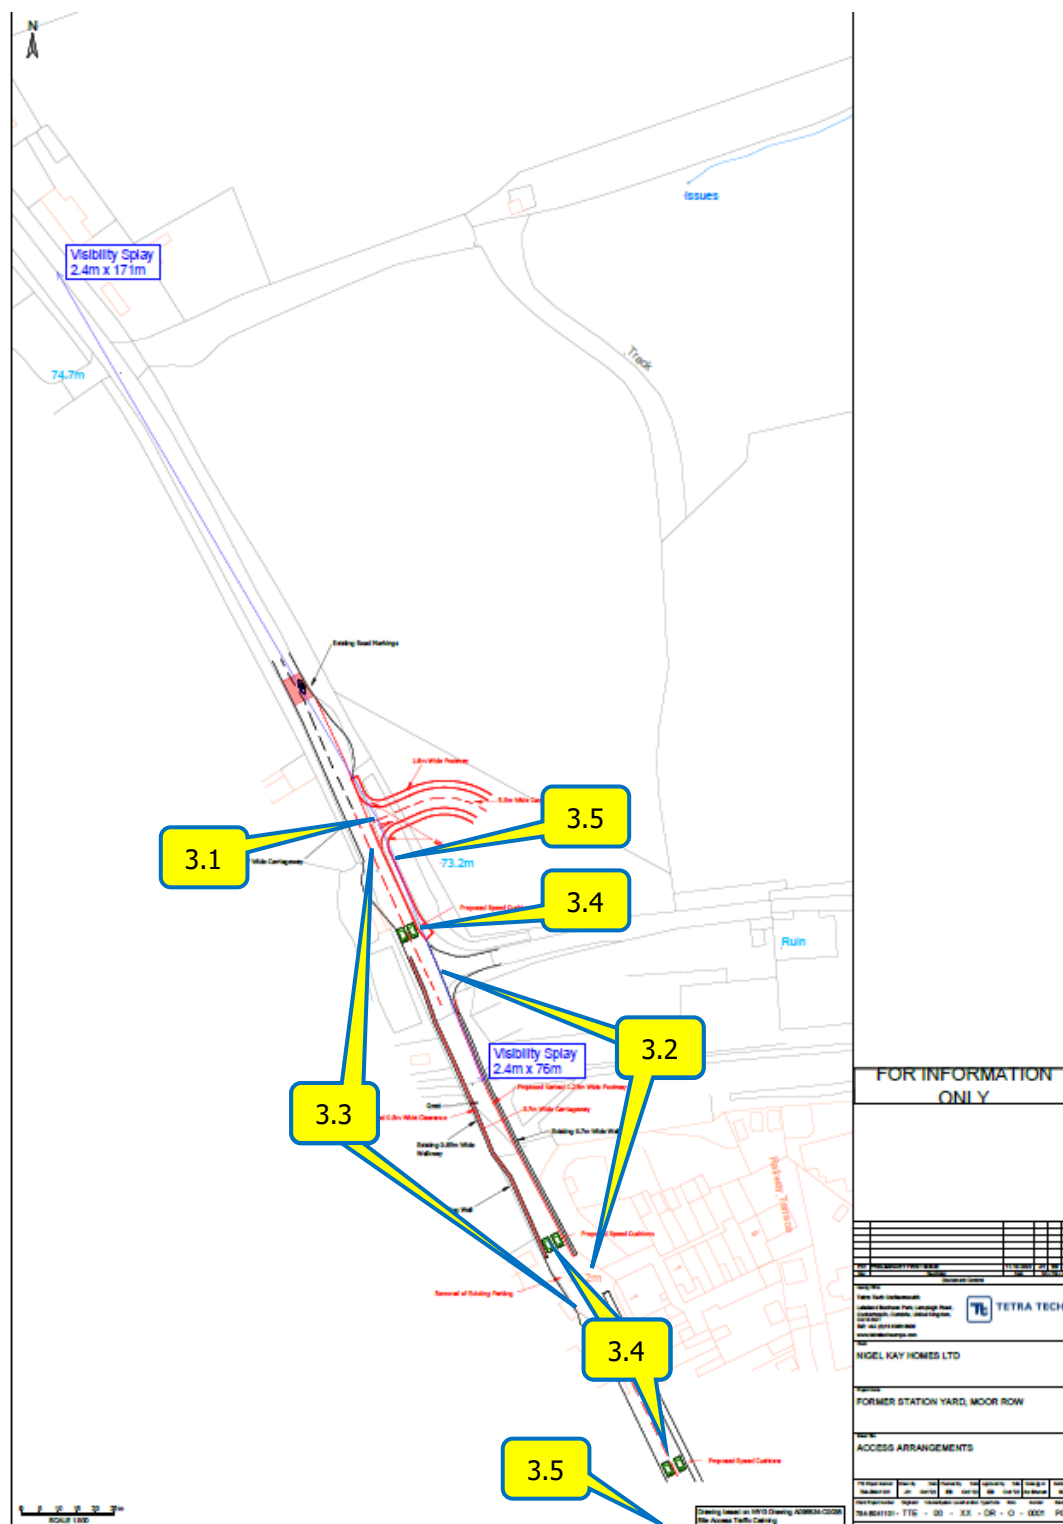
## 6. LOCATION PLAN OF ITEMS RAISED BY THIS AUDIT

Location: The junction of the development access road with Dalzell Street.

Although visibility splays are shown on the drawing, there is a substantial length of foliage along the development frontage. The treatment of the foliage should be specified in order to ensure that mutual visibility can be achieved between motorists turning out of the development access and those on Dalzell Street.

At this stage, dropped kerbs and tactile paving are not shown on the footways across the existing access road to the north of the bridge, or to the north of No 1 Dalzell Street. The Audit Team are aware that Cumbria County Council have a policy to install tactile paving only in areas of significant pedestrian traffic (they were not present at other junctions in the village) but if dropped kerbs are not provided as a minimum, wheelchair users could attempt to cross and find themselves stranded in the carriageway on the exit side, increasing the risk of collisions or of overturning. Visually impaired pedestrians could be confused as to where to cross, again increasing the risk of trips or of conflicts with vehicles.

It is assumed that the internal roads of the development will be lit. If so, it would be beneficial to extend the system of lighting to the northern edge of the village to reduce the risk of pedestrian trips. In addition, it could reduce the risk of a number of collision types involving vehicles as motorists move between lit and dark sections of road.

While perhaps schematic at present, the drawing show shark's tooth road markings on the same side of each of the pairs of speed cushions. If laid as such, northbound motorists unfamiliar with the area could be led to believe that they are on a one-way street and that they can drive in the 'offside' lane. This could increase the risk of collisions with opposing motorists and crossing pedestrians, neither of whom will expect vehicles to approach in that lane from that direction.

At this stage, there are no warning signs specified for the speed cushions. In their absence, drivers and riders could fail to notice the cushions, strike them at speed or brake suddenly and lose control. This can be particularly problematic for two-wheeled riders.

It is recommended that, as the design progresses, the foliage is specified for removal or relocation where it lies within or close to the splays, taking into account the potential for re-growth.

It is recommended that dropped kerbs are provided as a minimum, and that tactile paving is also installed if acceptable within the local policy.

It is recommended that, if the development is to be lit, the system of lighting is extended to the northern edge of the village.

It is recommended that the markings on the cushions are shown in the direction of travel only.

It is recommended that signs to Diagram 557.1, together with appropriate supplementary plates, are erected on the approaches to the speed cushions.
