Date: 06.08.2024  
Project No: GEO2024-6310  
Project: Griffin Close, Frizington  
Report Title: Supplementary Mining Investigation Report

Geo Environmental Engineering Ltd (GEO) were commissioned by the Consultant, RG Parkins & Partners Ltd, on behalf of the Client, Home Group to carry out a Supplementary Mining Investigation to aid the proposed development.

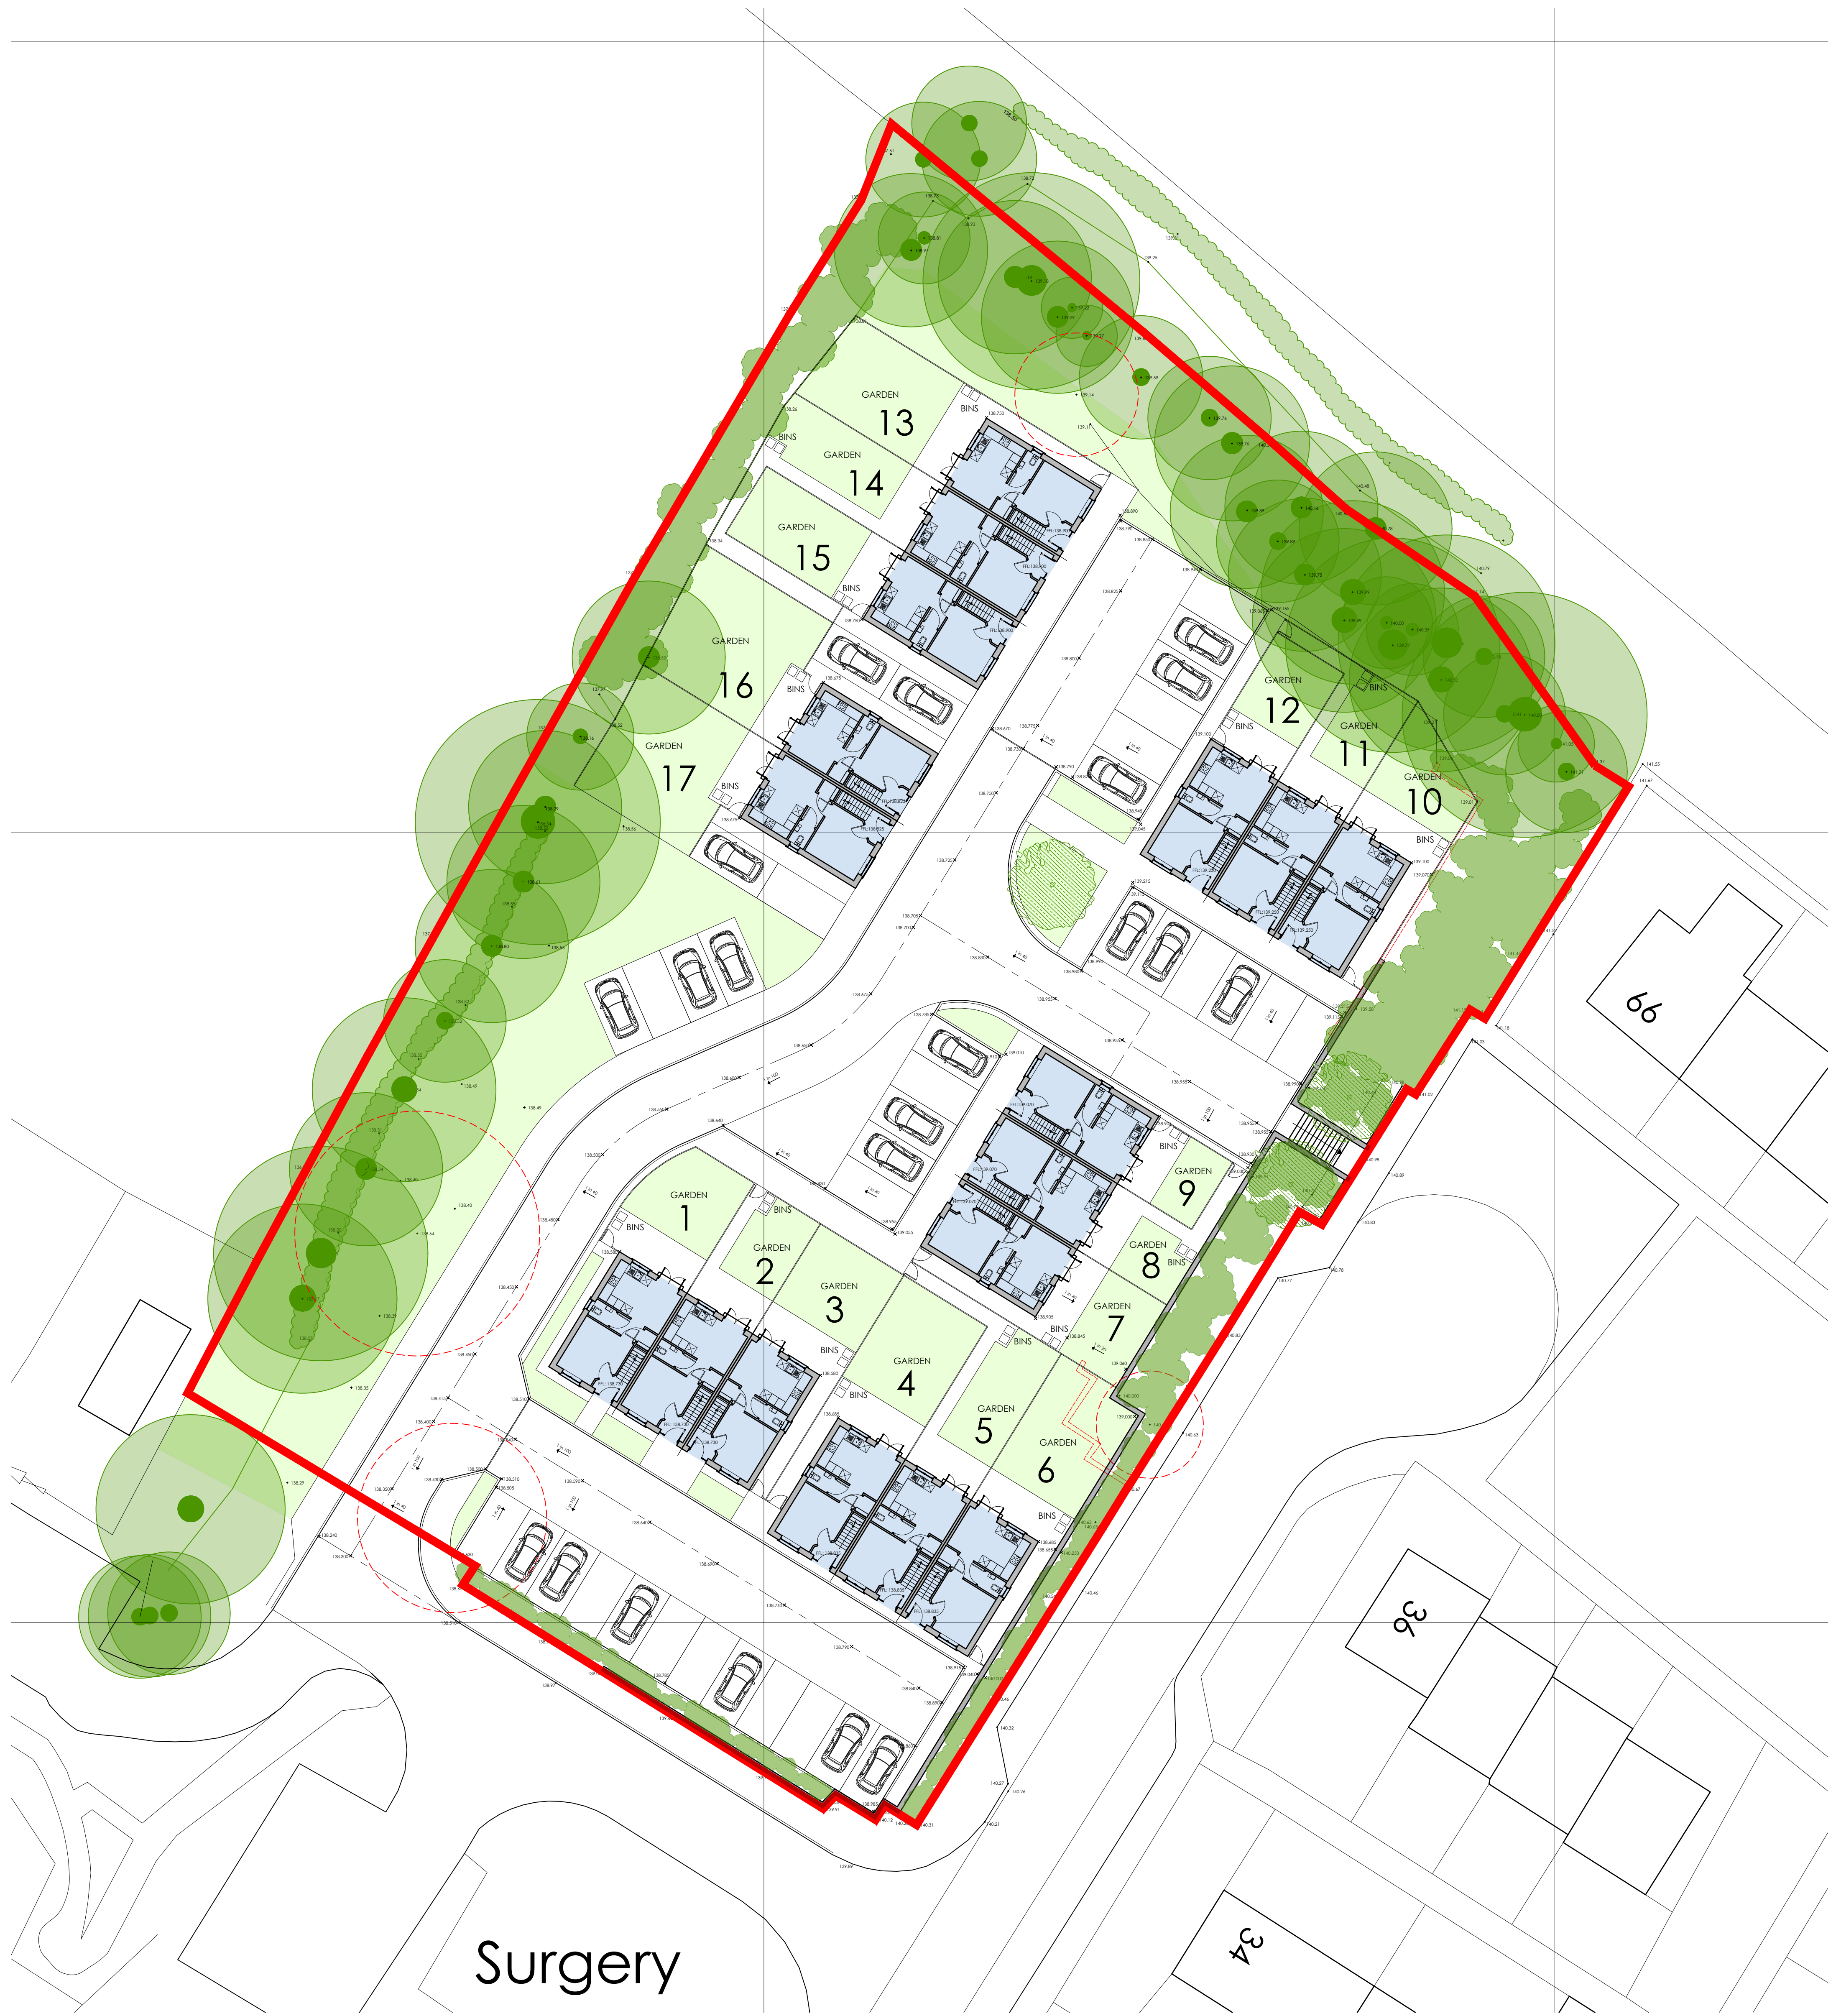
Proposed Site Plan  
Griffin Close, Frizington

It is understood that the Client plans to redevelop the land for residential end use. A proposed site layout plan has been provided and a copy is included. The plan indicates c.17 No. plots with private gardens, parking, access road, general soft landscaping and other associated infrastructure.

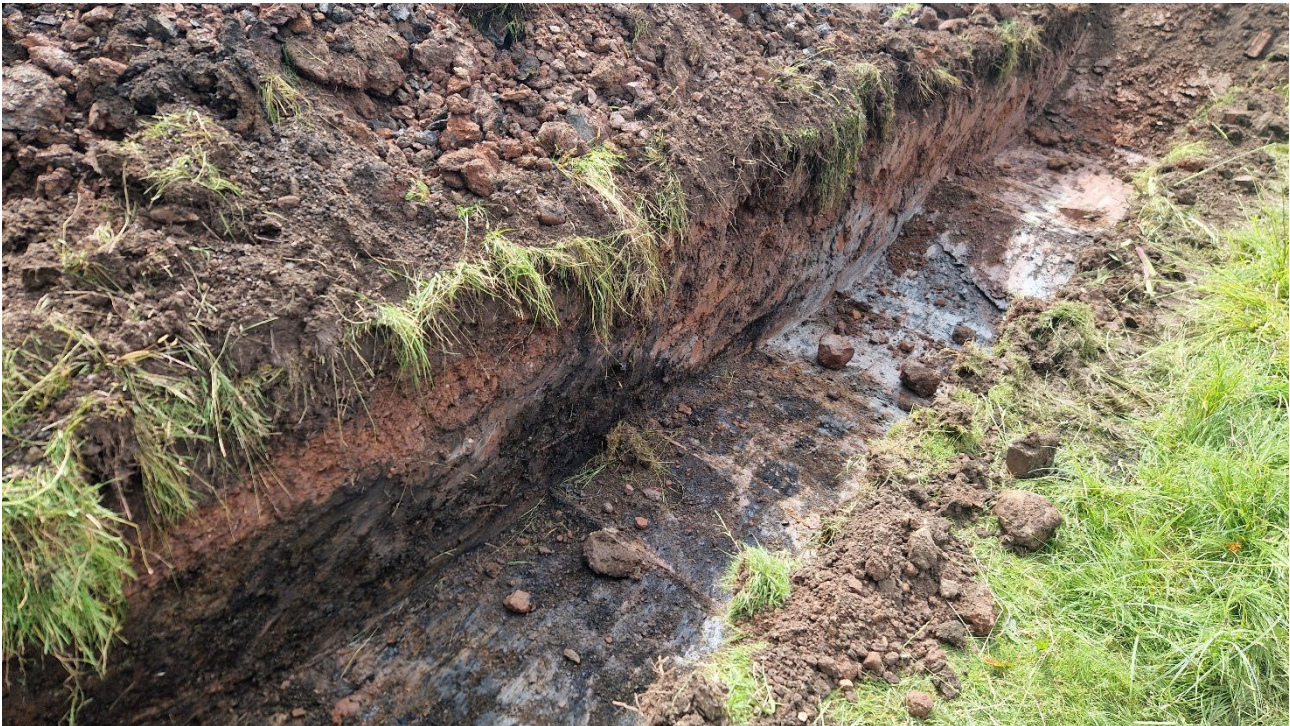
**GEO2024-6310: Griffin Close, Frizington, Cumbria – TT02**

Trench TT01 encountered a sub-cropping coal seam at a depth of c.1.10m bgl. The seam was recovered as angular gravel of black glassy, brittle coal which had thin quartz veining. Thin bands of iron ore were also noted. The coal appeared highly fractured / folded and of poor quality. The seam appeared to deepen to the south although this was difficult to discern. The surrounding ground was recorded as suspected weathered mudstone which was excavated as a very stiff light grey clay with angular gravel of mudstone.

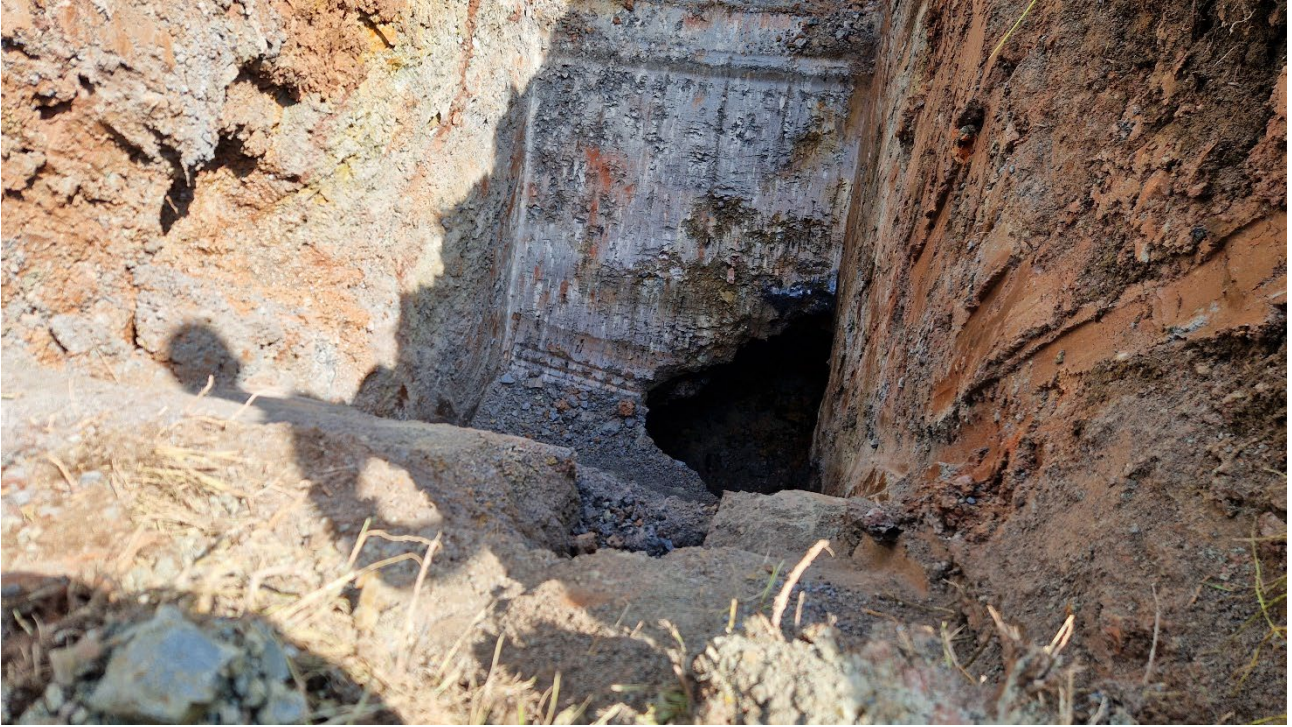
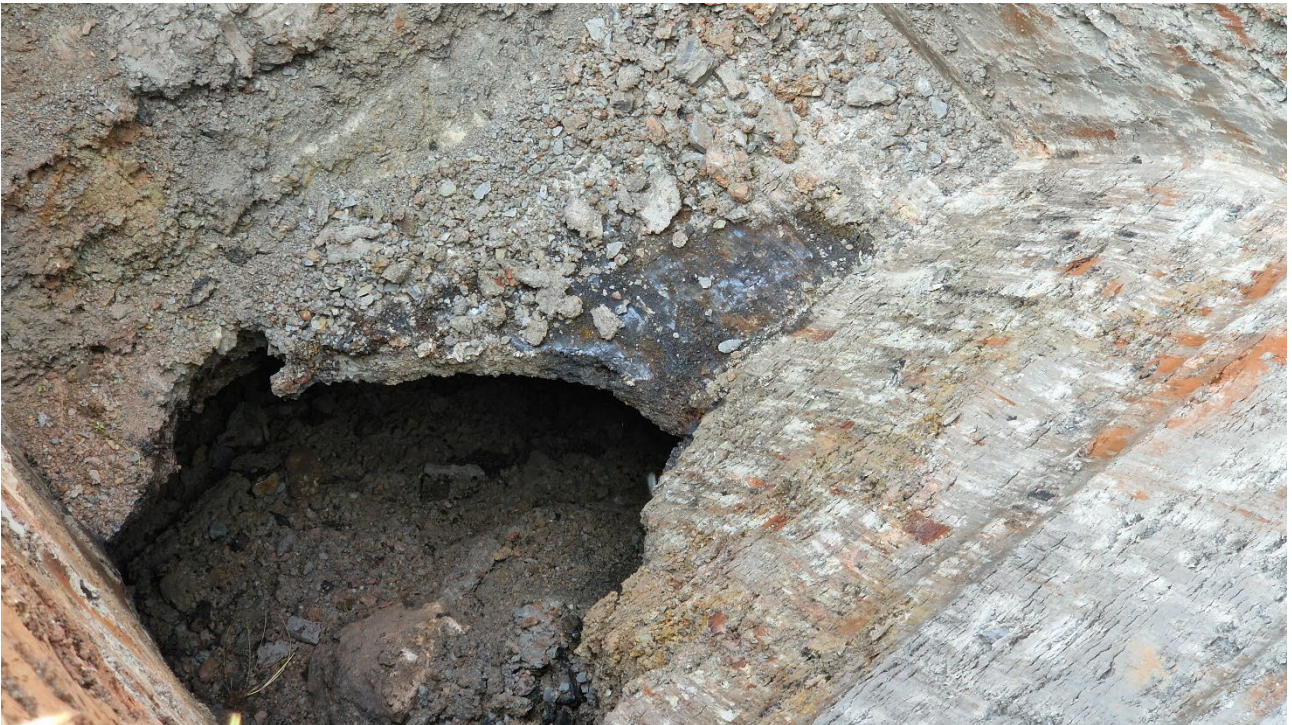
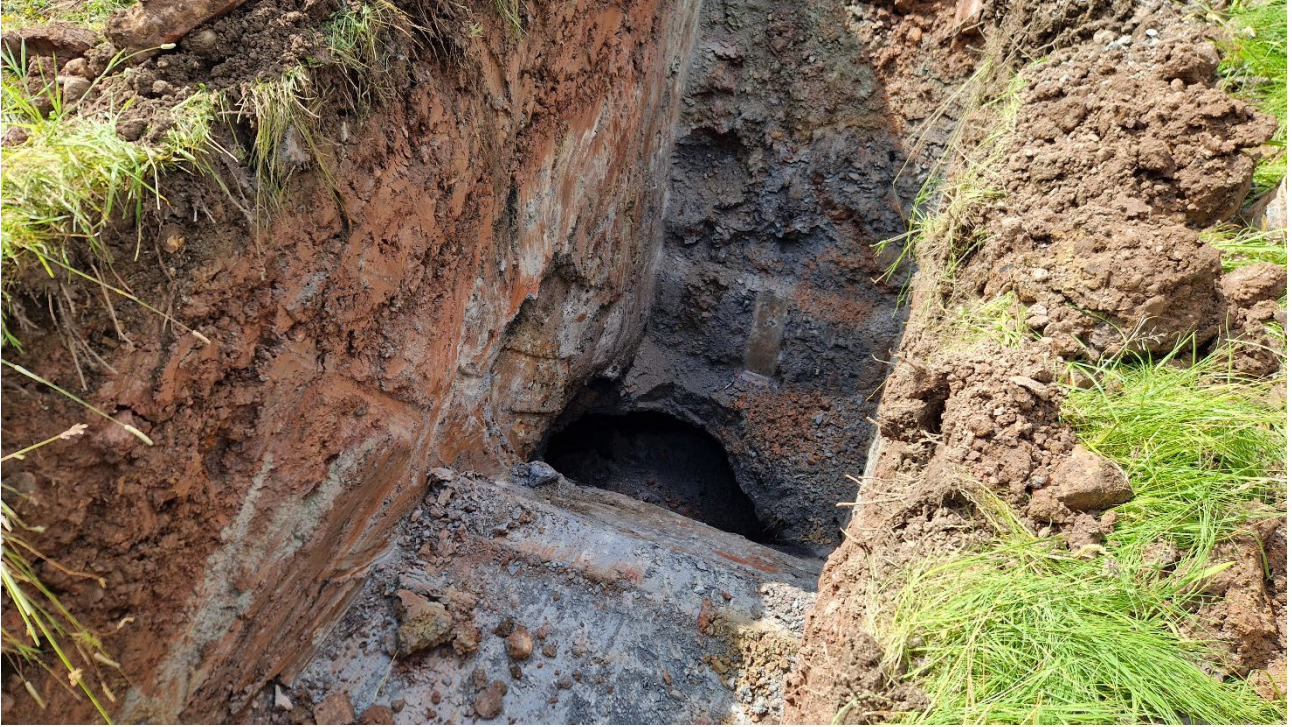
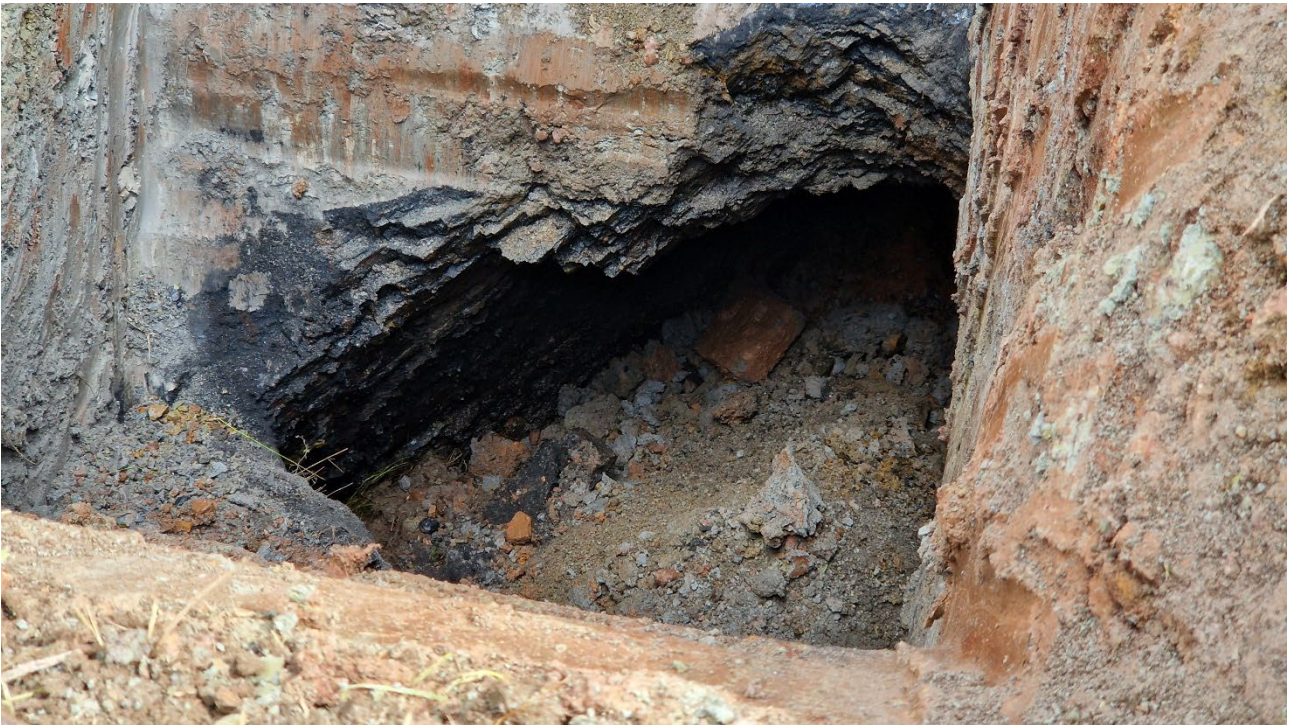
**GEO2024-6310: Griffin Close, Frizington, Cumbria – TT03 (Void Photos)**

Trench TT03 encountered the monitoring well from borehole WS02 which had previously recorded deep made ground overlying a suspected void between c.3.50m and c.5.00m bgl. The excavation followed the well and continued to a depth of 3.10m within suspected weathered mudstone. A coal seam was encountered at a depth of c.3.10m bgl and this had a similar appearance to the coal in trench TT01. A void opened up from the base of the trial pit at a depth of c.3.20m bgl. The void was noted as large and extended several metres to the south, east and west. A wall of coal (at least 1m thick) was noted along the northern edge of the void. The wall of coal may have been a column, left insitu to support the workings or could have been the former coal face. The void extended to a depth of c.5m bgl, however, it may continue further as it had partially infilled with loose material falling in during the excavation. Photos of the void are included with the logs. No evidence of deep made ground was encountered in the trench as was noted in WS01. It is possible that fragments of brick from the overlying made ground had fallen into the borehole during the drilling and was therefore, interpreted as made ground during logging.

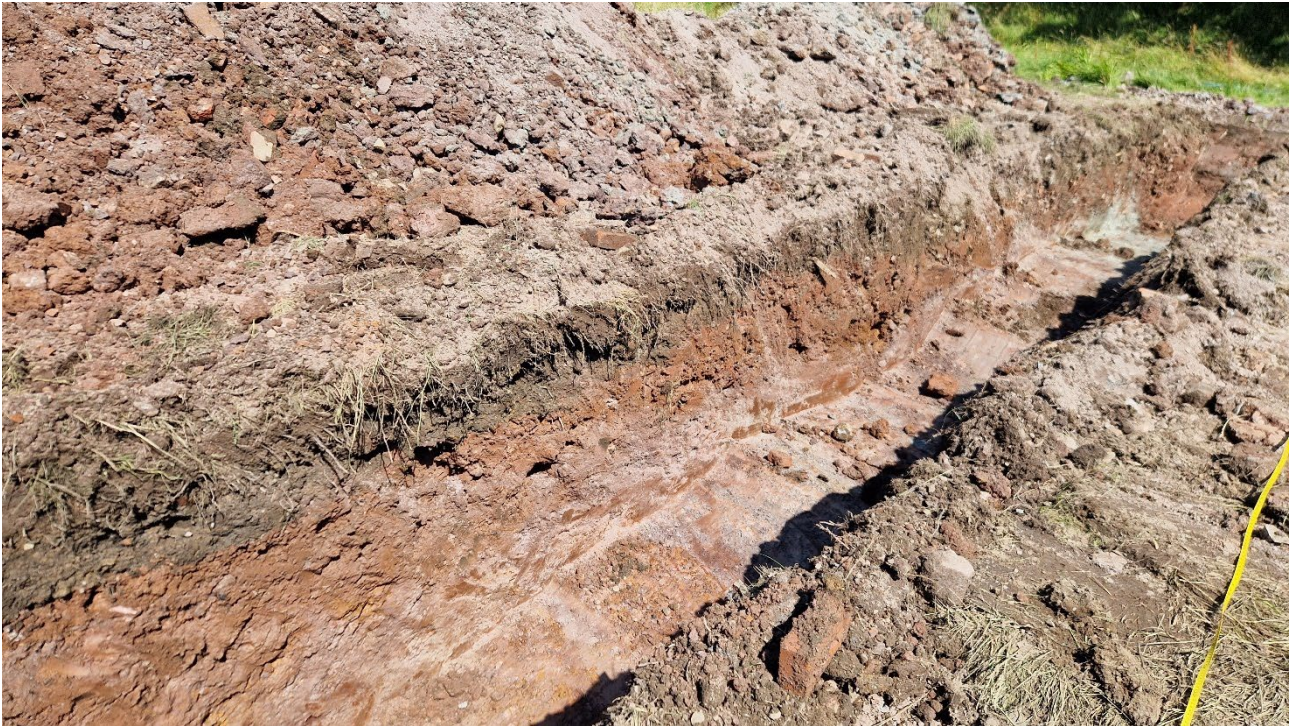
## GEO2024-6310: Griffin Close, Frizington, Cumbria – TT06

| Depth From (m) | Depth To (m) | Strata Description | Legend | Testing / Samples |
|---|---|---|---|---|
| 2.40 | 3.10 | SUSPECTED WEATHERED BEDROCK: Stiff Light grey CLAY with much angular gravel of mudstone (shale).<br><br>No resistance to excavator bucket (very loose). Appears natural. | | |

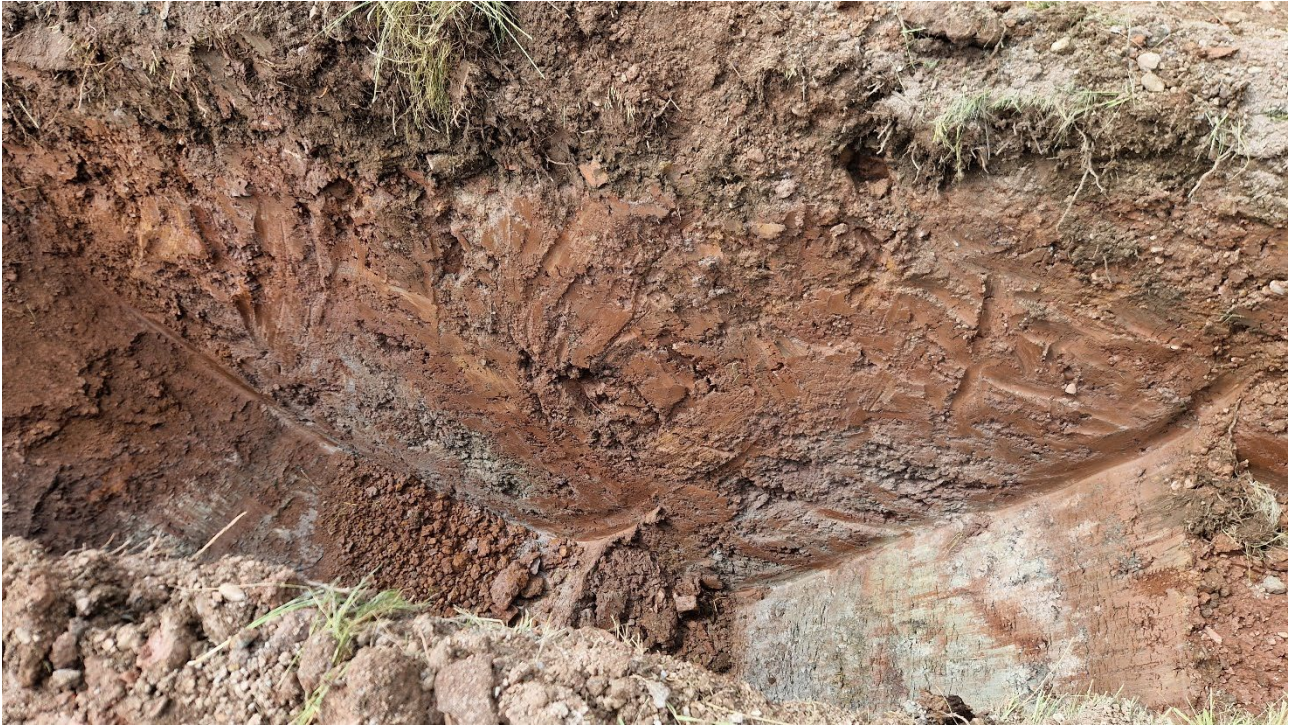
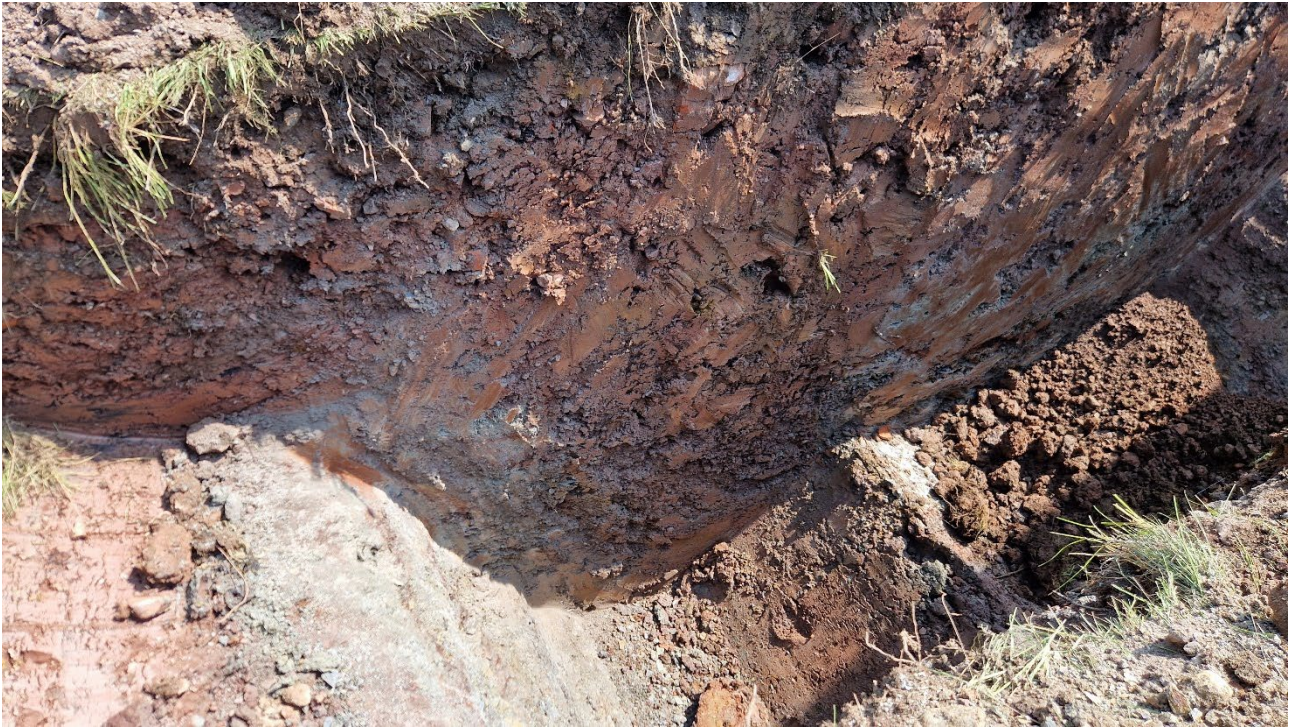
**GEO2024-6310: Griffin Close, Frizington, Cumbria – TT06 (Suspected Shaft Photos)**

The remaining trenches encountered suspected shallow weathered mudstone bedrock from depths of between c1.20m and c.1.50m bgl which appeared consistent across this area. However, Trench TT06 encountered a column of soft / soft to firm brown clay with pockets of gravel which appeared reworked. The trench was extended to a depth of c.3.60m bgl (maximum reach of the 8T excavator) and the column of soft clay was noted to continue below this depth. Light grey weathered bedrock was recorded either side of this feature. The column of soft reworked clay has been interpreted as an infilled mine shaft. The approximate location of the shaft is indicated on the exploratory hole location plan. Photographs and annotations are included on the trial pit logs. The location was recorded using a hand-held GPS unit at NGR: 303377.8, 517408.2. However, as the hand-held unit is only accurate to within a few metres, a marker post was inserted into the ground to mark the shaft location. It is recommended that the location of the shaft is accurately recorded with appropriate surveying equipment.

It is recommended that rotary probing is undertaken across this feature to confirm if it is a mine shaft and if so, what depth it extends to and how it has been filled beyond the depth of the trench. If the feature is confirmed to be a shaft, it is recommended that it is grouted (if possible) and/or stabilised using an appropriately designed geotextile or concrete cap. The remedial works should be completed under permit from The Coal Authority.

It is recommended that the site layout is redesigned to accommodate the mine shaft with no houses constructed within the zone of influence, i.e. 45 degrees from the intersection between the shaft and solid strata. Based on borehole RBH-F, solid strata was encountered at a depth of 5m bgl, therefore, no development should take place within 5m of the shaft edge.

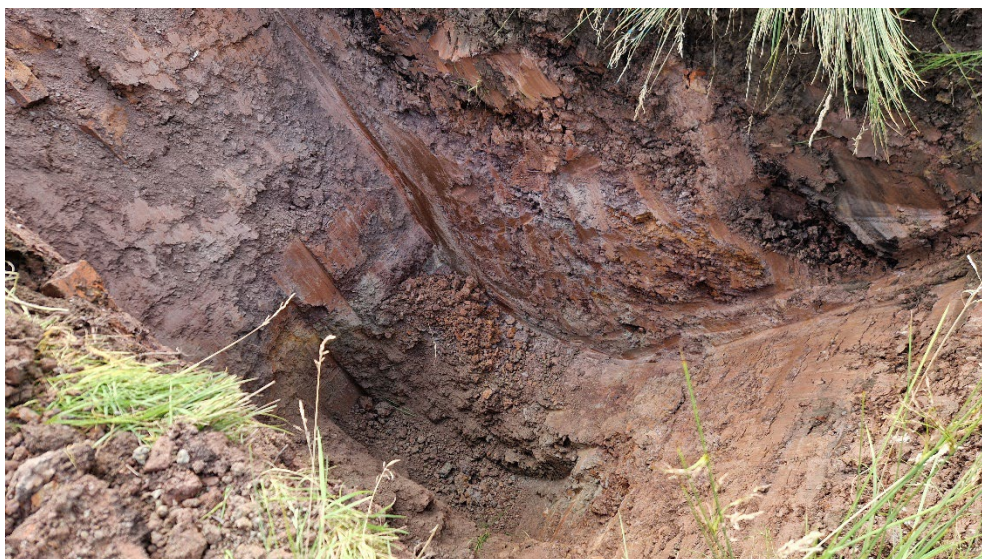
## 2024-6310: Griffin Close, Frizington – RBH-D

| Depth From (m) | Depth To (m) | Strata Description | Legend | Testing / ROP Samples |
|---|---|---|---|---|
| 4.25 | 6.00 | Grey MUDSTONE. Noted as soft to 5.60m. | | 4.50-6.00: 8 mins |
| 11.10 | 11.90 | Loss of flush. Noted as soft. Drill mud added. | | |
| 12.30 | 13.80 | No returns. BROKEN GROUND. | | 12.00-13.50: 12 mins |
