## Proposed Residential Development

Cleator Mills, Cumbria

# Flood Risk Assessment

# Cleator Flood Asset Condition Assessment

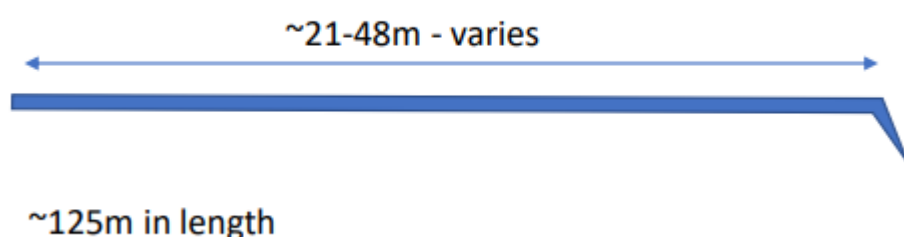
## CL2 – Natural High Ground

Natural high ground located in a grass field in front of residential properties with a width of 21-48m between the channel side and road.

Significant undermining, erosion and presence of light foreign objects on channel side. High ground in good condition.

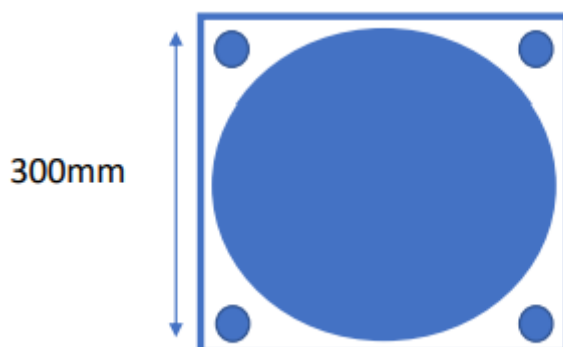
## CL4 – Outfall

300mm diameter flapped outfall with concrete apron located on channel side in front of wall. Owner and operator unknown.

Vegetation around headwall. Unable to see through pipe and no CCTV footage available.

| Years | Recommendations | Cumulative Cost (£) |
|---|---|---|
| 1 | <ul style="list-style-type: none"><li>Conduct annual visual asset inspections and maintain surrounding vegetation to avoid damage incurring to outfall</li></ul> | £600.00 |
| 5 | <ul style="list-style-type: none"><li>Continue to inspect the outfall yearly, including CCTV inspections of the pipe every 5 years</li><li>Monitor and remove moss growth and vegetation growth on headwall to reduce damage to the headwall</li></ul> | £3,500.00 |
| 10 | <ul style="list-style-type: none"><li>Continue yearly inspections of outfall including CCTV inspections of pipe every 5 years</li><li>Continue with vegetation management</li><li>Carry out small repairs to brick and mortar loss</li></ul> | £6,900.00 |
| 15 | <ul style="list-style-type: none"><li>Continue yearly inspections of outfall and manage vegetation growth</li><li>If there has been any serious structural damage to the outfall over time such as cracking or movement, employ an engineer to investigate. If investigations have found structural damage, employ relevant operative to repair damage</li></ul> | £17,400.00 |

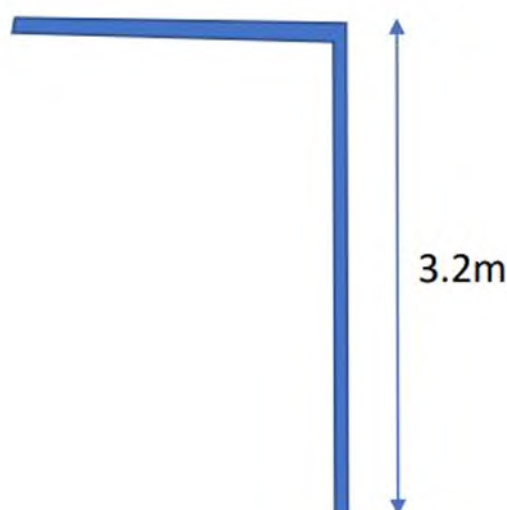
## CL14 – Engineered High Ground

Masonry retaining wall at edge of road with metal fencing above.

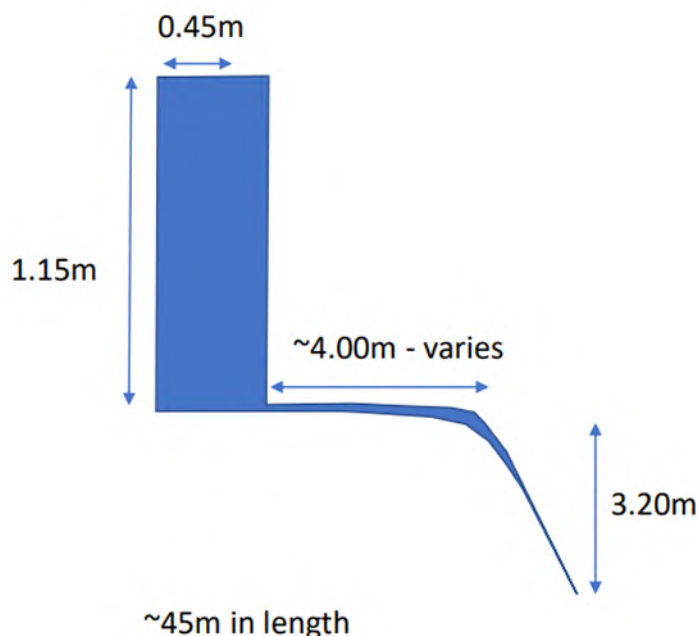
## CL15 – Wall

Masonry wall with capping stones with berm and channel side heavily vegetated with tree growth through wall.

Several heavy foreign objects on berm and channel side. Severe mortar loss in landward face, exposed face difficult to inspect but wall covered in ivy and some tree roots and growing through it. Crest is uneven where ivy has grown around it.

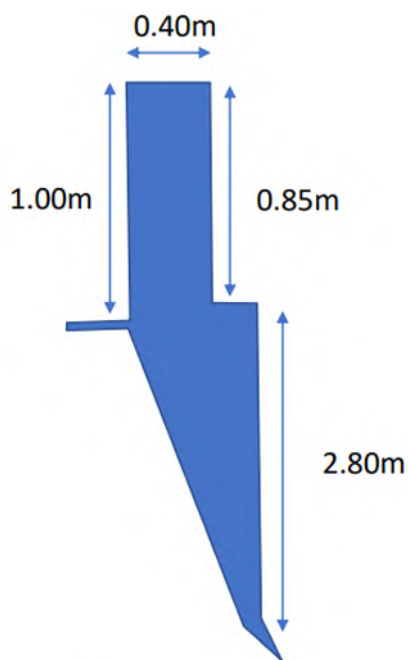
## CL16 – Wall

Brick wall with concrete landward face connecting to channel side brick retaining wall.

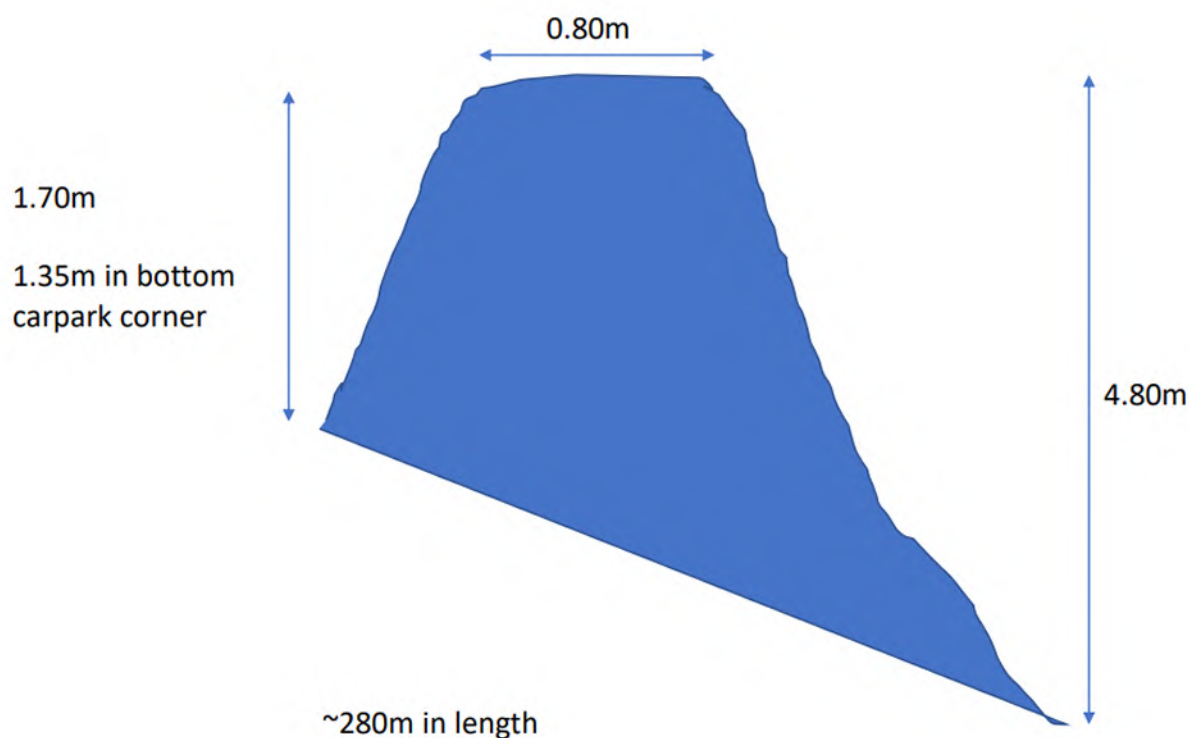
## CL18 – Embankment

Earth embankment with unknown construction materials and unstable tree-ridden channel side, reducing stability of embankment. Unlikely to have clay core and may be comprised of waste material.

Low points and rutting in crest but well vegetated. Variant used for exposed face due to steepness. Exposed and landward faces have isolated bare patches. Telegraph pole behind embankment but embankment build around it. Severe undermining of channel side around heavy foreign objects with extensive root exposure.

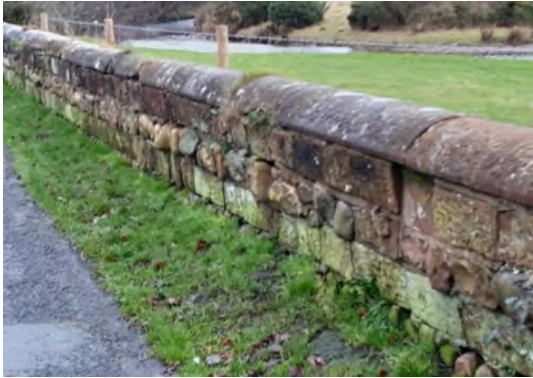
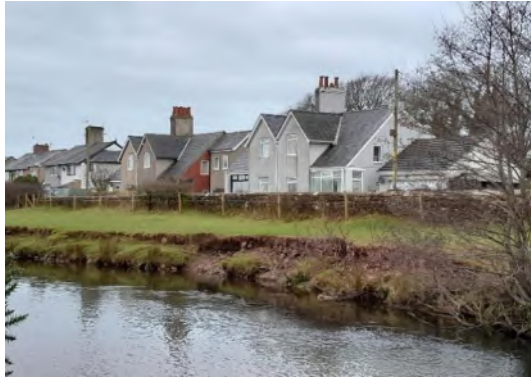
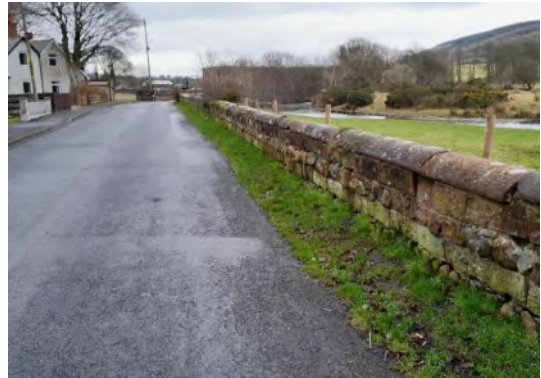
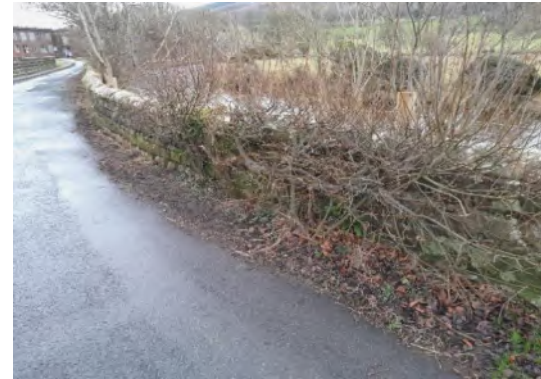
| Asset ID | CL3 | Frequency | | | | | |
|---|---|---|---|---|---|---|---|
| Comments | Variant weightings used for both faces as no revetments. Significant mortar loss to crest, holes through wall, bulging of wall where light foreign objects are growing in front on wall, distorting its shape and minor erosion to channel side. | | | | | | |

| Asset ID | CL3 | Frequency | | | | | |
|---|---|---|---|---|---|---|---|
| Recommendations | Rebuild wall and remove trees in front of wall. | | | | | | |

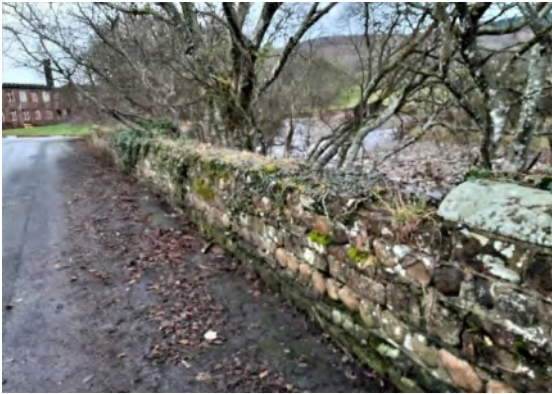
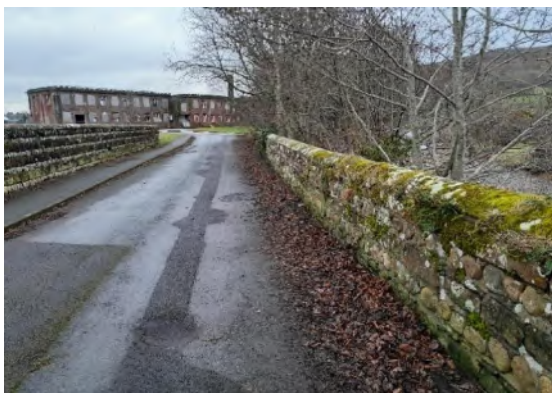
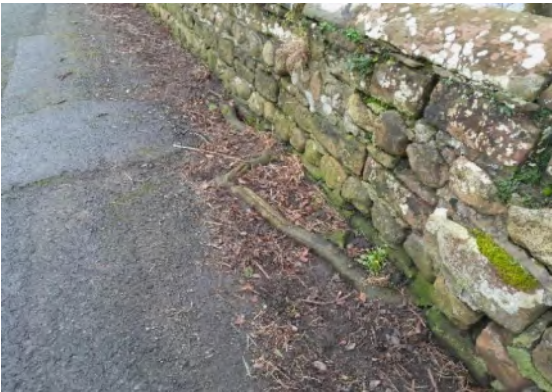
| Asset ID | CL6 | Frequency | | | | | |
|---|---|---|---|---|---|---|---|
| Comments | Heavy foreign objects growing towards channel on berm and channel side and undermining on channel side causing channel side to be unstable. Ivy growth on wall, heavy foreign objects growing close to wall causing bulging to wall and capping stones lost from crest halfway across wall. | | | | | | |

| Asset ID | CL6 | Frequency | | | | | |
|---|---|---|---|---|---|---|---|
| Recommendations | Rebuild wall, remove unstable trees and remove trees next to wall. | | | | | | |

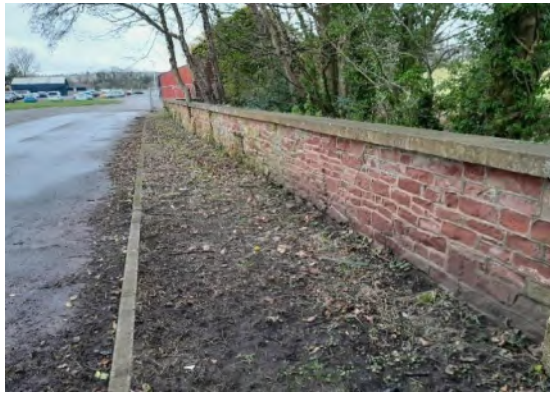
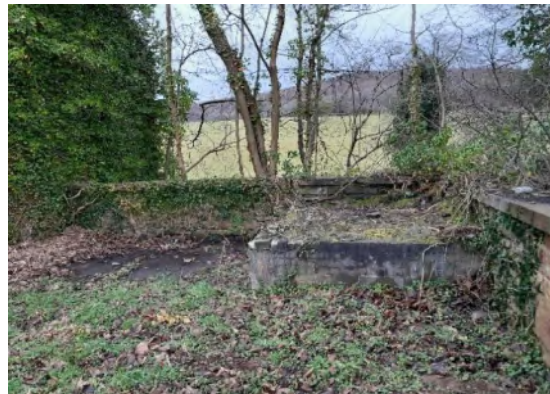
| Asset ID | CL15 | Frequency | | | | | |
|---|---|---|---|---|---|---|---|
| Comments | Several heavy foreign objects on berm and channel side. Severe mortar loss in landward face, exposed face difficult to inspect but wall covered in ivy and some tree roots and growing through it. Crest is uneven where ivy has grown around it. | | | | | | |

| Asset ID | CL15 | Frequency | | | | | |
|---|---|---|---|---|---|---|---|
| Recommendations | Rebuild wall, remove ivy and remove trees growing into wall. | | | | | | |

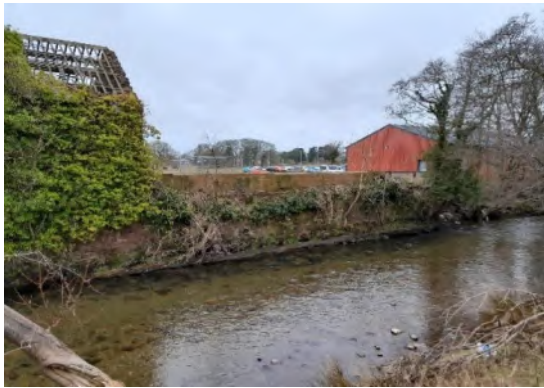
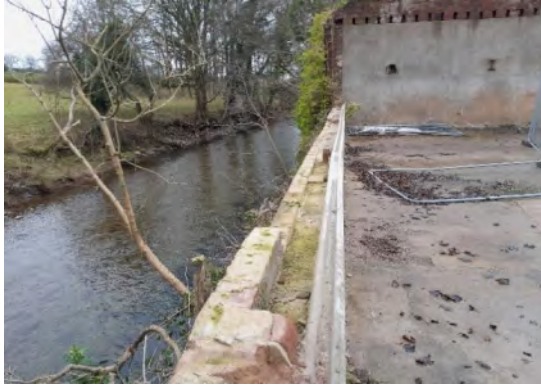
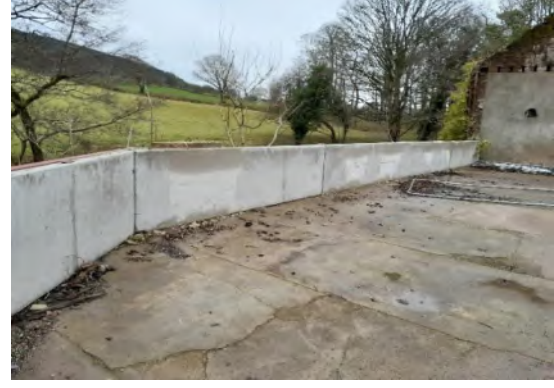
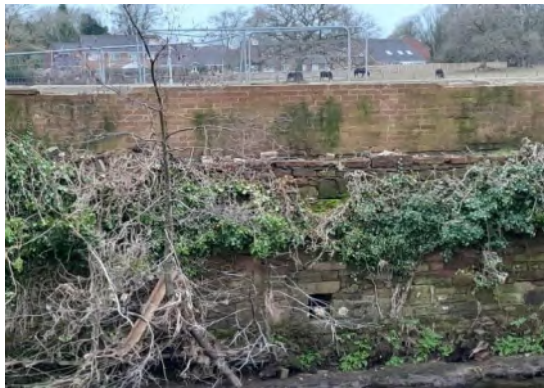
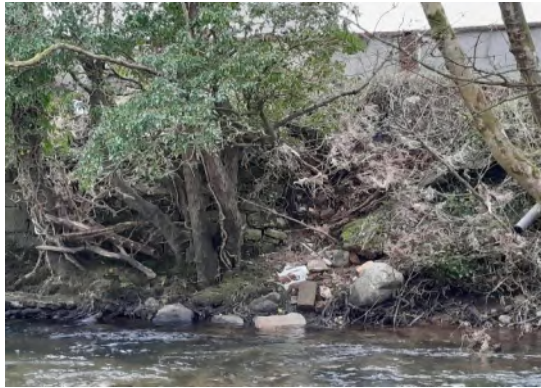
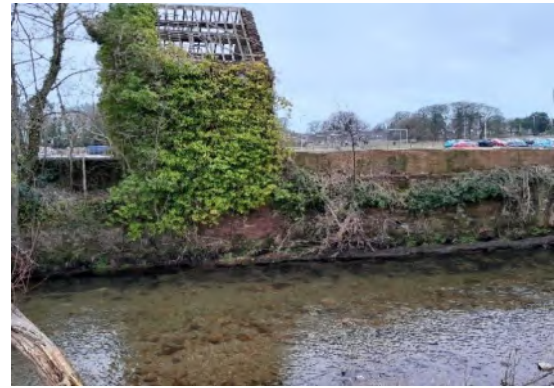
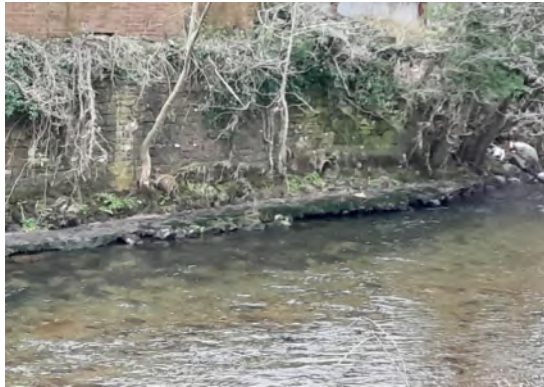
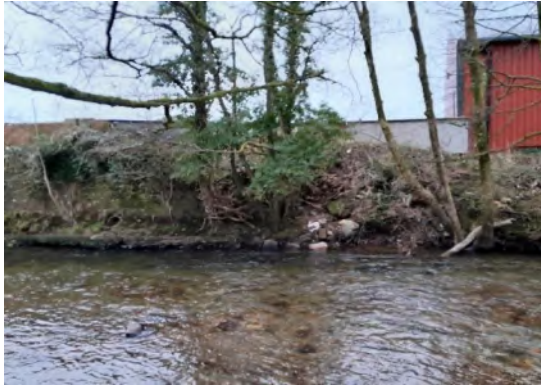
| Asset ID | CL16 | Frequency | | | | | |
|---|---|---|---|---|---|---|---|
| Comments | Extensive ivy growth, channel side wall is walling down with severe brick loss and root penetration. Heavy foreign objects growing on channel side causing brick displacement and loss. Crest is uneven due to brick loss but landward face is made from concrete slabs in good condition. | | | | | | |

| Asset ID | CL16 | Frequency | | | | | |
|---|---|---|---|---|---|---|---|
| Recommendations | Rebuild wall and remove heavy foreign objects. | | | | | | |

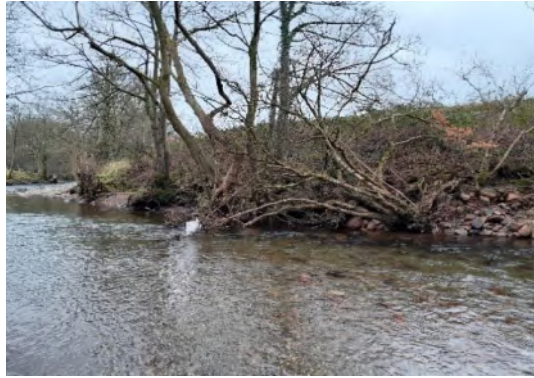
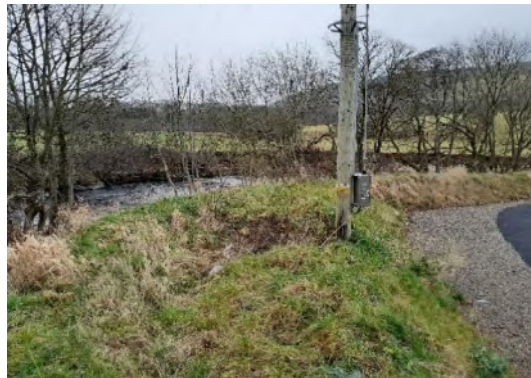
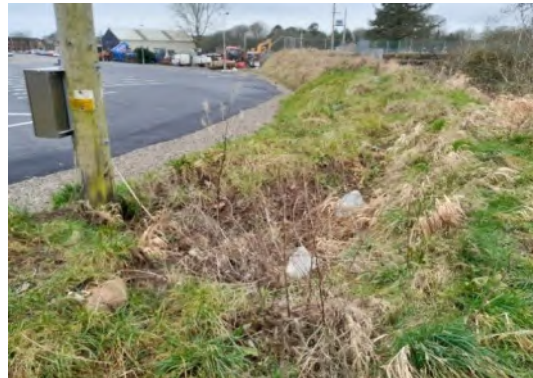
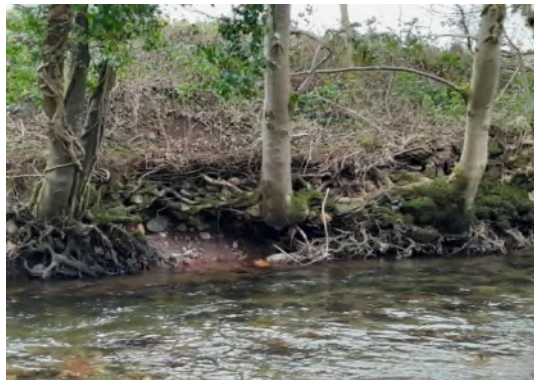
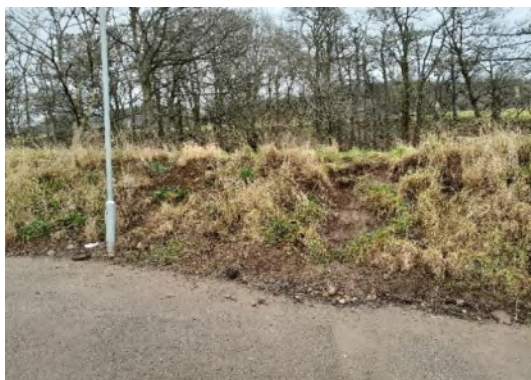
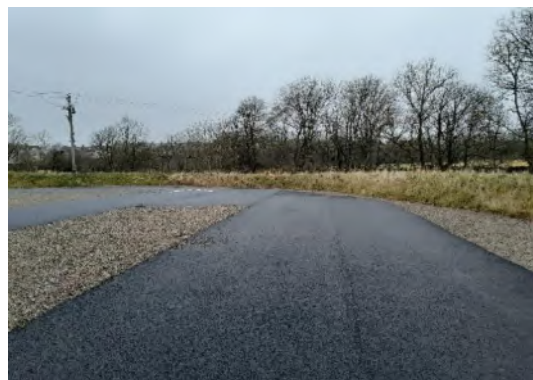
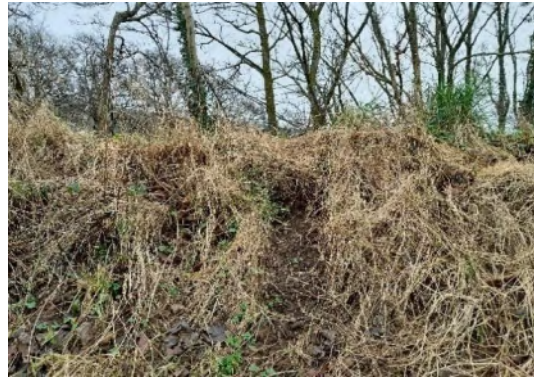
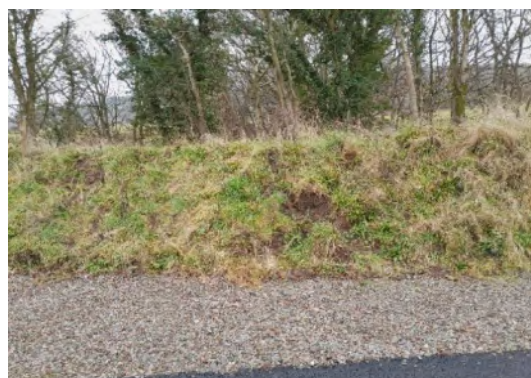
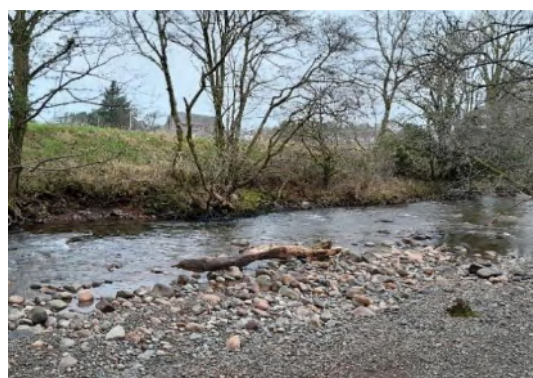
| <b>Comments</b> | Low points and rutting in crest but well vegetated. Variant used for exposed face due to steepness. Exposed and landward faces have isolated bare patches. Telegraph pole behind embankment but embankment build around it. Severe undermining of channel side around heavy foreign objects with extensive root exposure. | | | | | | |

| <b>Recommendations</b> | Remove unstable trees on channel side, infill low spots on crest and seed bare patches. | | | | | | |

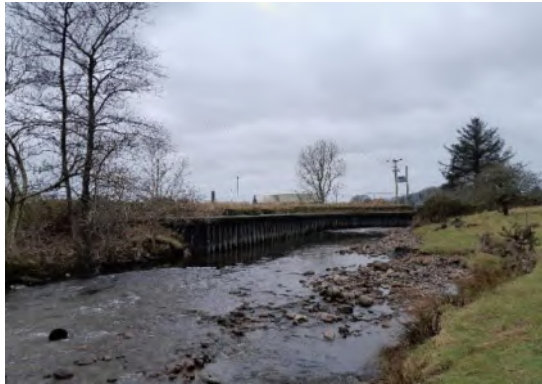
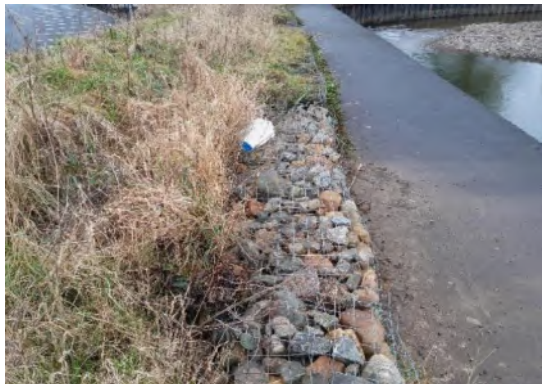
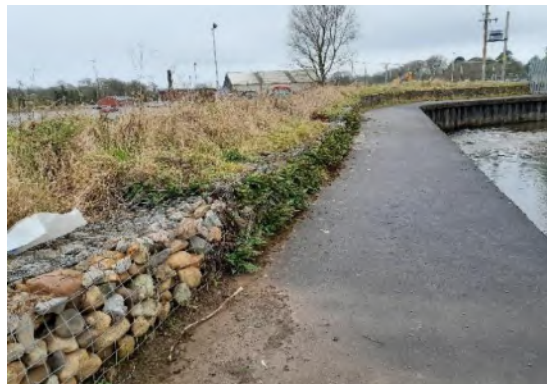
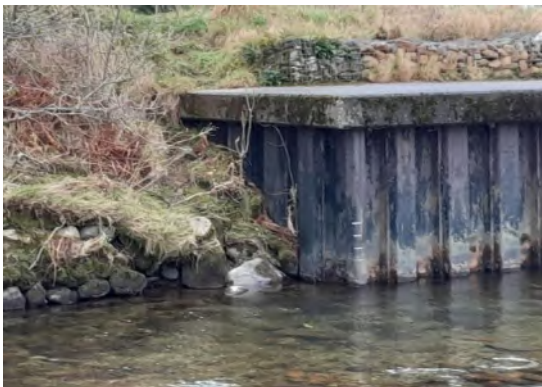
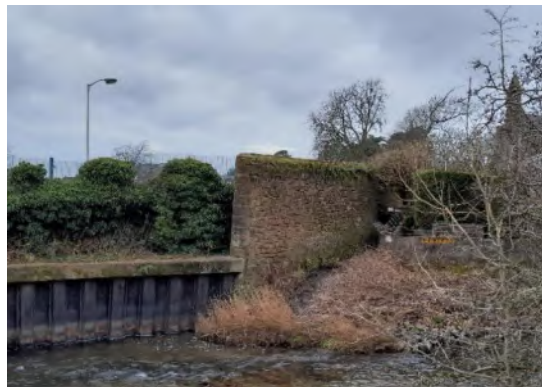
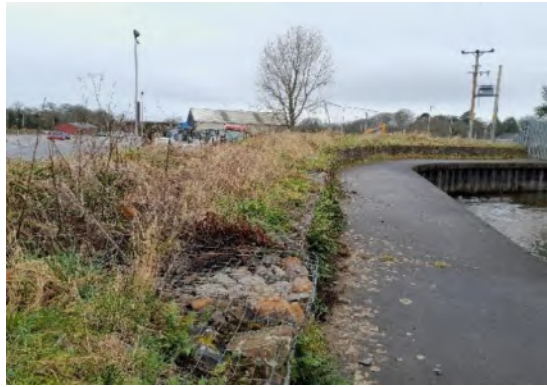
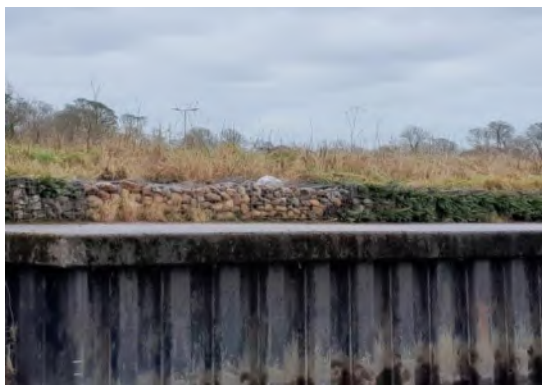
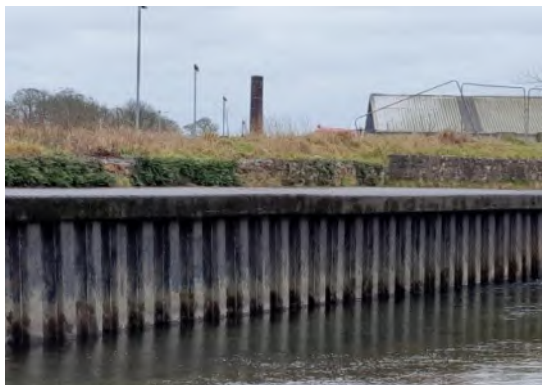
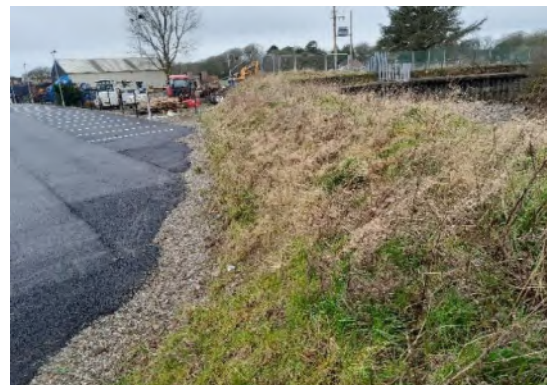
| <b>Comments</b> | Berm 2 and channel side in good condition with minor cosmetic defects to sheet piles. Vegetation growth through gabion baskets with a few broken wires but no gabion displacement. Uneven ground on exposed face 1 and landward face but well vegetated. Rutting and low spots in isolated places on crest. Variants used on crest as less than 4m wide and landward face due to steepness. | | | | | | |

| <b>Recommendations</b> | Remove vegetation in gabions and repair wires. Infill low spots on crest. | | | | | | |

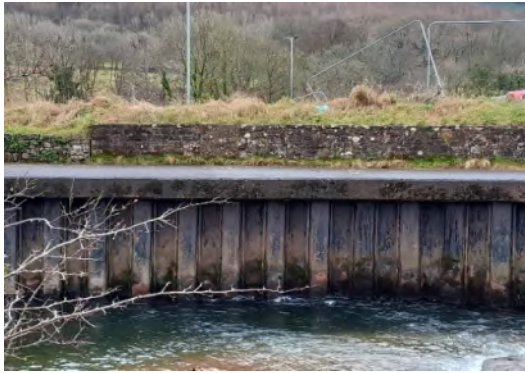
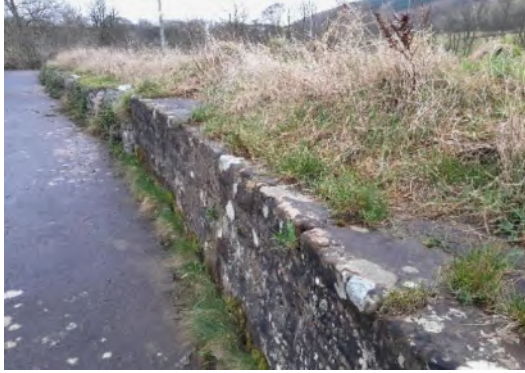
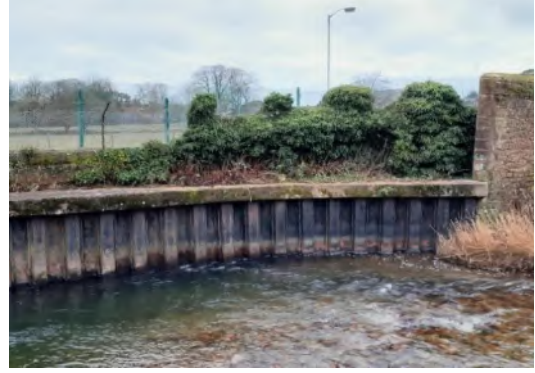
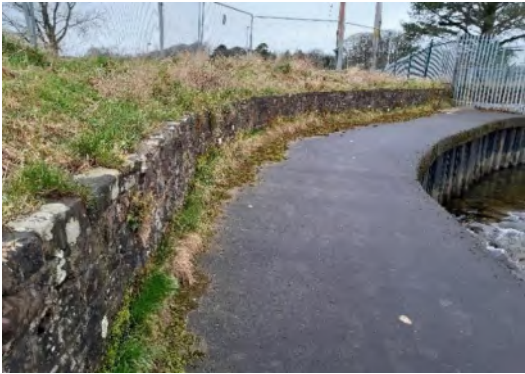
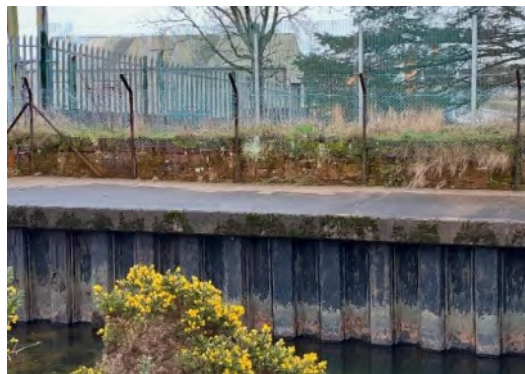
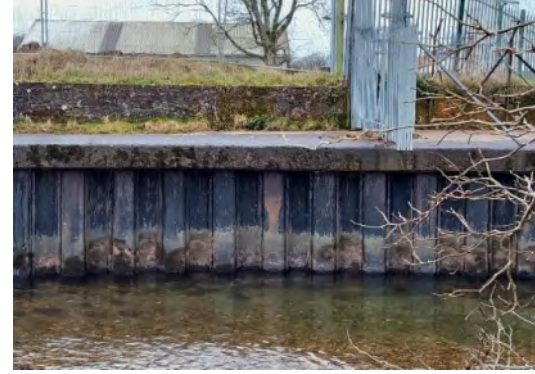
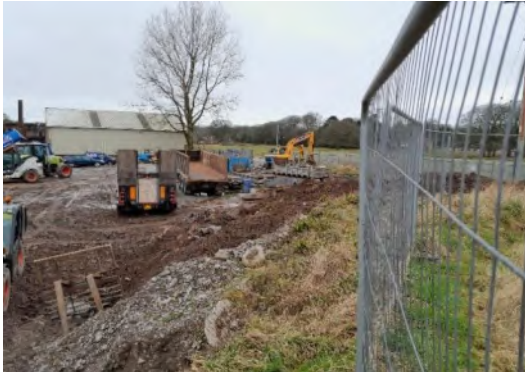
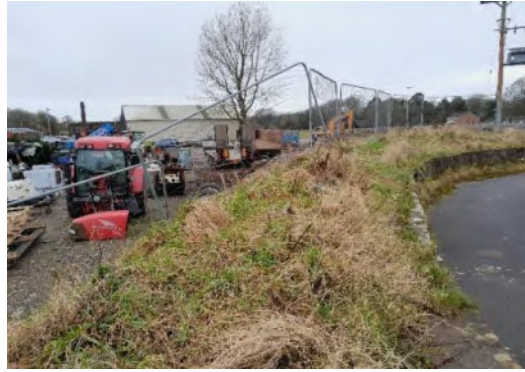
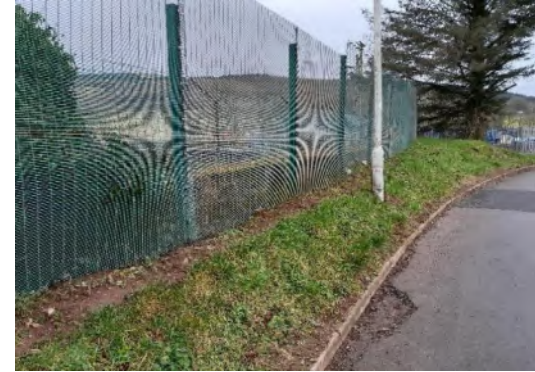
| Asset ID | CL22 | Frequency | | | | | |
|---|---|---|---|---|---|---|---|
| Comments | Minor vegetation growth within berm 1 and exposed face 2 with minor mortar loss. Uneven crest with some low spots but well vegetated. Berm 2 and channel side in good condition with minor cosmetic defects to sheet piling. Landward face and exposed face 1 are well vegetated but uneven. Landward face 2 around corner and has minor vegetation growing through stone and minor mortar loss. | | | | | | |

| Asset ID | CL22 | Frequency | | | | | |
|---|---|---|---|---|---|---|---|
| Recommendations | Monitor vegetation growth in wall and infill low spots in crest. | | | | | | |
