**Project Name:** 2025-11-33287 Thomas Armstrong CO Ltd Barfs Road  
Distington

**Project Date:** 12/01/2026

**Inspection Standard:** MSCC5 Sewers & Drainage GB (SRM5 Scoring)

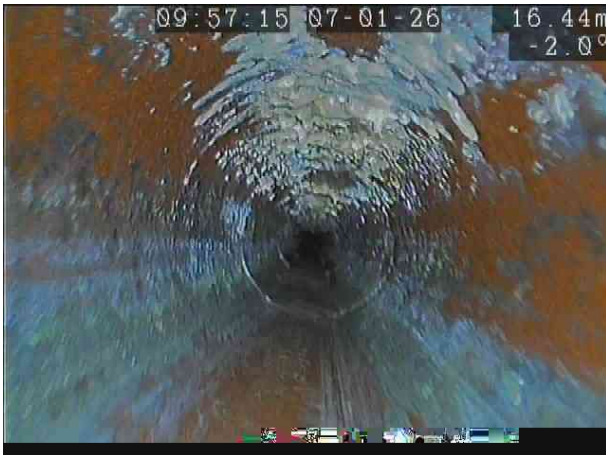
F2X\_6ea8c725-9d15-4891-b02f-e35e0dad0f40\_20260112\_153618\_517.jpg, 00:01:14, 16.44 m  
 Attached deposits, grease from 11 o'clock to 1 o'clock, 5% cross-sectional area loss

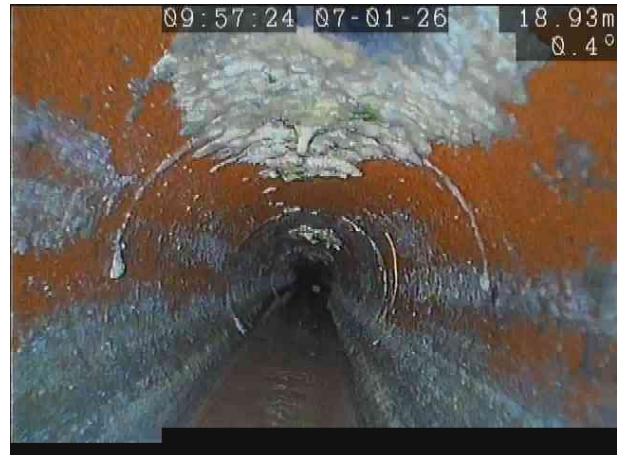
F2X\_846ea05a-ec3a-43e2-84c1-b983d22ed349\_20260112\_153831\_818.jpg, 00:01:24, 18.93 m  
 Attached deposits, grease from 11 o'clock to 1 o'clock, 5% cross-sectional area loss

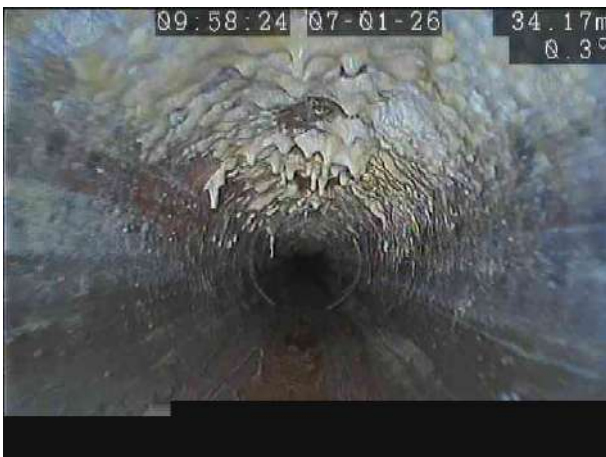
F2X\_23e92cbd-ea92-4317-941e-65617c6e4a8e\_20260112\_153830\_698.jpg, 00:02:23, 34.25 m  
 Attached deposits, grease from 10 o'clock to 2 o'clock, 5% cross-sectional area loss, start

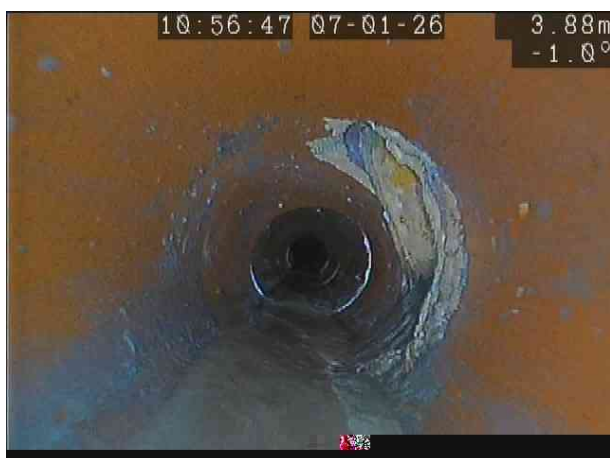
F5X\_9deb117e-8430-45e1-b373-aeb99019fc76\_20260112\_161859\_251.jpg, 00:00:28, 3.98 m  
 Hole in drain or sewer at 1 o'clock

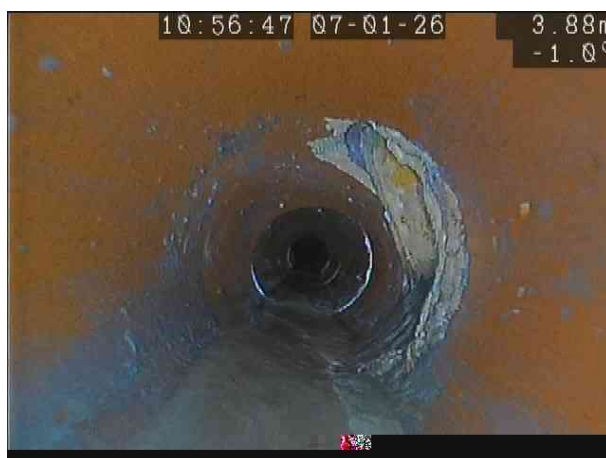
F5X\_25828314-b1b5-4540-ac4d-781a8ea3b468\_20260112\_161740\_593.jpg, 00:00:28, 4.06 m  
 Connection other than junction at 2 o'clock, 150mm dia

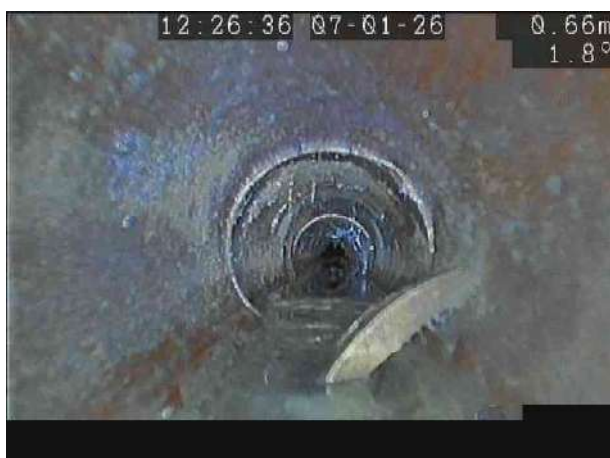
UTPX\_a97cce06-e967-4b8a-b8ab-1a1386f52b8b\_20260113\_100248\_391.jpg, 00:00:12, 0.66 m  
 Settled deposits, other, 15% cross-sectional area loss, Debris

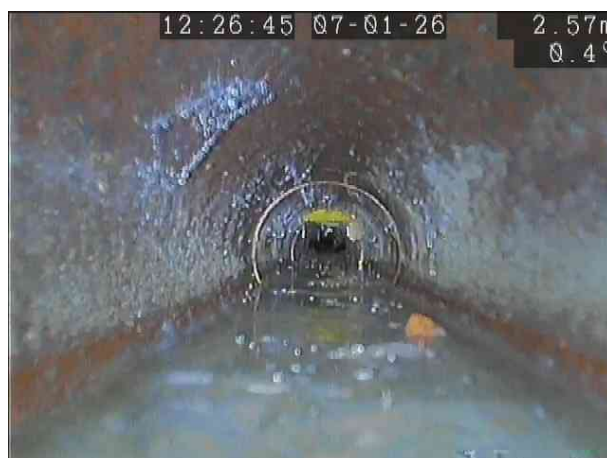
UTPX\_c85c12ec-a350-4859-b1b6-14da97e40086\_20260113\_100354\_232.jpg, 00:00:21, 2.68 m  
 Settled deposits, fine, 10% cross-sectional area loss

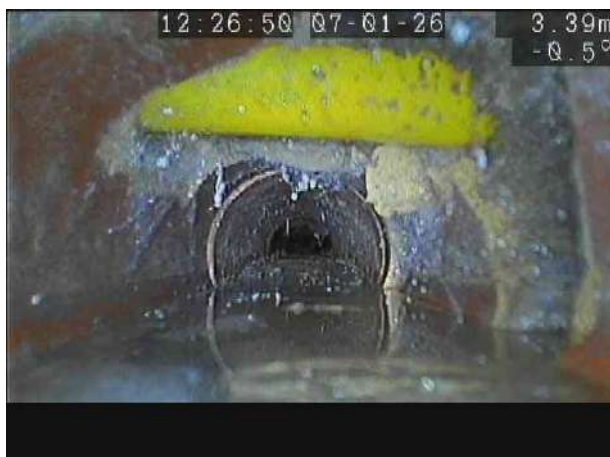
UTPX\_068653f2-f03b-49b8-a3ec-4a80fe382551\_20260113\_100413\_502.jpg, 00:00:26, 3.39 m  
 Hole in drain or sewer from 11 o'clock to 4 o'clock

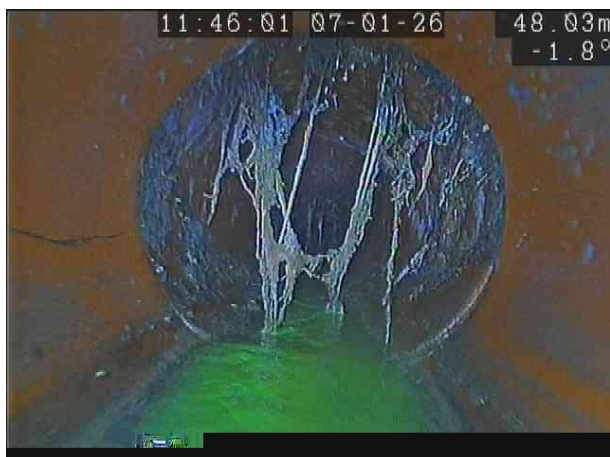
F6X\_f7482c4a-01b9-42b9-a6bb-3c2c921dccff\_20260112\_164  
 835\_226.jpg, 00:03:20, 48.03 m  
 Roots, fine at joint, start

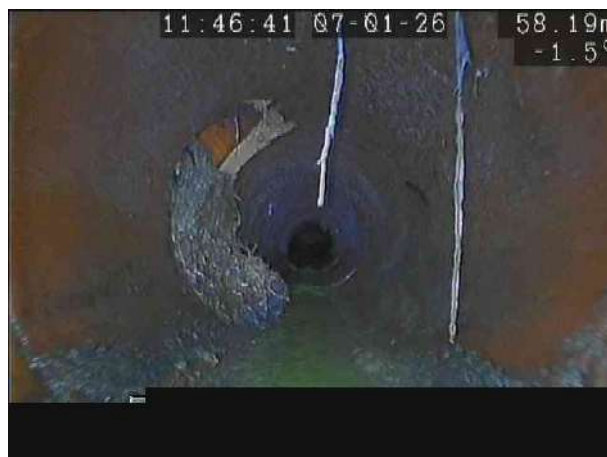
F6X\_f55eae9c-39f0-4812-8dcb-4fb0534bb419\_20260112\_165  
 048\_351.jpg, 00:04:01, 58.34 m  
 Roots, mass, 15% cross-sectional area loss

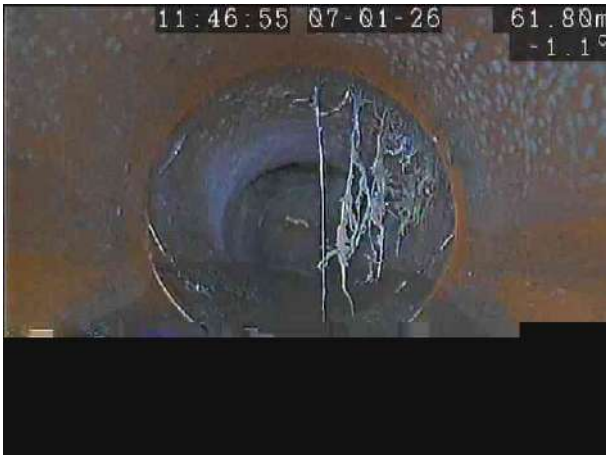
F6X\_36172d17-64c7-441e-8fcf-22b09bdb08cb\_20260112\_16  
 5135\_021.jpg, 00:04:15, 61.89 m  
 Roots, fine at joint

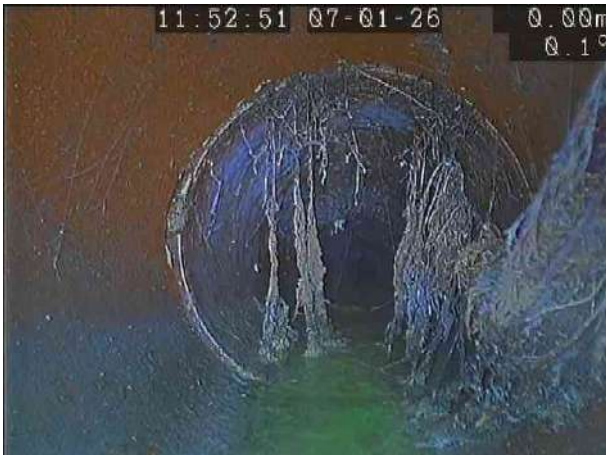
F7X\_a7617a19-1f64-4698-bac4-3a5d2f551734\_20260112\_165335\_651.jpg, 00:00:09, 0.01 m  
 Roots, mass at joint, 15% cross-sectional area loss

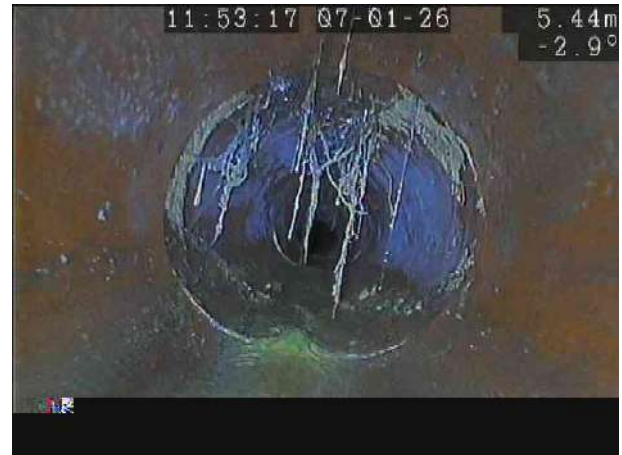
F7X\_3d5f8c96-7b21-4198-9444-d0aeda95a7ea\_20260112\_165653\_177.jpg, 00:00:35, 5.52 m  
 Roots, fine at joint

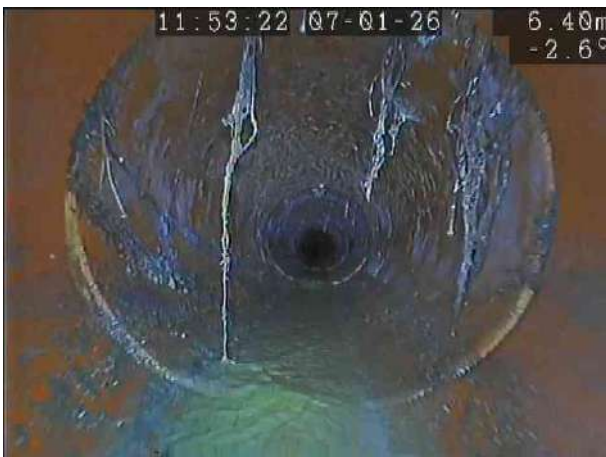
F7X\_f6897426-25d9-4469-9ce7-0d661897e67b\_20260112\_165704\_010.jpg, 00:00:39, 6.50 m  
 Roots, fine at joint

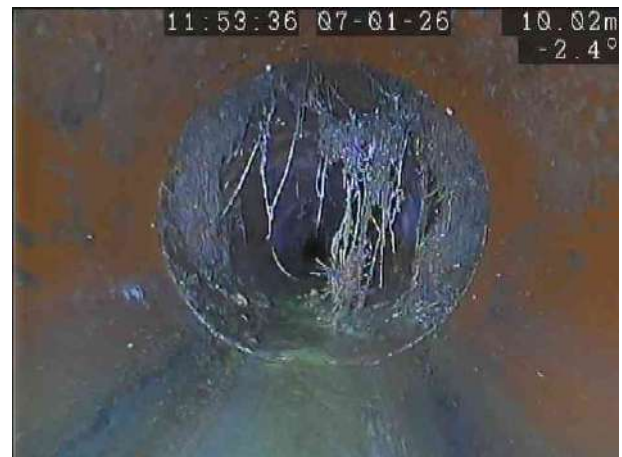
F7X\_16e2086c-53f8-490f-a301-c7bc64bf3d63\_20260112\_165733\_648.jpg, 00:00:54, 10.02 m  
 Roots, mass at joint, 10% cross-sectional area loss

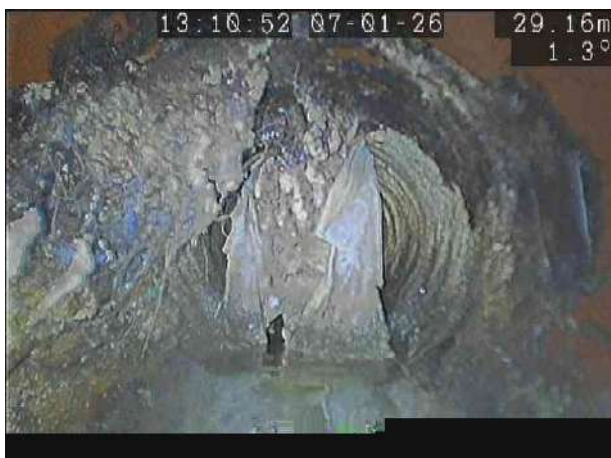
F7X\_3b807ff6-44d5-4f6b-8856-2940cd60b2aa\_20260113\_10  
 0934\_118.jpg, 00:02:11, 29.16 m

Settled deposits, hard or compacted, 20% cross-sectional area  
 loss

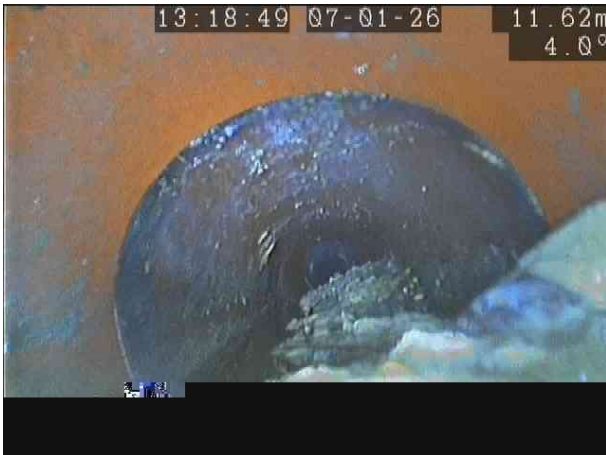
F8X\_9d3736a9-4645-4c38-9a23-6f34a04f16f3\_20260113\_10  
 1302\_611.jpg, 00:01:07, 11.62 m  
 Settled deposits, hard or compacted, 25% cross-sectional area  
 loss

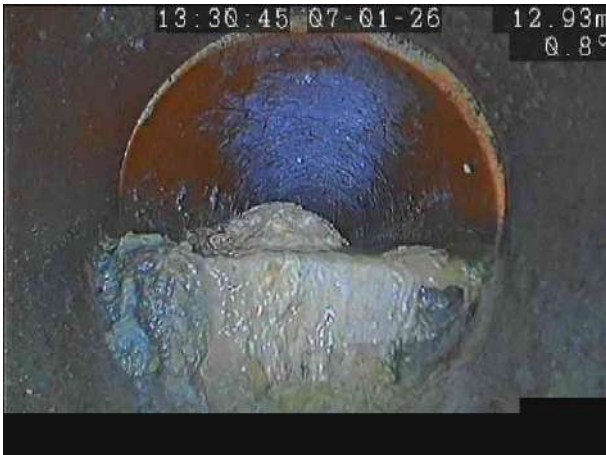
F8X\_84287667-c391-46db-8b65-e1f2f57a874d\_20260113\_10  
 1457\_371.jpg, 00:01:03, 12.92 m  
 Settled deposits, hard or compacted at joint, 30%  
 cross-sectional area loss

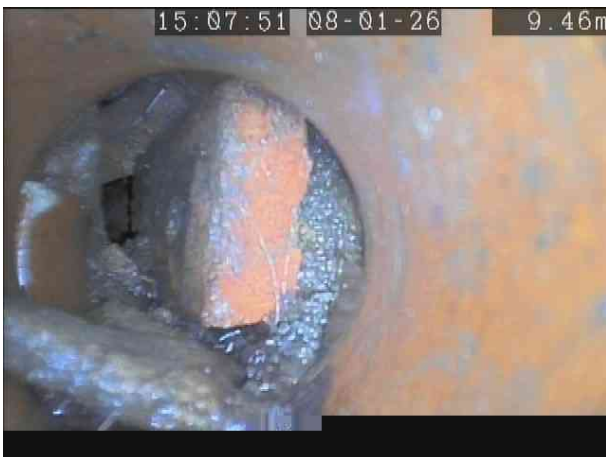
UTPX\_85b4a09b-db1d-44b5-8b91-6d594213f920\_20260114\_111750\_863.jpg, 00:00:35, 9.46 m  
 Settled deposits, other, 90% cross-sectional area loss, Debris

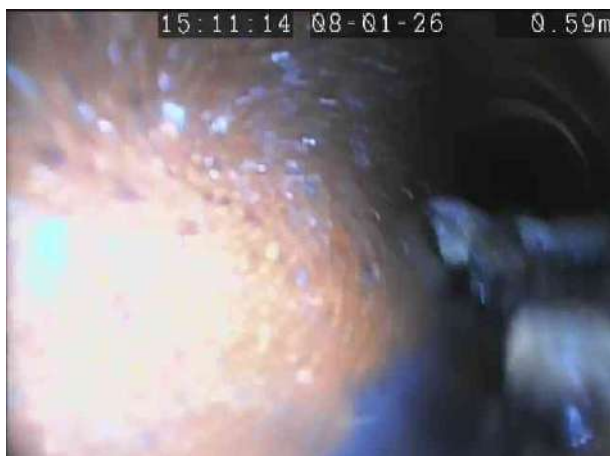
UTPX\_ca82abcc-7169-4572-9bf6-a26fde51f873\_20260114\_112821\_891.jpg, 00:00:11, 0.82 m  
 Settled deposits, other, 20% cross-sectional area loss, Debris

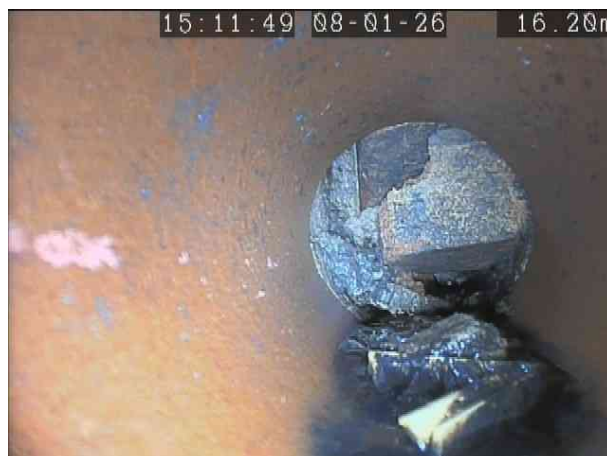
UTPX\_5e684cd7-e4e7-440e-8c9b-5b91ab39ce6e\_20260114\_112940\_235.jpg, 00:00:46, 16.20 m  
 Settled deposits, other, 80% cross-sectional area loss, Debris

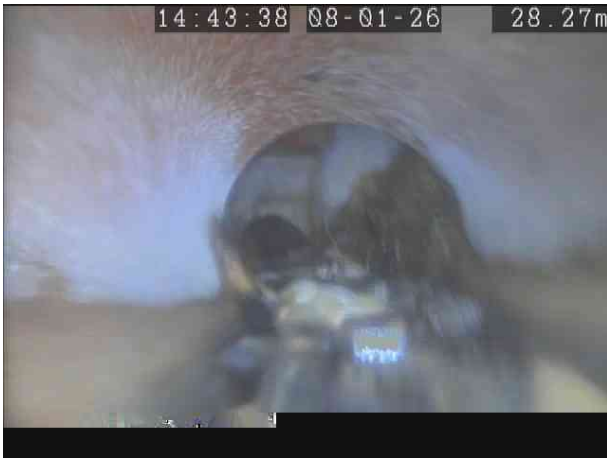
F16X\_2f838f91-d5d2-4b1d-8e11-553e0241beff\_20260114\_10  
 2301\_556.jpg, 00:01:53, 28.51 m  
 Settled deposits, coarse, 15% cross-sectional area loss

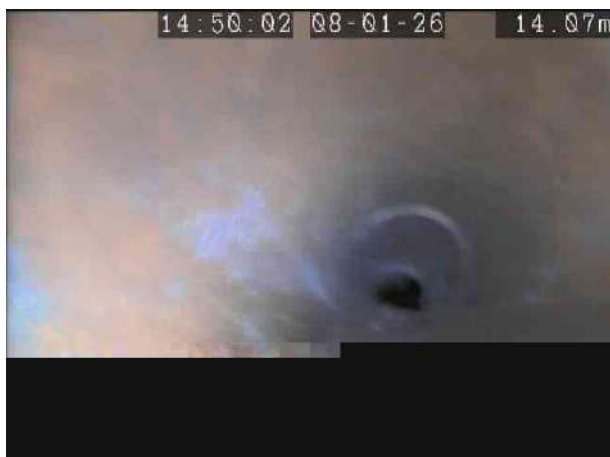
UTPX\_7b4baf4e-c8c3-4b1d-b022-2813a2cdd4bd\_20260114\_105323\_879.jpg, 00:00:58, 14.07 m  
 Joint displaced, medium

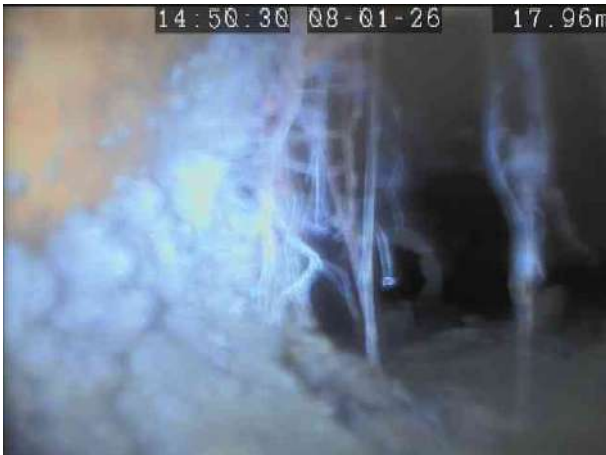
UTPX\_dbf57161-392c-4f6e-9c70-0c18ebe38cbd\_20260114\_1  
 10852\_764.jpg, 00:01:27, 18.09 m  
 Settled deposits, fine, 15% cross-sectional area loss

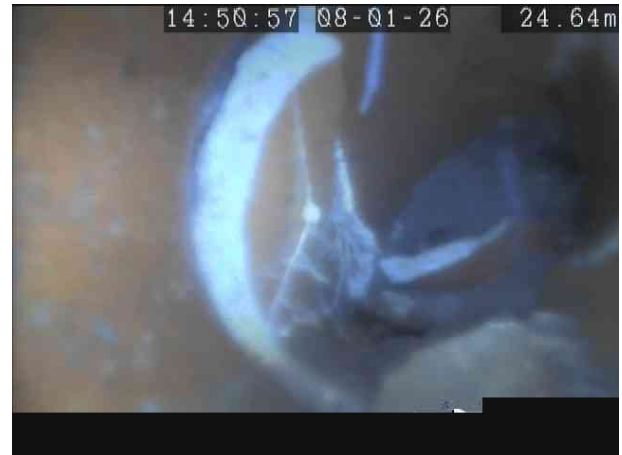
UTPX\_0f935942-1346-4250-94bf-d19fa8eb3824\_20260114\_1  
 10939\_005.jpg, 00:01:53, 24.64 m  
 Collapsed drain or sewer

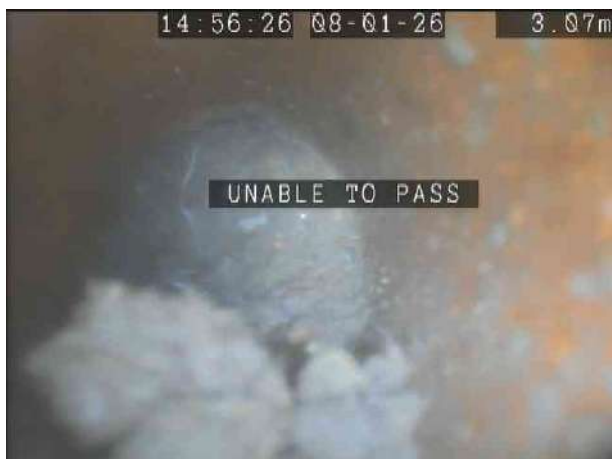
UTPX\_049c198c-9e2a-453d-b634-c4a30d34fb20\_20260114\_111259\_330.jpg, 00:00:24, 3.07 m  
 Settled deposits, other, 100% cross-sectional area loss, Debris

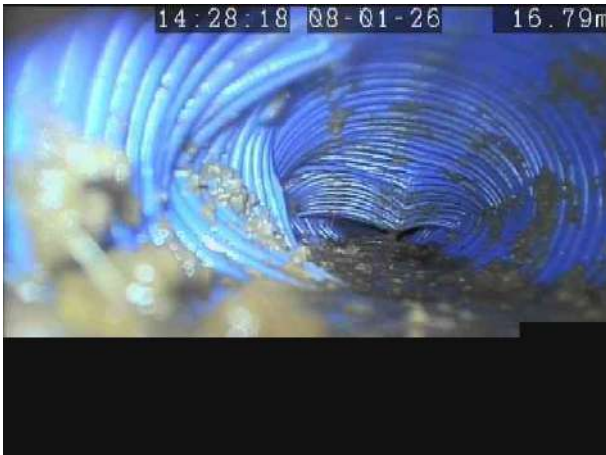
UTPX\_97496b37-96e3-48a7-8545-d3d9d306e267\_20260113\_164418\_848.jpg, 00:01:00, 16.91 m  
 Deformed sewer or drain, 20%

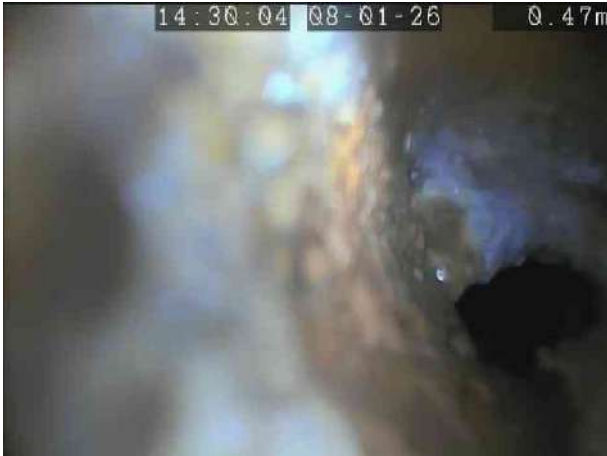
CPX\_09ef34f8-83c6-42a6-a88d-1e184cb17af3\_20260113\_16  
 4748\_242.jpg, 00:00:25, 0.40 m  
 Settled deposits, hard or compacted, 10% cross-sectional area  
 loss

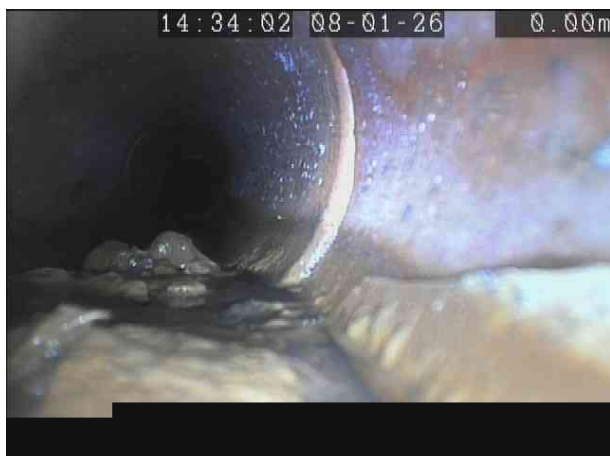
F15X\_e000a593-2e50-419e-b63e-41e633074d94\_20260113\_165104\_531.jpg, 00:00:08, 0.01 m  
 Settled deposits, coarse, 10% cross-sectional area loss

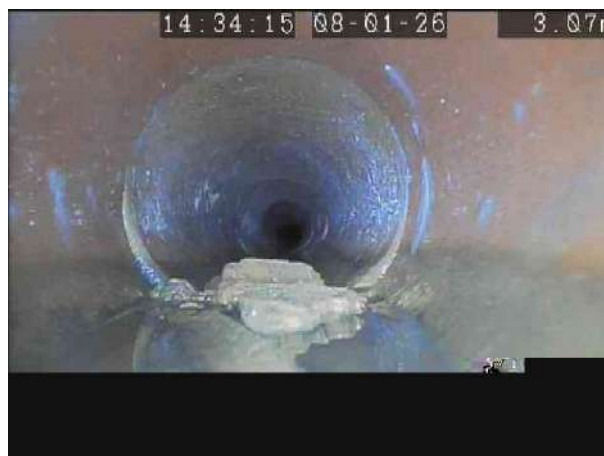
F15X\_b6078b49-660c-4a74-9086-629c58fe732a\_20260113\_165125\_038.jpg, 00:00:21, 3.19 m  
 Settled deposits, coarse, 10% cross-sectional area loss

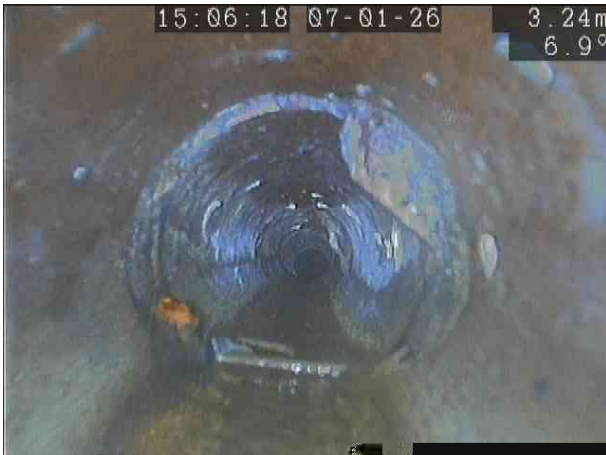
UTPX\_6ca9bd6e-4dae-4868-8449-57a16b147dad\_20260113\_112935\_007.jpg, 00:00:38, 3.31 m  
 Settled deposits, hard or compacted at joint, 15% cross-sectional area loss

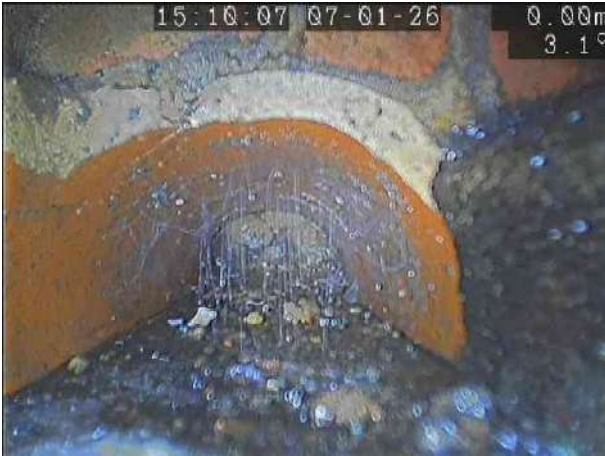
EndX\_c0c197a0-3d16-4a8e-8837-eab53fb0bc05\_20260113\_1  
 13044\_976.jpg, 00:00:06, 0.00 m  
 Settled deposits, coarse, 15% cross-sectional area loss

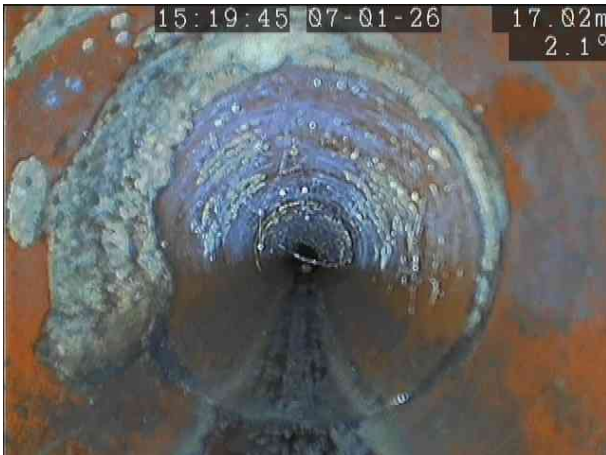
UTPX\_f1ed41dd-33af-4494-9a98-af8f18476f67\_20260113\_11  
 3448\_566.jpg, 00:01:38, 17.00 m  
 Settled deposits, hard or compacted at joint, 10%  
 cross-sectional area loss

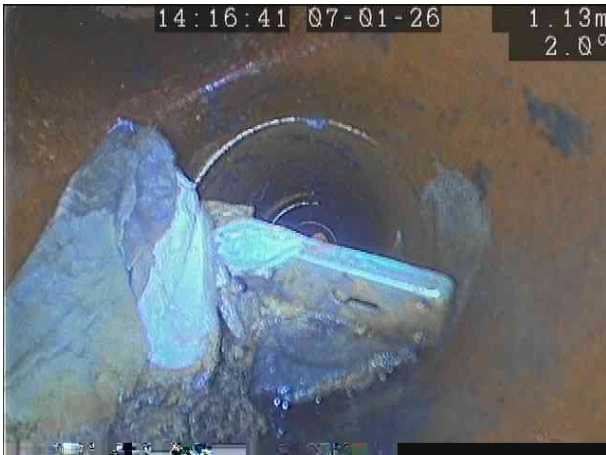
UTPX\_2f9e182f-578a-47a9-88cd-600bebfa87a2\_20260113\_1  
 12326\_332.jpg, 00:00:21, 1.17 m  
 Settled deposits, other, 50% cross-sectional area loss, Debris

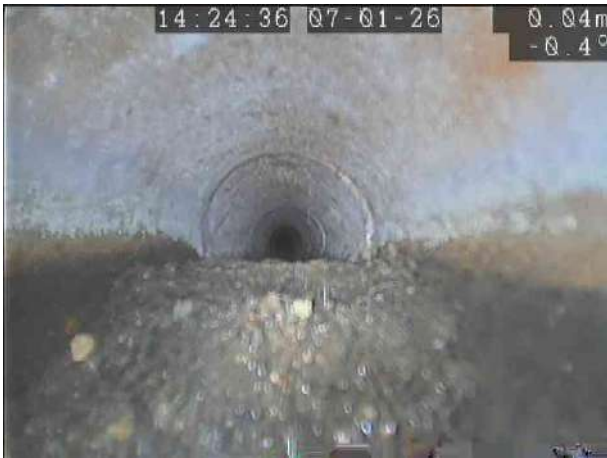
F12X\_90689cb1-e125-4233-8793-0bcb1e314596\_20260113\_112434\_945.jpg, 00:00:10, 0.10 m  
 Settled deposits, fine, 20% cross-sectional area loss

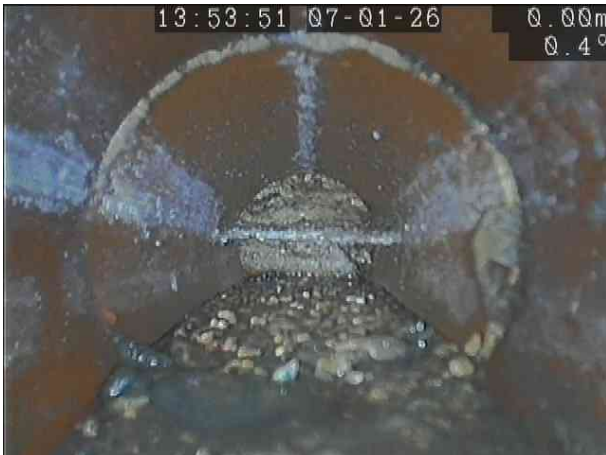
UTPX\_c607b103-f1d8-406d-be87-3c6d7c140bbb\_20260113\_111002\_082.jpg, 00:00:09, 0.01 m  
 Settled deposits, coarse, 10% cross-sectional area loss

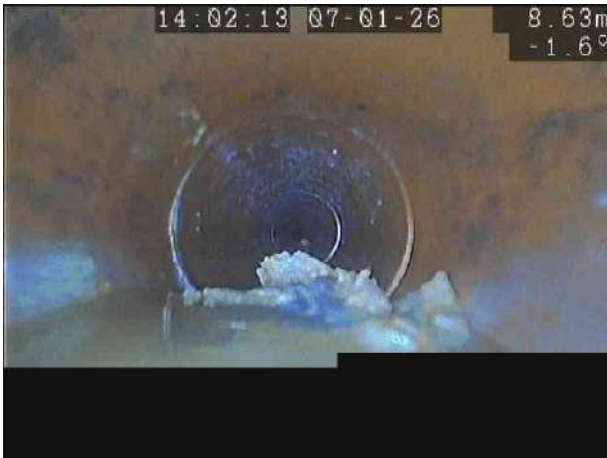
F10X\_2241bef5-0425-4b50-a731-9f2defc135dc\_20260113\_11  
 1929\_897.jpg, 00:01:08, 8.63 m  
 Settled deposits, coarse, 20% cross-sectional area loss

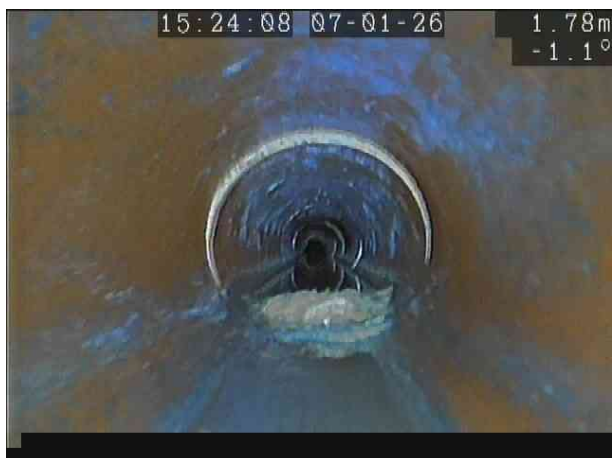
F10X\_88d41539-e7ef-4e7b-9146-b98c0a2fe256\_20260113\_1  
 13814\_053.jpg, 00:00:20, 1.95 m  
 Settled deposits, coarse, 10% cross-sectional area loss

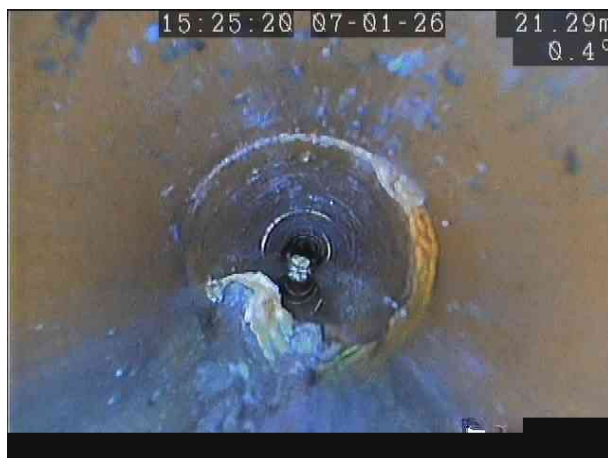
F10X\_03a1ed7f-639c-4285-9c20-3d476a801cbd\_20260113\_1  
 14036\_478.jpg, 00:01:31, 21.29 m  
 Settled deposits, coarse, 15% cross-sectional area loss

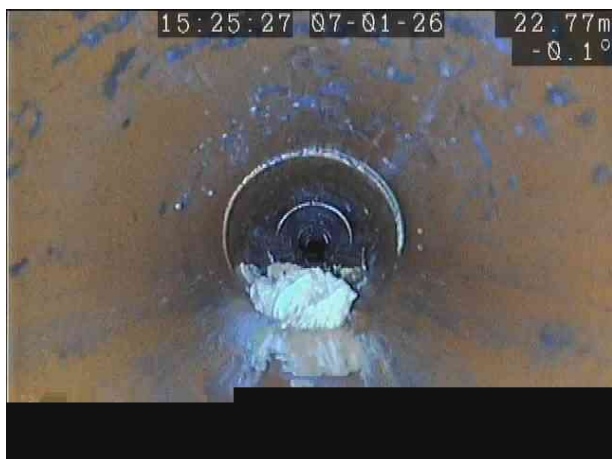
F10X\_118fc3c3-2726-4eb2-823e-ee4d103f9151\_20260113\_1  
 14053\_675.jpg, 00:01:39, 22.93 m  
 Settled deposits, coarse, 15% cross-sectional area loss

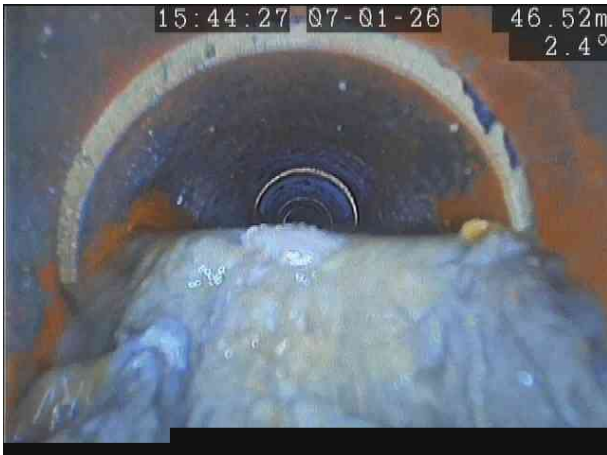
F14X\_1960642a-ba62-4ee5-b12e-33e46168597f\_20260113\_115826\_759.jpg, 00:03:34, 46.52 m  
 Settled deposits, other at joint, 55% cross-sectional area loss,  
 Debris/ concrete/ tissue build up

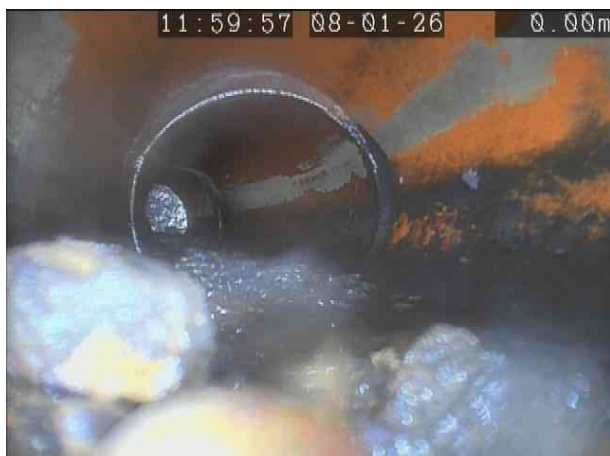
UTPX\_0ad9181f-6c8b-47ef-a044-a9811f1b18ec\_20260113\_151543\_568.jpg, 00:00:07, 0.01 m  
 Settled deposits, coarse, 10% cross-sectional area loss

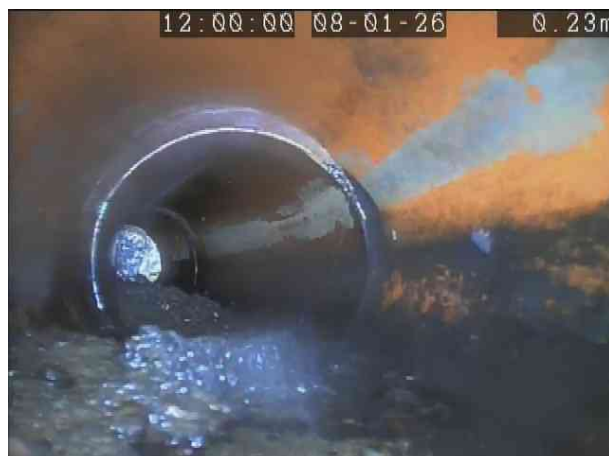
UTPX\_a7ab876b-5cf9-45df-ba0d-2c3f9d88bf90\_20260113\_151629\_947.jpg, 00:00:09, 0.05 m  
 Settled deposits, hard or compacted, 10% cross-sectional area loss

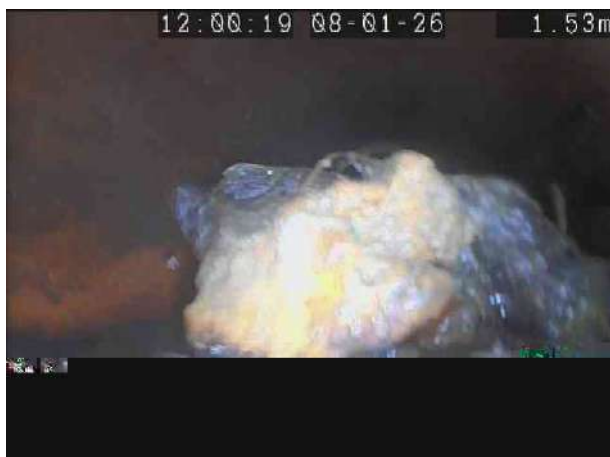
UTPX\_04fdff69-ce8d-4378-8e83-d3c481d01a17\_20260113\_151715\_952.jpg, 00:00:25, 1.41 m  
 Settled deposits, coarse, 20% cross-sectional area loss

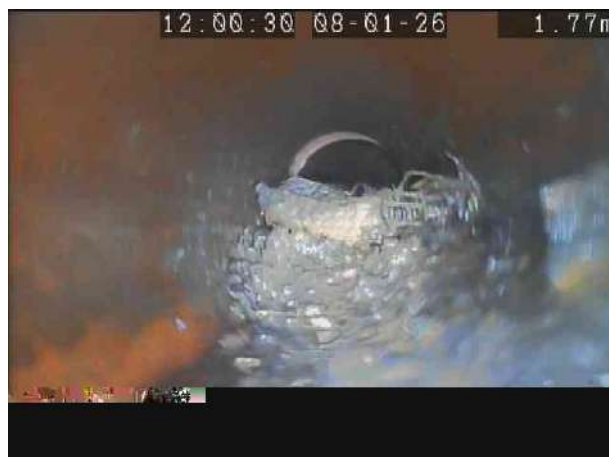
UTPX\_d5d5ac0d-9251-43e8-9573-b3638ff8d5a3\_20260113\_151810\_229.jpg, 00:00:39, 1.53 m  
 Settled deposits, hard or compacted, 30% cross-sectional area loss

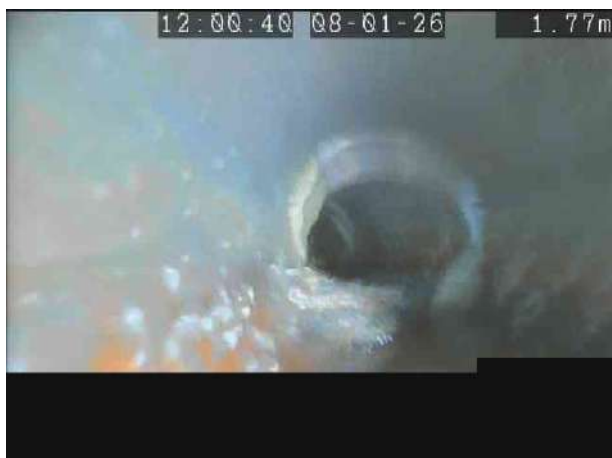
UTPX\_aa38b2df-9b9c-48cf-a93b-afed77c2890a\_20260113\_1  
 53614\_513.jpg, 00:00:50, 1.89 m  
 Settled deposits, hard or compacted, 10% cross-sectional area  
 loss

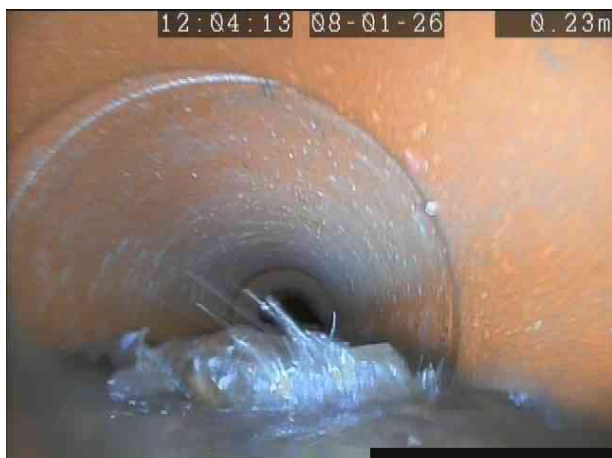
S5X\_52bd08b9-b6b4-4cd2-ad4a-e77698905989\_20260113\_155342\_968.jpg, 00:00:11, 0.47 m  
 Settled deposits, coarse, 15% cross-sectional area loss, start

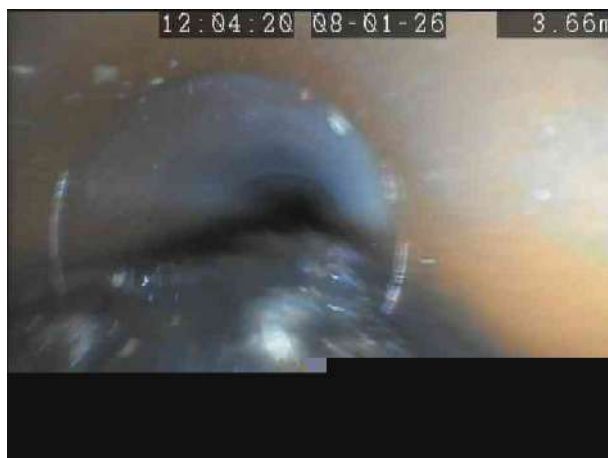
S5X\_6ada8f25-3e82-4602-b9c5-5f818bca0afc\_20260113\_155356\_917.jpg, 00:00:11, 0.47 m  
 Settled deposits, coarse, 15% cross-sectional area loss, start

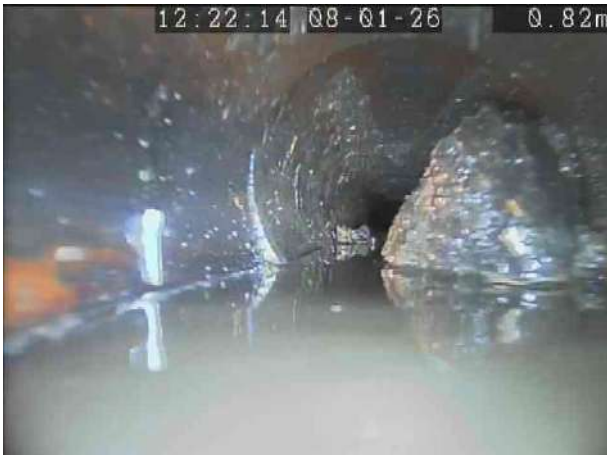
| Item No. | Inspection Direction | PLR | Client's Job Ref | Contractor's Job Ref |
|---|---|---|---|---|
| 35 | Downstream | S4X | | |

S4X\_c187923e-faa9-489e-92a3-b0c3965ce571\_20260113\_155921\_341.jpg, 00:00:17, 0.82 m  
 Settled deposits, other, 40% cross-sectional area loss, Stone, being pushed down line by camera

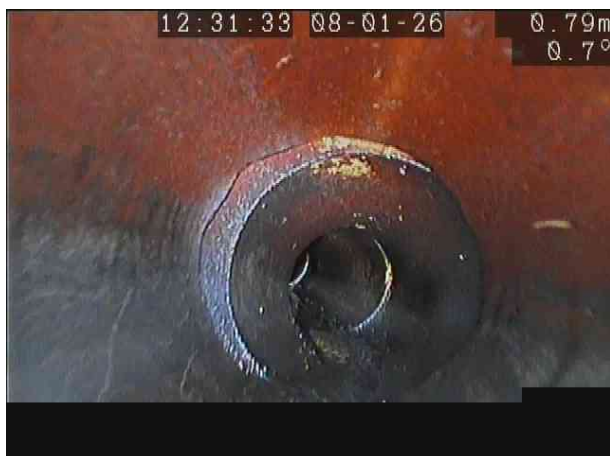
| Item No. | Inspection Direction | PLR | Client's Job Ref | Contractor's Job Ref |
|---|---|---|---|---|
| 36 | Downstream | S1X | | |

S1X\_5cbb6176-5e30-49f6-9dc7-2510361e1031\_20260113\_160632\_197.jpg, 00:00:09, 0.87 m  
 Joint displaced, medium

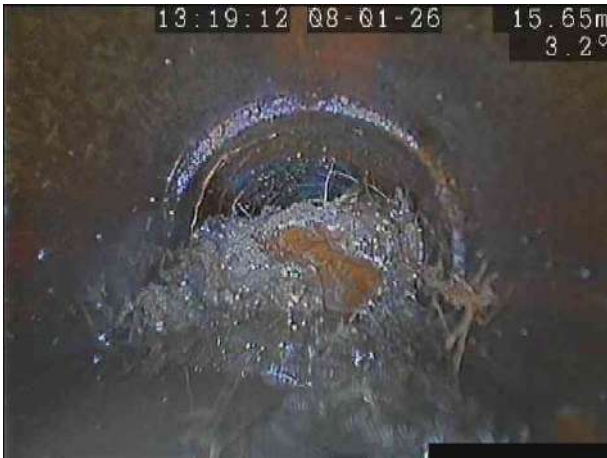
| Item No. | Inspection Direction | PLR | Client's Job Ref | Contractor's Job Ref |
|---|---|---|---|---|
| 37 | Upstream | S1X | | |

S1X\_f4f87085-bfee-4cdb-9785-e85c5f0aa447\_20260113\_161944\_601.jpg, 00:01:29, 15.65 m  
 Settled deposits, other, 70% cross-sectional area loss, Debris

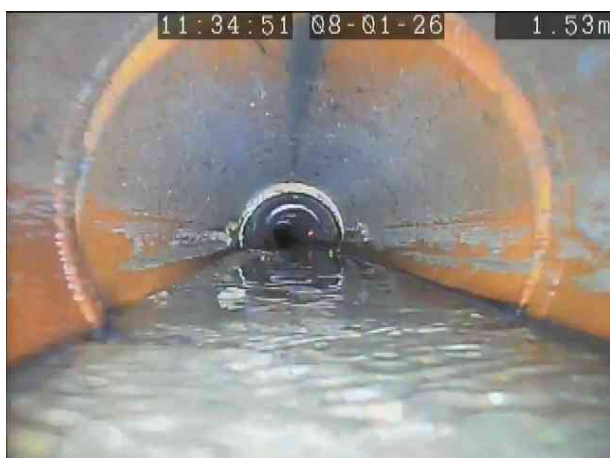
| Item No. | Inspection Direction | PLR | Client's Job Ref | Contractor's Job Ref |
|---|---|---|---|---|
| 38 | Upstream | UTPX | | |

UTPX\_9152fd47-bde0-450d-a431-ff0f6197922a\_20260113\_143244\_914.jpg, 00:00:21, 1.65 m  
 Settled deposits, fine, 10% cross-sectional area loss

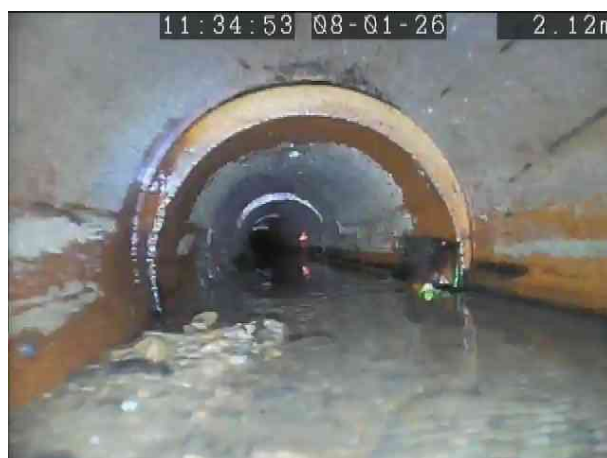
UTPX\_a2529226-ab90-4ce5-8443-b7ab9433e7bc\_20260113\_143304\_959.jpg, 00:00:23, 2.24 m  
 Joint displaced, medium

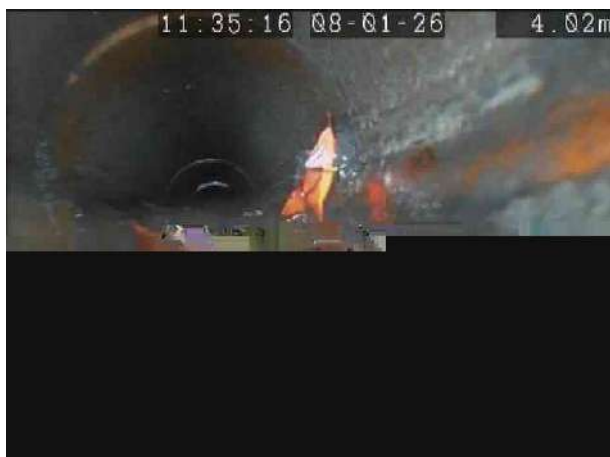
UTPX\_28e012c4-69e8-44f5-a731-faab1eb67e50\_20260113\_143405\_048.jpg, 00:00:45, 4.02 m  
 Settled deposits, fine, 10% cross-sectional area loss

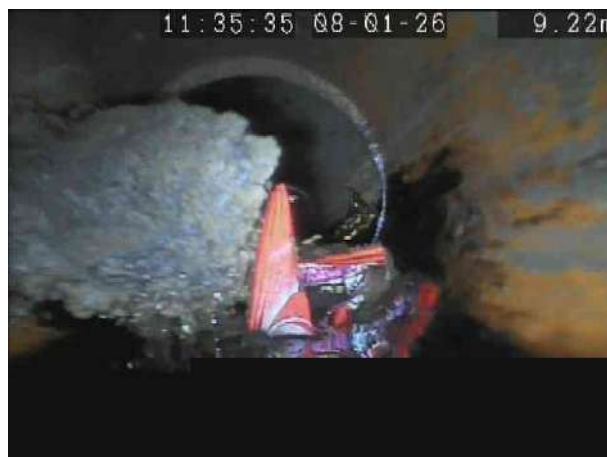
UTPX\_86c9f49b-461c-467a-a9d2-2ad092566d19\_20260113\_143438\_824.jpg, 00:01:05, 9.22 m  
 Settled deposits, hard or compacted, 30% cross-sectional area loss

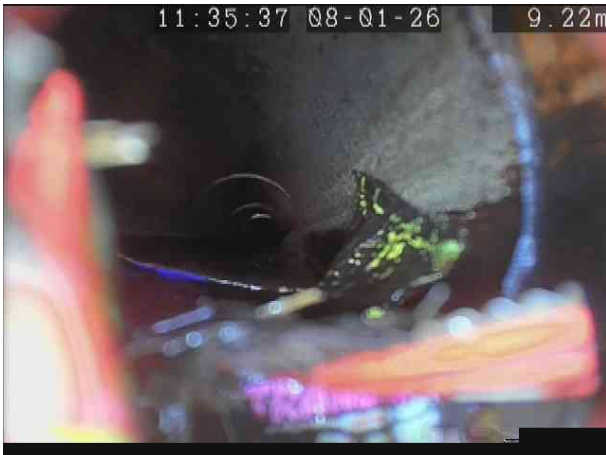
| Item No. | Inspection Direction | PLR | Client's Job Ref | Contractor's Job Ref |
|---|---|---|---|---|
| 38 | Upstream | UTPX | | |

UTPX\_2497b55d-662b-4426-9aa4-05de989d99aa\_20260113\_143450\_921.jpg, 00:01:06, 9.46 m  
 Settled deposits, other, 15% cross-sectional area loss, Debris

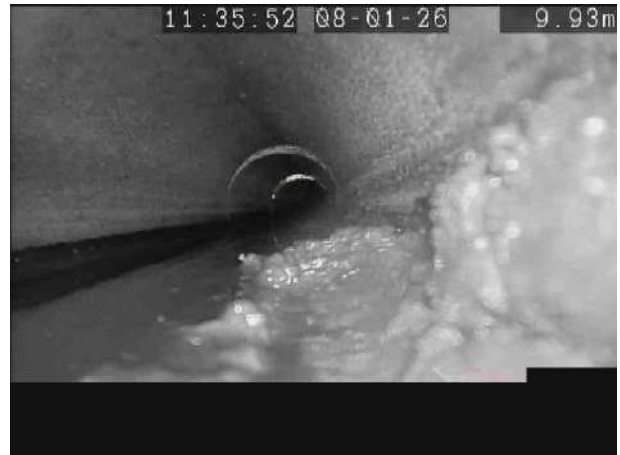
UTPX\_b4e2d67c-99ba-4679-9dbe-1ac11ad0f180\_20260113\_143523\_670.jpg, 00:01:22, 9.93 m  
 Settled deposits, fine, 20% cross-sectional area loss

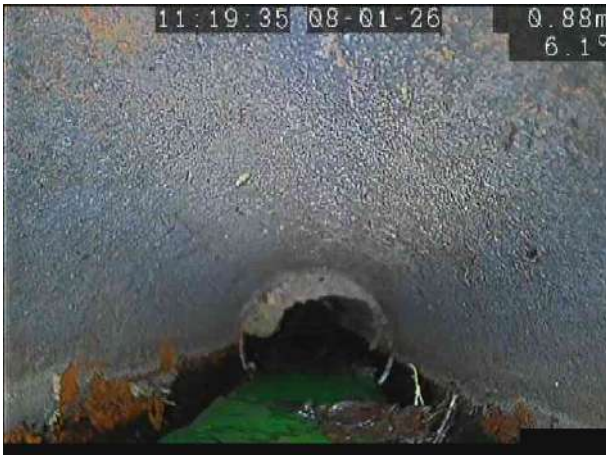
| Item No. | Inspection Direction | PLR | Client's Job Ref | Contractor's Job Ref |
|---|---|---|---|---|
| 39 | Downstream | S8X | | |

S8X\_5068fb8f-3040-4de8-9fec-f176815e66c3\_20260113\_134  
 602\_467.jpg, 00:00:15, 0.88 m  
 Settled deposits, hard or compacted, 15% cross-sectional area  
 loss

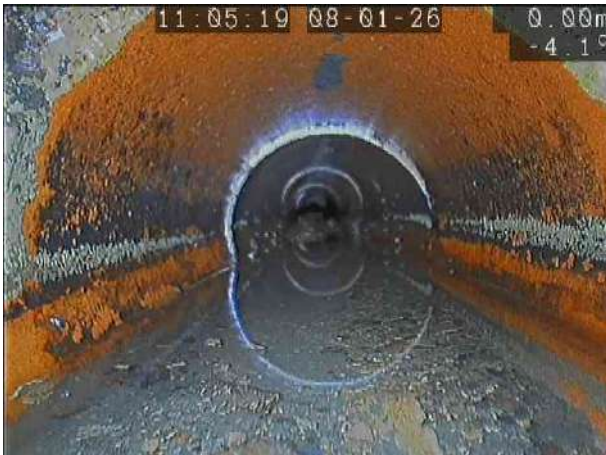
| Item No. | Inspection Direction | PLR | Client's Job Ref | Contractor's Job Ref |
|---|---|---|---|---|
| 39 | Upstream | S8X | | |

S8X\_c7d417f2-d3ed-491a-adc4-e6cd4da9f15a\_20260113\_134027\_752.jpg, 00:00:08, 0.01 m  
 Settled deposits, hard or compacted, 5% cross-sectional area loss, start

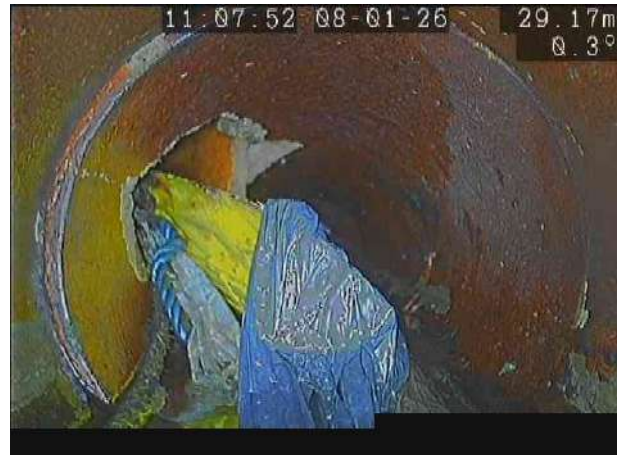
<table><tr> <td>0.00</td><td>MH</td><td></td><td>Start node, manhole, reference: S9</td><td>00:00:00</td><td></td><td></td></tr><tr> <td>29.17</td><td>JXD</td><td></td><td>Junction, damaged at 9 o'clock, 100mm dia: Crack, debris coming from junction</td><td>00:02:40</td><td></td><td></td></tr></table>

S8X\_5000703f-c1d5-4867-86c9-8a02e158d579\_20260113\_134438\_778.jpg, 00:02:40, 29.17 m  
 Settled deposits, other, 30% cross-sectional area loss, Debris

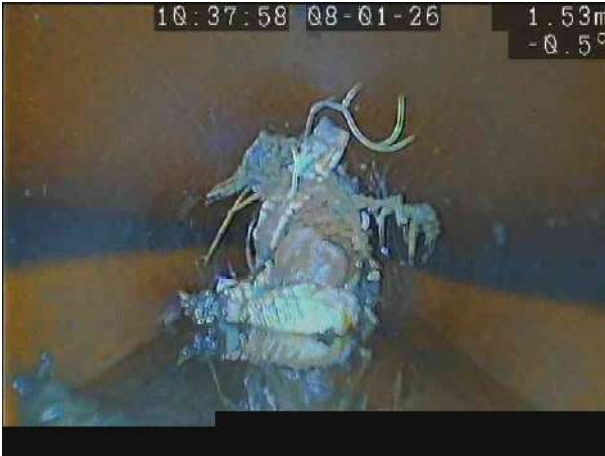
| Item No. | Inspection Direction | PLR | Client's Job Ref | Contractor's Job Ref |
|---|---|---|---|---|
| 41 | Downstream | S10X | | |

S10X\_671d00d3-4286-4051-8b0f-f1f60877df32\_20260113\_13  
 2257\_161.jpg, 00:00:25, 1.53 m  
 Settled deposits, other, 70% cross-sectional area loss, Debris

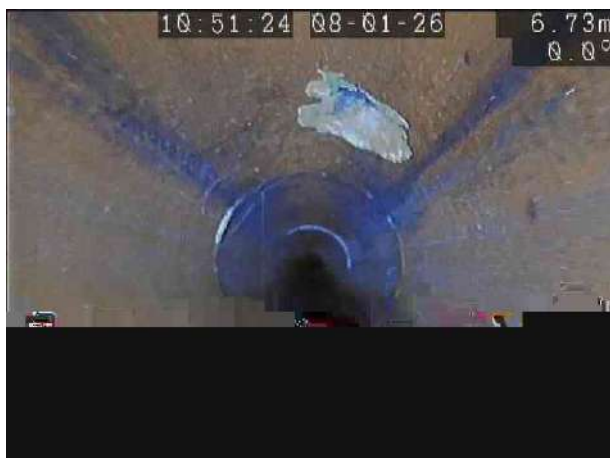
| Item No. | Inspection Direction | PLR | Client's Job Ref | Contractor's Job Ref |
|---|---|---|---|---|
| 42 | Downstream | S11X | | |

S11X\_a5ae82dc-8f31-4991-9271-556768b7a2e0\_20260113\_133702\_749.jpg, 00:00:36, 6.79 m  
 Hole in drain or sewer from 12 o'clock to 1 o'clock

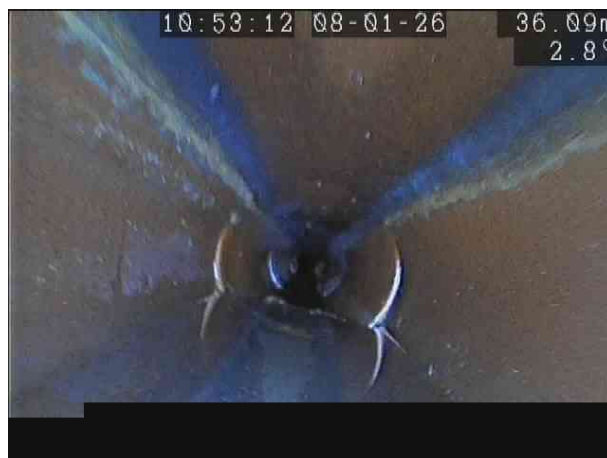
S11X\_78b2ec09-74c1-4bdc-9ab7-4dcf4bfc1edf\_20260113\_13801\_547.jpg, 00:02:24, 36.24 m  
 Settled deposits, coarse, 10% cross-sectional area loss

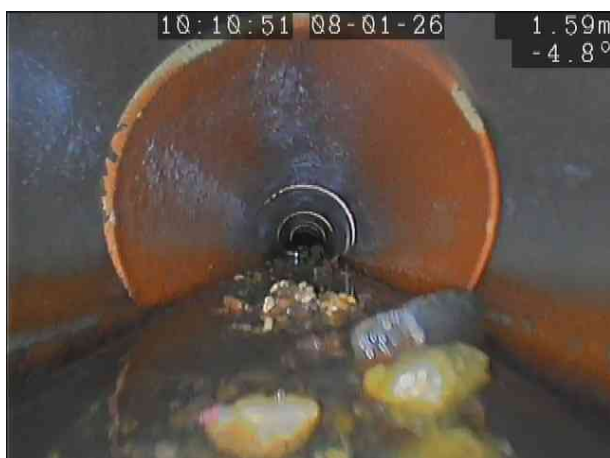
| Item No. | Inspection Direction | PLR | Client's Job Ref | Contractor's Job Ref |
|---|---|---|---|---|
| 45 | Upstream | S13X | | |

S13X\_0c0f28c0-cfb1-46c2-beb2-973ad5f70520\_20260113\_1311\_021.jpg, 00:00:16, 1.68 m  
 Settled deposits, coarse, 10% cross-sectional area loss

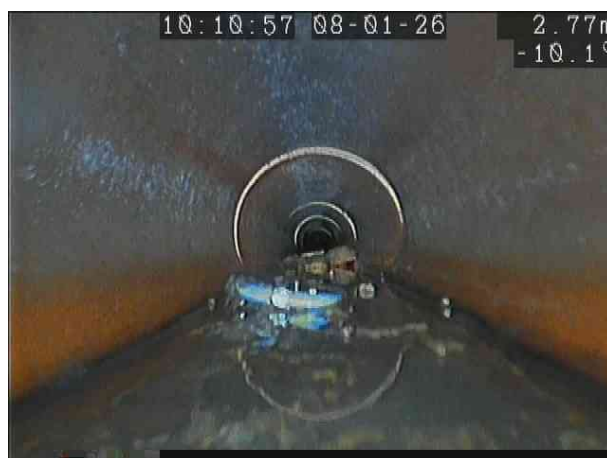
S13X\_52196364-0c1f-4e05-ac79-6a31fdc48fa8\_20260113\_1340\_009.jpg, 00:00:22, 2.89 m  
 Settled deposits, other, 5% cross-sectional area loss, Debris

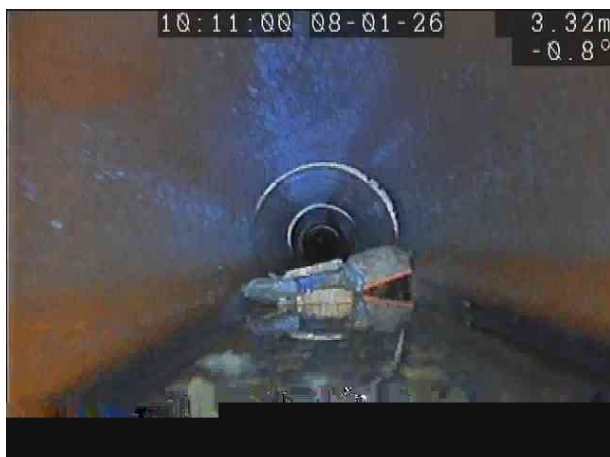
S13X\_284dbb6e-bbb9-4e68-9bf0-0350a6dba110\_20260113\_131353\_777.jpg, 00:00:25, 3.46 m  
 Settled deposits, other, 20% cross-sectional area loss, Debris

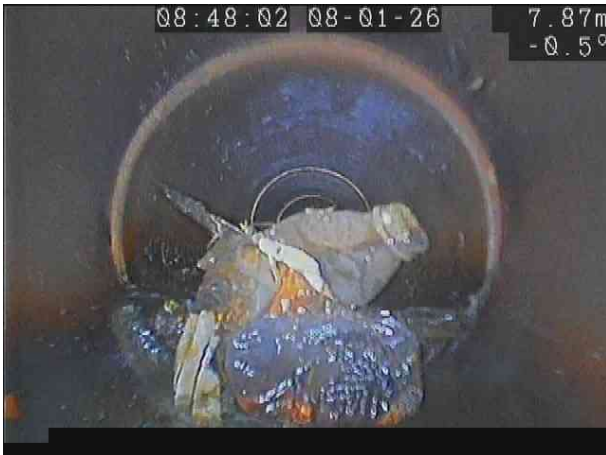
| Item No. | Inspection Direction | PLR | Client's Job Ref | Contractor's Job Ref |
|---|---|---|---|---|
| 47 | Upstream | S15X | | |

S15X\_a3e62ddc-09b3-4e1a-94f0-23bec06ba4d\_20260113\_121017\_307.jpg, 00:00:38, 7.97 m  
 Settled deposits, other at joint, 35% cross-sectional area loss,  
 Debris/ plastic bottle

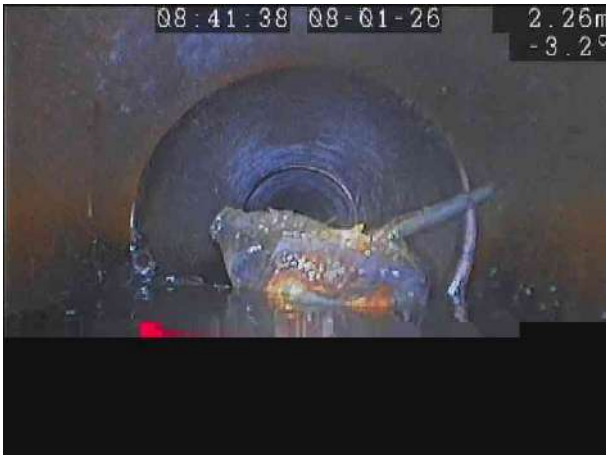
| Item No. | Inspection Direction | PLR | Client's Job Ref | Contractor's Job Ref |
|---|---|---|---|---|
| 47 | Downstream | S15X | | |

S15X\_9e7e1cf3-17cd-4139-ae9a-caa55bf70de6\_20260113\_1  
 20110\_231.jpg, 00:00:22, 2.26 m  
 Settled deposits, other at joint, 35% cross-sectional area loss,  
 Debris

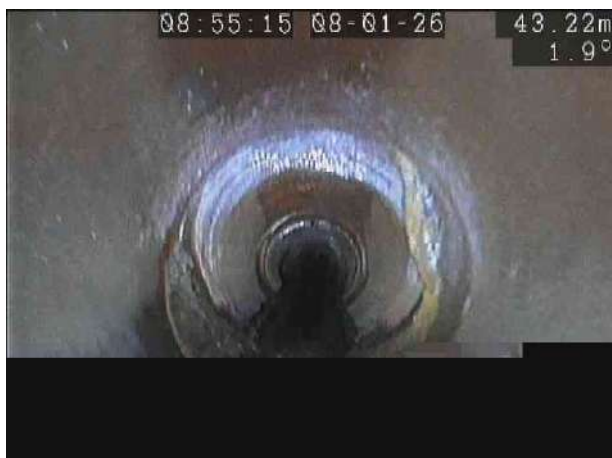
| Item No. | Inspection Direction | PLR | Client's Job Ref | Contractor's Job Ref |
|---|---|---|---|---|
| 48 | Downstream | S16X | | |

S16X\_a20f60a6-8377-404d-8f5c-93dc0efe2f6d\_20260113\_12  
 4859\_558.jpg, 00:02:15, 43.35 m  
 Settled deposits, hard or compacted at joint, 5%  
 cross-sectional area loss

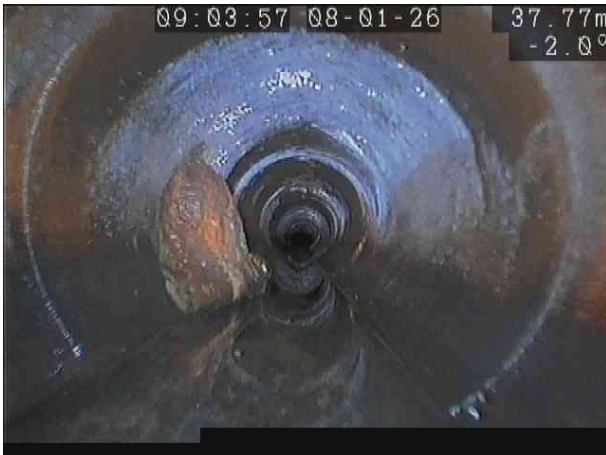
| Item No. | Inspection Direction | PLR | Client's Job Ref | Contractor's Job Ref |
|---|---|---|---|---|
| 49 | Downstream | S17X | | |

S17X\_5979d8a4-94d8-4be6-a938-2a4cfc9079a3\_20260113\_125213\_959.jpg, 00:02:21, 38.05 m

Settled deposits, hard or compacted, 15% cross-sectional area loss
