**Project Name:** 2025-11-33287 Thomas Armstrong CO Ltd Barfs Road  
Distington

**Project Date:** 12/01/2026

**Inspection Standard:** MSCC5 Sewers & Drainage GB (SRM5 Scoring)

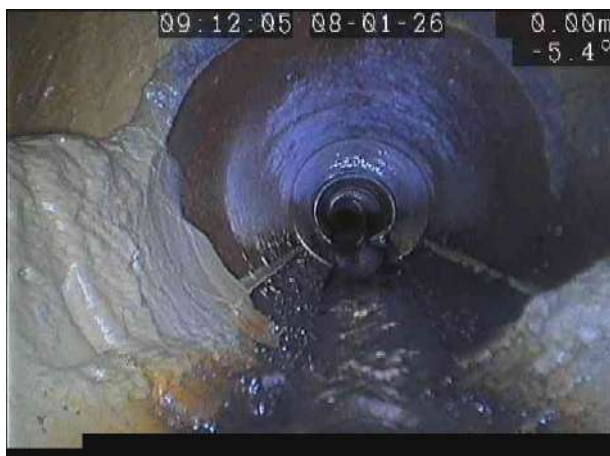
| Item No. | Inspection Direction | PLR | Client's Job Ref | Contractor's Job Ref |
|---|---|---|---|---|
| 50 | Downstream | S18X | | |

S18X\_ce43303f-2ea3-406a-82e7-b5ef4830f96d\_20260113\_125433\_537.jpg, 00:00:09, 0.01 m  
 Settled deposits, hard or compacted, 5% cross-sectional area loss

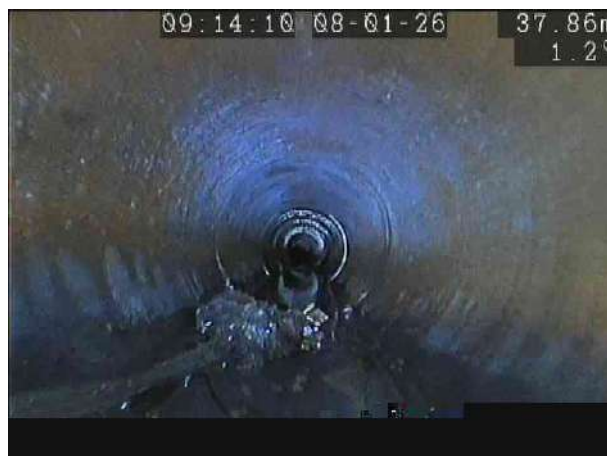
S18X\_4f0a740e-0d83-4d53-a602-a755721c1a30\_20260113\_125806\_873.jpg, 00:02:14, 38.03 m  
 Settled deposits, coarse, 5% cross-sectional area loss

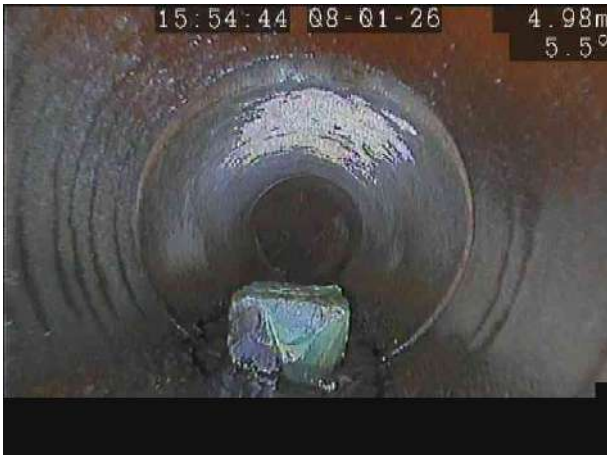
S19X\_ed8da343-b3db-47a3-9643-4201a8f57023\_20260114\_114237\_494.jpg, 00:00:27, 4.98 m  
 Settled deposits, coarse, 15% cross-sectional area loss

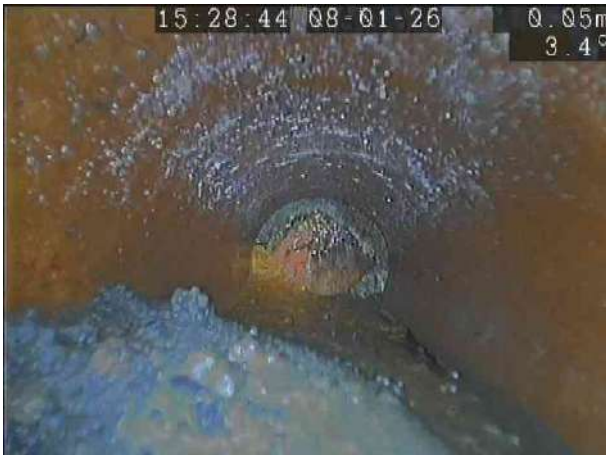
UTPX\_b1e6c33d-a59f-43bf-90de-e2c031dc2c8c\_20260114\_1  
 13303\_394.jpg, 00:00:11, 0.08 m  
 Settled deposits, hard or compacted, 20% cross-sectional area  
 loss

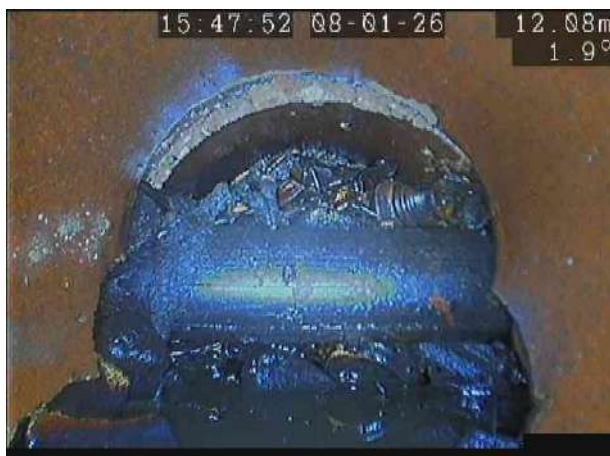
S20X\_7f59d065-45d9-45b2-b9bc-2632c20bd458\_20260114\_113539\_801.jpg, 00:01:05, 12.08 m  
 Hole in drain or sewer from 4 o'clock to 8 o'clock

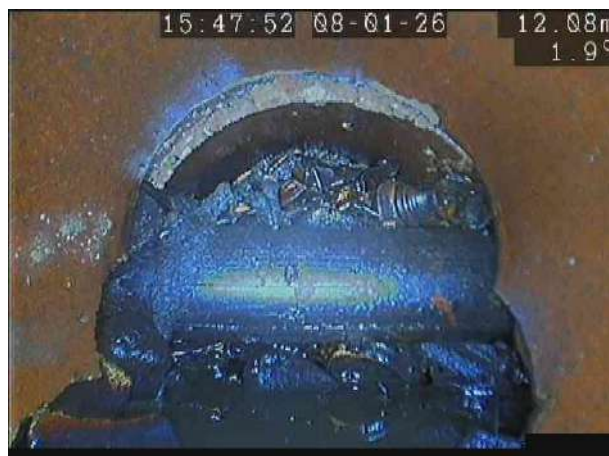
S20X\_adb40f5b-2bb3-40d9-b99d-dbb1c73a018b\_20260114\_113852\_481.jpg, 00:01:05, 12.08 m  
 Other obstacles at joint from 12 o'clock to 12 o'clock, 100% cross-sectional area loss, Pipe in drain

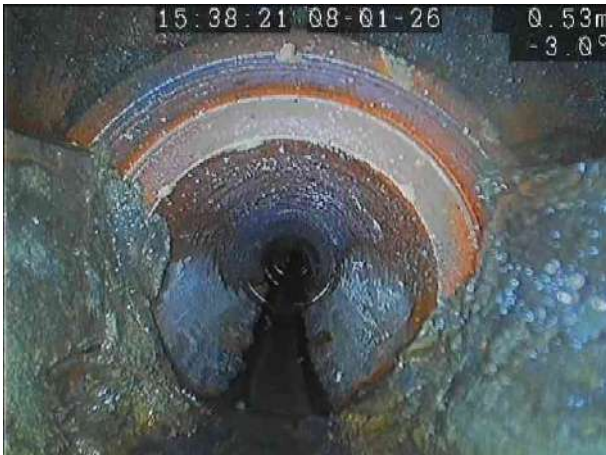
S20X\_85b2926b-581d-4bc9-92bc-5925b49397d3\_20260114\_113431\_706.jpg, 00:00:30, 0.53 m  
 Settled deposits, hard or compacted, 15% cross-sectional area loss

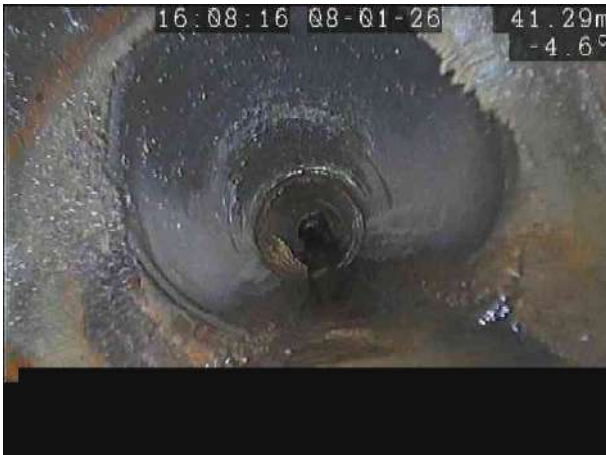
S21X\_d07d713c-ec8f-442b-a798-7d4515e179f9\_20260114\_1  
 14516\_639.jpg, 00:03:02, 41.29 m  
 Settled deposits, hard or compacted at joint, 15%  
 cross-sectional area loss

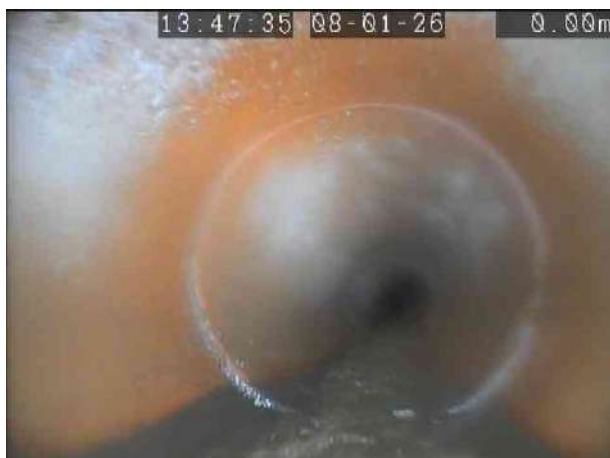
MH  
 DX\_e9422df4-dd7d-404b-b66d-610cfd9edc82\_20260113\_162  
 130\_805.jpg, 00:00:10, 0.05 m  
 Settled deposits, hard or compacted, 5% cross-sectional area  
 loss, start

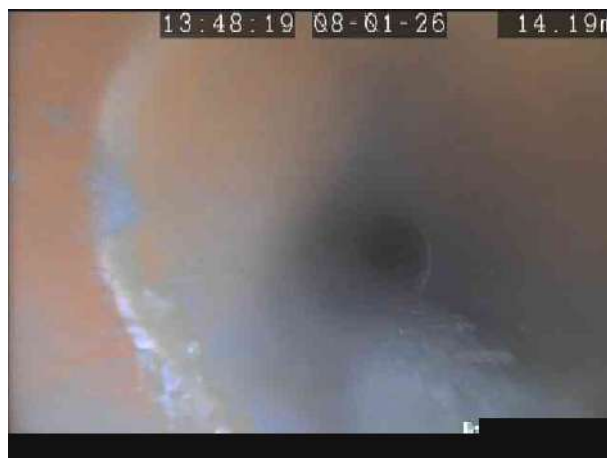
MH  
 DX\_4d03ee10-df75-476a-8073-63a1b75a21cd\_20260113\_16  
 2241\_781.jpg, 00:00:55, 14.43 m  
 Settled deposits, hard or compacted, 5% cross-sectional area  
 loss

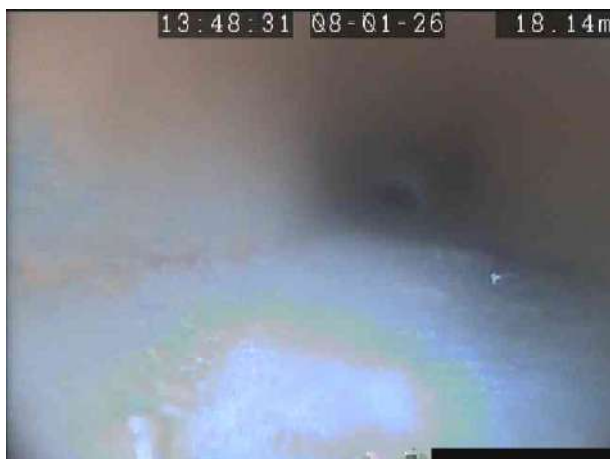
MH  
 DX\_899ca930-8445-46e7-aef0-201e26bab15e\_20260113\_16  
 2305\_554.jpg, 00:01:06, 18.14 m  
 Settled deposits, hard or compacted, 10% cross-sectional area  
 loss

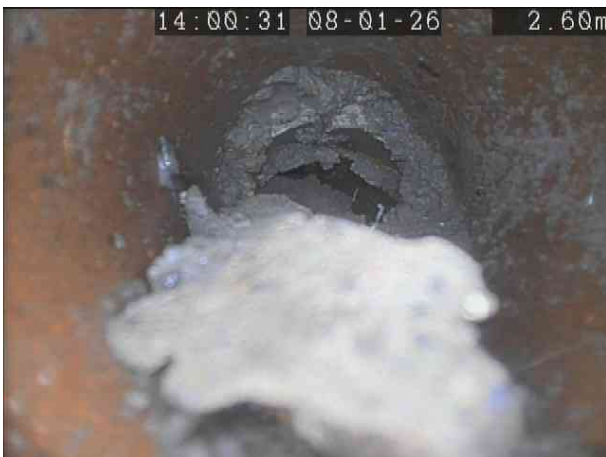
UTPX\_ed5cc436-2644-4cf9-9df2-8e11c174298c\_20260113\_163043\_417.jpg, 00:00:28, 2.60 m  
 Settled deposits, coarse, 30% cross-sectional area loss

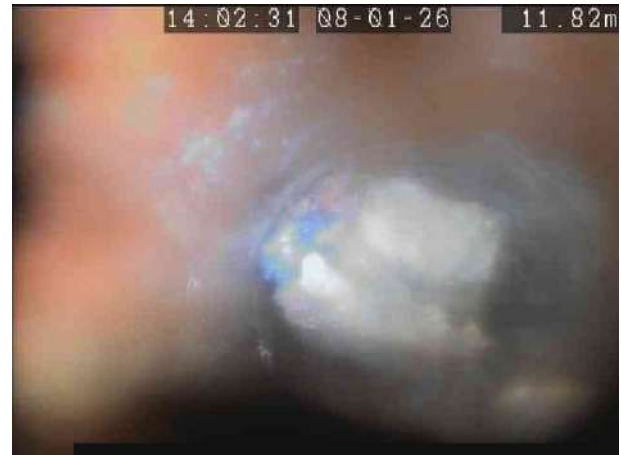
UTPX\_ab483161-6365-42ac-83cb-71230abc8909\_20260113\_163337\_861.jpg, 00:00:53, 11.82 m  
 Settled deposits, other, 90% cross-sectional area loss, Debris

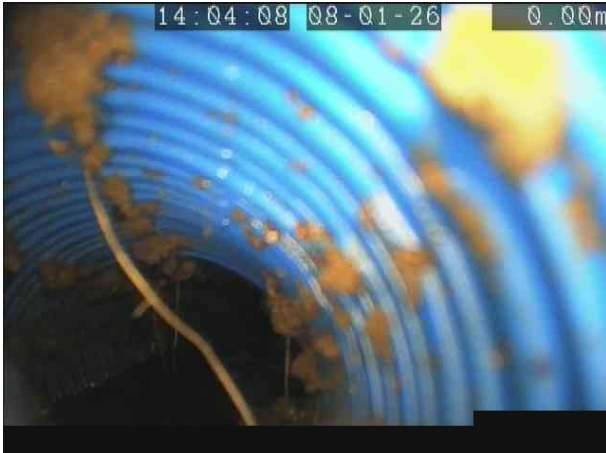
UTPX\_2ede97d7-f706-4200-879c-3324adf5b2be\_20260113\_163638\_691.jpg, 00:00:13, 0.05 m  
 Settled deposits, fine, 15% cross-sectional area loss
