Project Ref: 6046

## The Library – External & Internal Condition Examples

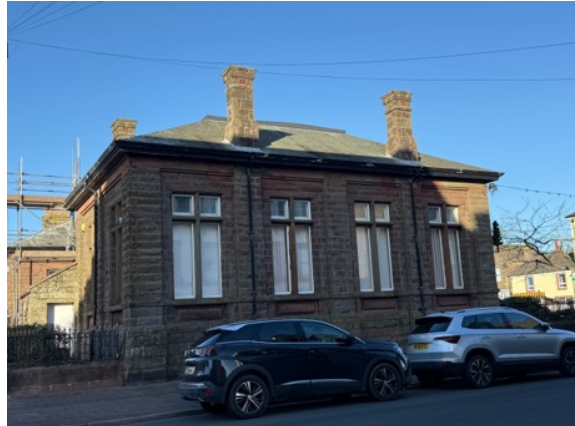
| <p><b>Southeast Elevation - General</b></p> | <p>Chimney Structure - Deleterious mortar pointing.</p> | <p>Above Ground Rainwater Goods – Defective cast iron downpipe.</p> |

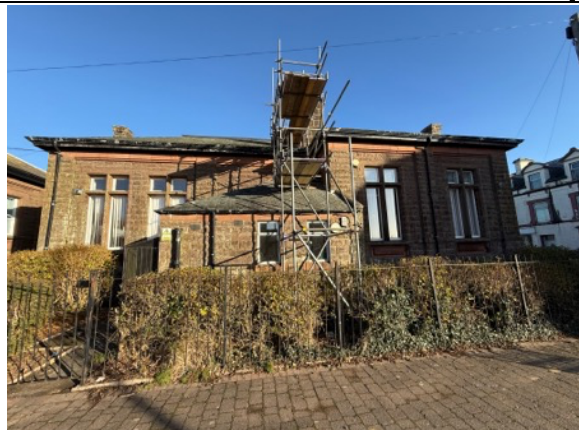
| <p><b>Southwest Elevation - General</b></p> | <p><b>Slate Repairs – Tagged and damaged roof slates.</b></p> | <p><b>Above Ground Rainwater Goods – Defective guttering.</b></p> |

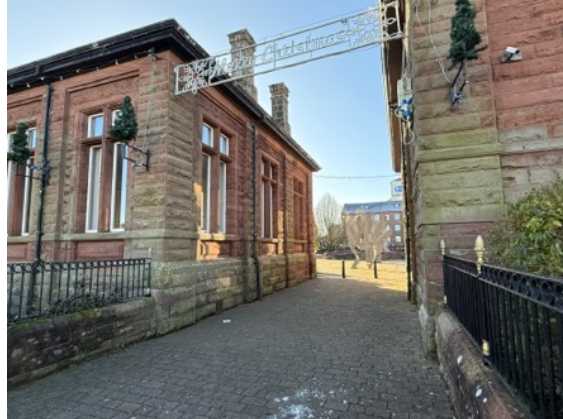
| <p><b>Northwest Elevation</b> - General</p> | <p>Chimney Structure - Deleterious mortar pointing.</p> | <p>Slate Repairs – Tagged and damaged roof slates.</p> |
