**Project****Project Name:** 2024-06-30014 RG Parkins Queens Park Drive Millom**Project Date:** 09/07/2024**Inspection Standard:** MSCC5 Sewers & Drainage GB (SRM5 Scoring)

**R. G. PARKINS & PARTNERS LTD**  
CONSULTING CIVIL & STRUCTURAL ENGINEERS

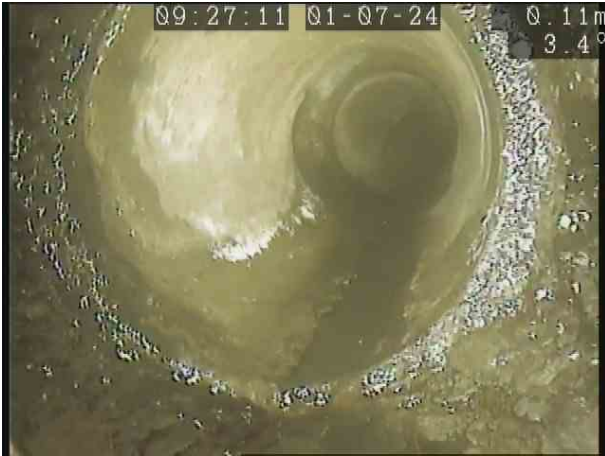
GullyX\_c0fb68e5-ac3c-4848-a10f-fa8c97e055ed\_20240710\_1  
14921\_945.jpg, 00:00:32, 0.11 m  
Joint displaced, medium

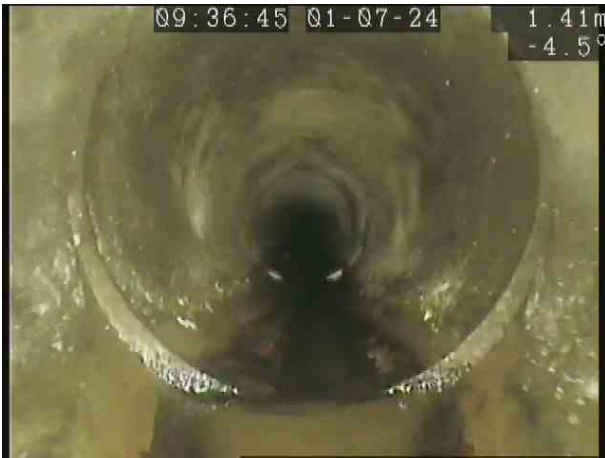
UU MH  
 6102X\_210052a5-baf9-4066-87cf-7e52002475c0\_20240710\_114315\_826.jpg, 00:00:23, 1.41 m  
 Joint displaced, medium

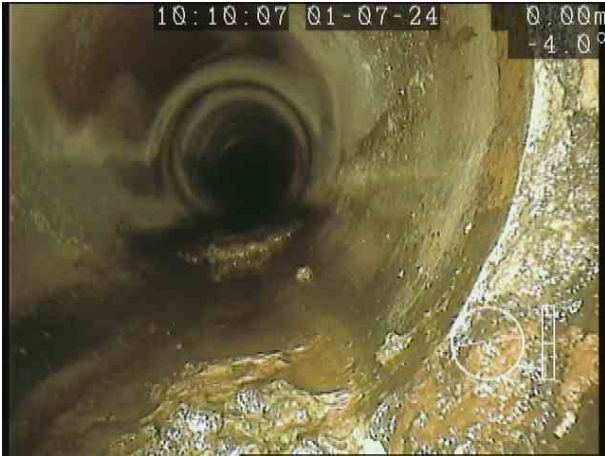
6101X\_18696ca0-ac4b-427f-a879-3084d0501363\_20240710\_113731\_112.jpg, 00:00:09, 0.01 m  
Settled deposits, hard or compacted, 5% cross-sectional area loss

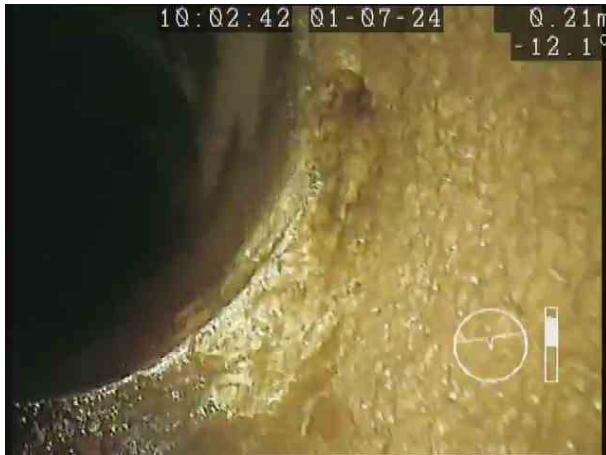
UU MH  
 6100X\_c2b53817-6b05-4afb-a3ce-e00b3135a098\_20240709\_161749\_557.jpg, 00:00:15, 0.21 m  
 Joint displaced, medium

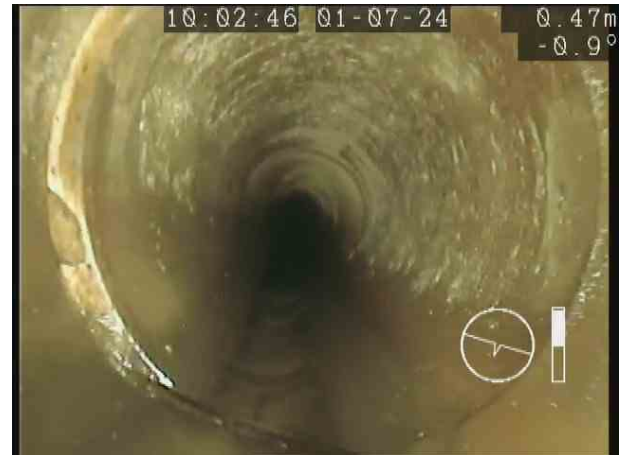
UU MH  
 6100X\_06f56600-acb1-4600-853b-23f0074acdaa\_20240709\_161808\_803.jpg, 00:00:19, 0.47 m  
 Joint displaced, medium

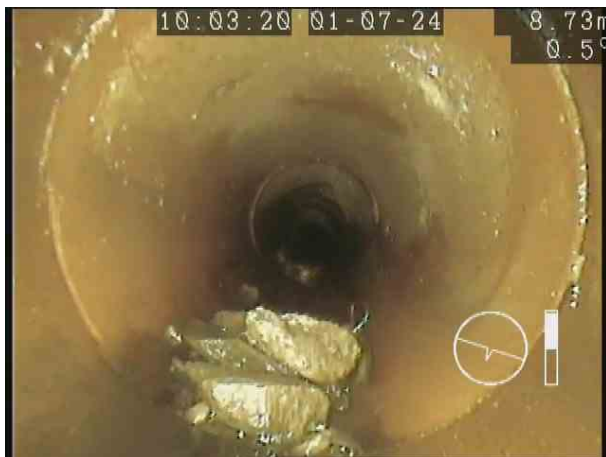
UU MH  
 6100X\_ce0da5d5-0174-49a1-bf84-31fe08bb20a0\_20240709\_161858\_455.jpg, 00:00:52, 8.73 m  
 Settled deposits, coarse, 10% cross-sectional area loss

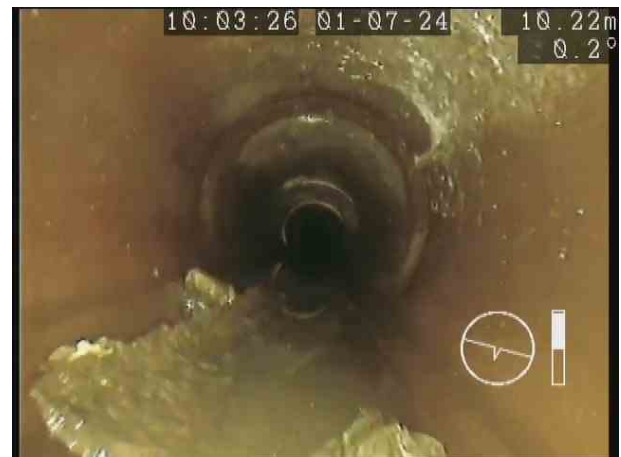
UU MH  
 6100X\_75dea4a6-2fd7-41bb-95b7-5ea55af680c4\_20240709\_161919\_149.jpg, 00:00:58, 10.22 m  
 Settled deposits, hard or compacted, 10% cross-sectional area loss

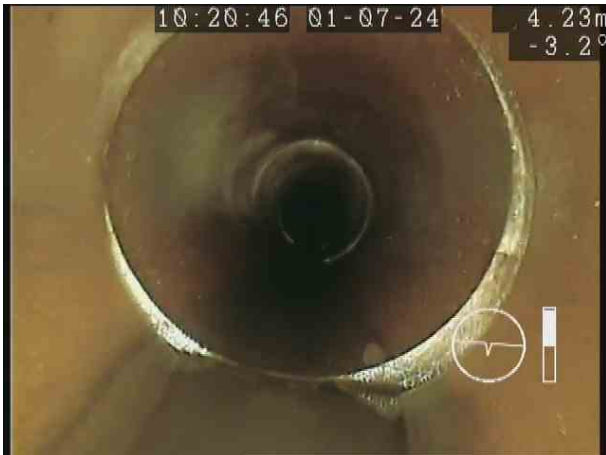
UU MH  
 5100X\_dabed396-6958-49cf-9c10-f389e09b3ef0\_20240709\_1  
 61444\_292.jpg, 00:00:50, 4.33 m  
 Joint displaced, medium

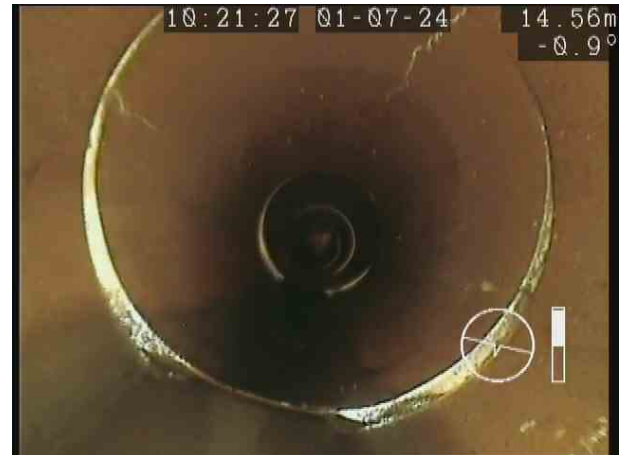
| Scale: 1:158 | Position [m] | Code | Observation | MPEG | Photo | Grade |
|---|---|---|---|---|---|---|
| | 14.56 | CLJ | Crack, longitudinal at joint at 1 o'clock | 00:01:30 | UU MH 5100X_aaf<br>636f2-577 | 2 / 2 |

UU MH  
 5100X\_aaf636f2-5770-42cd-81d5-3cd541612f48\_20240709\_1  
 61535\_640.jpg, 00:01:30, 14.56 m  
 Crack, longitudinal at joint at 1 o'clock

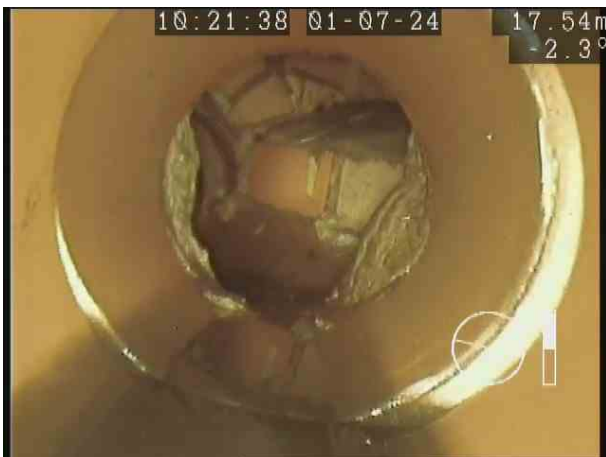
UU MH  
 5100X\_c785e845-9a03-41d0-b460-df0419c3a2c5\_20240709\_  
 161610\_181.jpg, 00:01:41, 17.54 m  
 Joint displaced, medium

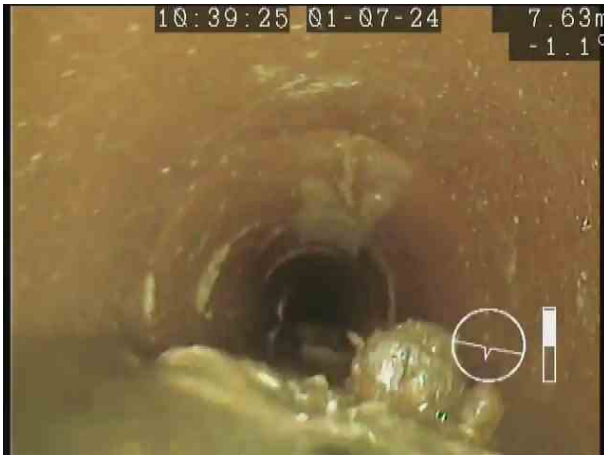
UU MH  
 6207X\_063d7feb-b4c6-43bc-8059-3273d38f87fd\_20240710\_130802\_697.jpg, 00:00:46, 7.63 m  
 Settled deposits, hard or compacted, 25% cross-sectional area loss

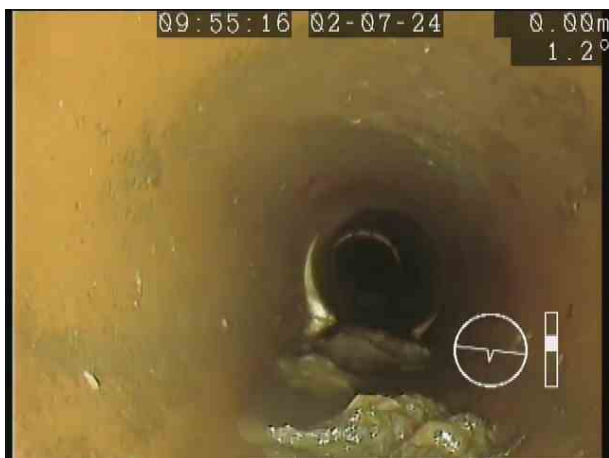
UU MH  
 6207X\_bb3f1c9c-5d26-4bc6-9104-c0a514c6bf04\_20240710\_102232\_924.jpg, 00:00:18, 0.05 m  
 Settled deposits, coarse, 5% cross-sectional area loss

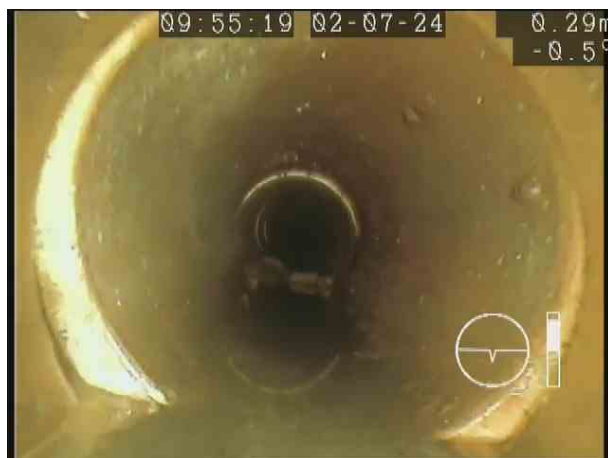
UU MH  
 6207X\_6ac81526-0cc3-4058-9d79-e8525e6cf71f\_20240710\_102242\_608.jpg, 00:00:20, 0.30 m  
 Joint displaced, medium

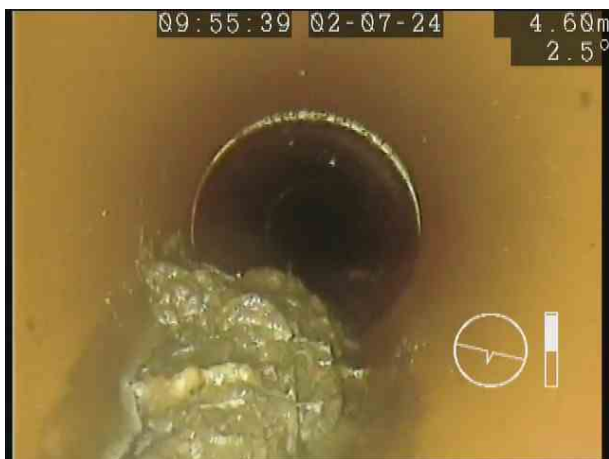
UU MH  
 6207X\_0ca55fe8-7b9b-461f-ba8d-3337b7ac9473\_20240710\_102324\_261.jpg, 00:00:41, 4.60 m  
 Settled deposits, coarse, 25% cross-sectional area loss

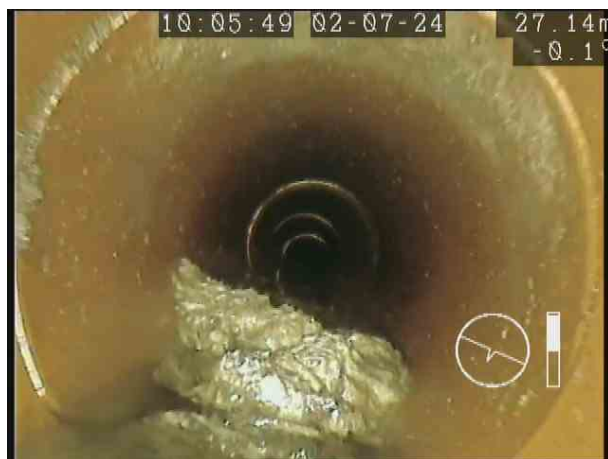
UU MH  
 6207X\_b5834c25-c68b-4485-9ecc-4058e51648b0\_20240710\_102518\_980.jpg, 00:02:27, 27.14 m  
 Settled deposits, coarse, 20% cross-sectional area loss

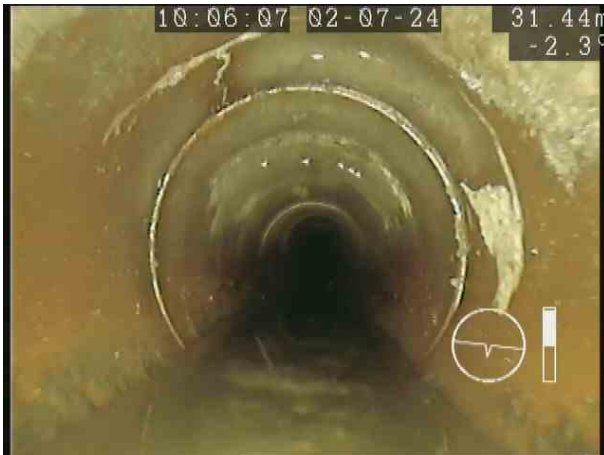
| Scale: 1:348 | Position [m] | Code | Observation | MPEG | Photo | Grade |
|---|---|---|---|---|---|---|
| 31.44 | | CC | Crack, circumferential from 10 o'clock to 4 o'clock | 00:02:45 | UU MH 6207X_27 a63495-2b | 2 / 2 |

UU MH  
 6207X\_27a63495-2bd2-4348-95e8-6975caa3cb4f\_20240710\_102819\_692.jpg, 00:02:45, 31.44 m  
 Crack, circumferential from 10 o'clock to 4 o'clock

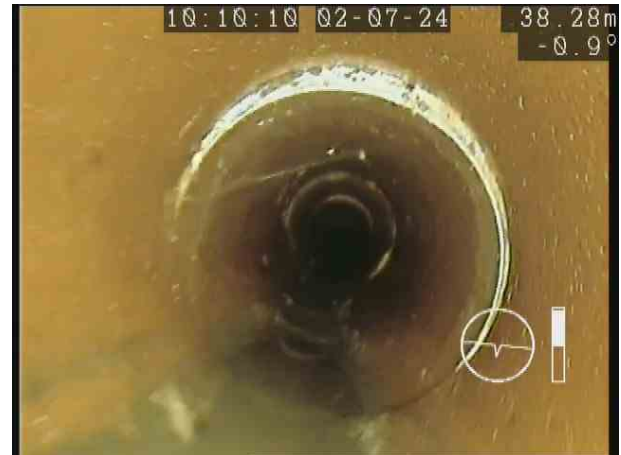
UU MH  
 6207X\_50d6488d-6145-42a9-90f6-950ad5a2d924\_20240710\_103033\_058.jpg, 00:04:33, 38.28 m  
 Joint displaced, medium

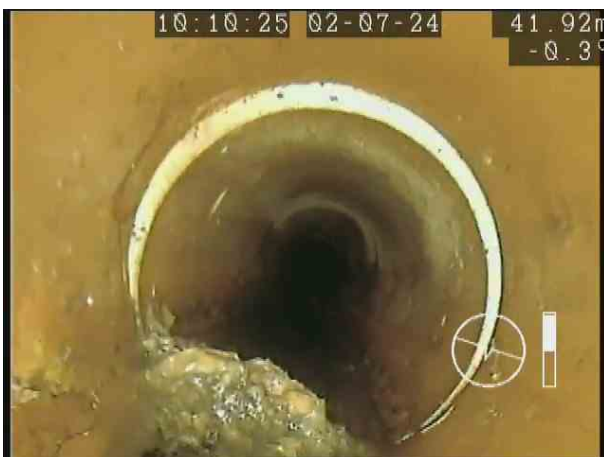
| | 41.92 | DERJ | Settled deposits, coarse at joint, 10% cross-sectional area loss | 00:04:49 | UU MH<br>6207X_57<br>088977-9e | 3 | | | |

UU MH  
 6207X\_57088977-9eb4-45b4-9e67-b9a661a7ae5f\_20240710\_103102\_897.jpg, 00:04:49, 41.92 m  
 Settled deposits, coarse at joint, 10% cross-sectional area loss

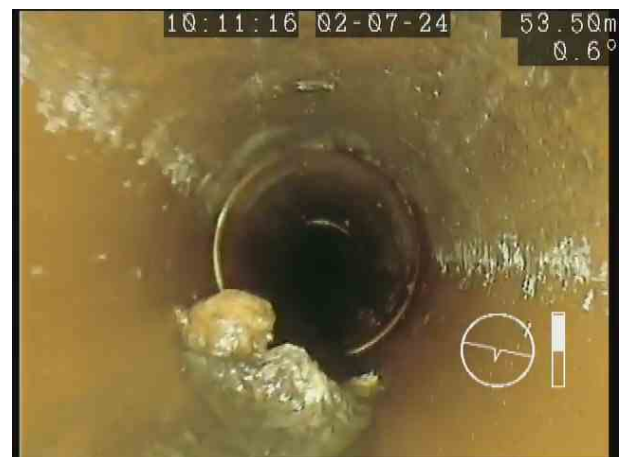
| | 53.50 | DER | Settled deposits, coarse, 10% cross-sectional area loss | 00:05:39 | UU MH<br>6207X_b7<br>cfd917-8e | 3 | | | |

UU MH  
 6207X\_b7cfd917-8e21-465a-ba94-a7a49212c62d\_20240710\_103154\_292.jpg, 00:05:39, 53.50 m  
 Settled deposits, coarse, 10% cross-sectional area loss

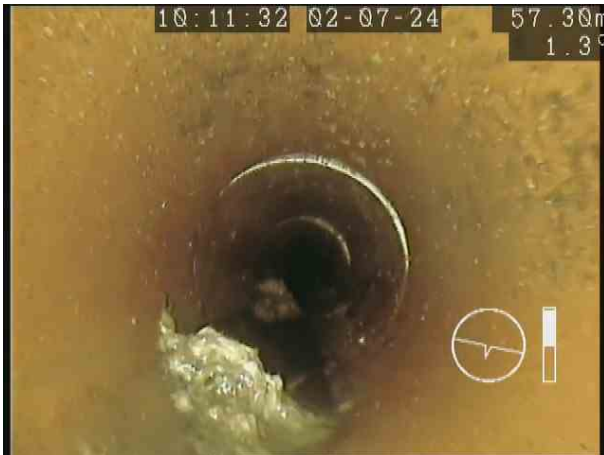
| | 57.30 | DER | Settled deposits, coarse, 10% cross-sectional area loss | 00:05:55 | UU MH<br>6207X_2b<br>e9c668-7d | 3 | | | |

UU MH  
 6207X\_2be9c668-7d39-435e-a14b-870aaf0c4e49\_20240710\_103223\_137.jpg, 00:05:55, 57.30 m  
 Settled deposits, coarse, 10% cross-sectional area loss

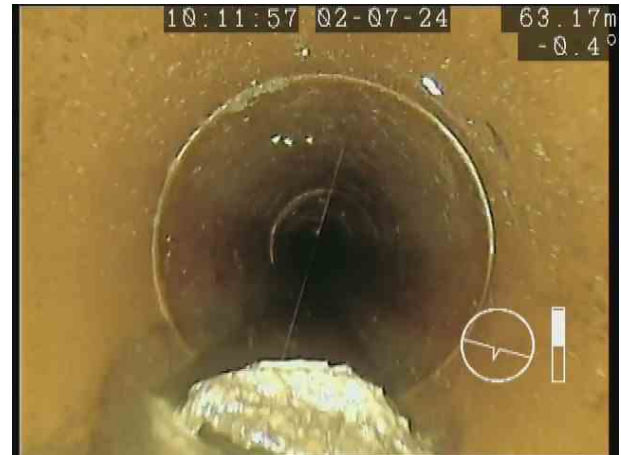
UU MH  
 6207X\_f921eaf1-a966-4dae-b781-45c95009adb5\_20240710\_103554\_089.jpg, 00:06:20, 63.17 m  
 Settled deposits, coarse, 10% cross-sectional area loss

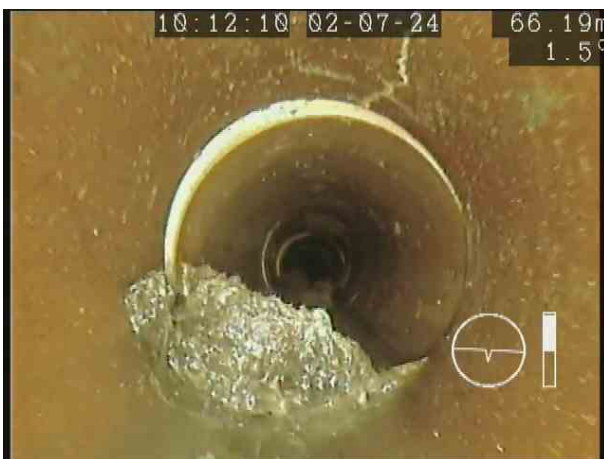
UU MH  
 6207X\_b3f5de73-a7ab-4c17-94dd-ee1b554ca530\_20240710\_103633\_998.jpg, 00:06:33, 66.19 m  
 Settled deposits, coarse at joint, 25% cross-sectional area loss

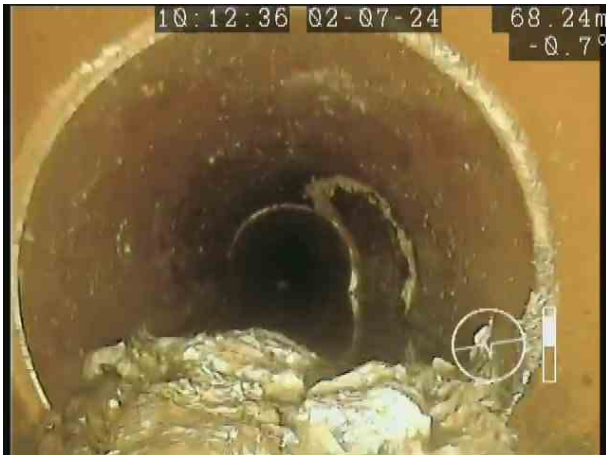
UU MH  
 6207X\_84e34e0f-8c01-41cf-8055-c24d84b8368d\_20240710\_  
 103925\_793.jpg, 00:06:59, 68.24 m  
 Settled deposits, hard or compacted at joint, 20%  
 cross-sectional area loss

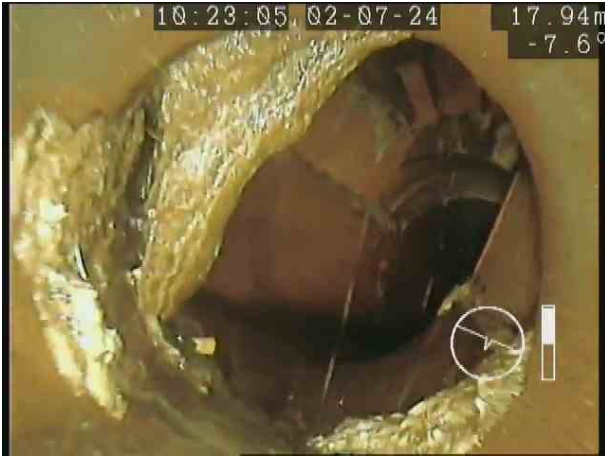
5201X\_e92996fc-b409-4ba5-8fa1-3aefeeba53a\_20240709\_1  
 65601\_706.jpg, 00:01:36, 17.94 m  
 Settled deposits, fine at joint, 20% cross-sectional area loss

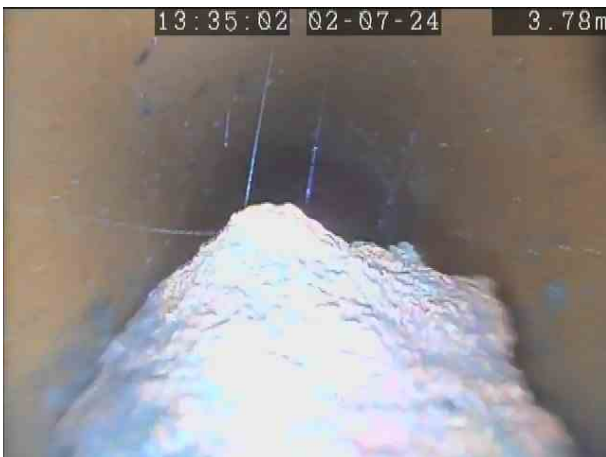
UTPX\_beed247e-ce6b-4a78-a922-51fea32361c1\_20240710\_105441\_123.jpg, 00:00:27, 3.78 m  
 Settled deposits, other, 40% cross-sectional area loss, Debris

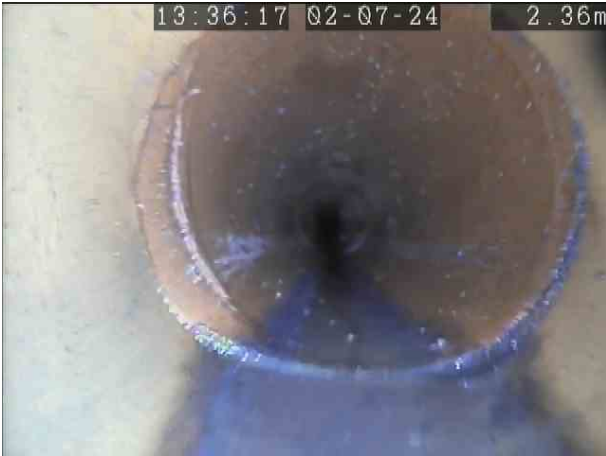
| Scale: 1:90 | Position [m] | Code | Observation | MPEG | Photo | Grade |
|---|---|---|---|---|---|---|
| | 2.36 | CC | Crack, circumferential from 7 o'clock to 10 o'clock | 00:00:18 | UU MH 5210X_3f1 6972f-491 | 2 / 2 |

UU MH  
5210X\_3f16972f-4912-46c5-8064-85a6e59f52ba\_20240710\_1  
05133\_216.jpg, 00:00:18, 2.36 m  
Crack, circumferential from 7 o'clock to 10 o'clock

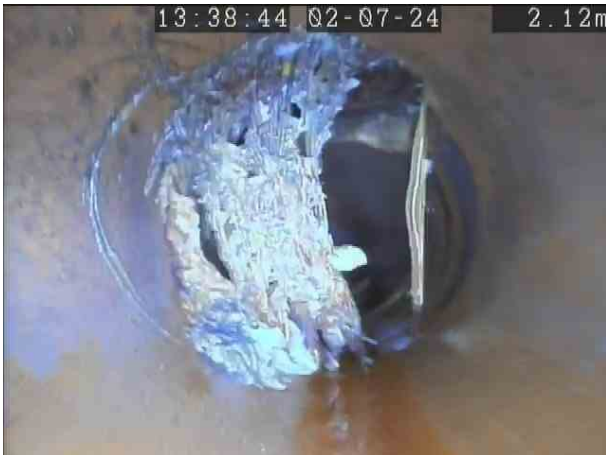
UU MH  
 5211X\_6b865c67-66ec-4510-aacd-cbd0aedc6223\_20240710\_105654\_642.jpg, 00:00:20, 2.12 m  
 Roots, mass, 40% cross-sectional area loss

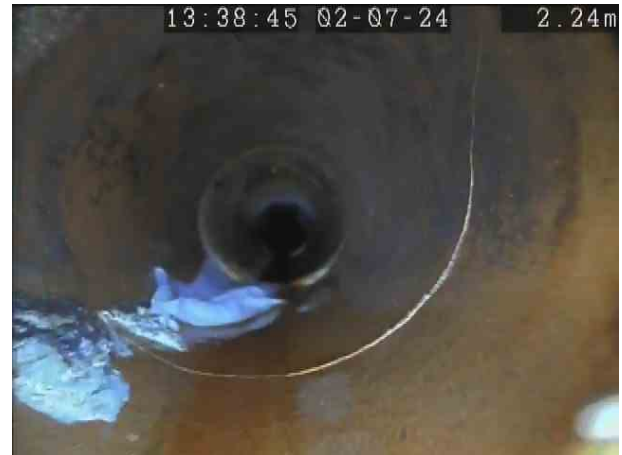
<table><tr><td>0.00</td><td>MH</td><td>Start node, manhole, reference: UU MH 5211</td><td>00:00:00</td><td></td><td></td></tr><tr><td>2.24</td><td>CC</td><td>Crack, circumferential from 2 o'clock to 7 o'clock</td><td>00:00:21</td><td>UU MH 5211X_37 e35f33-62</td><td>2 / 2</td></tr></table>

UU MH  
 5211X\_37e35f33-624f-4214-946f-d6d48fcd2c6a\_20240710\_105726\_327.jpg, 00:00:21, 2.24 m  
 Crack, circumferential from 2 o'clock to 7 o'clock

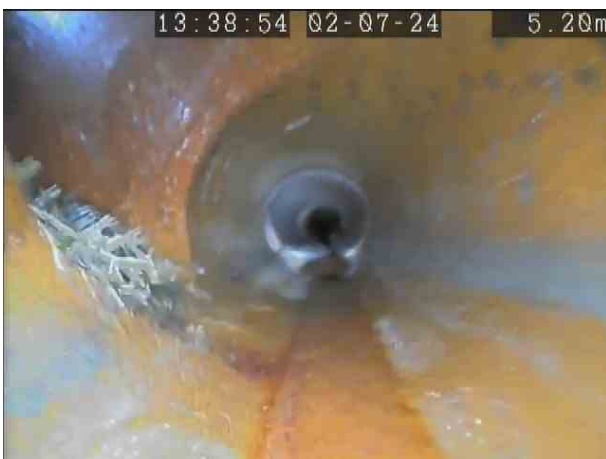
UU MH  
 5211X\_cde71070-dc8f-49d5-b3b3-1298bfbe0920\_20240710\_105757\_292.jpg, 00:00:30, 5.20 m  
 Roots, fine

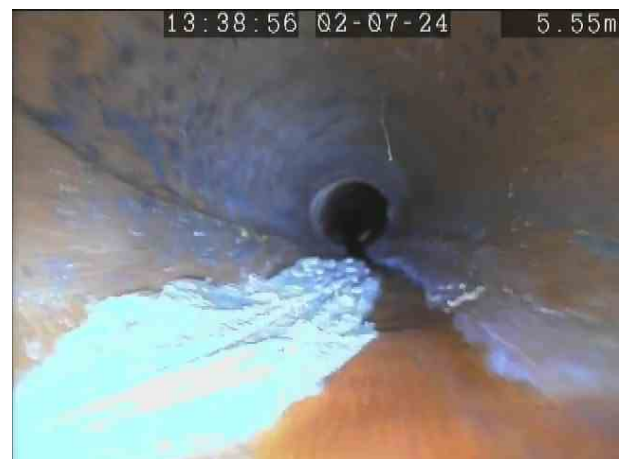
UU MH  
 5211X\_3ef15740-ad7b-4ea4-bd8b-1a8d4dc86e17\_20240710\_111813\_767.jpg, 00:00:32, 5.55 m  
 Settled deposits, other, 5% cross-sectional area loss, Wipe

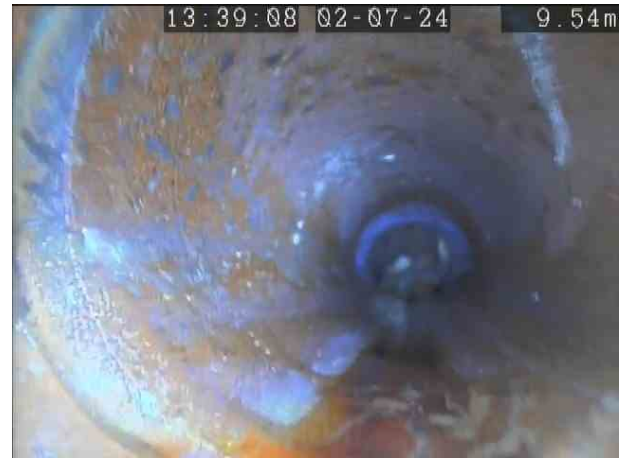
UU MH  
 5211X\_7b511660-2d8d-4962-9f5b-bf9645c94f94\_20240710\_1  
 12129\_465.jpg, 00:00:44, 9.54 m  
 Open joint, medium

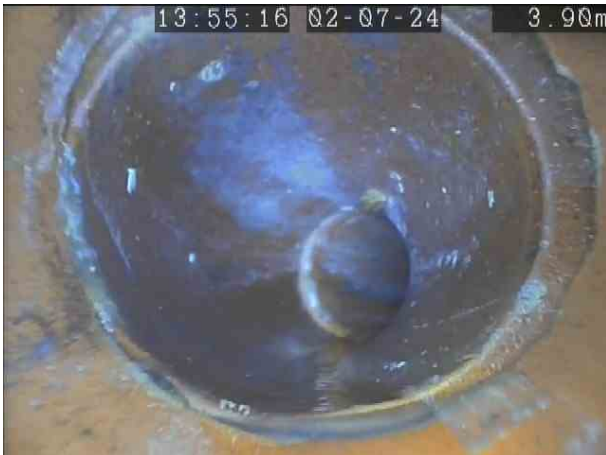
| Scale: | 1:64 | Position [m] | Code | Observation | MPEG | Photo | Grade |
|---|---|---|---|---|---|---|---|
| | | 3.90 | OJM | Open joint, medium | 00:00:29 | UU MH 5213X_64 931727-b7 | 1 |

UU MH  
 5213X\_64931727-b749-4265-b018-498b5aff5b9e\_20240710\_113559\_729.jpg, 00:00:29, 3.90 m  
 Open joint, medium

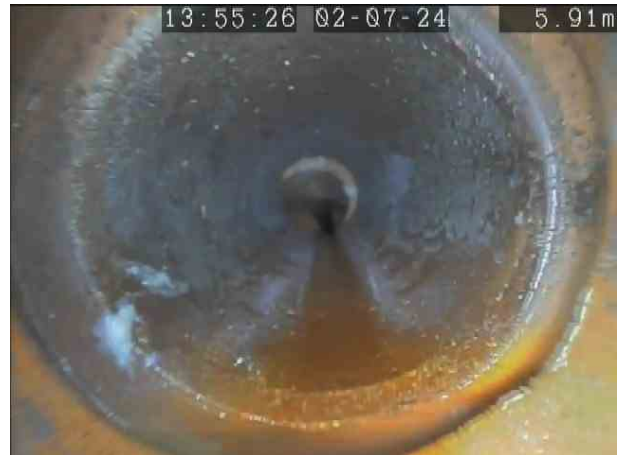
UU MH  
 5213X\_228e18da-f298-4bd3-8efa-29967bba6145\_20240710\_113639\_796.jpg, 00:00:40, 5.91 m  
 Open joint, medium

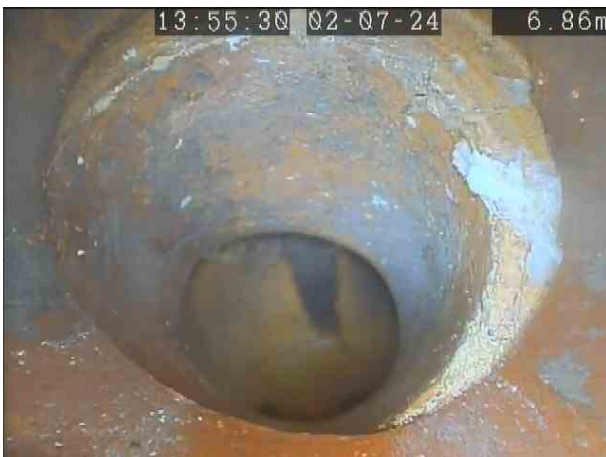
UU MH  
 5213X\_5870cb10-39e8-4fdb-86cd-f072cebb836a\_20240710\_113657\_427.jpg, 00:00:44, 6.86 m  
 Joint displaced, large

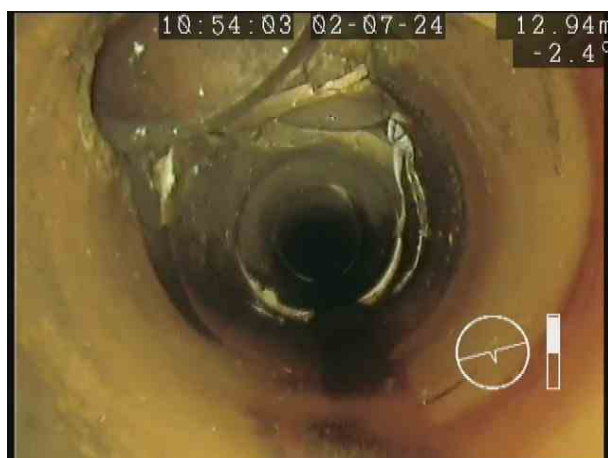
| Scale: 1:555 | Position [m] | Code | Observation | MPEG | Photo | Grade |
|---|---|---|---|---|---|---|
| | 12.94 | CX | Connection defective at 10 o'clock, 225mm dia | 00:01:10 | | |

UU MH  
 5200X\_6efc9d5e-2a46-4cac-9093-989770bcc7cf\_20240709\_164319\_582.jpg, 00:01:10, 12.94 m  
 Hole in drain or sewer from 11 o'clock to 12 o'clock

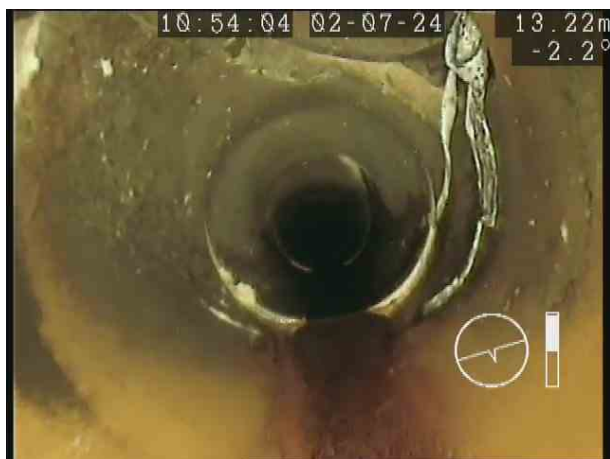
UU MH  
 5200X\_de6db484-6ea8-407a-97d5-1480165ec123\_20240709\_164347\_141.jpg, 00:01:11, 13.22 m  
 Hole in drain or sewer from 12 o'clock to 1 o'clock

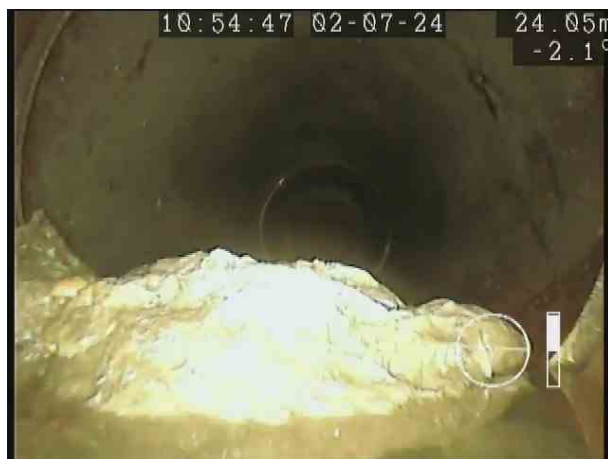
UU MH  
 5200X\_6f434d05-9c17-40f0-8d80-bfeef4df2417\_20240709\_164854\_279.jpg, 00:01:54, 24.05 m  
 Settled deposits, other at joint, 20% cross-sectional area loss,  
 Build of silt/ tissues

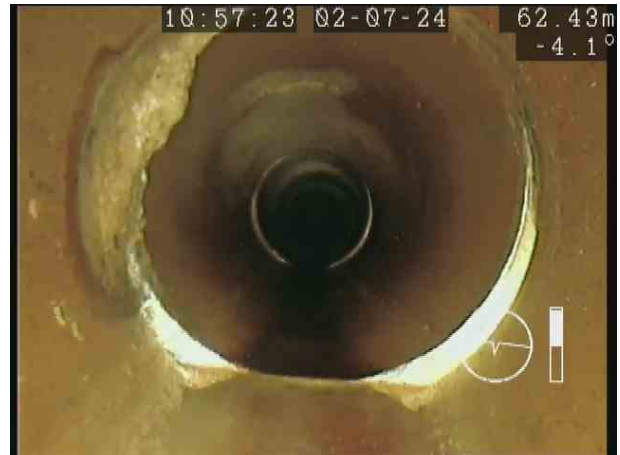
UU MH  
 5200X\_4d6e345a-ce44-4e67-bf9e-cc2b71976528\_20240709\_165056\_494.jpg, 00:04:30, 62.43 m  
 Joint displaced, medium

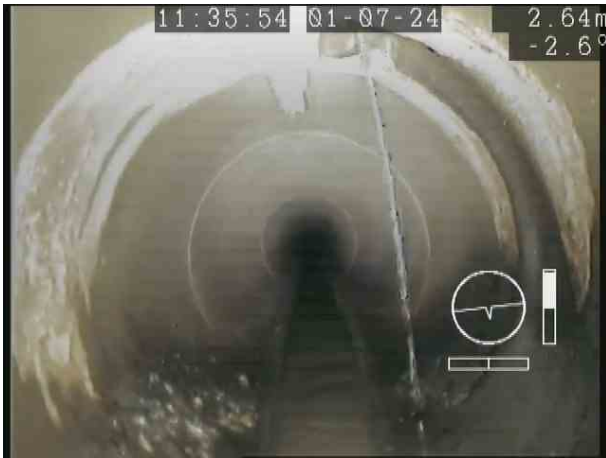
UU MH  
 4200X\_b3b71925-36fc-4632-8215-aaa0aa7d2fc7\_20240709\_151857\_279.jpg, 00:00:25, 2.64 m  
 Connection other than junction at 1 o'clock, 150mm dia

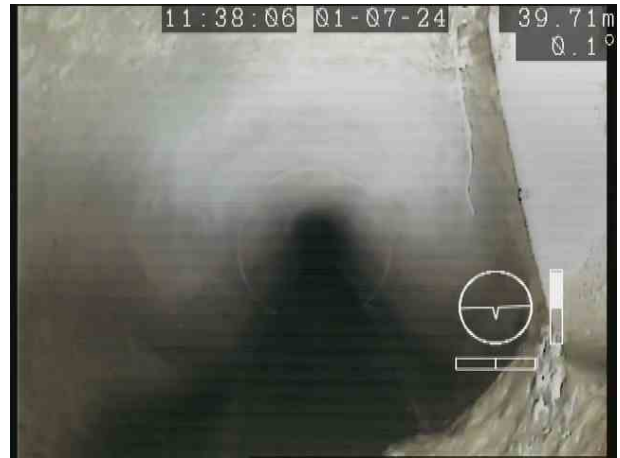
UU MH  
 4200X\_3540daf9-82a2-40d2-940f-2395e0dfdf0f\_20240709\_152007\_796.jpg, 00:02:38, 39.71 m  
 Connection other than junction at 3 o'clock, 450mm dia

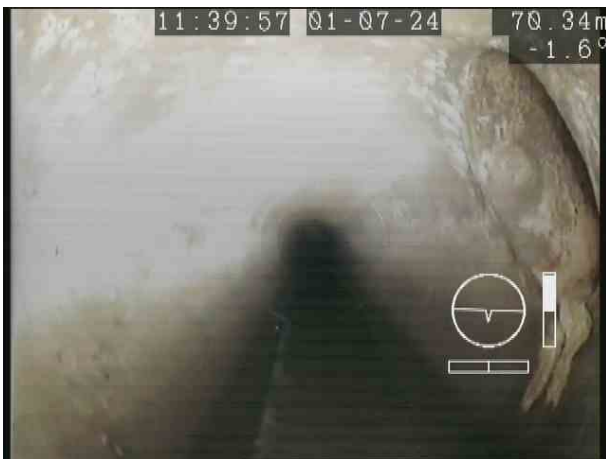
UU MH  
 4200X\_8e400569-45f9-4cf2-a3c7-bf77e5e22eec\_20240709\_152144\_127.jpg, 00:04:28, 70.20 m  
 Connection other than junction at 2 o'clock, 375mm dia

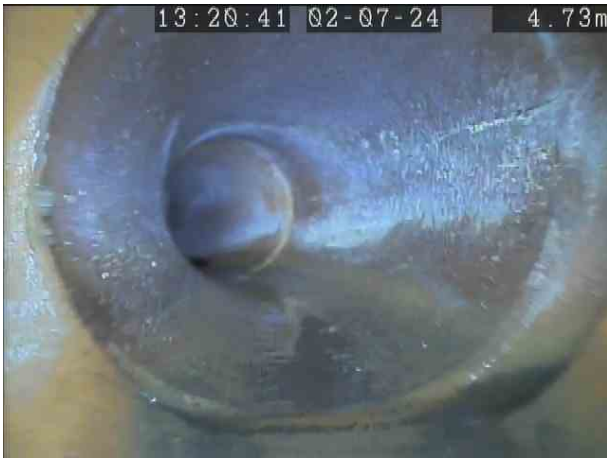
UU MH  
4115X\_21c7e9cd-9f85-408f-919a-1b3d42e95a3f\_20240709\_1  
50532\_358.jpg, 00:00:28, 4.73 m  
Open joint, medium

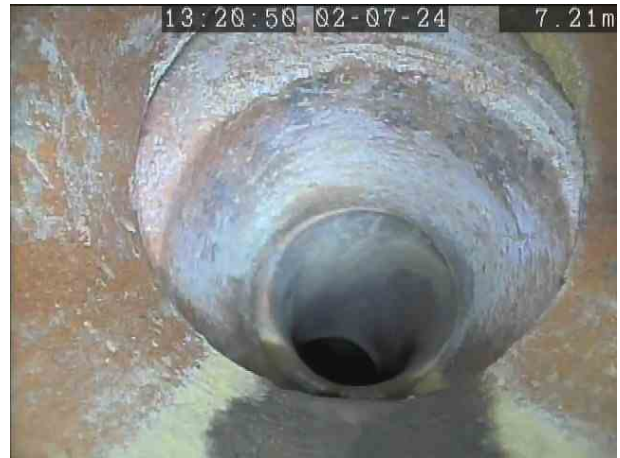
UU MH  
4115X\_fe222fd2-3392-42d1-b9a6-f58d2eb831c8\_20240709\_1  
50559\_290.jpg, 00:00:37, 7.21 m  
Joint displaced, large

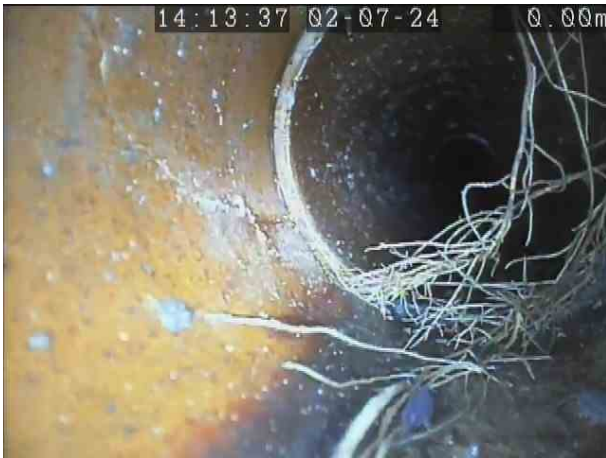
| Scale: | 1:50 | Position [m] | Code | Observation | MPEG | Photo | Grade |
|---|---|---|---|---|---|---|---|
| | | 0.05 | RFJ | Roots, fine at joint | 00:00:10 | UU MH 6104X_e5 7cd18b-47 | 2 |

UU MH  
 6104X\_e57cd18b-47aa-4901-9340-26b7bb8bac69\_20240710\_120853\_392.jpg, 00:00:10, 0.05 m  
 Roots, fine at joint

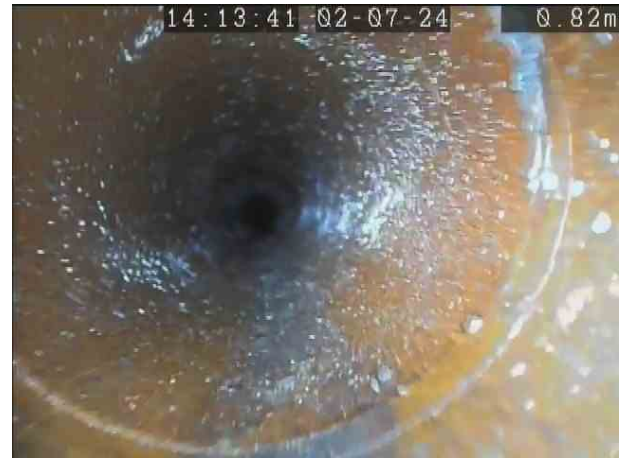
| Scale: | 1:50 | Position [m] | Code | Observation | MPEG | Photo | Grade |
|---|---|---|---|---|---|---|---|
| | | 0.82 | CCJ | Crack, circumferential at joint from 3 o'clock to 6 o'clock | 00:00:15 | UU MH 6104X_76 0edf22-03 | 2 / 2 |

UU MH  
 6104X\_760edf22-034b-4db0-be04-d189a115e6e9\_20240710\_120912\_063.jpg, 00:00:15, 0.82 m  
 Crack, circumferential at joint from 3 o'clock to 6 o'clock

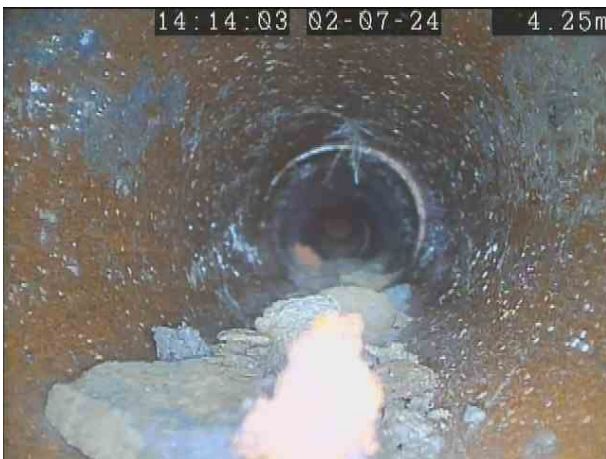
UU MH  
 6104X\_8f393437-a3a7-421d-8605-f4f3c697f217\_20240710\_120952\_541.jpg, 00:00:36, 4.25 m  
 Settled deposits, other, 15% cross-sectional area loss, Debris

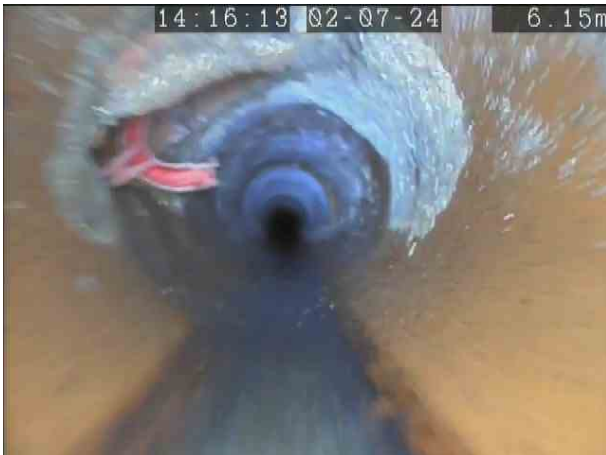
| Scale: 1:230 | Position [m] | Code | Observation | MPEG | Photo | Grade |
|---|---|---|---|---|---|---|
| | 6.15 | CXP | Connection defective, position incorrect at 10 o'clock, 100mm dia | 00:00:35 | UU MH 6105X_4d1f5dd7-85 | |

UU MH  
 6105X\_4d1f5dd7-8515-40d9-8cd8-5f252977e062\_20240710\_120258\_758.jpg, 00:00:35, 6.15 m  
 Connection defective, position incorrect at 10 o'clock, 100mm dia

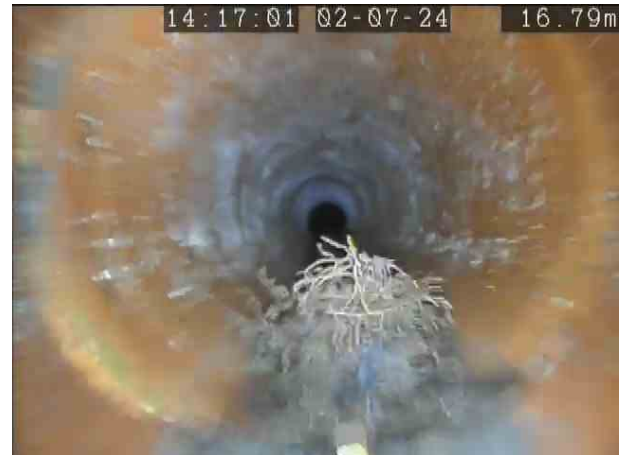
UU MH  
 6105X\_2910cbd9-8aaf-44f8-8c9c-7335619211cf\_20240710\_120500\_273.jpg, 00:01:22, 16.80 m  
 Roots, mass, 10% cross-sectional area loss

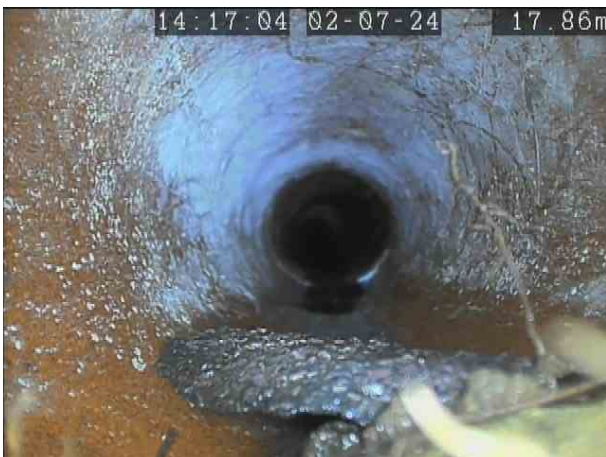
UU MH  
 6105X\_5a17e7c7-ee1c-44d1-ba17-b30ec715055a\_20240710\_120514\_998.jpg, 00:01:26, 17.86 m  
 Settled deposits, coarse, 10% cross-sectional area loss

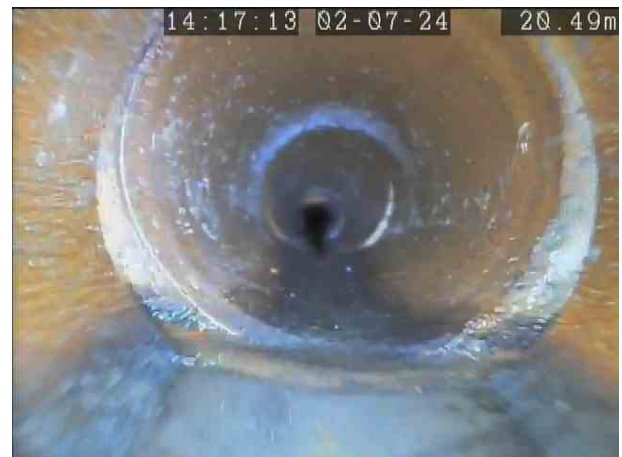
UU MH  
 6105X\_af3257f3-f8b8-428f-b884-add7e31acfee\_20240710\_120621\_025.jpg, 00:01:35, 20.49 m  
 Joint displaced, medium

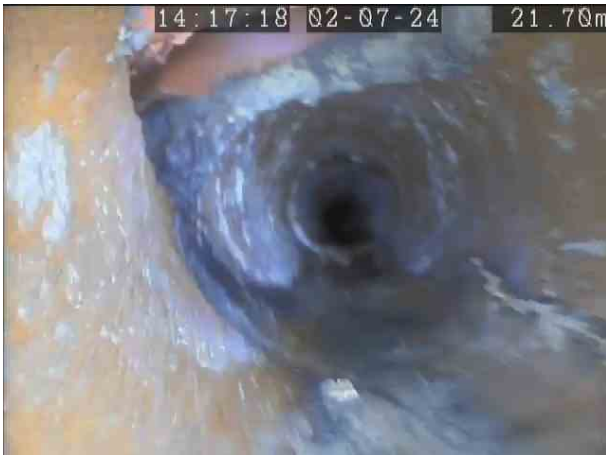
| Scale: 1:230 | Position [m] | Code | Observation | MPEG | Photo | Grade |
|---|---|---|---|---|---|---|
| | 21.70 | CXP | Connection defective, position incorrect at 11 o'clock, 100mm dia | 00:01:39 | | |

UU MH  
 6105X\_f235f7a2-17e9-461d-b9db-a8749b1bfd16\_20240710\_120715\_846.jpg, 00:01:39, 21.70 m  
 Hole in drain or sewer from 10 o'clock to 11 o'clock

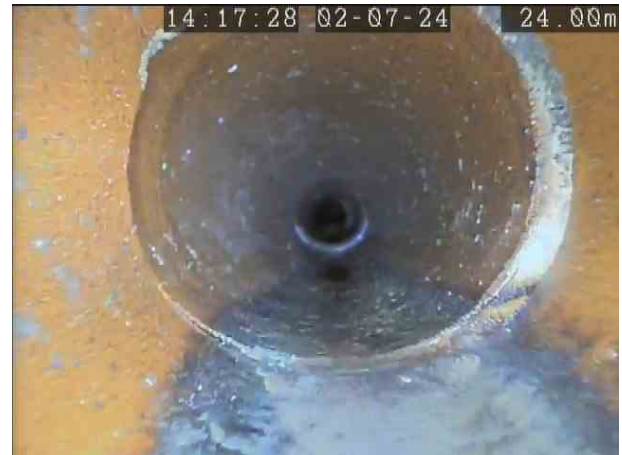
UU MH  
 6105X\_af66cf54-5101-4743-a9e5-3f663224a474\_20240710\_120736\_173.jpg, 00:01:50, 24.00 m  
 Joint displaced, medium

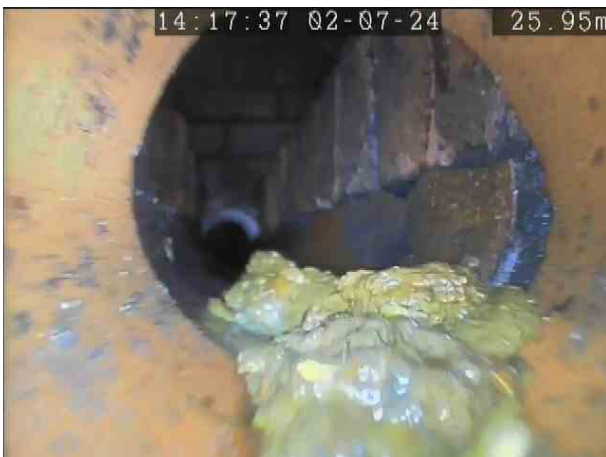
UU MH  
 6105X\_73e42c3a-37ce-435b-846a-90e6df6e0417\_20240710\_120829\_194.jpg, 00:01:58, 25.95 m  
 Settled deposits, other, 20% cross-sectional area loss, Foul waste

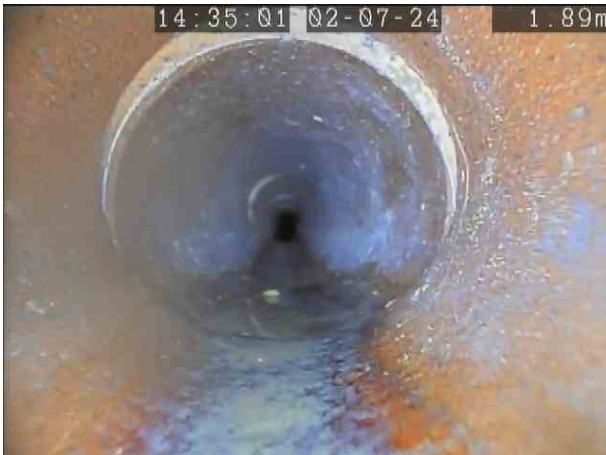
UU MH  
 6106X\_1fecc75b-9457-45b5-87be-956a8c22c349\_20240710\_121652\_147.jpg, 00:00:21, 1.90 m  
 Joint displaced, medium

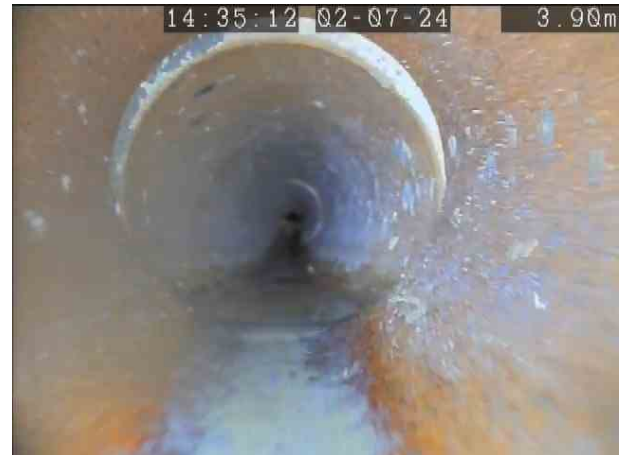
UU MH  
 6106X\_d6ad702c-0bcb-4aa7-8963-6140e1f2550a\_20240710\_121719\_714.jpg, 00:00:31, 3.90 m  
 Joint displaced, medium

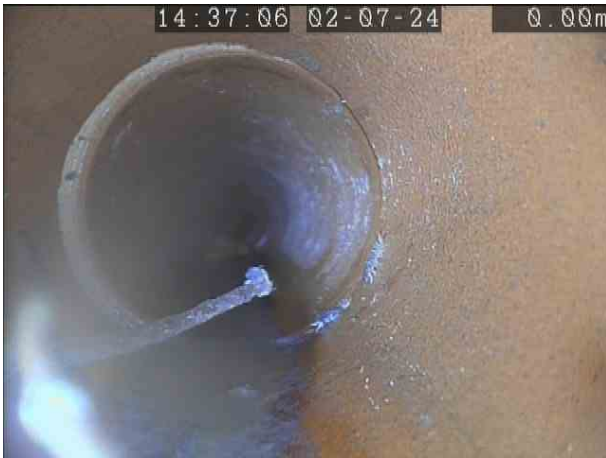
UU MH  
 6107X\_fd70e5fa-89cf-406f-92d8-bbf87f1bf373\_20240710\_12128\_447.jpg, 00:00:10, 0.01 m  
 Roots, tap

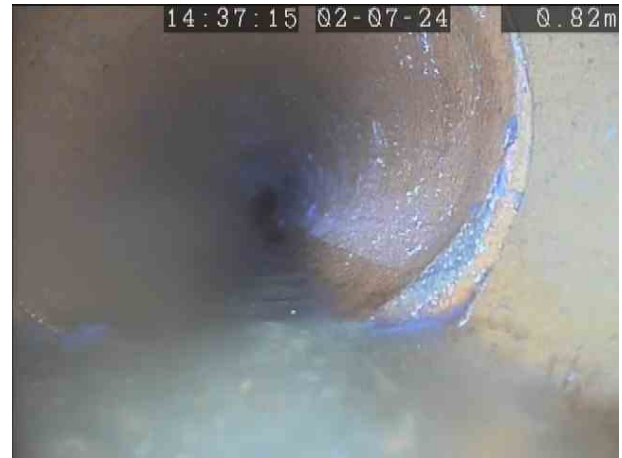
UU MH  
 6107X\_019db6a9-27da-4002-916a-c08b45844871\_20240710\_121142\_782.jpg, 00:00:18, 0.82 m  
 Joint displaced, medium

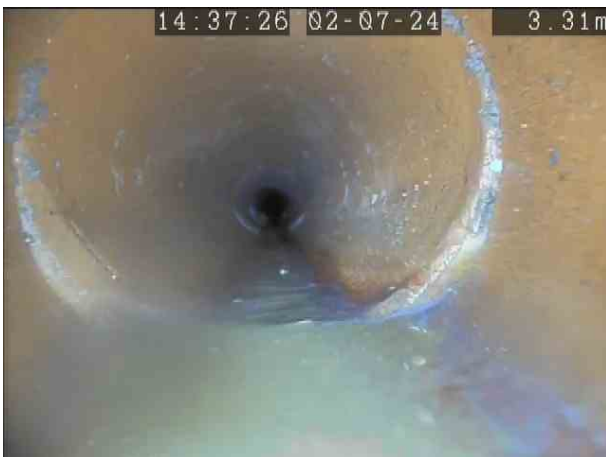
UU MH  
 6107X\_a3c12a4f-2a9f-4a6a-8ec4-60f7d860ce35\_20240710\_121218\_676.jpg, 00:00:30, 3.31 m  
 Joint displaced, medium

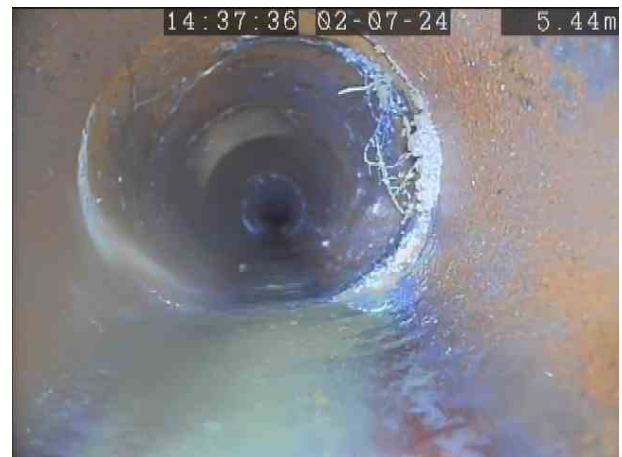
| Scale: 1:103 | Position [m] | Code | Observation | MPEG | Photo | Grade |
|---|---|---|---|---|---|---|
| | 5.44 | CCJ | Crack, circumferential at joint from 10 o'clock to 2 o'clock | 00:00:39 | | 2 / 2 |

UU MH  
 6107X\_43ef54ee-6462-4dd3-9629-f2ae5a6e2ad0\_20240710\_121301\_321.jpg, 00:00:39, 5.44 m  
 Joint displaced, medium

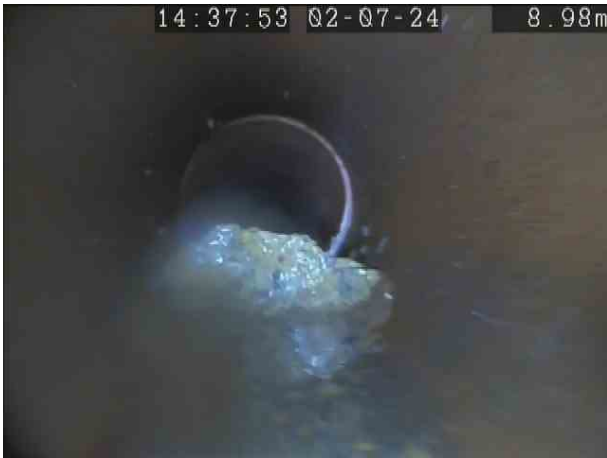
UU MH  
 6107X\_e9d9c869-a0fd-4339-8594-b4829b612499\_20240710\_121508\_481.jpg, 00:00:50, 8.98 m  
 Settled deposits, other, 20% cross-sectional area loss, Debris, being pushed down line by camera

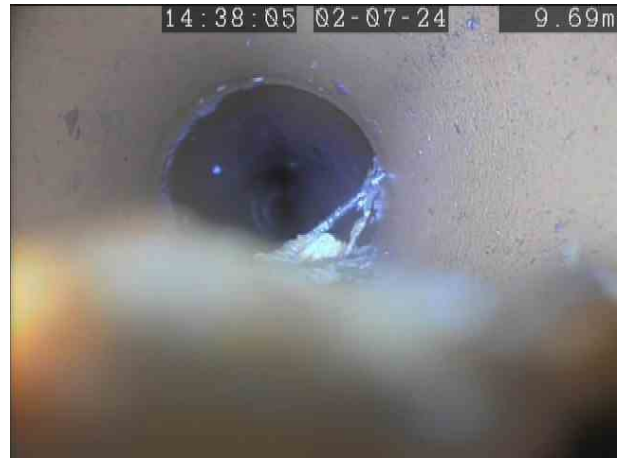
UU MH  
 6107X\_83a80ebc-aa1a-4e04-a946-016255bec334\_20240710\_121539\_392.jpg, 00:01:09, 9.70 m  
 Roots, fine at joint

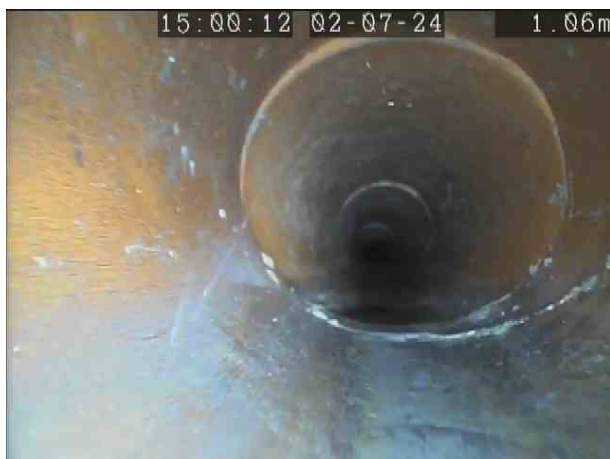
| Scale: 1:202 | Position [m] | Code | Observation | MPEG | Photo | Grade |
|---|---|---|---|---|---|---|
| | 1.06 | CCJ | Crack, circumferential at joint from 4 o'clock to 7 o'clock | 00:00:20 | UU MH6107B X_1c4efc2 | 2 / 2 |

UU  
 MH6107BX\_1c4efc2b-4ab0-48ae-9780-c502045f9894\_20240  
 710\_125511\_877.jpg, 00:00:20, 1.06 m  
 Crack, circumferential at joint from 4 o'clock to 7 o'clock

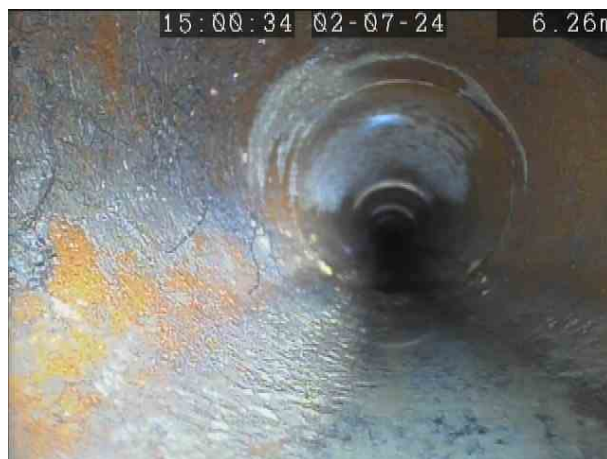
| Scale: 1:202 | Position [m] | Code | Observation | MPEG | Photo | Grade |
|---|---|---|---|---|---|---|
| | 6.26 | CCJ | Crack, circumferential at joint from 11 o'clock to 2 o'clock | 00:00:42 | UU MH6107B X_975968 | 2 / 2 |

UU  
 MH6107BX\_9759681b-13e9-42b2-b4ec-09378cc404ba\_2024  
 0710\_125837\_465.jpg, 00:00:42, 6.26 m  
 Crack, circumferential at joint from 11 o'clock to 2 o'clock

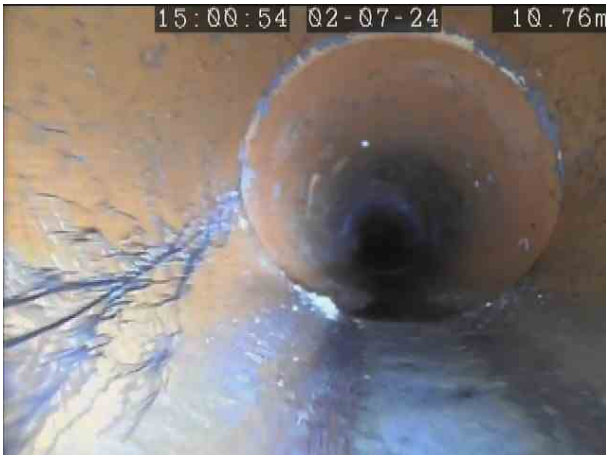
UU  
 MH6107BX\_e794da5a-2766-412c-8f4f-52b6a3a5d004\_20240  
 710\_125946\_733.jpg, 00:01:02, 10.76 m  
 Roots, fine at joint

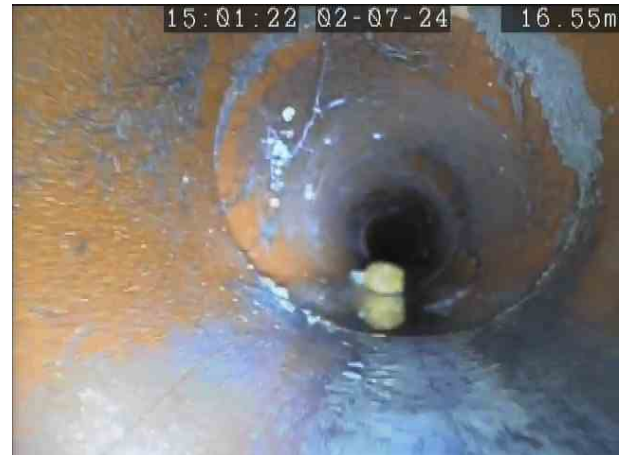
UU  
 MH6107BX\_f76e7b26-0422-4fc0-9573-3ca1455930bc\_20240  
 710\_130046\_218.jpg, 00:01:30, 16.55 m  
 Roots, fine at joint

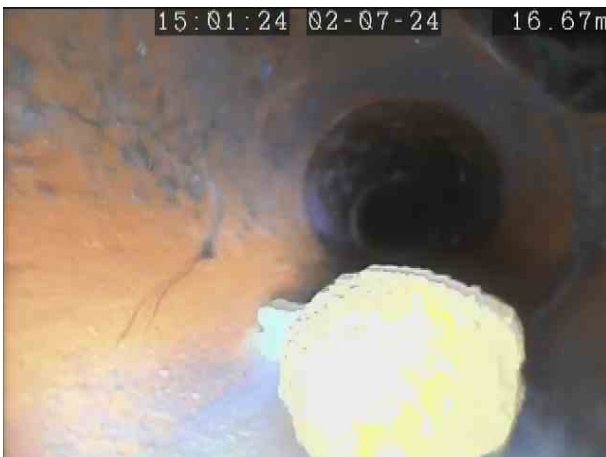
UU  
 MH6107BX\_f56d6128-7288-4543-869d-5a95a737b1ef\_20240  
 710\_130128\_747.jpg, 00:01:32, 16.67 m  
 Settled deposits, other, 10% cross-sectional area loss, Foul  
 waste

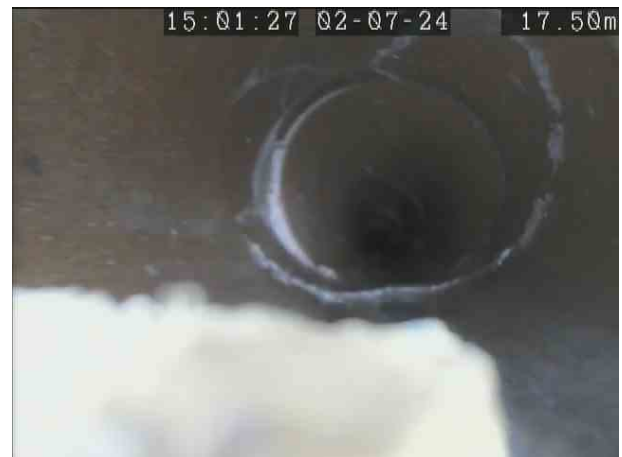
| Scale: 1:202 | Position [m] | Code | Observation | MPEG | Photo | Grade |
|---|---|---|---|---|---|---|
| | 17.50 | FCJ | Fracture, circumferential at joint from 12 o'clock to 12 o'clock | 00:01:35 | UU MH6107B X_5c0520 | 3 / 2 |

UU  
 MH6107BX\_5c05207c-31cc-4b04-85c6-74e607bf22b7\_20240  
 710\_130154\_126.jpg, 00:01:35, 17.50 m  
 Fracture, circumferential at joint from 12 o'clock to 12 o'clock

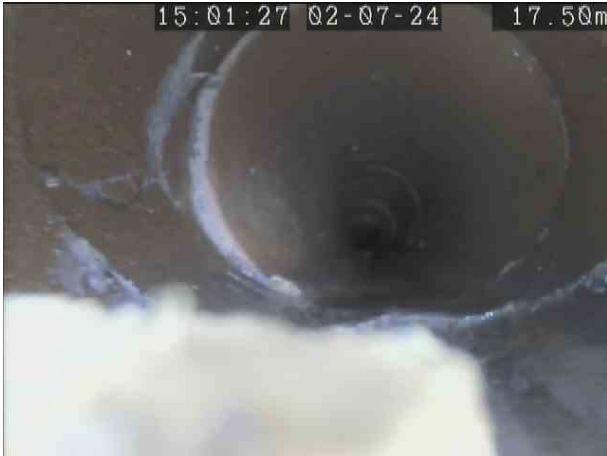
UU

MH6107BX\_3a0beda3-c1a8-496b-b11d-4520b258f644\_20240710\_130157\_022.jpg, 00:01:35, 17.50 m  
 Fracture, circumferential at joint from 12 o'clock to 12 o'clock
