**Project****Project Name:** 2024-06-30014 RG Parkins Queens Park Drive Millom**Project Date:** 09/07/2024**Inspection Standard:** MSCC5 Sewers & Drainage GB (SRM5 Scoring)

**R. G. PARKINS & PARTNERS LTD**  
CONSULTING CIVIL & STRUCTURAL ENGINEERS

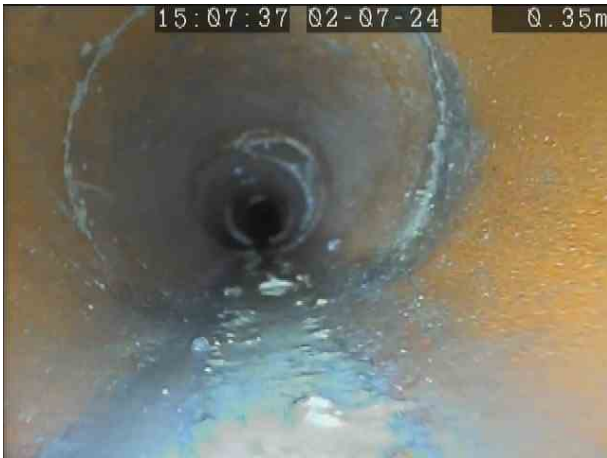
| Scale: 1:147 | Position [m] | Code | Observation | MPEG | Photo | Grade |
|---|---|---|---|---|---|---|
| | 0.35 | CC | Crack, circumferential from 8 o'clock to 5 o'clock | 00:00:18 | UU MH6107A X_60deee | 2 / 2 |

UU  
 MH6107AX\_60deeee9-b3ec-49dc-9e27-a0d542f1aef9\_20240710\_122640\_872.jpg, 00:00:18, 0.35 m  
 Crack, circumferential from 8 o'clock to 5 o'clock

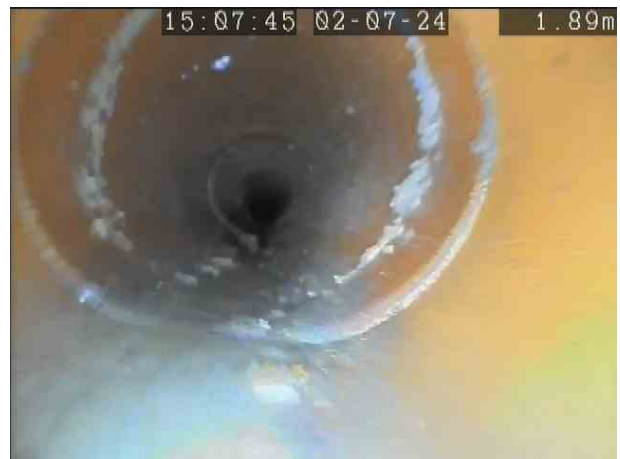
| Scale: 1:147 | Position [m] | Code | Observation | MPEG | Photo | Grade |
|---|---|---|---|---|---|---|
| | 1.90 | CCJ | Crack, circumferential at joint from 8 o'clock to 4 o'clock | 00:00:27 | UU MH6107A X_050904 | 2 / 2 |

UU  
 MH6107AX\_05090492-b964-4d08-a526-19632702de53\_20240710\_123512\_218.jpg, 00:00:27, 1.90 m  
 Crack, circumferential at joint from 8 o'clock to 4 o'clock

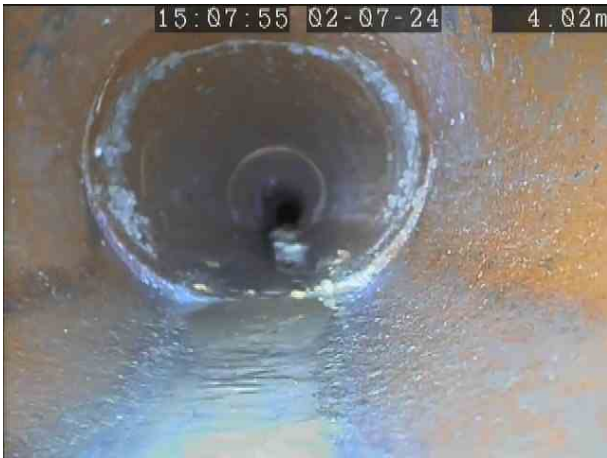
| Scale: 1:147 | Position [m] | Code | Observation | MPEG | Photo | Grade |
|---|---|---|---|---|---|---|
| | 4.02 | CCJ | Crack, circumferential at joint from 8 o'clock to 5 o'clock | 00:00:36 | UU MH6107A X_eebef5a | 2 / 2 |

UU  
 MH6107AX\_eebef5a0-0d76-464a-8169-e5fea1051d21\_20240710\_123858\_044.jpg, 00:00:36, 4.02 m  
 Crack, circumferential at joint from 8 o'clock to 5 o'clock

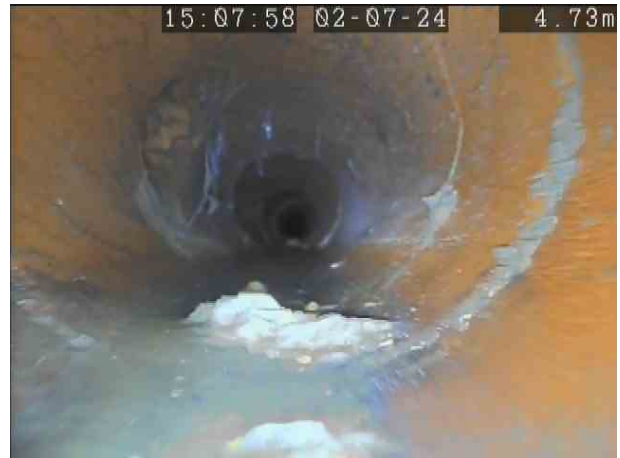
| Scale: 1:147 | Position [m] | Code | Observation | MPEG | Photo | Grade |
|---|---|---|---|---|---|---|
| | 4.73 | CC | Crack, circumferential from 2 o'clock to 5 o'clock | 00:00:40 | UU MH6107A X_775fc9b | 2 / 2 |

UU  
 MH6107AX\_775fc9b6-a6ee-499b-8e54-66e659bd058f\_20240710\_124000\_810.jpg, 00:00:40, 4.73 m  
 Crack, circumferential from 2 o'clock to 5 o'clock

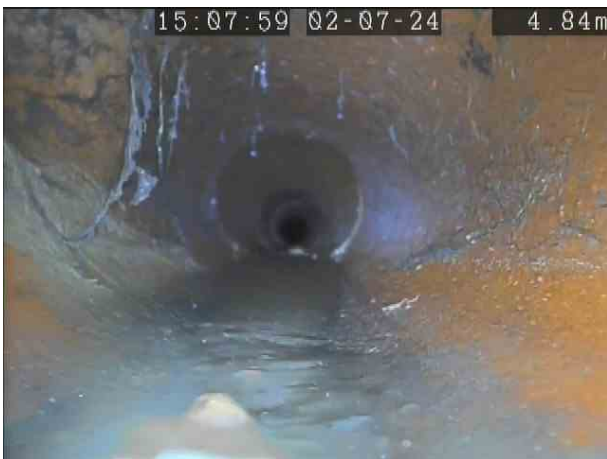
UU  
 MH6107AX\_fdf360c8-c7a8-4766-87ac-a77218163a15\_20240710\_124014\_117.jpg, 00:00:41, 4.84 m  
 Roots, fine

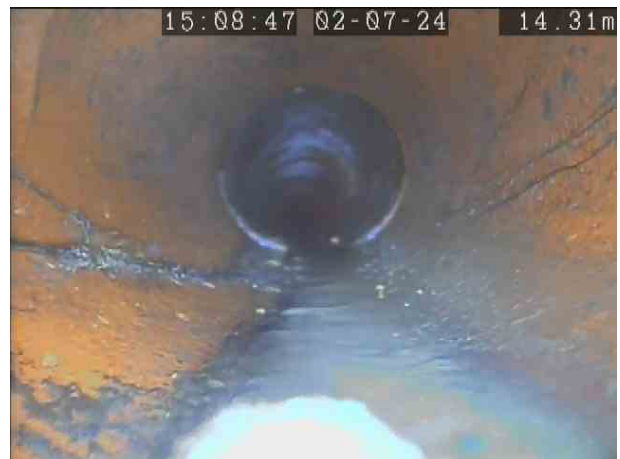
UU  
 MH6107AX\_70430c2e-8bc0-45aa-b2d9-8800030f61fd\_20240710\_124222\_497.jpg, 00:01:29, 14.31 m  
 Roots, fine

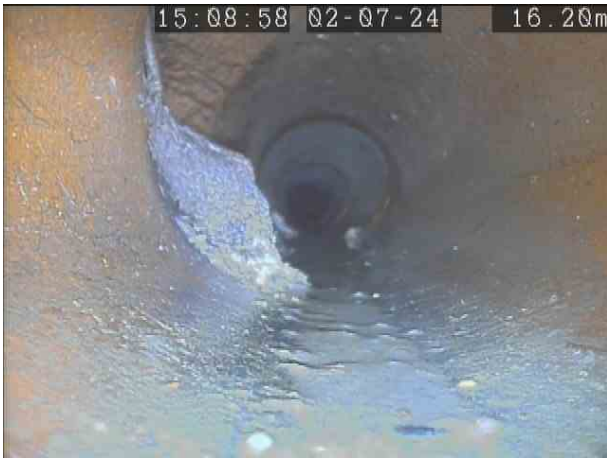
| Scale: 1:147 | Position [m] | Code | Observation | MPEG | Photo | Grade |
|---|---|---|---|---|---|---|
| | 16.20 | JX | Junction, defective at 10 o'clock, 100mm dia: Roots | 00:01:39 | | |

UU  
 MH6107AX\_6ede8f1f-d234-4ec7-a255-2f600592bcf3\_202407  
 10\_124318\_501.jpg, 00:01:39, 16.20 m  
 Roots, mass, 10% cross-sectional area loss

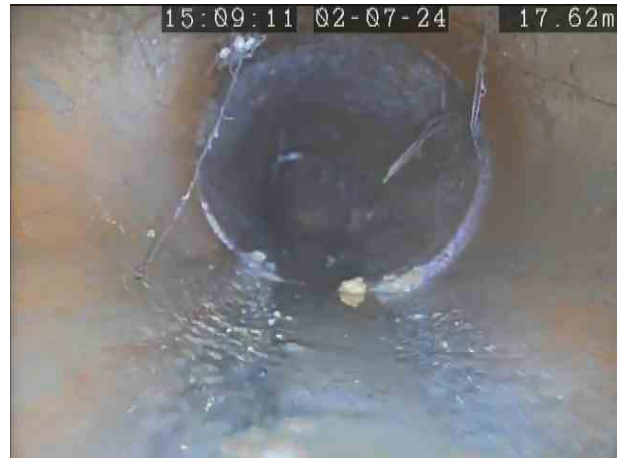
UU  
 MH6107AX\_5017909f-c386-426c-b254-316ba6b4dd71\_20240  
 710\_124341\_701.jpg, 00:01:53, 17.62 m  
 Roots, fine

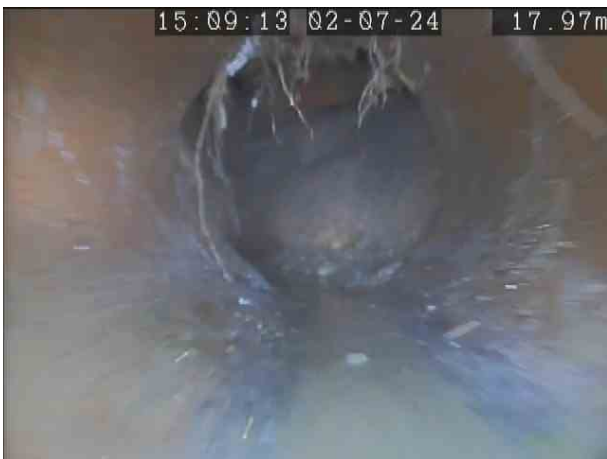
UU  
 MH6107AX\_0ec05cdd-4a87-4023-aed1-7880fe3c889f\_20240  
 710\_124400\_211.jpg, 00:01:55, 17.97 m  
 Roots, fine

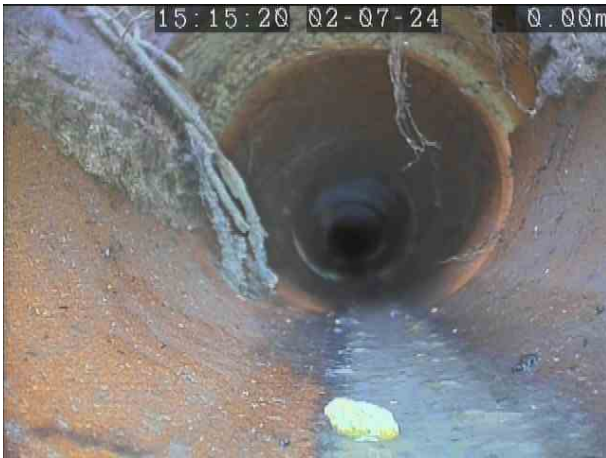
UU  
 MH6107CX\_09cbff7f-9bc6-4ce9-8915-7d9989a1bd12\_202407  
 10\_130335\_944.jpg, 00:00:12, 0.01 m  
 Roots, fine

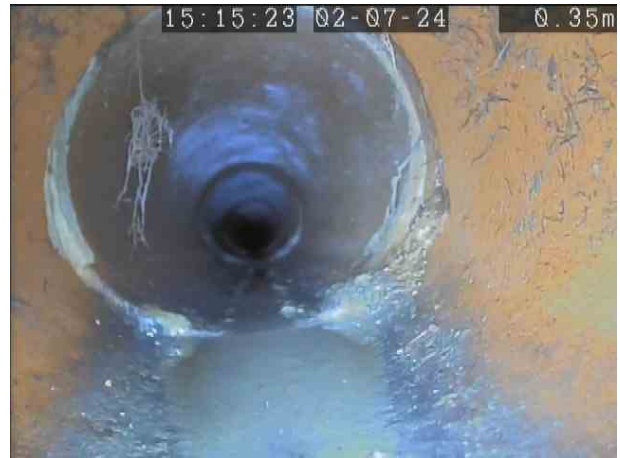
UU  
 MH6107CX\_ea0ddb5-7f23-4228-8dc1-2eb74ff659b8\_20240  
 710\_130347\_264.jpg, 00:00:15, 0.35 m  
 Roots, fine at joint

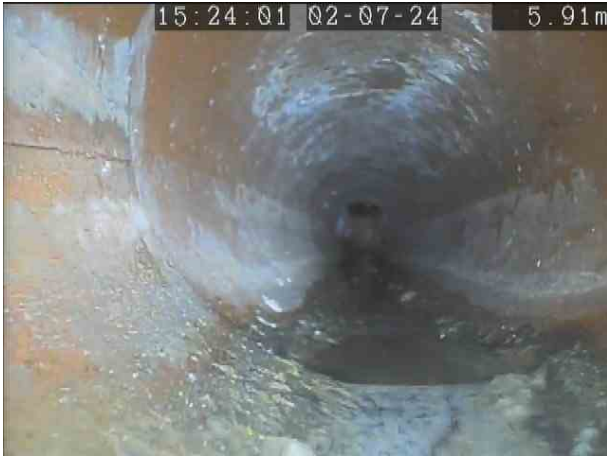
UU  
 MH6107DX\_0d254413-0e0f-4d09-9a84-87e98e0450d8\_2024  
 0710\_131915\_828.jpg, 00:00:34, 5.91 m  
 Crack, longitudinal at joint at 9 o'clock

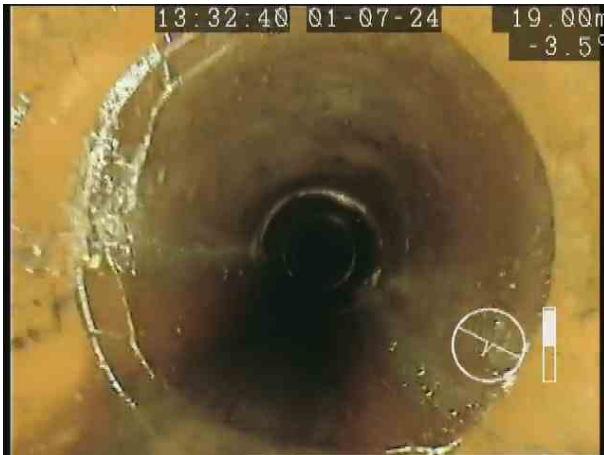
| Scale: 1:670 | Position [m] | Code | Observation | MPEG | Photo | Grade |
|---|---|---|---|---|---|---|
| | 19.00 | CCJ | Crack, circumferential at joint from 5 o'clock to 11 o'clock | 00:01:23 | UU MH 6103X_ad 477bb1-33 | 2 / 2 |

UU MH  
 6103X\_ad477bb1-3347-4377-926c-b51cec39dc9f\_20240710\_115331\_218.jpg, 00:01:23, 19.00 m  
 Crack, circumferential at joint from 5 o'clock to 11 o'clock

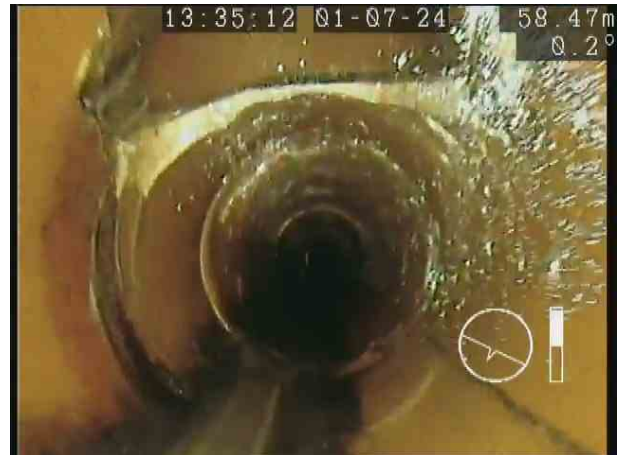
UU MH  
 6103X\_732ef41c-6fee-4791-b742-c1db137bfee3\_20240710\_115844\_918.jpg, 00:03:55, 58.47 m  
 Connection other than junction at 11 o'clock, 150mm dia

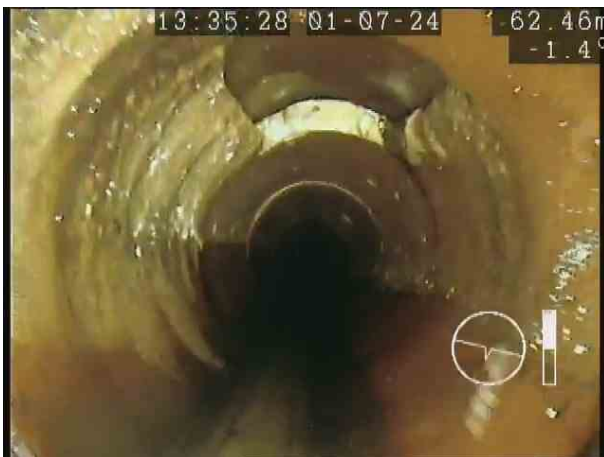
UU MH  
 6103X\_080152c5-dbb7-4dda-96cb-2171be9d353b\_20240710\_115916\_616.jpg, 00:04:10, 62.46 m  
 Hole in drain or sewer from 11 o'clock to 2 o'clock

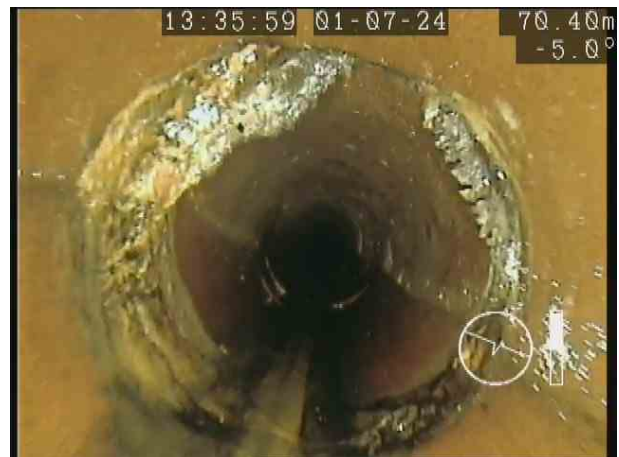
UU MH  
 6103X\_c3cb60a3-84c7-40d5-9167-26202aebd9b6\_20240710\_115957\_714.jpg, 00:04:41, 70.40 m  
 Attached deposits, encrustation at joint from 7 o'clock to 12 o'clock, 15% cross-sectional area loss

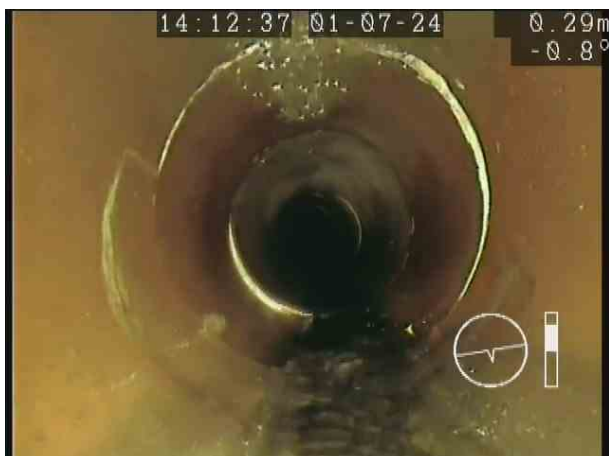
| Scale: 1:306 | Position [m] | Code | Observation | MPEG | Photo | Grade |
|---|---|---|---|---|---|---|
| | 0.30 | CC | Crack, circumferential from 12 o'clock to 12 o'clock | 00:00:14 | UU MH 7100X_6a00a2a1-d0 | 2 / 2 |

UU MH  
 7100X\_6a00a2a1-d015-41d1-a740-7944b7392f84\_20240710\_132141\_314.jpg, 00:00:14, 0.30 m  
 Crack, circumferential from 12 o'clock to 12 o'clock

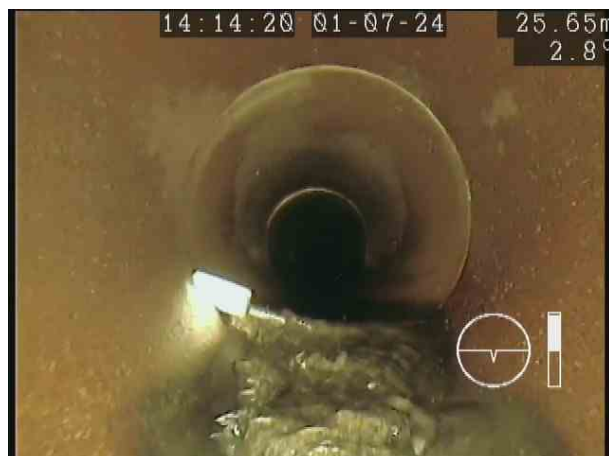
UU MH  
 7100X\_c7d91596-d8b9-48ad-a7f8-5a4550dc115c\_20240710\_132254\_026.jpg, 00:01:56, 25.65 m  
 Settled deposits, hard or compacted, 5% cross-sectional area loss

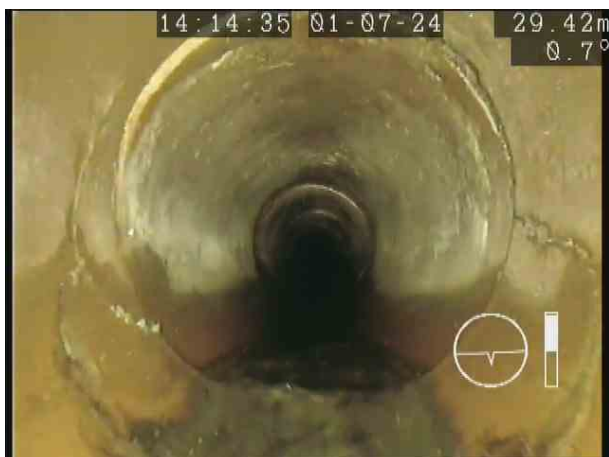
| Scale: 1:306 | Position [m] | Code | Observation | MPEG | Photo | Grade |
|---|---|---|---|---|---|---|
| | 29.42 | CCJ | Crack, circumferential at joint from 3 o'clock to 10 o'clock | 00:02:12 | UU MH 7100X_1db507ad-ea | 2 / 2 |

UU MH  
 7100X\_1db507ad-ea16-471e-9689-70e550d0655c\_20240710\_132319\_673.jpg, 00:02:12, 29.42 m  
 Crack, circumferential at joint from 3 o'clock to 10 o'clock

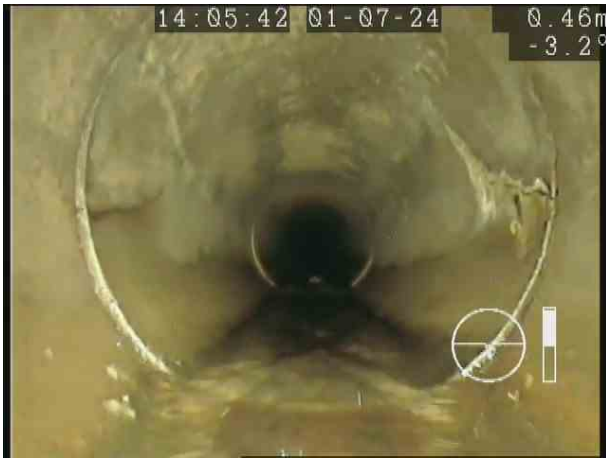
| Scale: 1:332 | Position [m] | Code | Observation | MPEG | Photo | Grade |
|---|---|---|---|---|---|---|
| | 0.46 | CLJ | Crack, longitudinal at joint at 3 o'clock | 00:00:22 | UU MH 7003X_39 d22598-ed | 2 / 2 |

UU MH  
 7003X\_39d22598-ed13-48dd-851e-36eb0247e3a5\_20240710\_131216\_796.jpg, 00:00:22, 0.46 m  
 Crack, longitudinal at joint at 3 o'clock

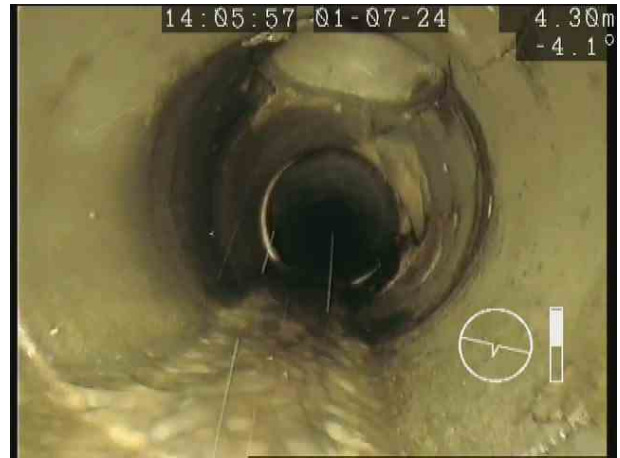
UU MH  
 7003X\_f878f780-b348-436f-9ff8-01ed2215a29e\_20240710\_131432\_748.jpg, 00:00:37, 4.30 m  
 Connection other than junction at 12 o'clock, 100mm dia

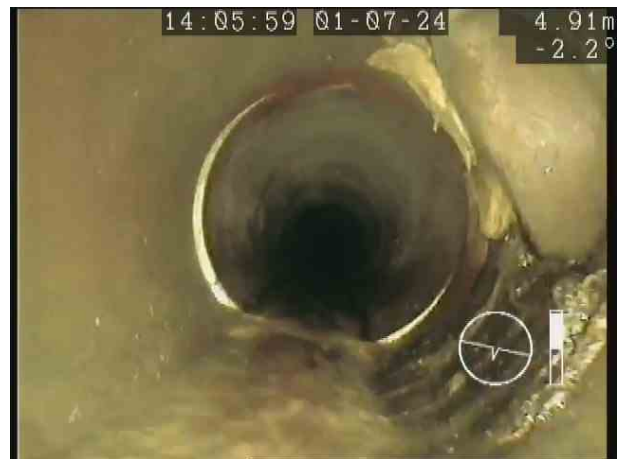
UU MH  
 7003X\_d072b720-dd94-4ec0-b578-884a22fa18aa\_20240710\_131430\_220.jpg, 00:00:39, 4.91 m  
 Connection other than junction at 2 o'clock, 150mm dia

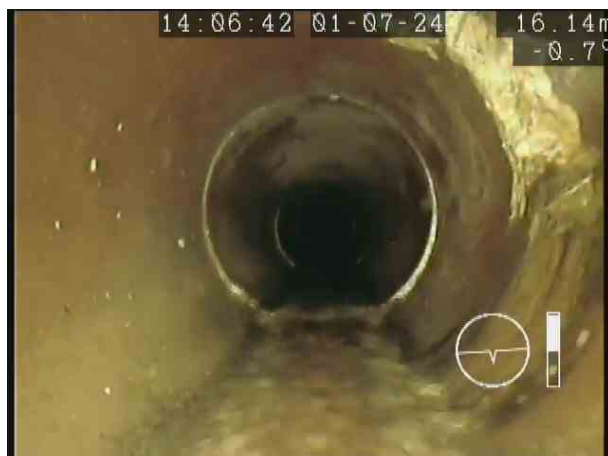
UU MH  
 7003X\_f044fae5-85bc-4edc-82ed-dc73e9bd882b\_20240710\_131629\_982.jpg, 00:01:22, 16.14 m  
 Connection other than junction at 2 o'clock, 100mm dia

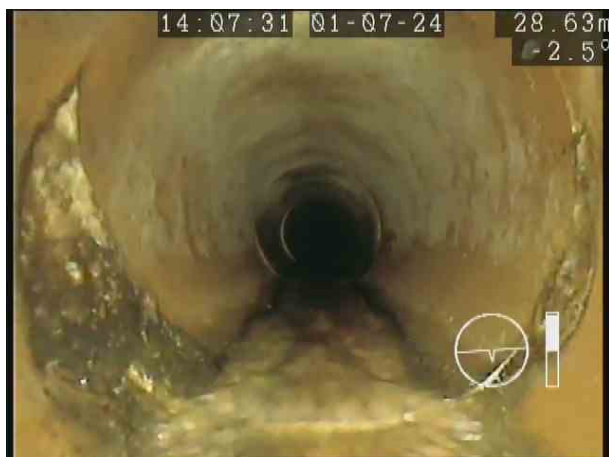
UU MH  
 7003X\_9b082942-0be2-48c7-b25c-257c7d28bdec\_20240710\_131711\_603.jpg, 00:02:11, 28.63 m  
 Attached deposits, encrustation at joint from 7 o'clock to 10 o'clock, 10% cross-sectional area loss

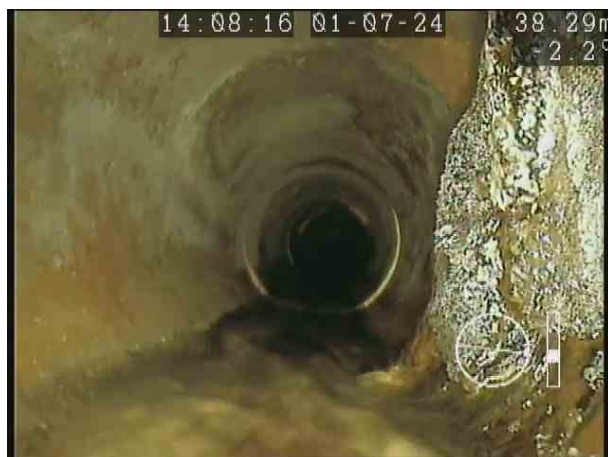
UU MH  
 7003X\_40b91952-7be8-420f-a027-267d743fc8e6\_20240710\_131821\_861.jpg, 00:02:45, 38.29 m  
 Settled deposits, hard or compacted, 25% cross-sectional area loss
