**VISUAL STRUCTURAL INSPECTION**

**OUTBUILDINGS  
GREENMOORSIDE FARM  
BECKERMET  
CUMBRIA**

**AVISON YOUNG**

**Reference - WDS/05/9858/REP01**

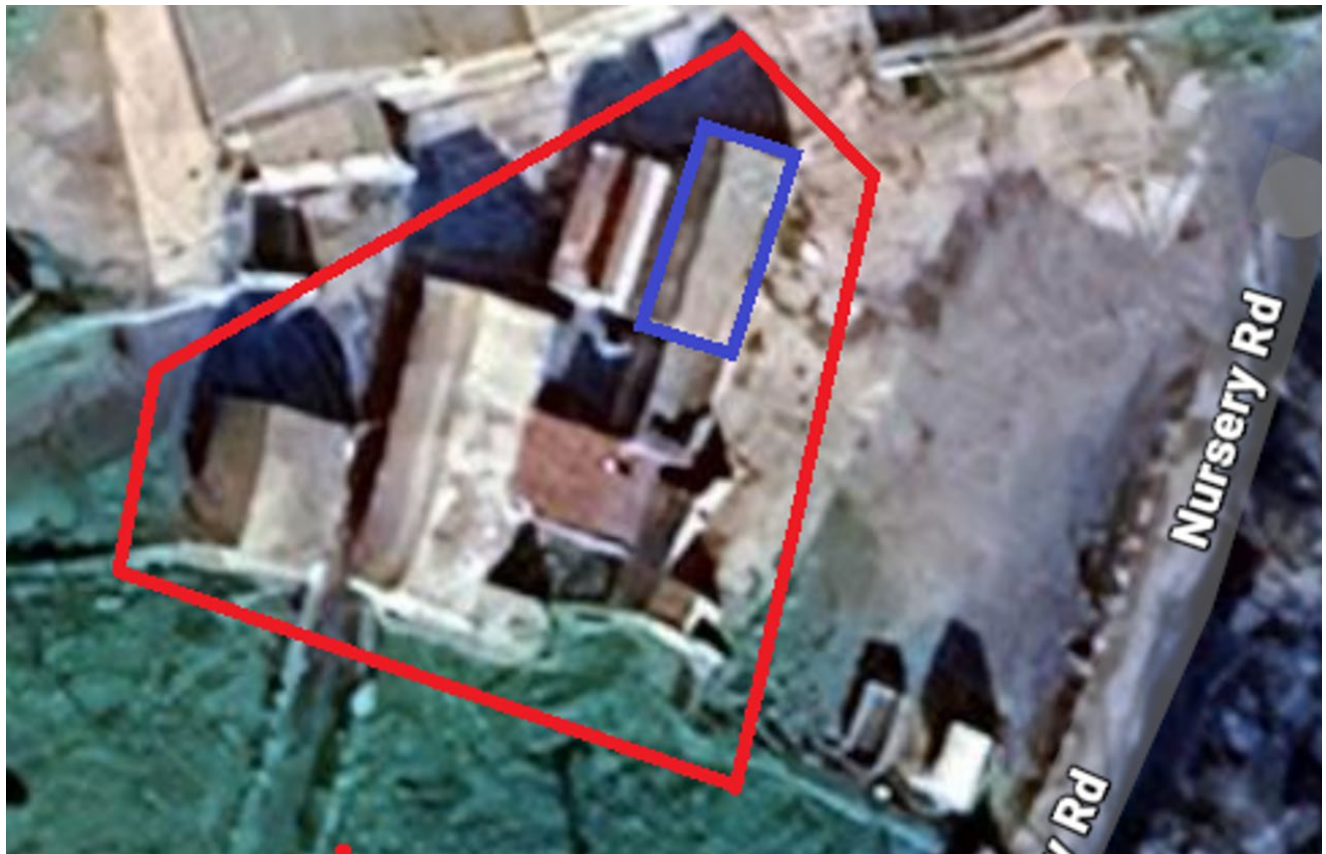
FIGURE 1 PLAN ON BUILDING INSPECTED

- 1.2** The buildings inspected are outlined in red on Fig1 in the Appendix. The buildings are disused apart from the building outlined in blue which is used as part of the current farm operations. The buildings inspected comprise a variety of differing structures. The two detached portal frame buildings to the rear of the site are clad timber framed structures. The front buildings comprise stone and brick single storey buildings with a combination of slate and fibre cement cladded roofs. The buildings connected to the rear of the front buildings are a series of ad hoc light weight steel framed and timber framed structures. Many of the buildings are derelict and some have suffered partial collapse. The buildings range in age from over 100 years to being erected in the past 30 years.

- 2.1** The random stone masonry building (outlined in blue on Fig 1) is in an adequate condition. The walls are slightly out of plumb and in need of repointing with historic cracking apparent to all elevations. The timber rafter, purlins and truss roof structure has been affected by woodworm and has suffered from creep leading to a deflection on the roof finish. See photographs 01 and 02 attached. The lean to roof off the front of the building is at risk of collapse and needs replaced, see photograph 03 attached.
- 2.2** The masonry buildings off the left hand gable of the building noted above are derelict, the roof has partially collapsed and the walls have suffered excessive movement. See photographs 04 and 05 attached.
