## FLOOD RISK ASSESSMENT

### **Cleator Mill, Proposed Commercial Development, Flood Risk Assessment.**

| Reference | RO/FRA/NEWCOM/13000.1 |

### **Asset Condition survey: River Ehen (right bank) Flood Defence at Cleator Mills**

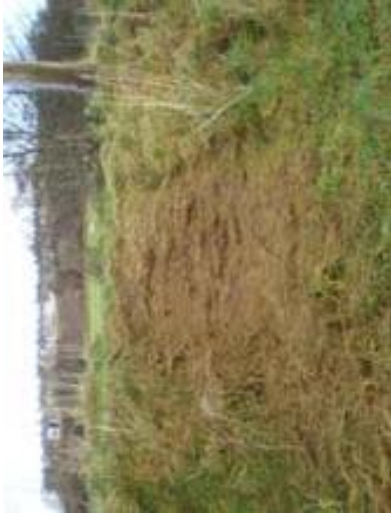
*Outward Face with vegetation cleared*
