## **FLOOD RISK AND DRAINAGE ASSESSMENT**

### **Cleator Mill, Proposed Residential Development, Flood Risk Assessment.**

# Cleator Flood Asset Condition Assessment

23 MAR 2022  
Version 1.0  
RAB: 2869

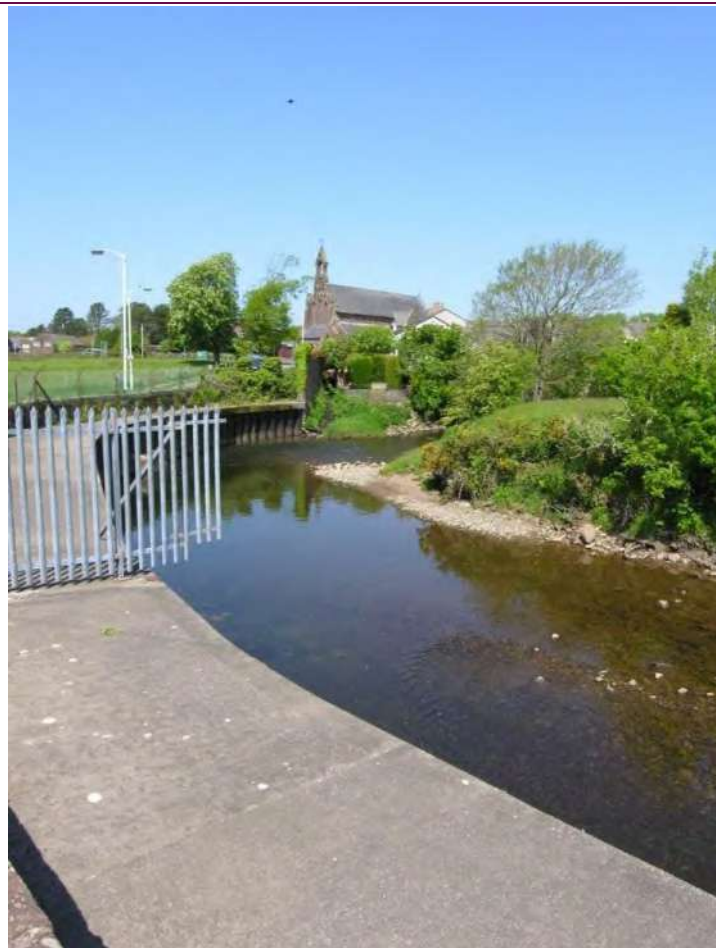
**Photo 1 – Hard flood defences between 1896 & 1726**

The proposed development has engineered hard flood defences to the northeastern extent, downstream of the hard defences, soft earth defences exist continuing north to the extents of the Kangol Factory/premises. These defences afford the site a level of protection to the 1:200-year modelled return period, which is confirmed by the Environment Agency River Ehen model from 2016. The location of the modelled reference points has been cross-referenced against a topographical survey undertaken; this is included in Appendix C; which includes sections showing the flood levels against the existing ground levels. Given the reliance of flood defences RAB Consultants were appointed to update the previous condition survey undertaken, A copy of the report is included in Appendix D.

The survey identifies various works which need undertaken immediately and within 1 year, it is recommended these works are carried out prior to works commencing, the total estimate value is £25,300 for the works as identified in the RAB report (RAB; 2869). It is then recommended that a condition survey be completed every 5 years as part of the management company's duties and the results are shared with the Environment Agency to ensure the flood defences are maintained and any further defects are rectified as part of the Environment Agencies' powers, should the Environment Agency deem that improvement/maintenance works necessary. At the most vulnerable point, on the northern boundary with the River Ehen hard defences are located on the right boundary located between modelled node points 1896 and 1726, as can be seen in Figure 3. The Environment Agency data shows these hard defences are at a 1:200-year standard. Based upon their model and information supplied as part of Product 4. These conditions are generally identified as being condition grade 2, which is a Good state of repair, except for some minor vegetation which is noted as condition grade 3. The vegetation should be dealt with and made good to ensure the asset is in all condition grade 2. The only flood defences graded Poor, condition 4, are located off-site southwest along Kiln Brow and do not impact the proposed development. The flood defences impacting the development site are graded mainly condition 3 and some condition 2, good to fair. As

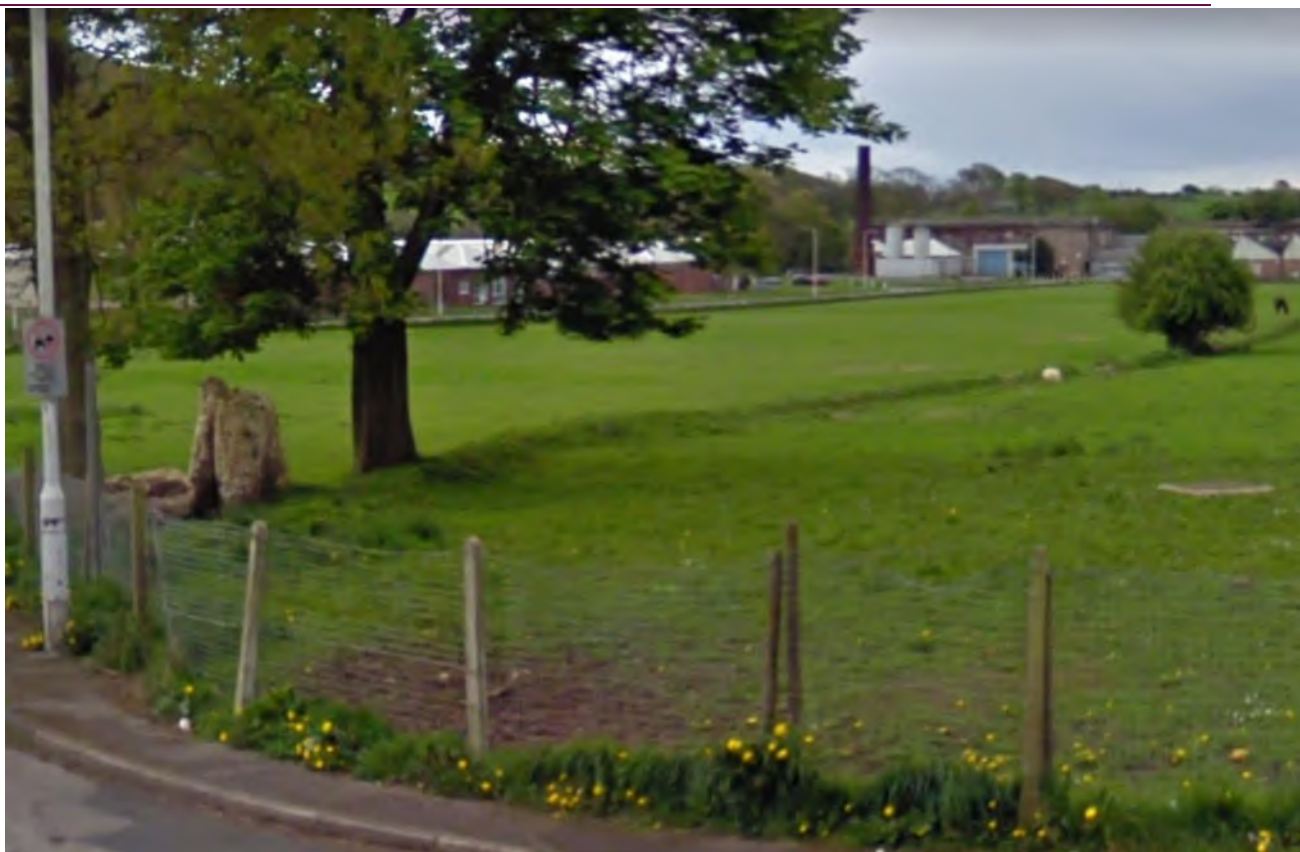
The flow route itself is somewhat questionable given the topography given the kerb face along the road is circa 100mm and the route of flows appears to follow a raised mound as can be seen in picture 2 below;

Photo 2 – Raised mound and kerbs along overland flood route

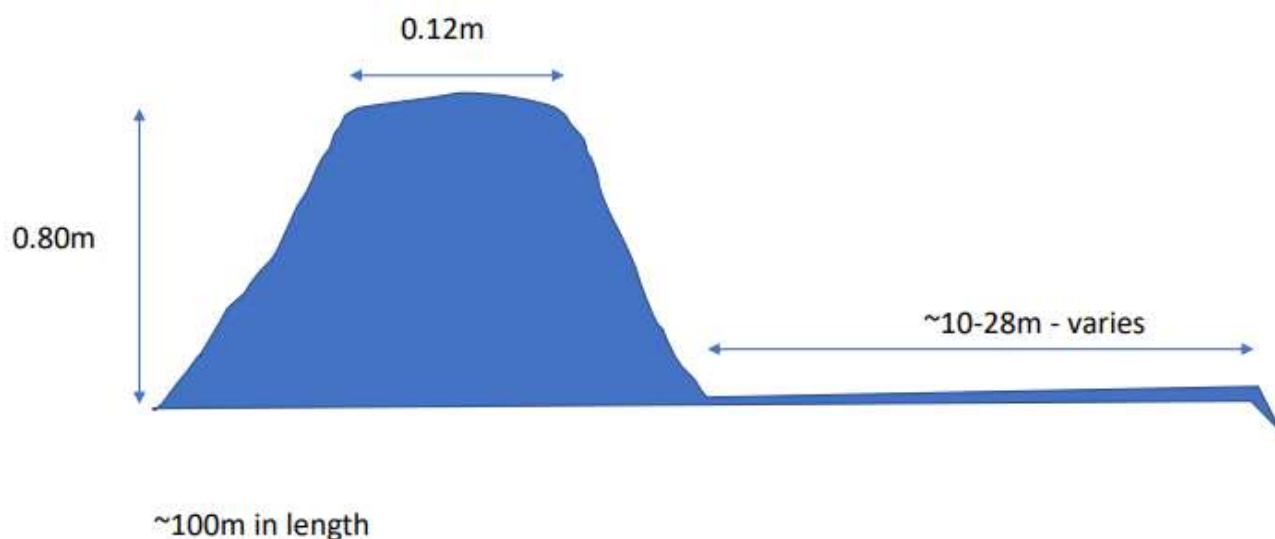
### CL1 – Embankment

Small earth embankment protecting residential properties behind.

Variant weighting used for crest as <4m wide. Drainage pipe running through entire width of embankment, low spots, some animal holes and rutting on crest, landward face and exposed face have some holes and uneven slopes but are well vegetated. Undermining, minor erosion and light foreign objects present on channel side but currently stable.

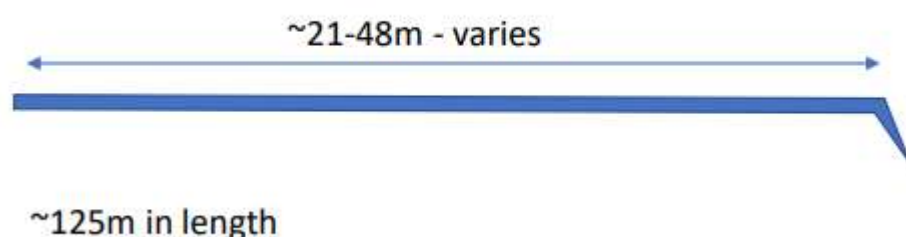
## CL2 – Natural High Ground

Natural high ground located in a grass field in front of residential properties with a width of 21-48m between the channel side and road.

Significant undermining, erosion and presence of light foreign objects on channel side. High ground in good condition.

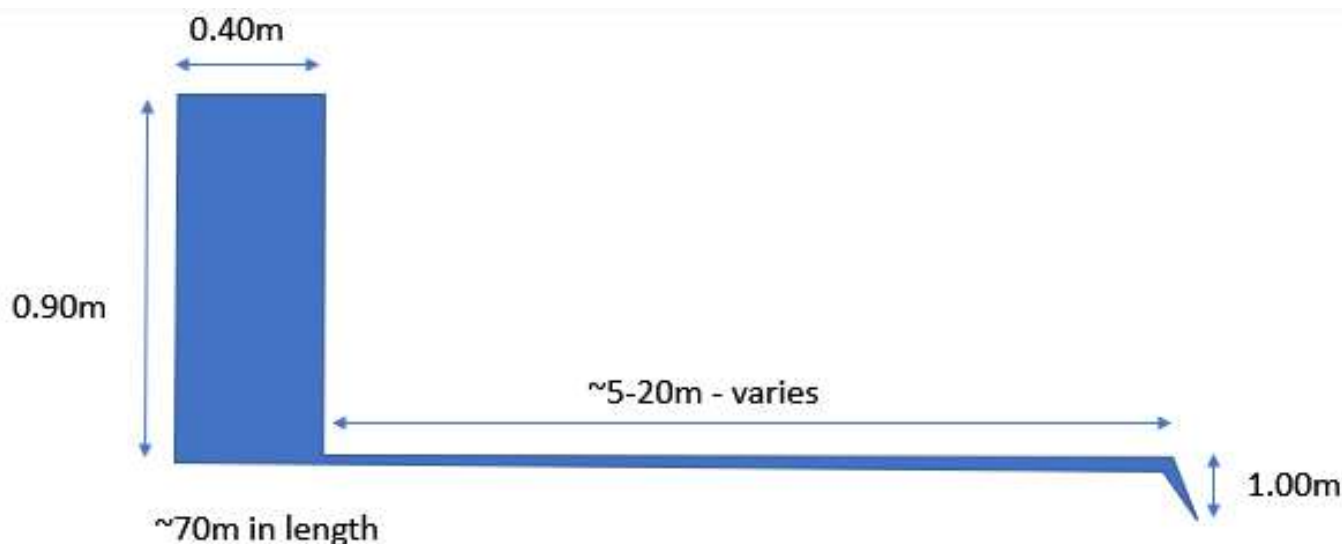
## CL3 – Wall

Stone wall next to road protecting residential properties but not designed as a flood wall.

Variant weightings used for both faces as no revetments. Significant mortar loss to crest, holes through wall, bulging of wall where light foreign objects are growing in front on wall, distorting its shape and some erosion to channel side.

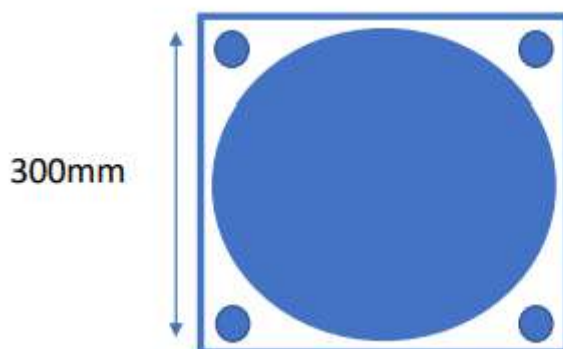
## CL4 – Outfall

300mm diameter flapped outfall with concrete apron located on channel side in front of wall. Owner and operator unknown.

Vegetation around headwall. Unable to see through pipe and no CCTV footage available.

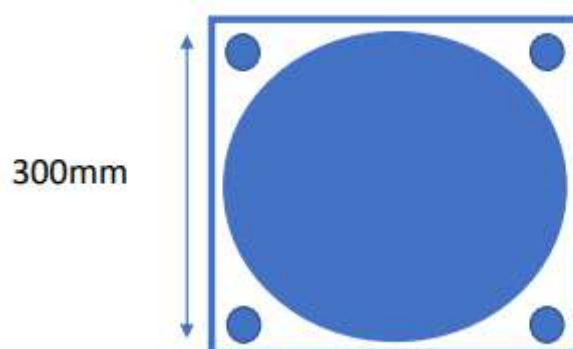
## CL5 – Outfall

300mm diameter flapped outfall with no apron located on channel side in front of wall. Owner and operator unknown.

Outfall in good condition, very minor corrosion present on frame and flap valve. Unable to see through pipe and no CCTV footage available.

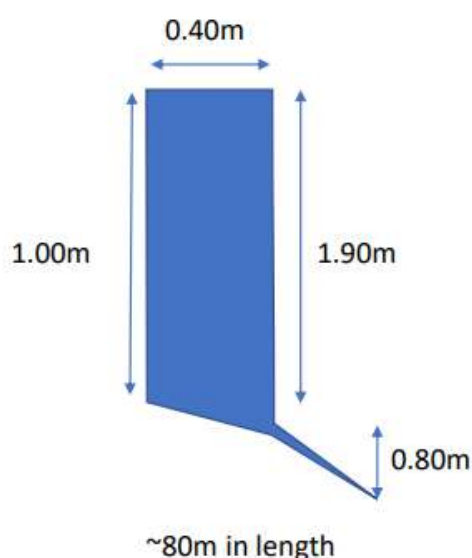
## CL6 – Wall

Stone wall with 6 highway outfalls in wall connecting to previous wall, also not a flood wall.

Heavy foreign objects growing towards channel on berm and channel side and undermining on channel side causing channel side to be unstable. Ivy growth on wall, heavy foreign objects growing close to wall causing bulging to wall and capping stones lost from crest halfway across wall.

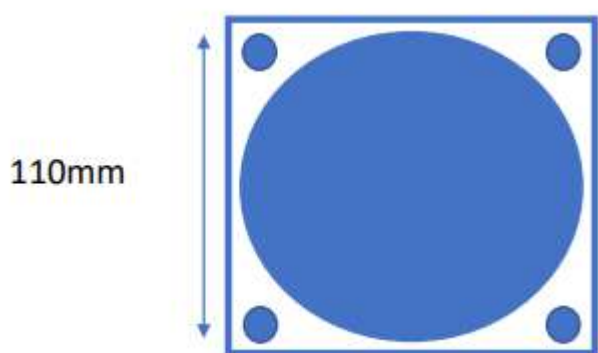
## CL7 – Outfall

110mm diameter flapped highway outfall located within stone wall.

No signs of corrosion to flap valve or frame, pipe has minor leaf debris but no blockages or damage. Downstream headwall has some cracks, vegetation growth and mortar loss.

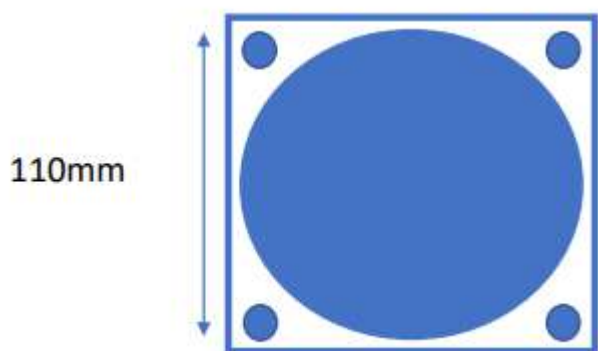
## CL9 – Outfall

110mm diameter flapped highway outfall located within stone wall.

No corrosion to flap valve or frame. Cracks and mortar loss on headwall. Pipe has minor leaf debris but no blockages or damage.

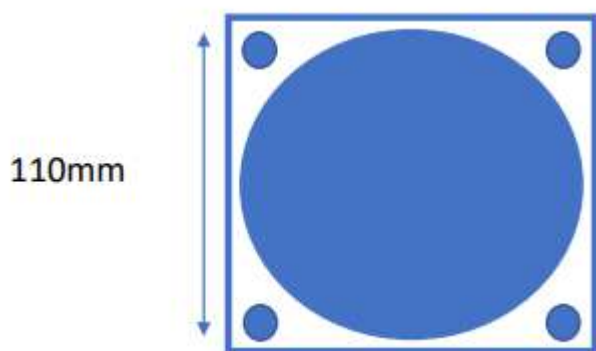
## CL11 – Outfall

110mm diameter flapped highway outfall located within stone wall.

Ivy growth around frame and headwall. No corrosion to flap valve. Minor cracks and vegetation growth on headwall. Pipe has vegetation debris but no blockages or damage.

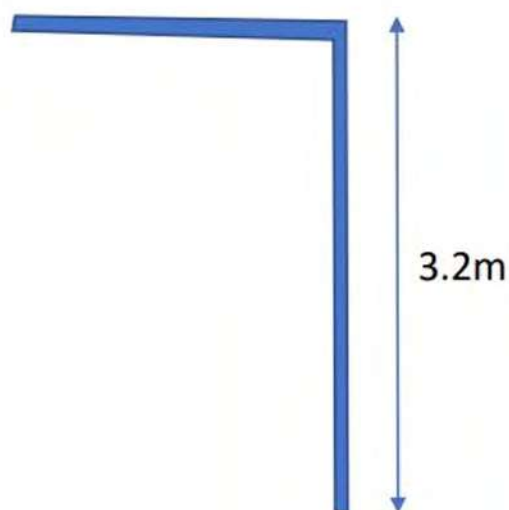
## CL14 – Engineered High Ground

Masonry retaining wall at edge of road with metal fencing above.

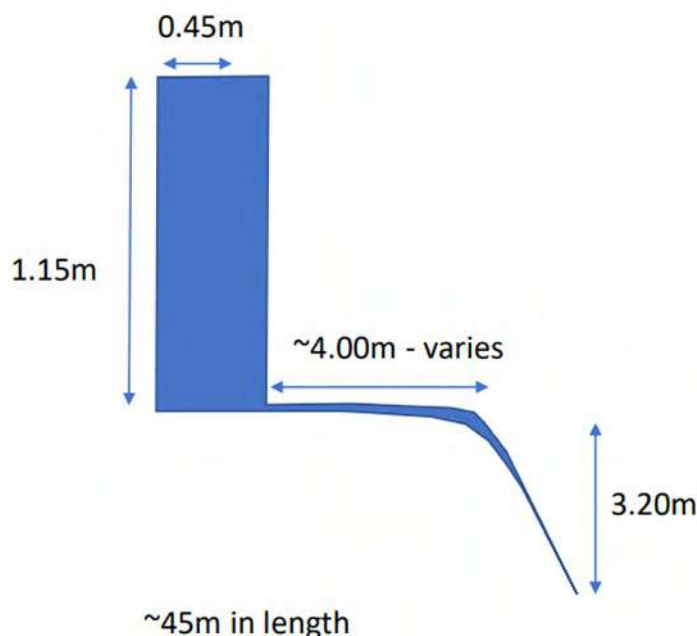
## CL15 – Wall

Masonry wall with capping stones with berm and channel side heavily vegetated with tree growth through wall.

Several heavy foreign objects on berm and channel side. Severe mortar loss in landward face, exposed face difficult to inspect but wall covered in ivy and some tree roots and growing through it. Crest is uneven where ivy has grown around it.

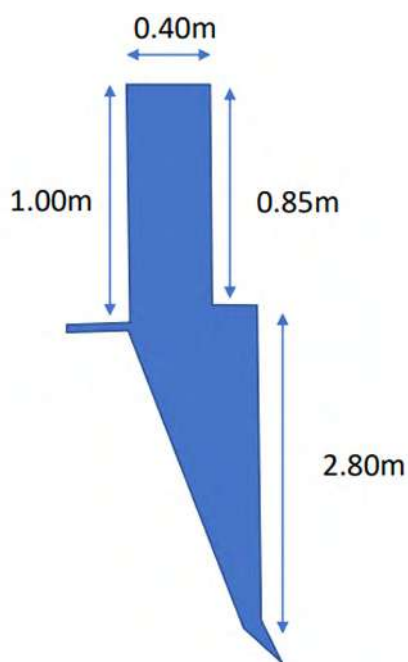
## CL16 – Wall

Brick wall with concrete landward face connecting to channel side brick retaining wall.

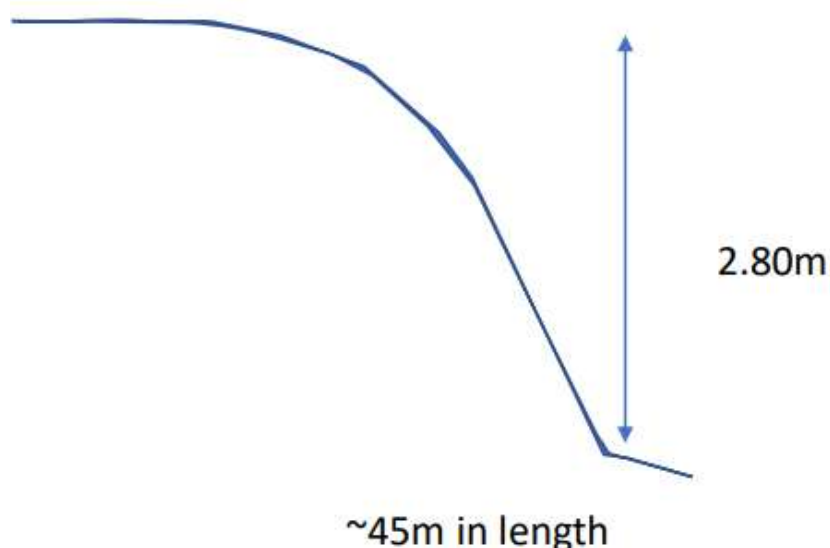
## CL17 – Natural High Ground

Natural high ground heavily vegetated with tree growth with brick building directly behind.

Heavy foreign objects on channel side leaning towards channel. Building <3m from channel on high ground.

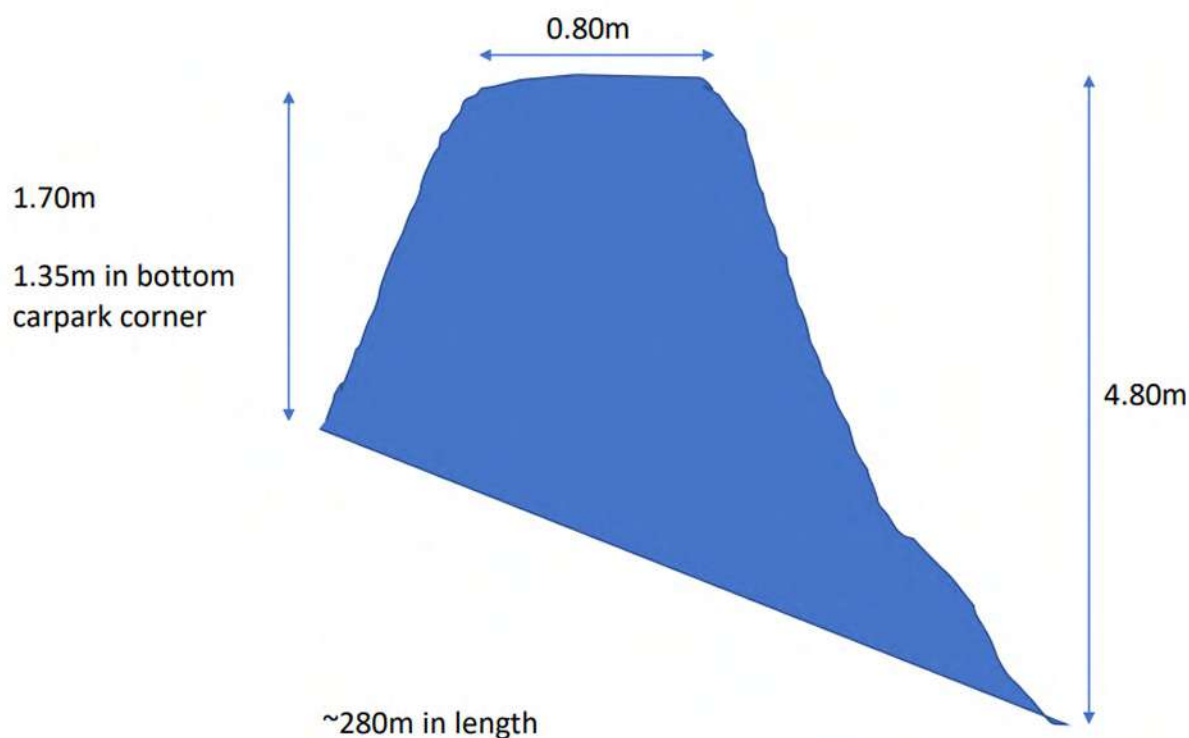
## CL18 – Embankment

Earth embankment with unknown construction materials and unstable tree-ridden channel side, reducing stability of embankment. Unlikely to have clay core and may be comprised of waste material.

Low points and rutting in crest but well vegetated. Variant used for exposed face due to steepness. Exposed and landward faces have isolated bare patches. Telegraph pole behind embankment but embankment build around it. Severe undermining of channel side around heavy foreign objects with extensive root exposure.

| 10 | <ul style="list-style-type: none"> <li>Continue yearly inspections and vegetation management</li> <li>Infill any identified low spots on crest with topsoil and lay down grass seed</li> <li>If extensive damage has been incurred to embankment, reprofile bank and lay down grass seed</li> </ul> | £90,100.00 |
| 15 | <ul style="list-style-type: none"> <li>Continue yearly inspections and vegetation management</li> <li>Infill any identified low spots on crest with topsoil and lay down grass seed</li> <li>If extensive damage has been incurred to embankment, reprofile bank and lay down grass seed</li> <li>Consider employing engineer to assess asset condition in detail to identify potential structural issues with embankment, employ relevant operative to repair damage</li> </ul> | £166,600.00 |

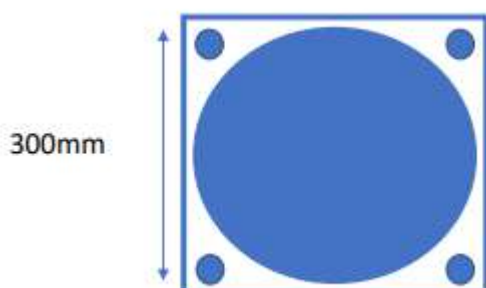
## CL19 – Outfall

300mm outfall on channel side of embankment with damaged concrete headwall.

Drainage pipe halfway between wall and building on high ground. Unable to see through pipe and no CCTV footage available. Vegetation around headwall and at base of pipe.

| Years | Recommendations | Cumulative Cost (£) |
|---|---|---|
| 1 | <ul style="list-style-type: none"><li>Investigate stability of headwall, rebuild if necessary</li><li>Conduct CCTV inspection of pipe to assess condition</li><li>Conduct annual visual asset inspections and provide ongoing management of surrounding vegetation to avoid damage incurring to outfall</li></ul> | £600.00 |
| 5 | <ul style="list-style-type: none"><li>Continue to inspect the outfall yearly, including CCTV inspections of the pipe every 5 years</li><li>Monitor and remove moss growth and vegetation growth on headwall to reduce damage to the headwall</li><li>Carry out small repairs to any brick and mortar loss on headwall</li></ul> | £3,500.00 |
| 10 | <ul style="list-style-type: none"><li>Continue yearly inspections of outfall including CCTV inspections of pipe every 5 years</li><li>Continue with vegetation management</li><li>Carry out small repairs to any brick and mortar loss on headwall</li></ul> | £6,900.00 |
| 15 | <ul style="list-style-type: none"><li>Continue yearly inspections of outfall and manage vegetation growth</li><li>If there has been any serious structural damage to the outfall over time such as cracking or movement, employ an engineer to investigate. If investigations have found structural damage, employ relevant operative to repair damage</li></ul> | £17,400.00 |

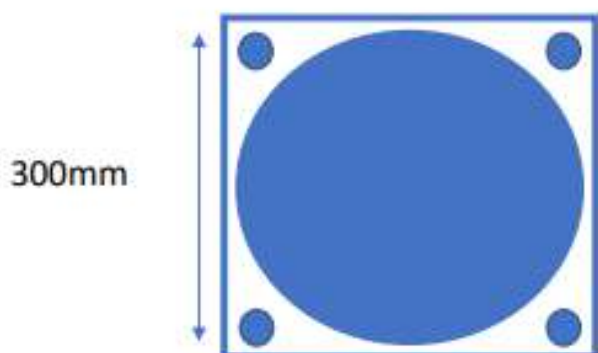
## CL20 – Outfall

150mm clay drainage pipe located on channel side of embankment surrounded by rocks providing unstable headwall.

Downstream headwall in pieces. Unable to see through pipe and no CCTV footage available.

| Years | Recommendations | Cumulative Cost (£) |
|---|---|---|
| 1 | <ul style="list-style-type: none"><li>Rebuild headwall</li><li>Conduct CCTV inspection of pipe to assess condition</li><li>Conduct annual visual asset inspections and provide ongoing management of surrounding vegetation to avoid damage incurring to outfall</li></ul> | £600.00 |
| 5 | <ul style="list-style-type: none"><li>Continue to inspect the outfall yearly, including CCTV inspections of the pipe every 5 years</li><li>Monitor and remove moss growth and vegetation growth on headwall to reduce damage to the headwall</li><li>Carry out small repairs to any brick and mortar loss on headwall</li></ul> | £3,500.00 |
| 10 | <ul style="list-style-type: none"><li>Continue yearly inspections of outfall including CCTV inspections of pipe every 5 years</li><li>Continue with vegetation management</li><li>Carry out small repairs to any brick and mortar loss on headwall</li></ul> | £6,900.00 |
| 15 | <ul style="list-style-type: none"><li>Continue yearly inspections of outfall and manage vegetation growth</li><li>If there has been any serious structural damage to the outfall over time such as cracking or movement, employ an engineer to investigate. If investigations have found structural damage, employ relevant operative to repair damage</li></ul> | £17,400.00 |

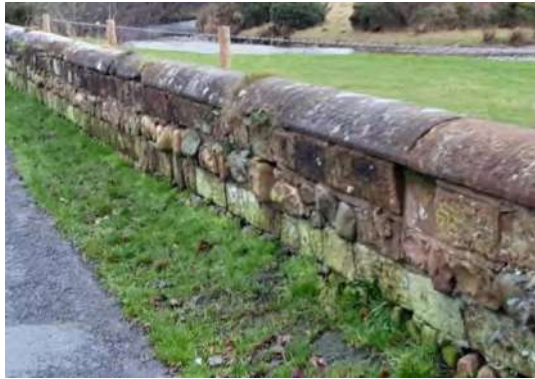
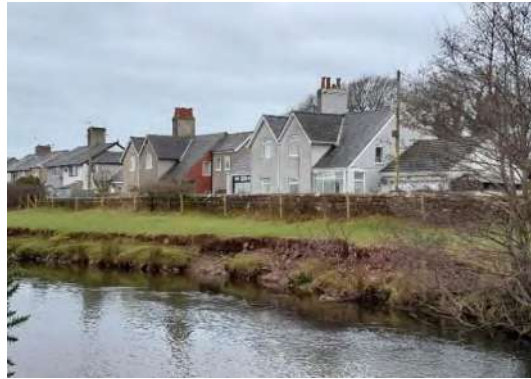
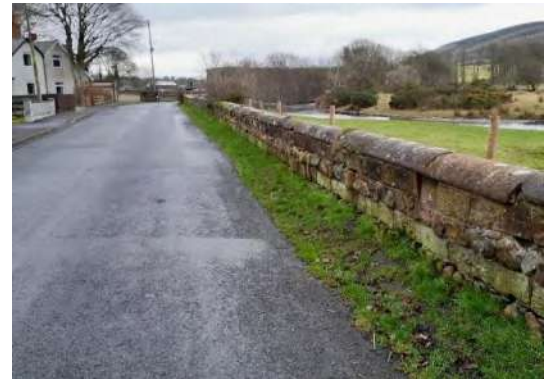
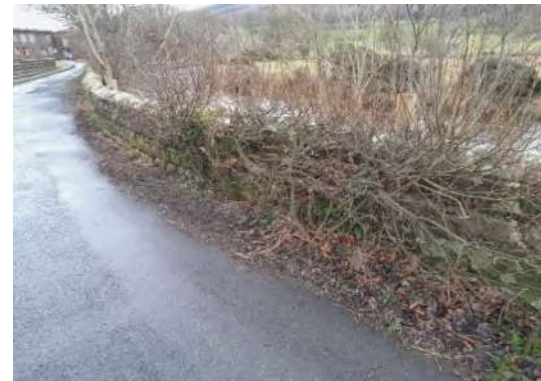
| Asset ID | CL3 | Frequency | | | | | |
|---|---|---|---|---|---|---|---|
| Comments | Variant weightings used for both faces as no revetments. Significant mortar loss to crest, holes through wall, bulging of wall where light foreign objects are growing in front on wall, distorting its shape and minor erosion to channel side. | | | | | | |

| Asset ID | CL3 | Frequency | | | | | |
|---|---|---|---|---|---|---|---|
| Recommendations | Rebuild wall and remove trees in front of wall. | | | | | | |

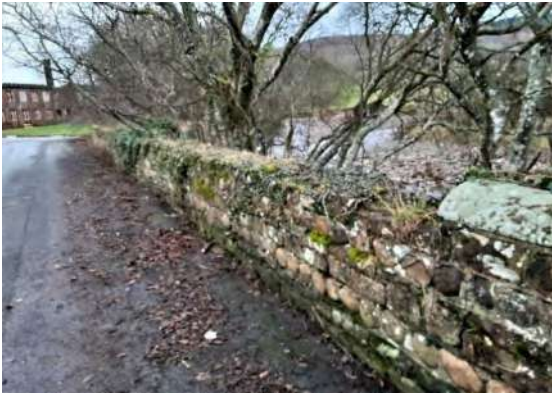
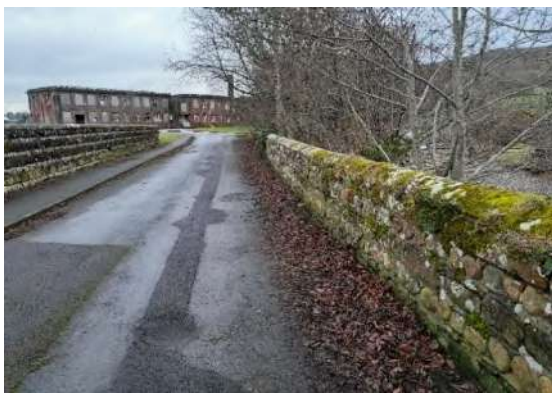
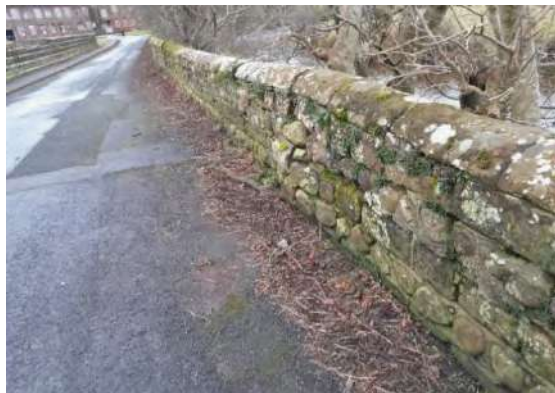
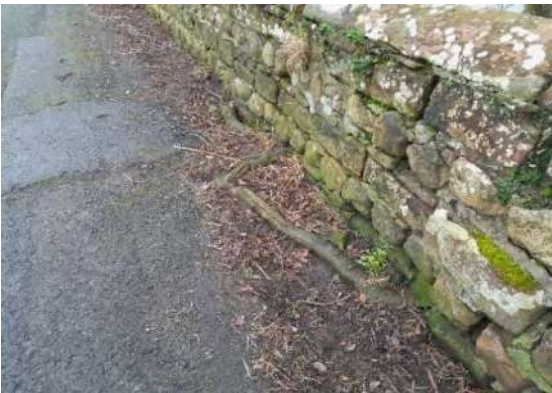
| Asset ID | CL6 | Frequency | | | | | |
|---|---|---|---|---|---|---|---|
| Comments | Heavy foreign objects growing towards channel on berm and channel side and undermining on channel side causing channel side to be unstable. Ivy growth on wall, heavy foreign objects growing close to wall causing bulging to wall and capping stones lost from crest halfway across wall. | | | | | | |

| Asset ID | CL6 | Frequency | | | | | |
|---|---|---|---|---|---|---|---|
| Recommendations | Rebuild wall, remove unstable trees and remove trees next to wall. | | | | | | |

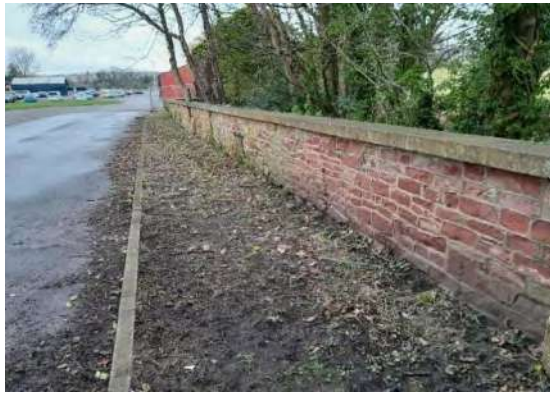
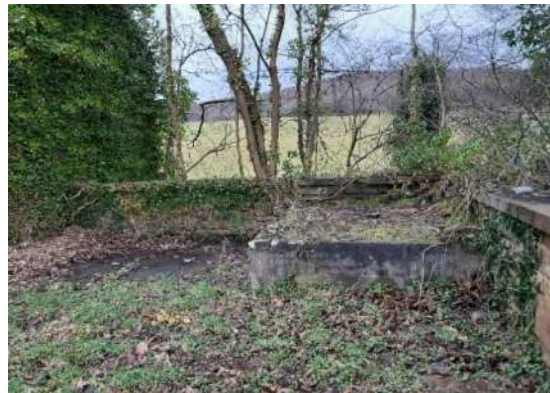
| Asset ID | CL15 | Frequency | | | | | |
|---|---|---|---|---|---|---|---|
| Comments | Several heavy foreign objects on berm and channel side. Severe mortar loss in landward face, exposed face difficult to inspect but wall covered in ivy and some tree roots and growing through it. Crest is uneven where ivy has grown around it. | | | | | | |

| Asset ID | CL15 | Frequency | | | | | |
|---|---|---|---|---|---|---|---|
| Recommendations | Rebuild wall, remove ivy and remove trees growing into wall. | | | | | | |

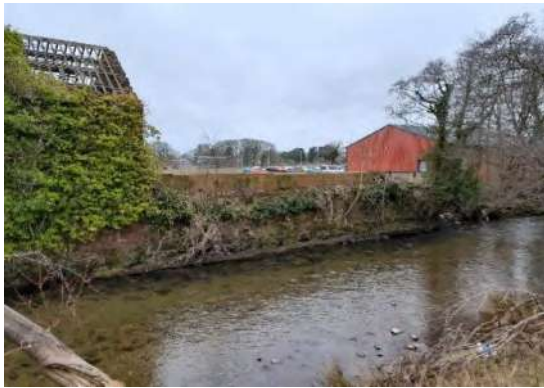
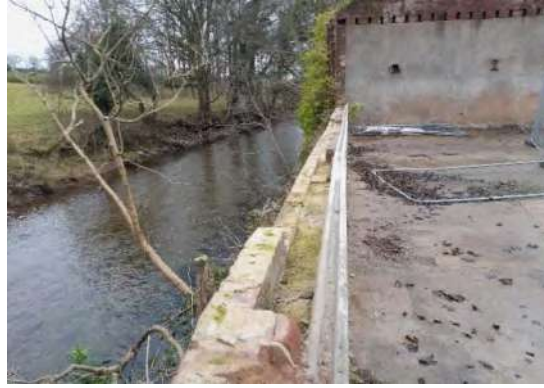
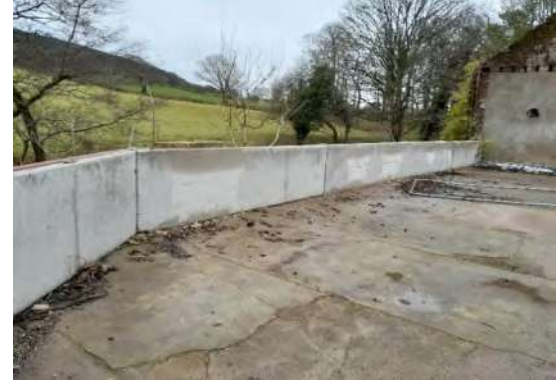
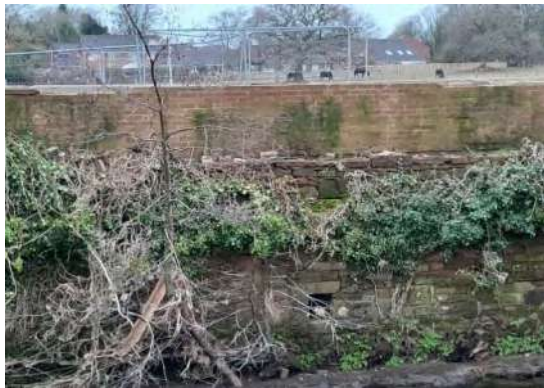
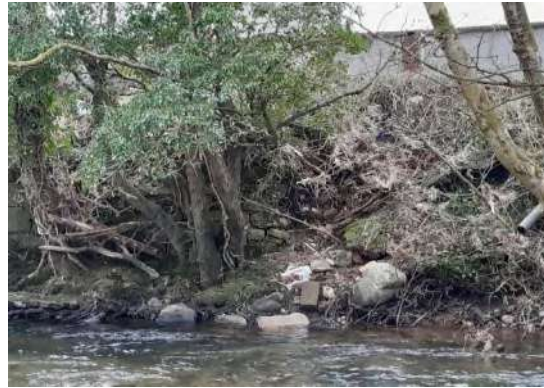
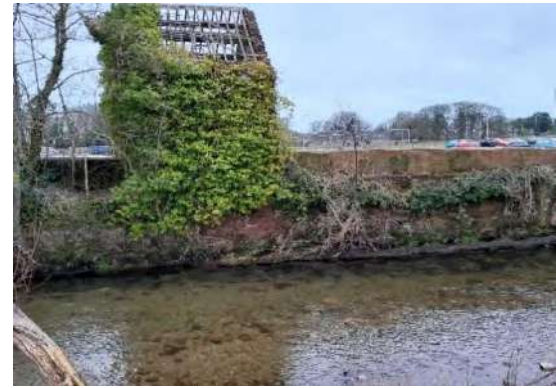
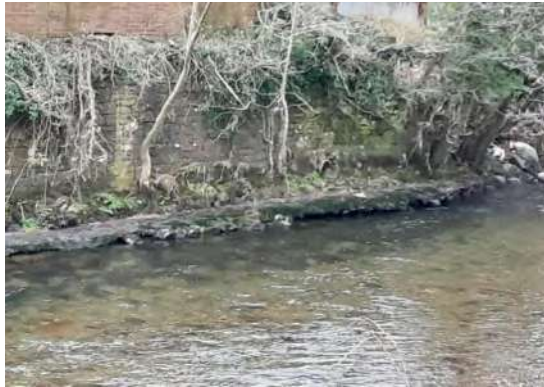
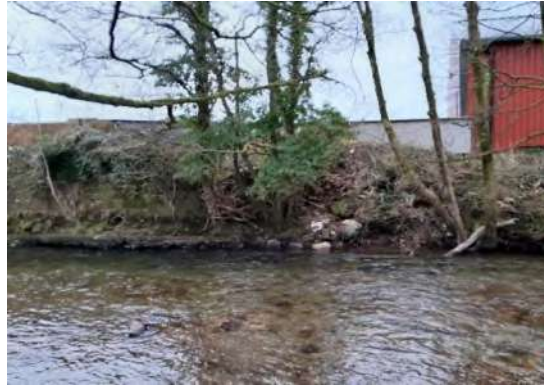
| Asset ID | CL16 | Frequency | | | | | |
|---|---|---|---|---|---|---|---|
| Comments | Extensive ivy growth, channel side wall is walling down with severe brick loss and root penetration. Heavy foreign objects growing on channel side causing brick displacement and loss. Crest is uneven due to brick loss but landward face is made from concrete slabs in good condition. | | | | | | |

| Asset ID | CL16 | Frequency | | | | | |
|---|---|---|---|---|---|---|---|
| Recommendations | Rebuild wall and remove heavy foreign objects. | | | | | | |

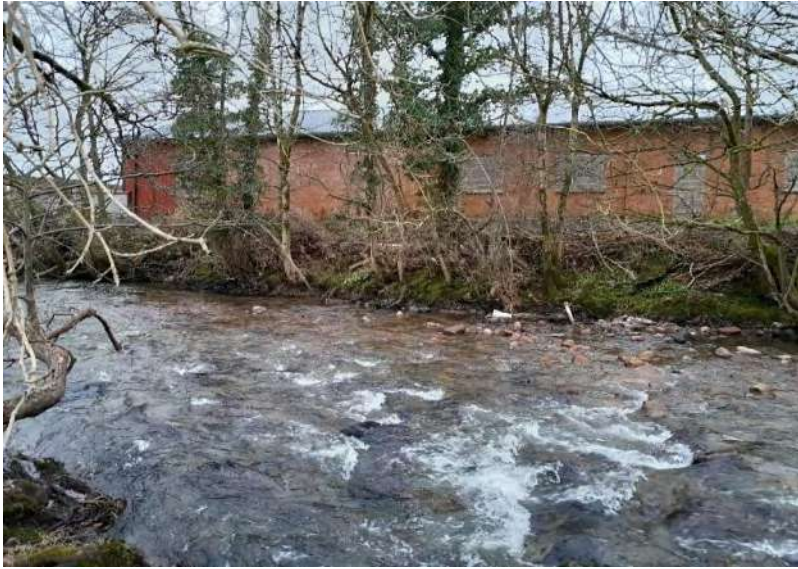
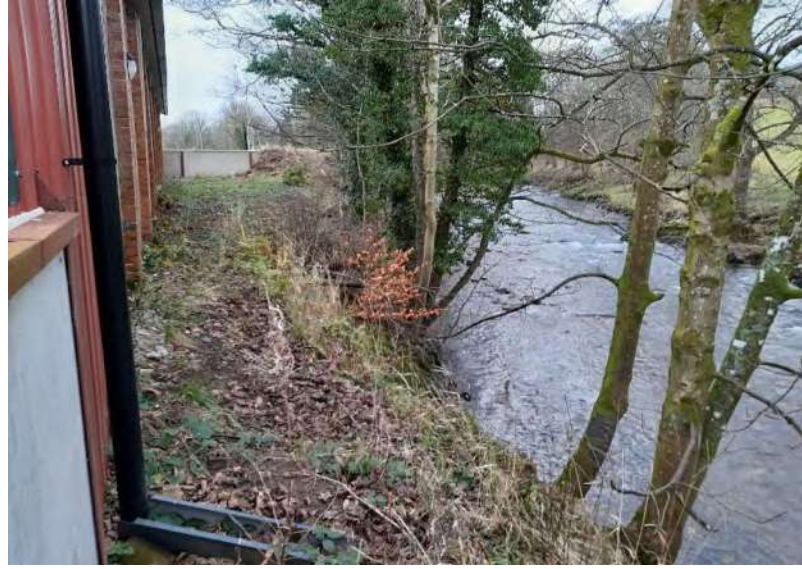
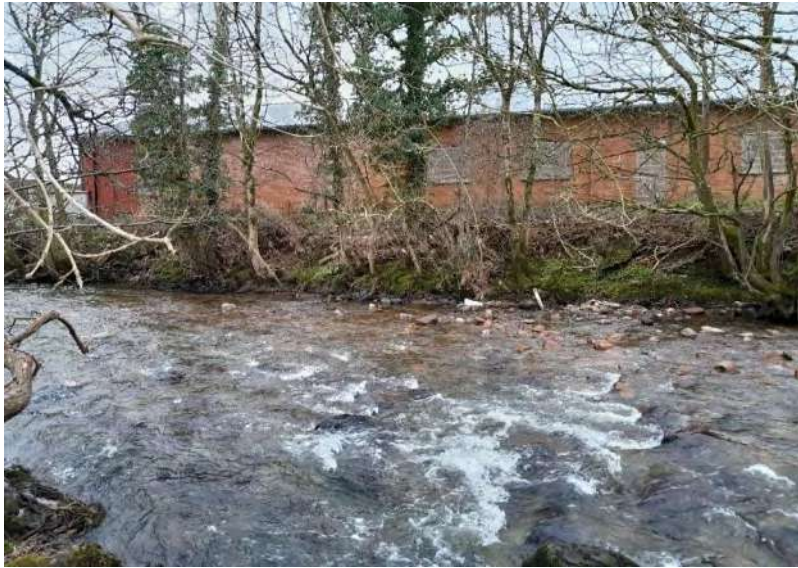
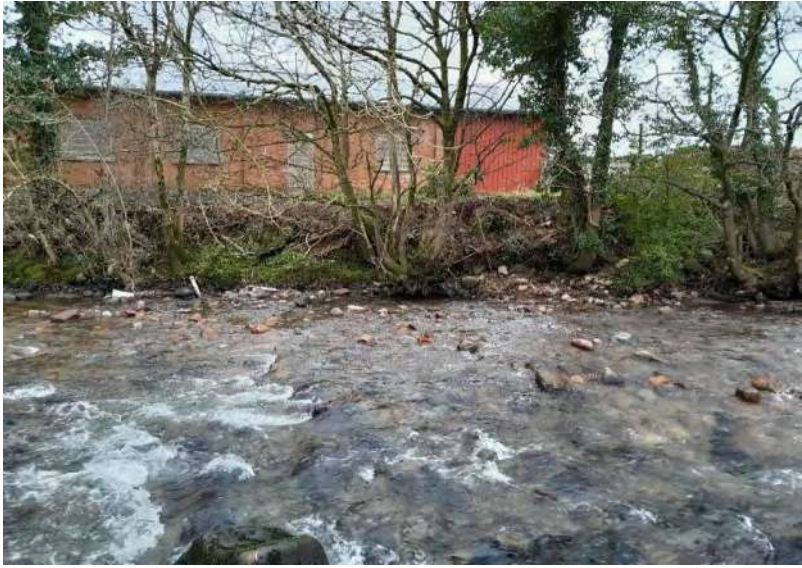
| Asset ID | CL17 | Frequency | | | | | |
|---|---|---|---|---|---|---|---|
| Comments | Heavy foreign objects on channel side leaning towards channel. Building <3m from channel on high ground. | | | | | | |

| Asset ID | CL17 | Frequency | | | | | |
|---|---|---|---|---|---|---|---|
| Recommendations | Continue with vegetation maintenance and monitor tree growth. | | | | | | |

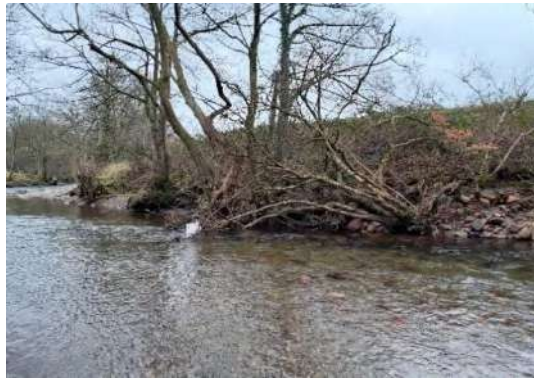
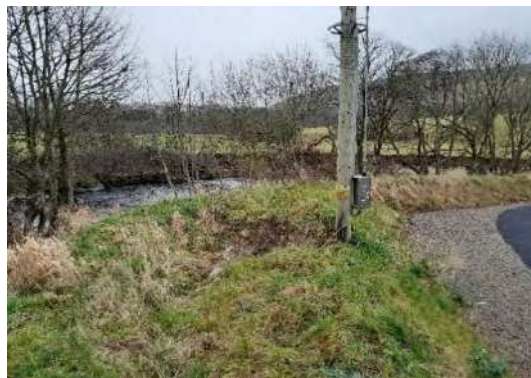
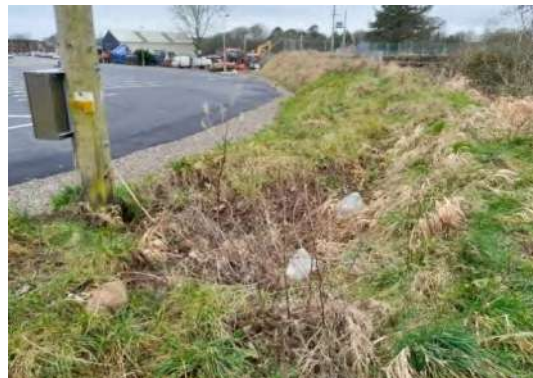
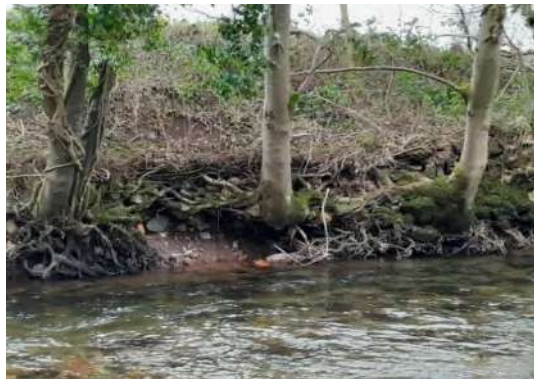
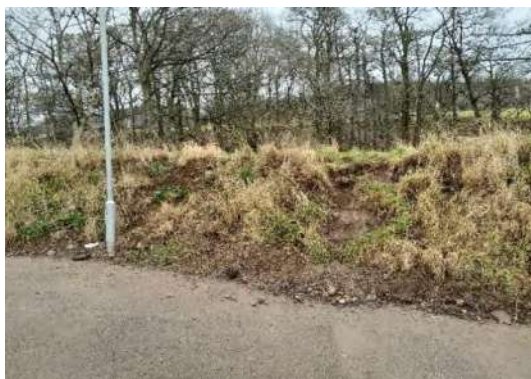
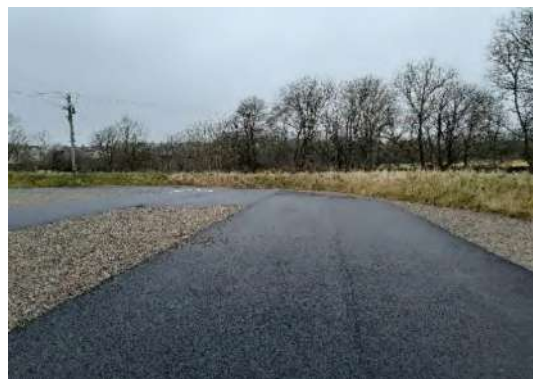
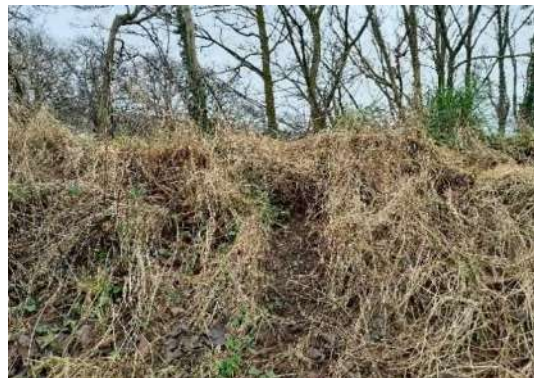
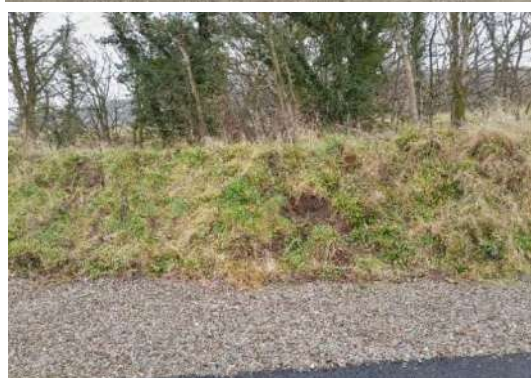
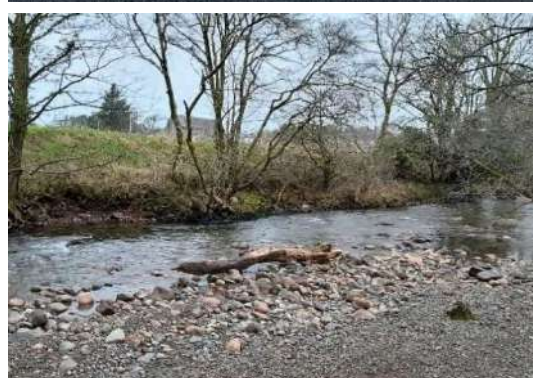
| <b>Comments</b> | Low points and rutting in crest but well vegetated. Variant used for exposed face due to steepness. Exposed and landward faces have isolated bare patches. Telegraph pole behind embankment but embankment build around it. Severe undermining of channel side around heavy foreign objects with extensive root exposure. | | | | | | |

| <b>Recommendations</b> | Remove unstable trees on channel side, infill low spots on crest and seed bare patches. | | | | | | |

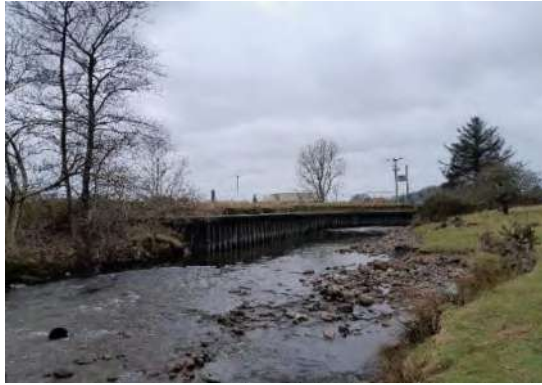
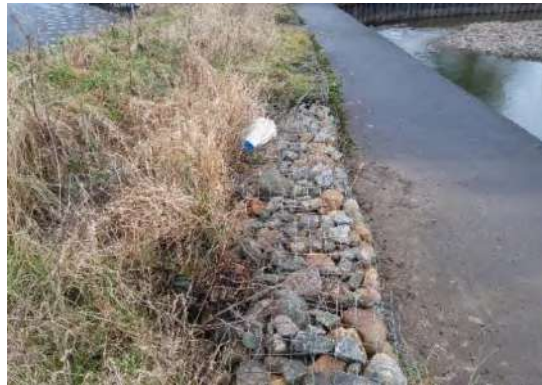
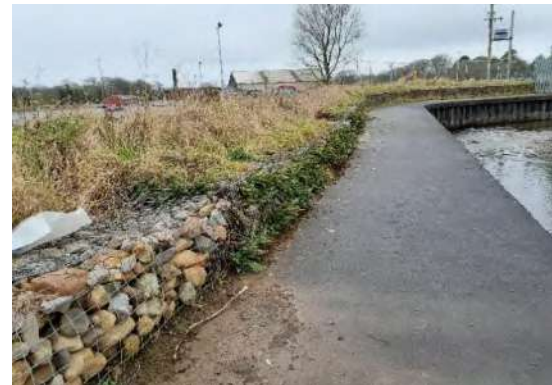
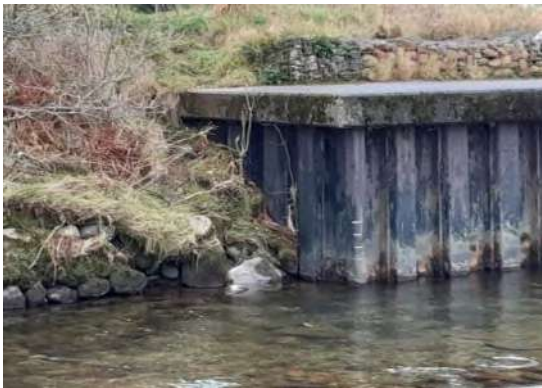
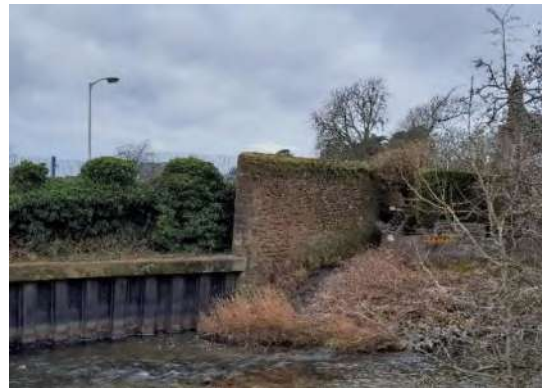
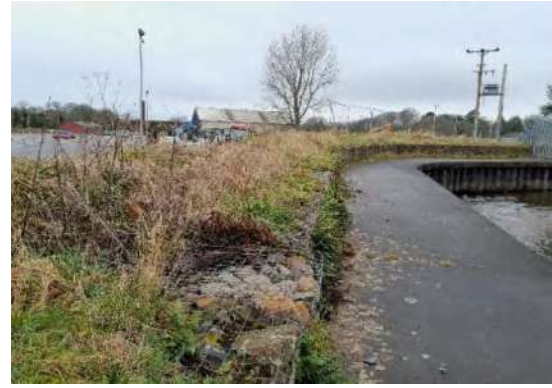
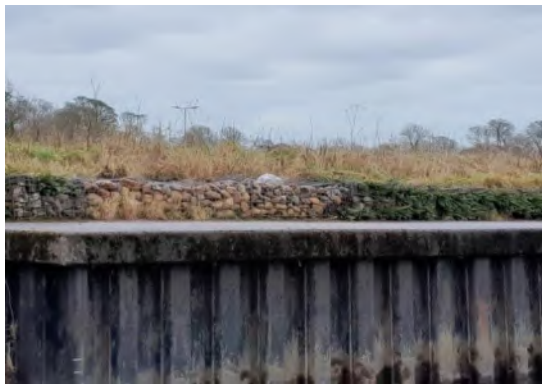
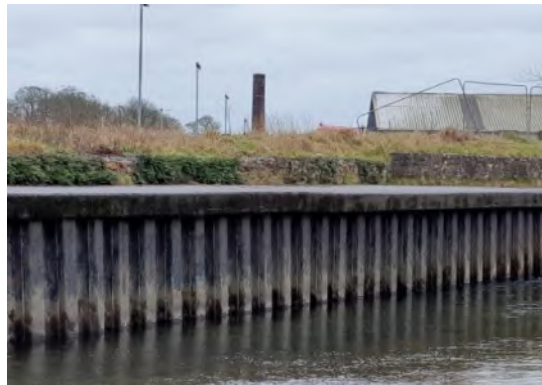
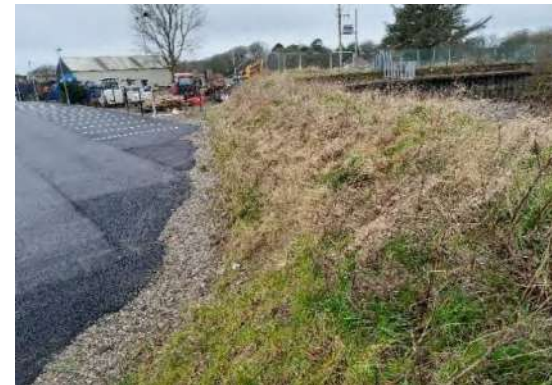
| <b>Comments</b> | Berm 2 and channel side in good condition with minor cosmetic defects to sheet piles. Vegetation growth through gabion baskets with a few broken wires but no gabion displacement. Uneven ground on exposed face 1 and landward face but well vegetated. Rutting and low spots in isolated places on crest. Variants used on crest as less than 4m wide and landward face due to steepness. | | | | | | |

| <b>Recommendations</b> | Remove vegetation in gabions and repair wires. Infill low spots on crest. | | | | | | |

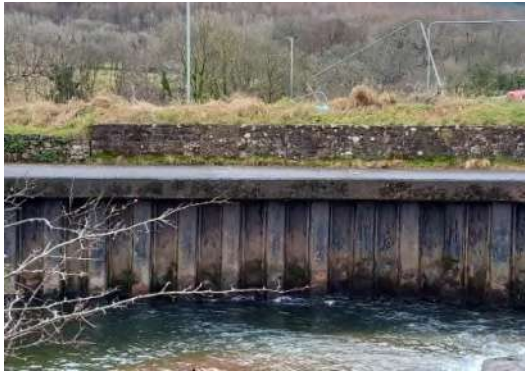
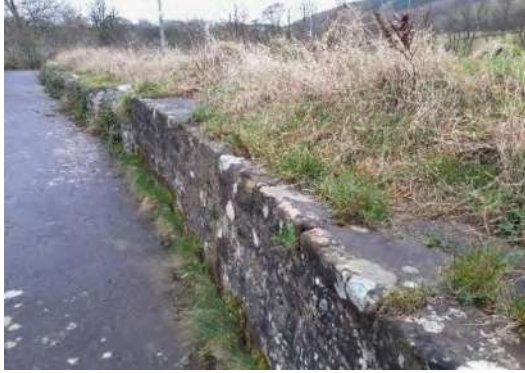
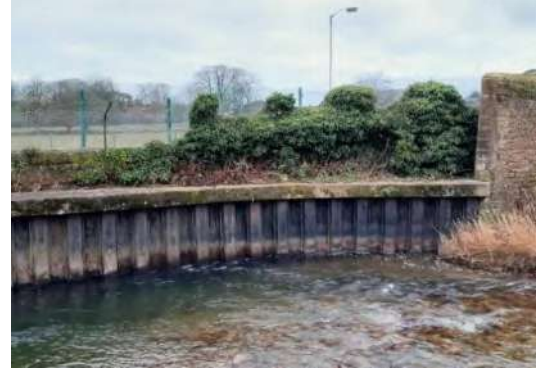
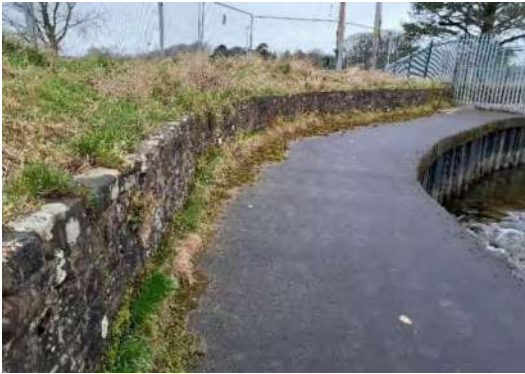
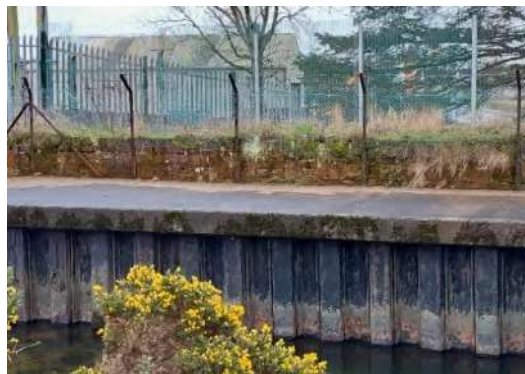
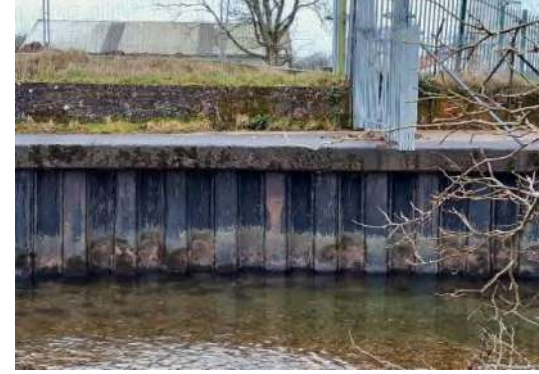
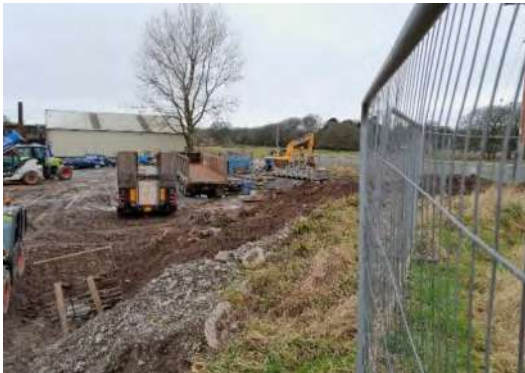
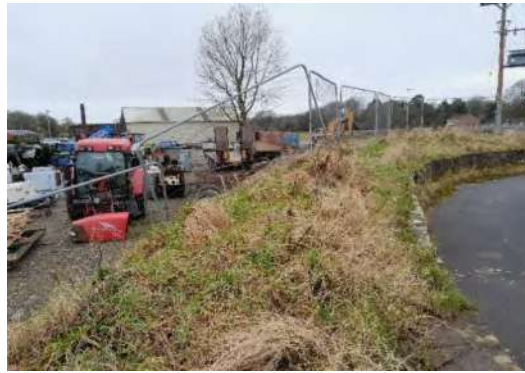
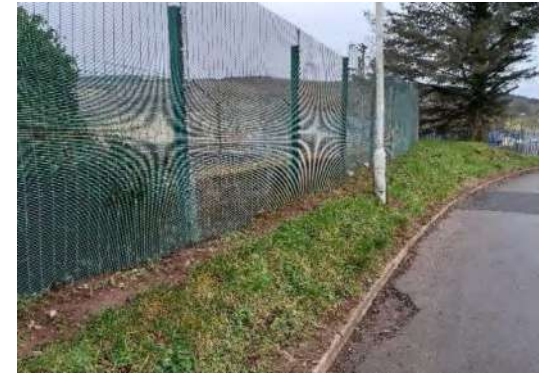
| Asset ID | CL22 | Frequency | | | | | |
|---|---|---|---|---|---|---|---|
| Comments | Minor vegetation growth within berm 1 and exposed face 2 with minor mortar loss. Uneven crest with some low spots but well vegetated. Berm 2 and channel side in good condition with minor cosmetic defects to sheet piling. Landward face and exposed face 1 are well vegetated but uneven. Landward face 2 around corner and has minor vegetation growing through stone and minor mortar loss. | | | | | | |

| Asset ID | CL22 | Frequency | | | | | |
|---|---|---|---|---|---|---|---|
| Recommendations | Monitor vegetation growth in wall and infill low spots in crest. | | | | | | |
