## **FLOOD RISK AND DRAINAGE ASSESSMENT**

### **Cleator Mill, Proposed Residential Development, Flood Risk Assessment.**

# Cleator Flood Asset Condition Assessment

23 MAR 2022  
Version 1.0  
RAB: 2869

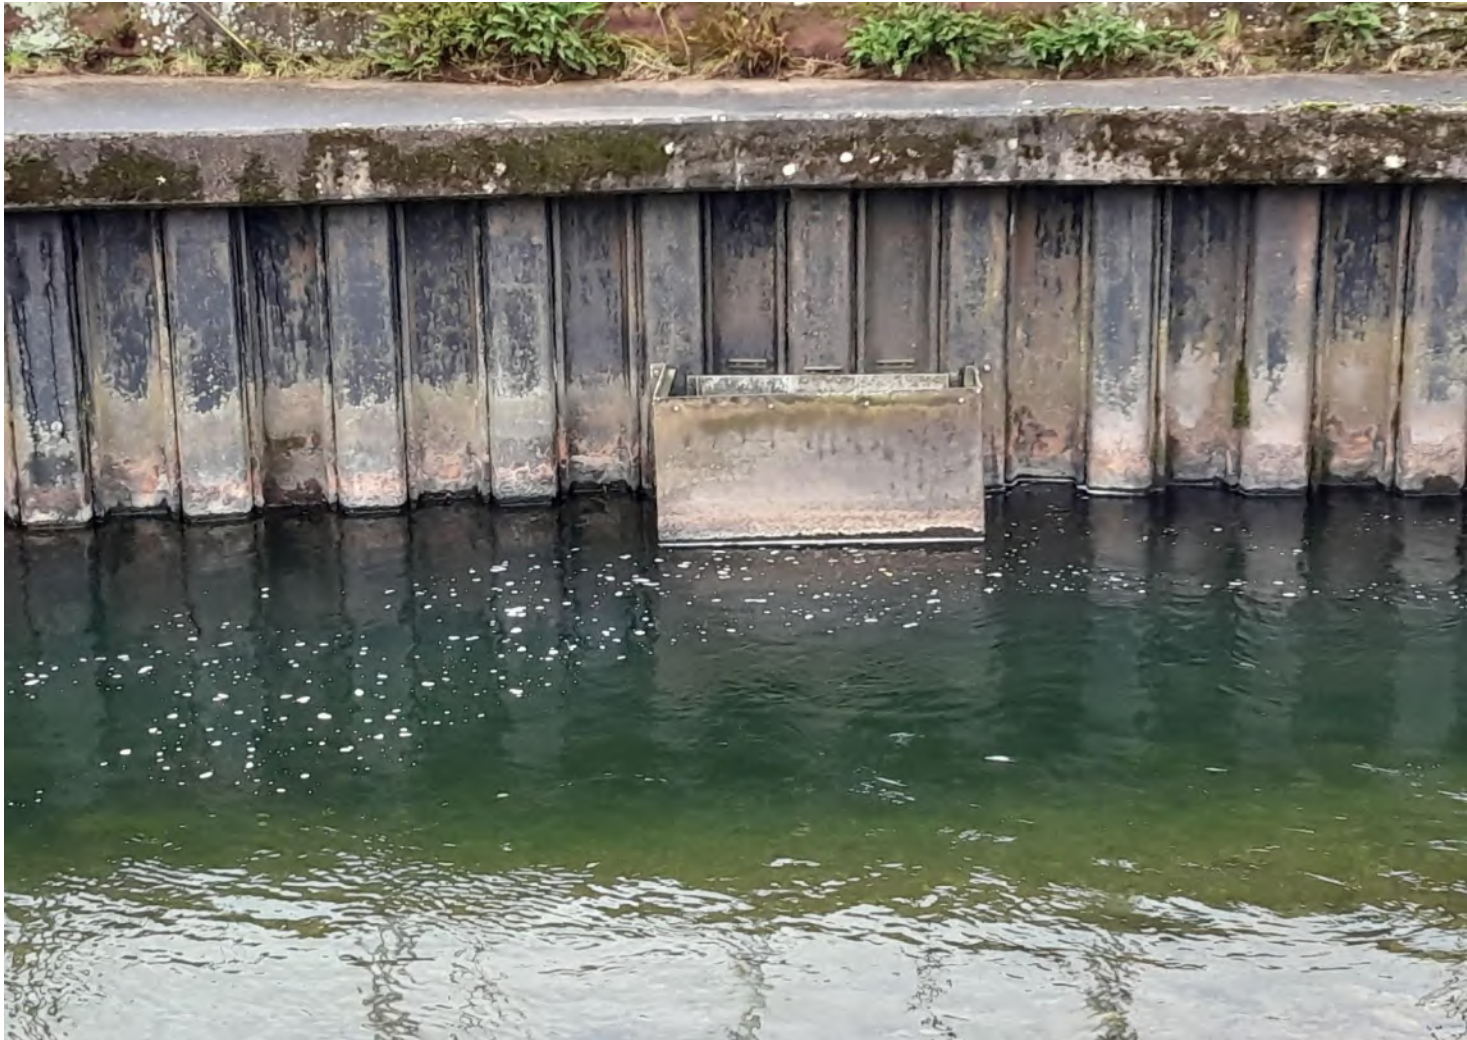
| Asset ID | CL23 | Frequency | | | | | | |

| Asset ID | CL23 | Frequency | | | | | | |
|---|---|---|---|---|---|---|---|---|
| Comments | Minor corrosion to barrier. Unable to see headwall and pipe due to high water level and barrier around. | | | | | | | |

| Asset ID | CL23 | Frequency | | | | | | |
|---|---|---|---|---|---|---|---|---|
| Recommendations | Conduct CCTV inspection for pipe and headwall. | | | | | | | |

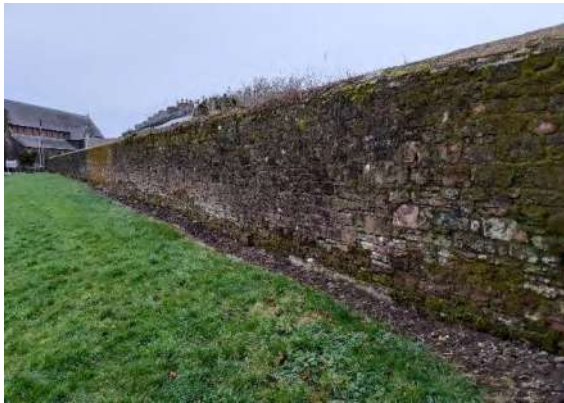
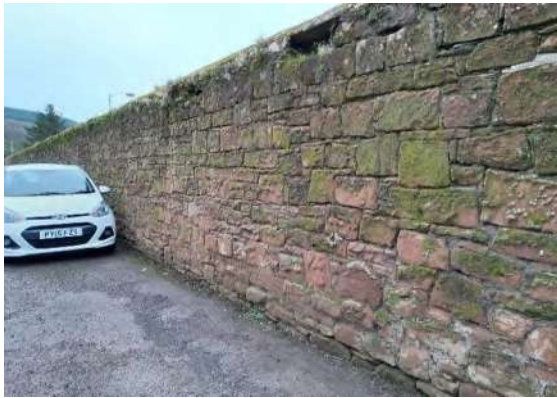
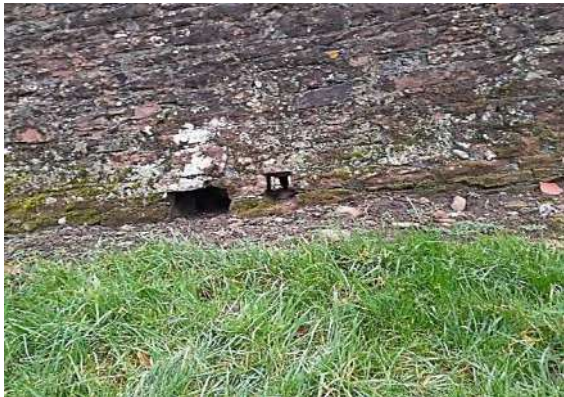
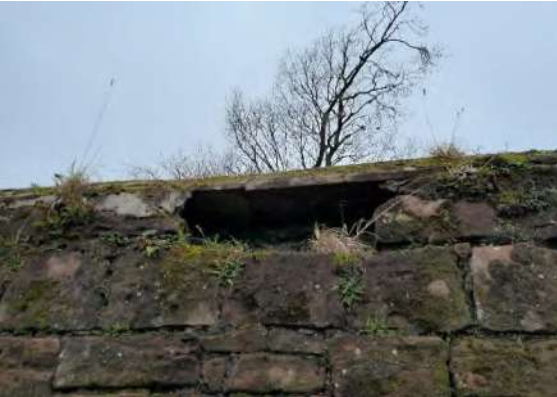
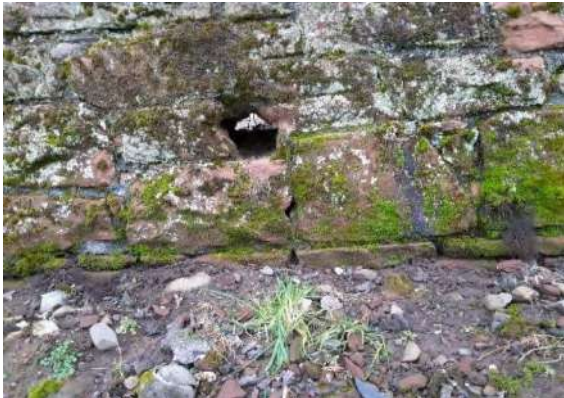
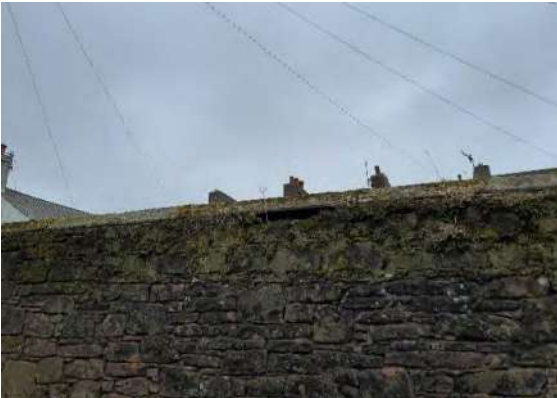
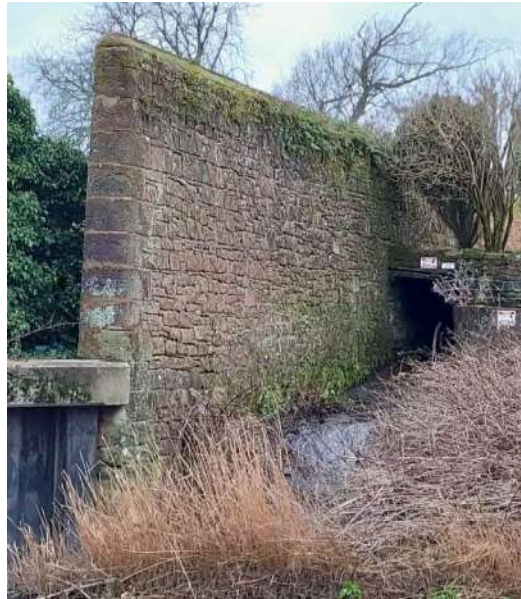
| <b>Comments</b> | Minor vegetation growth through crest. Minor mortar loss on exposed face and a couple of holes on both faces, not whole way though. Few bricks missing for drainage. | | | | | | |

| <b>Recommendations</b> | Repair holes in wall and remove vegetation. | | | | | | |
