# Stubsgill Farm, Wind Turbine Repowering

## Construction Traffic Management Plan

November 2025  
3369-01-CTMP01

Stubsgill Farm - Pre-Construction Highway Condition Survey

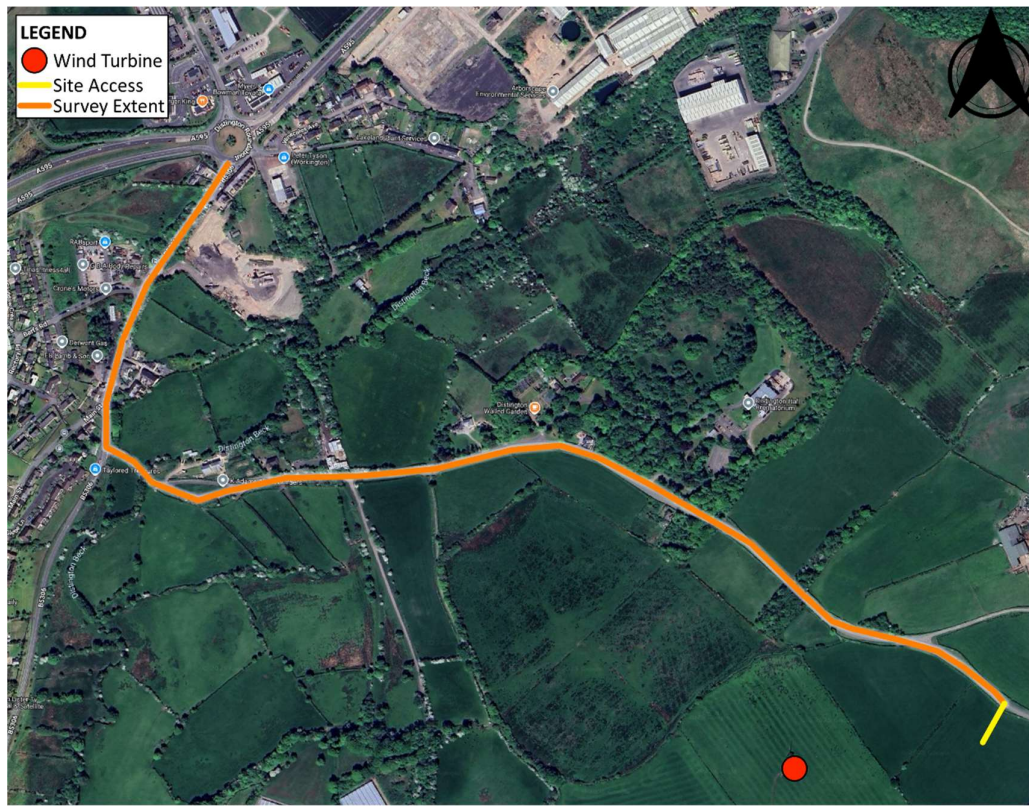
Image 2.1 – Extent of Carriageway to be Surveyed

2.2.2 The area of highway to be surveyed was agreed with CC on 22.08.2025 and is illustrated on **Image 2.1** following.

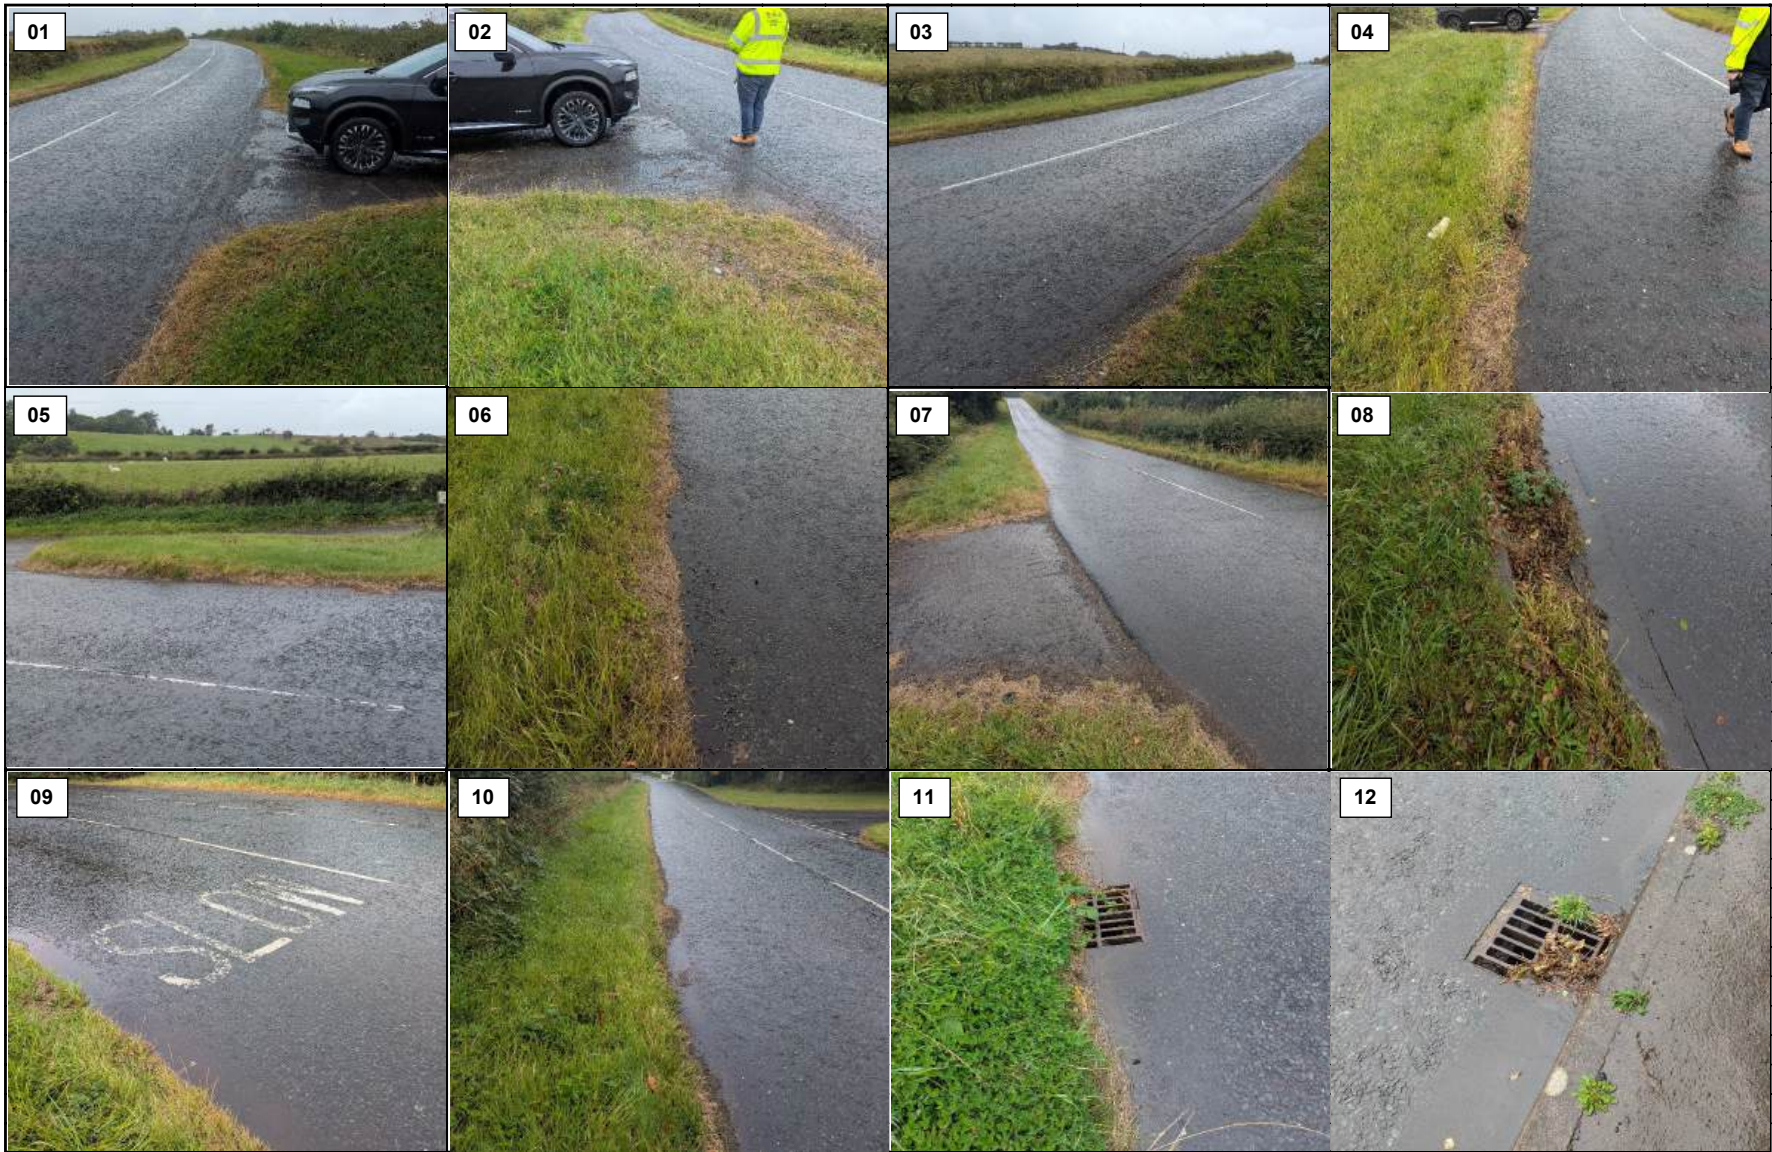
| | Pre-Construction Highway Condition Survey - Photograph Record: Sheet 1 | | Aug 2025 | 3369-01 |

- i) The B5306 / the A595 roundabout itself was observed to be in generally good condition.
- ii) Serious road marking wear and tear present across the southern arm (**Images 64-74**)
- iii) There are some potholes on the southern entry arm. (**Image 74**)
- iv) A strip of reinstated surfacing on the dropped kerb on the central refuge side of the southern arm. (**Images 72-73**)
- v) Road chippings seem to be scattered across the central refuge and around it. (**Images 69-71**)
- vi) Minor wear and tear present on the centre of the carriageway on the bend before the southern arm of the Distington Roundabout. (**Images 64-66**)
