## Demolition Survey (with MA + PA)

Millom School  
Salthouse Road  
Millom  
Cumbria  
LA18 5AB

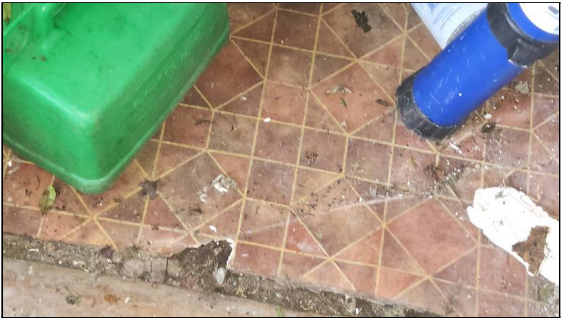
| 28 Oct 2024 | Paul Agnew | Demolition Survey | Ground Floor | No Asbestos Detected |

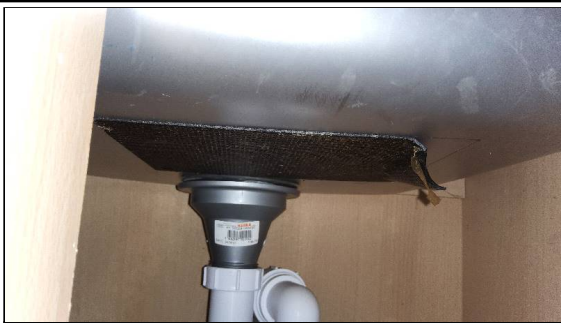
| | 28 Oct 2024 | Paul Agnew | Demolition Survey | Ground Floor | No Asbestos Detected | |

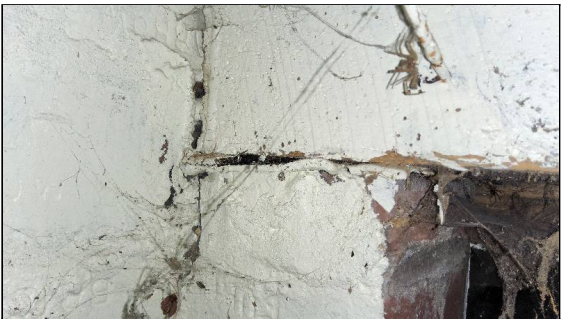
| | Survey Date: | Lead Surveyor | Survey Type | Floor | Analysis |
|---|---|---|---|---|---|
| | 28 Oct 2024 | Paul Agnew | Demolition Survey | Ground Floor | No Asbestos Detected |

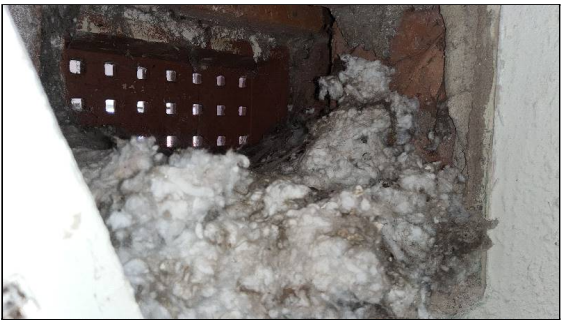
| Survey Date: | Lead Surveyor | Survey Type | Floor | Analysis |
|---|---|---|---|---|
| 28 Oct 2024 | Paul Agnew | Demolition Survey | Ground Floor | No Asbestos Detected |

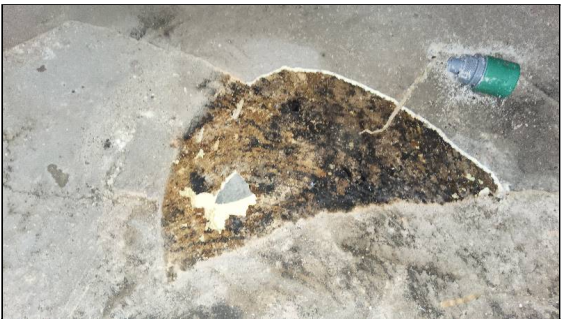
| | Survey Date: | Lead Surveyor | Survey Type | Floor | Analysis |
|---|---|---|---|---|---|
| | 28 Oct 2024 | Paul Agnew | Demolition Survey | Ground Floor | Chrysotile (1) |

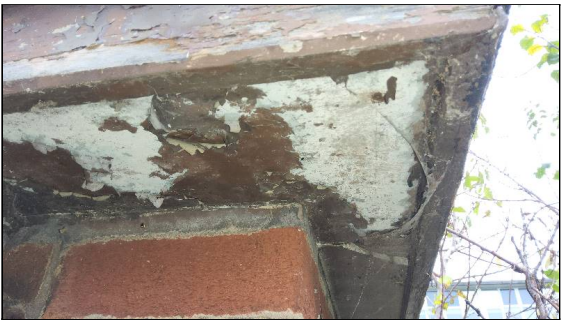
| | Survey Date: | Lead Surveyor | Survey Type | Floor | Analysis |
|---|---|---|---|---|---|
| | 28 Oct 2024 | Paul Agnew | Demolition Survey | External | Chrysotile + Crocidolite (3) |

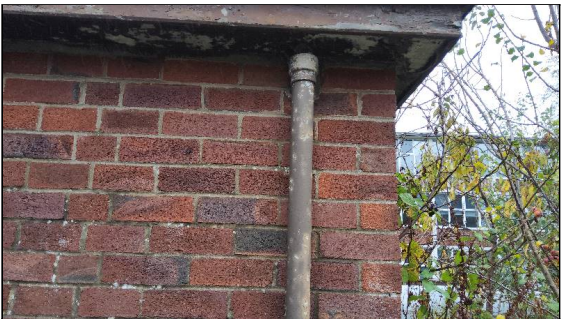
| | Survey Date: | Lead Surveyor | Survey Type | Floor | Analysis |
|---|---|---|---|---|---|
| | 28 Oct 2024 | Paul Agnew | Demolition Survey | External | Chrysotile (1) |

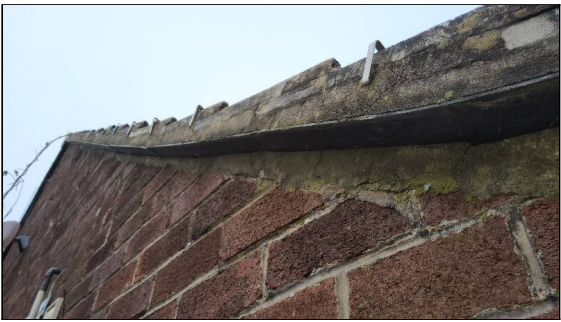
| 28 Oct 2024 | Paul Agnew | Demolition Survey | External | No Asbestos Detected |

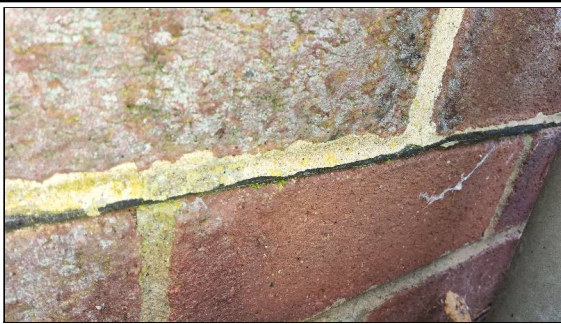
| | 28 Oct 2024 | | Paul Agnew | | Demolition Survey | | External | | No Asbestos Detected | |
